<http://www.lunspro.com>
inspections@lunspro.com
(770) 483-2808
5174 McGinnis Ferry Rd #136
Alpharetta, GA 30005
Inspector: Britt Baker
Inspector's email: britt.baker@lunspro.com
Inspector's phone: (678) 230-9011

Summary

Client(s): Dane Hinton
Property address: 3035 Roxburgh Dr
Roswell GA 30076
Inspection date: Saturday, August 15, 2020

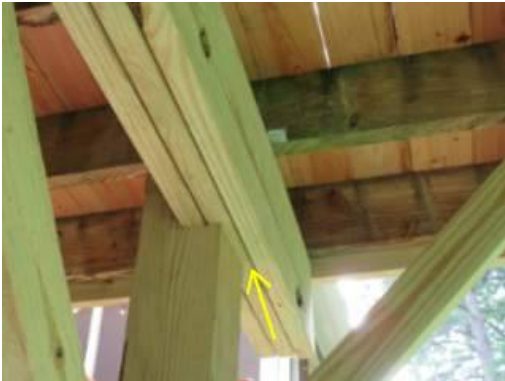
Photo 4-1

One or more wood support beams are properly supported by a support post. This is a safety issue. Recommend a qualified contractor evaluate and make the necessary repairs.

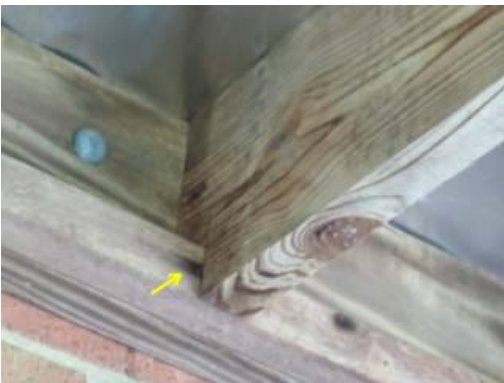
Photo 6-1

Joists for one or more decks, balconies or porches were fastened to ledger boards and/or perimeter joists with wood blocking and common nails rather than joist hangers and approved (Teco) nails. This was a common practice in the past but it is now considered unsafe due to the risk of such structures separating from the main building. It is a potential safety hazard. Modern standards call for a ledger board to be installed with 1/2 inch lag screws or bolts into solid backing, and brackets such as [Simpson Strong Tie DTT2 brackets and threaded rod](http://www.simpsonstrongtie.com/Products/Decking/Deck-Joist-Connectors.aspx), connecting interior and exterior joists. Joists should be fastened to ledger boards with correctly sized joist hangers. Recommend that a qualified contractor repair per standard building practices. For more information, visit: <http://www.reporthost.com/?LB>

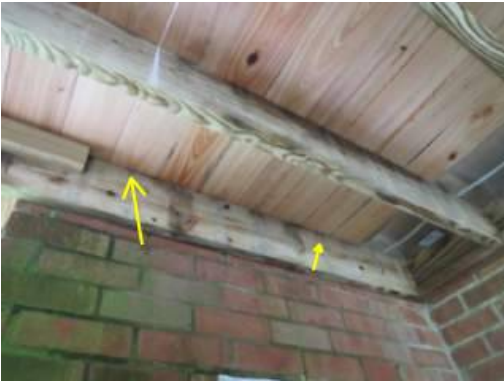
Photo 7-1

7) 🛠️💧 Flashing is missing from above one or more deck ledger boards. This can cause moisture to accumulate between the ledger board(s) and the structure. Rot may result in this area and cause the ledger board fasteners to fail. The deck may separate from the structure in this event and poses a significant safety hazard. A qualified contractor should install flashing above ledger board(s) where necessary. For more information on installing deck ledger boards visit: For more information, visit:

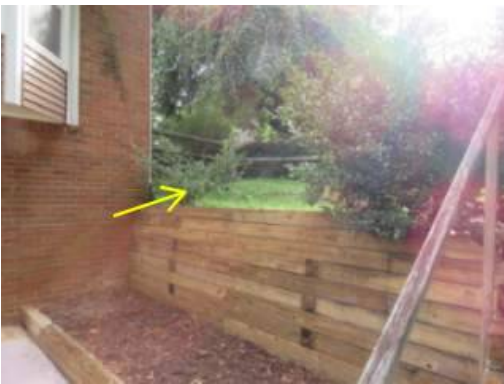
Photo 8-1

8) 🛠️ One or more retaining walls higher than three feet exist on this property and guardrails or barriers are missing or inadequate. This is a safety hazard due to the risk of falling. At a minimum, the client(s) should be aware of this hazard, especially when children are present. Ideally a qualified contractor should install adequate guardrails or make modifications to existing barriers as necessary above retaining walls higher than 3 feet to eliminate fall hazards. Dense shrubbery or vegetation may be acceptable as a barrier, but only when mature enough to be effective.

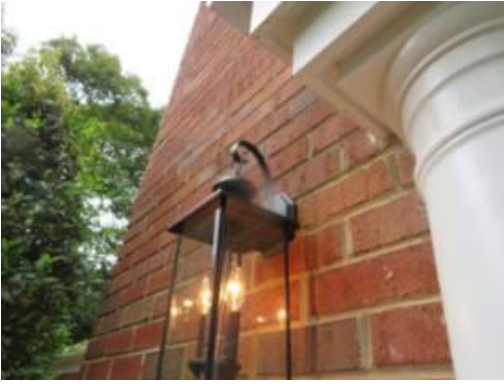
Photo 9-1

9) 🛠️🔌 One or more wall-mounted exterior light fixtures have wiring that's subject to water intrusion due to caulk not being installed around the light fixture's back plate. Caulk should be applied around the perimeter of back plates where missing. A gap should be left at the bottom for condensation to drain out.

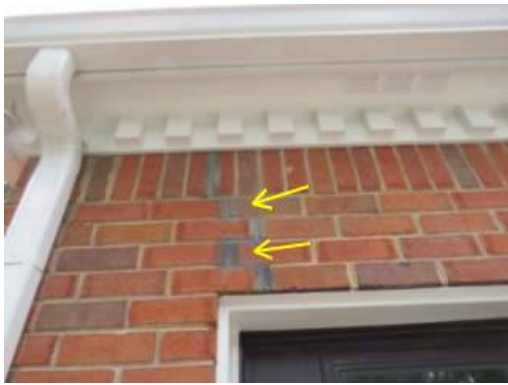
Photo 10-1

Major cracks or areas of deterioration were found in one or more sections of brick veneer. These are likely caused by significant movement of the foundation and/or walls. The client(s) are strongly advised to hire qualified contractors and/or engineers as necessary for further evaluation. Such contractors may include:

- Foundation repair contractors who may prescribe repairs, and will give cost estimates for prescribed repairs
- Masonry contractors who repair and/or replace brick veneer
- Geotechnical engineers who attempt to determine if settlement is ongoing, and what the cause of the settlement is
- Structural engineers who determine if repairs are necessary, and prescribe those repairs

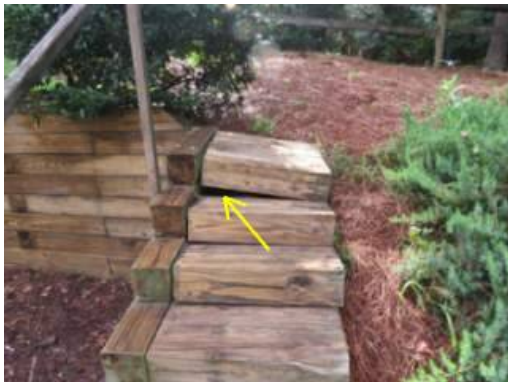
Photo 11-1

Wooden timbers in one or more sections of stairs are rotten or damaged. A qualified contractor should evaluate and repair or replace stairs as necessary.

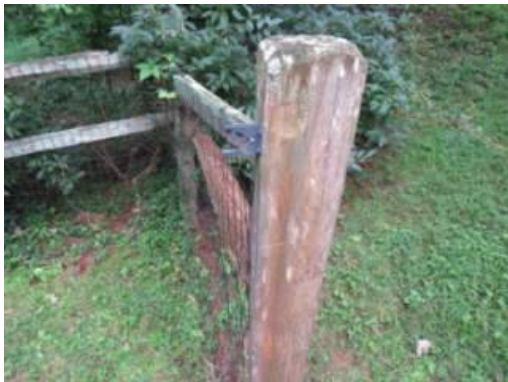
Photo 12-1

Fences and/or gates are damaged and/or deteriorated in some areas. A qualified contractor should evaluate and make repairs or replace sections as necessary.

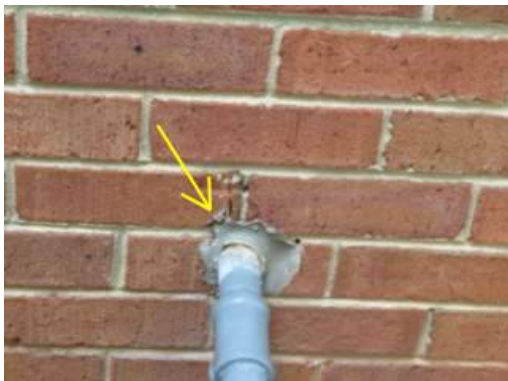
Photo 13-1

Gaps exist at one or more openings around the exterior, such as those where outside faucets, refrigerant lines, and/or gas supply pipes penetrate the exterior. Gaps should be sealed as necessary to prevent moisture intrusion and entry by vermin.

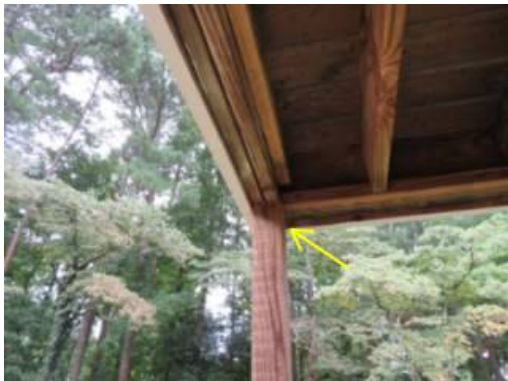
Photo 14-1

One or more deck or porch beams were not positively secured to the support posts below. Deck or porch beams are commonly connected to support posts by "toenailing," which is inadequate. Decks and porches are subject to movement under live loads and require a positive connection between their support posts and beams. Recommend that a qualified contractor repair per standard building practices. For example, by installing metal plates, plywood gussets or dimensional lumber to connect posts and beams.

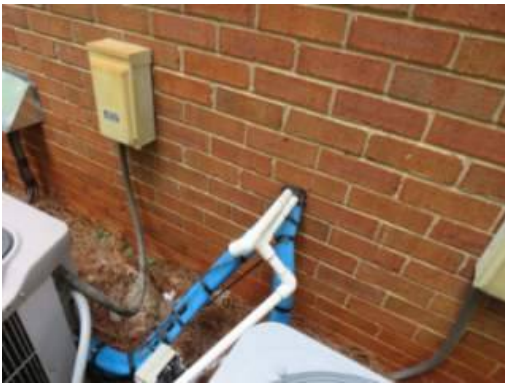
Photo 15-1

The HVAC condensation drainage lines are discharging too close to the foundation. This is a conducive condition for wood destroying organisms. Recommend that the drain pipes be extended so that condensation drains away from the foundation.

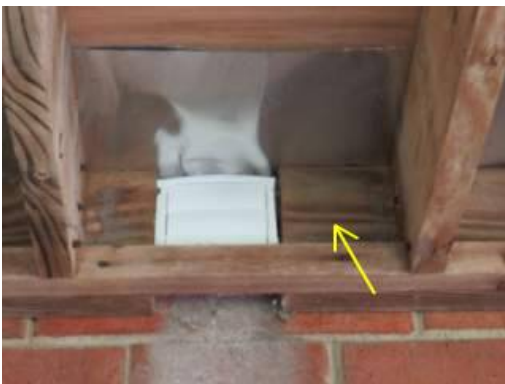
Photo 16-1

The clothes dryer exhaust duct appears to need cleaning. Significant amounts of lint build up was found. This is a safety hazard due to the risk of fire from decreased air flow. This duct should be cleaned now and annually, or more often if necessary in the future. Some chimney sweeps or heating/cooling duct cleaners perform this service.

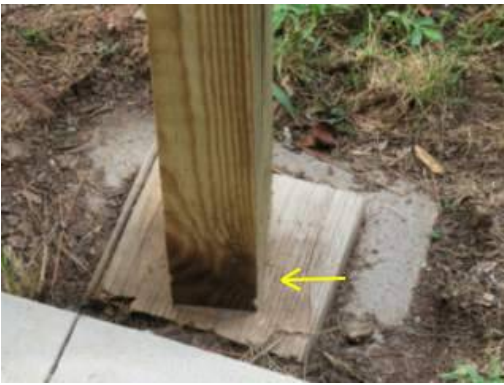
Photo 18-1

Wooden support posts for the deck or porch were resting directly on concrete piers or footings below. Water may wick up into the support post ends and result in elevated levels of moisture in the wooden support post ends. This is a conducive condition for wood-destroying organisms. Support posts should rest in metal brackets above concrete piers or footings, or should be separated from the concrete below by impervious membranes such as composition shingle scraps. Even if posts are made of treated wood the cut ends may not have been field-treated, leaving little or no preservative at the post center. Recommend that a qualified contractor repair per standard building practices. For example, by installing composition shingle scraps between the posts and the concrete below.

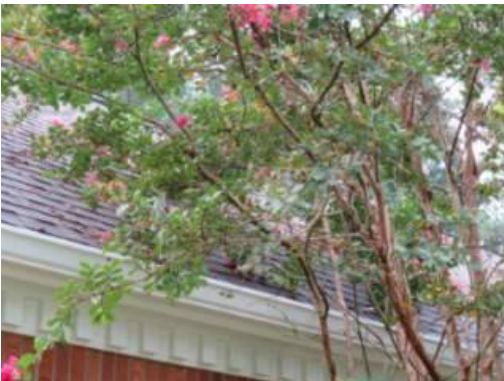
Photo 20-1

20) 🛠️💧 Trees and/or shrubs are in contact with or are close to the roof edge(s) in one or more areas. Damage to the roof may result, especially during high winds. Vegetation can also act as a conduit for wood destroying insects. Vegetation should be pruned back and/or removed as necessary to prevent damage and infestation by wood destroying insects.

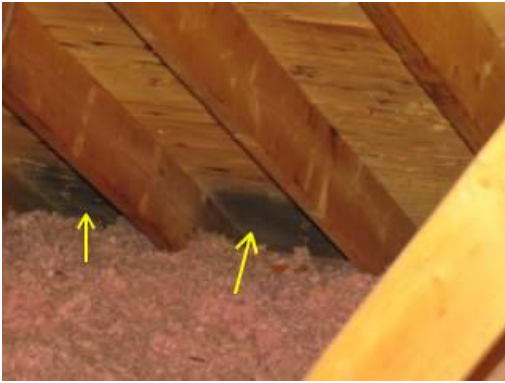
Photo 26-1

While inspecting the attic, the inspector noticed multiple areas of water intrusion and damage to some roof decking boards and rafters. A qualified roofing contractor should evaluate the entire roof and replace as necessary.

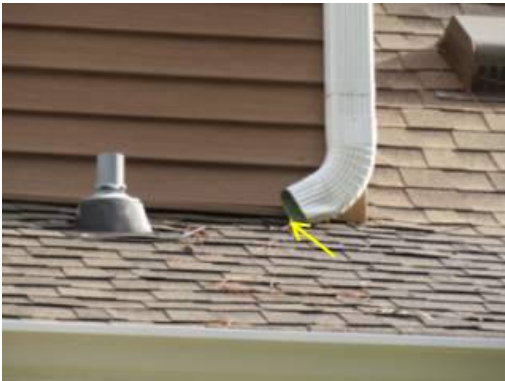
Photo 27-1

Downspouts that discharge onto the roof should be extended to discharge directly into the gutters below. This condition, if left unattended, can result in premature deterioration of the roofing under the end of the downspout.

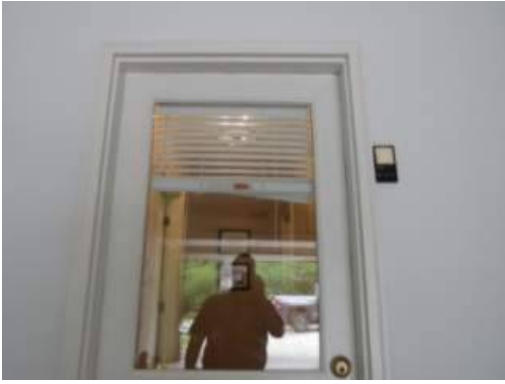
Photo 30-1

The garage-house door poses a fire risk because it's not fire-rated (metal or solid-core construction). A qualified contractor should replace this door with a fire-rated door.

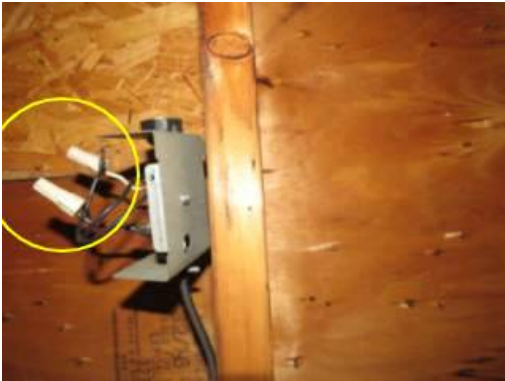
Photo 33-1

33) 🚧🔧🔌 Cover plate(s) are missing from one or more electric boxes, such as for receptacles, switches and/or junction boxes. They are intended to contain fire and prevent electric shock from exposed wires. This is a safety hazard due to the risk of fire and shock. Cover plates should be installed where missing.

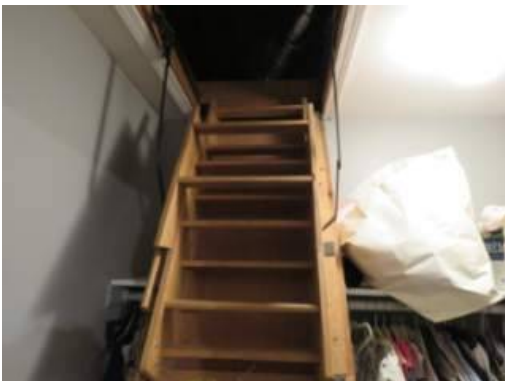
Photo 34-1

34) 🛠️ Pull-down stairs are installed for the attic access. No insulation is installed above the stairs and no weatherstripping is installed around the hatch perimeter. To reduce air leakage, recommend installing weatherstripping and an insulated hatch cover. An example of one can be seen at <http://www.batticdoor.com/>

Interior air leaking into the attic results in heating and cooling losses, increased energy costs, and a possible increase in moisture levels in the attic due condensation forming on the underside of the roof sheathing during cold weather.

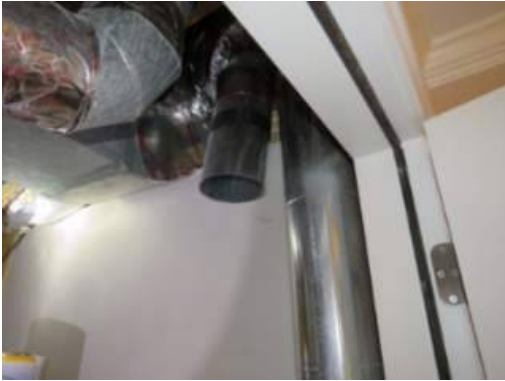
Photo 43-1

Based on the location of the water heater and the visible venting, the water heater may have an inadequate source of combustion and/or dilution air. All gas appliances require adequate air (approximately 50 cubic feet per 1000 BTU) for combustion, dilution and ventilation. This is a potential safety hazard, and may result in combustion fumes entering living spaces. A qualified contractor should evaluate and make repairs as necessary, such as installing exterior vents, or grills in walls or doors.

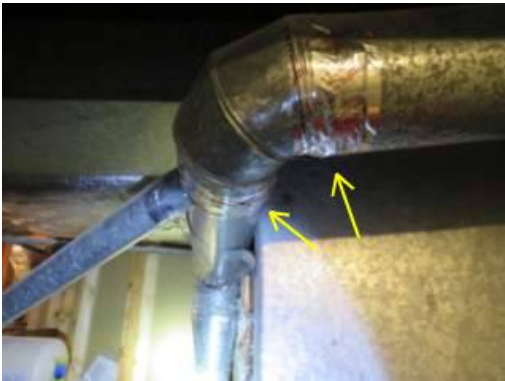
Photo 47-1

The furnace flue duct is taped in one or more areas. This is a safety concern. Carbon monoxide fumes could enter the living space. Recommend having a qualified contractor evaluate and make any necessary repairs.

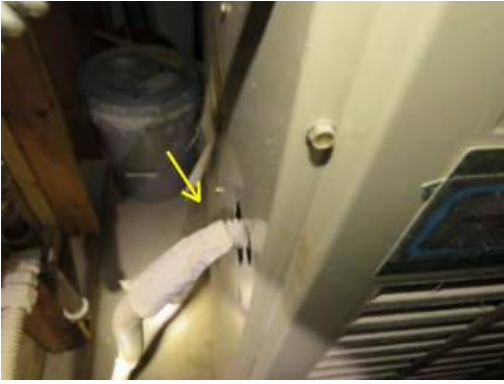
Photo 49-1

One or more flexible gas supply connectors are routed through a metal cabinet. Standard building practices require that solid iron pipe be used where gas supply lines are routed through holes in metal cabinets. Continued vibration from this equipment may cause the edge of the metal cabinet to wear through the flexible connector, resulting in gas leaks. This is a safety hazard. A qualified heating and cooling contractor should evaluate and make repairs and/or modifications as necessary.

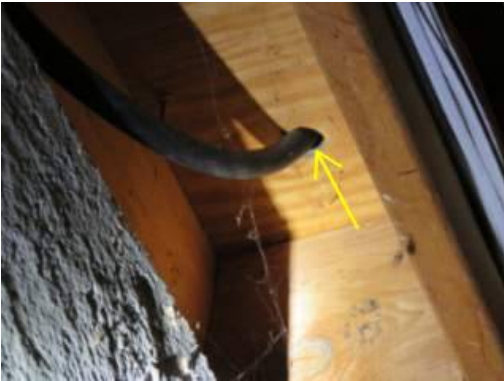
Photo 57-1

One or more flexible connectors used for gas supply lines passed through a floor. Flexible connectors passing through walls, floors, ceilings, shelving or cabinets can be damaged, and leaks can occur. This is a potential explosion and/or fire hazard. Recommend that a qualified contractor repair per standard building practices.

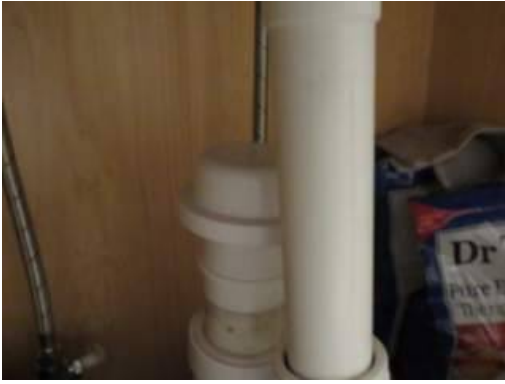
Photo 59-1

One or more sinks or fixtures used mechanical or auto vents. These are commonly installed in manufactured homes where it's difficult to install vents to the outside. However, most municipalities don't allow them for "stick-built" homes. The spring mechanisms in them can fail, resulting in sewer gases entering living spaces, and they have no screen to keep out vermin (mice). "Air admittance valves" (AAV) are recommended instead of these vents. AAVs have no spring to fail and have built-in screens. Recommend that a qualified plumber upgrade mechanical vents to AAVs. For more information, visit: <http://www.reporthost.com/?AUTOVENT>

Possible location master bathroom

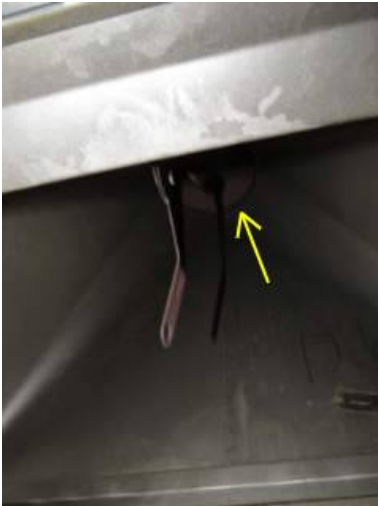
Photo 67-1

One or more fireplaces equipped with a gas burner has a damper that can be closed. This is a safety hazard due to the possibility of burner or pilot light exhaust gases entering living spaces. A qualified chimney service contractor should make repairs as necessary so the damper is made permanently open. Typically a bracket or bolt is installed for this purpose.

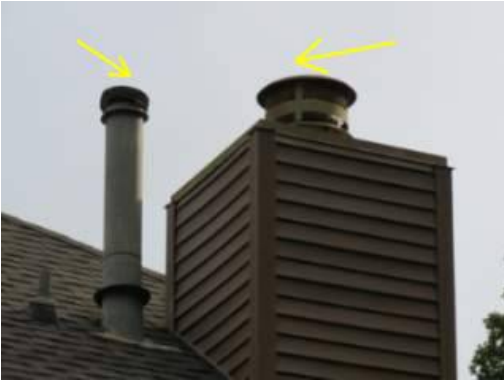
Photo 68-1

One or more solid fuel burning appliance chimneys terminate improperly above the roof surface and may result in drafting problems. Standard building practices require the following clearances for chimney terminations:

- At least 3 feet above the roof surface below
- At least 2 feet above all roof surfaces within 10 feet from the chimney
- At least 2 additional feet beyond the requirement in the second rule above if the roof ridge is more than 10 feet from the chimney

A qualified chimney service contractor should evaluate and make repairs or modifications as necessary.

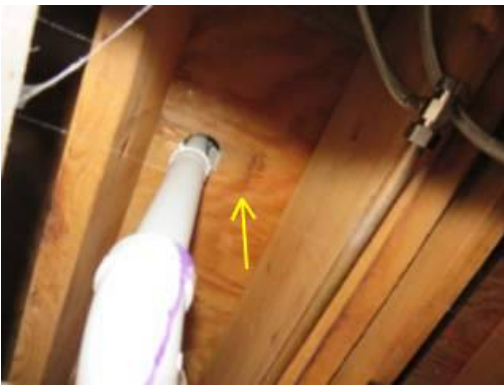
Photo 70-1

70) 🛠️🔍️ Stains were visible in the floor structure in one or more areas. These areas were dry at the time of the inspection. The stains may be caused by a past leak. Recommend asking the property owner(s) about past leaks. The client(s) should monitor these areas in the future to determine if active leaks exist. If leaks are found, a qualified contractor should evaluate and repair as necessary.

Possible location underneath the master tub.

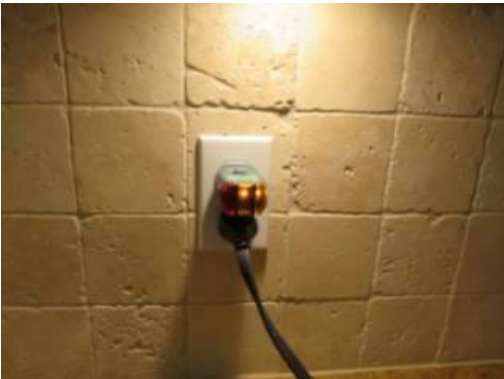
Photo 72-1

72) ⚡🔍️ One or more electric receptacles that serve countertop surfaces within six feet of a sink appear to have no ground fault circuit interrupter (GFCI) protection. This is a safety hazard due to the risk of shock. A qualified electrician should evaluate to determine if GFCI protection exists, and if not, repairs should be made so that all receptacles that serve countertop surfaces within six feet of sinks have GFCI protection. For example, install GFCI receptacles or circuit breaker(s) as needed.

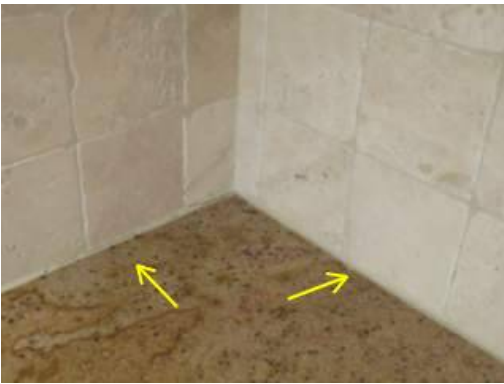
Photo 73-1

Caulk is missing and/or deteriorated where countertops meet backsplashes in wet areas, such as around sinks. Caulk should be replaced where deteriorated and/or applied where missing to prevent water damage.

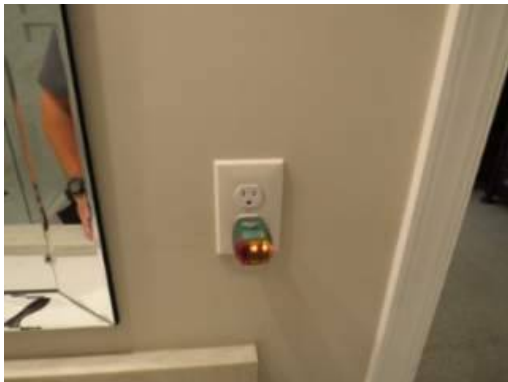
Photo 80-1

One or more ground fault circuit interrupter (GFCI) electric receptacles did not trip when tested with the inspector's test instrument. These devices should trip when tested with a test instrument in addition to tripping via the test buttons on the receptacles. This is a safety hazard due to the risk of shock. A qualified electrician should evaluate and repair as necessary.

Possible location right side of the master bathroom sinks

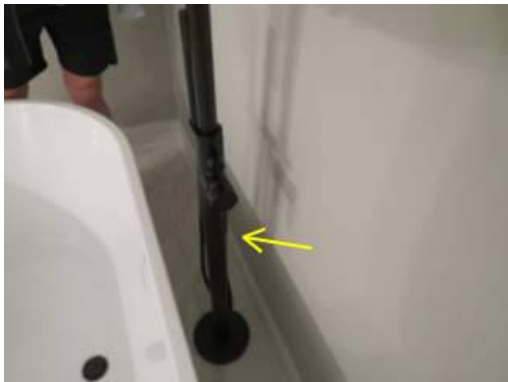
Photo 81-1

The tub faucet in the master bathroom is loose and moves when turning on and off the faucet. Recommend a qualified contractor evaluate and make the necessary repairs.

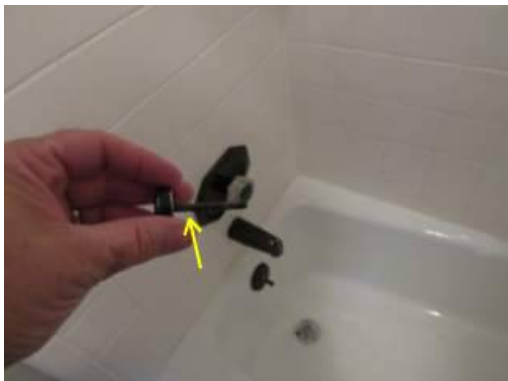
Photo 82-1

The shower diverter valve for one or more bathtub faucets is defective. A significant amount of water comes out of the bathtub spout when the shower is turned on. Water will be wasted as a result. A qualified plumber should evaluate and replace components or make repairs as necessary.

Possible location second floor jack and jill bathroom

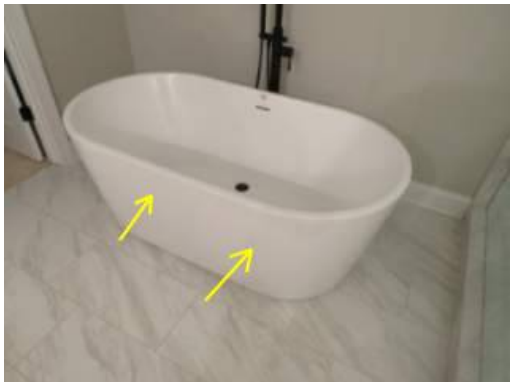
Photo 83-1

The bathtub in the master bathroom is loose. Recommend a qualified contractor make the necessary repairs.

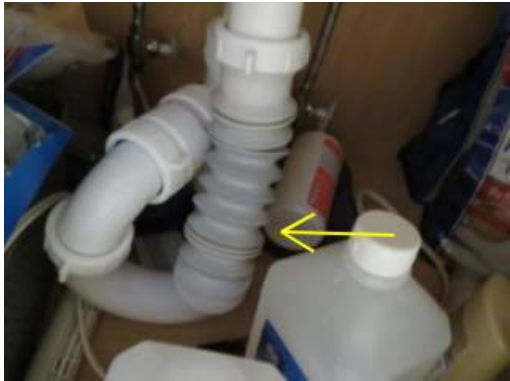
Photo 84-1

One or more sink drains use flexible drain pipe. This type of drain pipe is more likely to clog than smooth wall pipe. Recommend having a qualified plumber replace this pipe with standard plumbing components (smooth wall pipe) to prevent clogged drains.

Possible location master bathroom

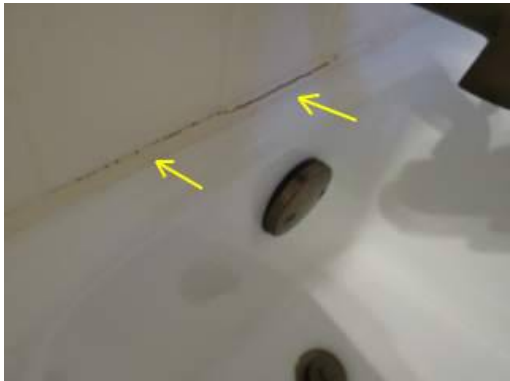
Photo 85-1

Caulk is missing or deteriorated above one or more bathtubs, where the tub surround meets the tub. It should be replaced where deteriorated and/or applied where missing to prevent water intrusion and damage to the wall structure.

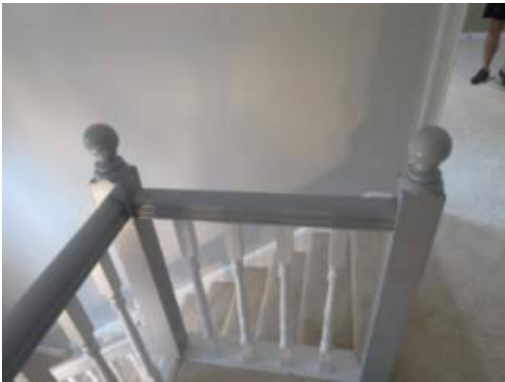
Photo 88-1

88) 🛠️ One or more guardrails are too low. This is a safety hazard due to the risk of falling. Standard building practices require that guardrails above drop-offs be 36 inches high. A qualified contractor should evaluate and modify or replace guardrails where necessary, and especially above drop-offs higher than 30 inches.

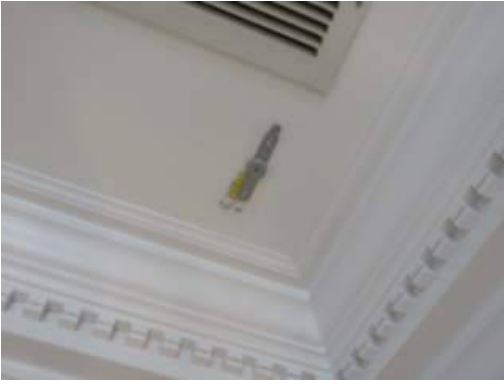
Photo 89-1

89) 🛠️ One or more smoke alarms are damaged, deteriorated and/or missing from their mounting brackets. Damaged and/or missing smoke alarms should be replaced as necessary so a functioning one exists in each hallway leading to bedrooms, and in each bedroom.

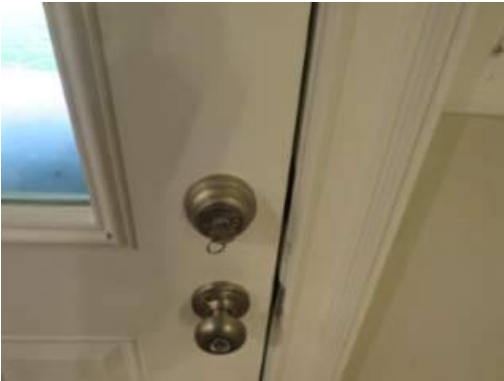
Photo 90-1

One or more entry doors have deadbolts installed with no handle, and require a key to open them from both sides. This can be a safety hazard in the event of a fire when the key is not available. The door cannot be used as an exit then, causing entrapment. Key-only deadbolts should be replaced with deadbolts that have a handle on the inside on entry doors in rooms with no other adequate egress nearby.

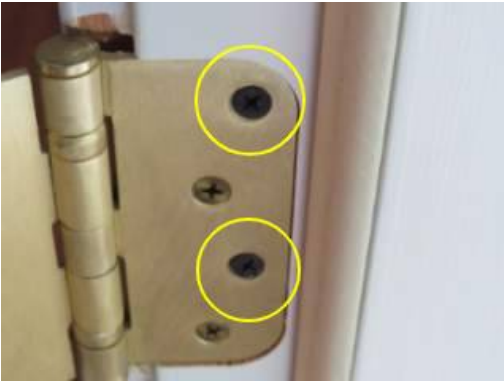
Photo 91-1

One or more exterior door hinges appear to have drywall screws in them. These type of screws are not made to support the weight of doors. Recommend a qualified contractor evaluate and make the necessary repairs.

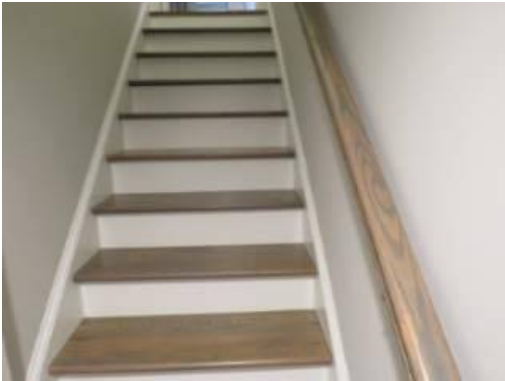
Photo 92-1

Squeaking or creaking noises occur when walking on one or more sections of flooring. This is usually caused by substandard construction practices where the subfloor decking is not adequately fastened to the framing below. For example, not enough glue was used and/or nails were used rather than screws. In most cases, this is only an annoyance rather than a structural problem. Various solutions such as [Squeeeeeek No More and Counter Snap fasteners](#) exist to correct this. Repairs to eliminate the squeaks or creaks may be more or less difficult depending on the floor covering, and the access to the underside of the subfloor. Recommend having a qualified contractor evaluate and repair as necessary.

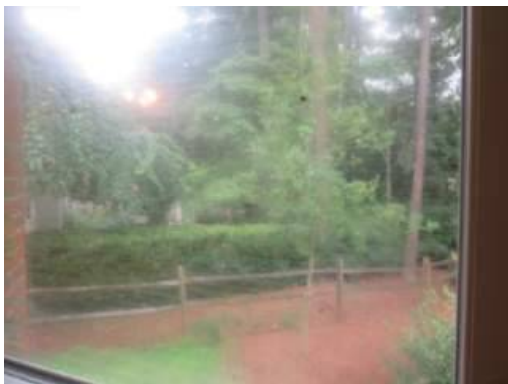
Photo 94-1

Seals between double-pane glass in one or more windows appear to have failed based on condensation or stains between the panes of glass. A qualified contractor should evaluate and replace glass where necessary.

The client(s) should be aware that evidence of broken seals may be more or less visible from one day to the next depending on the temperature, humidity, sunlight, etc. Windows or glass doors other than those that the inspector identified may also have failed seals and need glass replaced too.

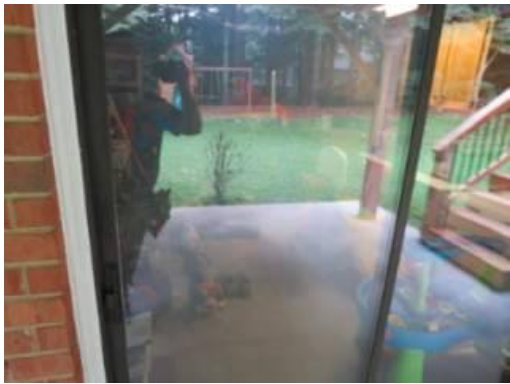
Photo 95-1

95) 🔧🔍 Seals between double-pane glass in one or more sliding glass doors appear to have failed based on condensation or stains between the panes of glass. A qualified contractor should evaluate and replace glass where necessary.

The client(s) should be aware that evidence of broken seals may be more or less visible from one day to the next depending on the temperature, humidity, sunlight, etc. Glass doors or windows other than those that the inspector identified may also have failed seals and need glass replaced too.

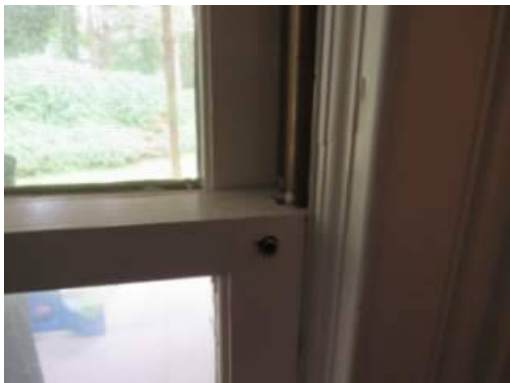
Photo 96-1

96) 🛠️ One or more windows that were built to open, will not open, or open only minimally due to their being painted shut, damaged and/or deteriorated in some way. Repairs should be made as necessary, and by a qualified contractor if necessary so windows open fully, and open and close easily.

Possible locations basement windows

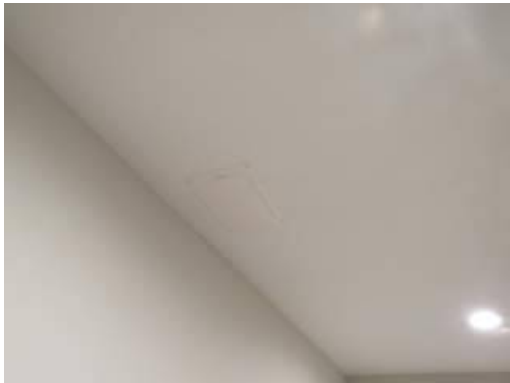
Photo 97-1

97) 🧑‍🔧 Minor cracks or nail pops were found in ceilings in one or more areas. They do not appear to be a structural concern, but the client(s) may wish to repair these for aesthetic reasons.
