# Home Inspection Report

**Property Address:**  
87 Woodpecker Way  
Big Canoe GA 30143

**Inspection Date:**  
8/8/2020

**Report: 20-Egan-87 Woodpecker Way**

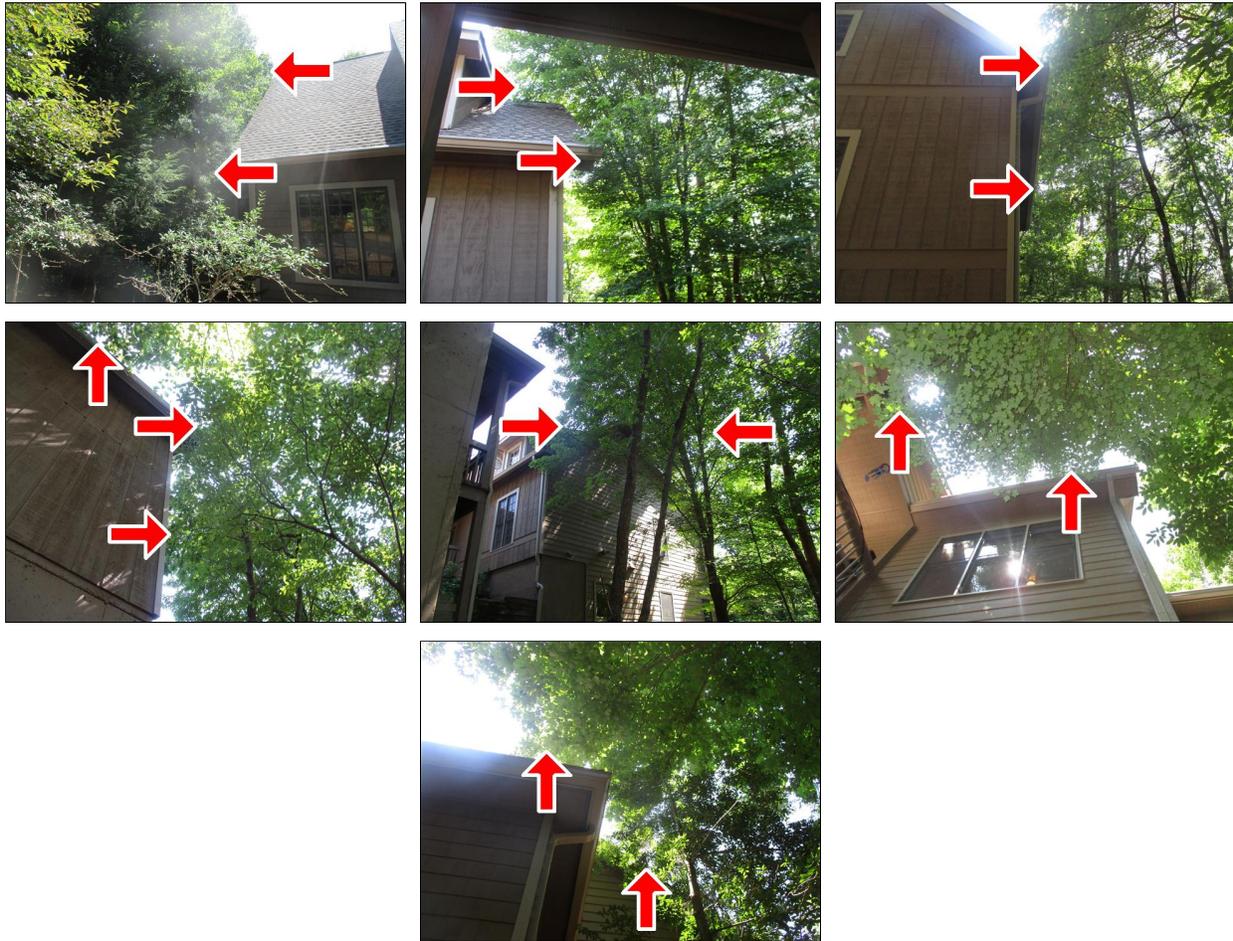
**Improve:** All overhanging limbs as noted at the house left, right, and rear and the garage right should be cut back to prevent further damage to the roofing shingles and gutters and to prevent rodent infestations into the attic.

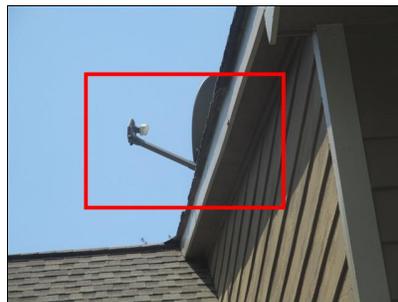
**Improve:** If the TV / "Dish" antenna as noted at the left dormer is no longer in service, it should be removed from the roof along with all related hardware and wiring. The roofing shingles at the mounting bracket will need repair or replacement to prevent future leakage.

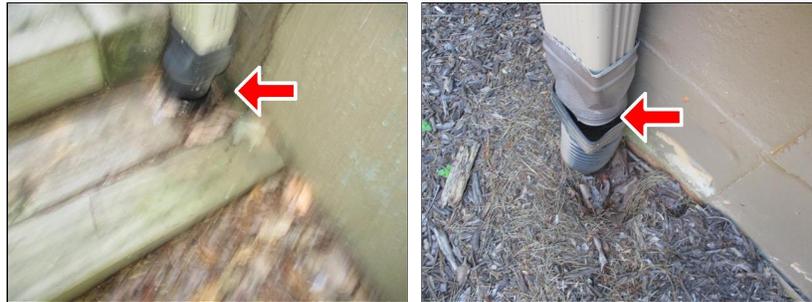
2. **Repair:** Downspout connections to underground piping need to be better secured and sealed as noted at both front house corners. The piping should be screwed to the downspout and sealed to prevent moisture leakage next to the foundation, a potential source of leaks into the basement. Make sure all piping is clear and free flowing. Ribbed (black corrugated) piping is more prone to become blocked with debris than smooth wall piping.

**Repair:** Downspout connections to underground piping need to be better secured and sealed as noted at both front house corners. The piping should be screwed to the downspout and sealed to prevent moisture leakage next to the foundation, a potential source of leaks into the

*basement. Make sure all piping is clear and free flowing. Ribbed (black corrugated) piping is more prone to become blocked with debris than smooth wall piping.*

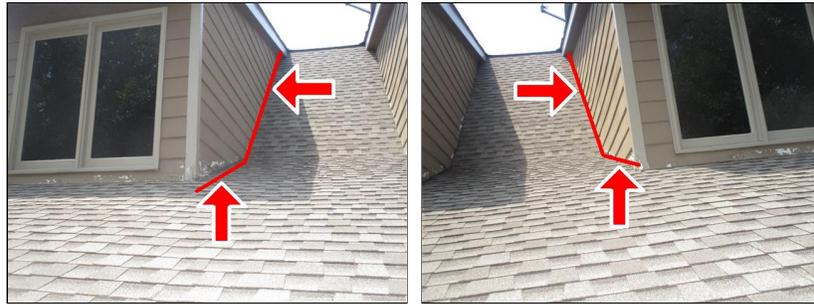
3. **Monitor, Future Repair:** *The clearance between the roofing and siding at the flashing is insufficient (1" minimum clearance required) as noted at the roof lines at the rear dormers. This condition leaves the siding vulnerable to rot. This detail is usually repaired when siding needs repair or replacement or when re-roofing work is performed. In the meantime, all wood components should be kept well painted and sealed to prevent future damage.*

**Monitor, Future Repair:** *The clearance between the roofing and siding at the flashing is insufficient (1" minimum clearance required) as noted at the roof lines at the rear dormers. This condition leaves the siding vulnerable to rot. This detail is usually repaired when siding needs repair or replacement or when re-roofing work is performed. In the meantime, all wood components should be kept well painted and sealed to prevent future damage.*

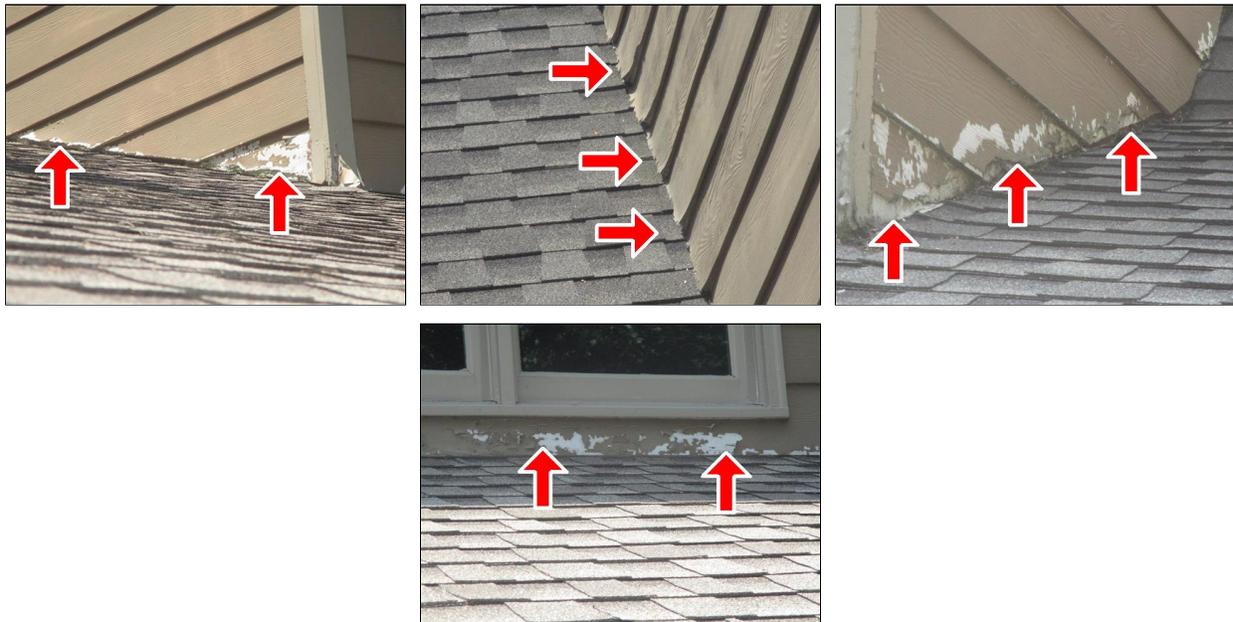
4. **Repair:** *The siding material is delaminating (coming apart) as noted at the roof lines at the rear dormers, which is due to inadequate clearance between the siding and the roof shingles (see preceding comment). Recommend that damaged siding be repaired or replaced as needed. Also, the paint is peeling on the siding and trim at the dormers and the areas should be repainted as needed for proper weather protection.*

**Repair:** The siding material is delaminating (coming apart) as noted at the roof lines at the rear dormers, which is due to inadequate clearance between the siding and the roof shingles (see preceding comment). Recommend that damaged siding be repaired or replaced as needed. Also, the paint is peeling on the siding and trim at the dormers and the areas should be repainted as needed for proper weather protection.

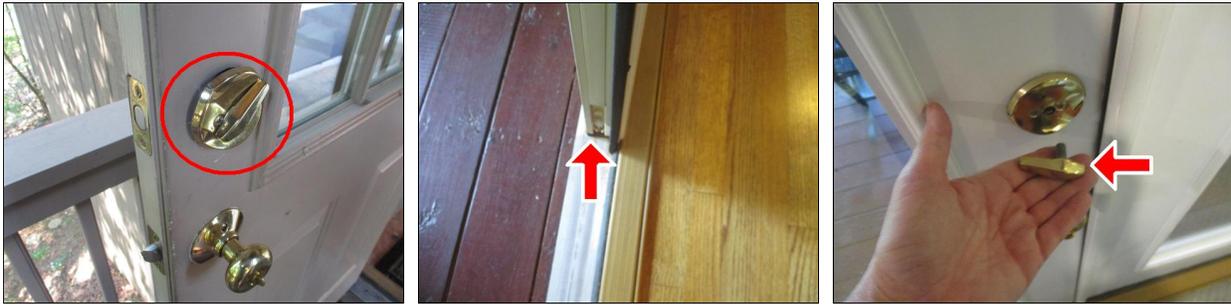
5. **Repair:** *Non-operative exterior door locks as noted with the deadbolts lock for the rear garage door and lower floor French door and the bottom latch for the family room French door should be repaired or replaced for proper locking of the doors.*

**Repair:** Non-operative exterior door locks as noted with the deadbolts lock for the rear garage door and lower floor French door and the bottom latch for the family room French door should be repaired or replaced for proper locking of the doors.

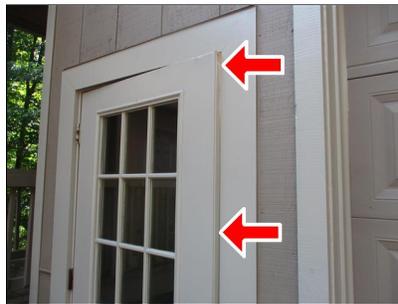
**Improve:** The left garage entry door binds in the door jamb and could use adjustment for improved ease of operation.

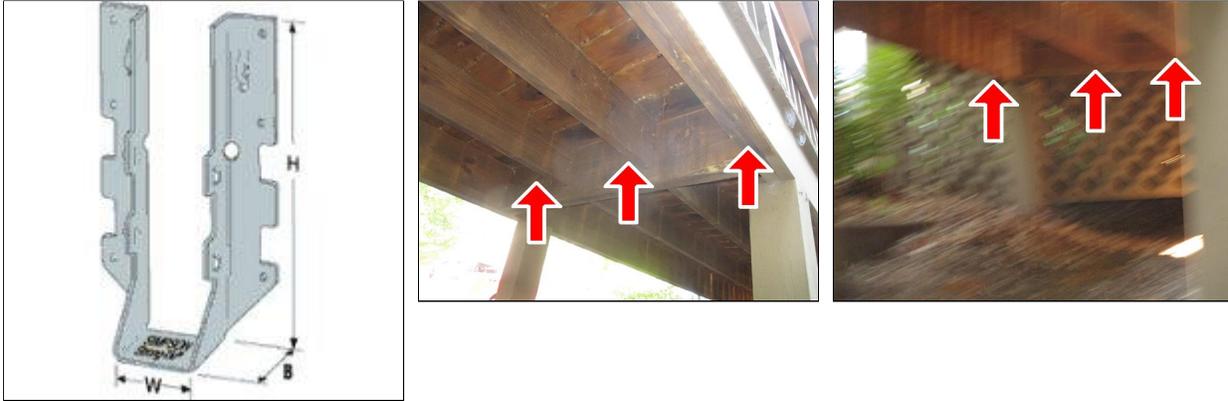
**Improve:** Some of the joists supporting the deck flooring for the breezeway to the garage are only attached with nails. Installing joist hangers at these locations would help to prevent future settlement of these structural components.

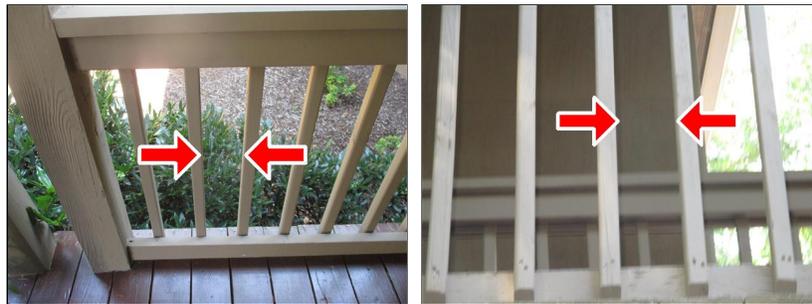
**Improve, Safety Issue:** The pickets for the porch, decks, and breezeway railings do not meet current safety standards for child protection (max. 4" between pickets allowed). Recommend covering these with mesh or a plastic shield if young children are present.

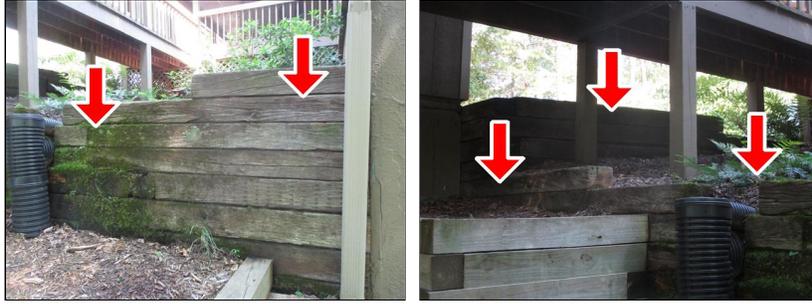
**Monitor:** Wood cross-tie retaining walls as noted at the front left and at the air conditioner units have a limited life (typically 15-20 years) and should be monitored closely for repairs and movement that may need attention in the future. Be sure to keep storm water from collecting above the wall, which can cause damage if left unattended. Recommend installing a storm drainage system that would remove water away from this area.

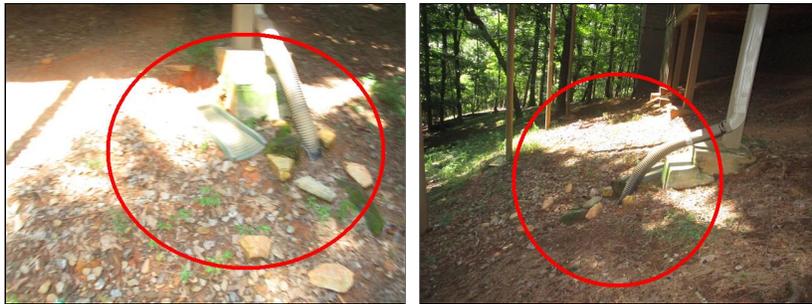
7. **Monitor, Possible Repair:** *Signs of soil erosion and wash were noted at the rear of the property. If this condition persists, drainage improvements or grade stabilization measures may be necessary to prevent further erosion of the ground and undermining of the footings for the deck support posts.*

**Monitor, Possible Repair:** Signs of soil erosion and wash were noted at the rear of the property. If this condition persists, drainage improvements or grade stabilization measures may be necessary to prevent further erosion of the ground and undermining of the footings for the deck support posts.

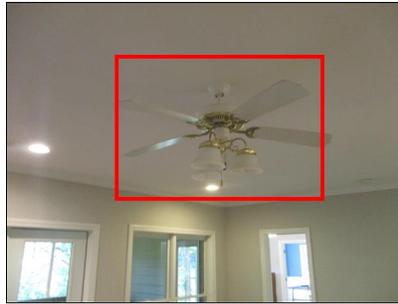
**Monitor, Possible Repair:** The ceiling fan in the basement den did not come on with the wall switch or pull-chain switch on the fan. Consult with the seller concerning all switch locations and/or remote control device that may be controlling the fan, as repair or replacement could be needed..

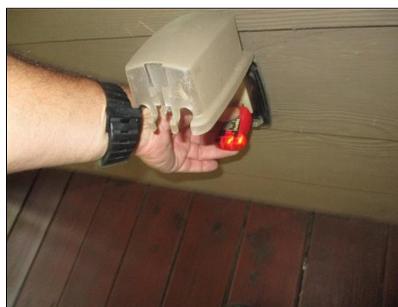
8. **Repair, Safety Issue:** *A ground fault circuit interrupter (GFCI) outlet as noted at the lower covered deck did not respond correctly to testing with an outlet tester. The receptacle and circuit should be investigated and repaired by a licensed electrician as needed for proper protection. The electrician should check all GFCI outlets for proper operation and locations and make repairs as needed.*

**Repair, Safety Issue:** A ground fault circuit interrupter (GFCI) outlet as noted at the lower covered deck did not respond correctly to testing with an outlet tester. The receptacle and circuit should be investigated and repaired by a licensed electrician as needed for proper protection. The electrician should check all GFCI outlets for proper operation and locations and make repairs as needed.

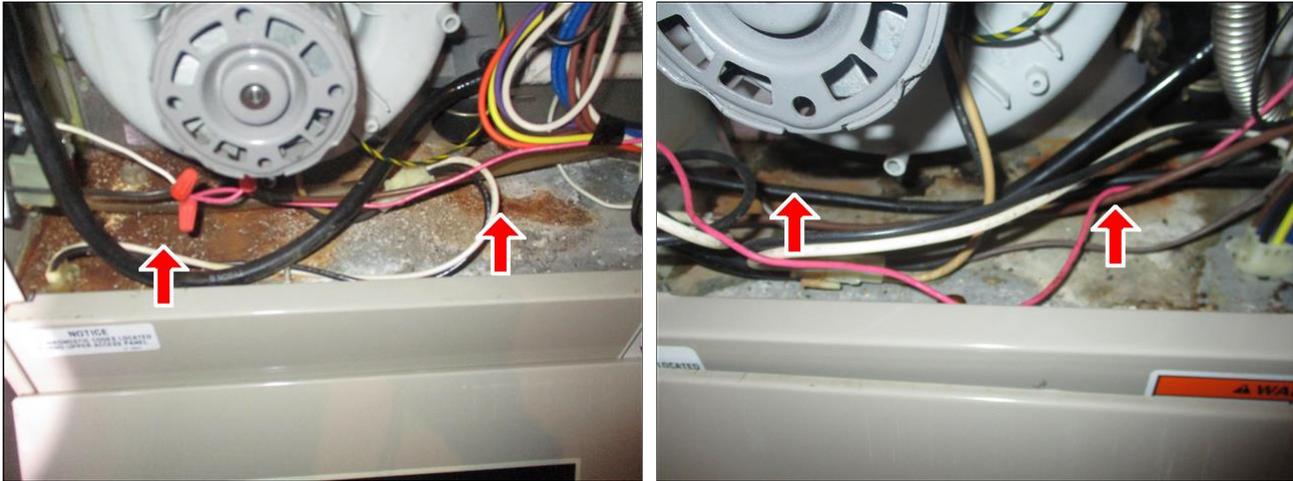
12. **Monitor, Possible Repair:** *Evidence of previous condensate leakage was noted in both high efficient condensing furnaces. This condition should be monitored and repaired if needed by a licensed heating and air conditioning service company to prevent further damage to the furnace and other surrounding components.*

**Monitor, Possible Repair:** Evidence of previous condensate leakage was noted in both high efficient condensing furnaces. This condition should be monitored and repaired if needed by a licensed heating and air conditioning service company to prevent further damage to the furnace and other surrounding components.

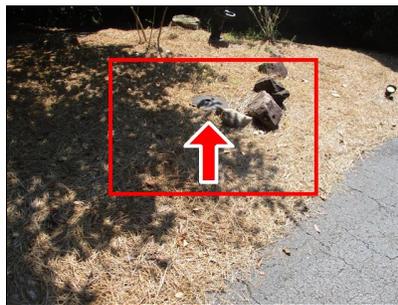
**Monitor:** It appears that the gas service for the furnaces and fireplaces is provided by propane as evidenced by a tank located in the front left yard. Because the inspection of this tank and related piping are outside the scope of this inspection, it is recommended that it be inspected by the HVAC technician during servicing or the propane company that is providing it's supply.

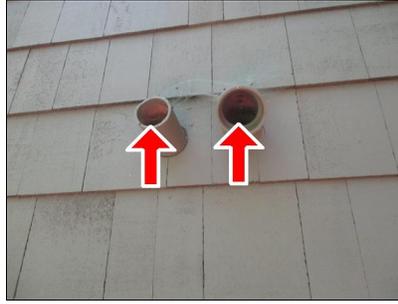
13. **Repair:** *The plastic vent terminations for the furnaces as noted at the left exterior wall should be screened to prevent rodent infestations and/or bird nesting inside the flues.*

**Repair:** The plastic vent terminations for the furnaces as noted at the left exterior wall should be screened to prevent rodent infestations and/or bird nesting inside the flues.

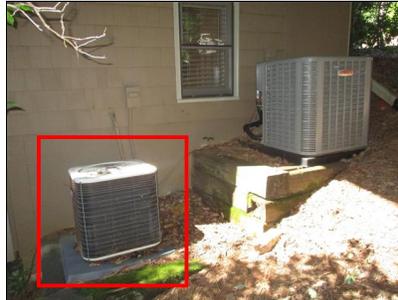
16. **Monitor, Future Repair:** *The outdoor condensing unit located at the rear (serving lower floor) appear to have been manufactured before 2010 and more than likely used an older R-22 refrigerant (typically known as "Freon"). This refrigerant is no longer allowed in equipment manufactured after 2010 due to environmental concerns and was replaced by R-410A refrigerant (typically known as "Puron"). By the year 2020, the older "Freon" will no longer be available as would be needed for servicing and recharging A/C equipment. You should therefore budget for the replacement of these components in the near future as needed to meet this requirement.*

refrigerant (typically known as "Puron"). By the year 2020, the older "Freon" will no longer be available as would be needed for servicing and recharging A/C equipment. You should therefore budget for the replacement of these components in the near future as needed to meet this requirement.

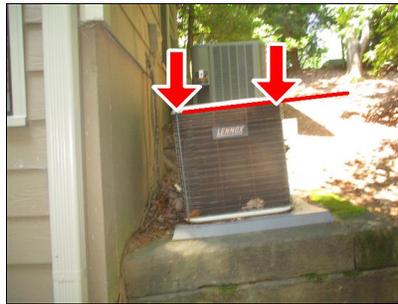
17. **Repair:** *The rear outdoor unit of the air conditioning system is out of level. This condition should be corrected to allow for proper operation of the fan motor and compressor.*

**Repair:** The rear outdoor unit of the air conditioning system is out of level. This condition should be corrected to allow for proper operation of the fan motor and compressor.

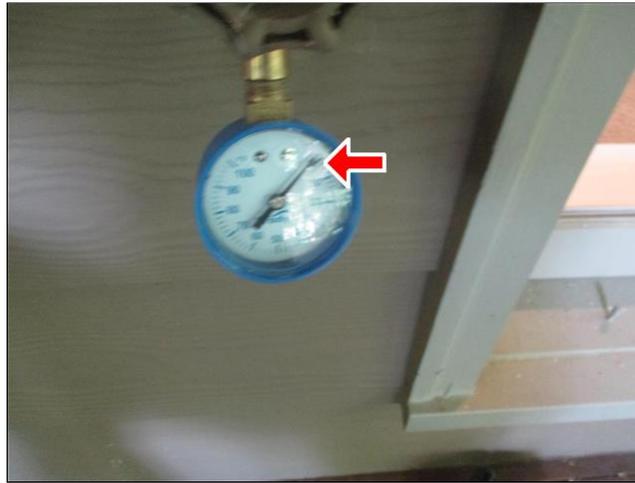
19. **Repair:** *The water pressure at the rear exterior hose faucet was over 100 psi, which is higher than normal (40-80 psi is typical). It may be necessary to adjust or otherwise replace the pressure regulator valve to prevent future leaks in piping, fittings or other equipment caused by higher than normal water pressure. Consult with a plumber concerning this condition and make repairs made as needed.*

*pressure regulator valve to prevent future leaks in piping, fittings or other equipment caused by higher than normal water pressure. Consult with a plumber concerning this condition and make repairs made as needed.*

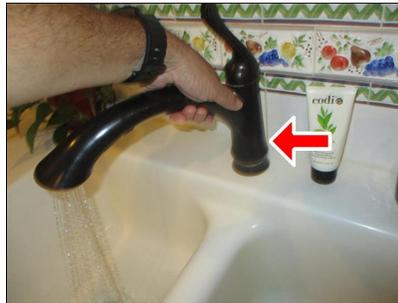
22. **Repair:** The kitchen faucet is stiff and difficult to operate (does not pivot from sink-to-sink) and needs repair and lubrication for proper operation. Replacing the fixture may be a preferred option.

**Repair:** *The kitchen faucet is stiff and difficult to operate (does not pivot from sink-to-sink) and needs repair and lubrication for proper operation. Replacing the fixture may be a preferred option.*

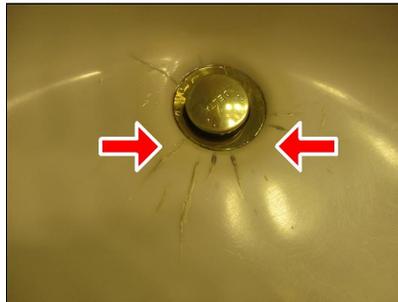
23. **Monitor, Possible Repair:** The left master bath sink appears to be cracked and may need repair. No signs of leaks were noted through the sink, however.

**Monitor, Possible Repair:** *The left master bath sink appears to be cracked and may need repair. No signs of leaks were noted through the sink, however.*

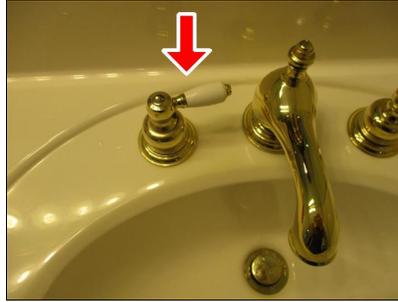
**Improve:** The left faucet handle at the right master bath sink is not oriented properly and use adjustment and re-positioning.

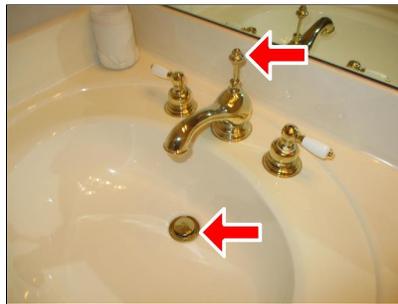
24. **Repair:** The sink stopper located in the main-floor Jack & Jill bathroom (left sink) did not function properly and needs adjustment for proper seating of the plug.

**Repair:** The sink stopper located in the main-floor Jack & Jill bathroom (left sink) did not function properly and needs adjustment for proper seating of the plug.

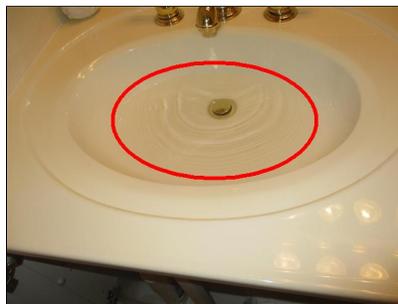
25. **Repair:** The left sink in the Jack & Jill bath was draining slowly indicating that an obstruction may exist or the sink stopper needs adjustment. Have the stopper adjusted and then check the P-trap and drain line for blockages and clear as needed.

**Repair:** The left sink in the Jack & Jill bath was draining slowly indicating that an obstruction may exist or the sink stopper needs adjustment. Have the stopper adjusted and then check the P-trap and drain line for blockages and clear as needed.

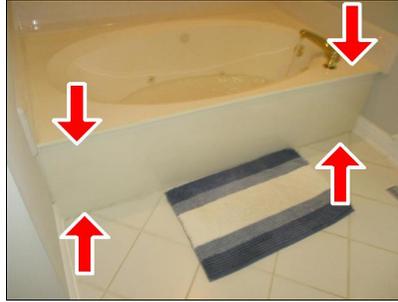
26. **Monitor, Possible Repair:** Access to the whirlpool motor should be provided (or its whereabouts should be verified with the current owner).

**Monitor, Possible Repair:** Access to the whirlpool motor should be provided (or its whereabouts should be verified with the current owner).

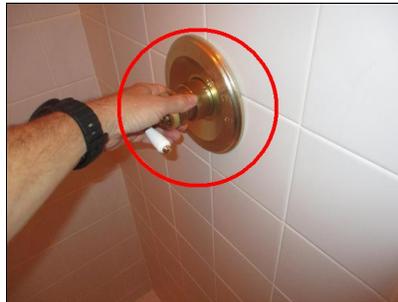
27. **Repair:** The shower faucet valve is loose in the wall as noted at the main-floor Jack & Jill bath. This condition may cause future leaks in the piping. The valve should be properly secured and the escutcheon plates caulked and sealed to prevent moisture intrusion behind the tile.

**Repair:** The shower faucet valve is loose in the wall as noted at the main-floor Jack & Jill bath. This condition may cause future leaks in the piping. The valve should be properly secured and the escutcheon plates caulked and sealed to prevent moisture intrusion behind the tile.

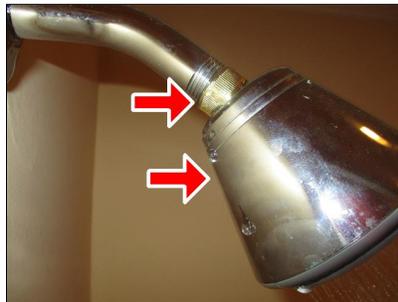
**Improve:** The shower head located in the lower-floor Jack & Jill bath is leaky and could use replacement of the washers or shower head itself.

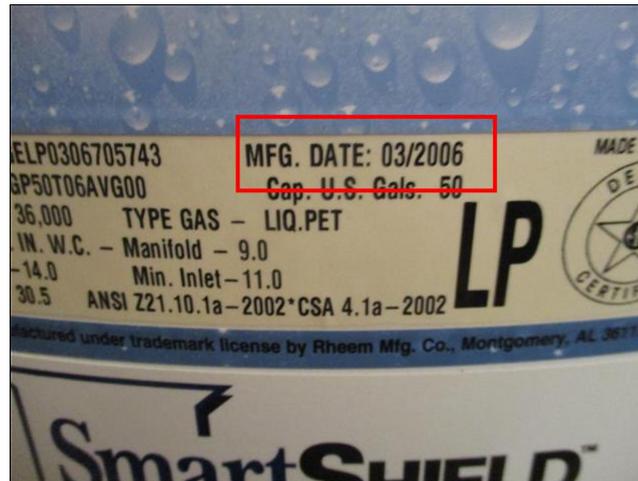
28. **Monitor, Future Repair:** The water heater is an older unit (14 years) that has lasted beyond its typical life span (9-12 years). It would be wise to replace this unit in the near future. One cannot predict with certainty when replacement will become necessary.

**Monitor, Future Repair:** The water heater is an older unit (14 years) that has lasted beyond its typical life span (9-12 years). It would be wise to replace this unit in the near future. One cannot predict with certainty when replacement will become necessary.

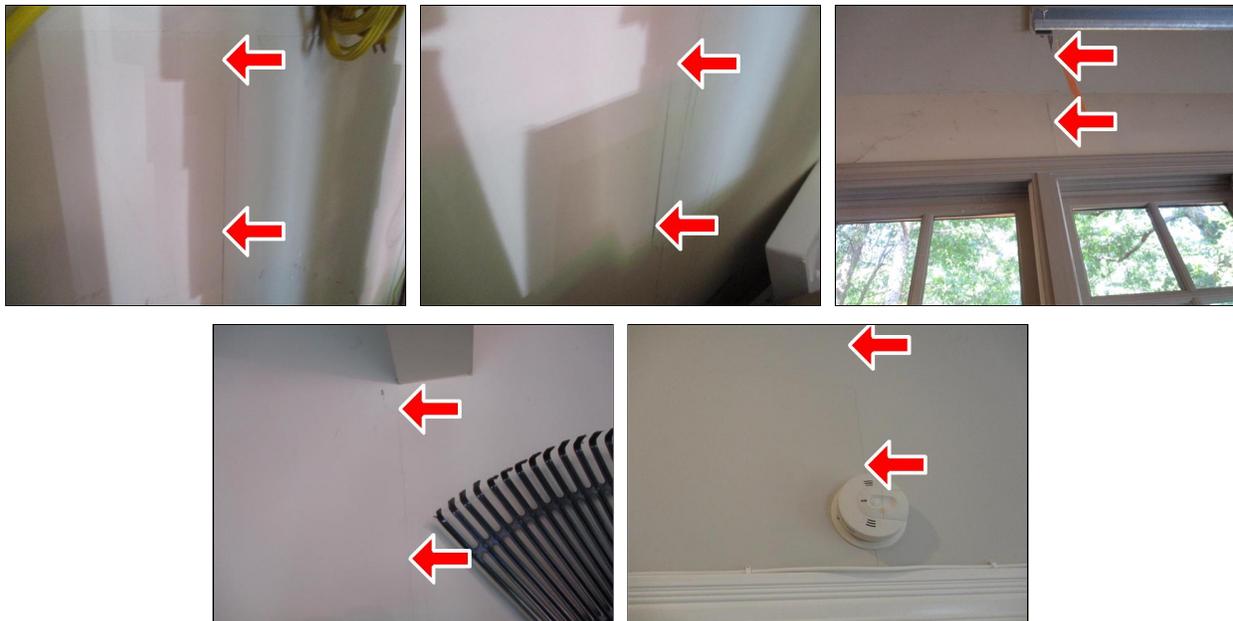
**Improve, Monitor:** Fairly typical cracks in the walls as noted in the garage (front and right walls) and master bedroom (above entry doorway) should be patched and monitored for further movement.

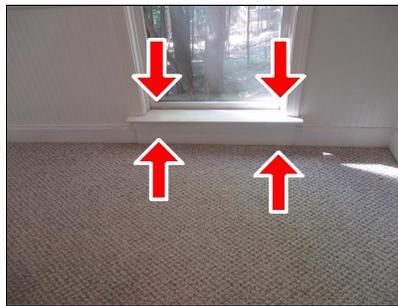
**Improve, Safety Issue:** It could not be confirmed that the window glass is safety rated (no etchings visible that would indicate tempered glass) as would be required by present day safety standards due to their close proximity to the floor. Extra protection should be provided for these areas or the glass replaced to protect occupants from injury in case of accidental breakage.

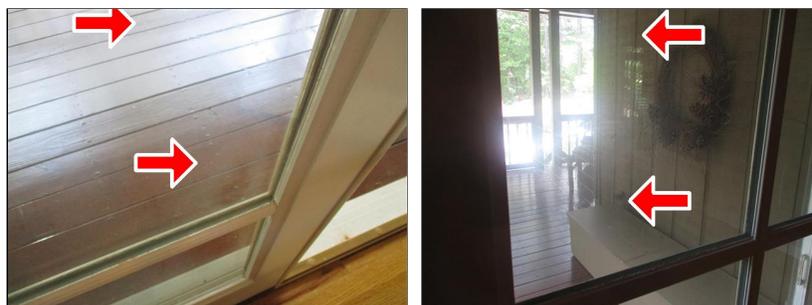
29. **Repair:** "Fogged" glass was noted with the double-pane exterior doors at the dining room and kitchen. This condition is typically caused by damaged seals around the perimeter of the insulated glass, which in turn allows condensation to develop between the panes. All damaged glass panels in this area should be replaced by a qualified glass replacement contractor to prevent further moisture damage to wood components and for proper visibility through the glass. The contractor should inspect all other insulated panels in the house for

**Repair:** "Fogged" glass was noted with the double-pane exterior doors at the dining room and kitchen. This condition is typically caused by damaged seals around the perimeter of the insulated glass, which in turn allows condensation to develop between the panes. All damaged glass panels in this area should be replaced by a qualified glass replacement contractor to prevent further moisture damage to wood components and for proper visibility through the glass. The contractor should inspect all other insulated panels in the house for additional condensation that may be occurring in the glass. Other windows/doors may be fogged but cannot be positively determined until the glass is cleaned.

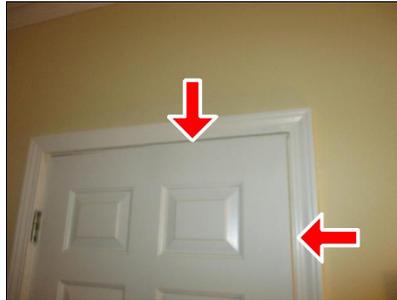
**Improve:** The front door at the lower-floor Jack & Jill bath binds in the door jamb. The door should be trimmed or the hardware adjusted as necessary to latch and close properly.

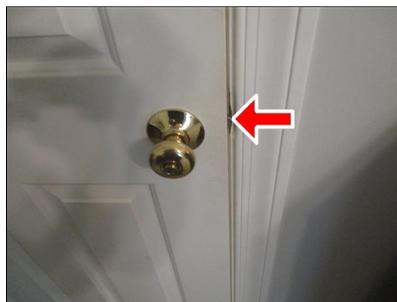
**Improve:** The left basement office door did not latch properly. Adjustment of the strike plate and hardware is recommended for proper latching of the door.

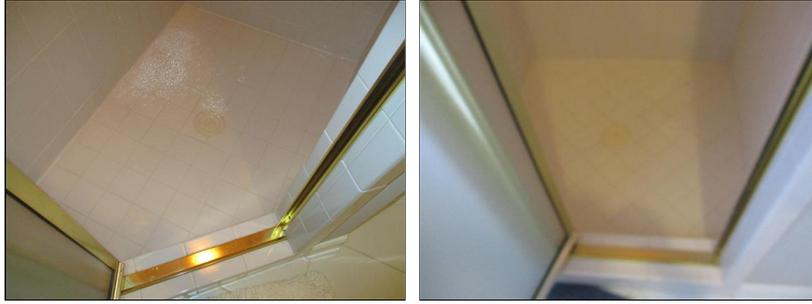
**Monitor:** The shower stalls located in the master and Jack & Jill bathrooms were tested with a standing water test (drain line plugged and the stall filled with water to a depth of 1" - 2") to determine if leaks might be present in the shower pans. While no evidence of leakage was noted at the time of the inspection, this does not preclude that leakage will be experienced in the future. Leakage that may be occurring may not be evident until the day after the inspection. The ceilings/floor system below the showers should be monitored for future leakage and the pan repaired or replaced as needed.

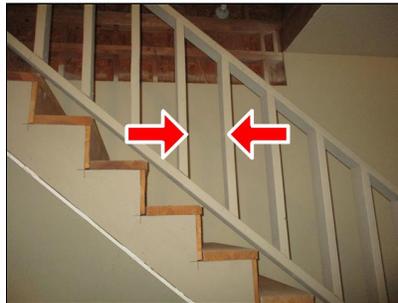
**Improve, Safety Issue:** The pickets for the railings at the garage interior stairs do not meet current safety standards for child protection (max. 4" between pickets allowed). Recommend covering these with mesh or a plastic shield if young children are present.

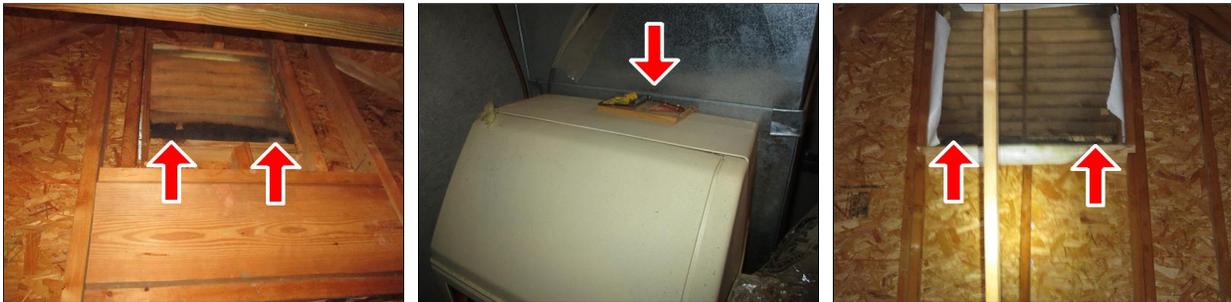
30. **Monitor, Possible Repair, Safety Issue:** *No evidence of active rodent infestation was visible in the home at the time of the inspection; however, a rodent trap was noted in the basement furnace room. Also, apparent bat droppings were noted on the exterior of the gable vents in the house and garage attics. It should be understood that it is impossible to predict if this will become a problem in the future. All outside openings into the structure should be kept covered with screen wire or otherwise sealed. If infestations occur, a pest control specialist should be consulted to eliminate future activity. Consult with the seller concerning remedies taken to address past activity, if any. Rodents can damage electrical wiring and other building components and can create unhealthy conditions within the home.*

**Monitor, Possible Repair, Safety Issue:** *No evidence of active rodent infestation was visible in the home at the time of the inspection; however, a rodent trap was noted in the basement furnace room. Also, apparent bat droppings were noted on the exterior of the gable vents in the house and garage attics. It should be understood that it is impossible to predict if this will become a problem in the future. All outside openings into the structure should be kept covered with screen wire or otherwise sealed. If infestations occur, a pest control specialist should be consulted to eliminate future activity. Consult with the seller concerning remedies taken to address past activity, if any. Rodents can damage electrical wiring and other building components and can create unhealthy conditions within the home.*

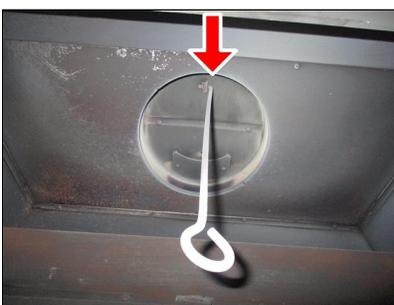
**Improve, Safety Issue:** There was no safety clip installed at the metal damper above the gas logs in the main floor fireplace, which could allow the damper to be closed during the operation of the gas logs. Consider installing this safety device or otherwise insure that the damper is left open when the gas logs are turned on. Also recommend installing a carbon monoxide alarm near the fireplace.
