Inspection Report for Lindsey and George Evagoras

Property Address: 135 Ludwell Court, Alpharetta, GA

Atlanta Elite Home Inspection

9/8/2020

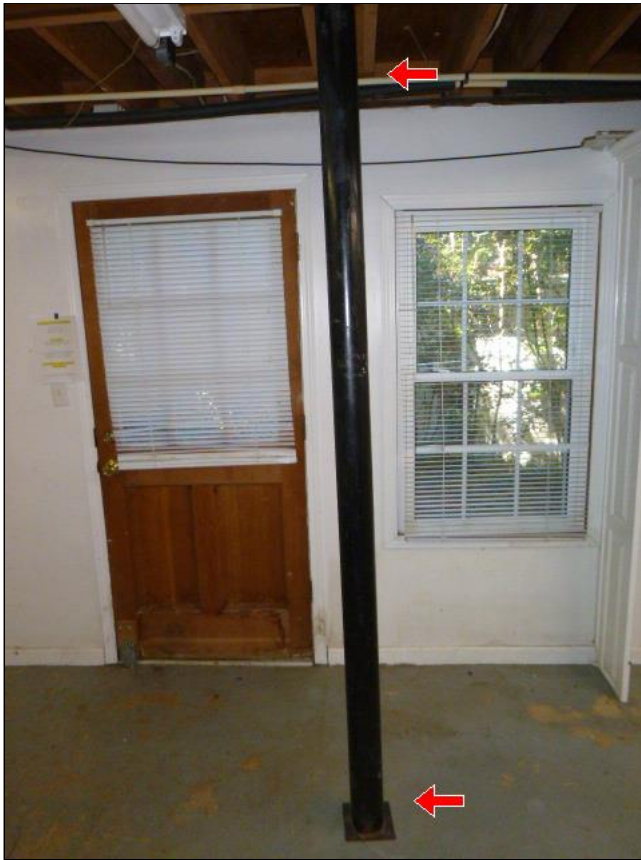
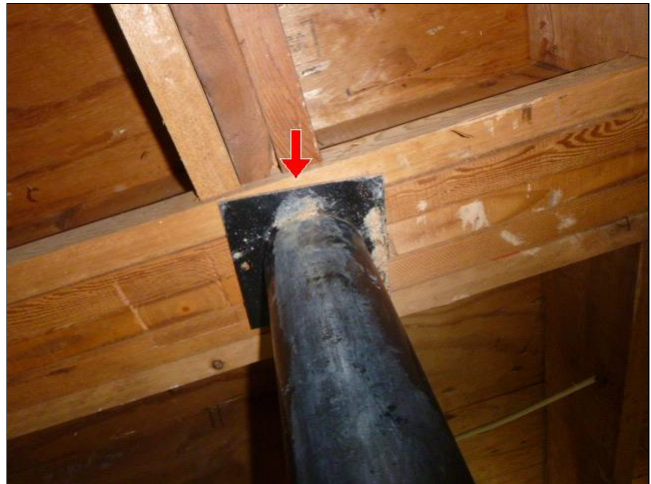
Repair: Columns should be bolted to the concrete floor and to the beam they are supporting to limit damage and possible collapse of the structure. The column at the left basement has shifted and should be adjusted and secured.

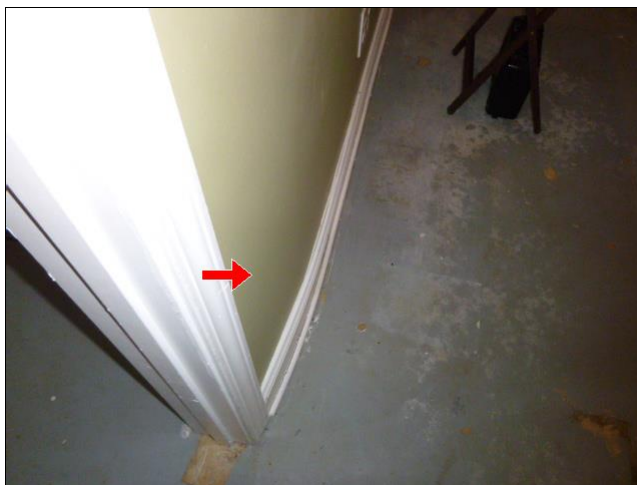
Monitor: A bowed wall was noted at the right basement, which could be caused by wall settlement, warping studs, or a pipe or duct in the wall. This area should be monitored for future movement and repaired as necessary.

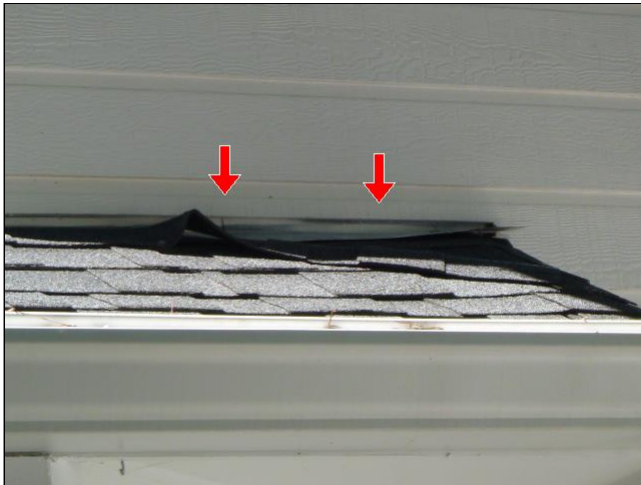
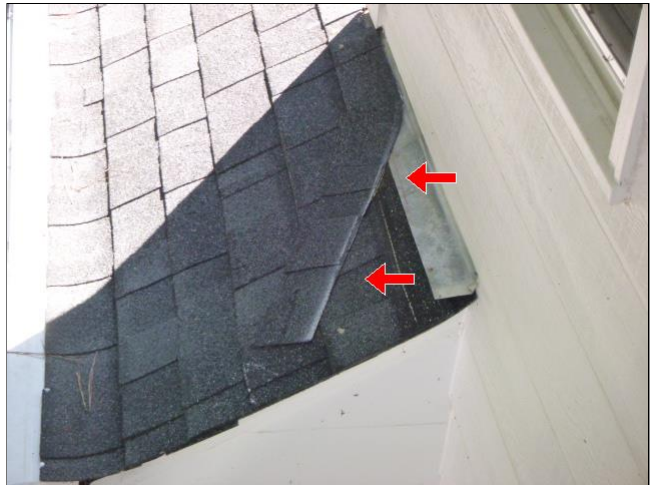
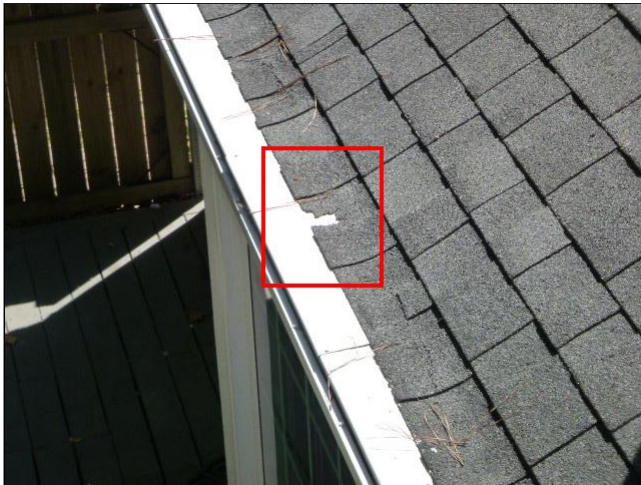
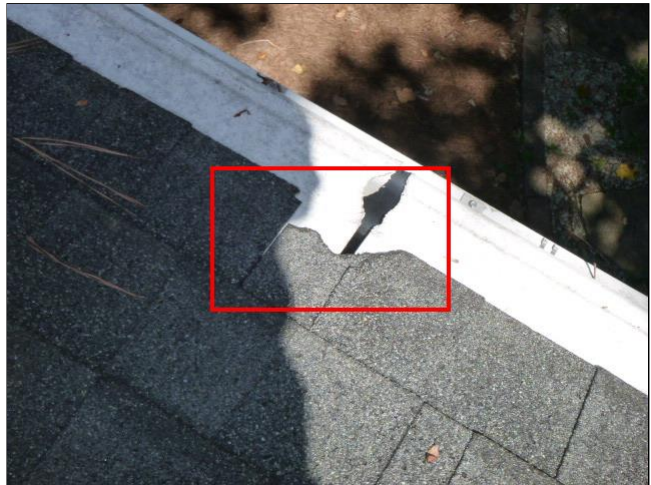
***Repair:** General repairs to the roofing are needed, which should be performed by a qualified roofing contractor. Damaged, loose or missing roofing shingles at the rear should be replaced. All "eyebrows" (shingles that are lifted up by protruding nail heads) should be repaired by lifting the shingles and re-driving the nails in the decking. All holes and exposed nail heads should be caulked and sealed. All roof penetrations should also be examined and sealed as necessary.*

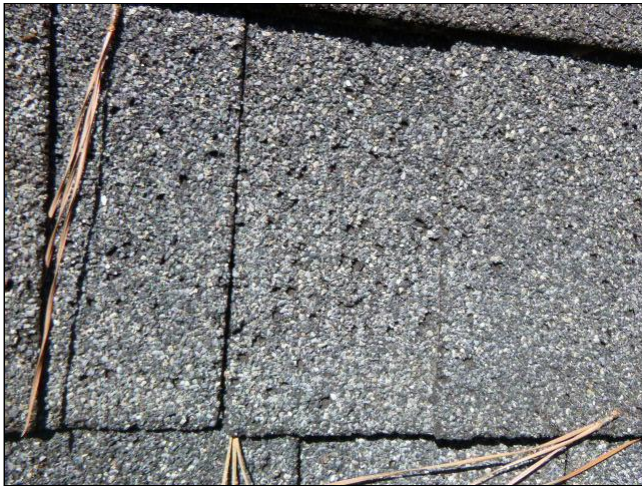
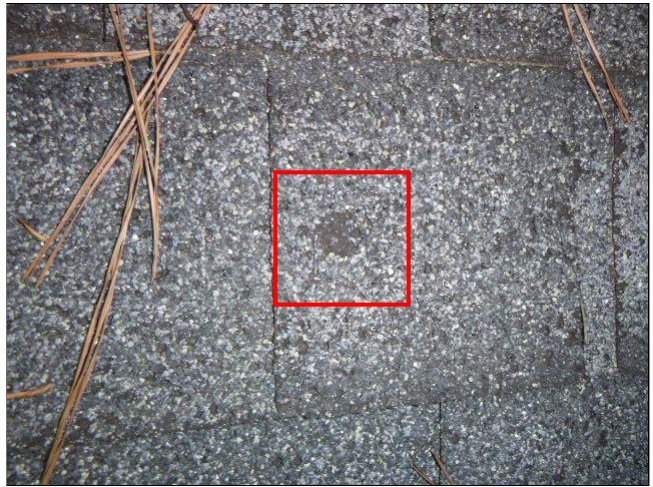
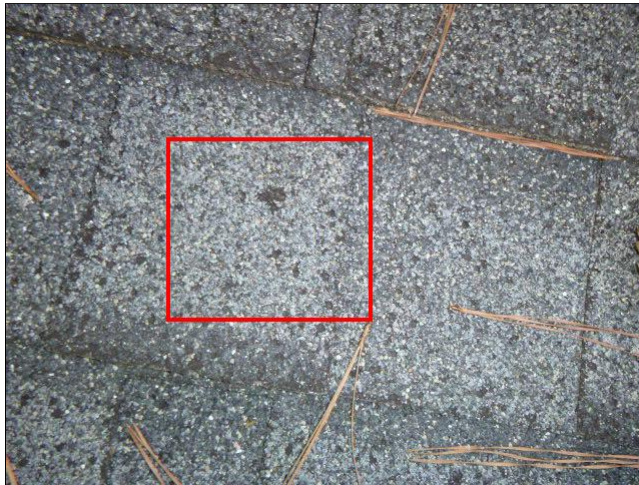
Monitor: Possible Concern: The roofing shingles appear to have experienced hail damage as indicated by "pot" marks on the shingles. A qualified roofing contractor or the seller's insurance company should inspect the roofing to determine if replacement will be necessary. Hail damage greatly inhibits the normal life expectancy of the roofing shingles.

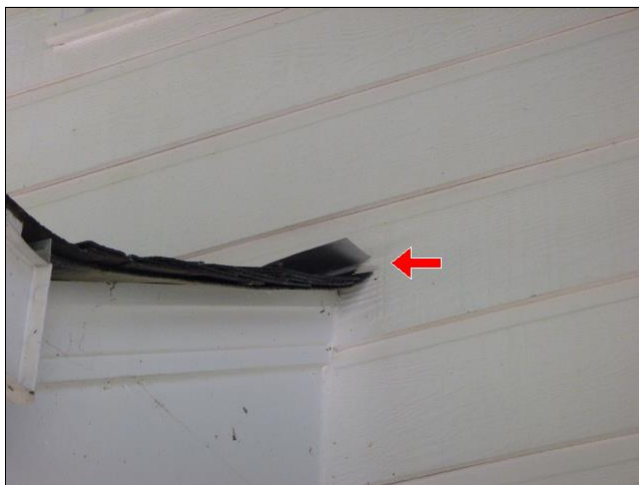
Repair: A loose and open flashing component was noted at the rear, which should be re-nailed and sealed by a qualified roofing contractor to prevent leakage. All roofing shingles and flashing components should be examined and sealed as necessary. All exposed nail heads should be caulked.

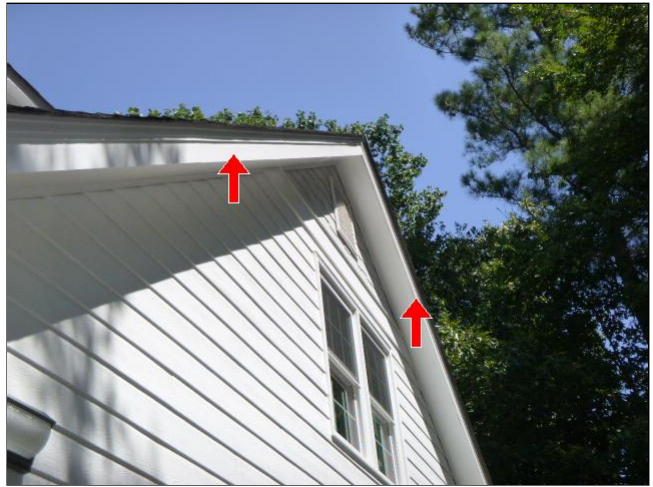
Improve: A drip edge flashing should be installed around the perimeter of the roof to ensure that water drains from the roof directly into the gutters. This flashing also helps protect the roof sheathing from damage at the eave.

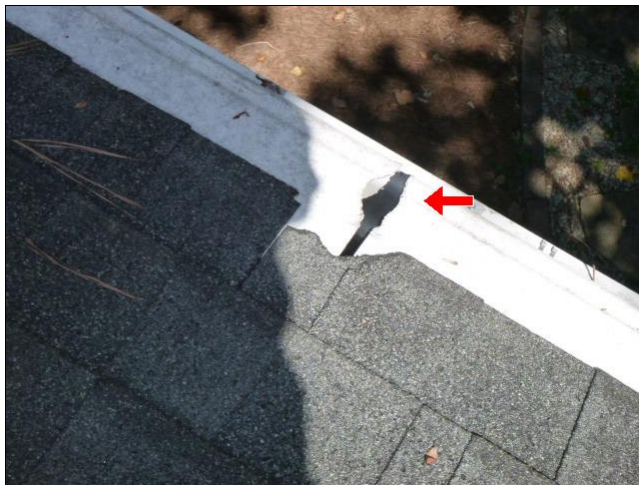
Repair: Damaged sections of gutter helmets at the rear should be replaced as necessary.

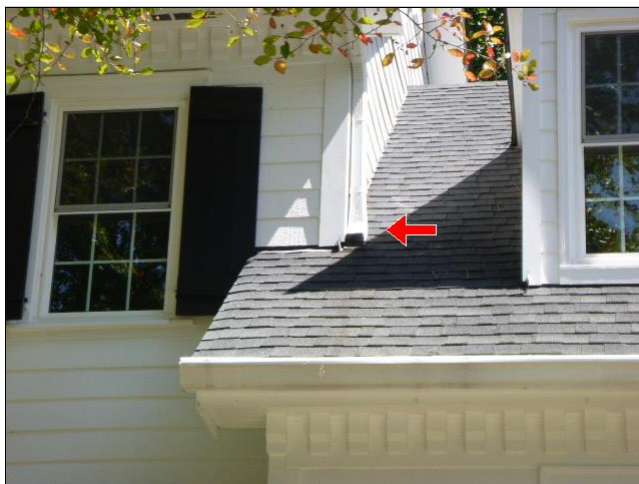
Improve: Downspouts that discharge onto the roof should be extended to discharge directly into the gutters or to the ground below. This condition can result in premature deterioration of the roofing shingles and flashing components near the end of the downspout and places additional water run-off next to the side-wall, which can allow moisture intrusion into the structure.

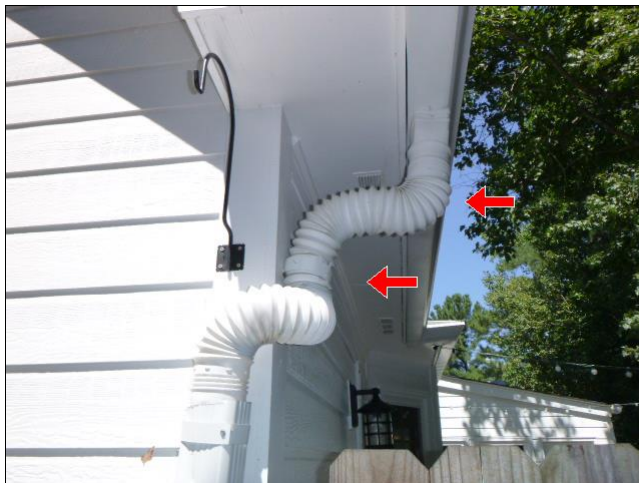
Monitor: It appears that "ribbed" pipelines have been used for the piping of the rear downspout, which is more prone to blockages than smooth wall piping. These should be monitored for proper flow and flushed on a regular basis to prevent obstructions in the lines.

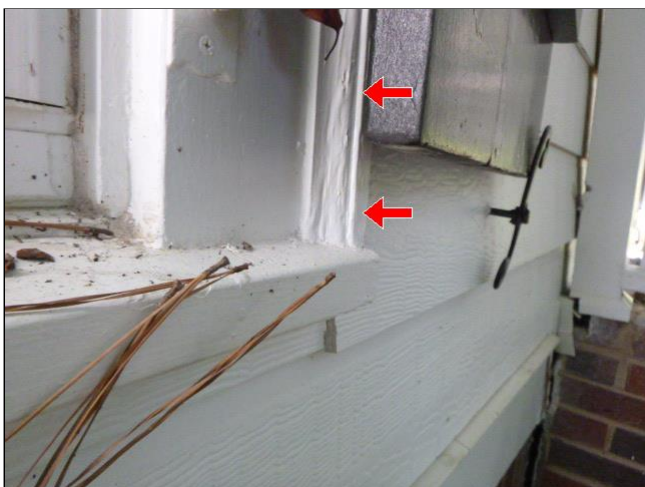
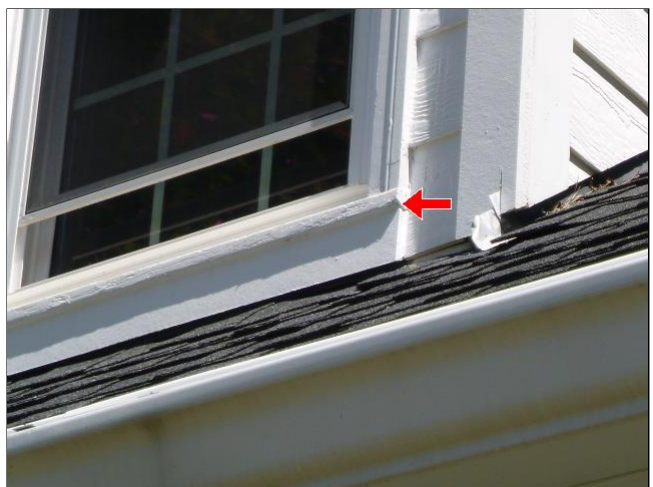
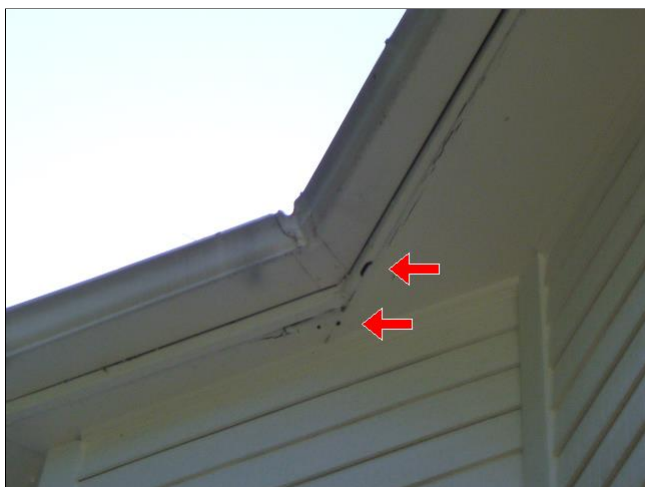
Repair: Signs of rot were observed at the soffit and fascia at the rear left and at the window trim at the right dormer, rear window and left window, which should be repaired by a qualified carpenter. Following repair of the damaged areas (which should be combined with exterior painting/maintenance) proper maintenance of the siding and wood trim and control of water from roof or surface runoff can avoid further damage. The carpenter should check all exterior wood components for further damage and repair as necessary.

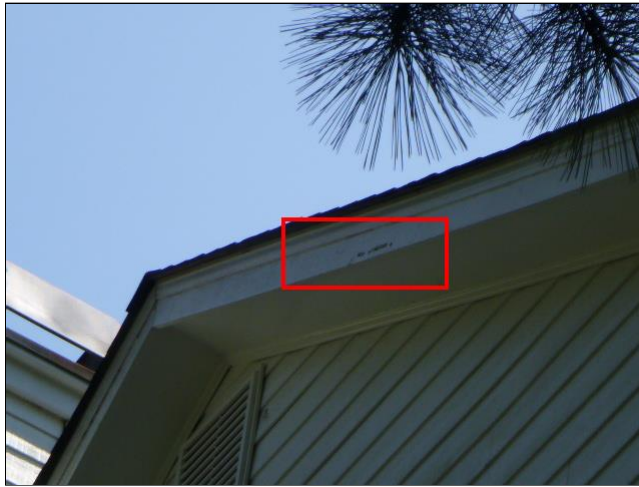
Repair: Minor areas of carpenter bee damage were noted in some of the wood components, especially at the left, which should be repaired and repainted as needed to prevent moisture intrusion into the structure.

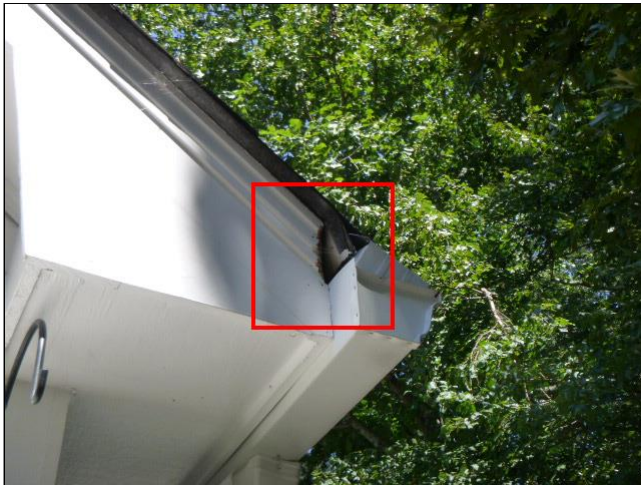
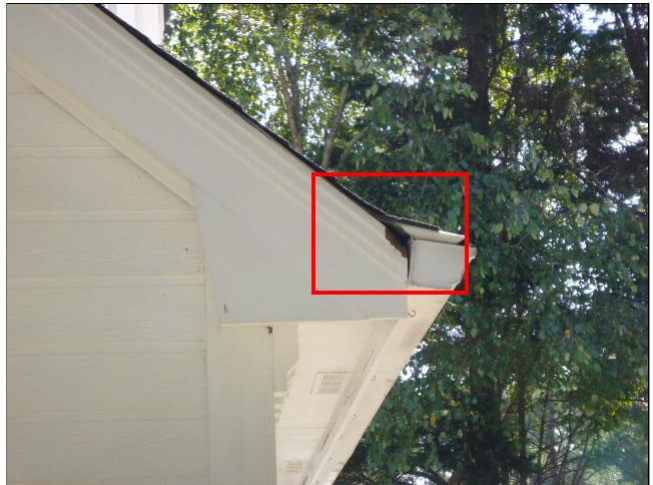
Repair, Monitor: Damage to the eaves at the front and rear right corner appears to be the result of rodent activity, which should be repaired as needed. Depending on the nature of this activity, an animal control specialist may need to be consulted to prevent further damage and rodent intrusions into the attic.

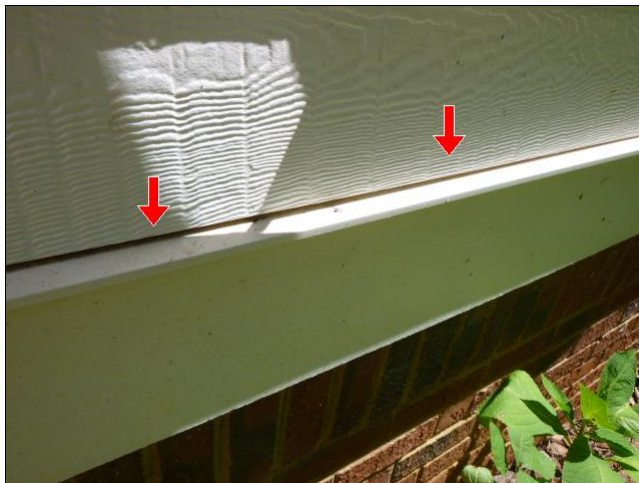
Repair: The siding should be caulked and sealed where it meets the trim to prevent moisture infiltration in to the structure and rotting of these components.

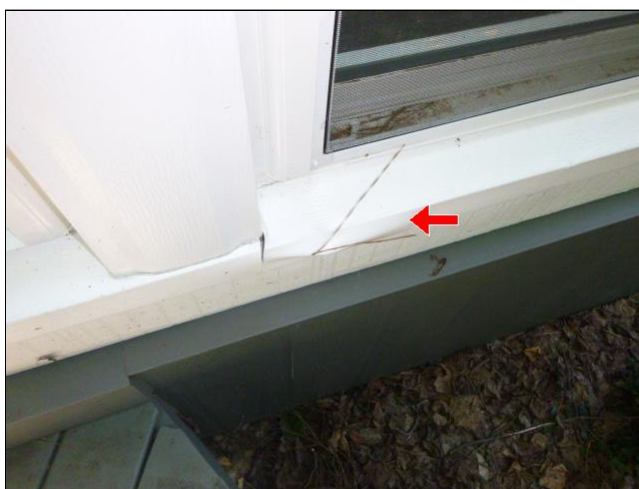
Improve: Damage to the window trim at the rear should be repaired as needed..

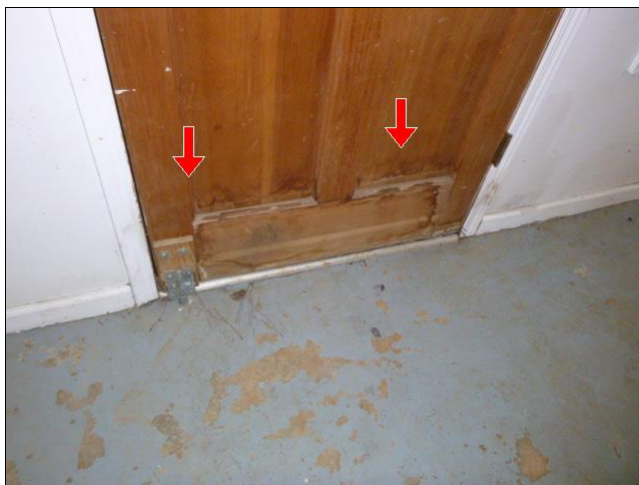
Repair: Signs of leaks were noted at the left basement door, indicating previous moisture infiltration through these components. All exterior frames should be properly caulked and sealed and flashed as necessary to avoid further moisture damage.

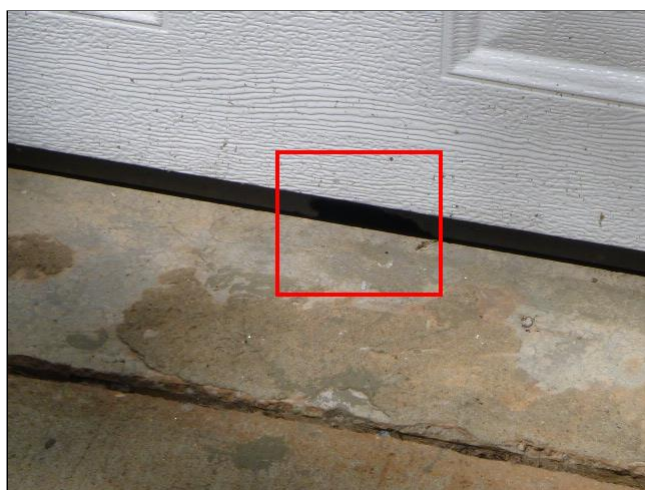
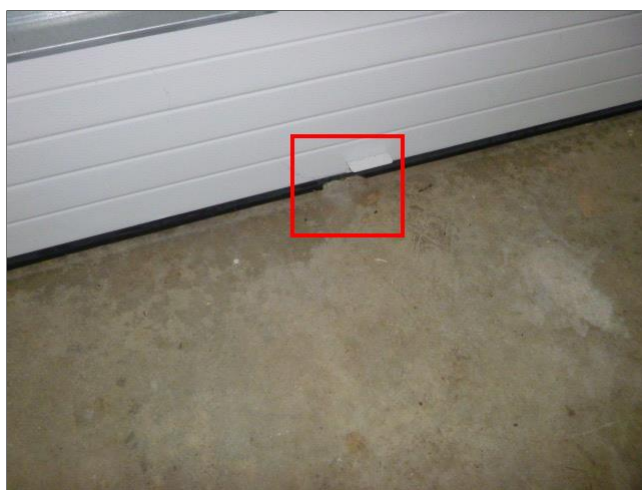
Repair: The garage door weatherstripping is damaged and should be repaired to limit moisture and rodent intrusion into the garage.

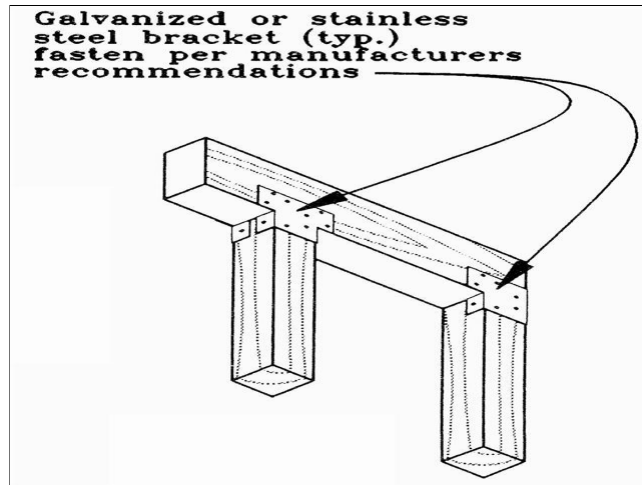
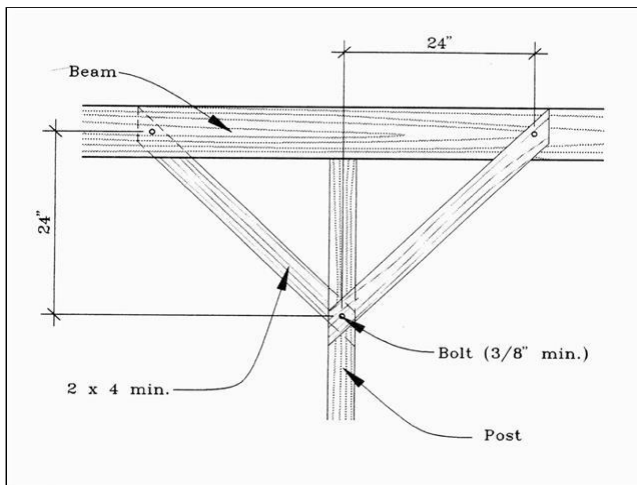
The grade is in contact with the base of the support wood posts for the deck and sunroom, which can cause moisture and termite damage in the future. Recent studies have shown that even pressure treated wood can rot over time due to constant contact with the soil. Make sure the footings for the posts are in place and extend at least 2" above the ground to keep the bottoms of the posts dry and free from soil contact.

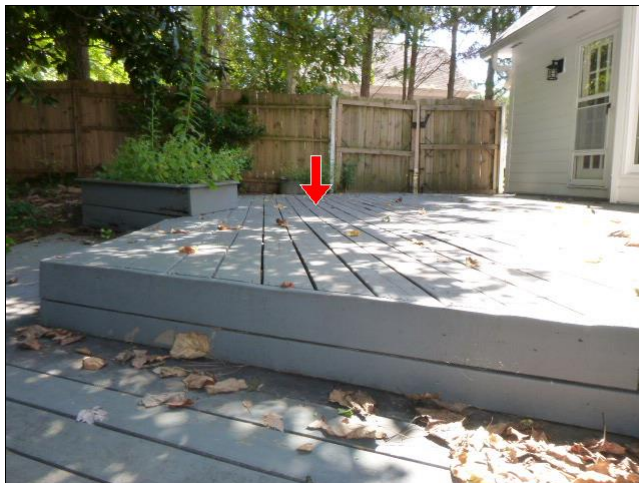
Monitor, Possible Repair: The floor structure of the deck shows signs of sagging and settlement, which indicates that this structure is somewhat under-designed for the loads and spans imposed. The deck should be monitored for further movement and the floor system strengthened, as necessary, by adding beams supported by columns under the deck.

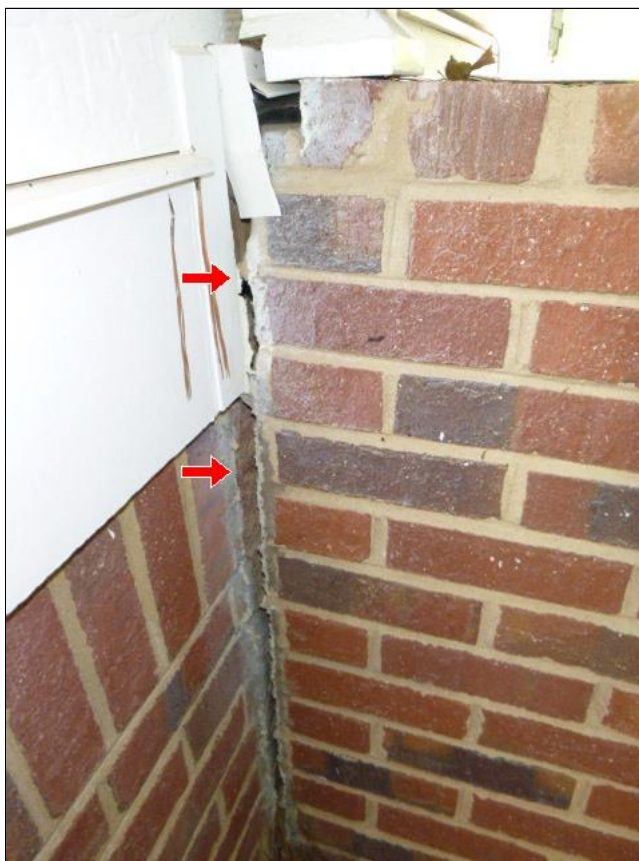
Repair, Monitor: The front steps and stoop have settled exposing gaps in the brick. These openings should be grouted and sealed to prevent moisture intrusion and further deterioration of these components. These areas should then be monitored for future movement.

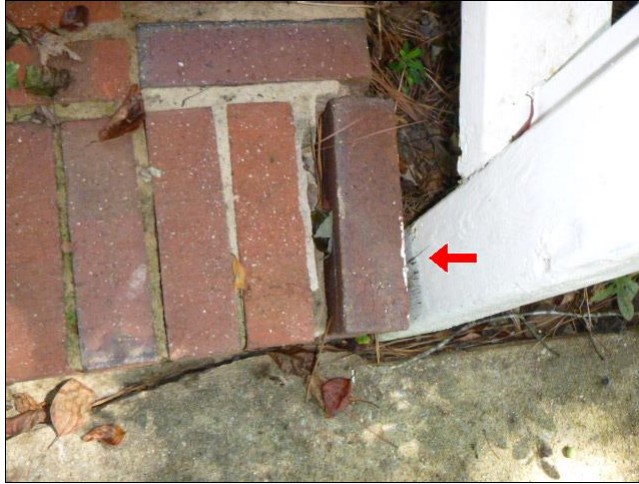
Repair, Safety Issue: Loose brick at the front stoop should be re-secured and re-grouted to prevent tripping hazards.

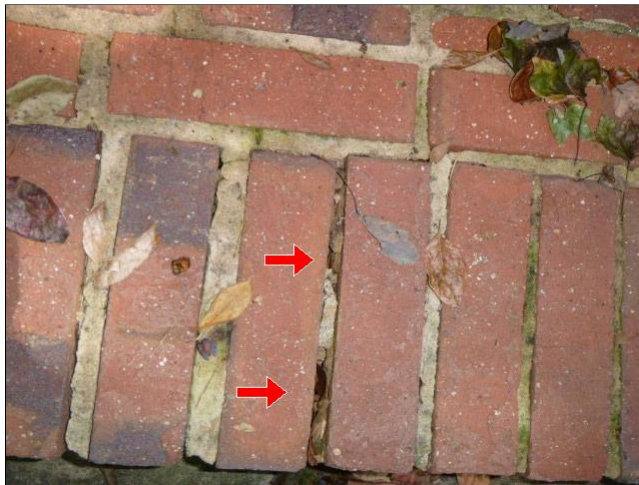
Repair: Open joints were noted in the brick at the front steps and stoop, which should be kept well grouted and sealed to prevent moisture intrusion into the wall and floor framing. Make sure all other cracks in the stoop and steps are grouted and sealed.

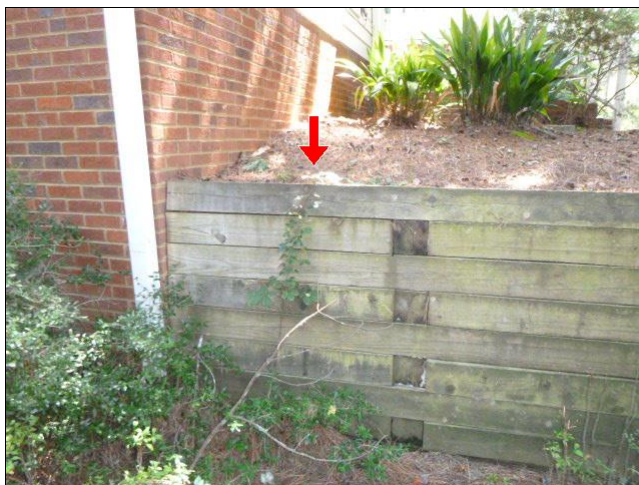
Improve, Safety Issue: Current safety standards require a guardrail for walking areas that are more than 30" off the ground. This provision also applies to finish grades above retaining walls that are attached to the structure. There was no guardrail at the retaining wall as noted at the left front and should be installed as needed.

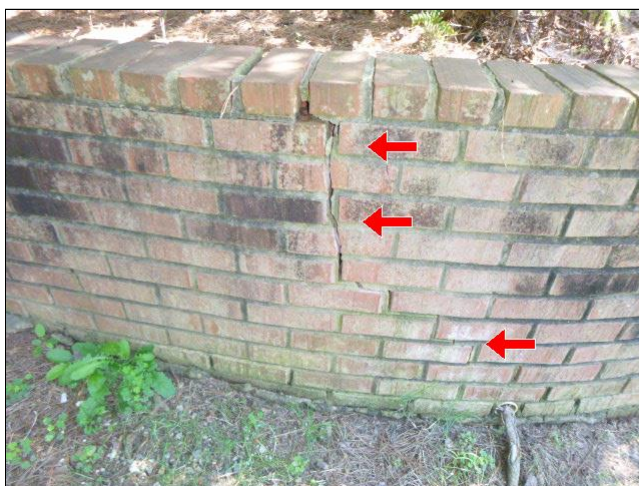
Improve, Monitor: The retaining wall at the front yard shows somewhat typical signs of movement and cracking. The cracks should be grouted and sealed and monitored for future movement. If further cracking occurs, then further repair and re-support may be necessary. It is impossible to determine the rate of movement during a one-time visit to the house.

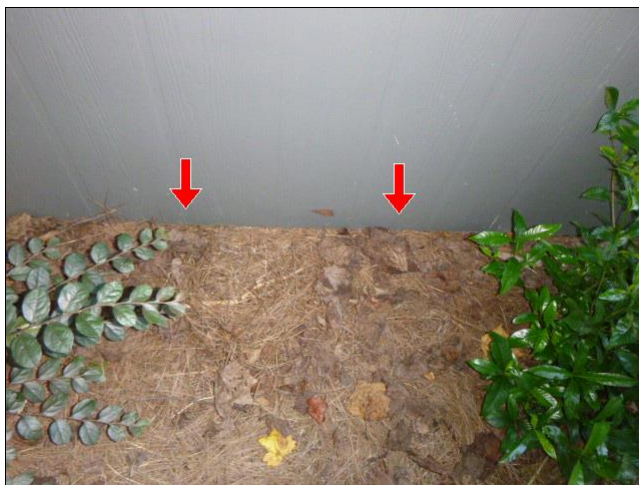
Repair: Wood to soil contact was noted at the rear. This condition can lead to termite infestations and moisture damage to the structure. A minimum of 4" (optimum 6") of clearance should be provided between grade and wood components. The grade in these areas should be lowered to provide such clearance. A drainage structure may be needed to remove water from the area. The ground should slope away from the house at a rate of 6" within ten feet of the foundation to prevent moisture intrusion into the crawlspace/basement. All damaged wood should be repaired or replaced as necessary.

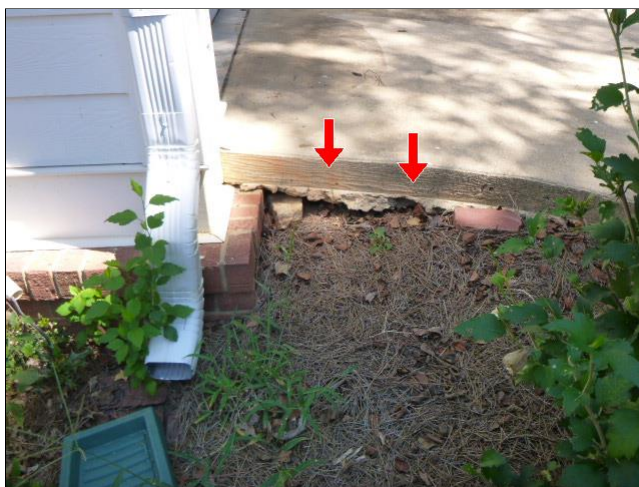
Monitor, Possible Repair: Signs of soil erosion and wash were noted the driveway. If this condition persists, drainage improvements or grade stabilization measures may be necessary to prevent further erosion of the ground.

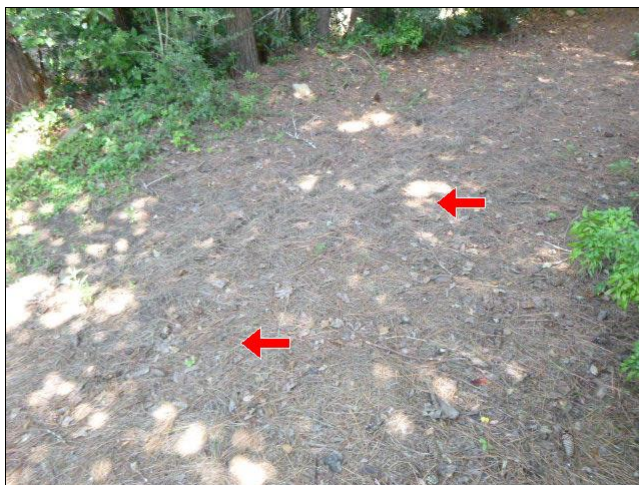
Improve: It appears that storm water is ponding in certain areas of the yard at the left yard. The installation of a "catch" basin with underground piping carrying the water out of the area would alleviate these conditions.

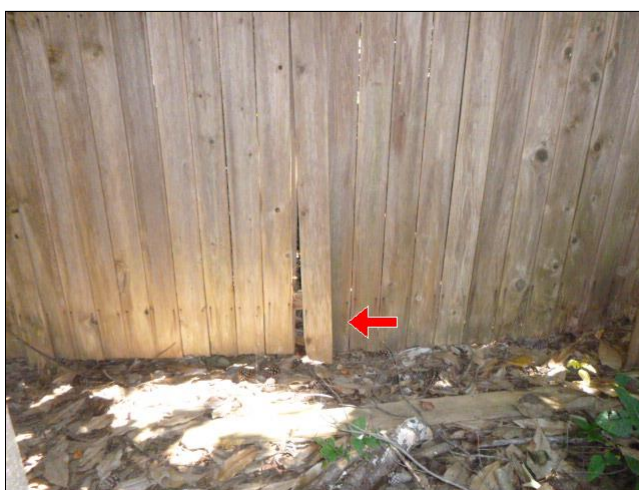
Monitor, Future Repair: Some of the wood fencing components are in poor condition. Replacement of these will ultimately be necessary.

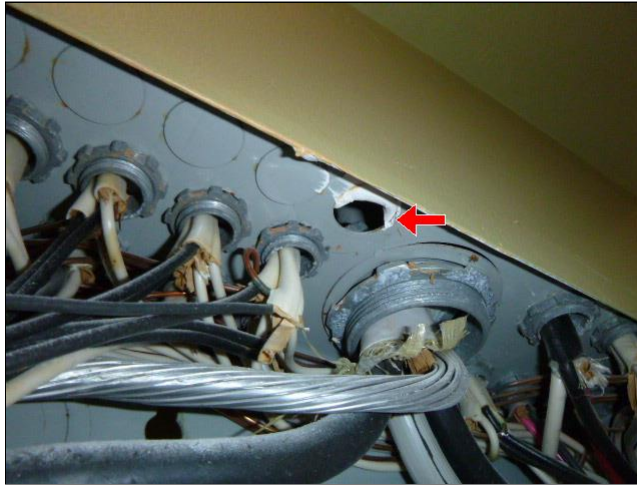
Repair: *All open knockouts in the edge of the main panel should be properly sealed to prevent fire risks in the event of shorts in the panel.*

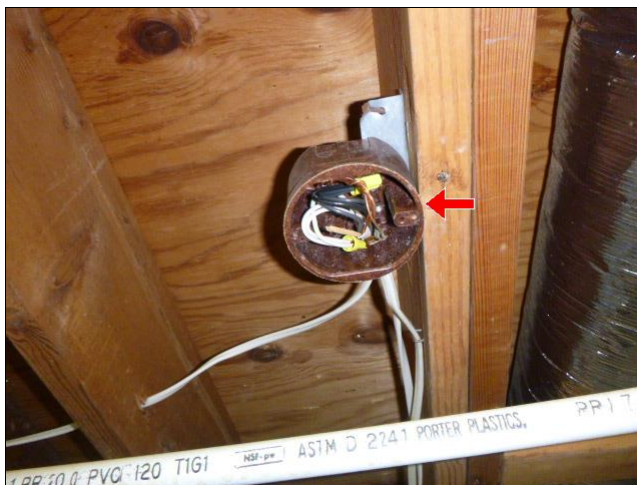
Repair: *All open junction boxes at the left basement should be fitted with cover plates, in order to protect the wiring and to reduce the risks of potential fires that may be caused by poor connections.*

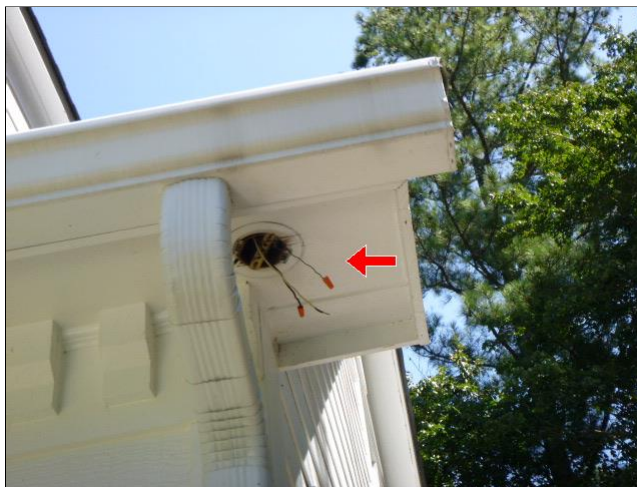
Repair: Missing light fixtures at the front right exterior should be re-installed or the wiring properly terminated in a covered junction box.

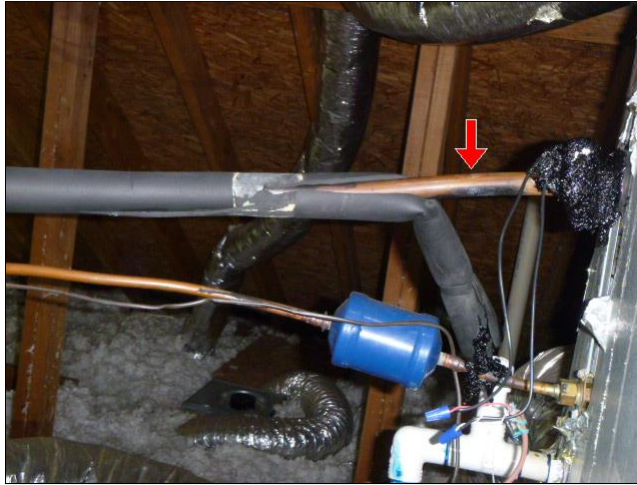
Repair: Damaged and missing insulation on refrigerant lines should be repaired, especially in the attic where condensation can cause damage to interior finishes. All lines should also be insulated near the coils to prevent condensation leaks into the furnace, which can cause rusting and damage to the unit.

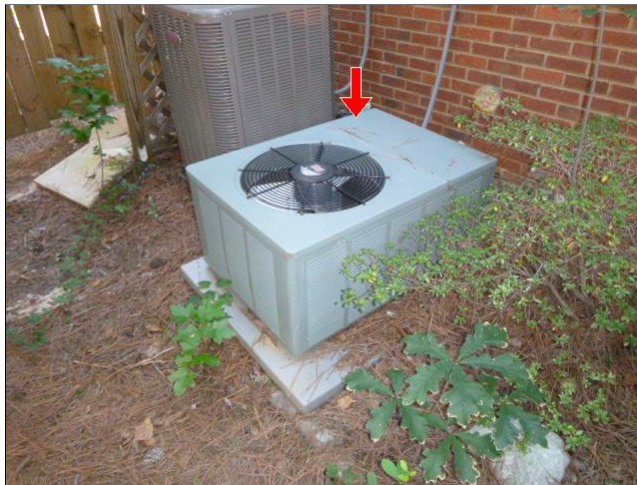
Repair: The outdoor unit of the air conditioning system is out of level. This condition should be corrected to allow for proper operation of the fan motor and compressor.

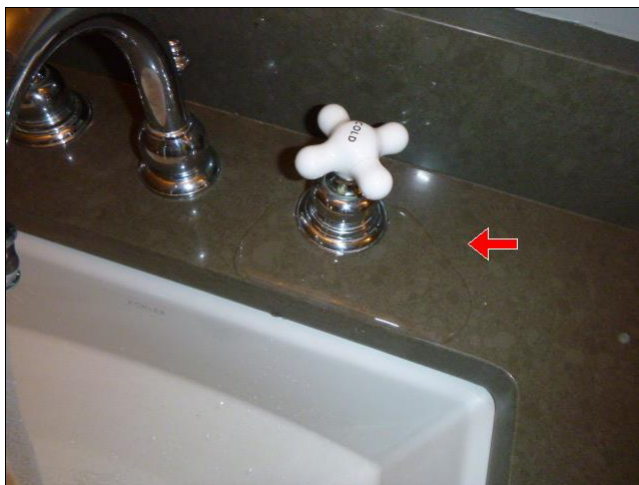
Repair: Some of the faucet handles leak slightly as noted at the left master sink. This typically indicates that washers inside the handles or valves need replacement.

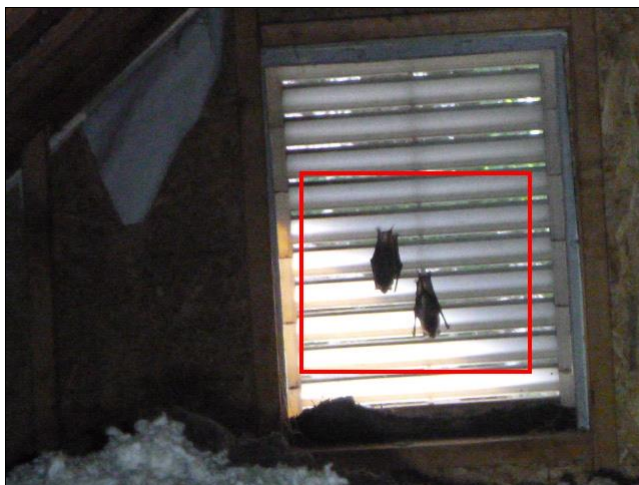
Repair, Safety Issue: *There is evidence of active bat infestations as noted in the attic gable vents. A pest control specialist should be consulted to eliminate future activity. All outside openings into the structure should be covered with screen wire or otherwise sealed. The gable vents should be screened on the outside to prevent further bat activity and any accumulations of guano should be removed. Any damaged insulation should also be removed and replaced as needed. Consult with the seller concerning remedies taken to address this condition. Rodents and other wildlife can damage electrical wiring and other building components and can create unhealthy conditions within the home.*

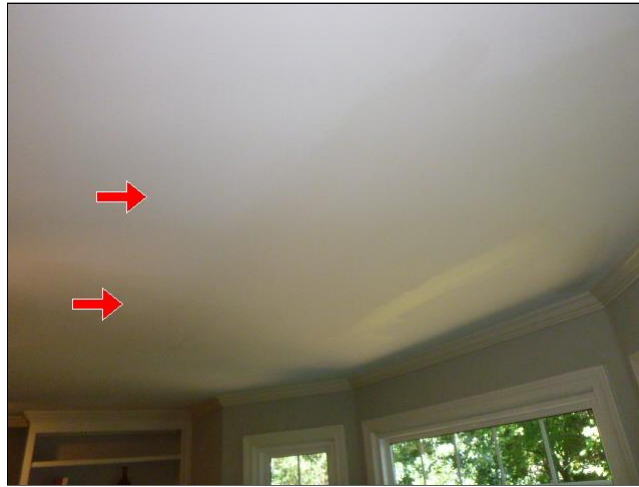
Monitor: Evidence of previous patching and repairs was detected at the family room ceiling. Consult with the seller concerning the nature of these repairs and monitor for future activity.

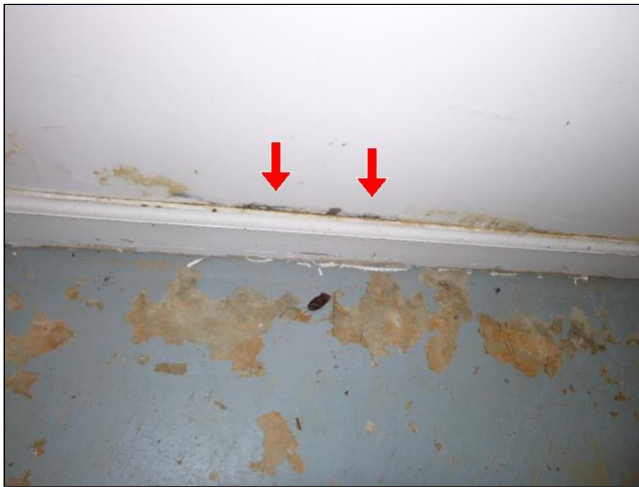
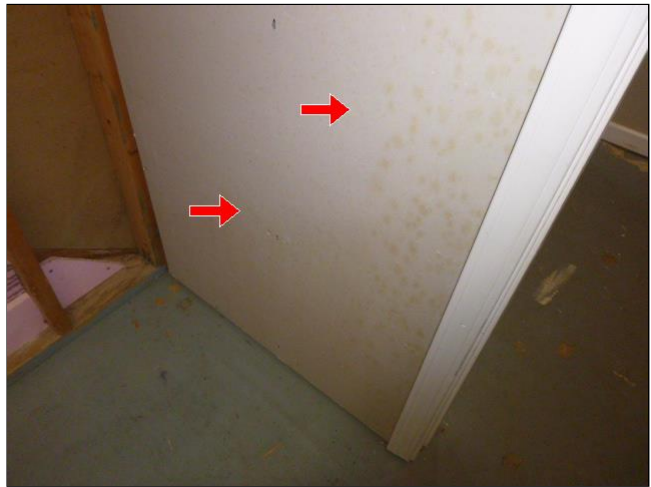
Repair, Safety Issue: Evidence of possible mold and mildew was noted at the left basement wall and the wall in the basement furnace closet. Bacteria growth within the house contaminates indoor air quality could pose a health risk. These areas may need cleaning with a fungicide or otherwise sanitized. All damp and damaged sheetrock should be replaced as needed. The source of the moisture should be eliminated to prevent further growth. The identification and testing for mold growth is not a part of this inspection.

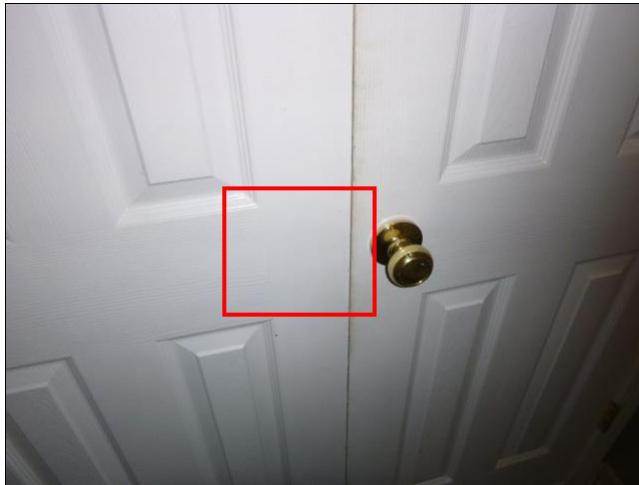
Improve: Recommend installing a door knob at the left basement door.
