Inspection Report

**339 South Esplanade
Alpharetta, Georgia 30009**

Inspection Date September 10, 2020
Inspector Jay Cao
www.HouseChecked.com
jc@housechecked.com
(678) 557-8958
interNACHI Certified Inspector, GA Registered Professional Engineer

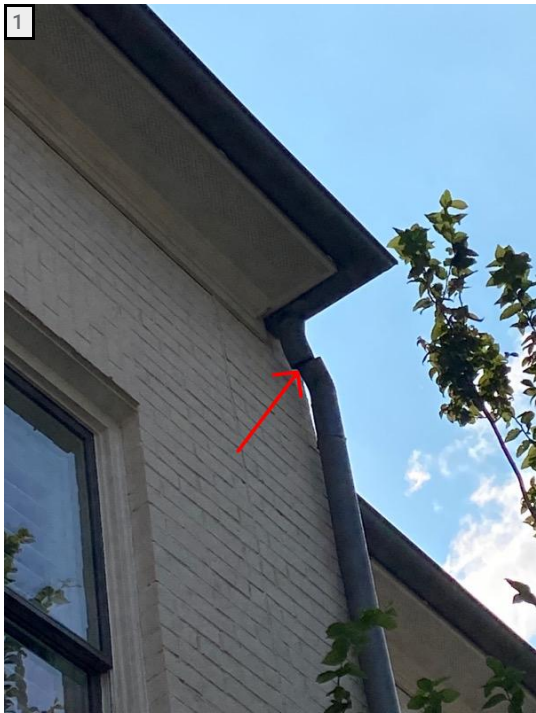
Location	Exterior: Ground View
Impact	Improper connections prevent water drainage is not optimally contained
Suggested Action	Secure or replace the elbow connector
Other Information	The elbow connector should be securely fastened to prevent the elbow from coming loose and assure a leak-free elbow

3. Downspout(Exterior: Ground View): Elbow(s) are not properly connected

Elbow(s) are not properly connected

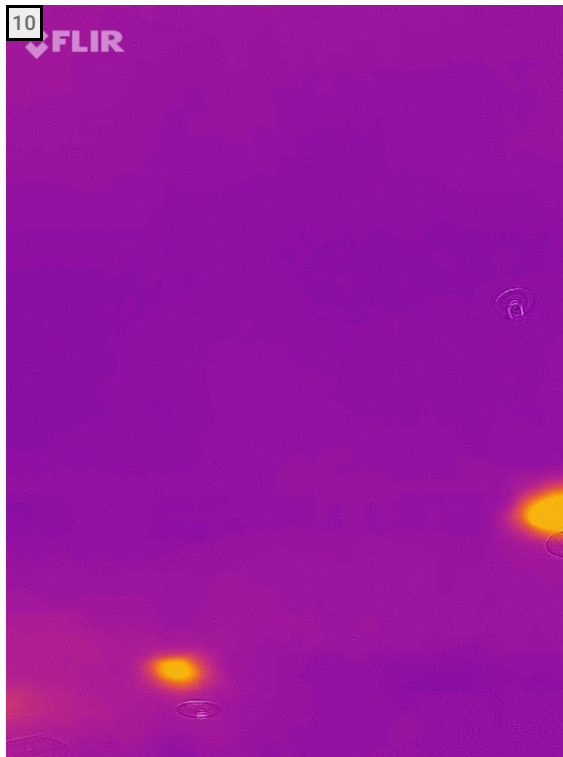
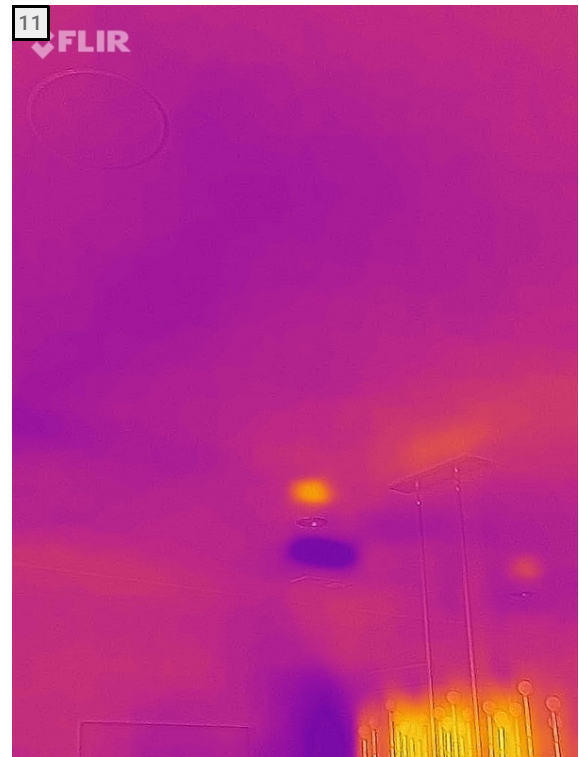
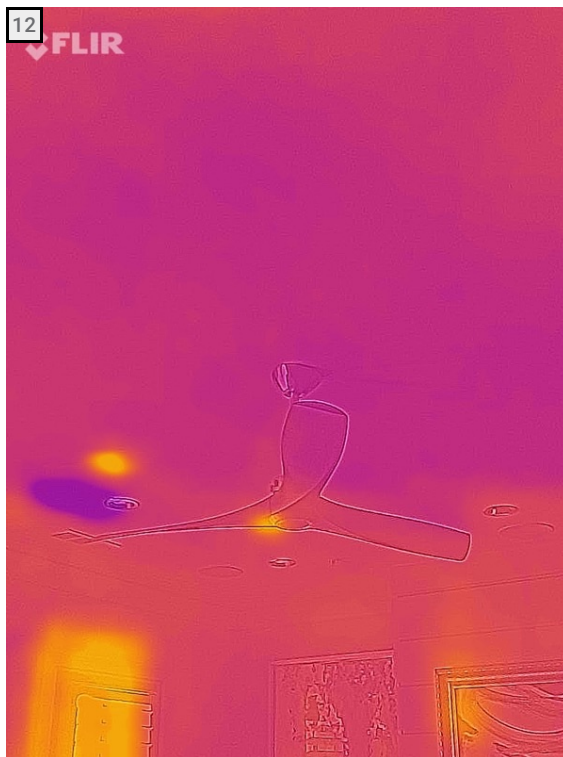
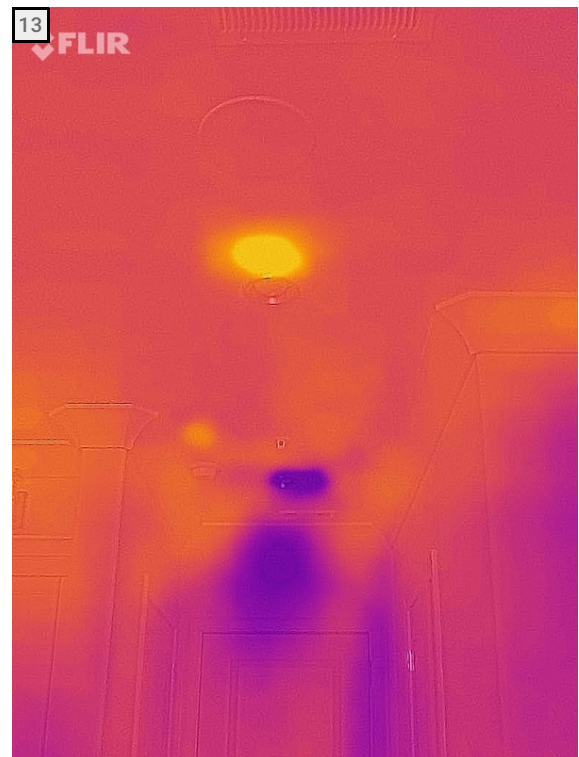
In Working Order**thermal scan shows there is no active water leak for the area noted****Location** Living Room

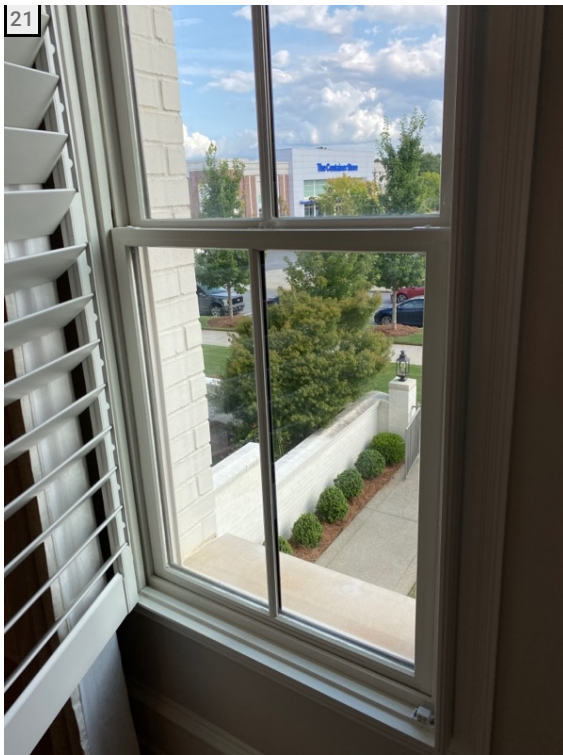
Location Master Bedroom

4. Window(Master Bedroom): a number of representative windows were inspected, some of them are painted shut, or difficult to open.

a number of representative windows were inspected, some of them are painted shut, or difficult to open.

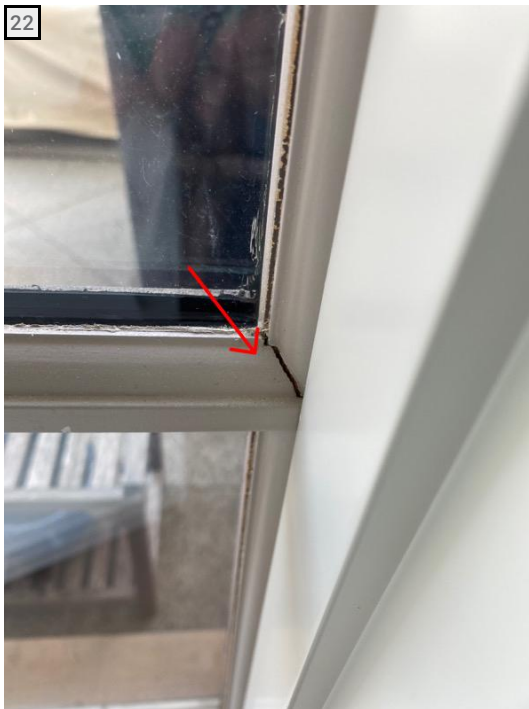
Location Living Room

5. Window(Living Room): majority of window frames have caulking cracked

majority of window frames have caulking cracked

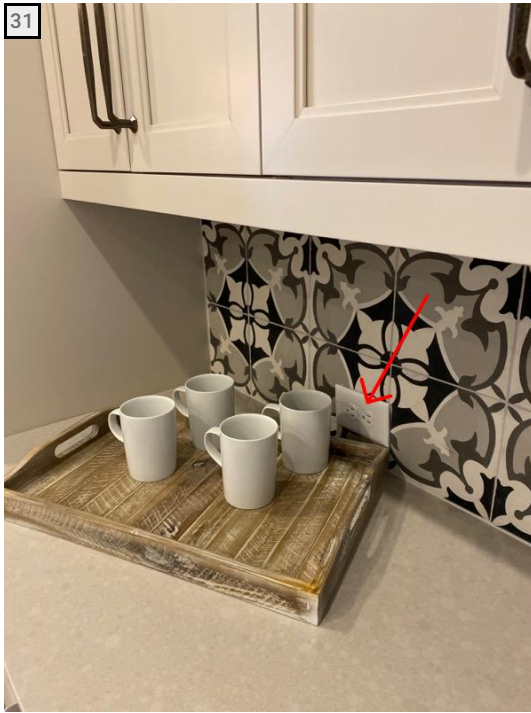
Location Kitchen

6. GFCI(Kitchen): outlet box is loose, need to be fastened to the wall

outlet box is loose, need to be fastened to the wall

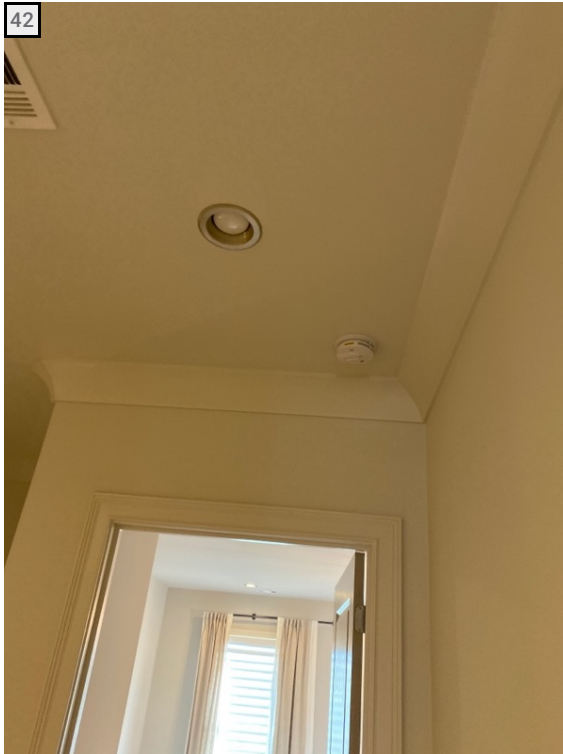
Location Hallway and Stairs

2. Smoke Alarm(Hallway and Stairs): all the smoke alarms and CO alarms throughout the house shall be tested at the time of moving in, current code requires each bedroom shall have smoke detector, older house without major renovation doesn't need to meet this requirement but it is strongly recommended

all the smoke alarms and CO alarms throughout the house shall be tested at the time of moving in, current code requires each bedroom shall have smoke detector, older house without major renovation doesn't need to meet this requirement but it is strongly recommended

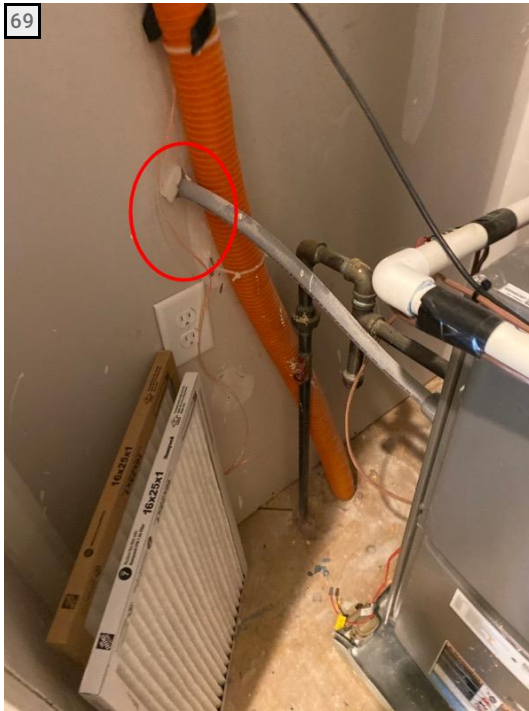
Location Utility Room

7. Furnace 2(Utility Room): disconnect switch is missing

disconnect switch is missing

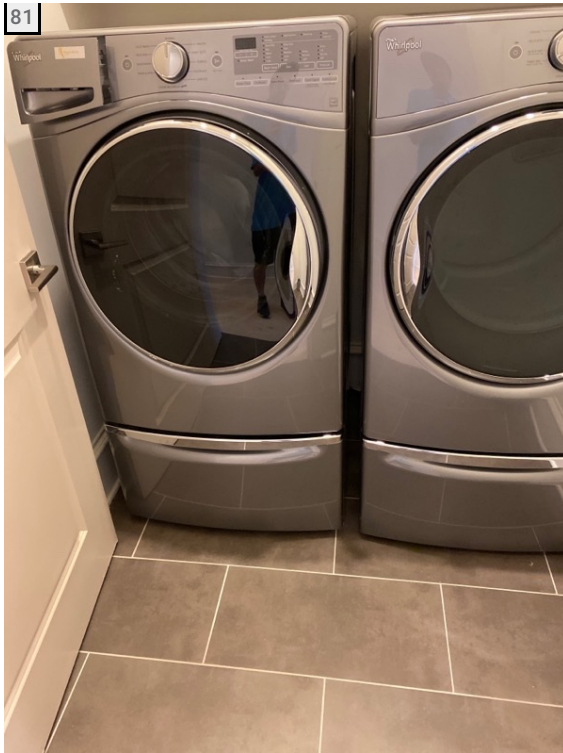
Location Utility Room

8. Floor drain(Utility Room): no washer wet pan drain connection found, highly recommended to install.

no washer wet pan drain connection found, highly recommended to install.

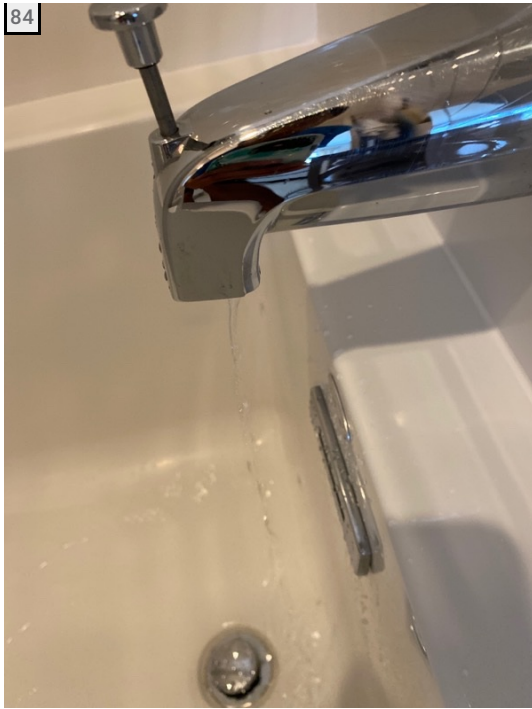
Location 3rd Bathroom

9. Shower / Tub(3rd Bathroom): Spout diverter is leaking

Spout diverter is leaking

Impact The leak may become a nuisance. If not repaired, calcium deposits may form at the base of the valve and water flow to the shower head will be reduced

Suggested Action Replace the tub spout including the diverter
