Your Inspection Report

3180 Lynwood Drive
Atlanta, GA 30319

INSPECTION DATE:
Wednesday, September 16, 2020

RE: Report No. 35642
3180 Lynwood Drive
Atlanta, GA
30319

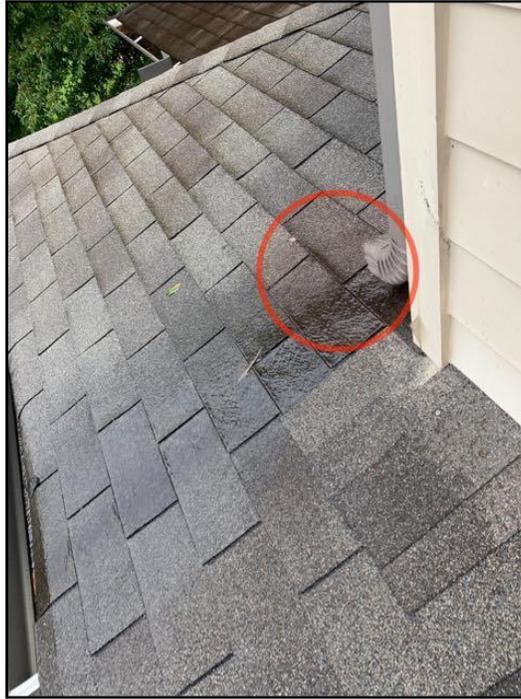
9. Discharging onto roof covering

1. **Condition:** • Discharging onto roof covering

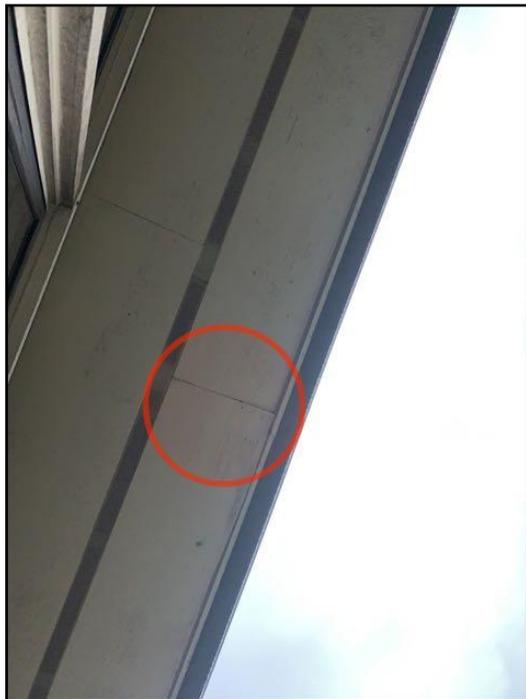
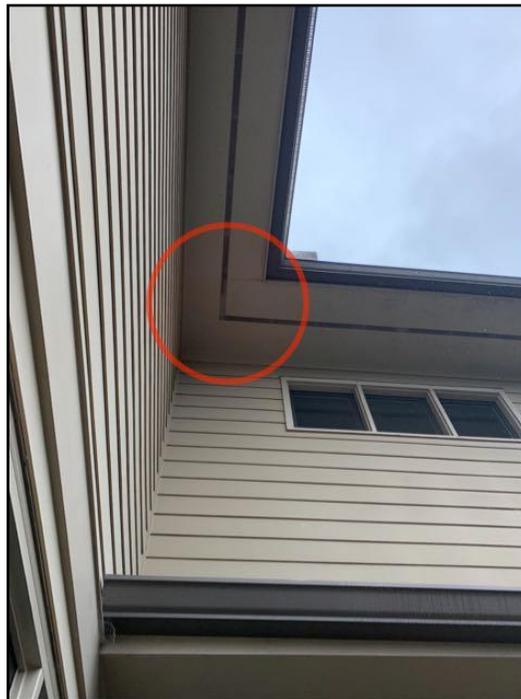
2. Condition: • Loose/Missing pieces

10. Loose/Missing pieces

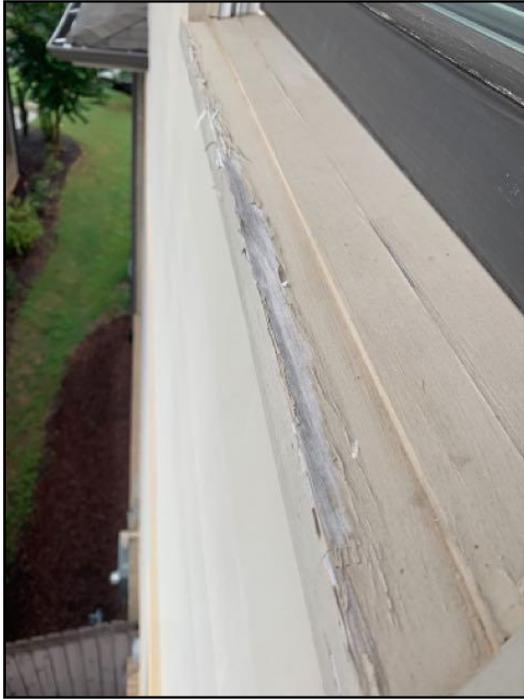
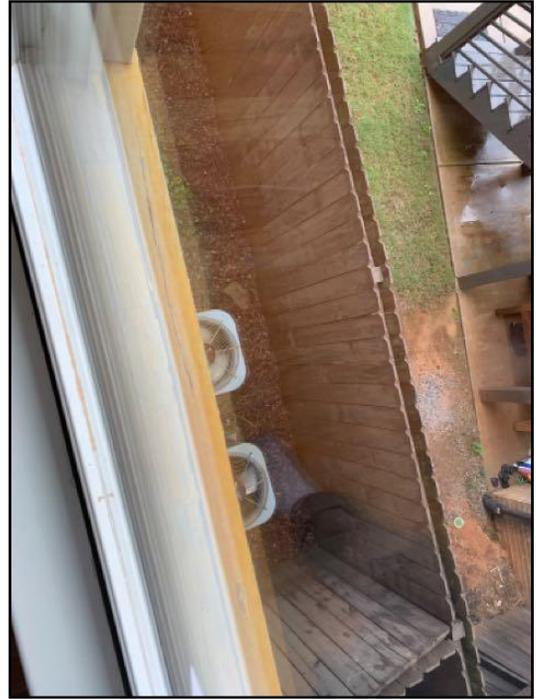
3. Condition: • Paint or stain needed

Peeling paint and rust stains noted in several areas

12. *Paint or stain needed*

Cost: As a general rule, painting is about \$1,000 per side. Spot repairs may be less and it is unlikely the paint will match.

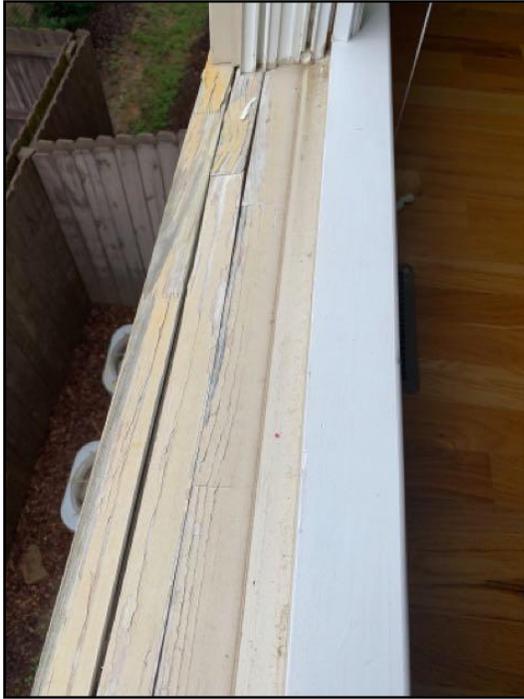
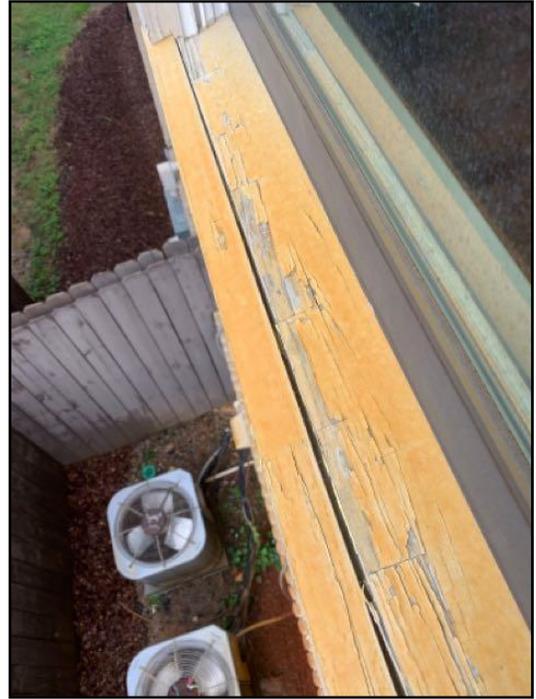
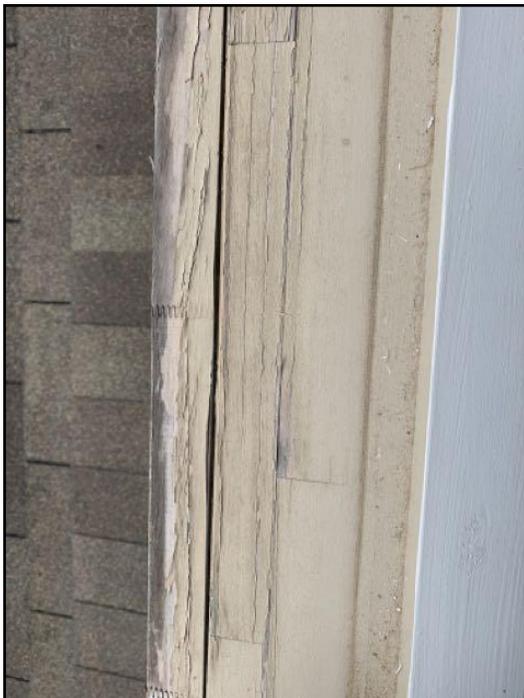
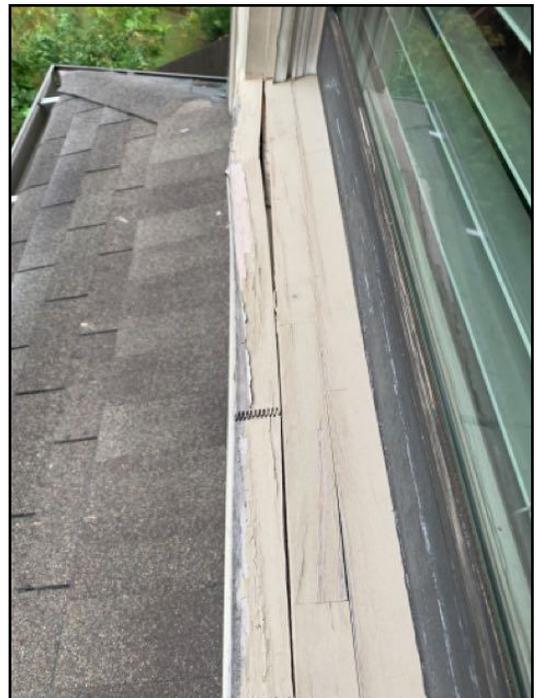
4. Condition: • Damaged sill on several windows

Task: Repair As Needed

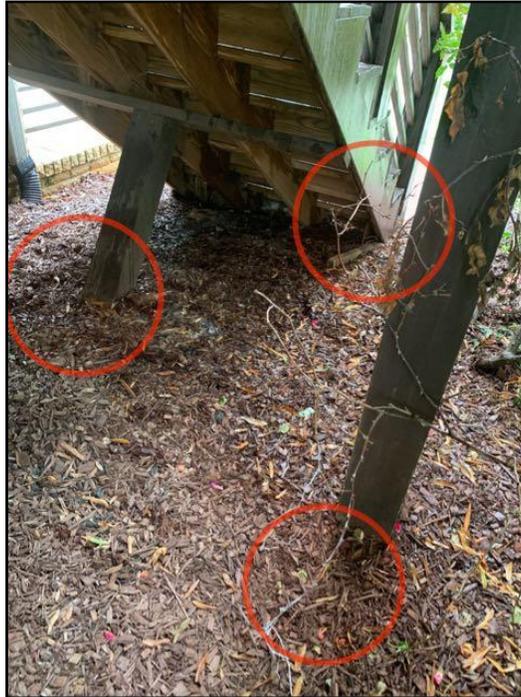
5. Condition: • [Wood/soil contact](#)

18. Wood/soil contact

Recommend excavating 6 to 8 inches away from the wood and replace with gravel or like material for drainage.

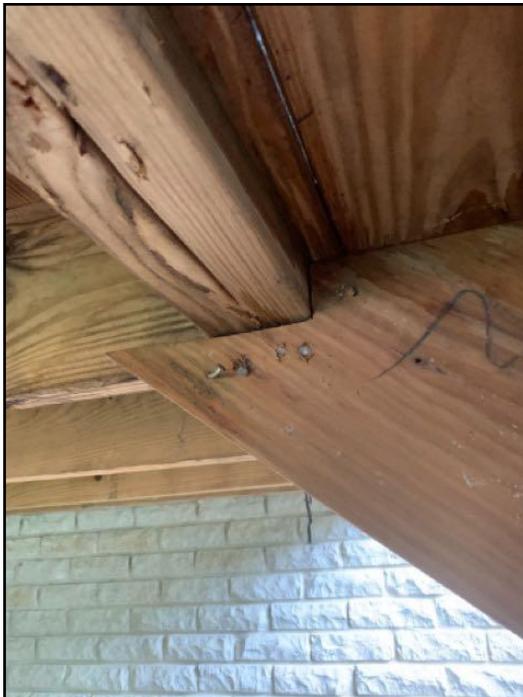
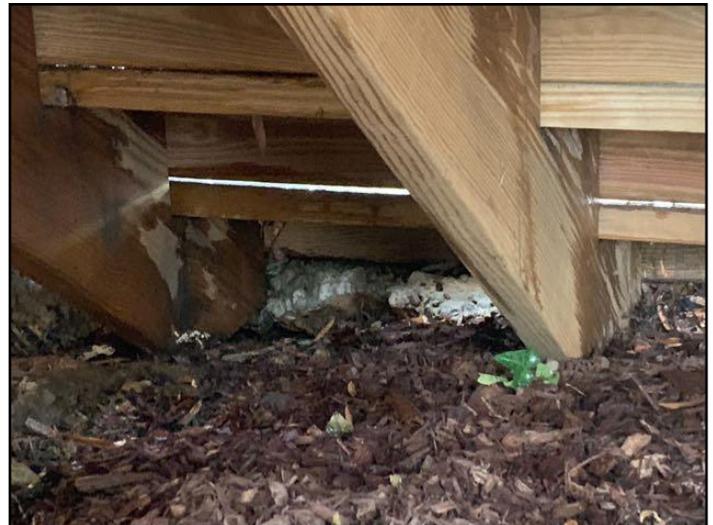
6. Condition: • Poor Bearing at top or bottom of stair stringer

19. Poor Bearing at top or bottom of stair...

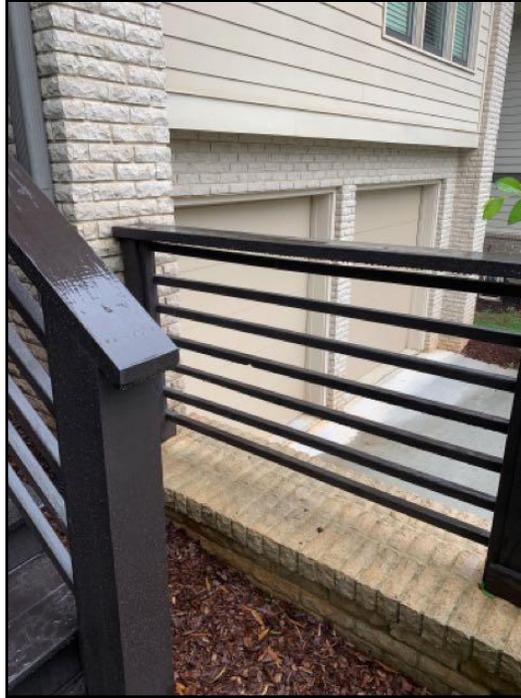
7. Condition: • Balusters/spindles climbable

21. *Balusters/spindles climbable*

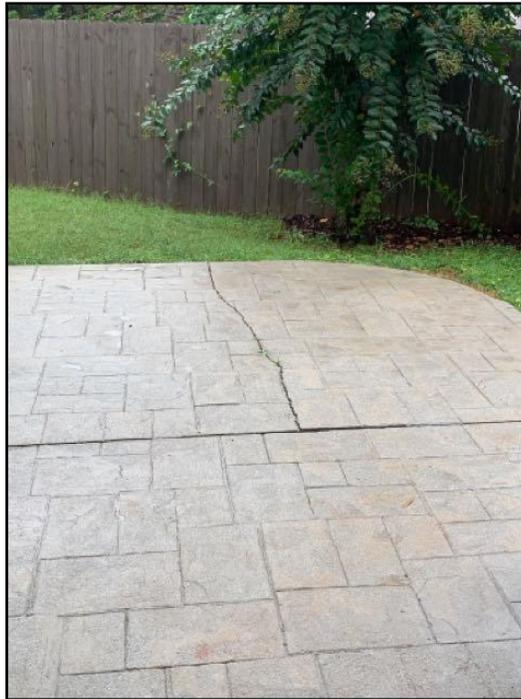
8. Condition: • Cracked or Damaged Surfaces

22. Cracked or Damaged Surfaces

Task: Repair As Needed

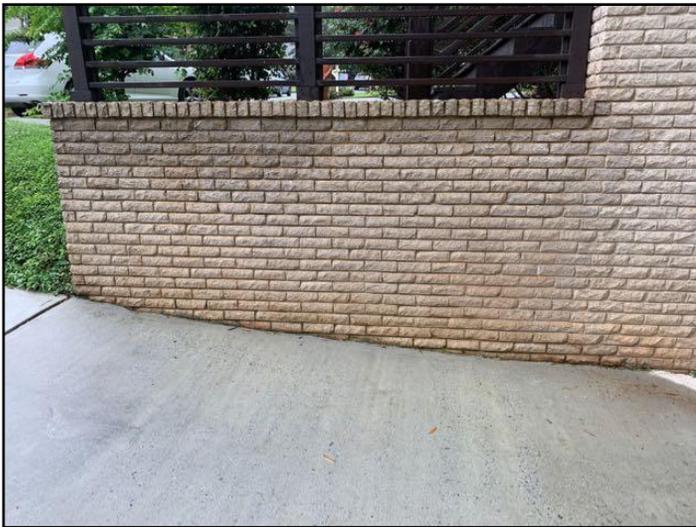
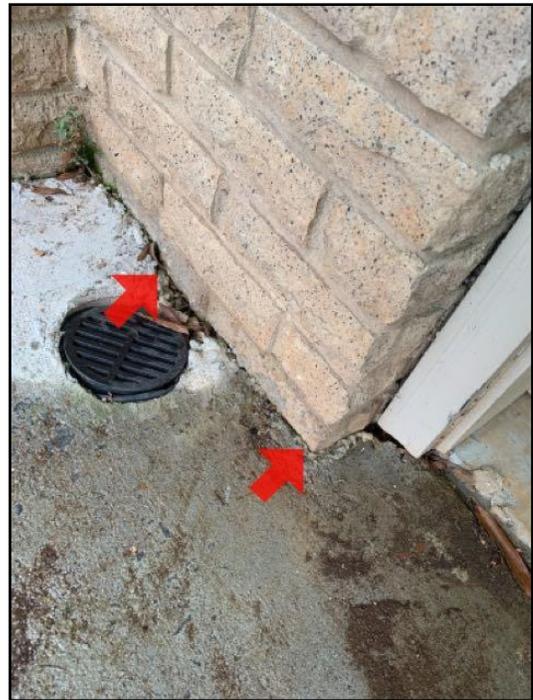
9. Condition: • Drainage system for retaining wall is missing

A proper installation of a retaining wall will allow drainage of any water trapped on the back side of the wall. Without drainage, pressure can build on the wall. The process of installing drainage after the fact is usually cost prohibitive and monitoring is recommended.

23. Drainage system for retaining wall is missing

Recommend sealing gaps at driveway drain near exterior corner of garage.

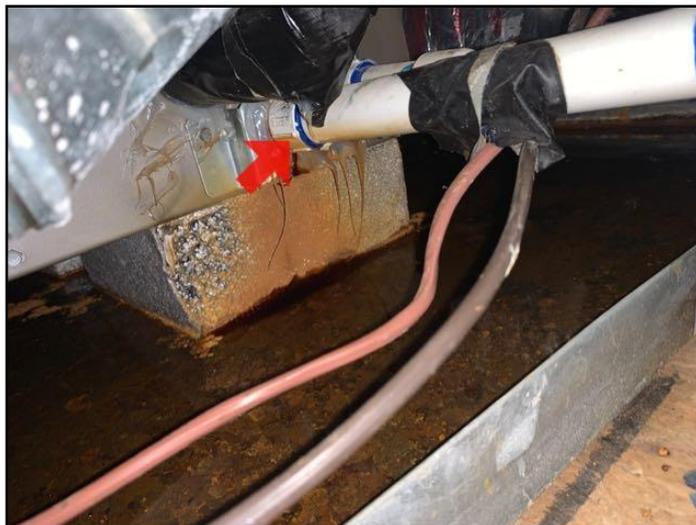
11. Condition: • Leak in condensate system

Visible leak at drain line connection. Drain pan is full of water and rust

39. Leak in condensate system

Task: Repair

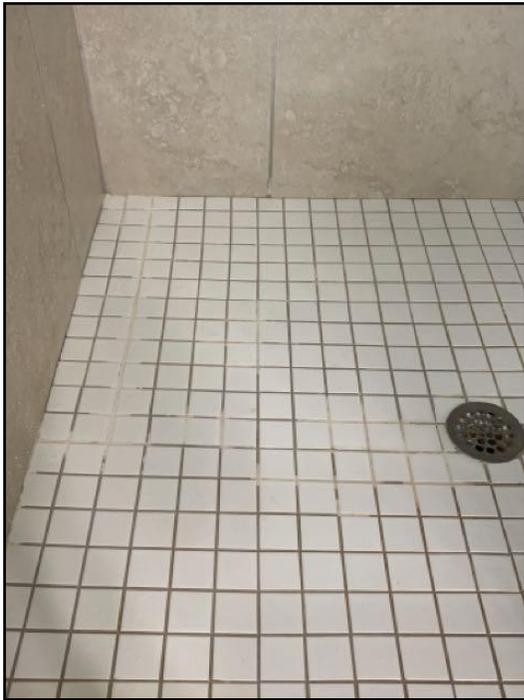
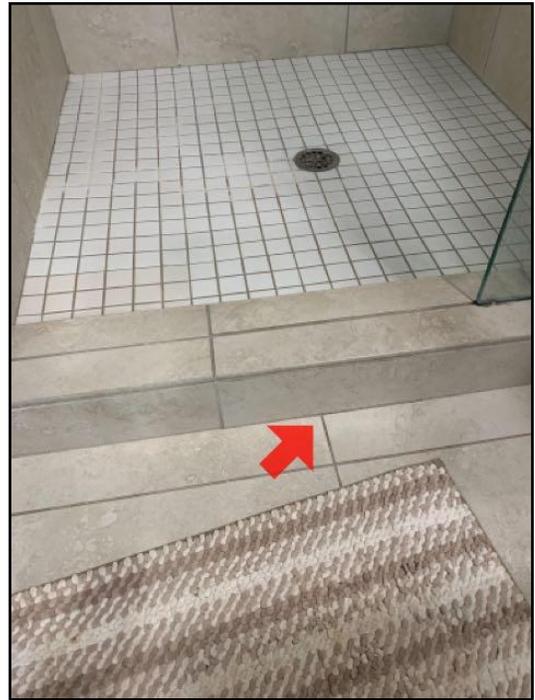
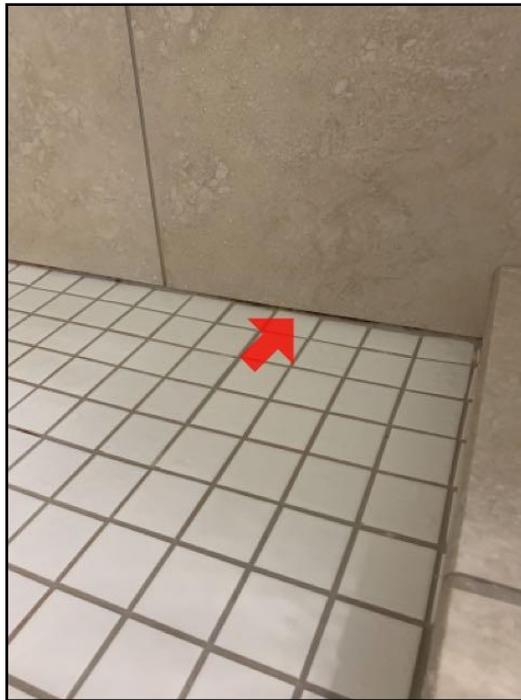
14. Condition: • Caulking/Grout missing and or deteriorated

Previous repairs noted.

42. Caulking/Grout missing and or deteriorated

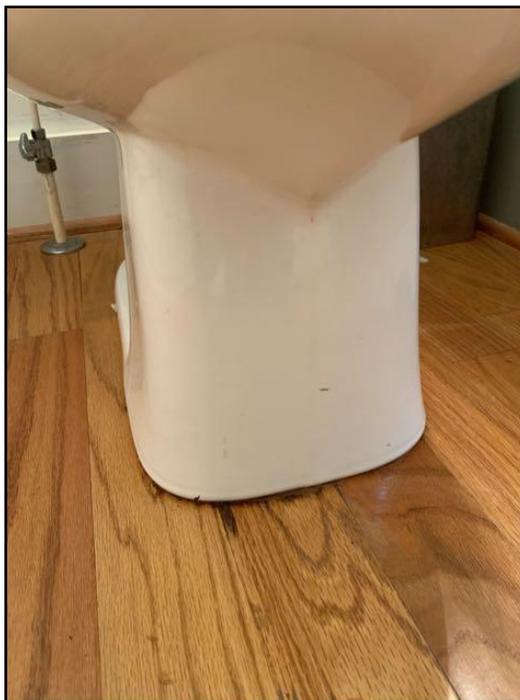
45. Leak

15. Condition: • [Leak](#)

Water stains noted, this area tested wet at time of inspection. This is an active issue

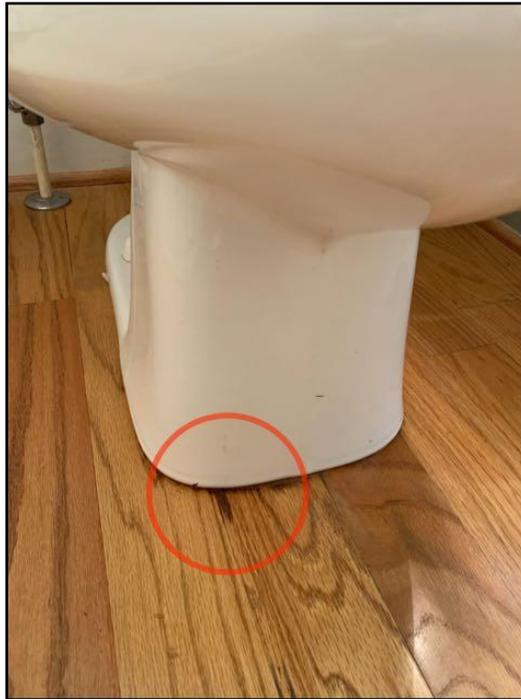
16. Condition: • [Water damage](#)

Water stains noted on wood floor at base of toilet.

49. Water damage

Task: Repair As Needed

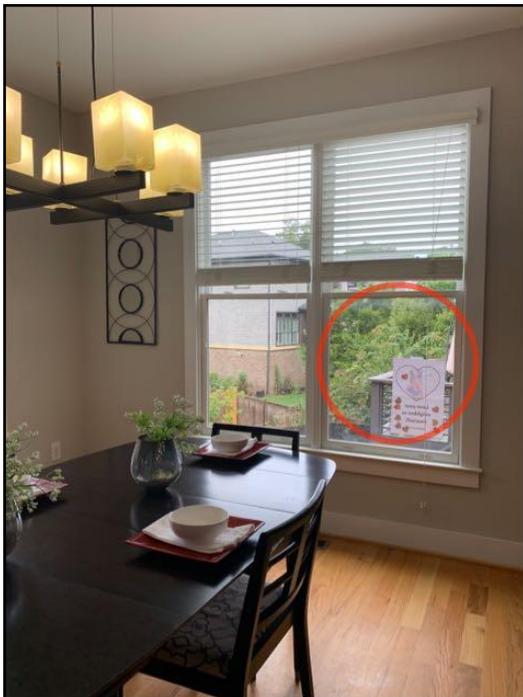
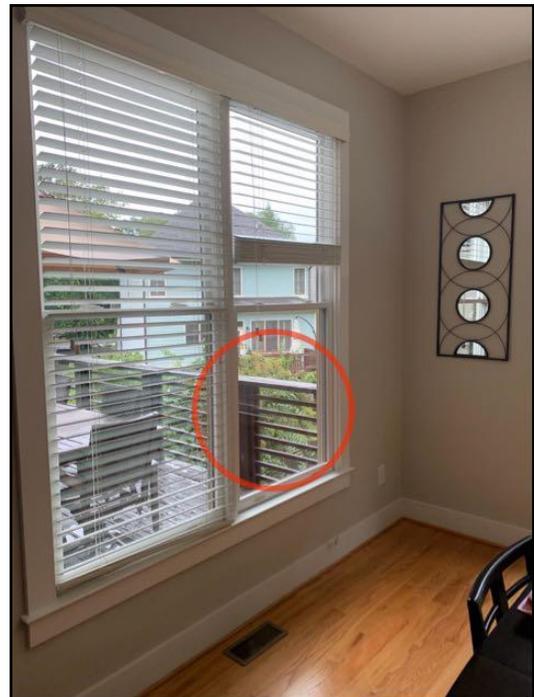
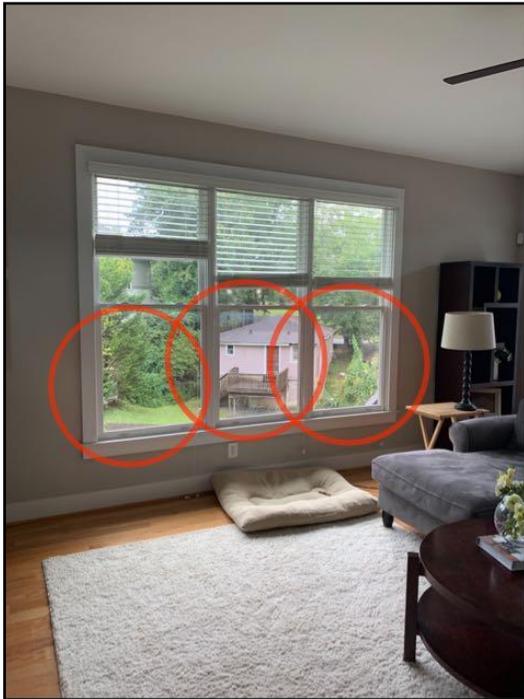
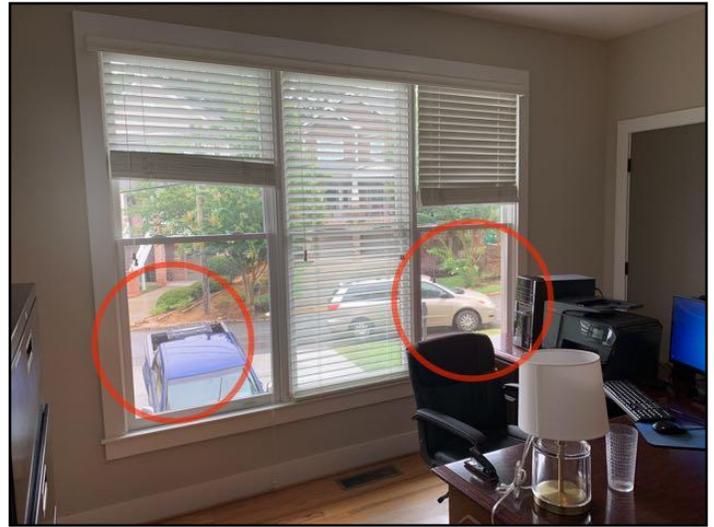
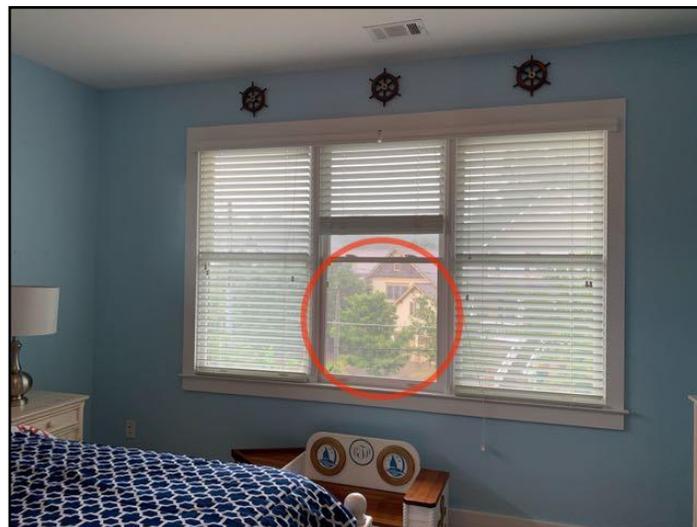
17. Condition: • Windows Inoperative

50. Windows Inoperative

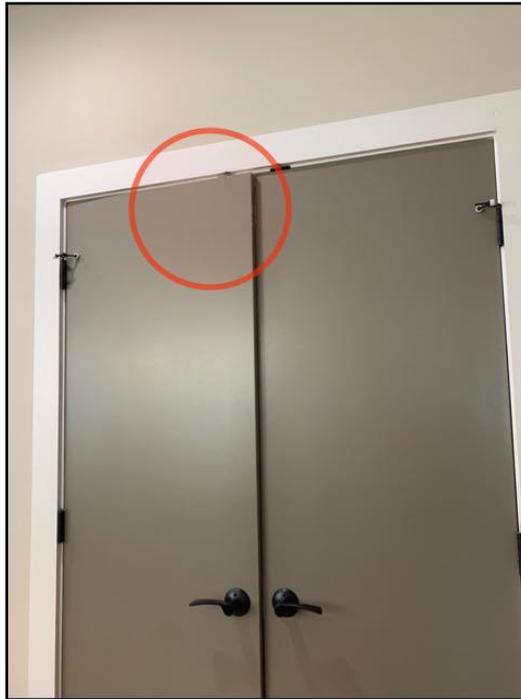
18. Condition: • Latch/Lock Not Effective

Ball latch at top of door is missing

55. Latch/Lock Not Effective
