Inspection Report

Property Address:
12657 Lecomma Trace
Milton GA 30004

Date: 9/17/2020	Time:	Report ID: 7651
Property: 12657 Lecomma Trace Milton GA 30004	Customer: Jennifer Salazar	Real Estate Professional:

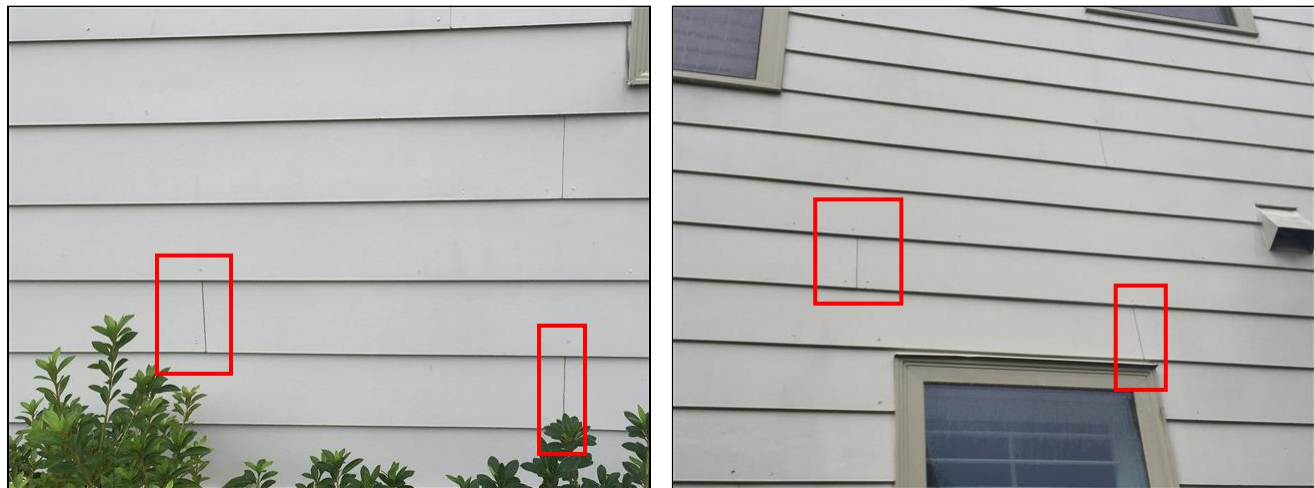
2.0 (1) Open caulk joints were noted at several locations including all sides of the cement fiber siding. Correction is recommended so that the exterior walls are fully sealed to prevent air infiltration and possible water entry.

2.0 Open Caulk Joints

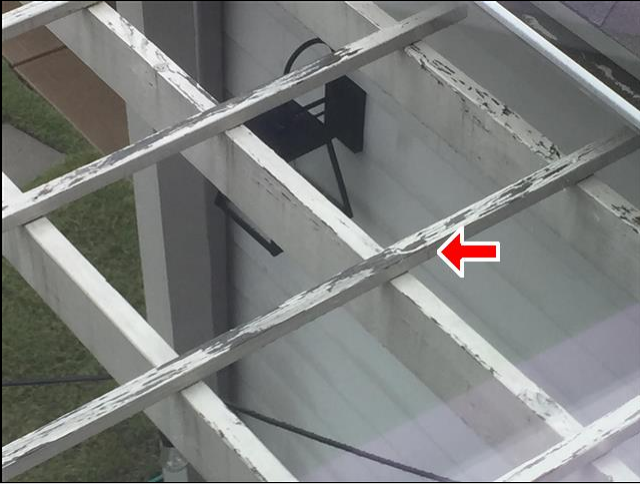
2.0 (2) Peeling paint and bare wood were noted at several wood locations (rear patio trellis). Scraping off loose paint, recaulking, and repainting is recommended soon to fully seal and protect the wood surfaces.

2.0 Peeling Paint

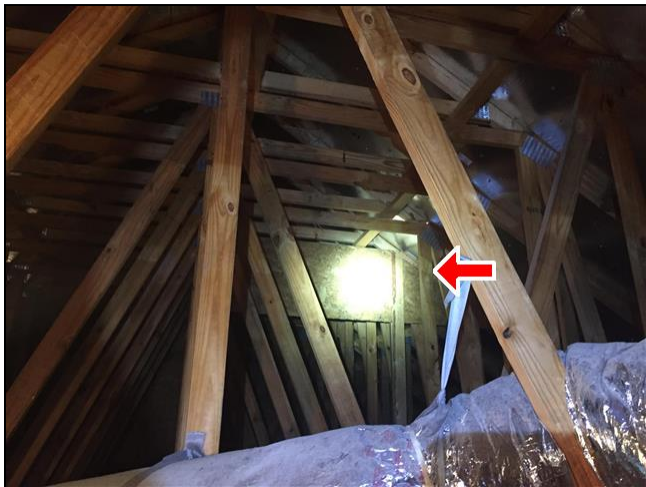
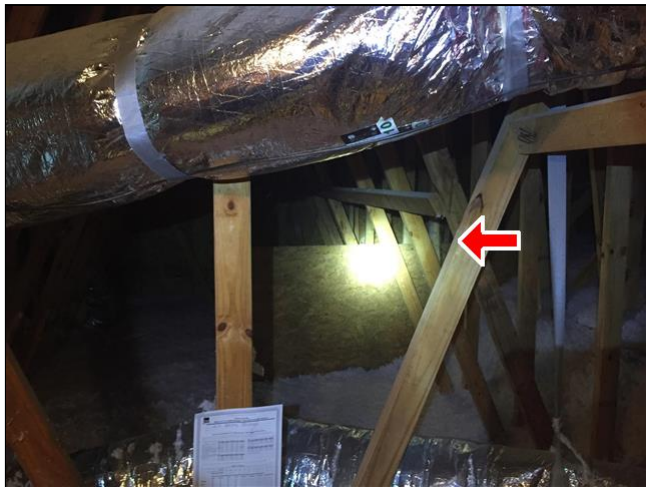
3.1 (1) An engineered roof truss has been cracked, broken or damaged at the left center rear. The truss has been partially braced but the repair does not appear to be adequate. This type of repair is most often completed by installing full size bracing on both sides of the damaged truss member for the full length of the truss.

3.1 Damaged Truss

Further evaluation is advised by an engineer or a truss design professional to determine the full extent of repair needs and to prescribe the repair specifications to meet all structural loads.

It is suggested that a copy of the repair design and certification be posted in the attic, in a plastic bag, and stapled to the repaired truss member. In addition, client may want to keep a copy of the original for disclosure when selling the home in the future and pass it on to the home buyers.

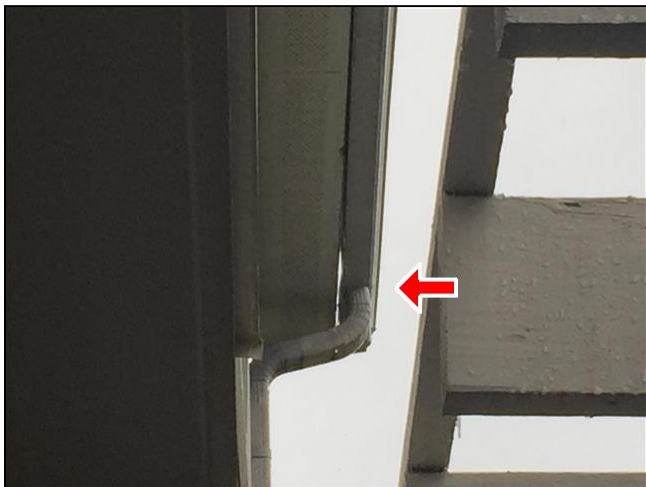
3.8 (1) A gutter is loose at the rear left corner. Repair is recommended so that the gutter is secure and drains properly to the downspout.

3.8 Loose Gutter

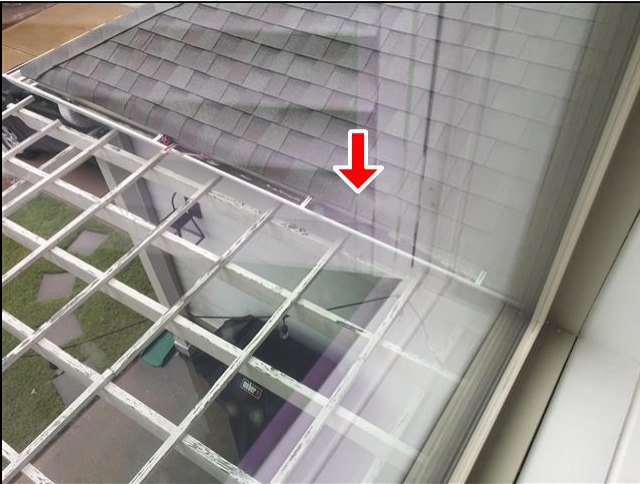
3.8 (2) A gutter is improperly sloped at the left side of the garage and is holding water. Repair / adjustment is recommended so that the gutter is properly sloped and water flows to the downspout.

3.8 Gutter Holding Water

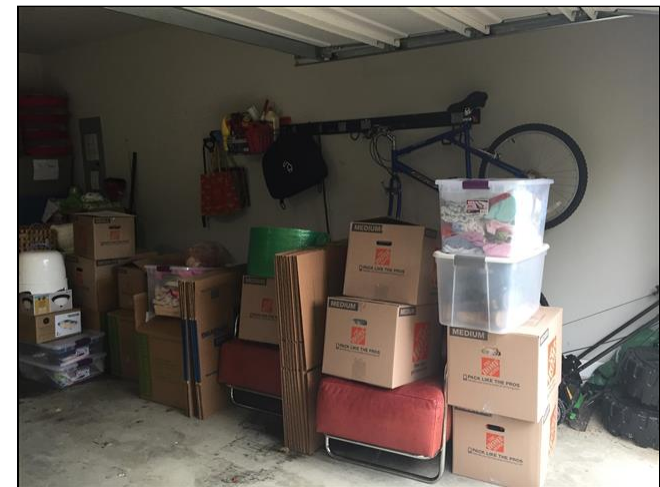
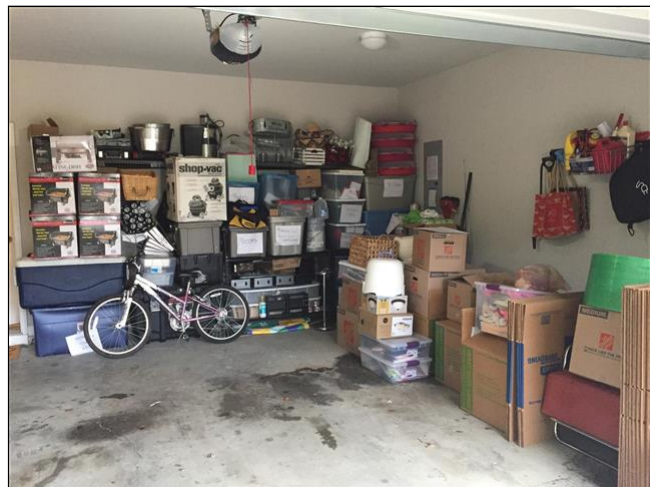
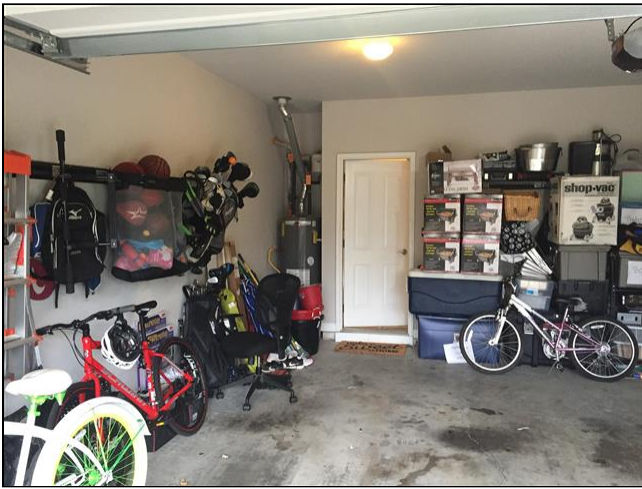
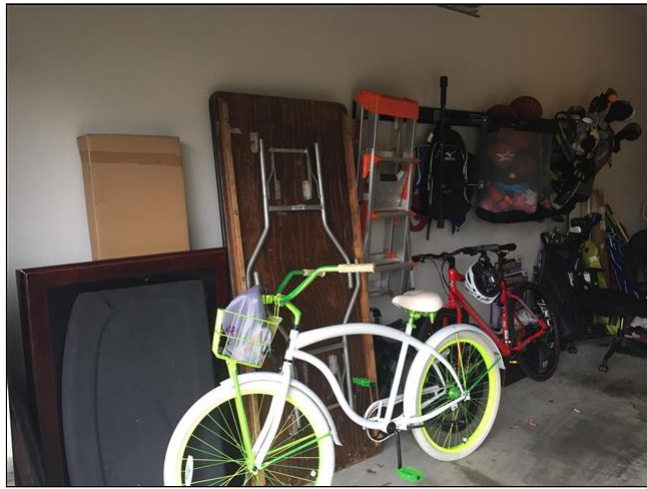
4.2 (2) Storage obstructions in the garage restrict full visibility of the floor and lower walls, unable to fully inspect. Further evaluation is recommended after the storage items have been removed.

4.2 Storage Items

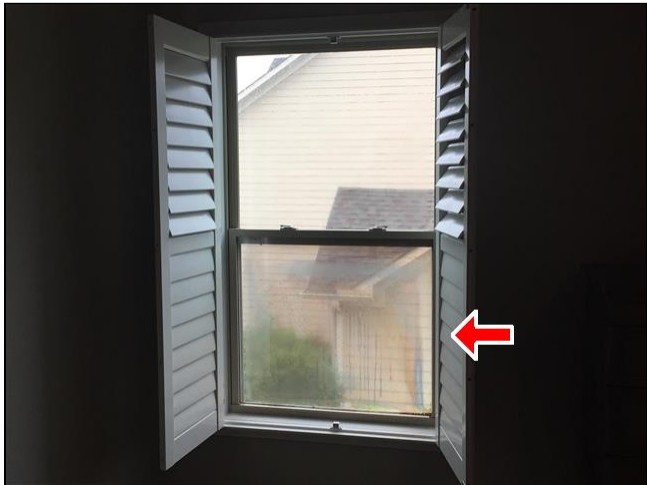
5.5 (1) The exterior coating of the master bedroom left side front window appears to be defective - the surface of the glass has a splotchy / streaky appearance that is not considered normal and can not be removed with cleaning.

5.5 Defective Glazing

Although the window appears to be operating normally, this is a noticeable cosmetic defect. Further evaluation is recommended by a professional window replacement contractor to determine the full extent of repair needs and costs.

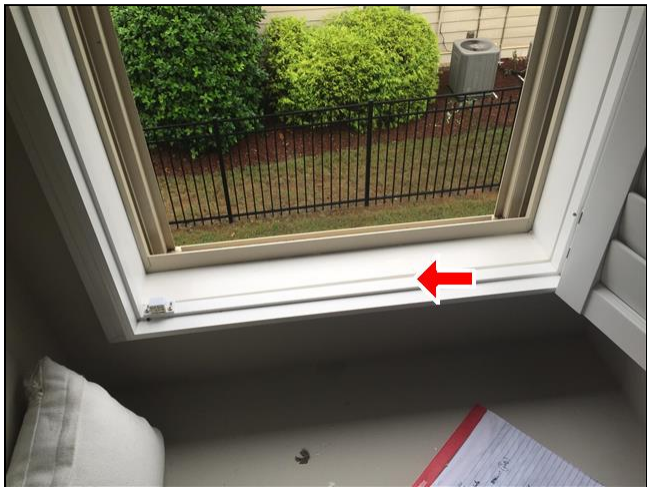
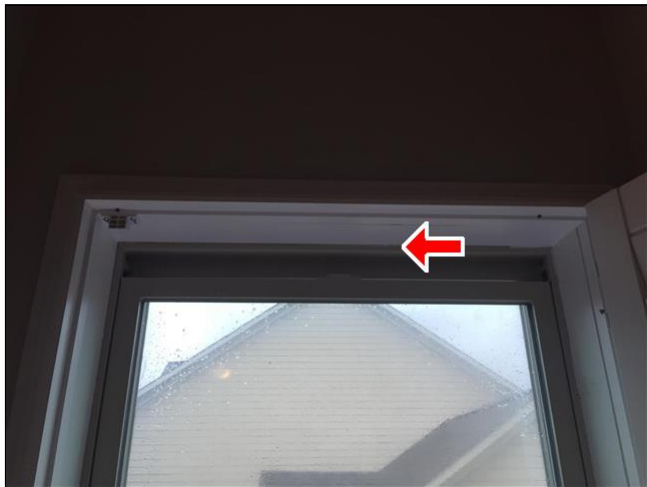
5.5 (2) An active leak and standing water at the sill were noted at the 2nd floor left window at the top of the staircase. May be caused by defective or leaking flashing at the top of the window. Further evaluation and repair/replacement is recommended by a professional window contractor.

5.5 Standing Water

5.5 Leaking From This Area
