# Inspection Report

**Property Address:**  
3461 Henderson Reserve  
Atlanta GA 30341

<b>Date:</b> 9/26/2020	<b>Time:</b> 01:00:00 PM	<b>Report ID:</b> 092620DM922
<b>Property:</b> 3461 Henderson Reserve Atlanta GA 30341	<b>Customer:</b> Kyndal Burton	<b>Real Estate Professional:</b> Mike Ross Muffley & Associates

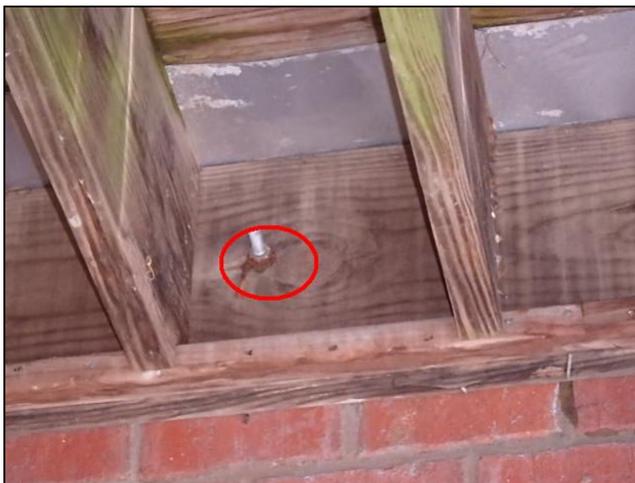
1.4

Rusted hardware noted at various locations at deck. Replace damaged components as needed.

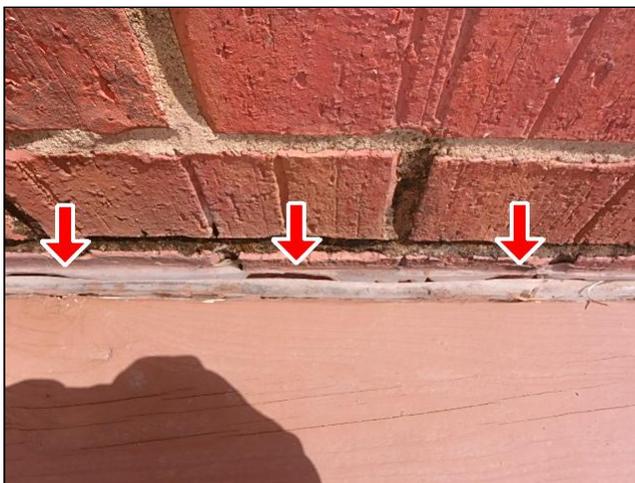
1.8

Seal flashing to brick at top of deck.

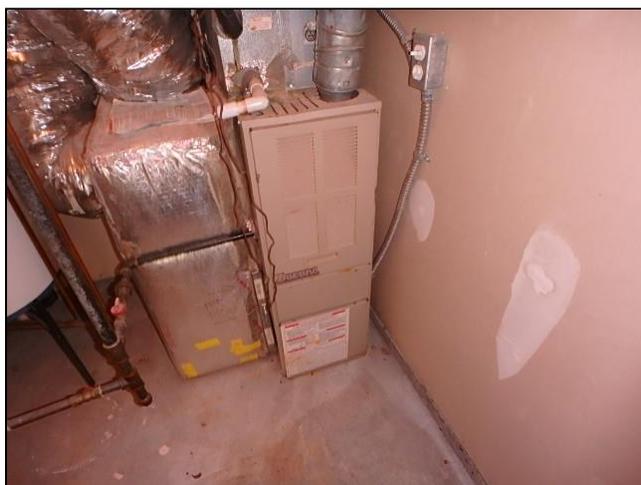
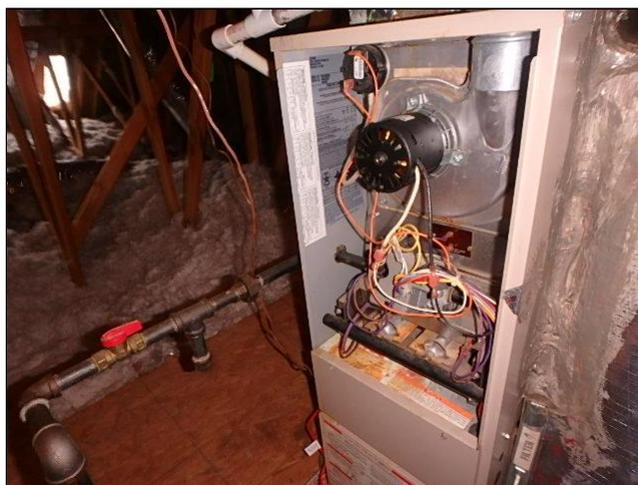
🔧 Have an hvac tech service the heating and cooling equipment to clean the blower motor, the evaporator coils, the condensing coils, the electrical contacts, check refrigerant levels, check size of units compared to size of home and ascertain that the heat exchangers are not cracked and the equipment is safe to operate and functioning properly. Most of internal parts of the hvac system are concealed from view, and our inspection is visual and is intended to check the function of the systems. This inspection does not make any assessment of the internal parts of the air duct system, since it is not visible. Therefore, an hvac tech should evaluate for any concealed defects or hazards in the system. Furthermore, manufacturers recommend annual maintenance and servicing to keep the system working at peak efficiency.

Furnaces usually last to be about 20-25 years and it can be expected that this unit will need replacement in the near future.

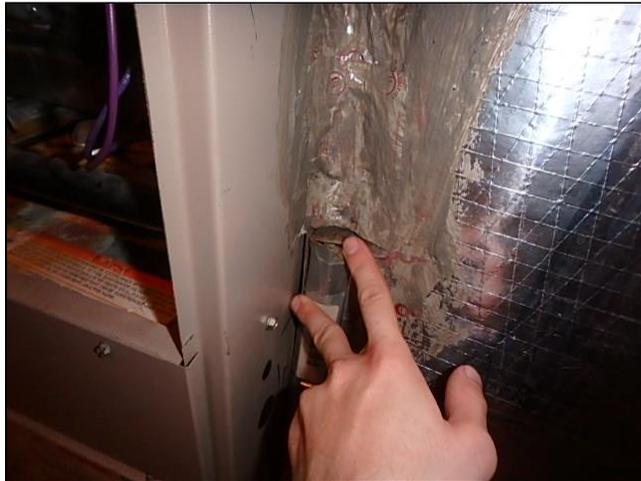
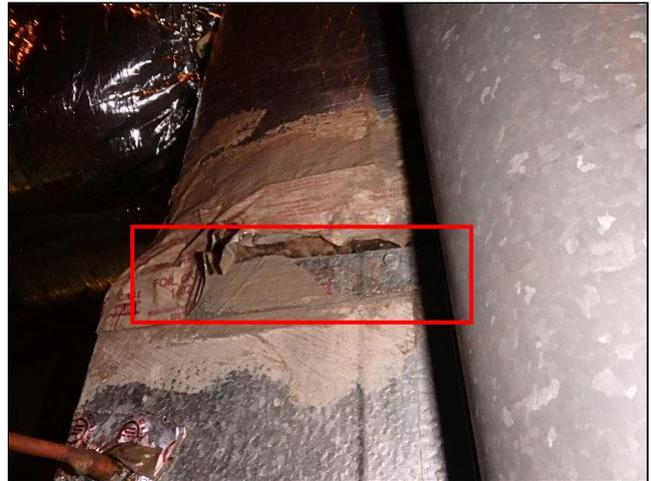
(1) Gaps noted at duct connections to furnaces. Seal to prevent air leaks.

🔧 (1) Gaps noted at duct connections to furnaces. Seal to prevent air leaks.

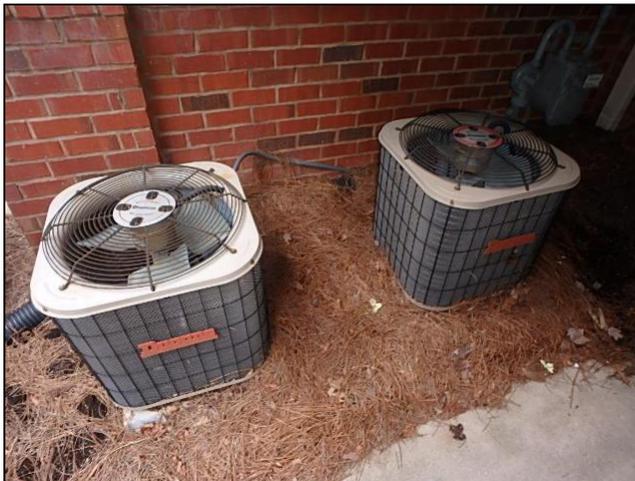
6.6

🔧 (1) Along with servicing the heating unit(s), hvac tech should check refrigerant levels in the a/c system to ensure that the systems are working at peak efficiency. This inspection is visual and checks the operation of the system(s). Unit was not disassembled.

A/c unit(s) usually last about 15 years, and it is likely that the unit(s) in this home will need replacement in the near future.

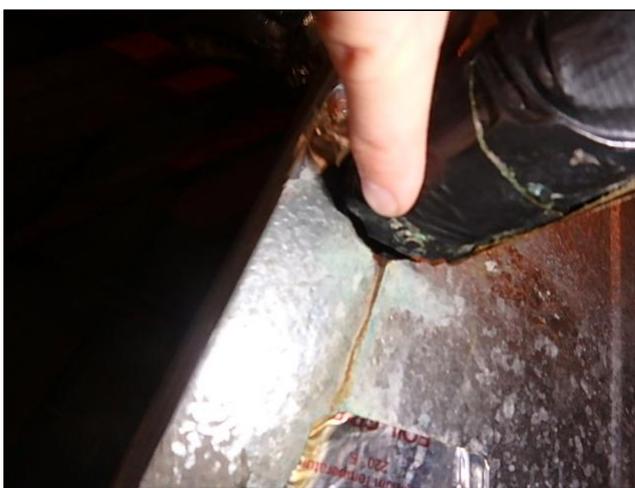
6.6

(2) Gaps found in the insulation wrapping around the refrigerant pipes from the a/c units where these pipes pass through the attic. See photo. Have re-wrapped with more insulation to prevent condensate from dripping on the ceiling.
-

🔧 (2) Gaps found in the insulation wrapping around the refrigerant pipes from the a/c units where these pipes pass through the attic. See photo. Have re-wrapped with more insulation to prevent condensate from dripping on the ceiling.

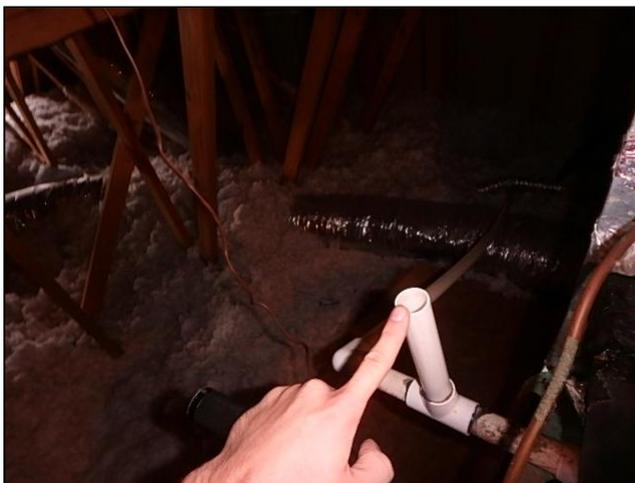
6.6

(3) Cap missing at condensate drain line. Replace cap to prevent cool air loss.
-

🔧 (3) Cap missing at condensate drain line. Replace cap to prevent cool air loss.

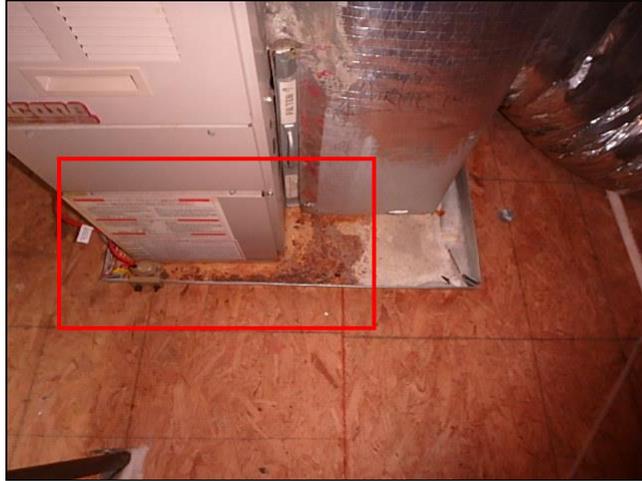
6.6

(4) Rust noted at emergency overflow pan in attic. This indicates a previous issue with the AC system. It can not be verified during the inspection if this issue has been resolved. Consult with an HVAC tech to evaluate as needed.

🔧 (4) Rust noted at emergency overflow pan in attic. This indicates a previous issue with the AC system. It can not be verified during the inspection if this issue has been resolved. Consult with an HVAC tech to evaluate as needed.

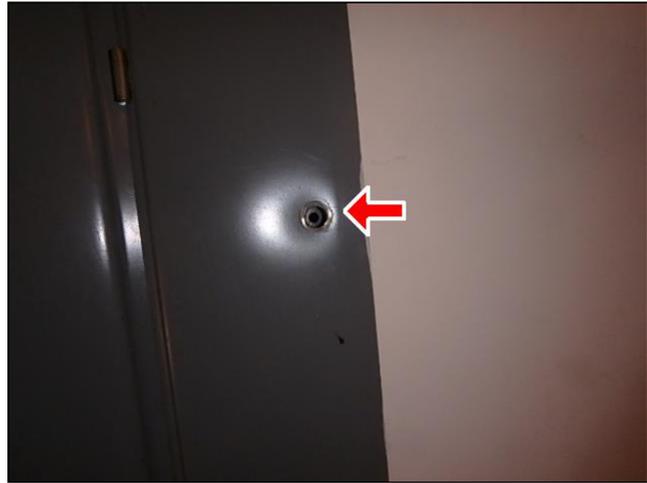
7.2

(2) Replace missing screw at panel cover.

🔧 (2) Replace missing screw at panel cover.

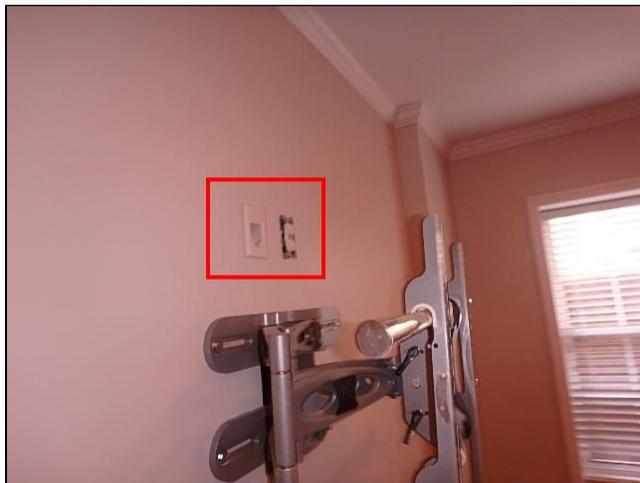
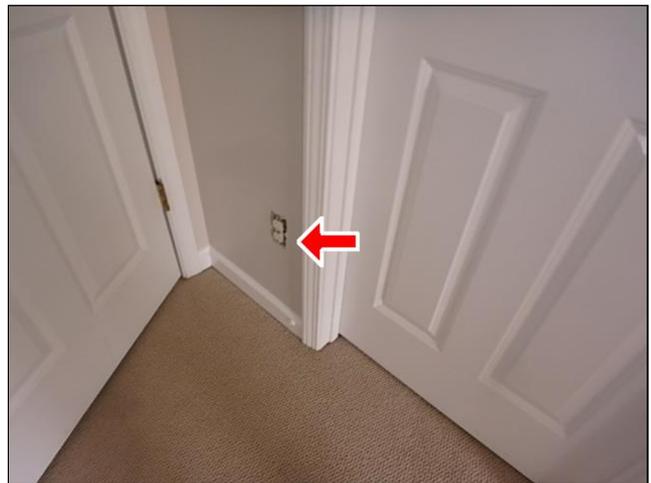
Cover needed on the open junction box in the locations in photos. Covers are used to control sparking.

🔧 Cover needed on the open junction box in the locations in photos. Covers are used to control sparking.

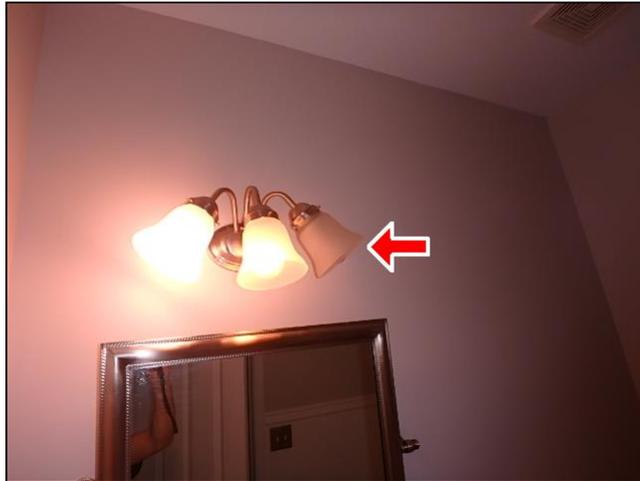
7.4 Basement Bath

(1) Replace out bulb at basement bathroom.
-

🔧 (1) Replace out bulb at basement bathroom.

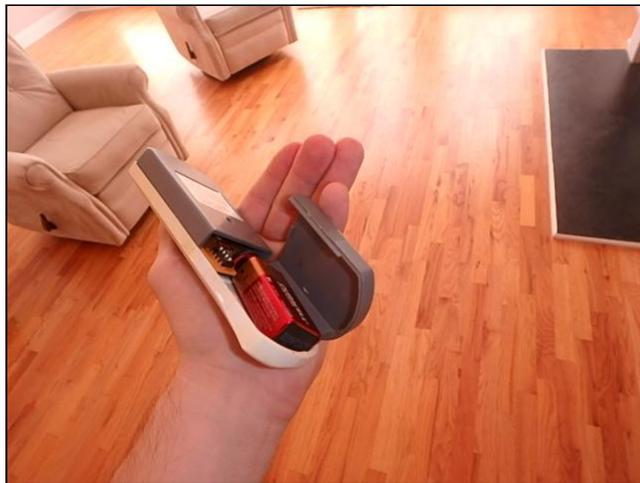
7.4

(2) Family room light remote is damaged. Repair/replace as needed.

🔧 (2) Family room light remote is damaged. Repair/replace as needed.

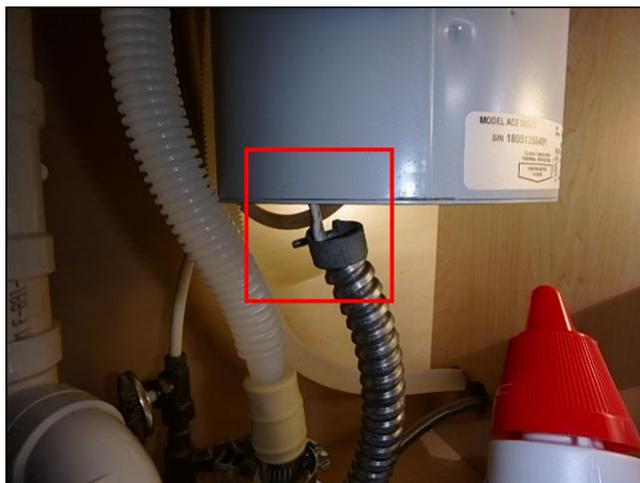
7.5

Loose conduit attachment noted at garbage disposal. Secure conduit to prevent chaffing on the wire.

🔧 Loose conduit attachment noted at garbage disposal. Secure conduit to prevent chaffing on the wire.

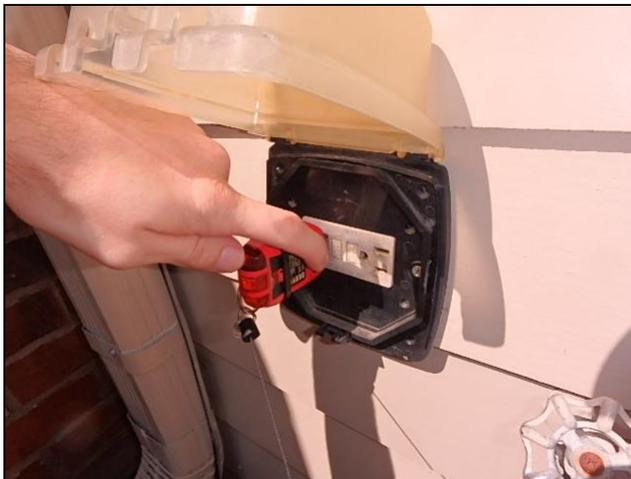
7.6 Rear Deck

- 🔧 Defective gfci outlet noted at the location in photo. Outlet(s) did not trip when tested. Have electrician replace with a working unit. GFCI outlets are used to protect personnel in wet areas.

🔧 Defective gfci outlet noted at the location in photo. Outlet(s) did not trip when tested. Have electrician replace with a working unit. GFCI outlets are used to protect personnel in wet areas.

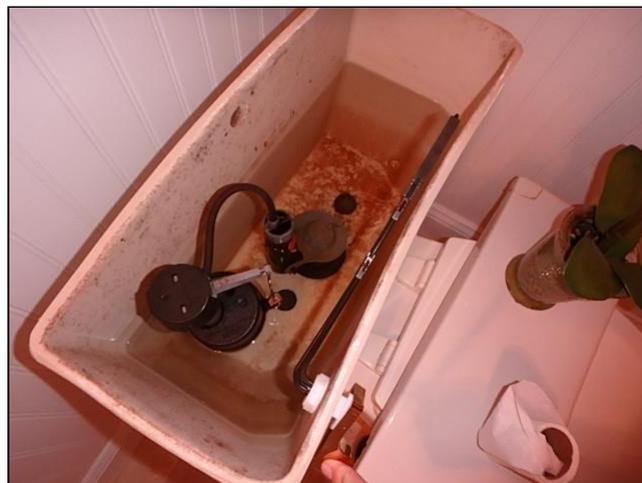
8.2 Basement Bath

🔧 (1) Replace damaged flush mechanism at basement bathroom toilet.

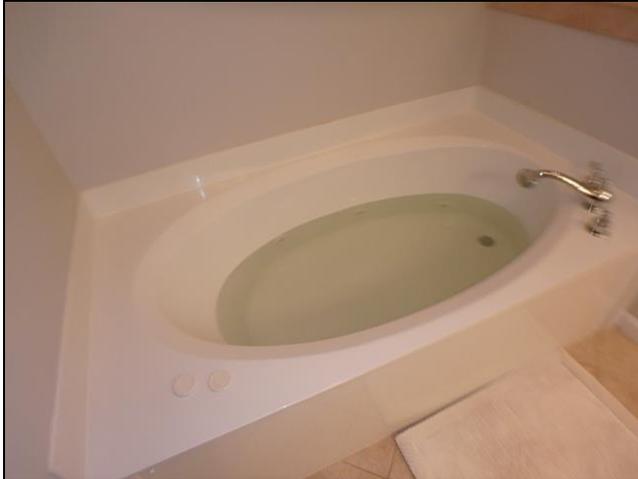
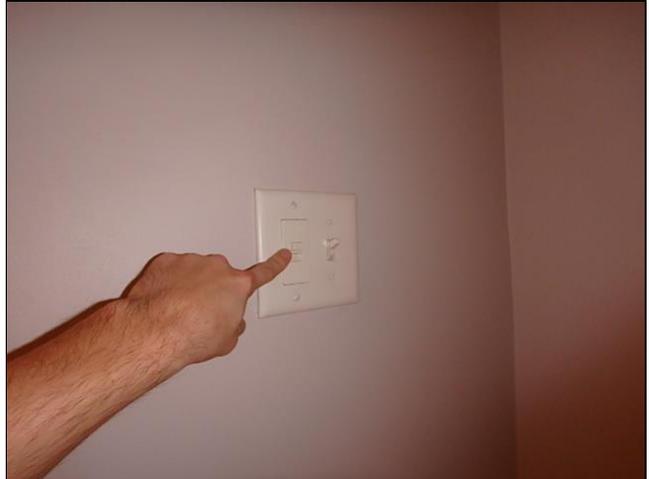
🔧 (2) The jacuzzi tub did not operate during inspection. The GFCI would trip anytime the motor was activated. Consult with a plumber to evaluate and repair/replace as needed.

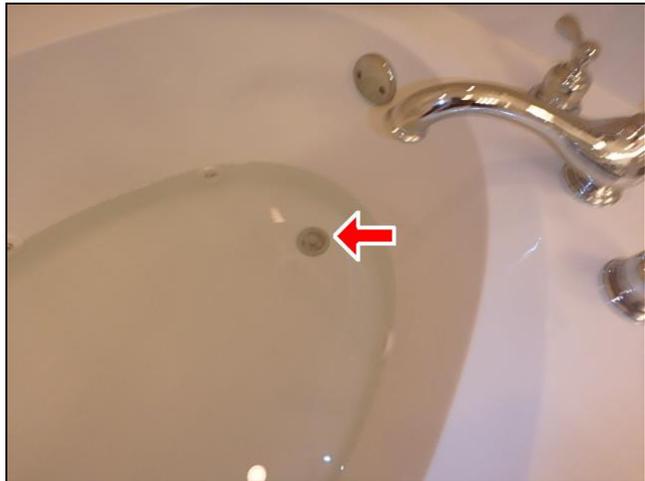
8.2

🔧 (3) Stopper defective/missing at bathroom fixture in photo. Adjust/replace as needed.

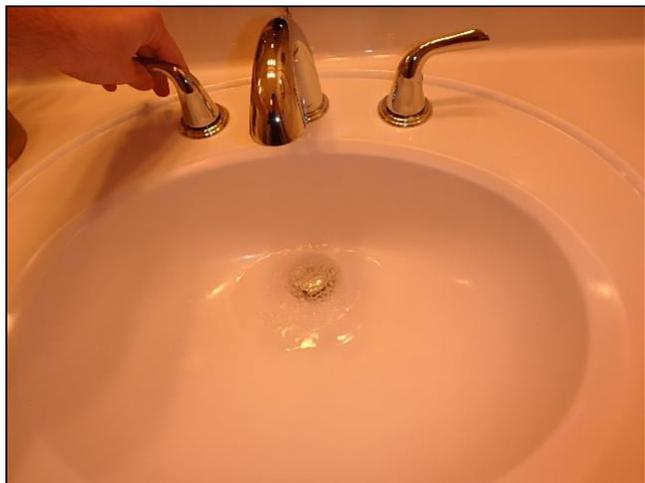
8.2 Master Bath

🔧 (4) Slow drain in the fixture in photo noted. Have checked for a clog.

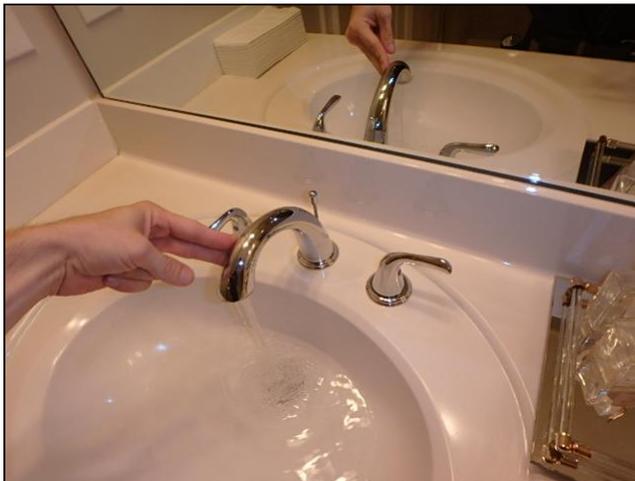
8.2 Master Bath

🔧 (5) Secure the loose sink fixture in the master bath as needed.

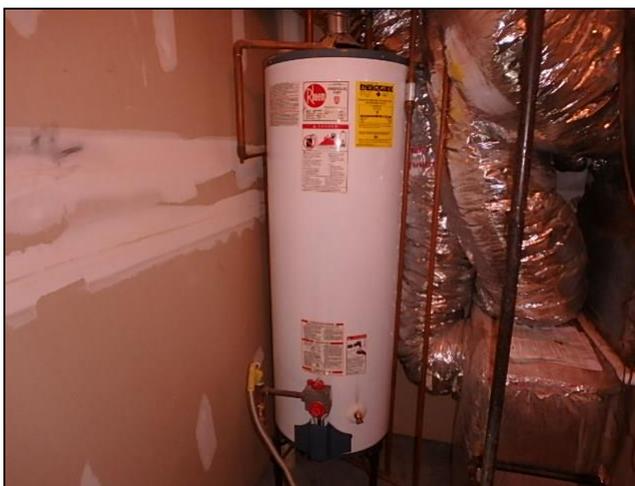
8.3

- 🔧 Water heaters generally last about 10-12 years before needing replacement. Current water heater works and makes hot water but will likely need replacement in the near future due to its age.

🔧 Water heaters generally last about 10-12 years before needing replacement. Current water heater works and makes hot water but will likely need replacement in the near future due to its age.

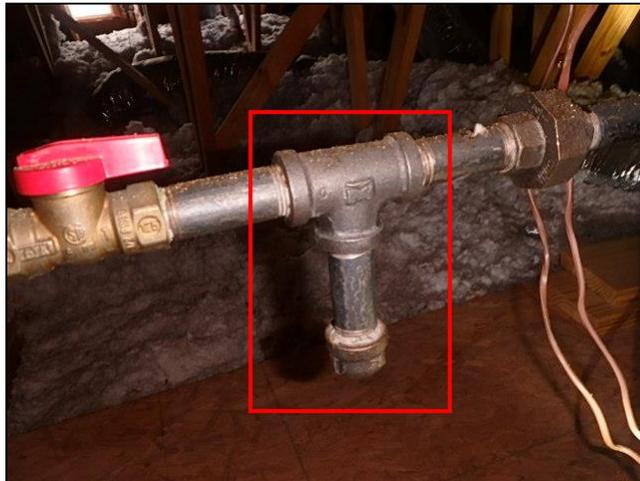
8.5

- 🔧 Sediment traps (or drip legs/slang term) are not installed in the correct orientation for the attic furnace This was permitted when the home was built, however, it does not meet current standards and the gas companies requirements. Hvac tech can evaluate. Gas company may not connect gas for new owner if this is discovered. See photo(s).

🔧 Sediment traps (or drip legs/slang term) are not installed in the correct orientation for the attic furnace. This was permitted when the home was built, however, it does not meet current standards and the gas company's requirements. HVAC tech can evaluate. Gas company may not connect gas for new owner if this is discovered. See photo(s).

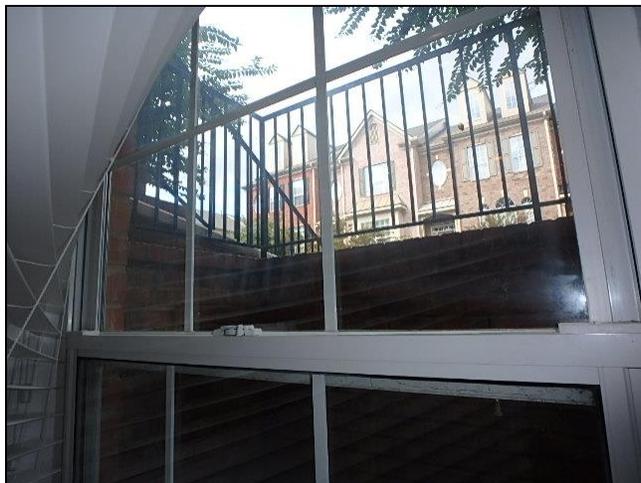
9.5 Basement Bedroom

👉 (1) Replace all "fogged" windows. The seal between the panes of glass has failed allowing moisture to enter between the panes. It is possible that more may fog in the future. Have window contractor evaluate all windows because it is highly likely that if one window has had a seal failure, that more seal failures in different windows will occur. See photos for examples. It is difficult to identify seal failure in windows when the weather is rainy, over cast, foggy or the glass is wet from recent rains or condensation. Buyer should resolve all concerns prior to closing.

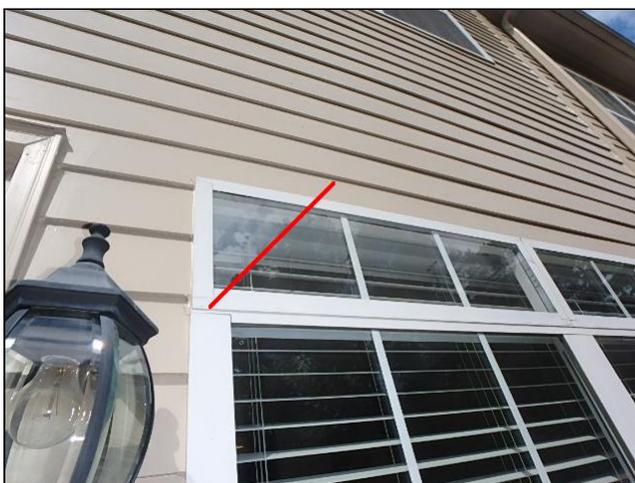
9.5 Rear Deck

🔧 (2) Replace cracked glass found in windows pictured.

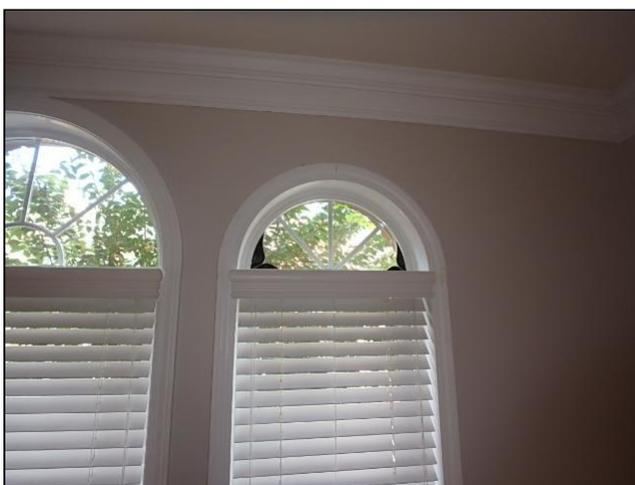
9.5 Dining Room

🔧 (3) Seals between panes of glass in the dining room window have moved out of position and can be seen in between the panes of glass. Seals have not failed and windows do not appear to be fogged.

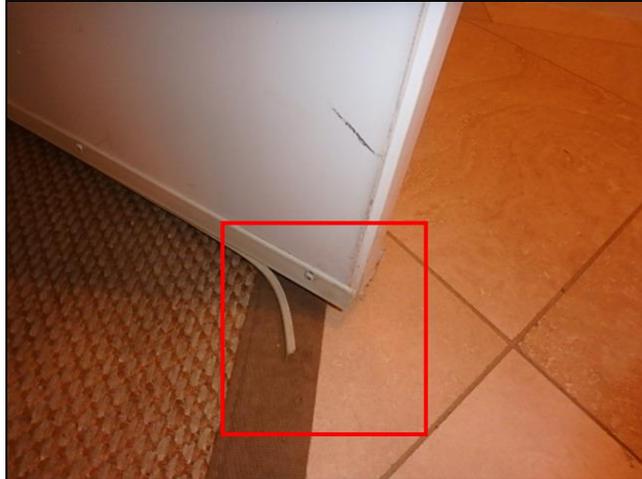
9.7 Garage Entry

Repair/replace the damaged door sweep at the garage entry.

🔧 Repair/replace the damaged door sweep at the garage entry.

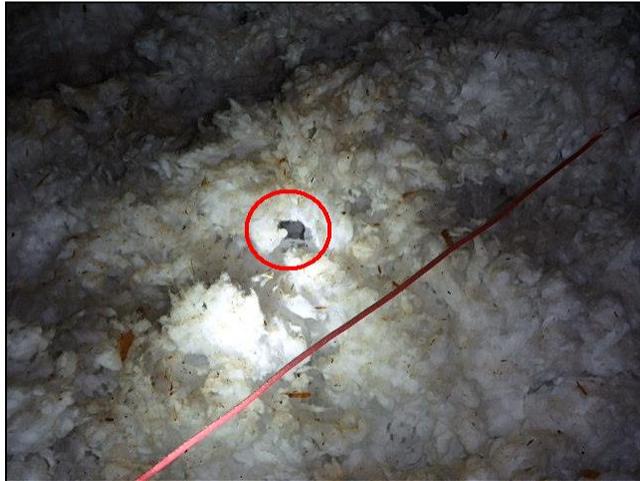
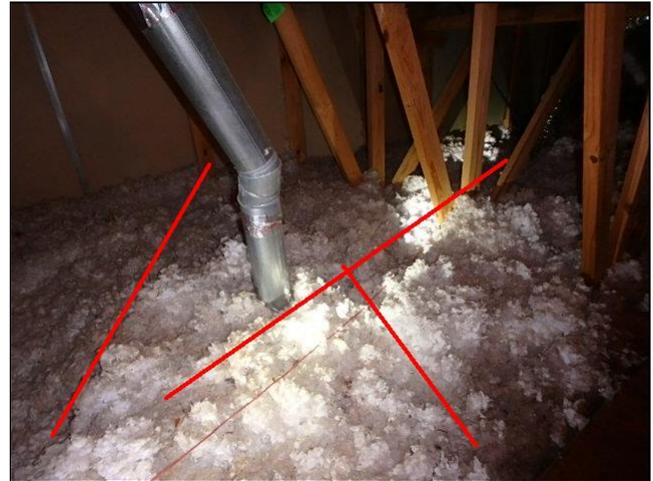
Evidence of past animal entry into the attic, as noted by the paths and "tunnels" in the insulations. Exact entry point into attic from outside is not known. Wild life exclusion company can evaluate to seal off attic from outside

🔧 Evidence of past animal entry into the attic, as noted by the paths and "tunnels" in the insulations. Exact entry point into attic from outside is not known. Wild life exclusion company can evaluate to seal off attic from outside

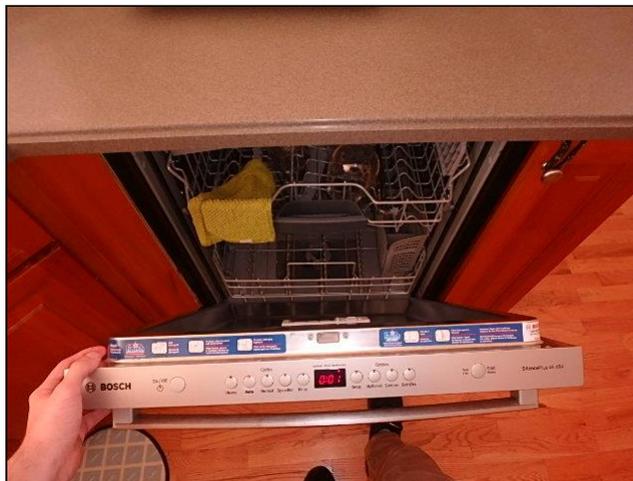
10.0

Secure the loose dishwasher to the counter top in the kitchen.

🔧 Secure the loose dishwasher to the counter top in the kitchen.

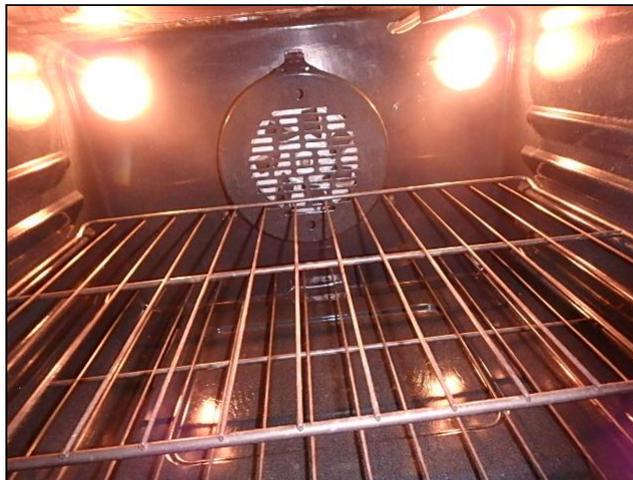
10.1

Convection fan did not operate during inspection. Have seller demonstrate function. Consult with an appliance tech to evaluate and repair as needed.

🔧 Convection fan did not operate during inspection. Have seller demonstrate function. Consult with an appliance tech to evaluate and repair as needed.
