# AccuSpect Home Inspections, Inc.

## SUMMARY REPORT

**Client:** Kathy Varuolo  
**Realtor:** Mendy Short, Sherry & Co Real Estate  
**Inspection Address:** 9010 Carroll Manor Dr, Atlanta, GA 30350  
**Inspection Date:** 9/28/2020 Start: 8:30 am End: 1:00 pm  
**Weather:** Partly Cloudy  
**Temperature:** 70-80 Degrees  
**Inspected by:** Gary Edge

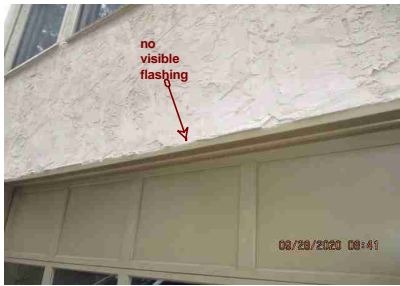
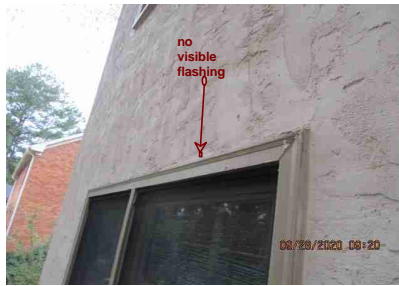
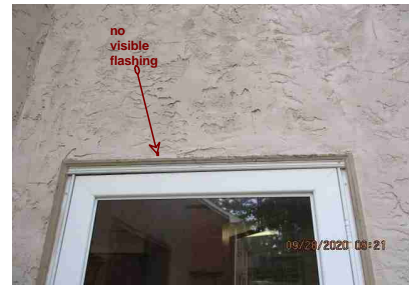
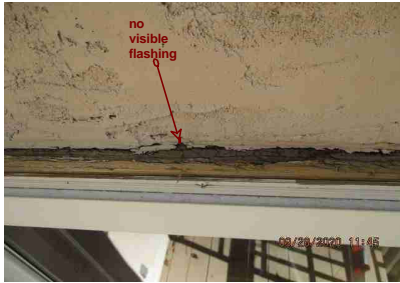
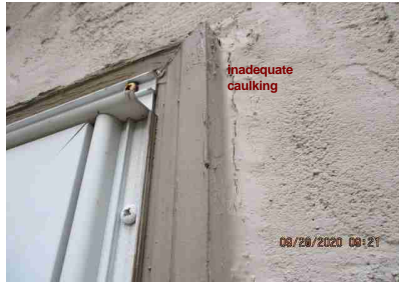
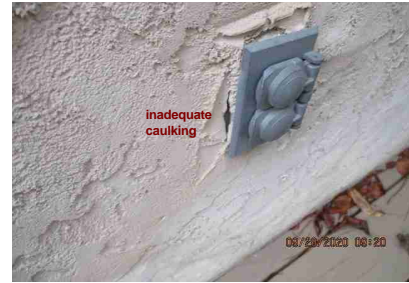
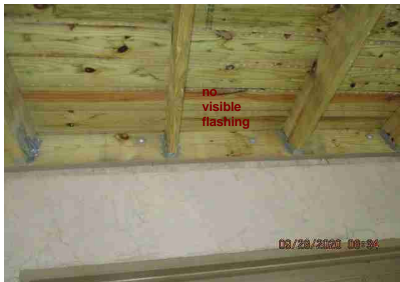
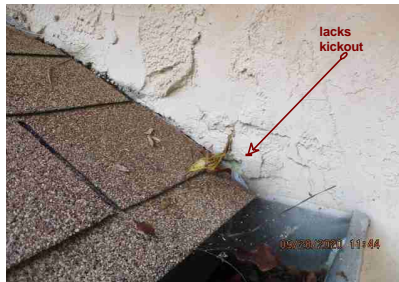
- 2.1 - The house is stucco and it extends to and below grade level. We recommend that you have an EDI certified stucco inspector or contractor evaluate and recommend any repairs required  
We noticed the following areas which should be addressed:
1. There is no visible flashings over the windows and doors,
  2. The caulking of penetrations appear inadequate.
  3. There is no visible flashing between the house and deck ledger.
  4. There is no kickout where roof eave meets vertical wall.

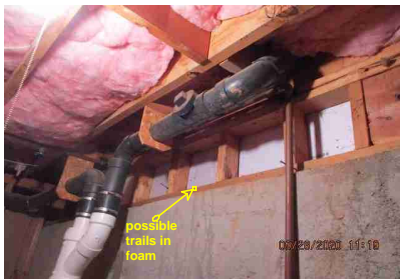
- 2.2 - Georgia is in the very heavy termite infestation zone and an inspection by a qualified termite contractor is recommended before closing. We did notice some trails in the foam insulation above the foundation wall which the contractor should evaluate. We did determine the foam insulation has enough clearance to grade (more than 6 inches).

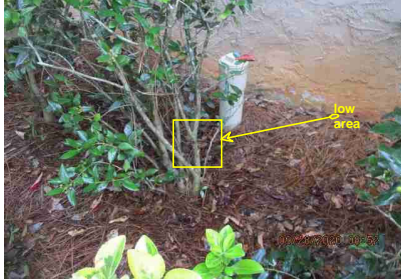
- 2.3 - There is a low area adjacent the sewer cleanout near the front of house. This area should be filled with soil, compacted and sloped away from the structure.

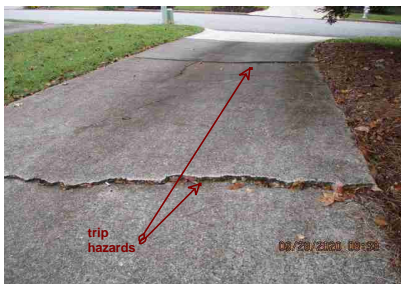
- 2.4 - There are settled and raised areas in the driveway that could prove to be trip-hazards which should be repaired by a concrete leveling contractor..

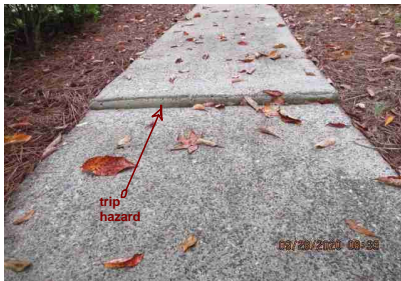
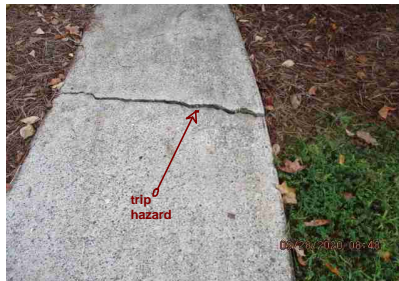
- 2.5 - There are raised areas in the walkway that could prove to be trip-hazards and should be repaired by a concrete leveling contractor.

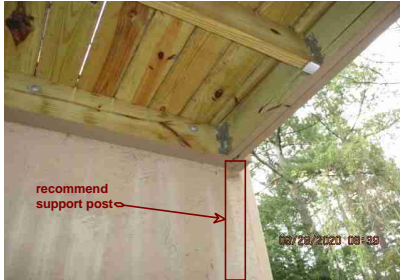
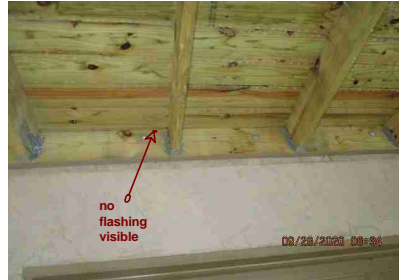
- 2.6 - The rear deck is not constructed in compliance with the 2012/2018 IRC R507.2.2. The following items do not comply:
1. The deck girder (beam) is supported by a ledger at the house. The IRC states" ...Girders supporting

deck joists shall not be supported on deck ledgers or band joists..."  
Recommend supporting this girder with a support post with proper footing.  
2. There is no flashing at the ledge as required by Table 507.2 c.

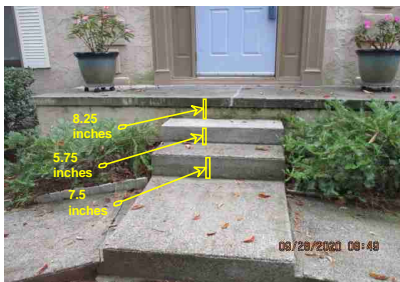
2.7 - The steps at the front porch have unequal risers. Steps are required to be uniform to prevent trip-hazards. The rise of any step should be no greater than 7 3/4 inches. Also, the dimensions of the largest step should not exceed that of the smallest by more than three-eighths of an inch. These exceed the maximum difference in rise and are trip hazards.

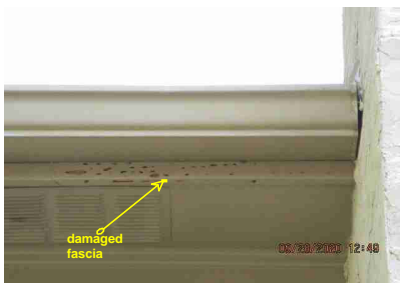
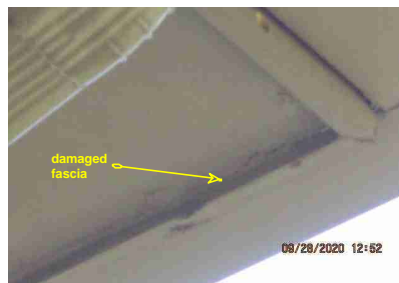
2.8 - There is damage to the fascia at the right front. Most appears to be from carpenter bees.

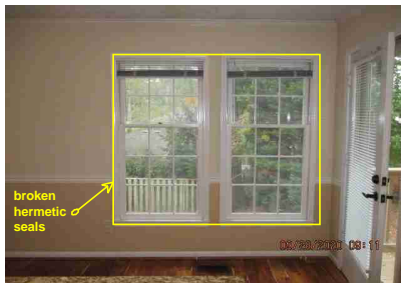
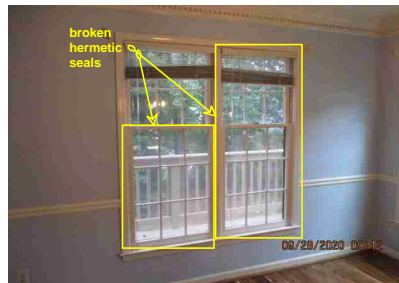
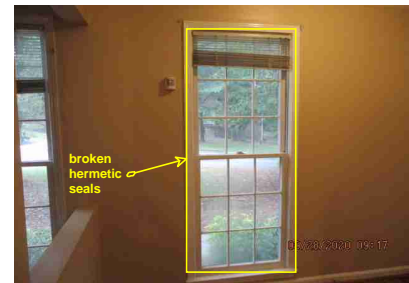
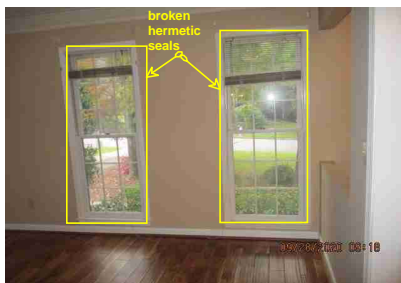
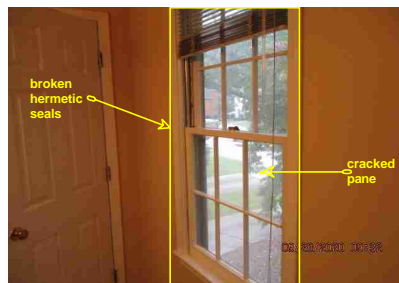
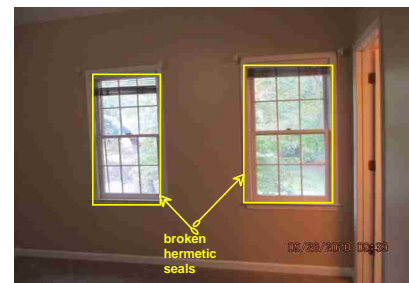
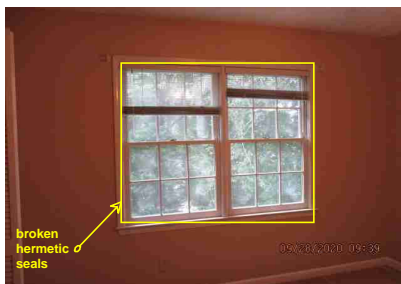
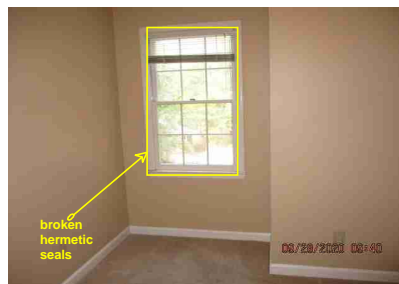
2.9 - There are 25 window panes with broken hermetic seals in the house. These are the obvious ones listed, but it is possible there are more which do not yet show signs of moisture. The following panes should be replaced by a qualified glass or window contractor:

1. Breakfast room--All four panes
2. Dining room--Upper and lower right and lower left panes

3. Foyer--Both panes
4. Living room--All four panes
5. Master bathroom--Both panes (Bottom pane is cracked also)
6. Master (front) bedroom--All four panes
7. Right rear bedroom--All four panes
8. Left rear bedroom--Both panes

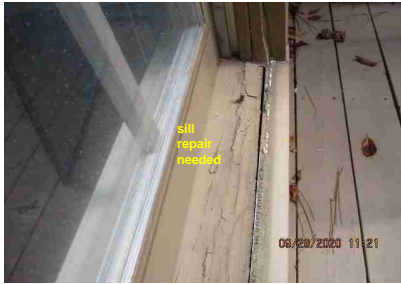
2.11 - The dining room rear window needs rear and caulking at the sill.

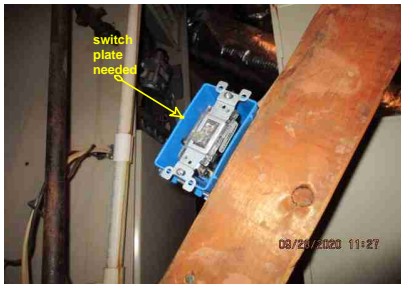
- 3.1 - There is a switch in the attic which needs a faceplate. (The seller should advise the purpose of the switch)

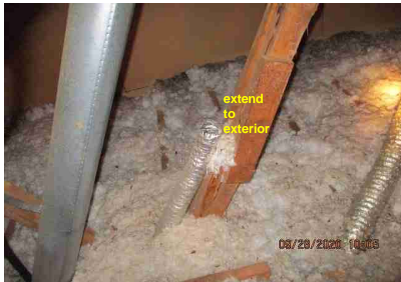
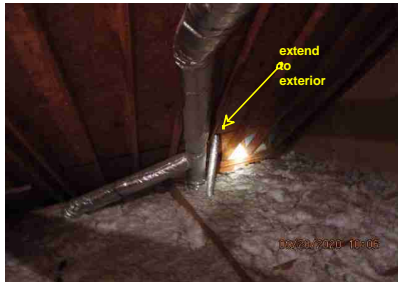
- 3.2 - The bathroom exhaust ducts vent into the attic and should be extended to the exterior to prevent warm moist air discharging into the attic.

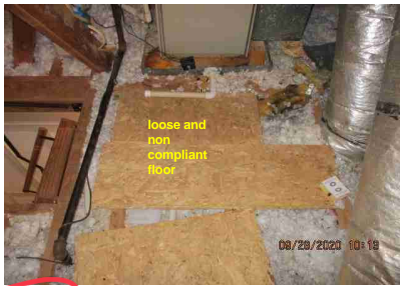
- 3.3 - The service platform installed for the attic air handler is not wide or deep enough. Current requirements are a 30" deep and at least 30" wide platform on the service side of furnace/air handler. This platform should be secured in place for safety.

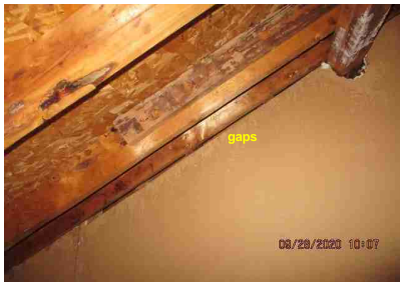
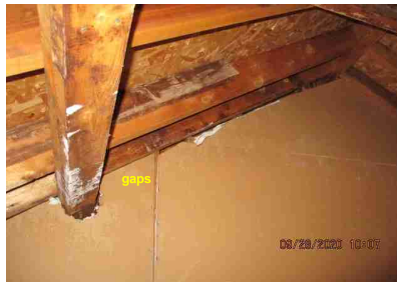
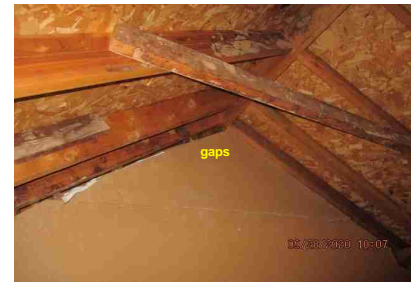
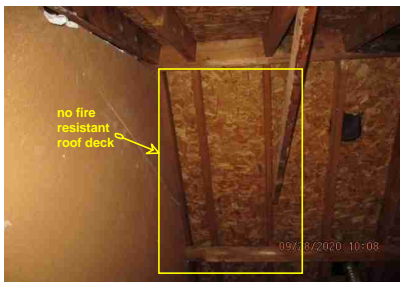
3.5 - The firewall which is designed to retard the spread of fire from an adjoining unit needs repair as there are gaps that should be sealed by a qualified contractor. There is also no fire resistant roof deck within 4 feet of the firewall as would be required by current requirements.

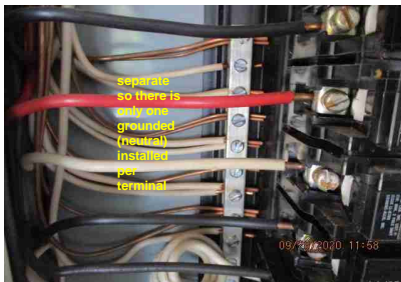
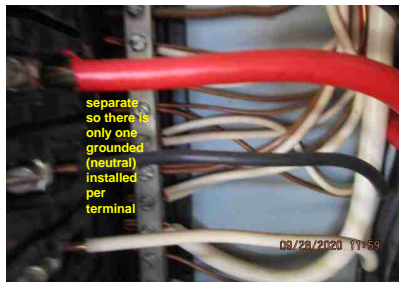
- 5.2 - There are neutral terminals in the electric panel with two grounded (neutral) conductors attached. The manufacturer did not identify these terminals for more than one conductor. A licensed electrician should separate these conductors and install one conductor on one terminal per the NEC 110.14 and 408.41.

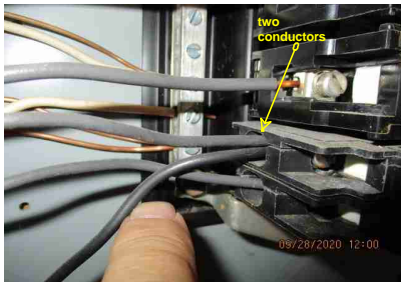
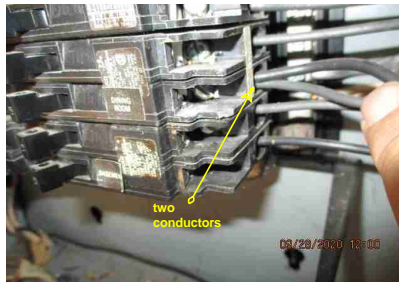
- 5.3 - Two breakers in the main panel are serving two circuits and there is no room within the panel to add additional breakers. This condition should be corrected by a licensed electrician.

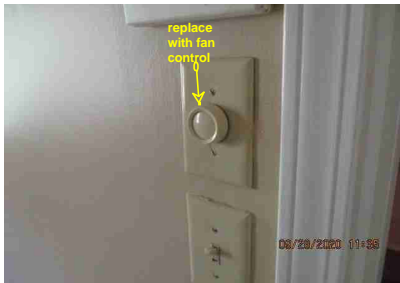
- 5.8 - The dimmer used as a fan control in the master bedroom should be replaced with a proper fan control switch.

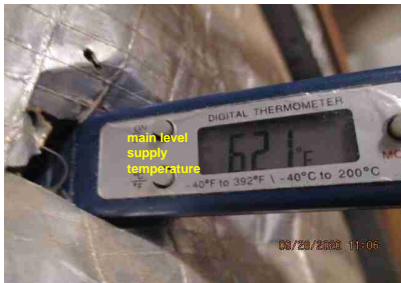
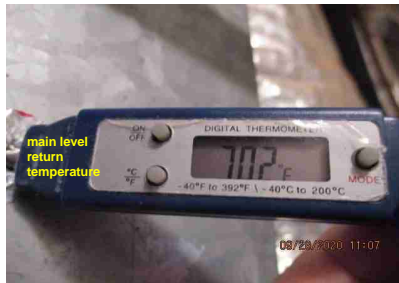
- 7.2 - The main level air-conditioning responded, but only achieved a low differential temperature split (8 degrees) between the air entering the system and that coming out. This could indicate that the system is low on refrigerant, and should be serviced by a licensed HVAC contractor.

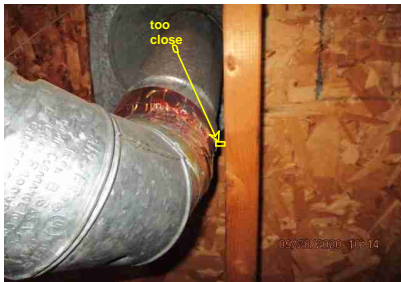
- 7.4 - The double-walled attic furnace vent pipe should be at least one inch away from the roof framing, and should be corrected by an HVAC contractor.

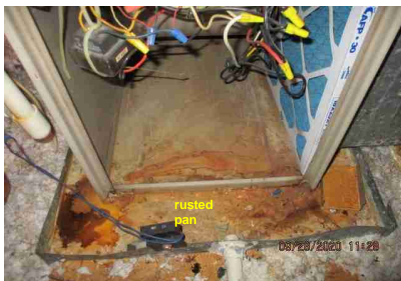
- 7.5 - The drip pan for the attic furnace is corroded which indicates a condensation drain blockage in the past that the seller should explain.

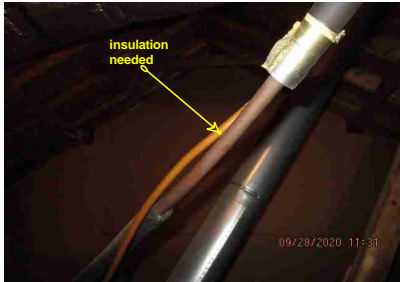
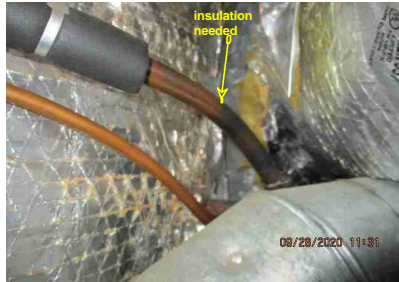
- 7.6 - There are small areas of refrigerant line missing insulation in the attic. These areas should be insulated to prevent condensate dripping on the ceiling below.

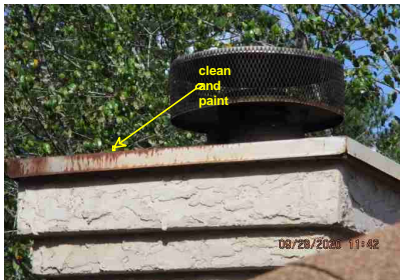
8.1 - The metal rain pan on the chimney should be cleaned and painted with a rust resistant paint to prevent further deterioration.

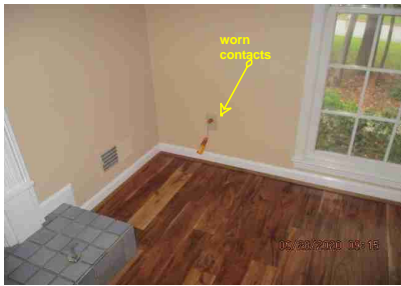
9.2 - The receptacle outlet between the front window and the living room fireplace has worn contacts and should be replaced.

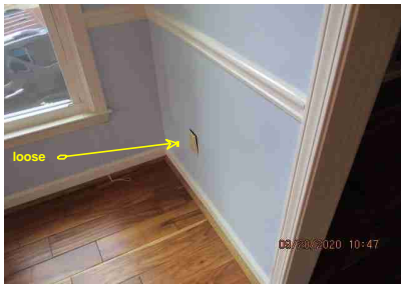
9.4 - The loose receptacle outlet in dining room should be secured.

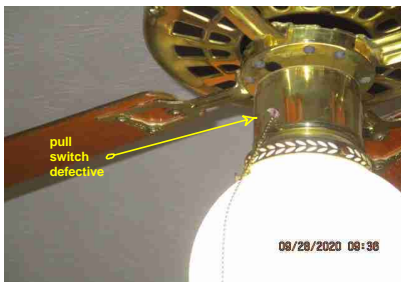
10.1 - The ceiling fan and light in the master bedroom did not respond. This should be shown to function or should be replaced. The pull switch appears defective.

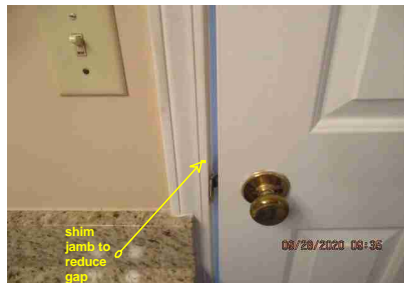
11.1 - The master bathroom door jamb should be shimmed to reduce gap so the latch pin can engage and lock the door.

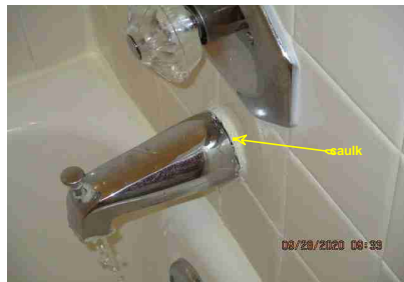
11.2 - The master bathroom tub faucet should be caulked at the wall to prevent moisture intrusion into the wall.

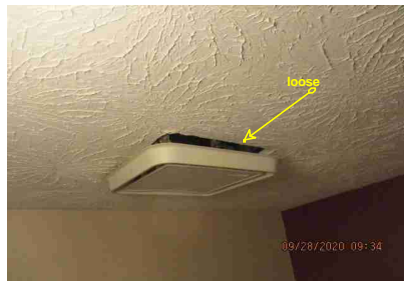
11.3 - The loose fan cover in the master bathroom should be secured flush with the ceiling.

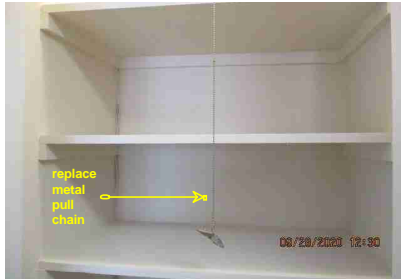
19.2 - Recommend replacing the metal pull chain on the pantry light. It is electrically conductive

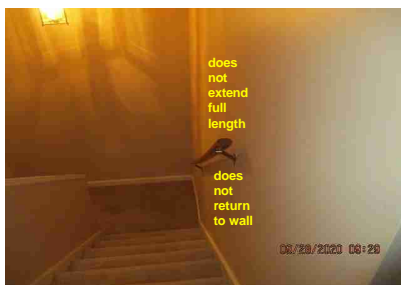
19.4 - The handrails on the stairs do not comply with the requirement of continuous the full length of the flight, from a point directly above the top riser to a point directly above the bottom riser. (They also do not return to the wall for safety)

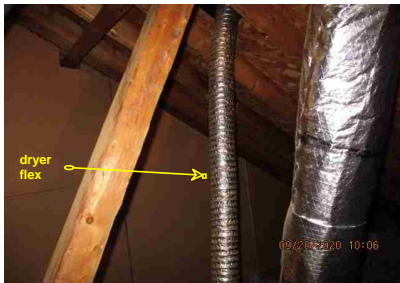
19.5 - The dryer duct in the attic should be a smooth-walled, metal type to avoid trapping lint and becoming a fire hazard. The flex duct should be replaced by a qualified contractor.

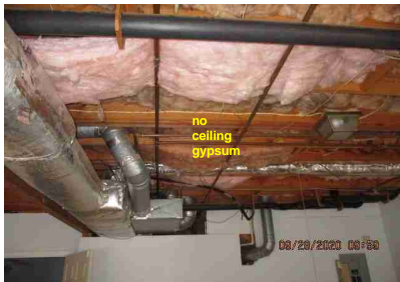
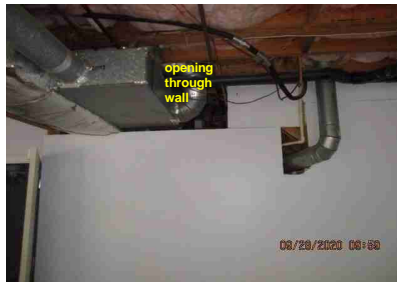
19.6 - There is no fire separation between the garage and the living areas above and the finished basement area, and you should consider installing a 1/2" gypsum ceiling as a safety upgrade, as well as repairing all openings through the wall.

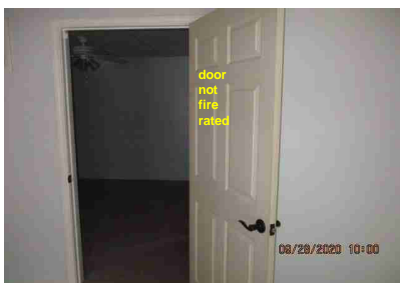
19.7 - The entry door from the garage into the house is hollow-core and should be solid-core or fire rated, to maintain the necessary fire separation between a garage and living quarters, and should be replaced as a safety upgrade.
