Atlanta Property Inspections, Inc. HOME INSPECTION REPORT

130 Lambdin Lane, Alpharetta, GA 30022

Inspection prepared for: Nancy Aranson

Date of Inspection: 9/26/2020 Time: 28 Years Old (1992)

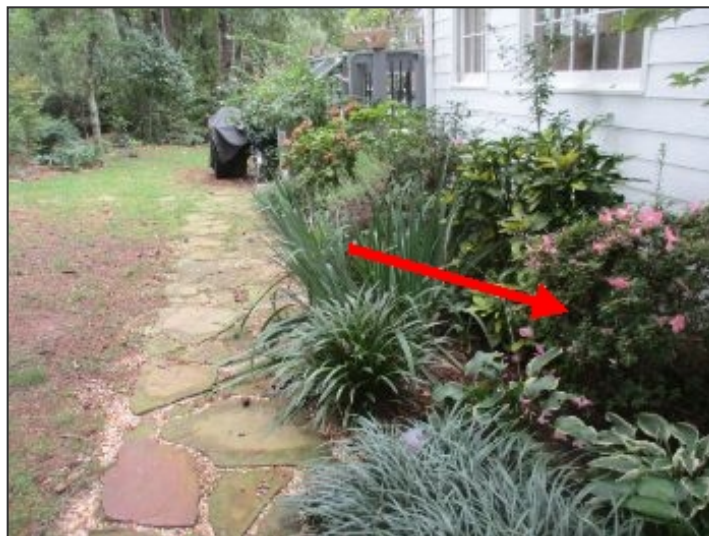
Reverse grading was observed at the rear family room yard. The soil incorrectly slopes back towards the foundation. This condition can lead to water entry issues if not corrected. No signs of water entry was noted in the basement.

Reverse grade at family room rear yard

General construction practice requires a positive slope away from the foundation for adequate drainage. It is recommended that the slope be at least 6 inches within the first 10 feet to meet current drainage requirements, (other approved methods such as catch basin drains may be used). Due to this concern, regrading of the soil is recommended to provide a positive slope away from the foundation wall area. Continue to monitor.

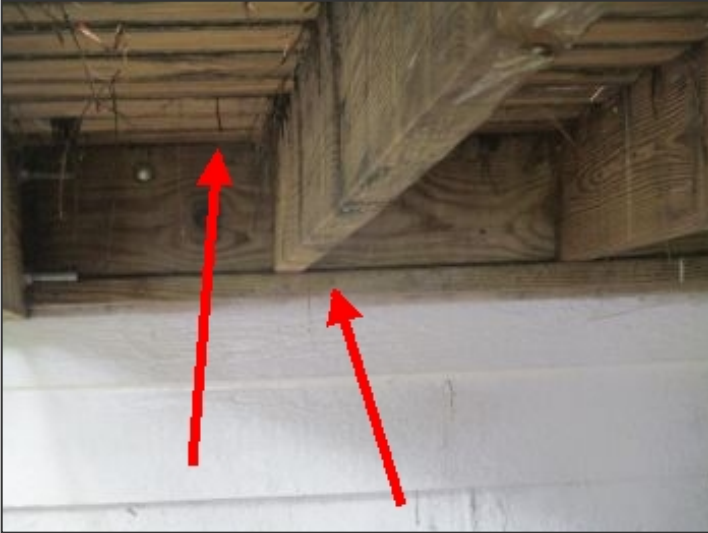
1. No ledger flashing is present at the deck connection to the house;
2. The deck ledger board is anchored to the rear bay window / door which is no longer allowed in newer building codes; the bay window is not framed or rated for this type of structural attachment. Although there are no signs of any structural stress at this location during this limited visual inspection, it is recommended that vertical support be installed below the deck to bay window connection, to relieve the bay window of any additional future stress.
3. Inadequate nailing at the 2x2 strip; joist hangers are recommended;

Missing flashing and joist hangers
recommended at ledger board

Due to these concerns, further evaluation is recommended by a professional deck contractor to determine the full scope of repair needs and costs. All repair or replacement work should meet the safety requirements and standards of the current building codes for decks. Client is advised to obtain written receipts and warranties of the work completed.

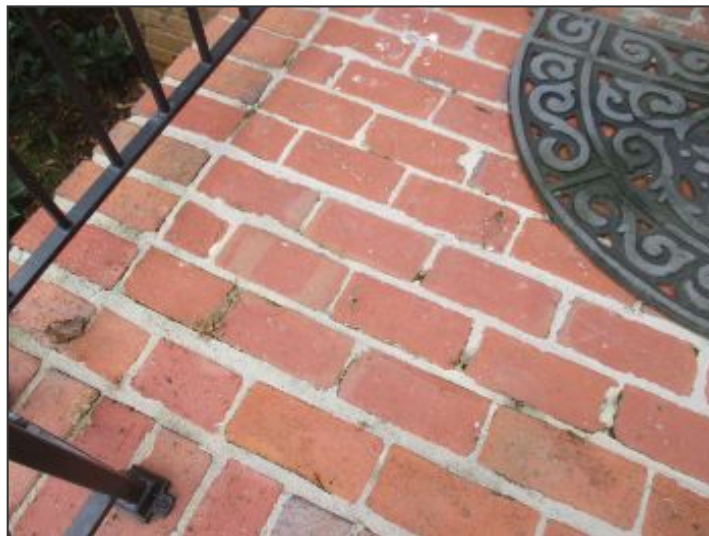
Deteriorating mortar joints were noted at the brick porch; repair is recommended to prevent continued water entry and ice formation which can cause further damage to the brick mortar.

Deteriorating mortar at front porch

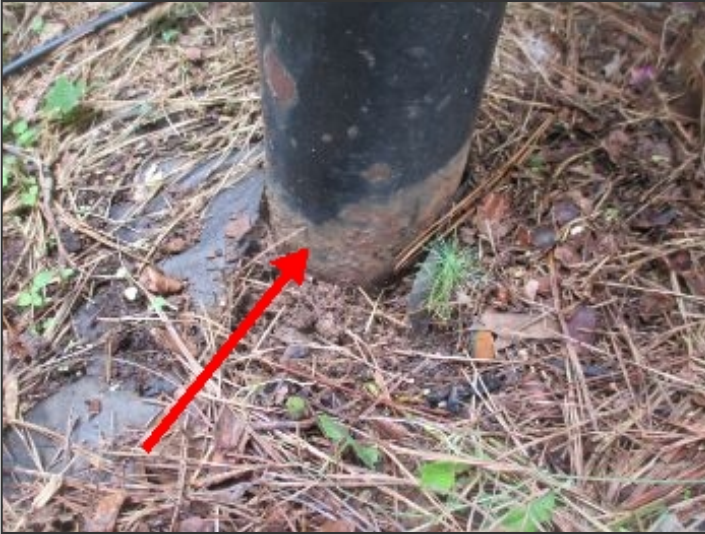
1. The left side rim joist support post shows signs of settlement - a two inch wood shim is present at this location. Further evaluation is recommended by a professional deck contractor to determine repair needs and costs.
2. The steel support posts are installed below grade which is not recommended (see photo); this condition can lead to water and corrosion damage at the lower post areas. Surface corrosion is present at some of the poles. Correction is recommended, eliminate all steel to soil contact.

Deck support poles installed below grade

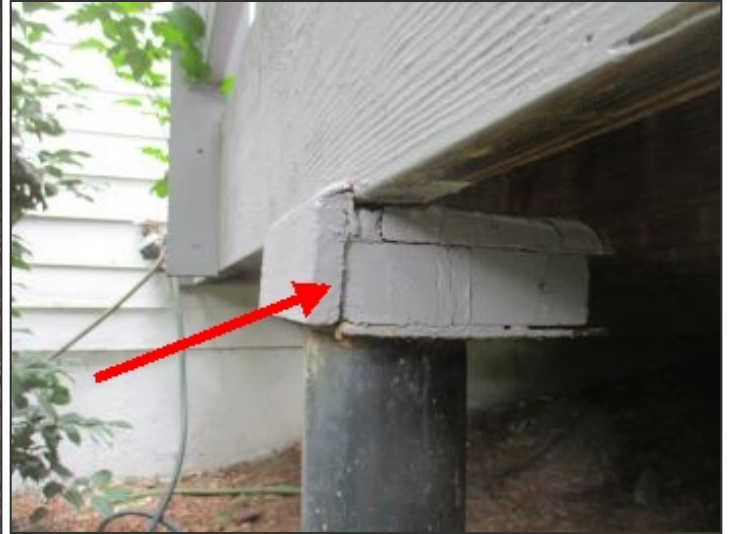
Wood shim at deck side rim joist

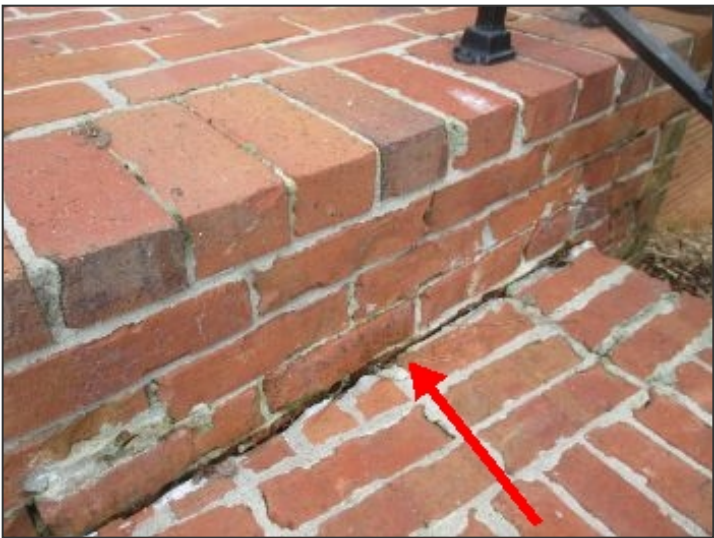
1. The brick stairs have dropped and settled approximately 2-3 inches. The stairs may not be adequately supported; further evaluation is recommended to determine the full scope of repair needs.
2. A separation gap is present at the brick steps connection to the porch; repair is recommended to prevent continued water entry and ice formation which can cause further damage to the brick mortar.

Settlement and separation at front porch stairway

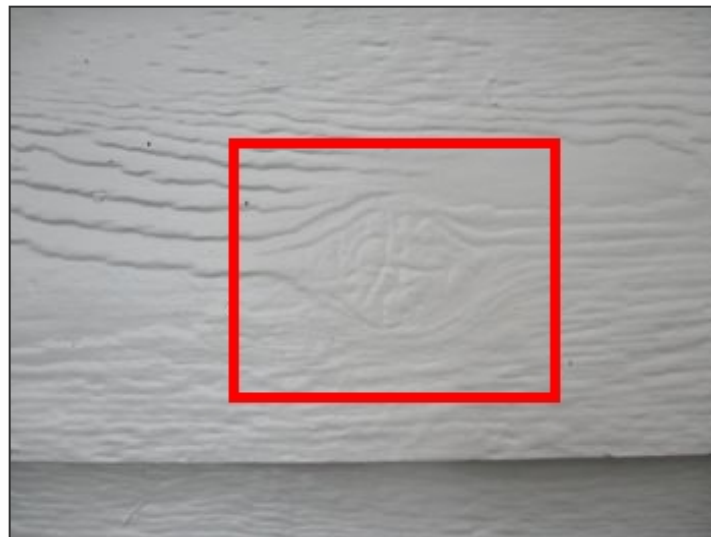
This type of siding has a history of product defect claims and class action litigation and is no longer used due to concerns with moisture damage. Continue to monitor and keep the siding well painted and caulked. Future replacement of some, or all of the siding may be needed.

Louisiana Pacific wood fiber present

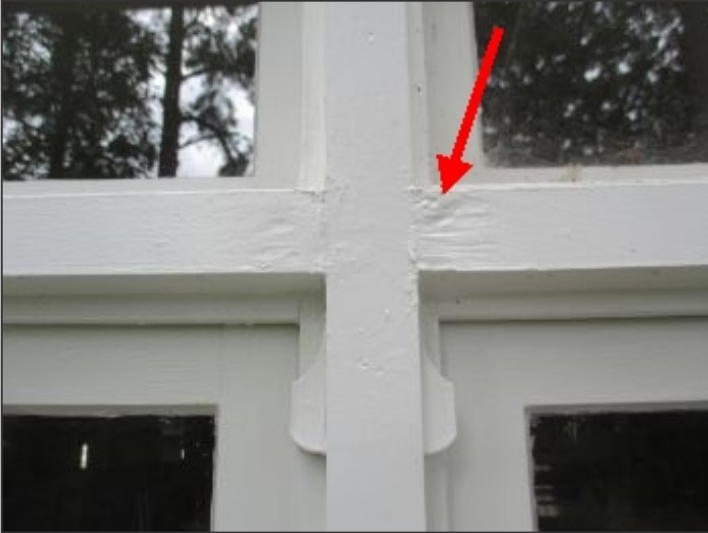
1. The basement side entry door;
2. The kitchen sink transom window;
3. The family room fixed window;

Damaged trim at kitchen sink transom window

Replacement of the affected wood trim is recommended.

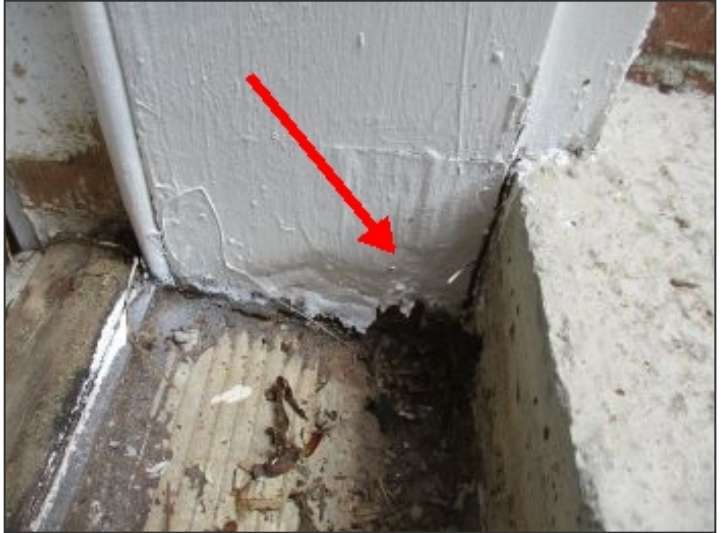
Damaged trim at basement side entry door

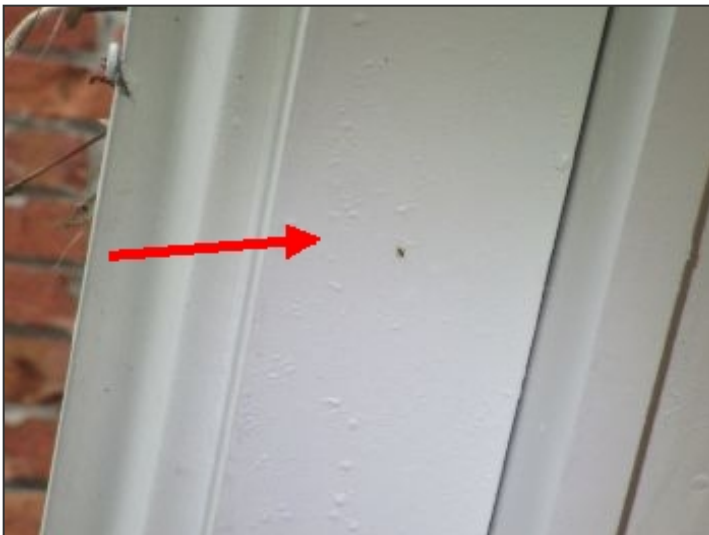
• Rust staining was noted at the steel gutters; this condition is an indication that the gutters are approaching the end of their normal expected lifespan. Client should continue to monitor and budget for gutter replacement.

Corrosion staining at gutters

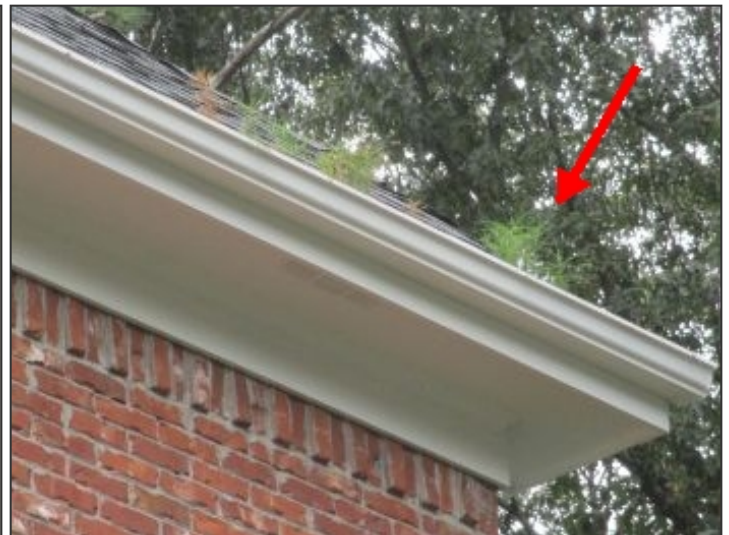
• The gutters / covers are full of debris at a few locations around the perimeter of the home including the right side roof and the rear left side upper roof near the chimney (see photo). Gutter cleaning is recommended so that the gutters can drain correctly.

Debris in gutters at right side roof

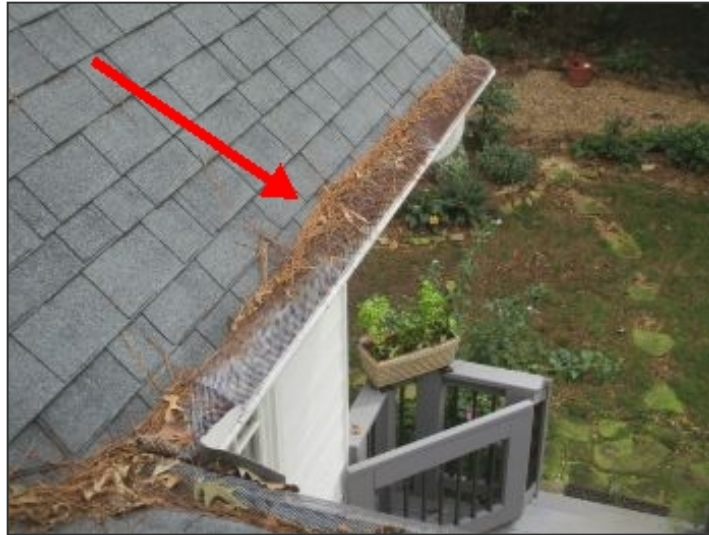
Debris on gutter covers

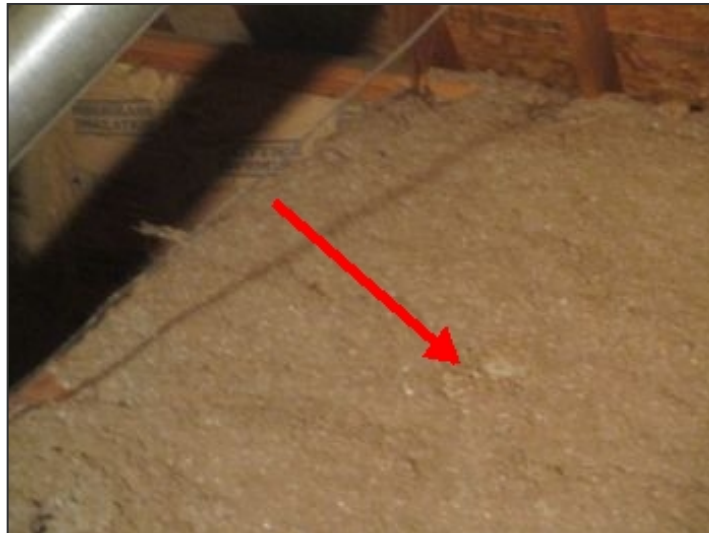
• Evidence of a roof leak was observed in the attic at the exhaust vent from the basement based on a water stain / divot in the insulation below the vent (see photo). This condition is evidence of a possible roof leak but could not be verified during this limited visual inspection. Further evaluation is recommended by a professional roofer to determine the full scope of repair needs and costs.

Water stain / divot in insulation below exhaust vent

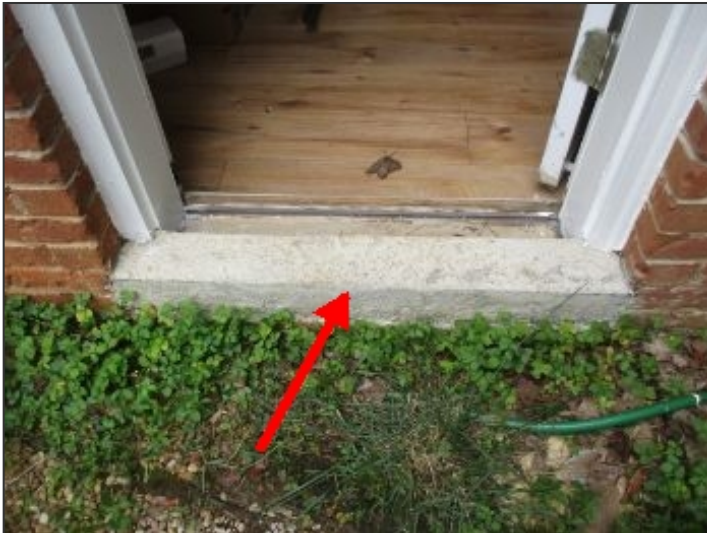
In addition, a concrete barrier was observed at the exterior side of the door and indications previous water entry at this location. No water stains or evidence of recent water entry is present. Ask seller for full disclosure information regarding this concern. Continue to monitor.

Concrete barrier at basement side entry door

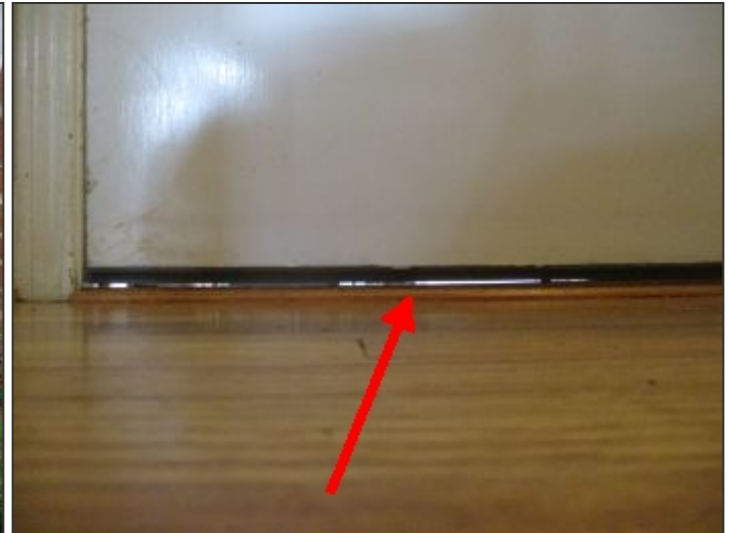
Threshold gap at garage entry door

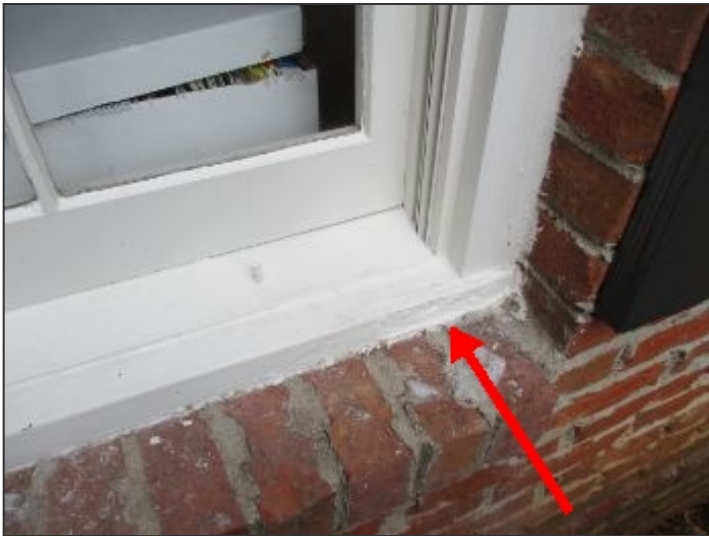
- Minor water damage was noted to the window sill at the office and the left side dining room windows (see photo). The damaged area appears to be isolated to the "nose" of the sill only which is often a relatively easy and inexpensive repair. Replacement of the damaged wood is recommended; continue to keep this window well sealed.

Damaged "nose" at office window sill

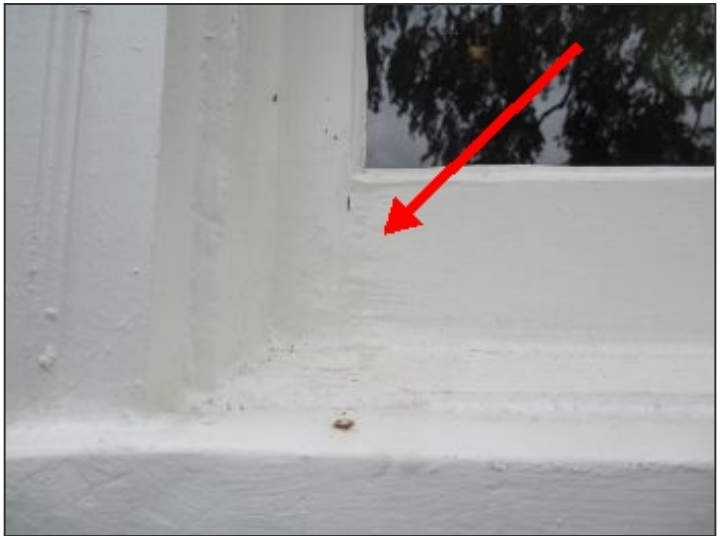
Damaged frame at living room window

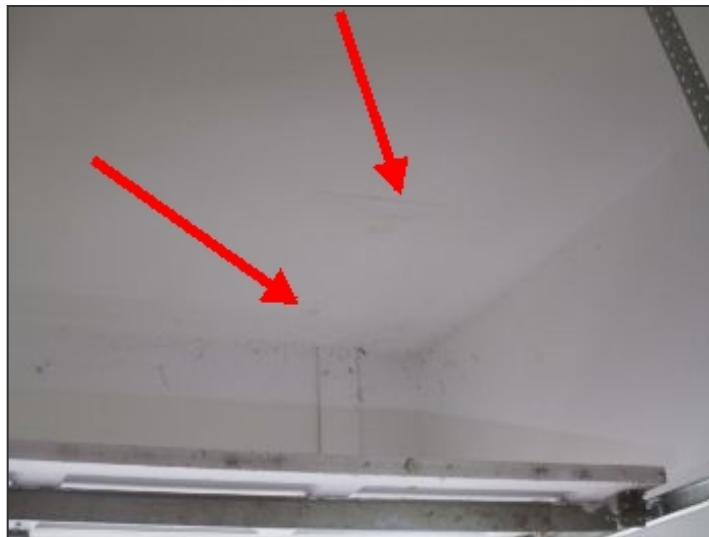
Water stain at garage ceiling

1. Ask seller for full disclosure information regarding this leak.
2. Further evaluation may be needed to determine repair needs, if any.
3. Continue to monitor, future repairs may be needed.

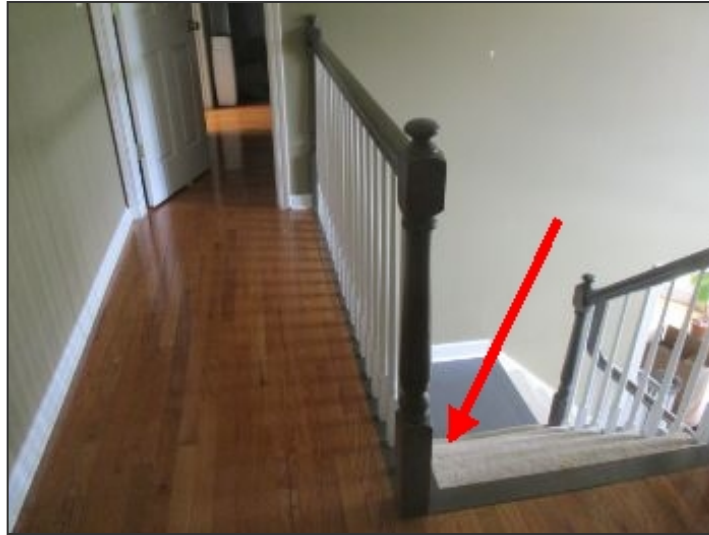
• **UNSAFE CONDITION:** The guard railing at the upstairs hallway is loose; this condition is a potential safety hazard. Correction is advised by a professional stair / railing contractor. Current standards require that guard railings meet a safety rating of 200 pounds.

Loose guard rail at second floor hallway

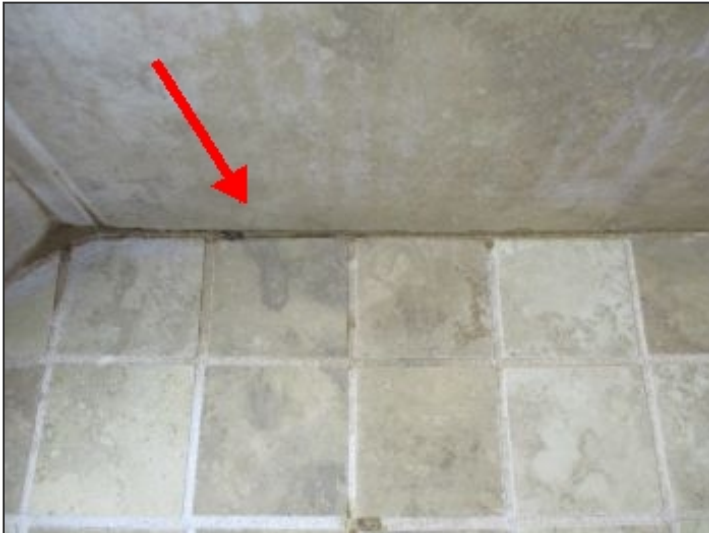
Openings in master bathroom shower grout

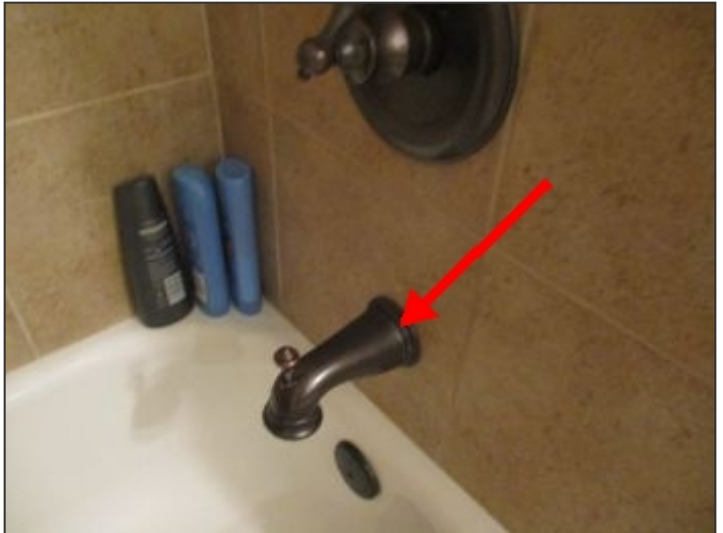
Unsecured faucet at basement tub

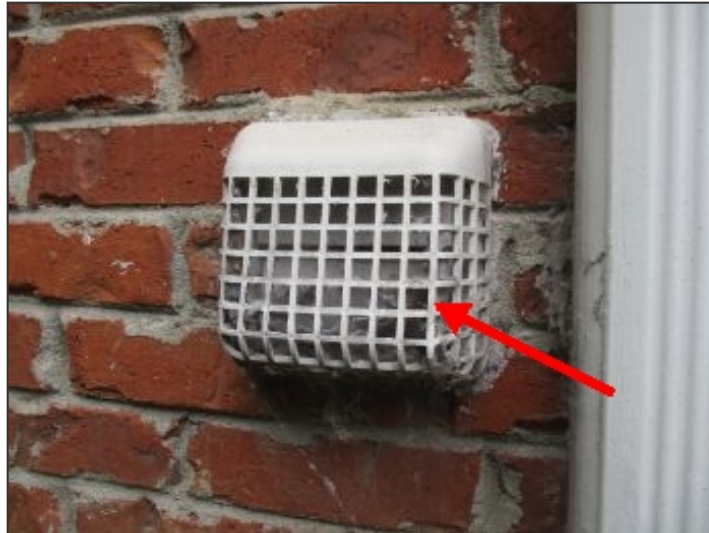
- **SAFETY CONCERN:** The dryer exhaust vent cover has a screened cover that can allow dryer lint to collect and clog the vent cover; this condition is a safety concern. Removal of the dryer vent screened cover is advised. Continue to monitor and clean as needed.

Screened dryer vent at exterior wall

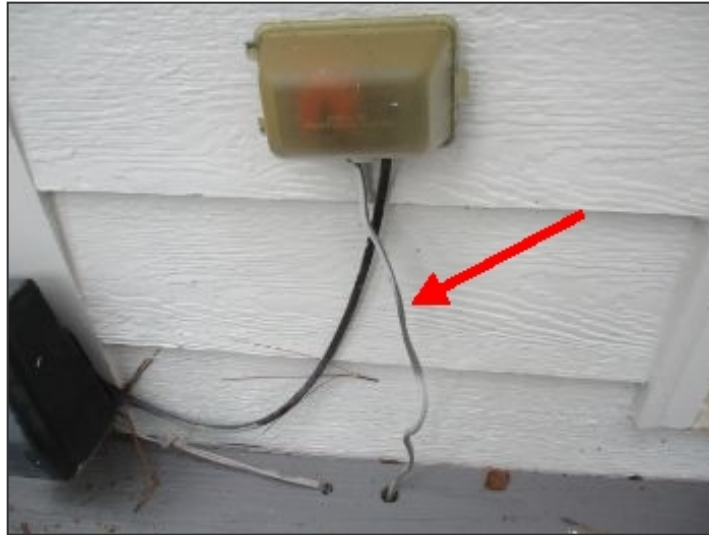
- Improper wiring was noted at the rear deck extension cord to the rear yard water feature. The wiring is not enclosed in protective conduit as required to protect the wire from physical damage. This condition is a safety concern and a violation of the National Electric Code (NEC). Further evaluation and correction is advised by a licensed electrician to meet the safety requirements of the NEC.

Missing conduit at rear deck extension cord

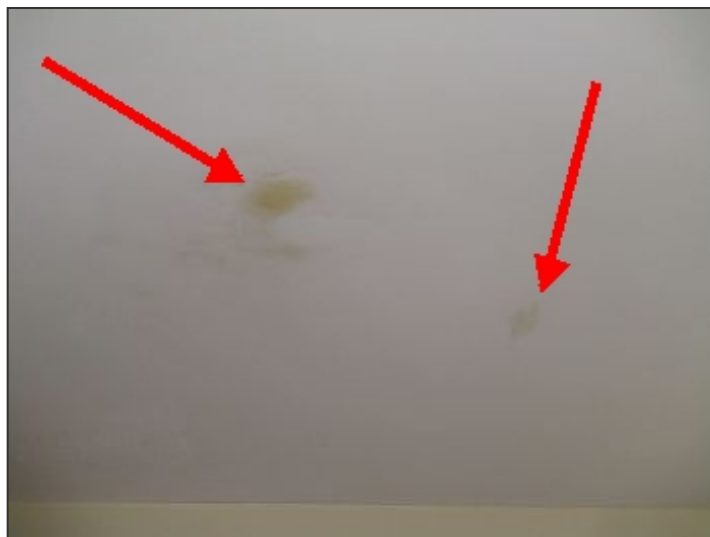
Suspected mold growth at basement ceiling below family room
