House Smart

**4980 Hidden Branches Circle
Dunwoody GA 30338**

Client(s): Schnitzer
Inspection Date: 8/5/2020
Inspector: Keith Cook , ASHI 202558

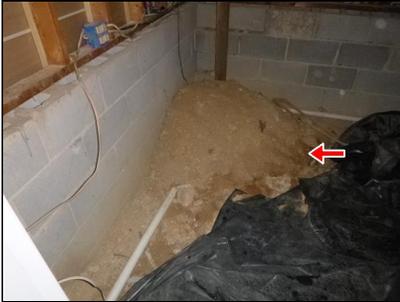
Item 1 - Picture 1

- ❌ 1. **SERVICE / REPAIR:** An inadequate vapor barrier is present in the crawlspace. The installation of a complete vapor barrier is advised to prevent moisture rising from the crawlspace area into the home. Not installing a vapor barrier can lead to high humidity problems in the home and may result in mold growth.

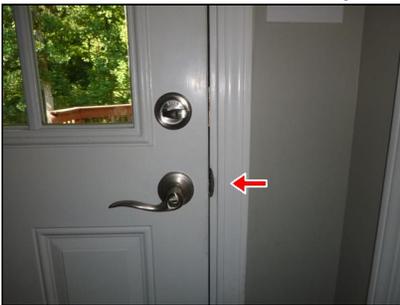
Item 2 - Picture 1

- ❌ 2. **SERVICE / REPAIR:** Latching mechanism on door to Door to Deck does not catch when door closed. Recommend hardware be adjusted to allow door to close as intended.

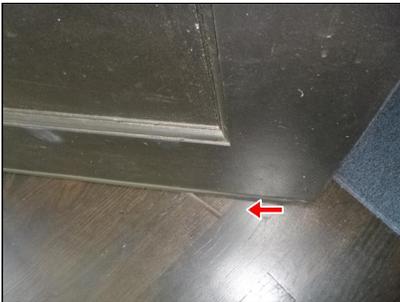
Item 3 - Picture 1

- ❌ 3. **SERVICE / REPAIR:** The sweep on bottom of door is damaged and should consider having replaced and insure that threshold is adjusted to avoid excess friction when door is used. Fairly early stages. Advise repair, installation or replacement as needed to reduce energy loss at Front door.

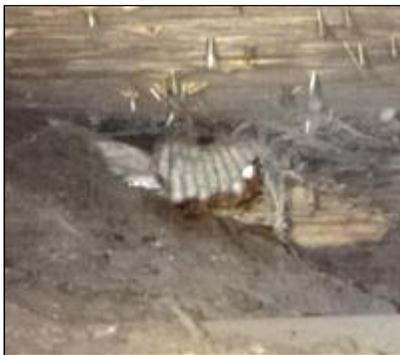
Item 4 - Picture 4

- ❌ 4. **SERVICE / REPAIR:** Openings found near roof level at time of inspection. Openings exist at bottom of valleys where roofing curves up on inside corner. ALSO, Opening where roof flashing intersects chimney. Have modified

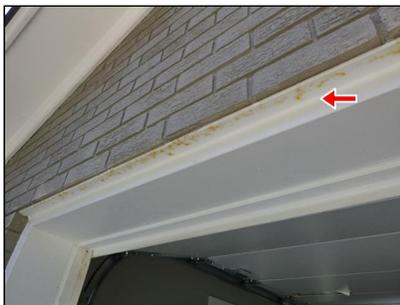
Item 5 - Picture 1

- ❌ 5. **SERVICE / REPAIR:** Lintels above window and door openings are rusting. Lintels are the steel sections that hold up the brick over the windows and doors and it expands when it rusts which may lead to damage to brick veneer. Recommend clean with wire brush and paint with rust inhibitor.

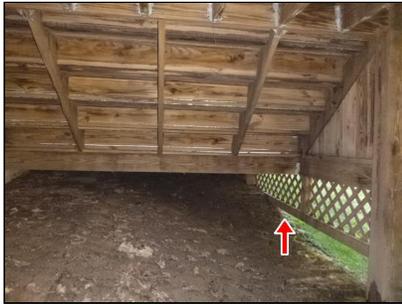
Item 7 - Picture 1

- ☒ 7. **SERVICE / REPAIR:** Load of stairs should be transferred to the ground by support post added point where intersecting. Include new footing. Stringers should have blocking added to support head ends of lumber.

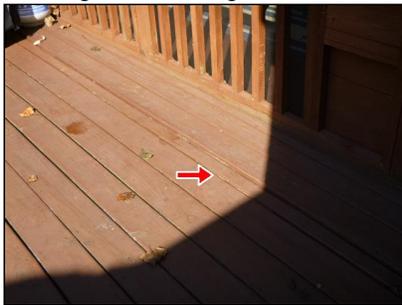
Item 8 - Picture 1

- ☒ 8. **SAFETY / HEALTH:** Uneven deck flooring just outside of screen porch area. Framing transition below likely to have caused issue. Recommend having modified to limit potential for tripping. Little awkward to have deck flooring and framing run in the same direction in that one location.

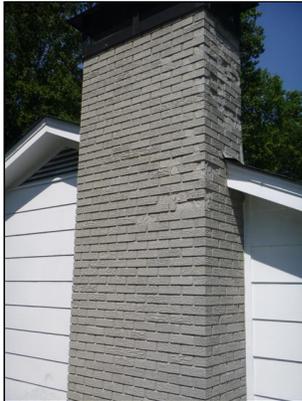
Item 10 - Picture 1

- ❌ 10. **SERVICE / REPAIR:** Spalling of bricks noted in chimney above roof surface with potential for continued deterioration. Recommend having mason or other contractor experienced with this issue to review and make necessary modification to brick surfaces (already painted at least once) or provide alternate resurfacing technique to make assembly better protected. Flaking brick surface can continue to get wet and freeze in winter causing more damage.

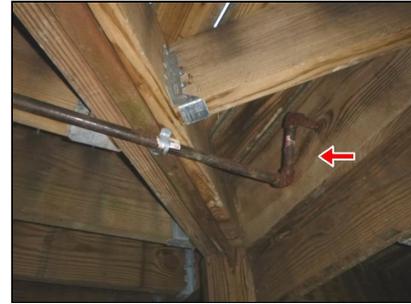
Item 11 - Picture 3

- ❌ 11. **SERVICE / REPAIR:** Paint rusty gas line at meter outside as required by 95 CABO Section 2608.3 or IRC Section G2414.8 (404.8) which lists corrosion resistant material used for gas line outside. Have cleaned and painted with rust inhibitor to prevent further oxidation. **ALSO:** Penetrations of siding not sealed at: Gas line. Seal to prevent moisture and insect access.

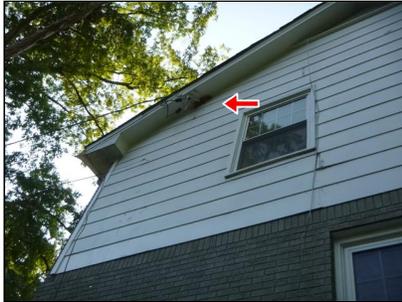
Item 12 - Picture 1

- ❌ 12. **SERVICE / REPAIR:** Expandable foam sealant observed at power line penetration of rake soffit. This product is not manufactured for exterior use and is not intended as a moisture barrier. Repairs are necessary to prevent sunlight from breaking down the foam and allowing water entry. Recommend foam be removed and replaced with appropriate calking material or have foam cleaned and painted to reduce UV damage.

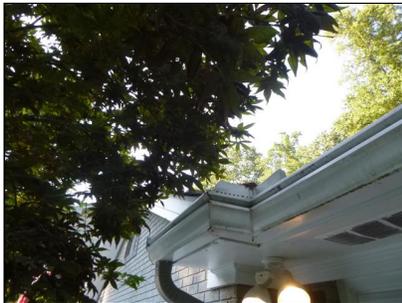
Item 13 - Picture 1

- ❌ 13. **SERVICE / REPAIR:** Trees overhanging or near roof area and would recommend having kept trimmed back to reduce possible damage from wind and to reduce access avenues for climbing pests to roof level.

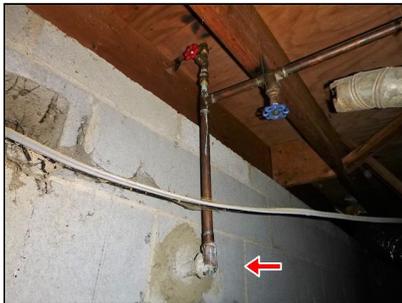
Item 15 - Picture 1

- ❌ 15. **MAJOR DEFECT:** The water service line to this property was found to be galvanized pipe. Galvanized service line is responsible for reduced pressure with multiple fixture use. Brown tint is also a common upon initial use. Replacement is only remedy to provide normal pressure - decision to replace is somewhat subjective in many cases. A marked reduction in water pressure with multiple fixture use and would suggest having replaced to avoid having lost pressure during day to day activities.

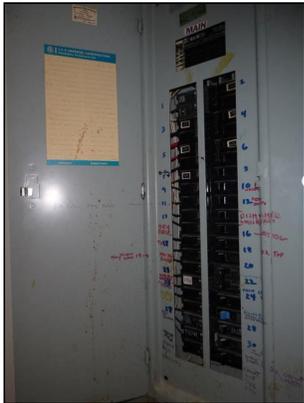
Item 18 - Picture 1

- ❌ 18. **SAFETY / HEALTH:** Panel box located in Basement closet is offset from original wall framing by 1 1/2 inches causing a gap between box and panel cover making fire protection aspect of system less effective. ALSO, Permits access to wiring between cover and breakers. Recommend having wall modified to permit cover to be flush to box as required. This will include work from carpenter and drywall trades.

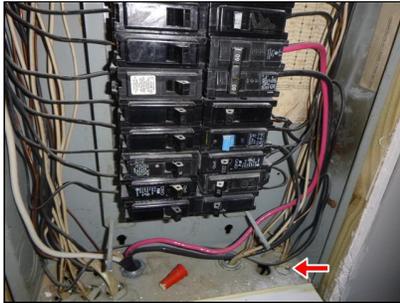
Item 20 - Picture 1

- ❌ 20. **SAFETY / HEALTH:** Openings in the panel enclosure observed. All unused openings should be capped to prevent access to the interior of the panel, damage to the wiring and to maintain the fire resistance integrity of the panel.

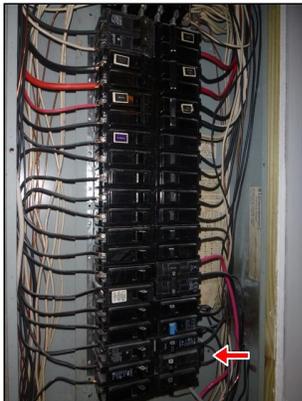
Item 21 - Picture 1

- ❌ 21. **SAFETY / HEALTH:** There are different breaker manufacturer types within panel box and found to be uneven suggesting different types of mountings. Recommend having reviewed by electrician and replaced to be of proper type to insure safety in use. Different manufacturers have different mountings and are not universal. Panel box is a GE and Mismatched Breakers are ITE. NEC 110-3b

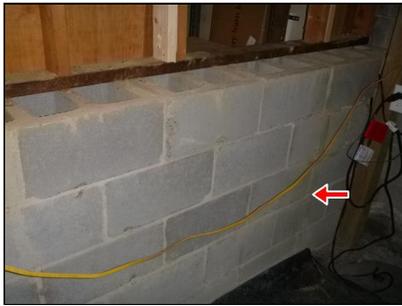
Item 22 - Picture 1

- ❌ 22. **SAFETY / HEALTH:** Unsupported electrical wiring noted at Crawlspace and should have fastened to structure as required not to exceed 4.5 feet. Fasteners should be approved devices and not be secured beyond a snug fit.

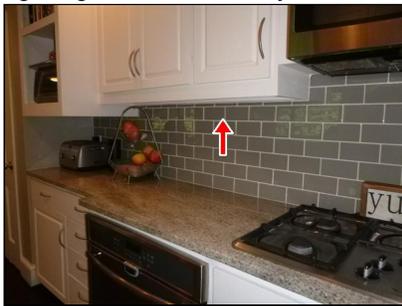
Item 23 - Picture 1

- ❌ 23. **SAFETY / HEALTH:** Under cabinet lighting was removed and left live wiring next to wall. Recommend having lighting reestablished by electrician OR have wiring properly terminated for safety.

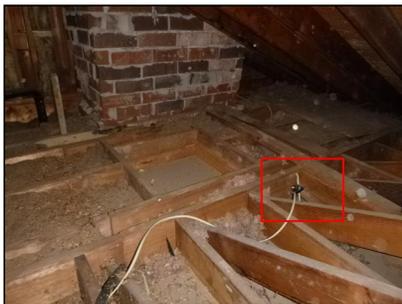
Item 24 - Picture 1

- ❌ 24. **SERVICE / REPAIR:** Spliced electrical wires outside of a junction box observed above Storage closet. All electrical splices should be inside of an approved junction box and connected with wire nuts for safety. Advise a licensed electrician to correct as needed for safety.

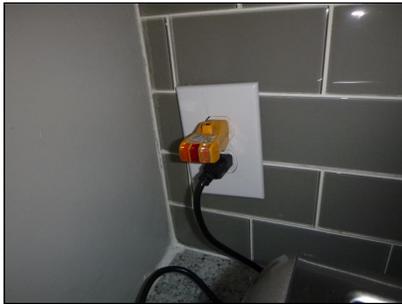
Item 26 - Picture 1

- ❌ 26. **SAFETY / HEALTH:** Upgrades made to include GFCI protection through Kitchen in this home except for: Ones on other side of galley way. Recommend adding GFCI protection to be consistent and complete in upgrades. One by doors to porch is reverse polarity and should be corrected. ALSO, Recommend having GFCI protection included at device in garage so that house will be complete in upgrades.

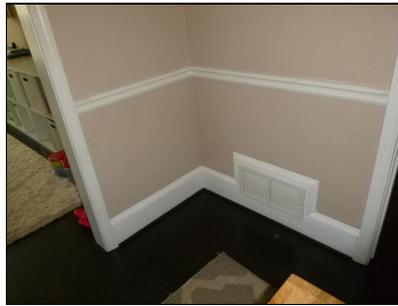
Item 27 - Picture 2 Dining

- ❌ 27. **SERVICE / REPAIR:** Not all of the habitable rooms have a sufficient number of receptacles and/or within spacing limits. Current standards state there should be a receptacle on any wall two feet or wider, with spacing not to exceed six feet to openings or wall ends. Recommend a licensed electrician to evaluate the condition and correct for compliance.

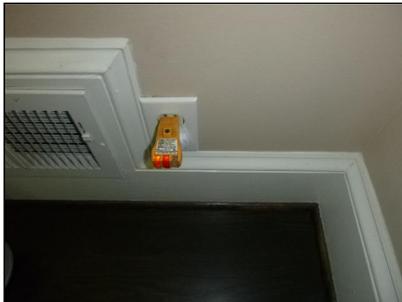
Item 28 - Picture 1

- ❌ 28. **SAFETY / HEALTH:** Reverse polarity at receptacle observed at Living Room, Dining, Master bedroom. This is a somewhat common error in wiring where the hot (black wire) and neutral (white wire) are reversed. With a series of devices incorrect, looking for and correcting the one error made will usually correct every other device downstream. Recommend having electrician review and address to insure that repairs are done properly.

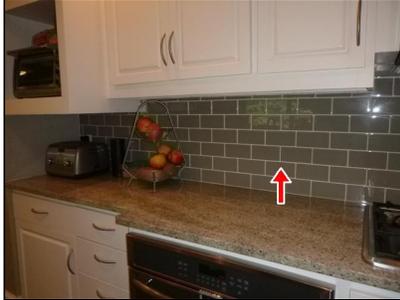
Item 30 - Picture 1

- ❌ 30. **SERVICE / REPAIR:** Insufficient receptacles observed in the kitchen. Current standards state that all counter tops 12 inches wide should have at least one receptacle and there be no more than four feet between receptacles and no more than two feet from an end, appliance or sink. Recommend a licensed electrician to evaluate the condition and correct for compliance.

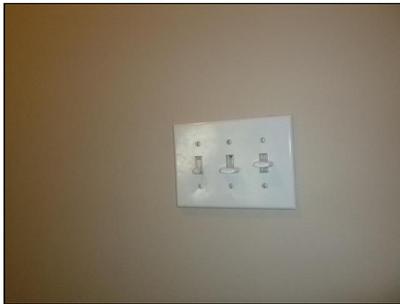
Item 31 - Picture 1

- ❌ 31. **SERVICE / REPAIR:** Dimmer device does not dim lights of Family room cans. Device should be repaired / replaced to operate as intended.

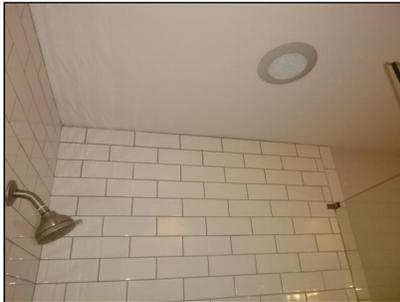
Item 32 - Picture 1

- ❌ 32. **SERVICE / REPAIR:** Inoperable lights observed at the time of inspection at: 1) Basement shower, 2) Deck sconce. Replace bulbs and verify that the fixture is operational. If not, consult an electrician for repairs.

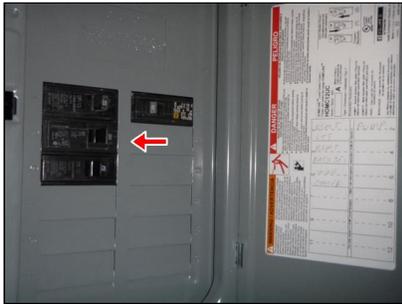
Item 34 - Picture 1

- ❌ 34. **SAFETY / HEALTH:** There are different breaker manufacturer types within panel box and found to be uneven suggesting different types of mountings. Recommend having reviewed by electrician and replaced to be of proper type to insure safety in use. Different manufacturers have different mountings and are not universal. Panel box is a Square D and Mismatched Breakers are Siemens. NEC 110-3b

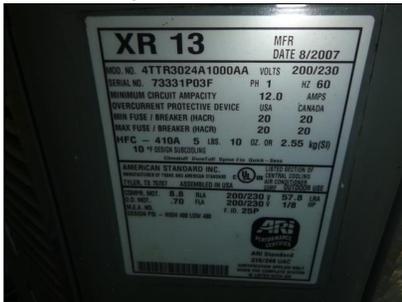
Item 35 - Picture 1

- ❌ 35. **GENERAL NOTE:** A/C compressors have an average life expectancy of 12 -15 years. The compressor(s) is/are 13 and 16 years old. Advise to budget for future replacement or recommend that warrantee program be set up.

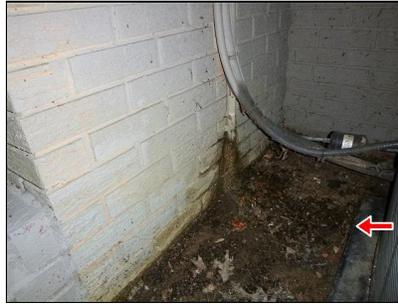
Item 36 - Picture 2

- ❌ 36. **SERVICE / REPAIR:** The condensation drain line terminates next to the building. This will release a considerable amount of water next to the foundation. Recommend the drain line be extended to terminate at least three feet from the foundation and beyond the A/C condensation units. This is also to reduce conducive conditions for termites.

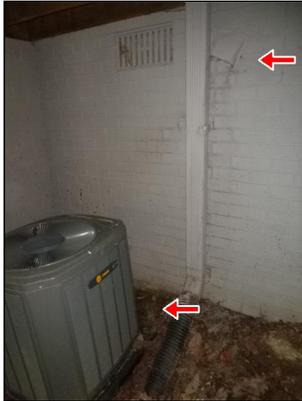
Item 37 - Picture 1

- ❌ 37. **SERVICE / REPAIR:** Dryer vent terminates behind A/C unit which is not advised due to heat, lint and potential chemical reaction of coil with harsh detergents. Advise relocating either vent or A/C unit to protect system. (10 feet clearance is general rule for separation.) If no relocation is done, the next best thing to have fins of unit cleaned routinely and avoid drying clothes during the heat of the day in the summer.

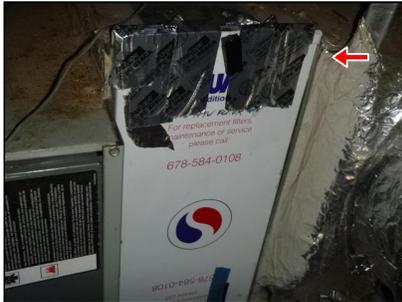
Item 40 - Picture 1

- ❌ 40. **SERVICE / REPAIR:** Filter cover at attic unit is taped closed. This works but would recommend having latching devices repaired. Have opening in panel cover sealed better.

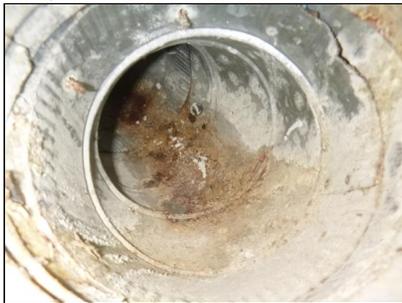
Item 41 - Picture 1

- ❌ 41. **SAFETY / HEALTH:** Debris within floor registers is limited but would recommend having vacuumed to reduce spread of dust during system operation. Although duct cleaning is available professionally, would at least have shop vacuumed to reduce dust.

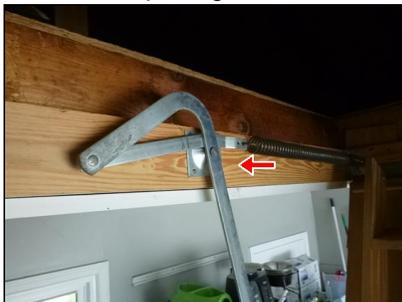
Item 42 - Picture 1

- ❌ 42. **SERVICE / REPAIR:** The pull down ladder leading to the attic area is not secured to the framing correctly. Add nails to all openings in metal mounting brackets provided by manufacture.

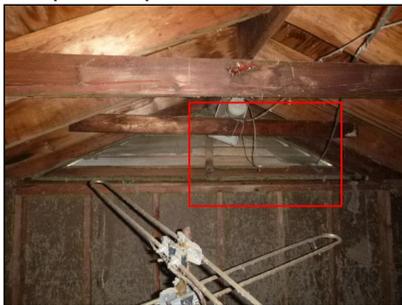
Item 44 - Picture 1

- ☒ 44. **SERVICE / REPAIR:** Damaged attic vent screens observed. Repairs are necessary to prevent pest entry. Replace any screens that have hole or tears. NOTE: Hardware cloth installed on outside of vents but would permit wasp sized pests.

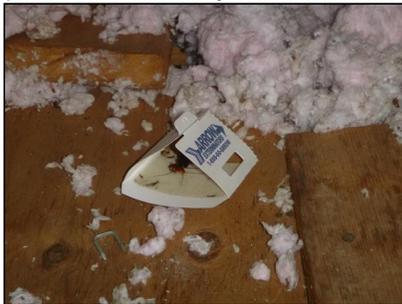
Item 46 - Picture 1

46. **SAFETY / HEALTH:** Evidence of roaches noted in attic spaces with traps set. Recommend having information provided on history of issues for reference.

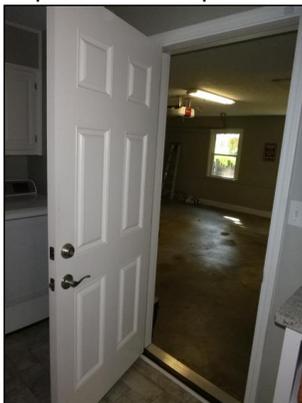
Item 47 - Picture 1

47. **SAFETY / HEALTH:** Hollow core exterior vinyl door currently exists between garage and house. Not currently allowed for safety concerns and strongly recommended to be replaced with solid core or 20 minute fire rated door to provide some protection from spread of fire.

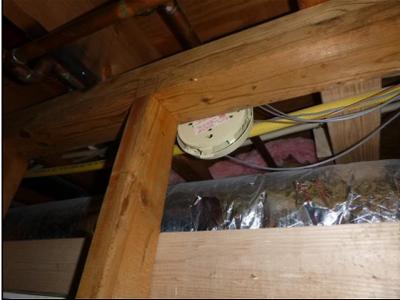
Item 48 - Picture 1

- ❌ 48. **SAFETY / HEALTH:** Missing smoke detectors noted within Basement level. One visible from crawlspace but doubt it would function due to age and location. Install smoke detectors and test operation where missing for safety. Today's requirements including having detector in every bedroom and have wireless interconnected operation provided which is available with newer models.

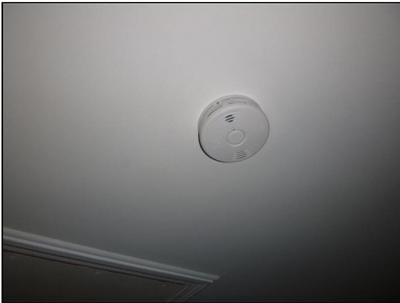
Item 49 - Picture 1

- ❌ 49. **RECOMMENDED UPGRADE:** Older model smoke detector observed. Manufacturers recommend the replacement of smoke detectors every ten years due to the declining sensitivity of the internal sensors. Consider the combination device that includes CO detection for added safety.

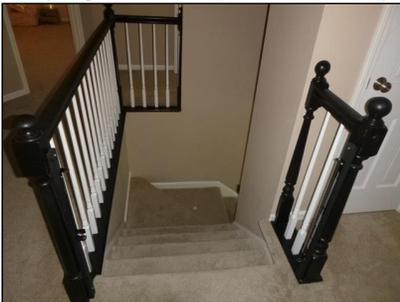
Item 50 - Picture 1

- ❌ 50. **SAFETY / HEALTH:** Handrails for stairways should be continuous for the full length of the stairs, from a point directly above the top step of the flight to a point directly above lowest step of the flight. Have configured for safety keeping in mind the cosmetic aspect of stairway.

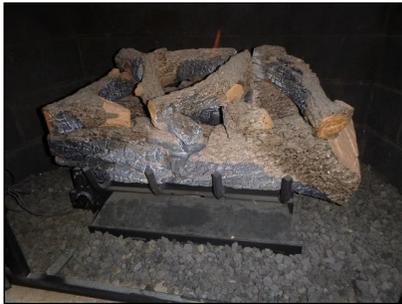
Item 52 - Picture 1

- ❌ 52. **SERVICE / REPAIR:** Firelog set is designed to be remotely controlled after lit but failed to respond to remote when checked. Fireplace can be adjusted manually at fireplace. Recommend having repaired. **NOTE:** Fireplace pilot light was lit and unit tested. Left unit in OFF position before leaving and would require relighting when electing to use.

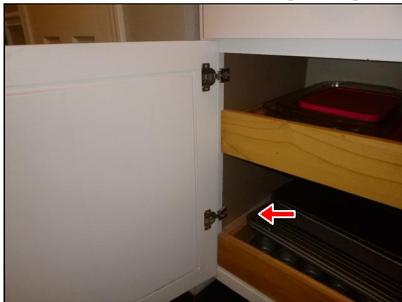
Item 53 - Picture 1

- ❌ 53. **SERVICE / REPAIR:** Loose door hardware observed in kitchen by pantry. Secure all hardware for proper function and to avoid conditions getting worse. Stripped screws should be modified to secure adequately.

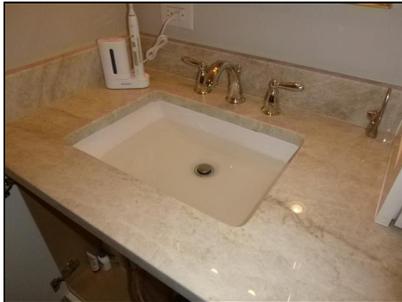
Item 55 - Picture 1

- ❌ 55. **SERVICE / REPAIR:** Slow drain observed at Master bathroom sink and should be cleaned and/or cleared to function normally. May require disassembly of drain line to clear properly.

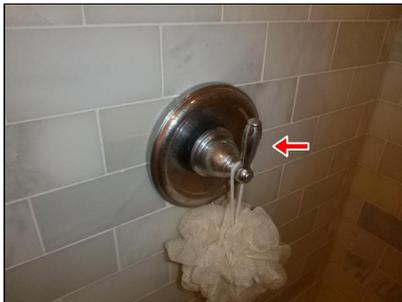
Item 56 - Picture 1

- ❌ 56. **SERVICE / REPAIR:** The control handle is loose on the shower fixture and would recommend having properly secured by tightening set screw to avoid handle falling off during use. May require a hex key of proper size to fit screw head.

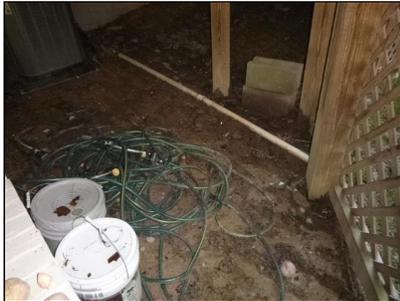
Item 64 - Picture 1

64. **GENERAL NOTE:** Very wet conditions below deck above retaining wall and onto patio. Possibly conditions that occurred after very heavy rain on Monday. Verify conditions are not routine.

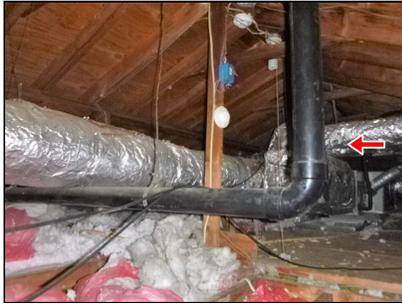
Item 70 - Picture 1

70. **SERVICE / REPAIR:** Plumbing vent located near pull down stairs is supported with metal strap from rafters but permitted to sway as installed. Recommend having better supported to avoid using for balance and causing it to shift too much.

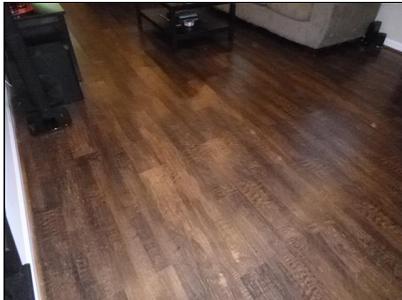
Item 92 - Picture 1

92. **GENERAL NOTE:** Basement flooring appears to have been affected by elevated moisture. Possibly prior to sump pump installation but cannot confirm how well it will perform over time.

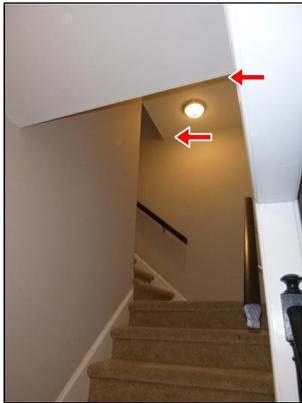
Item 94 - Picture 1

94. **GENERAL NOTE:** Headroom less than 6 feet 8 inches in stairway from Basement and from Foyer as measured along plane of leading edge of steps as denoted in code publications. The height measured around 6'-0" and 6'-6" by the measurement definition. Not usually easy to modify due to structural conditions. Aside from obvious condition in taller persons, may contribute to difficulty in moving larger pieces of furniture.

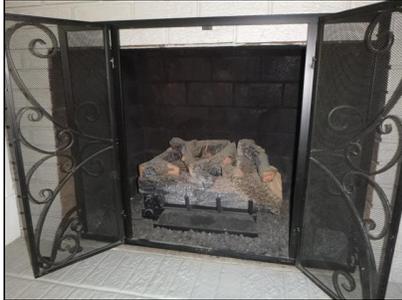
Item 96 - Picture 1

96. **GENERAL NOTE:** The fireplace located at Family room is presently set up with artificial gas log set and was tested. Dampers are required to have clamps installed to prevent fully closing (Damper clamp not installed on damper within this fireplace). This manufacturer required clamp is for safety since exhaust gases contain carbon monoxide. (Partially open dampers often responsible for drafts during winter months and clamp could be removed at owner's discretion.) [If electing to convert back to burning real wood, the present burner mechanism will have to be replaced with cast iron burner because artificial burners cannot withstand the heat and abuse of real wood fires.]

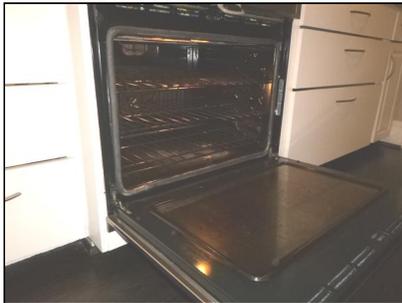
Item 97 - Picture 1

97. **GENERAL NOTE:** The oven was found to be more dirty than commonly found and would recommend having cleaned prior to use to avoid smoking up the place.
