# **Trademark Home Inspections**

Property Inspection Report

**162 Highgrove Dr, Suwanee, GA 30024**

**Date of Inspection: 10/2/2020 Time: 9:00 AM**

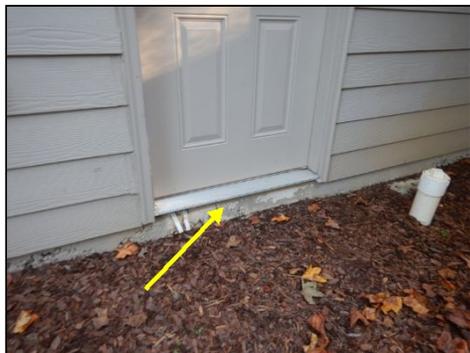
Threshold missing kick plate noted. Kick plate provides additional support for threshold. Recommend installing kick plate by qualified contractor.

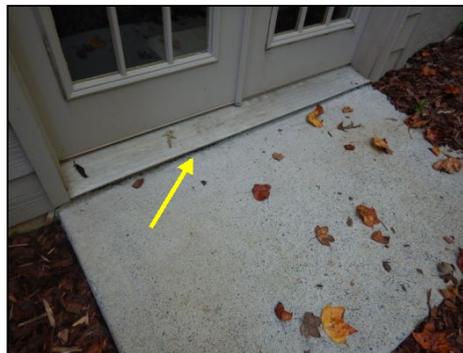
Threshold missing kick plate noted. Kick plate provides additional support for threshold. Recommend installing kick plate by qualified contractor.

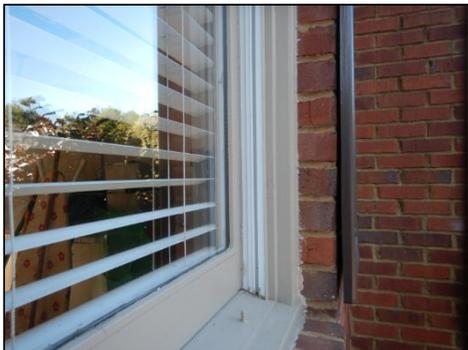
Missing screens noted. Recommend repair or replacement by qualified professional.

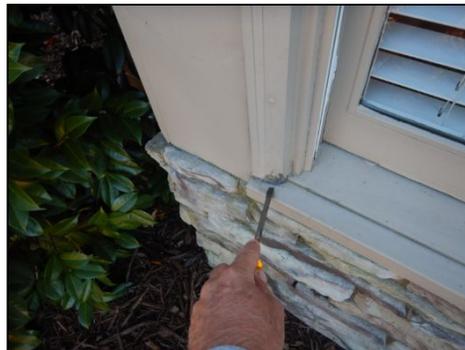
Moisture damage and wood rot noted. Recommend areas be addressed for repairs to include priming, painting and caulking by qualified contractor. front of home

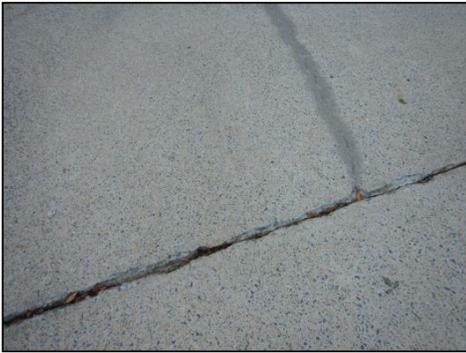
Common settlement cracks noted. Recommend sealing to prevent further expansion.

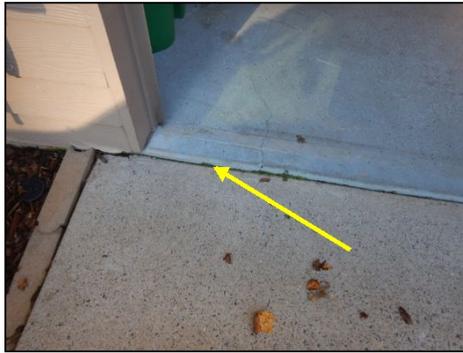
Uneven concrete surfaces noted. This is a potential tripping hazard. Recommend review/repair or replacement by qualified contractor.

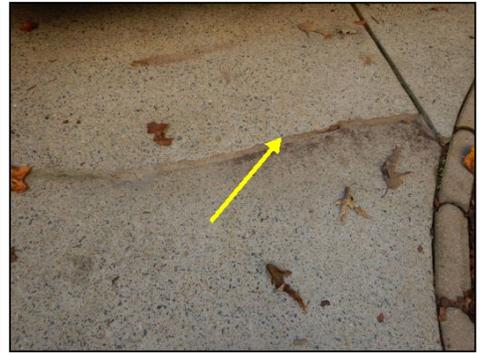
Uneven concrete surfaces noted. This is a potential tripping hazard. Recommend review/repair or replacement by qualified contractor.

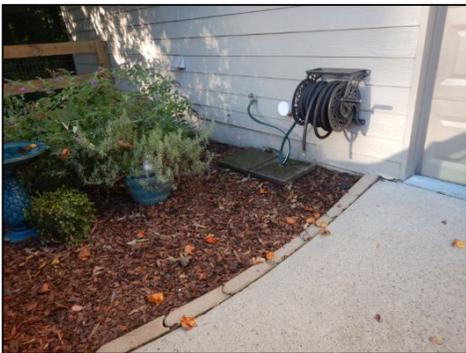
Improper grading noted. Water can intrude into interior spaces. Recommend qualified professional to address drainage issues.

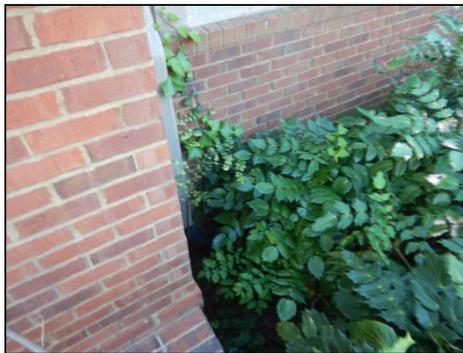
Improper grading noted. Water can intrude into interior spaces. Recommend qualified professional to address drainage issues. front of home

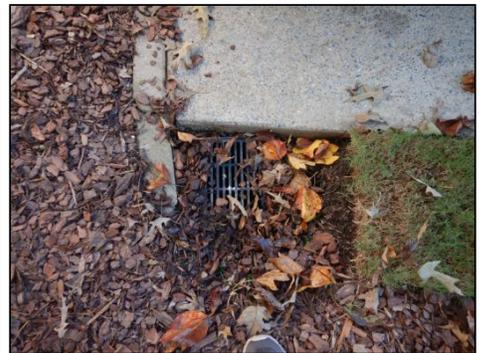
Drain noted. Keep debris cleared to allow proper drainage. left side of home

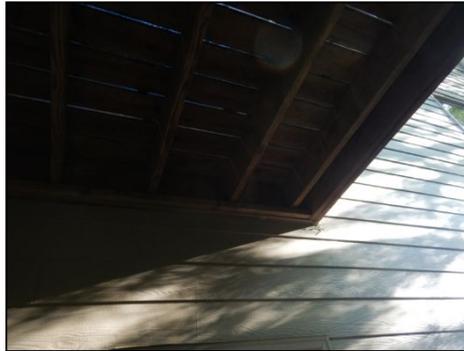
Improper attachment of ledger board. Ledger board is installed over siding. Recommend review by qualified contractor.

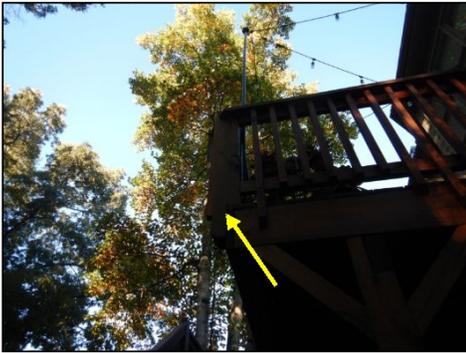
Improperly notched supports. Recommend review by qualified contractor.

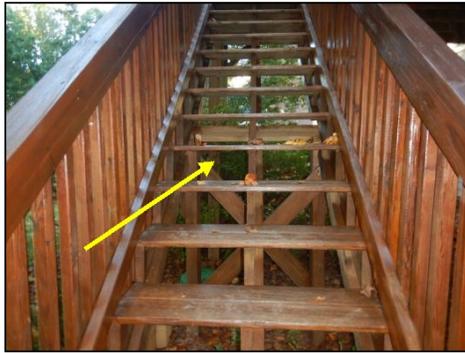
Open stair riser noted. No more than 4" between one tread to the next. This is a tripping hazard and child safety issue. This Does not apply to a total rise of 30" or less. Recommend review by qualified general contractor.

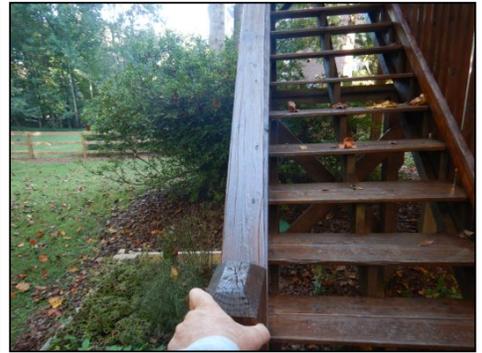
Noted the hand rails/stairs are loose. In the interest of safety, recommend repair by a qualified contractor.

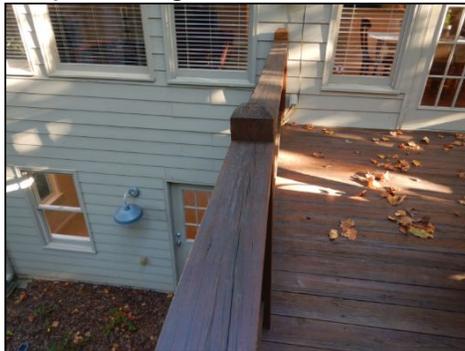
Noted the hand rails are loose. In the interest of safety, recommend repair by a qualified contractor.

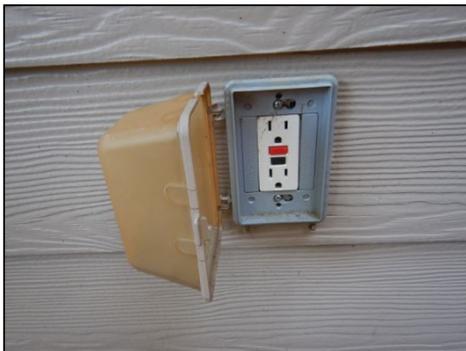
GFCI tripped when tested but would not reset. Recommend review or replacement by qualified electrical contractor. rear of home

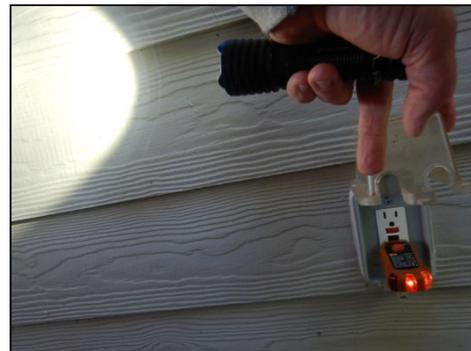
GFCI did not trip when tested. In the interest of safety, recommend review by qualified electrical contractor. rear of home

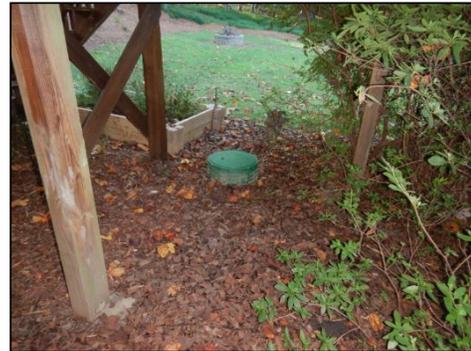
Septic system noted. Client is advised to seek the services of a specialist in evaluating this system.

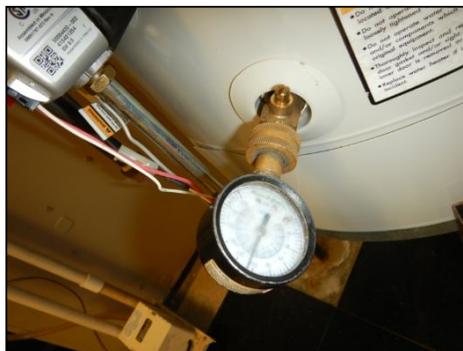
High pressure noted at above 80 psi. Recommend 50 to 80 PSI. High water pressure can damage plumbing, faucet valves causing leaking and or dripping faucets. Recommend adjusting and or replacing pressure regulator by qualified plumbing contractor. 105 PSI noted

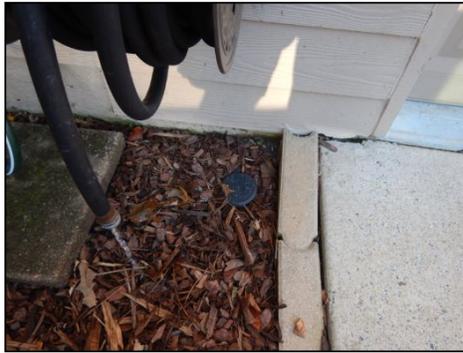
Termite bait system noted. Recommend reviewing disclosure statement or consulting current owners for contracts or transfers of policies.

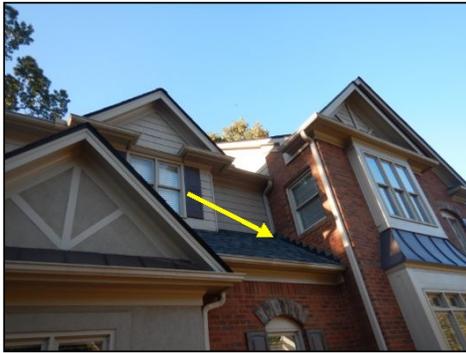
Gutter discharges over roof materials, this may limit the life of these materials. Recommend review by a qualified contractor.

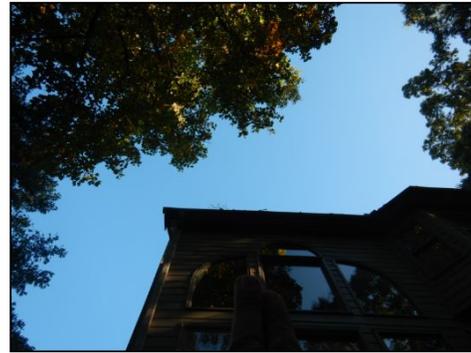
Gutter filled with debris. This can cause inefficiency of gutter system and potentially cause water damage to fascia. Recommend clearing debris by qualified contractor.

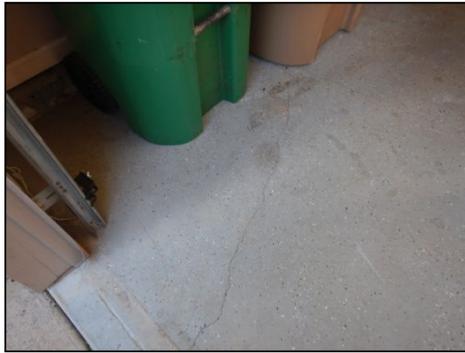
Common settlement cracks noted. Recommend sealing to prevent further expansion.

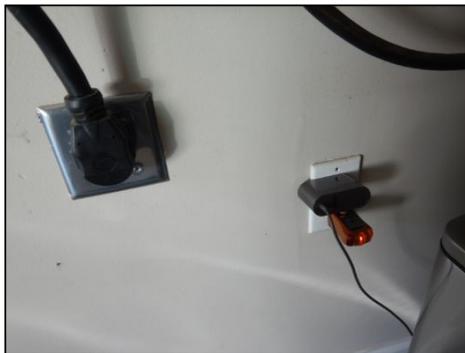
GFCI did not trip when tested. In the interest of safety recommend review by qualified electrical contractor.

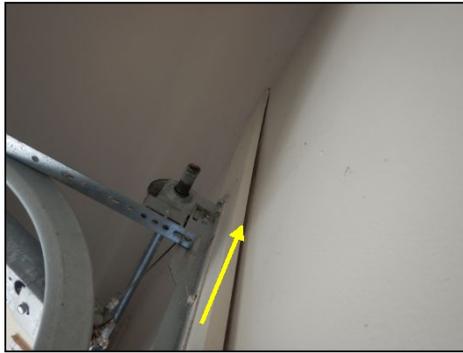
spring pad pulling away from wall. Recommend properly securing to prevent damage to the door. noted both sides.

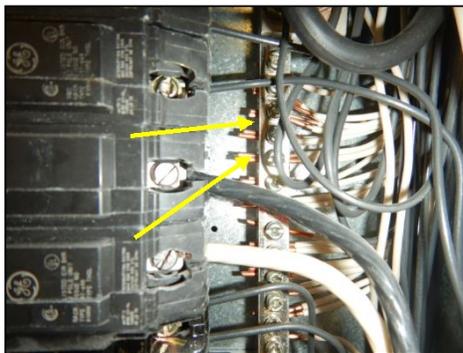
Double tapped neutrals on bus bar. Possible arcing issue. Recommend repair by qualified electrical contractor.

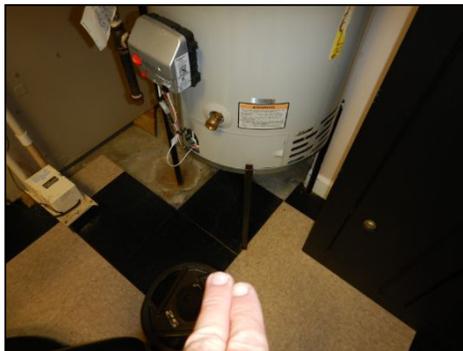
No overflow pan noted. Pan is suggested for leakage of water heater. Recommend review or installing by qualified plumbing contractor.

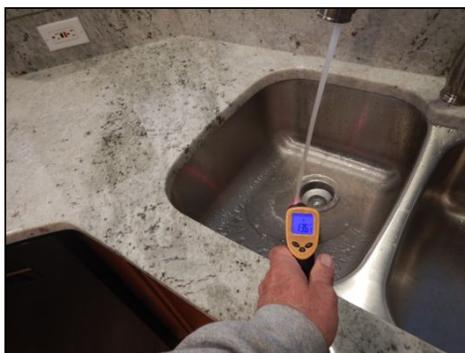
\*Water temperature noted. This is extremely hot. Recommend 120° or less for the safety of children. Water temperature can be adjusted at water heater. Recommend review by qualified plumbing contractor.

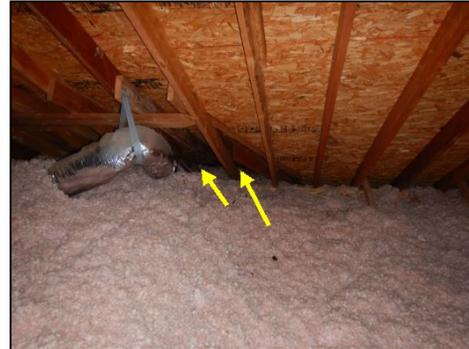
Construction gap observed. Recommend sealing to prevent moisture intrusion and wildlife entry. Recommend review and repair by qualified contractor. rear of home

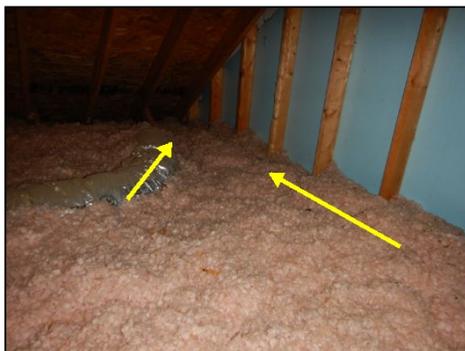
Rodent or wildlife trails observed in attic. Recommend a professional Pest or wildlife company to evaluate and monitor for activity. If activity is present... Trapping and sealing to prevent future infestation is recommended.

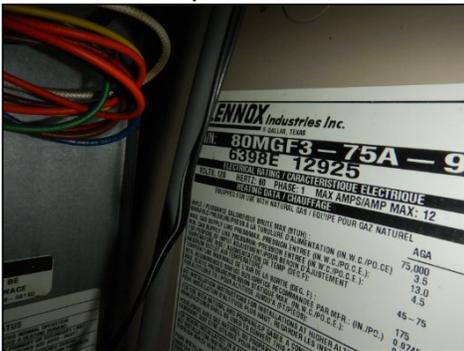
**DATA PLATE:** Furnace (air handler) manufactured in 1998. National average life expectancy of furnace is 15-20 years. However, this average varies according to the quality of the unit, how frequently it's used, and whether it's properly maintained. If within years stated or beyond budget for possible repair or replacement in the near future.

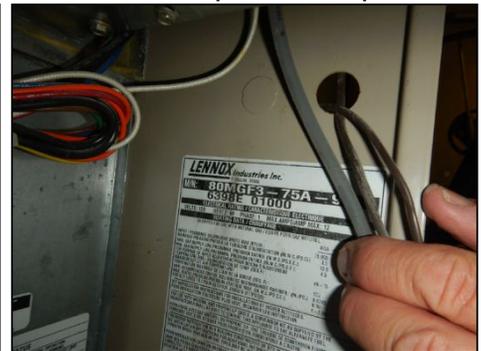
**DATA PLATE:** Furnace (air handler) manufactured in 1998. National average life expectancy of furnace is 15-20 years. However, this average varies according to the quality of the unit, how frequently it's used, and whether it's properly maintained. If within years stated or beyond budget for possible repair or replacement in the near future.

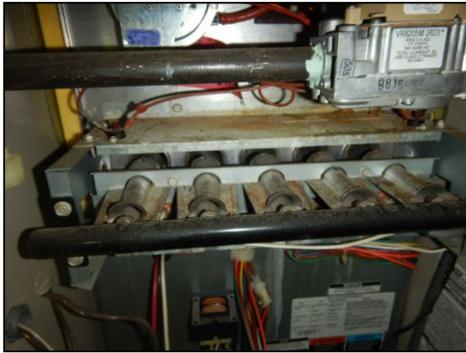
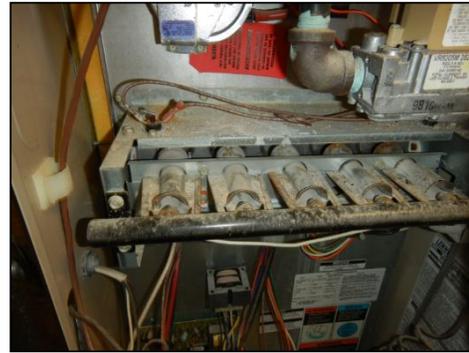
Enclosure rusty, dusty/dirty. Dirty enclosure suggest a lack of proper maintenance.

Recommend review by qualified HVAC contractor. Recommend review by qualified HVAC contractor.

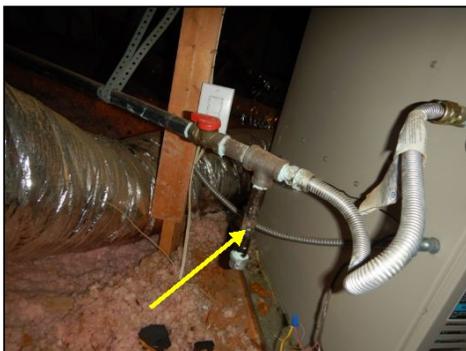
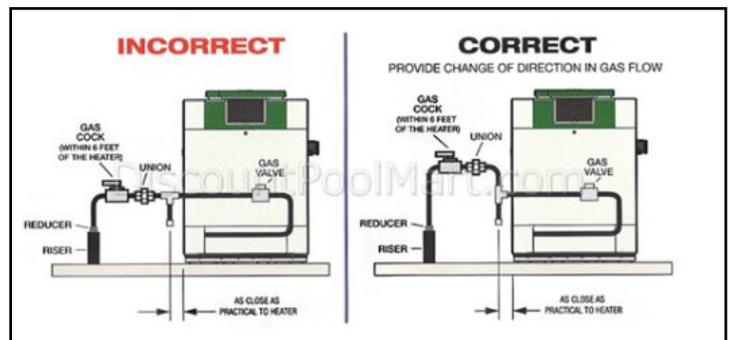
Improper sediment trap noted at time of inspection. Sediment traps do as name notes, they trap sediment before it enter water heaters or HVAC systems and help prolong life. Recommend correction by qualified HVAC contractor.

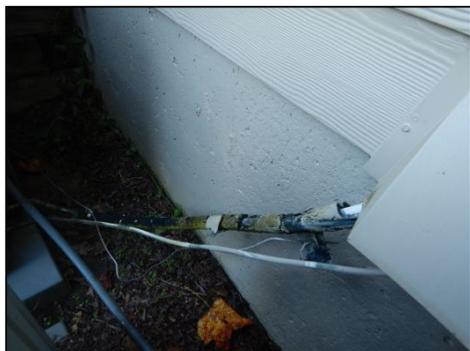
Insulation is deteriorated at refrigerant lines. This may effect the efficiency of unit. Recommend repairing or replacing by qualified HVAC contractor.

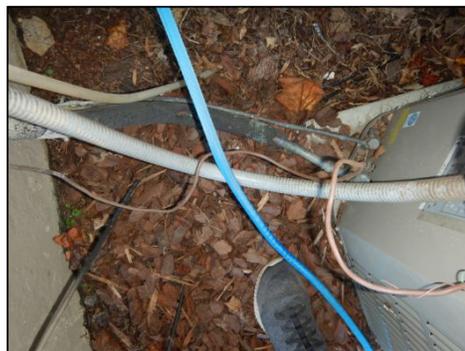
Insulation is deteriorated at refrigerant lines. This may effect the efficiency of unit. Recommend repairing or replacing by qualified HVAC contractor.

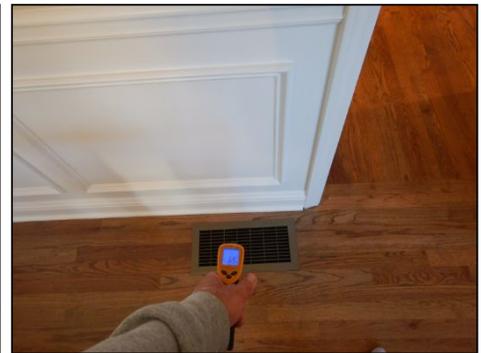
main

System inspected accepts only R22 refrigerant. After R22 becomes illegal on January 1, 2020, it will become much more difficult (and expensive) to get R22. As a result, repairing older R22 systems will become expensive when the repair requires adding refrigerant to the system. Except for some simple electrical issues, many types of emergency repairs do require recharging refrigerant.

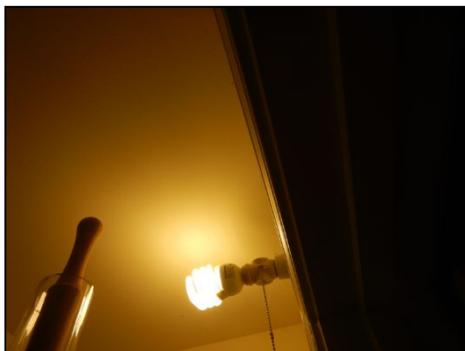
**FIRE HAZARD:** No globe at closet lights. This can cause a fire should stored items come in contact with a hot bulb. Recommend install globe or install new fixture by qualified electrical contractor.

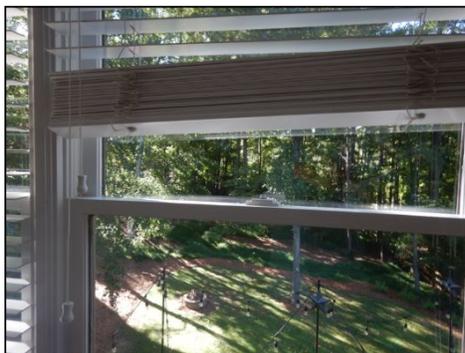
In the interest of safety and egress, all windows should be operational. At the time of the inspection, the windows were painted/stuck shut. Noted several in the home, not all pictured.

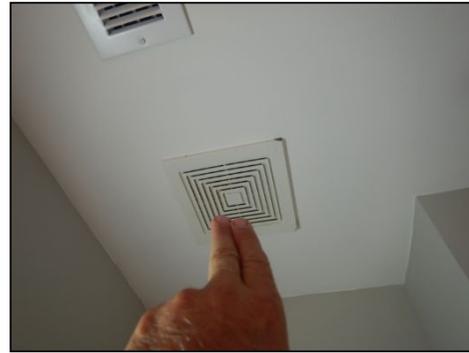
Exhaust fan did not function properly at time of inspection. Recommend review or replacement by qualified electrical contractor. JJ bath

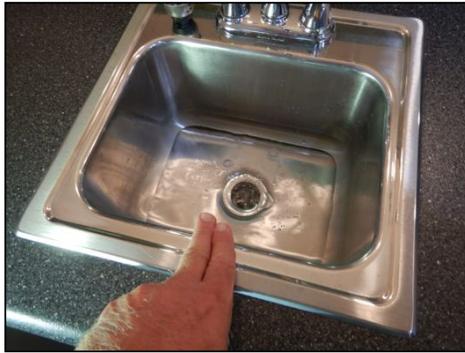
Slow drain at sink with gurgling which may indicate drain line needs cleaning and/or drain not properly vented. Recommend review and repair by qualified plumbing contractor. basement

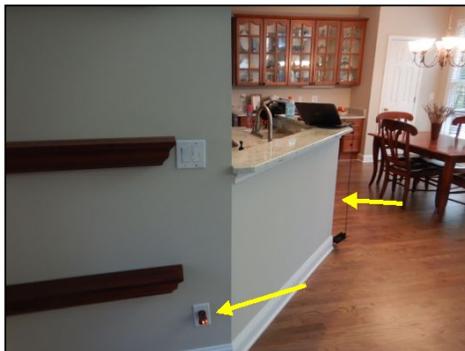
Outlet is not GFCI protected. In the interest of safety, locations such as garages, unfinished basements, kitchens, laundry rooms, outside area and all plumbing fixtures within 6 feet should be GFCI protected. Recommend review by qualified electrical contractor.

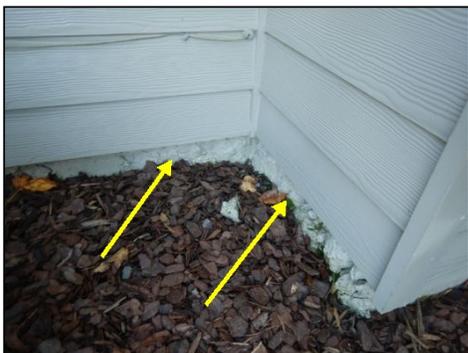
Repair may have been made to foundation wall near chimney. Recommend asking seller for disclosure.

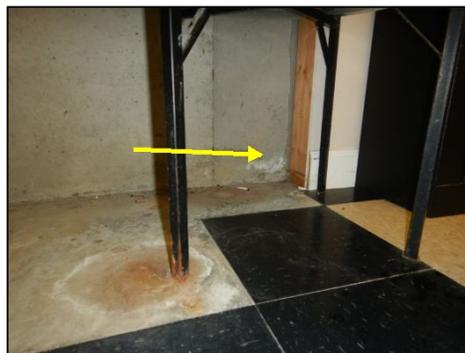
Efflorescence noted. This is a mineral deposit left behind from exterior water intrusion. Recommend review by qualified contractor.
