SafeHarbor Inspection Group

Building Inspection Report

229 Kirkwood Rd NE

Atlanta GA 30317

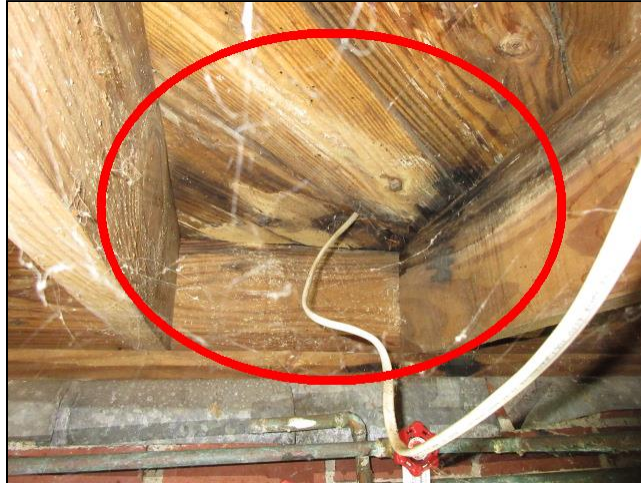
Repair: Damaged subflooring (supporting layer of flooring above floor joists and below finish flooring) was noted under the kitchen. This material should be re-supported or otherwise replaced as needed to reduce the risk of floor settlement.

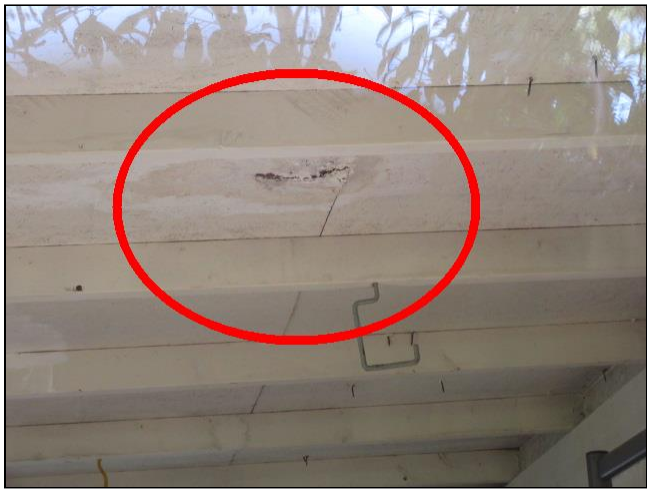
Monitor, Possible Repair: Signs of previous leaks were noted in the roof framing (e.g. at the rear shed). Consult with the seller concerning the history of all leakage encountered in the roofing system and previous repairs performed to correct these conditions. If these repairs have not been made, a qualified roofer should investigate the flashing and shingles in the area(s) and make repairs as necessary. All flashing and roofing components should be monitored in the future for further leakage and repaired as necessary.

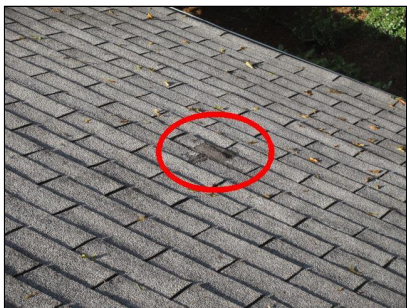
Repair Above Living Room

Bucket Noted (Empty) Above Stain in Living Room

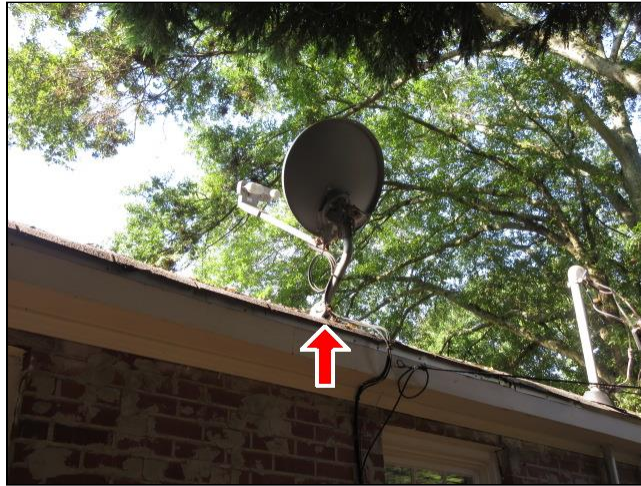
Improve: If the TV / "Dish" antenna as noted at the left roof is no longer in service, it should be removed from the roof along with all related hardware and wiring. The roofing shingles at the mounting bracket will need repair or replacement to prevent future leakage.

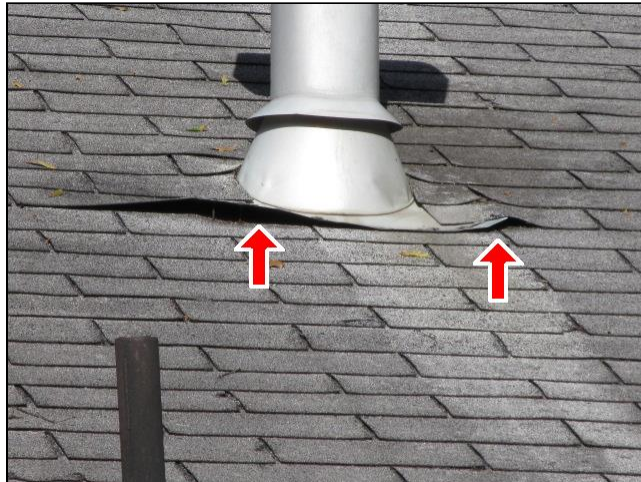
2.1 Roofing: Flashings

Repair: A loose and open flashing component was noted at the rear roof, which should be re-nailed and sealed by a qualified roofing contractor to prevent leakage. All roofing shingles and flashing components should be examined and sealed as necessary. All exposed nail heads should be caulked.

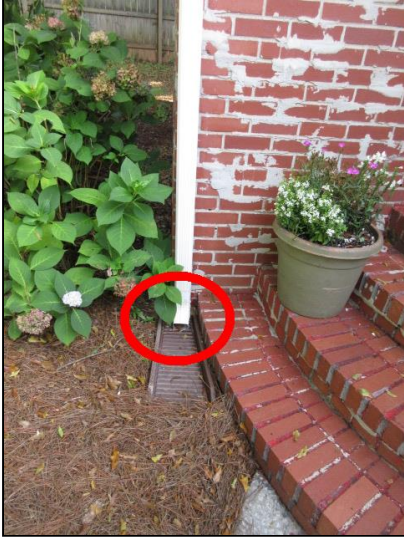
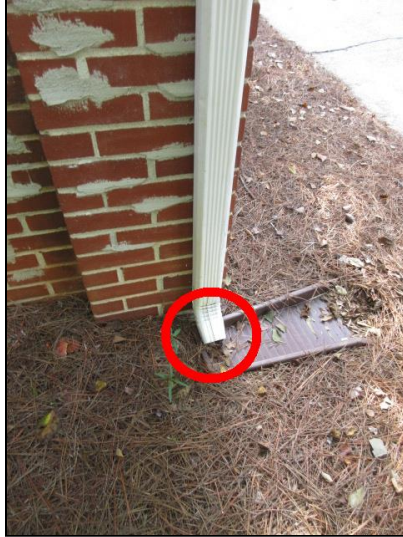
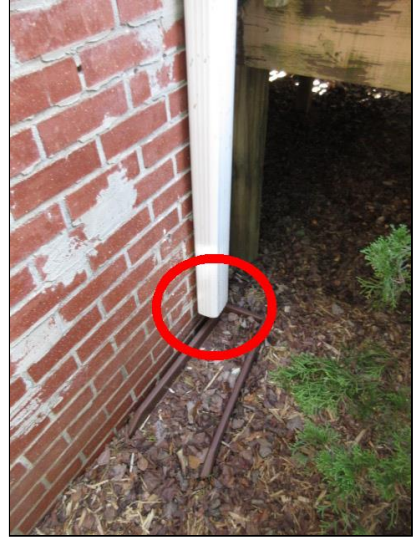
Repair: All of the downspouts at the front of the house should be piped away from the foundation so that they discharge water at least ten (10) feet from the house or into an underground drainage system to prevent moisture infiltration into the structure and settlement of the foundation. It is recommend use smooth wall piping as opposed to the black ribbed piping, which is more prone to blockages. Storm water should be encouraged to flow away from the building at the point of discharge.

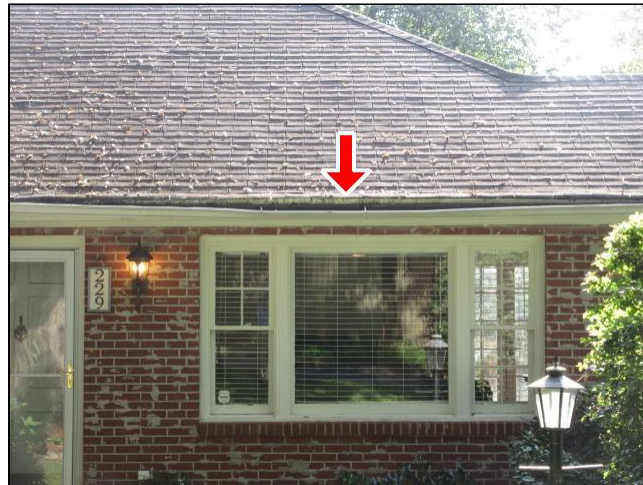
Repair: The gutters as noted at the front of the house are loose and do not appear to have sufficient slope to drain properly. The slope should be adjusted to avoid spilling roof runoff around the building and into the cornice - a potential source of water entry or water damage. All gutters should be checked and cleaned for proper function.

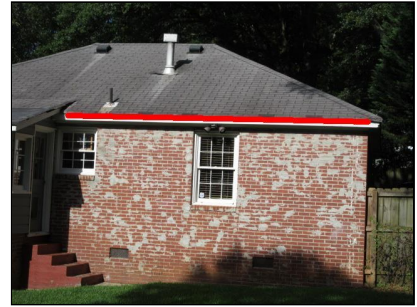
Improve: It is recommended that gutters and downspouts be installed at the sides and rear roof to avoid spilling roof runoff around the building, which is a potential source of water entry or water damage. The downspouts should be piped away from the foundation so that they discharge water at least ten (10) feet from the house to prevent moisture infiltration into the crawlspace. Storm water should be encouraged to flow away from the building at the point of discharge.

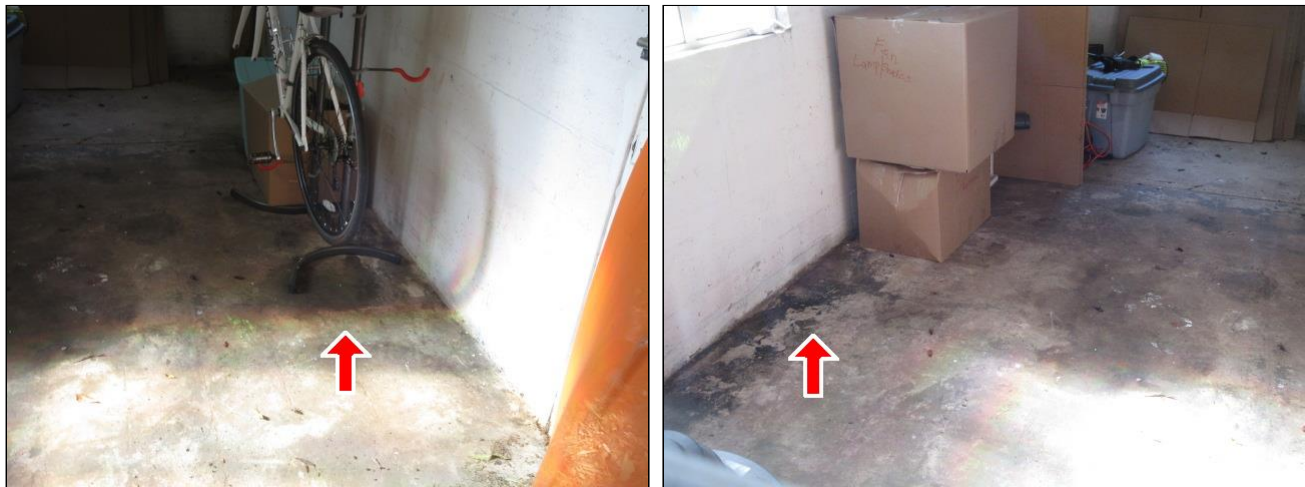
Repair: Evidence of active or past water intrusion through the rear shed as indicated by stains on the flooring. A qualified contractor should assess this condition and make recommendations for repair. Damaged components should be replaced as needed.

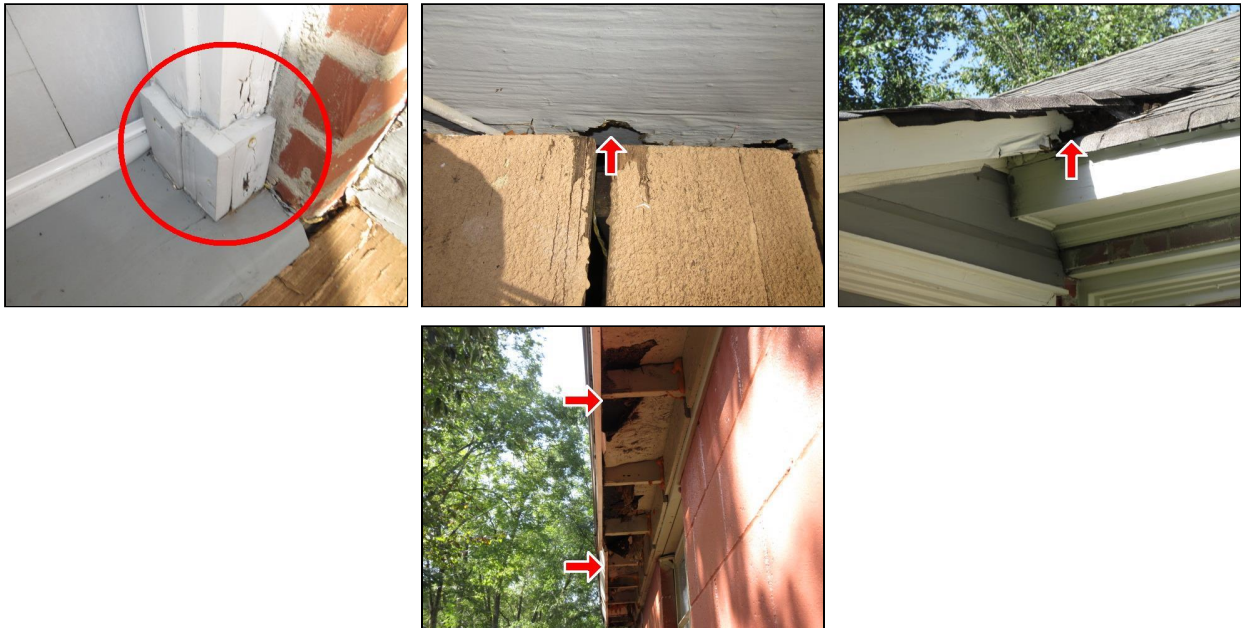
Repair: Signs of rot were observed at the rear deck trim, rear roof trim, and at the rear shed as noted, which should be repaired by a qualified carpenter. Following repair of the damaged areas (which should be combined with exterior painting/maintenance) proper maintenance of the siding and wood trim and control of water from roof or surface runoff can avoid further damage. The carpenter should check all exterior wood components for further damage and repair as necessary.

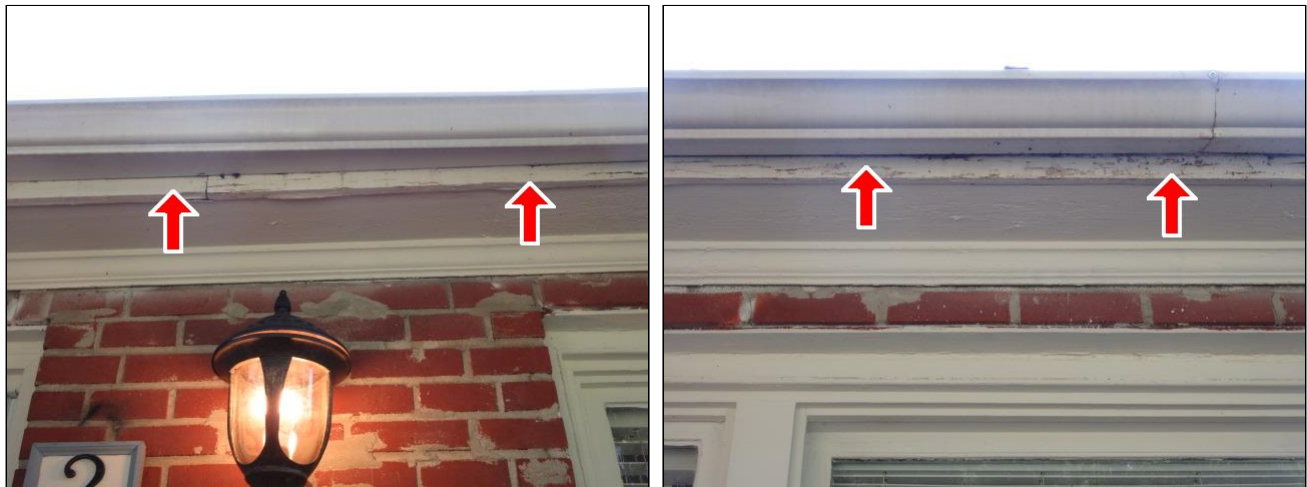
Monitor, Future Repair: Areas of wood distress and mild rot were noted in some wood components as noted at the front roof trim, and rear siding adjacent to the deck, which should be repaired as needed when repainting. After repair of the damaged areas, control of water runoff from roof surfaces and monitoring of the gutters can prevent further damage.

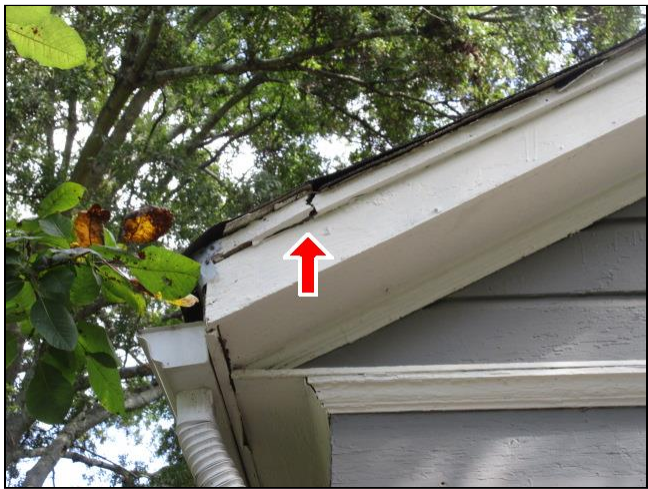
Repair: Damaged trim as noted at the front right side of the house should be repaired to prevent moisture intrusion into the structure.

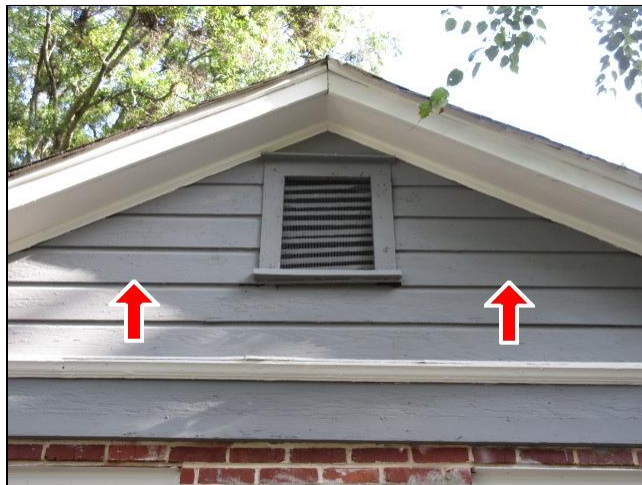
Monitor, Future Repair: Minor areas of wood distress and mild rot were noted at the right side wood siding and trim, which have been puttied and painted over. This is a temporary repair and should be addressed in the near future/when re-painting. All damaged wood should be replaced and repainted for proper protection against further damage to surrounding components.

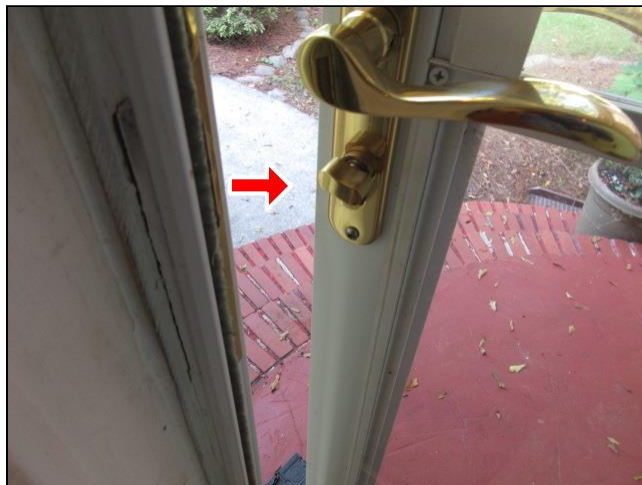
Repair: Inoperative exterior door locks as noted at the front storm door should be repaired or replaced for proper locking of the door.

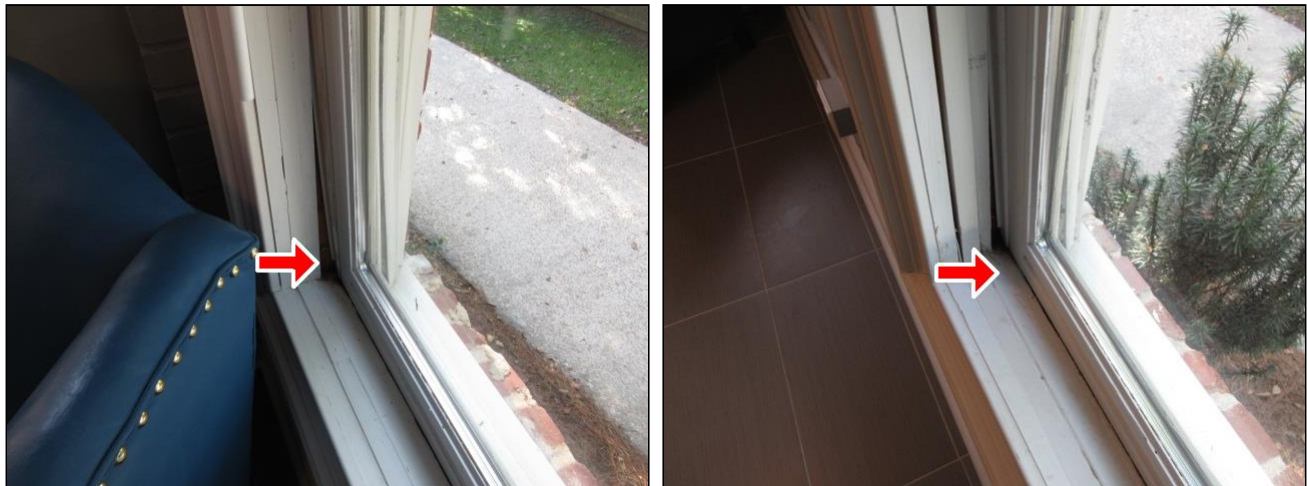
Improve: The windows as noted at the right side sunroom, while operational, are not seated properly in the window frame and should be adjusted as needed.

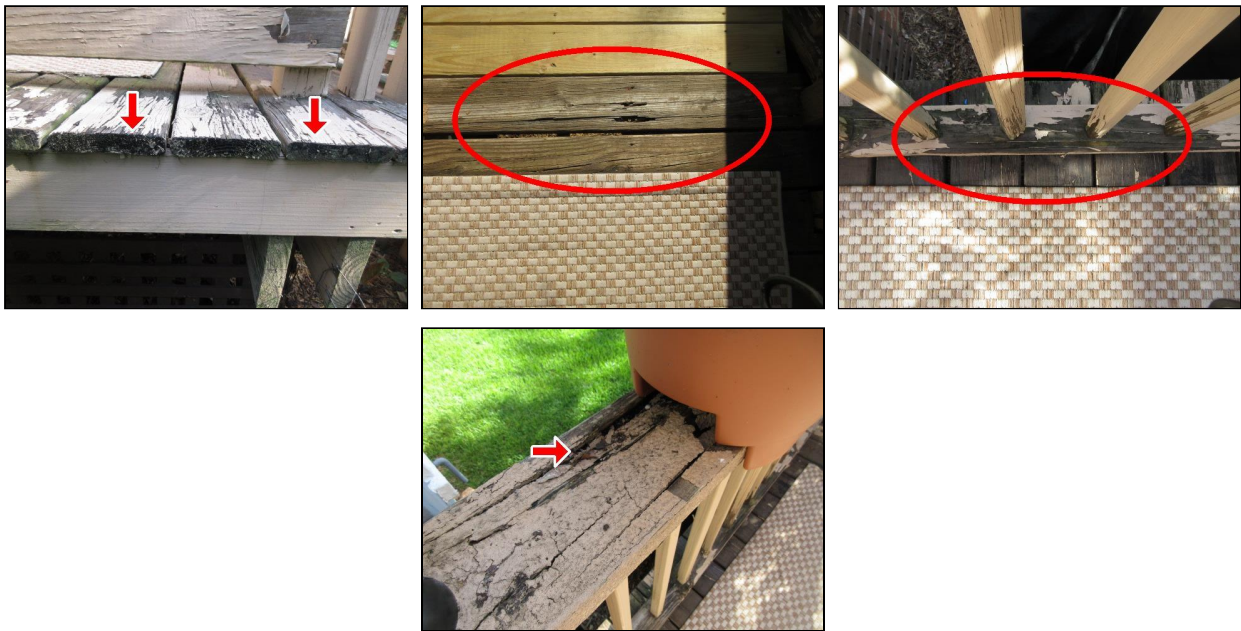
Repair: Signs of rot were observed in the floor boards and railing of the deck structure. All damaged members should be replaced or otherwise re-supported with new wood. Following repair of the damaged areas, proper staining and weather protection of the wood and control of water from roof or surface runoff can avoid further damage.

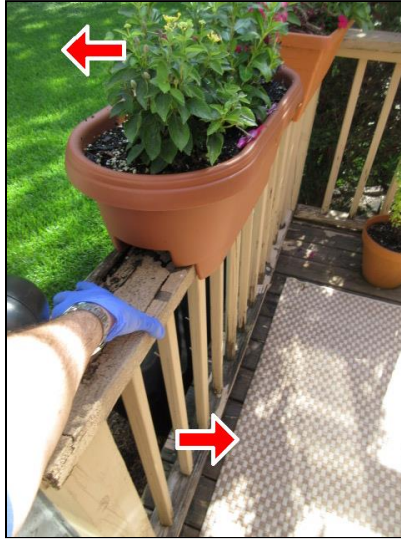
Repair, Safety Issue: The deck railing as noted is loose and needs repair. Strengthening of the posts by bolting or other means of support would resist further movement.

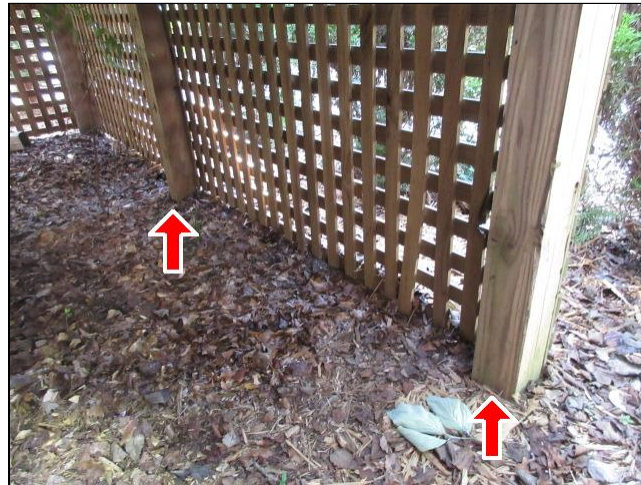
Repair: The grade is in contact with the base of the support wood posts for the deck, which can cause moisture and termite damage in the future. Recent studies have shown that even pressure treated wood can rot over time due to constant contact with the soil. Make sure the footings for the posts are in place and extend at least 2" above the ground to keep the bottoms of the posts dry and free from soil contact.

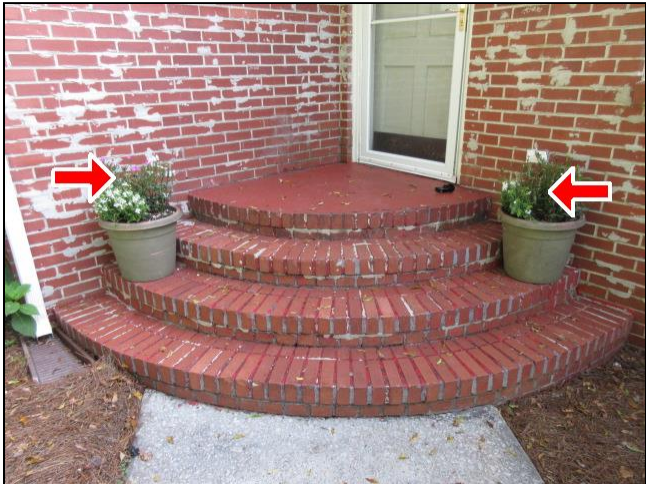
Improve, Safety Issue: Recommend installing a handrail at the exterior steps located at the front yard for improved safety. Current safety standards recommend a handrail for steps of four (4) or more risers.

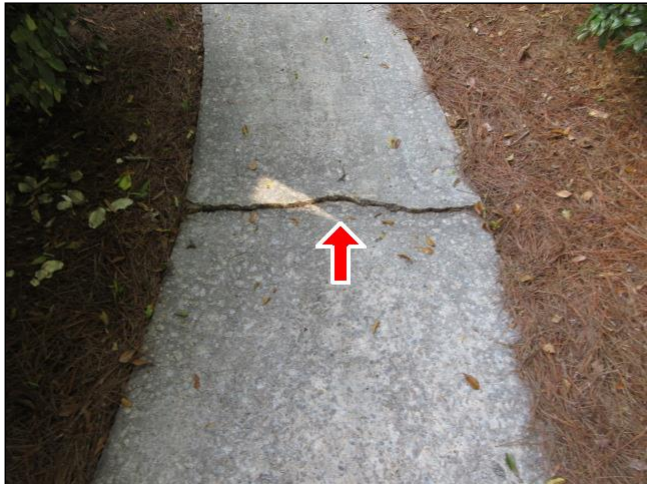
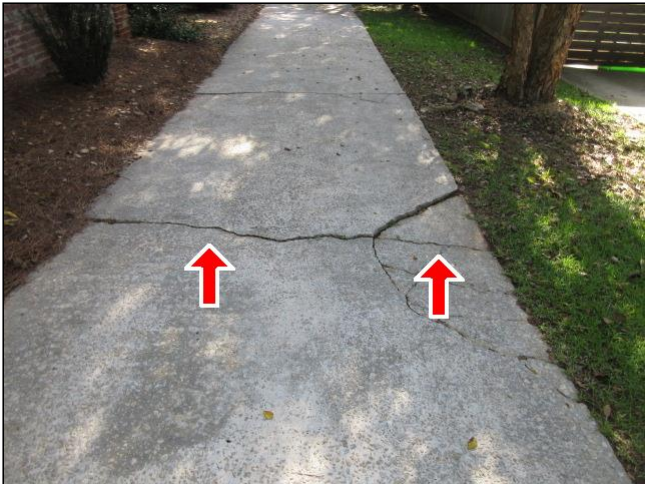
Monitor, Future Repair: The front walkway and driveway has heaved and cracked in some areas as noted and will need repair or replacement in the future.

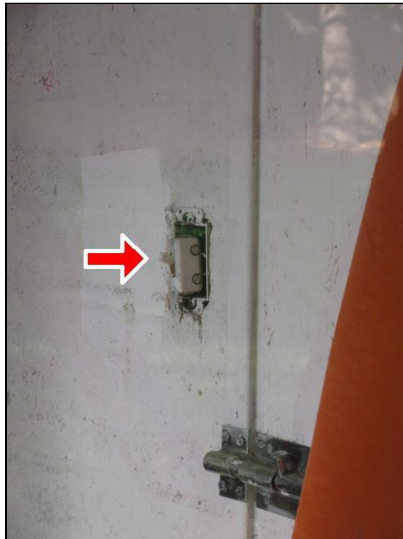
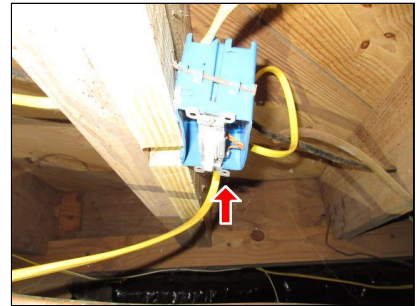
Repair, Safety Issue: Missing outlet and switch cover plates as noted in the rear shed and in the crawlspace (next to furnace) should be replaced as needed to avoid a shock hazard.

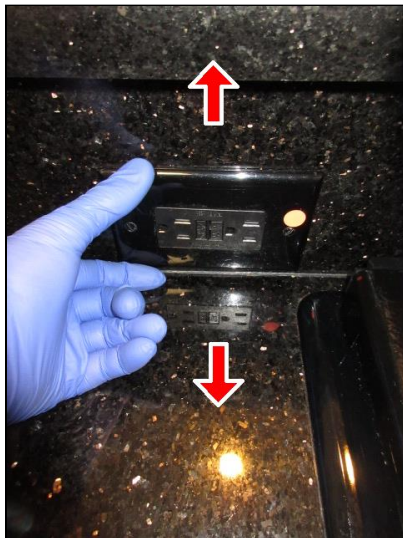
Repair: Loose outlets as noted in the kitchen (marked with orange dot) should be tightened to prevent the loosening of the wiring connections in the future.

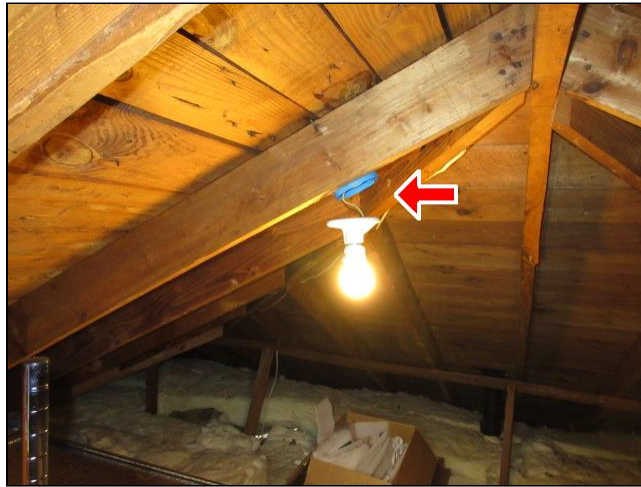
Repair: Loose light fixtures as noted in the attic should be tightened and properly mounted to prevent exposure of the wiring and loosening of wiring connections.

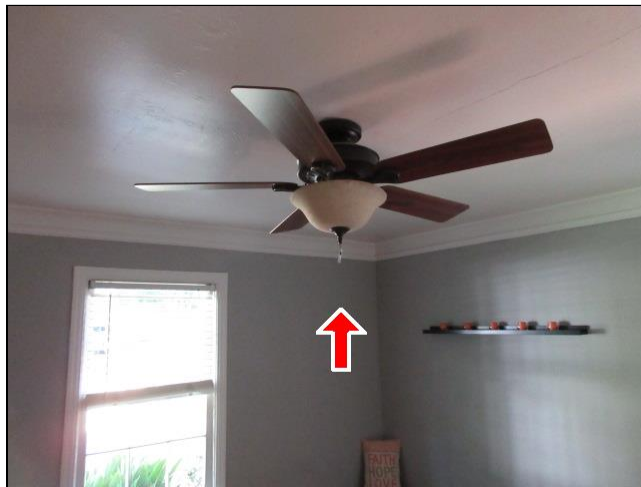
Monitor, Possible Repair: The front bedroom ceiling fan cannot be controlled independently without turning on and off the ceiling fan light. Consult with the seller regarding any and all automatic switches or remote controls that may be needed to control the ceiling fans, if any.

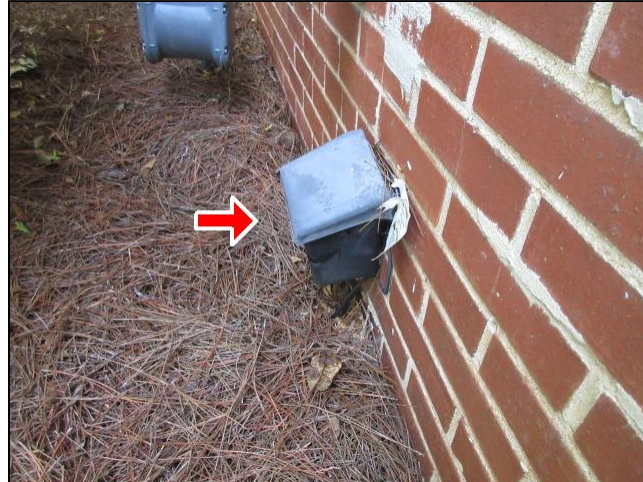
Monitor: It appears there may be an exterior low voltage lighting system, which is not part of the primary electrical system for the house and was not inspected. These systems are often controlled by timers or photocells, which also impedes testing. Recommend consulting with the seller concerning the proper operation of this system (if present) and maintenance required. The control panel for the exterior lighting system appears to be located at the front yard.

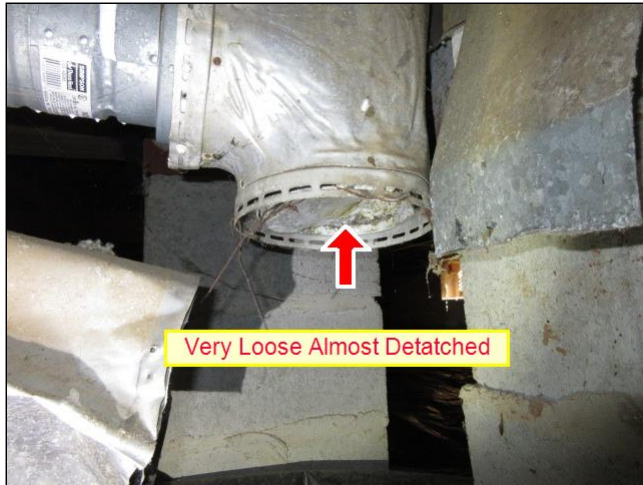
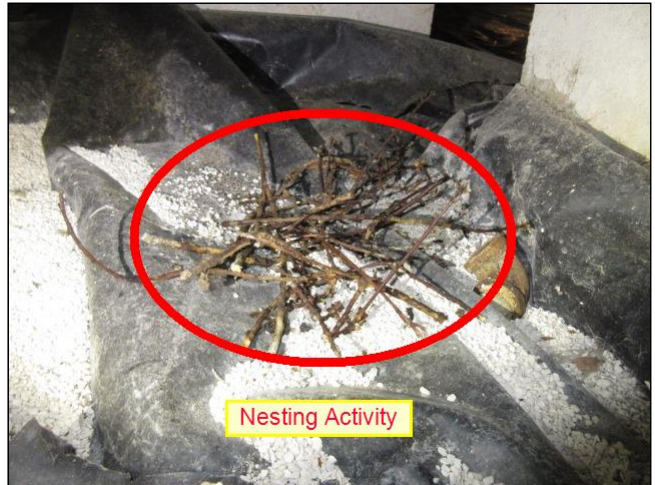
21. **Repair, Safety Issue:** Poor exhaust flue connections as noted in the crawlspace where the horizontal flue meets the vertical flue should be improved immediately by screwing and sealing all open joints. Poor connections risk flue gas and carbon monoxide leakage or other unsafe conditions. Additionally sticks were noted inside the flue, which suggest that birds have been nesting in the flue from the roof. The entire flue system should be reviewed by a qualified HVAC technician to prevent future animal intrusion.

connections risk flue gas and carbon monoxide leakage or other unsafe conditions. Additionally sticks were noted inside the flue, which suggest that birds have been nesting in the flue from the roof. The entire flue system should be reviewed by a qualified HVAC technician to prevent future animal intrusion.

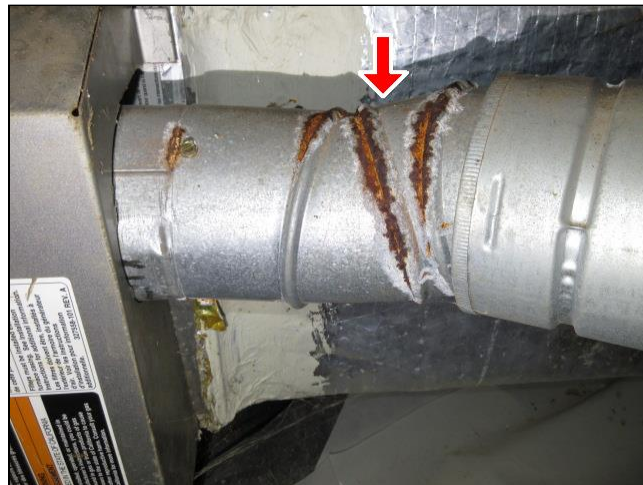
Repair, Safety Issue: Damaged and rusted flue vent piping was noted for the furnace in the crawlspace. Rust in these vents may indicate that they are not venting properly. Open piping and connections also risk flue gas and carbon monoxide leakage or other unsafe conditions. A qualified heating and air conditioning service company should assess these conditions and make repairs as necessary. All damaged piping sections should be replaced as necessary. All connections should be properly secured and sealed.

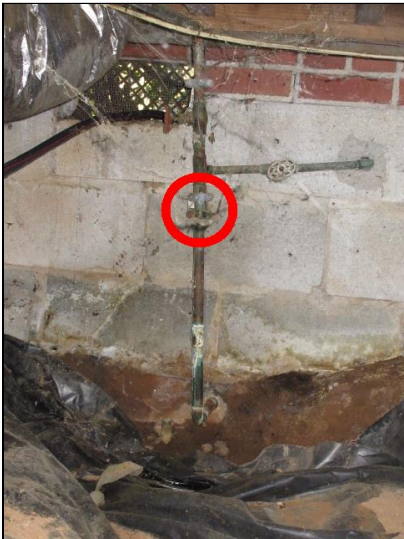
Improve: Because of the poor accessibility of the main water shut off valve (located in the crawlspace at the front foundation), we recommend the installation of an automatic shut off valve that can be operated by a switch in a more convenient location. Consult with a qualified plumbing contractor concerning the possibility of installing this device if so desired.

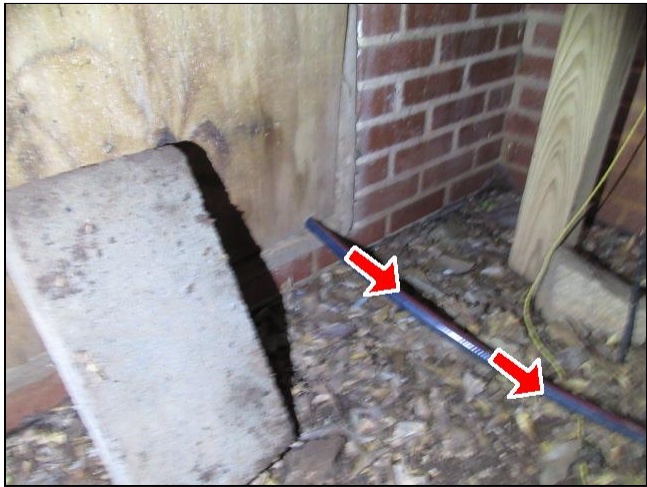
Hose Stretched Through the Crawlspace

28. **Improve:** Single family homes should not have less than two exterior hose bibs, sill cocks or outside hydrants with one being located on the side or rear of the structure as specified by current codes. This condition should be corrected by adding a hose bib at the rear wall as needed. Currently a hose is running from the front faucet through the crawlspace to the rear of the house.

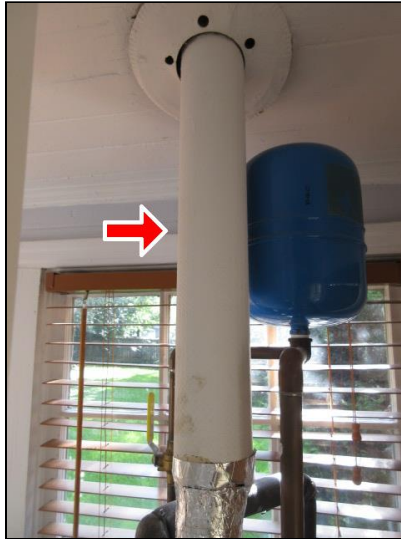
Monitor, Safety Issue: The vent piping for the water heater appears to be a material that may contain asbestos. Extreme care should be taken when contact is made with this material. Consider replacing this piping altogether with metal vent pipe. Proper disposal of the old pipe according to EPA guidelines may be necessary. Because of the age of this structure, there may be other components within the home that may contain asbestos that are not identified in this report.

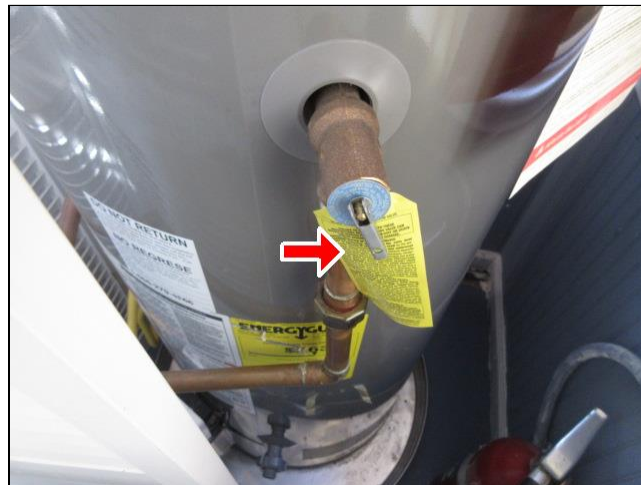
Monitor, Safety Issue: The Temperature and Pressure Relief (TPR) Valve noted at the water heater is an important safety valve that protects the unit from undue pressure build-up in the tank. The valve should always be in good working order to ensure the water heater is safe in the event of extreme pressure buildup. It's designed to open temporarily and discharge short spurts of water when the temperature exceeds about 210 degrees F, and it releases pressure if the tank gets above 150 psi. It's important to locate your water heater pressure relief valve so you can test it at least once a year and address leaks as they occur.

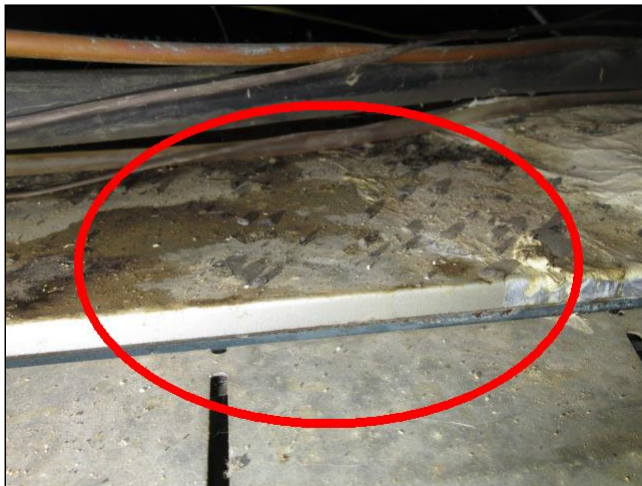
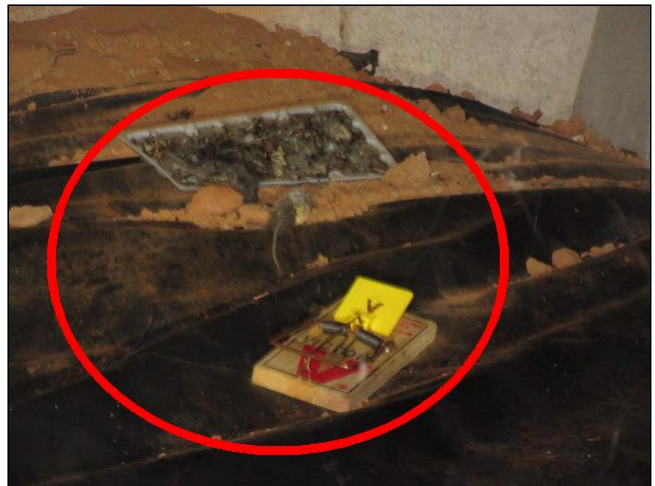
Repair, Safety Issue: There is evidence of past rodent activity in the crawlspace as evidenced by droppings, traps and remains present. A pest control specialist should be consulted to eliminate future activity. All outside openings into the structure as noted ??? should be covered with screen wire or otherwise sealed. Consult with the seller concerning remedies taken to address this condition. Rodents can damage electrical wiring and other building components and can create unhealthy conditions within the home.

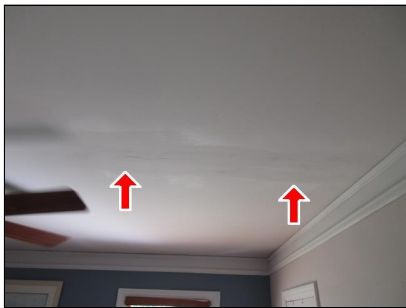
Monitor: Evidence of previous patching and repairs was detected at the living room, rear bedroom and kitchen. Consult with the seller concerning the nature of these repairs and monitor for future activity.

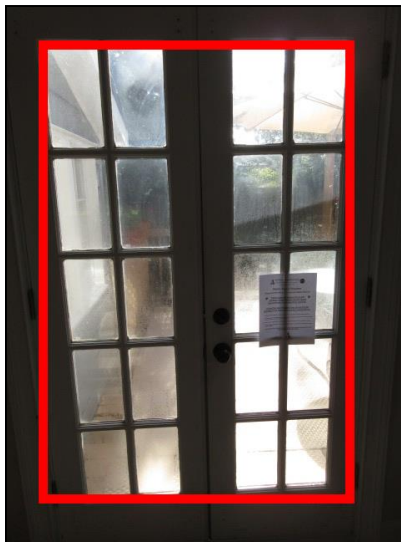
Monitor, Possible Repair: "Fogged" windows were noted in the rear door. This occurs when the seals around double paned glass become compromised, which allows humidity to penetrate and become trapped in the window pane. There is no mechanical or insulation issue with windows in this condition, however if desired, the fogged window(s) should be budgeted for replacement and all of the windows reviewed by a qualified window repair contractor for potential existing or future fogging that may occur.

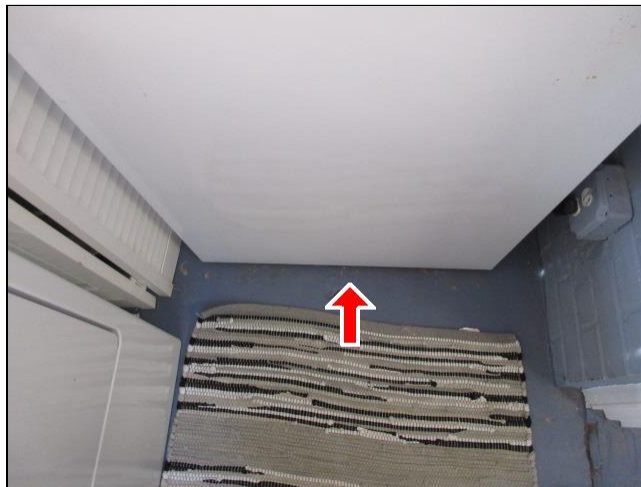
Improve: Recommend installing a metal overflow pan connected to a drain line under the washing machine to prevent damage to interior finishes from possible leaks at the washing machine. Otherwise, a leak detection system should be used. It is also recommended to use metal braided hoses for the washer connection for added protection.
