Welch Engineering  
1345 BridgeMill Avenue  
Canton, Georgia 30114

# Residential Inspection

120 Colton Crest Drive  
Johns Creek, Georgia 30005

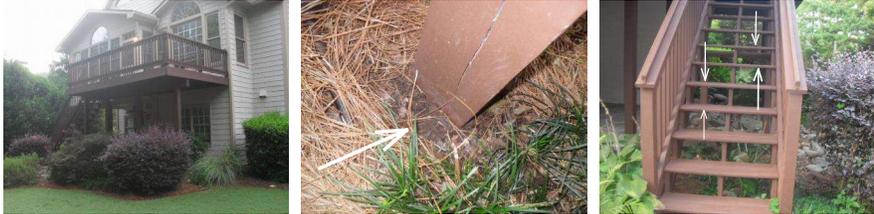
6.      **Deck:** Stained wood Deck in rear, Because a deck is exposed to the weather daily, the average life of a wooden deck structure is about 15 years. To extend the life, it has to be monitored and properly maintained, especially in this case where the deck is high off the ground. To help prevent failure, the deck structure must be properly secured to the house framing, properly braced from movement and must have a properly secured guardrailing system. Areas of this deck that could cause problems are the deck support post that are in ground contact and the open step risers. Even treated wood will eventually decay when they are in ground contact and these should be monitored and repaired as needed. The open step risers are a safety hazard. A large opening could allow a small child to could get caught between the openings or fall through openings causing injury. It is recommended that a licensed and qualified deck contractor evaluate the deck and provide estimate/recommendation for needed repairs.

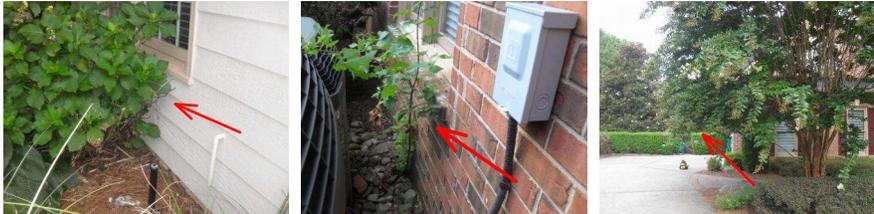
8.      **Vegetation:** Large trees and shrubs Shrubs in contact with siding. Vegetation behind A/C unit and shrub limbs blocking driveway. See photos. Recommend monitoring, cutting back limbs and removing vegetation from siding contact as needed to help prevent siding/AC damage.

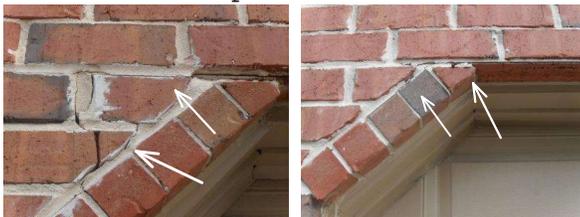
1.      **Type:** Brick veneer Some settlements cracks at edge of garage doors. See photos. It is recommended that a qualified masonry contractor evaluate and provide estimate/recommendation for needed repair.

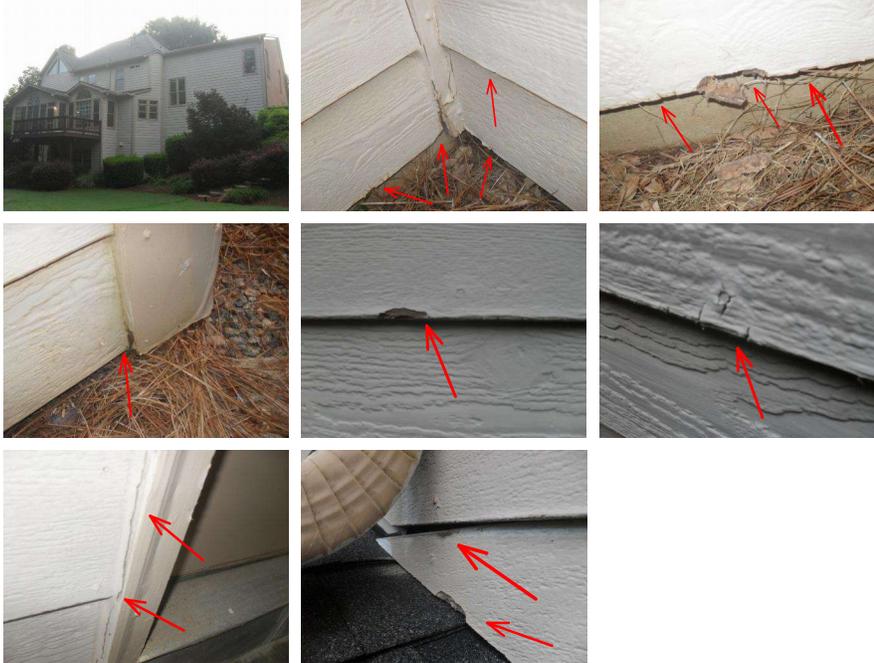
2.      **Type:** Composite wood board siding and cement fiber siding The siding on the rear of the house is a composite wood board siding that is made from wood particles/saw dust and glue. There have been class action law suits over this type product and courts have found it to be a defective product. It appears that this is LP siding and that some of the siding has been replace over the years and some cement fiber siding installed on the sunroom. The siding performs only if is properly installed and properly sealed/caulked/maintained to prevent water entry. When moisture enters the siding, wicking takes place, the glue breaks down and the siding deteriorates. Some of the siding has started to deteriorate along the bottom, around nail holes and

cracked caulking. See photos. It is recommended that a qualified siding contractor evaluate all composite wood board siding and provide estimate/recommendation for needed repairs/replacement.

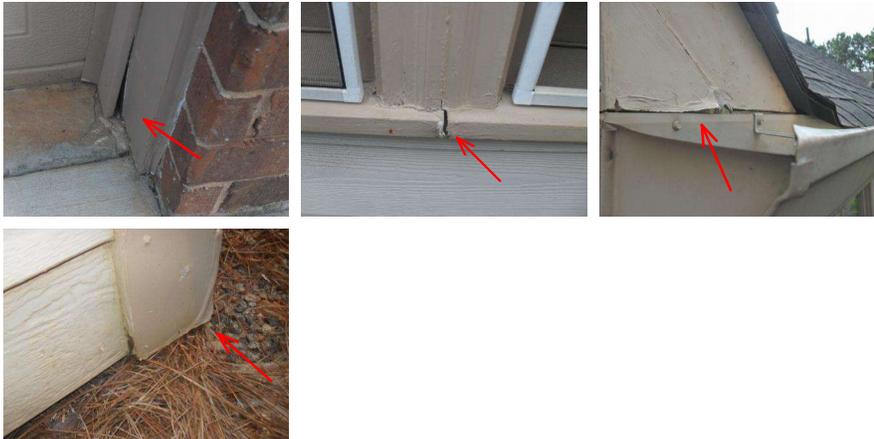
3.      **Trim:** Wood Some paint peeling/blistering, loose trim, cracked caulking and decay starting. See photos. It is recommended that a qualified contractor evaluate and provide estimate/recommendation for needed repair.

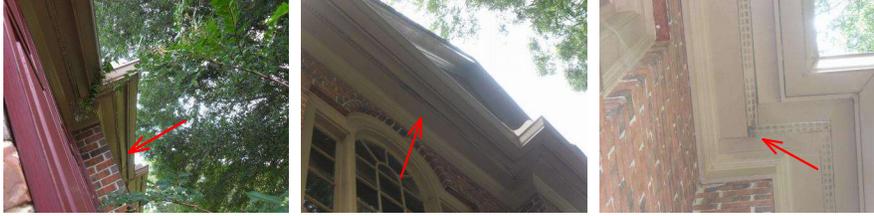
4.      **Soffits:** Vented plywood Appears front soffit is hanging down/loose. See photos. It is recommended that a qualified contractor evaluate all soffits and provide estimate/recommendation for needed repairs

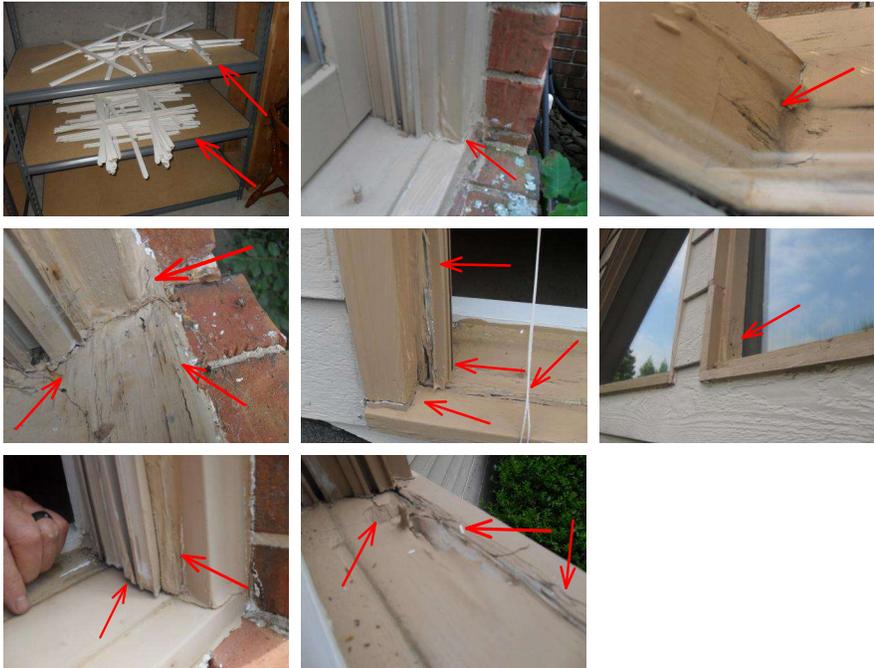
**Windows:** Wood double hung, Non-opening Muntin strips have been removed from most windows and stored in basement. Many windows with blistered paint and decay. See photos. A qualified contractor is recommended to evaluate all wooden windows and provide estimate/recommendation for needed repairs/replacement/paint.

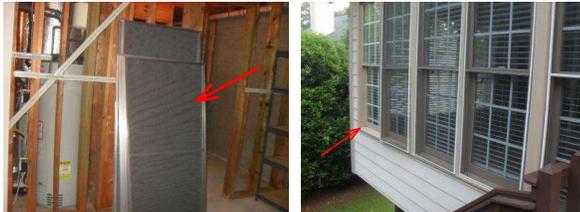
**Window Screens:** Removed from most windows Screens stored in basement. Recommend screens for all windows that open, because screens help protect the window from the elements and allow fresh air into the house during spring and fall.

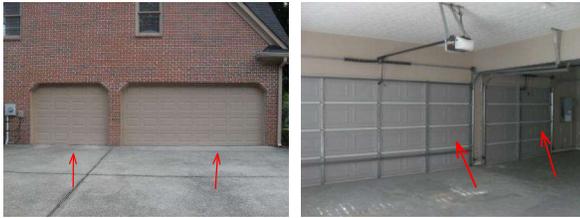
2.      Garage Doors: Metal panels Single & double door, Required safety warning stickers missing on inside garage door. Recommend installation.

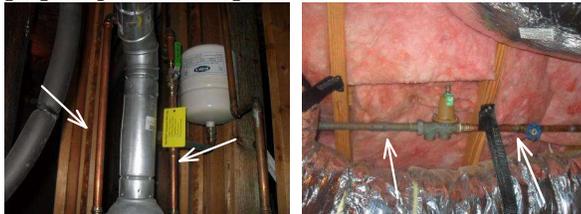
7.      **Bonding** Water heater & water pressure regulator are not bonded. Water heater & water pressure regulator are not bonded as required. Safety hazard. It is recommended that a licensed electrician evaluate & provide estimate/recommendation for needed bonding. Safety hazard. Lack of bonding wires can cause plumber to suffer shock/electrocution when there is an electrical potential difference between the open piping. See photos.

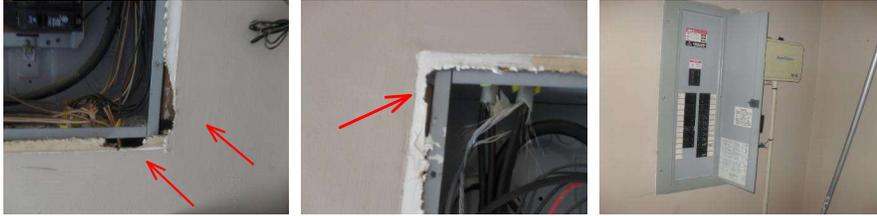
8.      **Manufacturer:** Challenger Excessive gap where panel meets drywall. Safety/fire hazard. It is recommended that a licensed electrician evaluate and provide estimate/recommendation for needed repair. The electrical panel/cabinet should have no more gap than 1/8 " from wall surface. Any arcing or sparks inside electrical panel could cause a fire in the wall. It appears previous workers opened the gaps to run wiring without repairing the gap. It is recommended that a licensed electrician evaluate and provide estimate/recommendation for needed repair.

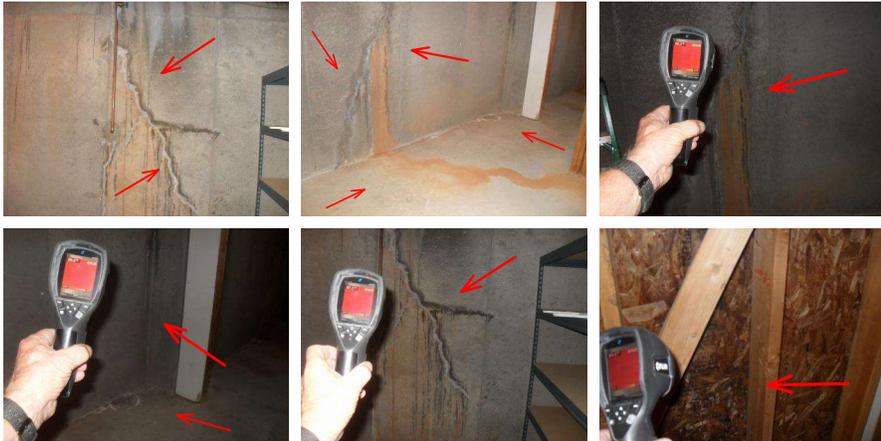
**Foundation:** Poured concrete It appears previous foundation cracks were allowing water to enter basement, which is evidenced from the stains & efflorescence on walls & floor. Epoxy has been injected into cracks for repair. See photos. An infrared camera was used to evaluate repairs, which showed no moisture present along front foundation wall & at chimney framing. See photos. Humidity in basement measured 53 percent without the de-humidifier running.

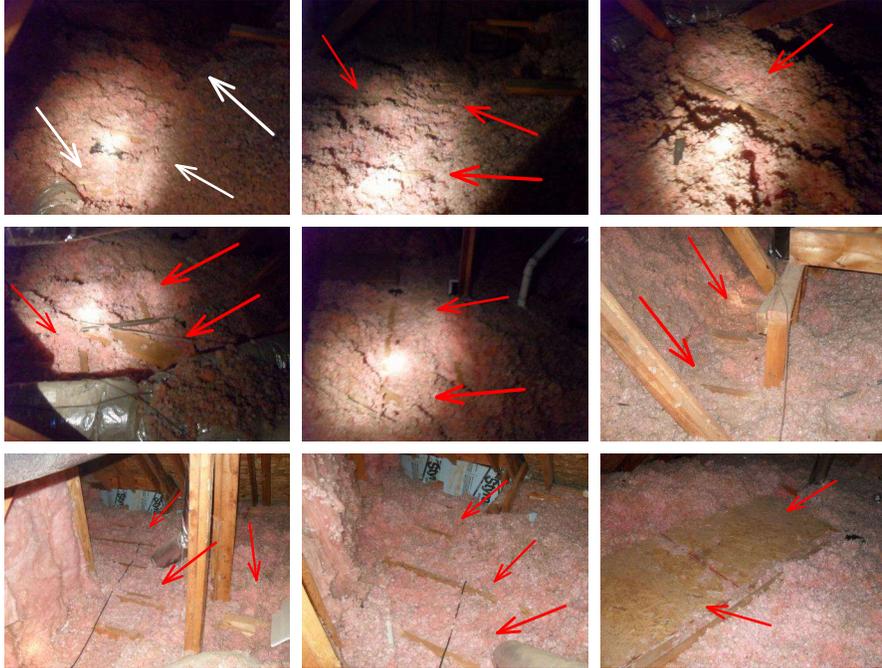
7.      **Insulation Depth:** 0 - 12" The attic insulation has been walked through, moved and compressed from its uniform 12" depth for R-30. Plywood has been laid on top of loose fill reducing the R-value. See photos. The joist are about 7" high so if the attic joist are visible, about 5" of insulation is missing. It is recommended that a qualified insulation contractor evaluate the attic insulation and install additional loose fill insulation to equal R-30 and post certificate certifying R-30.

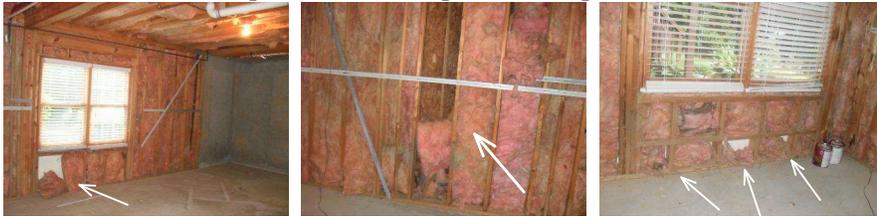
2.      **Walls:** Exposed framing, Concrete foundation walls Some insulation batts have fallen from framed walls. Recommend replacement. Security device on wall - not part of inspection process

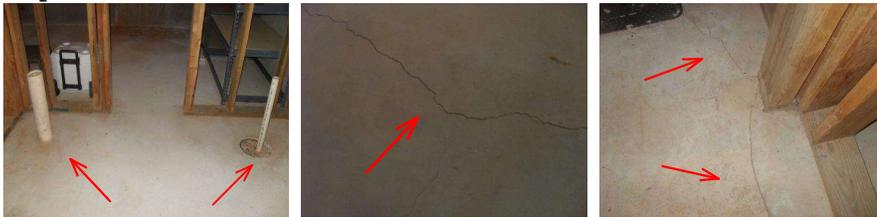
3.      **Floor:** Concrete Basement has been plumbed for additional bathroom. Minor settlement cracks. Recommend caulking cracks & monitoring. Repair as needed.

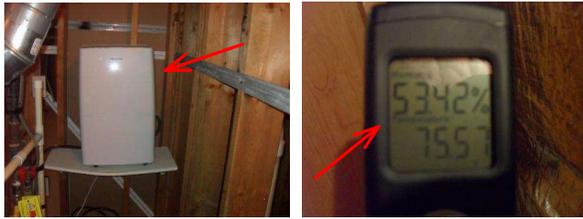
11.      De-humidifier Not running at time of inspection Humidity in basement measured 53.42%

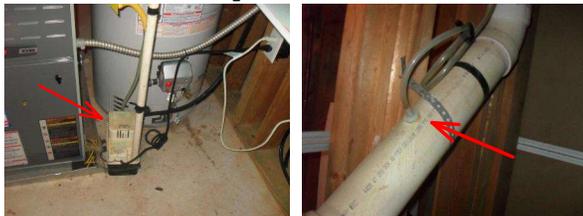
1.      A/C System Operation: Functional at time of inspection
2.      Condensate Removal: Electric pump with clear plastic tubing Condensate being improperly emptied into plumbing pipe. Not allowed because sewer gas can enter conditioned air when pump not in use. Safety hazard. A licensed and qualified HVAC contractor is recommended to evaluate and provide estimated/recommendation for needed repair.

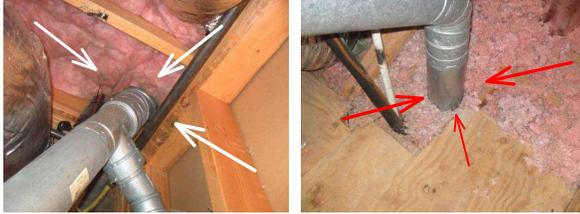
25.      Flue Pipe: Double wall Class B furnace flue in contact with combustibles. Insulation is a combustible material. Fire hazard. This should have been repaired when furnace was replaced. Codes require new replacements to be installed according to current code. Class B vent pipe requires at least 1" clearance. A licensed HVAC contractor is recommended to evaluate and make needed repairs. According to the 2000 IFGC (International Fuel Gas Code of Georgia), section 502.4, an insulation shield shall be installed where a furnace flue vent passes through attic insulation. An insulation shield constructed of not less than 26 gage sheet metal shall be installed to provide clearance between the vent and the insulation material. Where a flue vent passes through an attic space, the shield shall terminate not less than 2 inches above the insulation materials and shall be secured in place to prevent displacement.

Attic insulation must be separated from a flue vent by a distance of 1" for class B double wall vent. If the insulation in the attic is 12" deep the shield should be at least 14" long, totally isolating the flue pipe from attic insulation. Safety/fire hazard. Recommend an

insulating shield be installed & ensure at least 1" clearance from combustibles

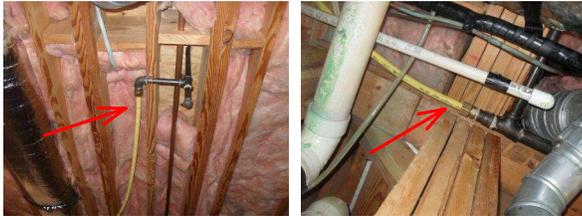
8.      **Gas Service Lines:** Steel pipe, Flexible connector, Yellow CSST Yellow CSST tubing was used to run gas to kitchen, which has not been bonded as required by code & manufactures installation instructions. The thin wall tubing can burn through from nearby lightning strikes if tubing is not properly bonded causing house fire. Appears gas line was not run with required permit or city inspection. See [www.csstfacts.org](http://www.csstfacts.org), [csstsafety.com](http://csstsafety.com) & Georgia Fuel Gas Code Section 310.1.1 for additional information. According to manufacturer, this tubing may only installed by a qualified installer who has completed installation certification. If this tubing is installed improperly, fire, explosion, or asphyxiation may result, according to product label. Installation and bonding instructions, and local codes must be strictly followed. See [Homeflex.com](http://Homeflex.com). Does not appear tubing was installed by a licensed or certified plumber. It is recommended that a qualified & licensed plumbing/HVAC contractor evaluate & provide estimate/recommendation for needed repairs that comply with manufacturer's instructions & State Fuel Gas Code

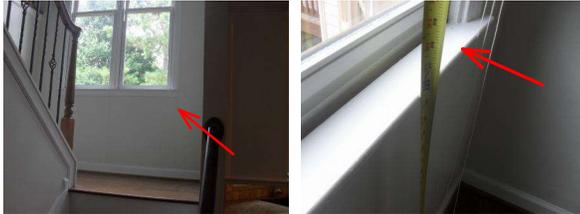
66.      Windows: Wood double hung Windows at stairway landing are Non-tempered glass. Safety hazard - person could trip/fall against glass causing serious cut/injury. Windows in walls enclosing stairway landings where the glass is less than 60 inches above the walking surface, the windows should be tempered/safety glass. A qualified glazier is recommended to evaluate and estimate repairs/replacement

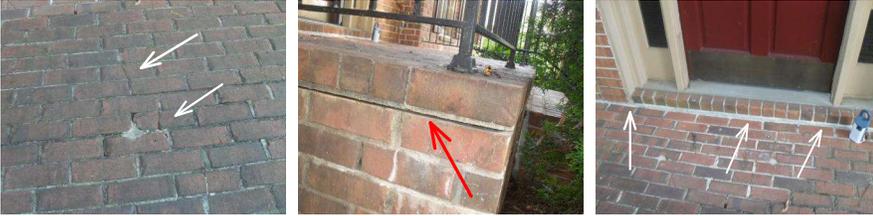
1. **Porch:** Brick floor with metal railings There has been some settlement and brick cracking for front porch. It appears settlement open gap along front wall that was allow water entry, which has now been sealed. See photos. Recommend monitoring and repair as needed.

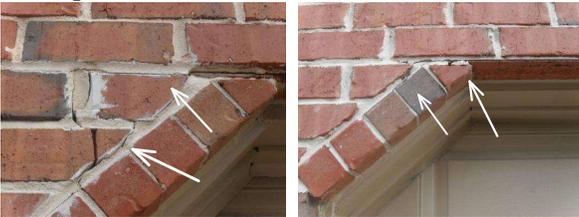
3. **Front and sides Exterior Surface Type:** Brick veneer Some settlements cracks at edge of garage doors. See photos. It is recommended that a qualified masonry contractor evaluate and provide estimate/recommendation for needed repair.

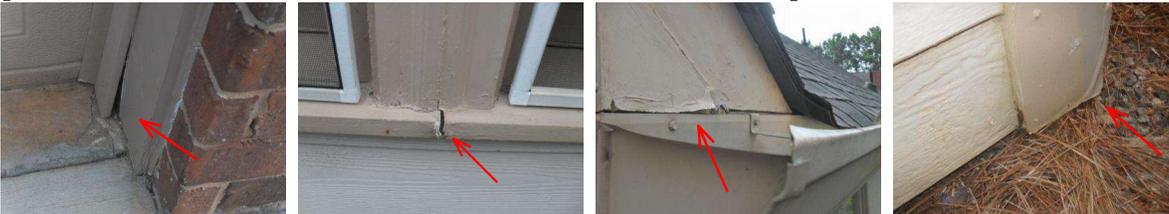
4. **Trim:** Wood Some paint peeling/blistering, loose trim, cracked caulking and decay starting. See photos. It is recommended that a qualified contractor evaluate and provide estimate/recommendation for needed repair.

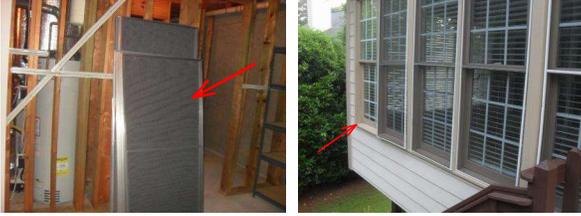
5. **Window Screens:** Removed from most windows Screens stored in basement. Recommend screens for all windows that open, because screens help protect the window from the elements and allow fresh air into the house during spring and fall.

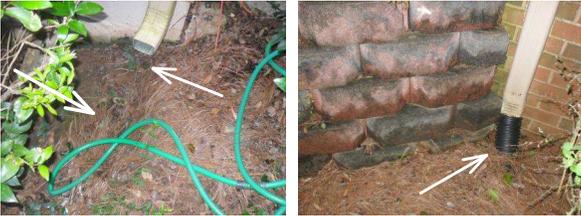
6. **Leader/Extension:** Elbows, Plastic pipe Splashblock missing at rear corner of garage which is causing erosion. See photo. Recommend installation. Plastic downspout extensions can easily clog. Recommend observing during heavy rain to ensure proper drainage & recommend cleaning & inspecting annually.

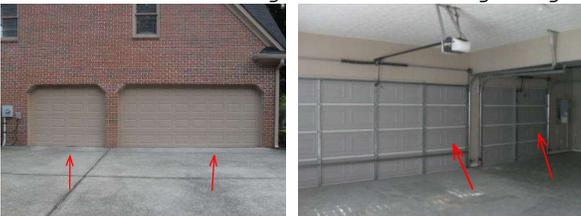
7. **Left side Garage Garage Doors:** Metal panels Single & double door, Required safety warning stickers missing on inside garage door. Recommend installation.

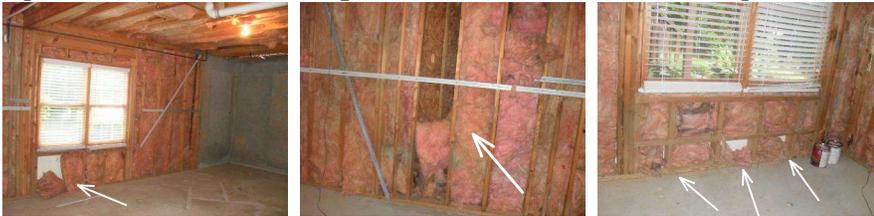
11. **Large unfinished basement area - terrace level Basement Walls:** Exposed framing, Concrete foundation walls. Some insulation batts have fallen from framed walls. Recommend replacement. Security device on wall - not part of inspection process

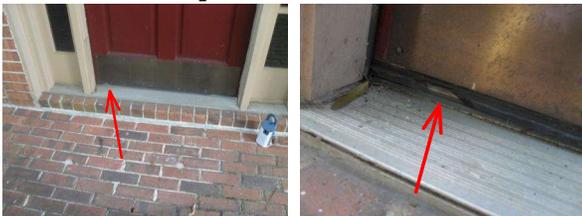
23. **Living Room Living Space HVAC Source:** HVAC system registers Lint build-up in return HVAC register & duct, Recommend a qualified HVAC contractor evaluate & clean ducts as required.
24. **Foyer Living Space Closet:** Coat closet Door stop missing for door. Recommend installation.
25. **Foyer Living Space Doors:** Six Panel entrance Door Gasket torn at bottom. See photo. Recommend replacement

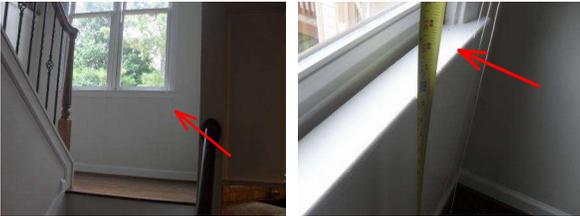
33. **Garage foyer & hall Living Space Windows:** Wood double hung Windows at stairway landing are Non-tempered glass. Safety hazard - person could trip/fall against glass causing serious cut/injury. Windows in walls enclosing stairway landings where the glass is less than 60 inches above the walking surface, the windows should be tempered/safety glass. A qualified glazier is recommended to evaluate and estimate repairs/replacement

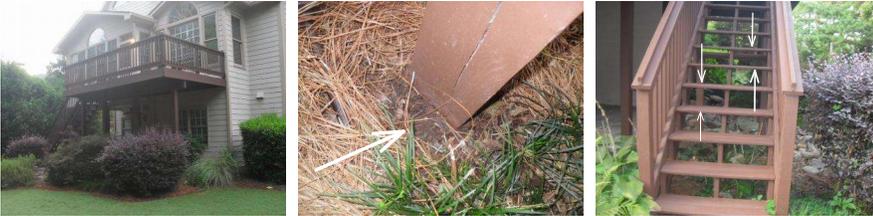
- Deck:** Stained wood Deck in rear, Because a deck is exposed to the weather daily, the average life of a wooden deck structure is about 15 years. To extend the life, it has to be monitored and properly maintained, especially in this case where the deck is high off the ground. To help prevent failure, the deck structure must be properly secured to the house framing, properly braced from movement and must have a properly secured guardrailing system. Areas of this deck that could cause problems are the deck support post that are in ground contact and the open step risers. Even treated wood will eventually decay when they are in ground contact and these should be monitored and repaired as needed. The open step risers are a safety hazard. A large opening could allow a small child to could get caught between the openings or fall through openings causing injury. It is recommended that a licensed and qualified deck contractor evaluate the deck and provide estimate/recommendation for needed repairs.

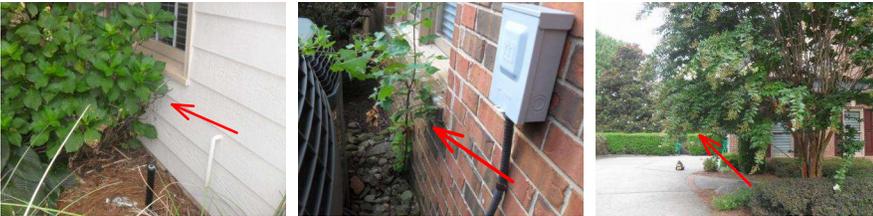
- Vegetation:** Large trees and shrubs Shrubs in contact with siding. Vegetation behind A/C unit and shrub limbs blocking driveway. See photos. Recommend monitoring, cutting back limbs and removing vegetation from siding contact as needed to help prevent siding/AC damage.

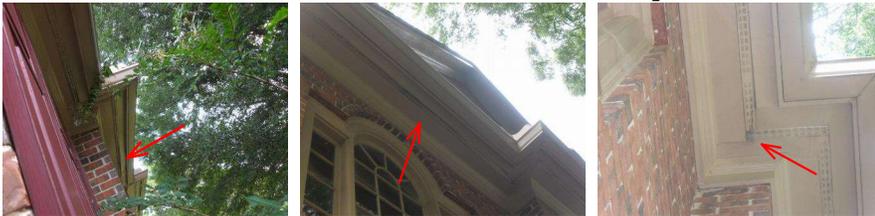
4. **Soffits:** Vented plywood Appears front soffit is hanging down/loose. See photos. It is recommended that a qualified contractor evaluate all soffits and provide estimate/recommendation for needed repairs

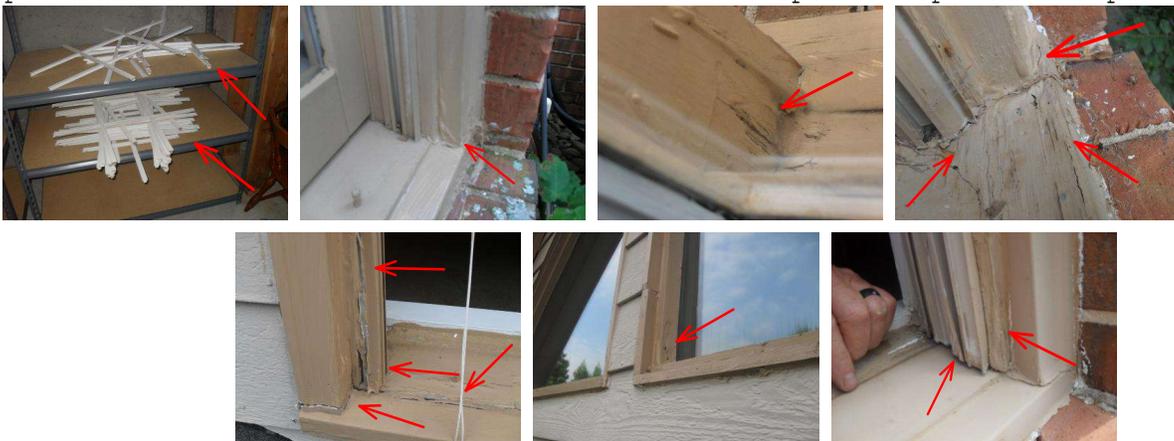
5. **Windows:** Wood double hung, Non-opening Muntin strips have been removed from most windows and stored in basement. Many windows with blistered paint and decay. See photos. A qualified contractor is recommended to evaluate all wooden windows and provide estimate/recommendation for needed repairs/replacement/paint.

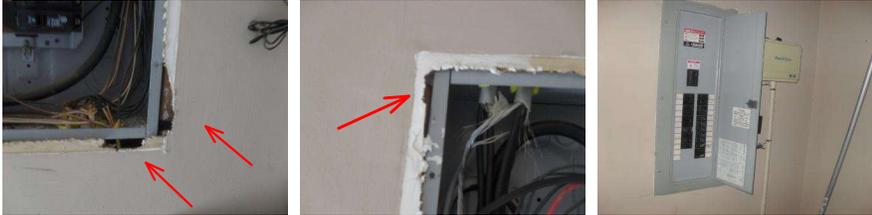
10. **Garage Electric Panel Manufacturer:** Challenger Excessive gap where panel meets drywall. Safety/fire hazard. It is recommended that a licensed electrician evaluate and provide estimate/recommendation for needed repair. The electrical panel/cabinet should have no more gap than 1/8 " from wall surface. Any arcing or sparks inside electrical panel could cause a fire in the wall. It appears previous workers opened the gaps to run wiring without repairing the gap. It is recommended that a licensed electrician evaluate and provide estimate/recommendation for needed repair.
