Inspection Report

Property Address:
1220 Briers Creek Dr
Alpharetta GA 30004

Dana Inspection Services

Date: 9/2/2020	Time: 01:00:00 PM	Report ID: 090220DO11
Property: 1220 Briers Creek Dr Alpharetta GA 30004	Customer: Allison Owenby	Real Estate Professional: Reid Casey

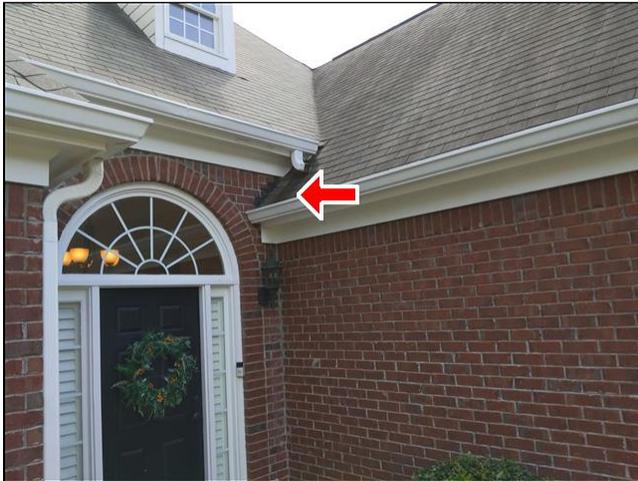
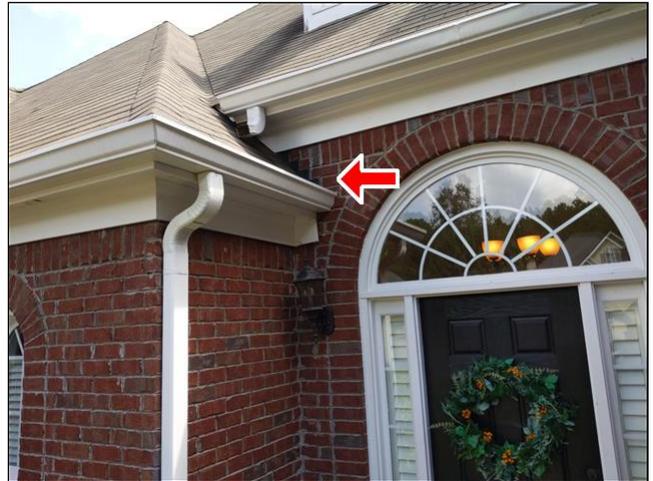
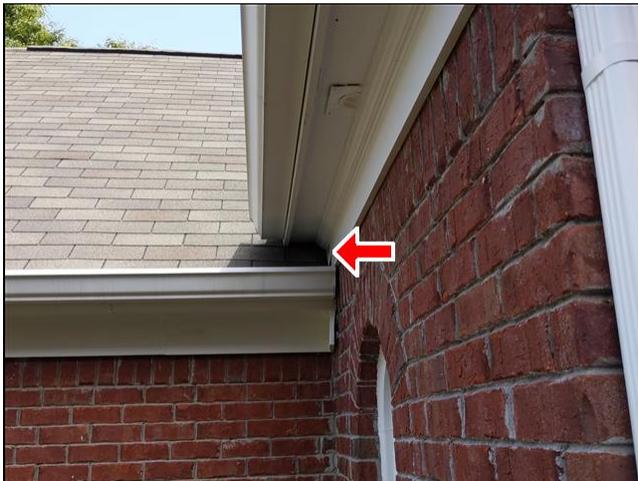
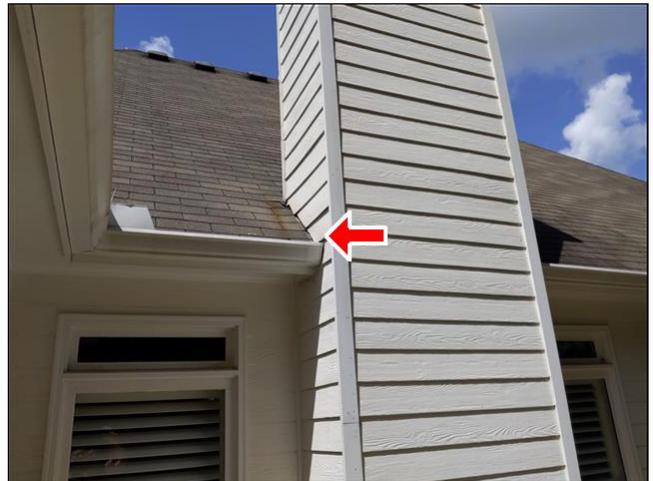
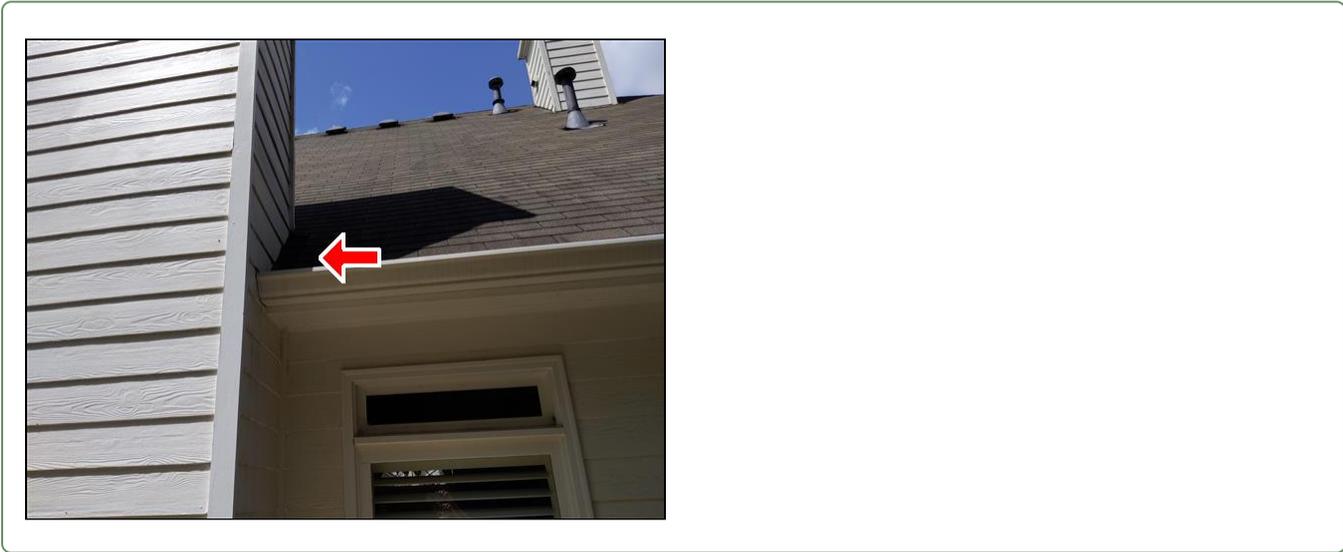
Kick out flashing is missing at the intersections of walls and gutters. Kick out flashing is used to divert water from the shingles into the gutter system. This helps prevent water intrusion into wall structures.

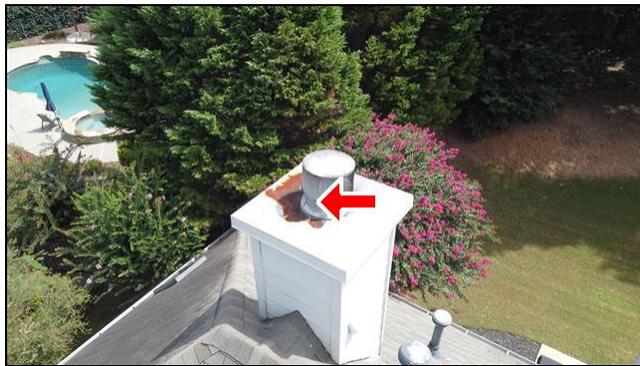
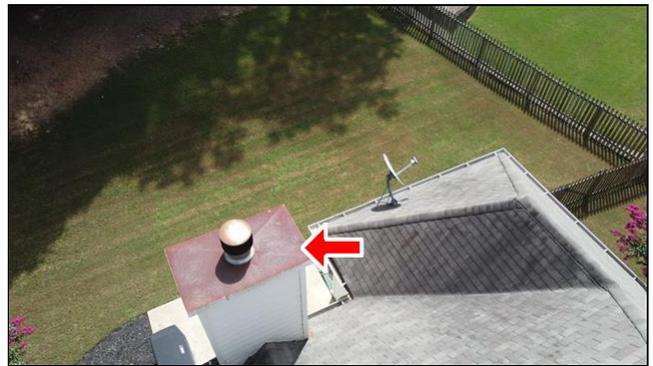
(1) Rust was observed on the chimney caps. This should be cleaned and painted with a rust inhibitor to prolong its useful life.

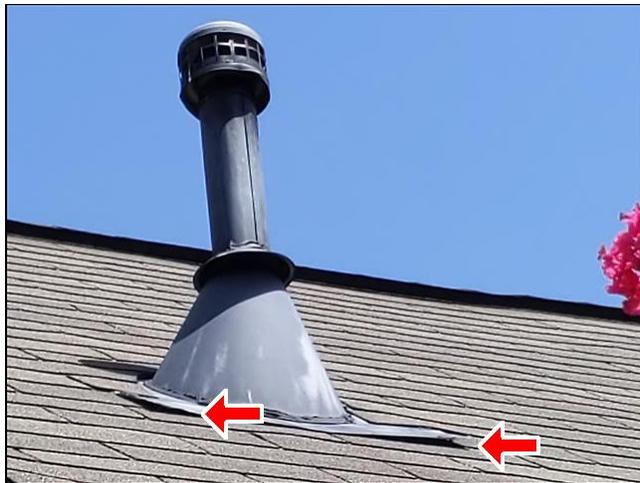
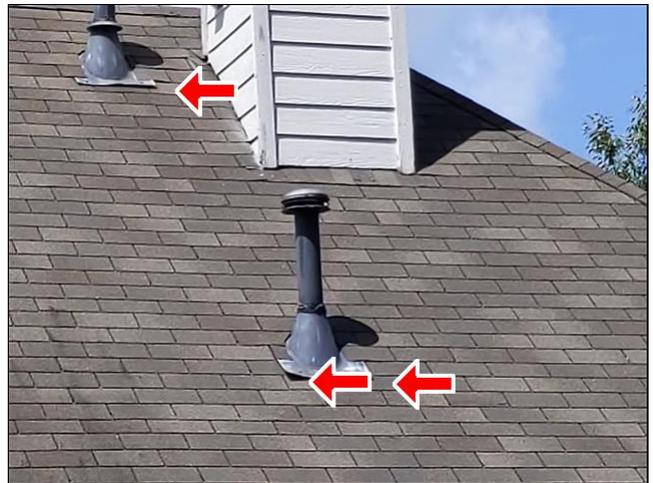
(2) Exhaust flue flashing right hand side above garage and rear of house is loose. Recommend qualified roofer repair.

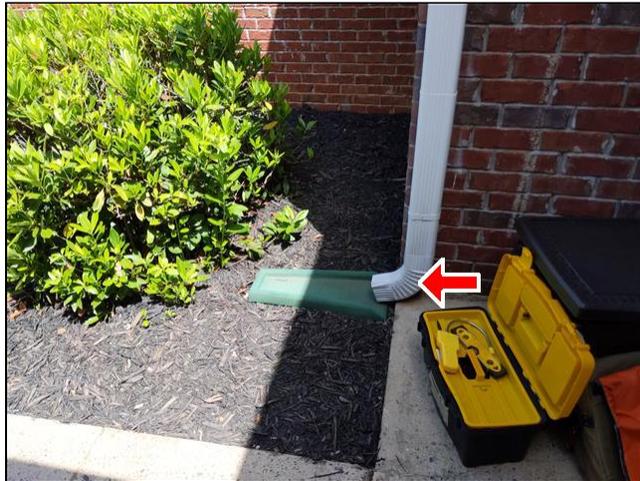
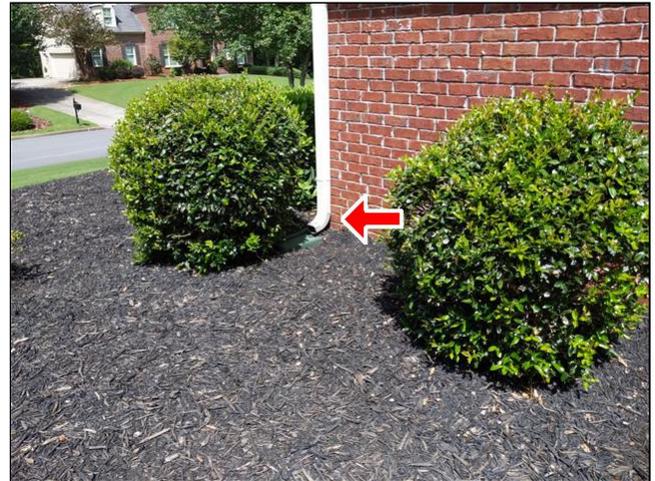
It is recommended that all downspout have downspout extensions.

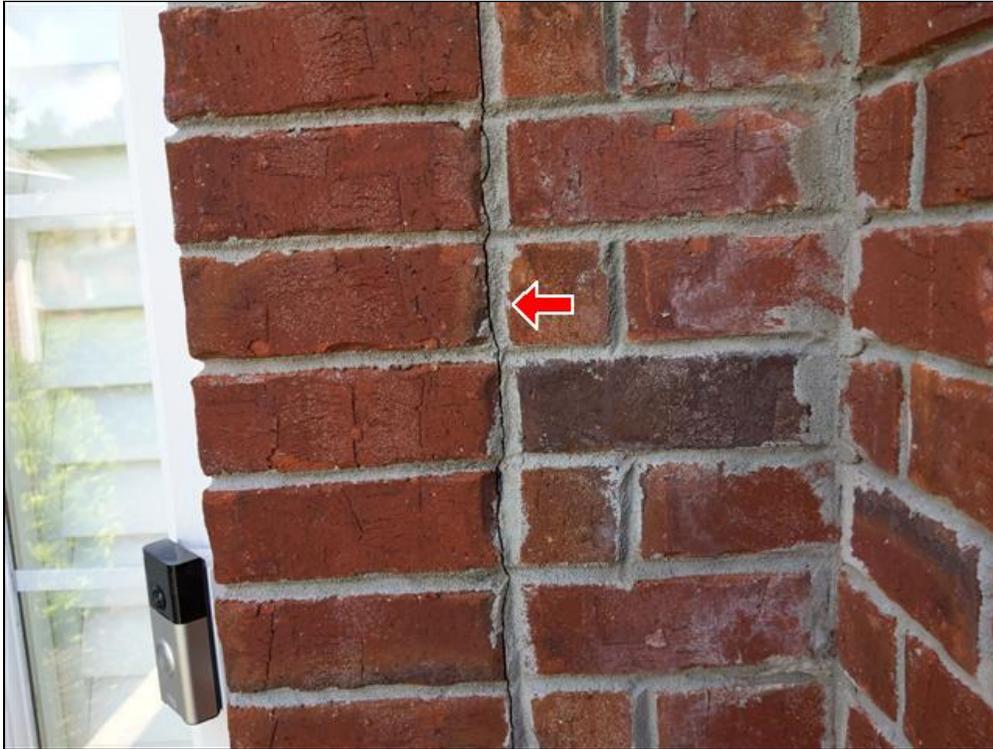
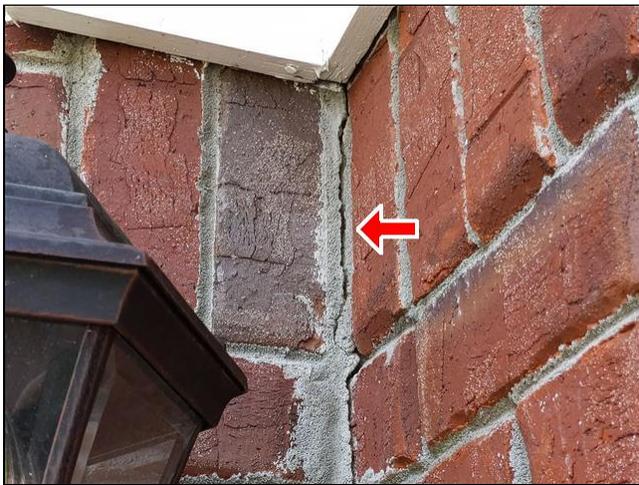
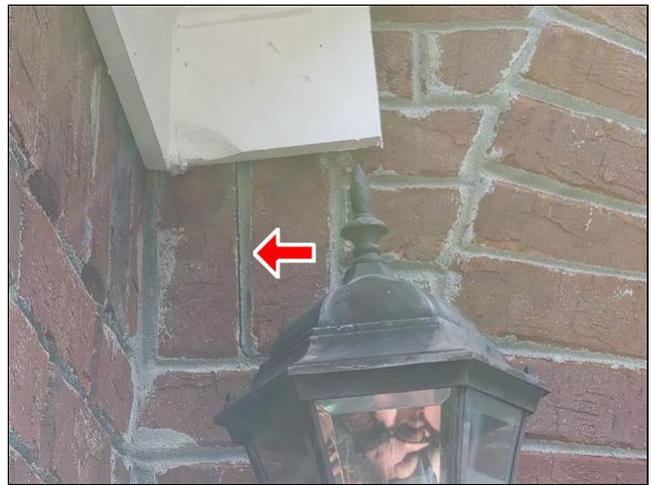
(1) Cracking in the mortar on both sides of the front door. Recommend a qualified brick mason repair.

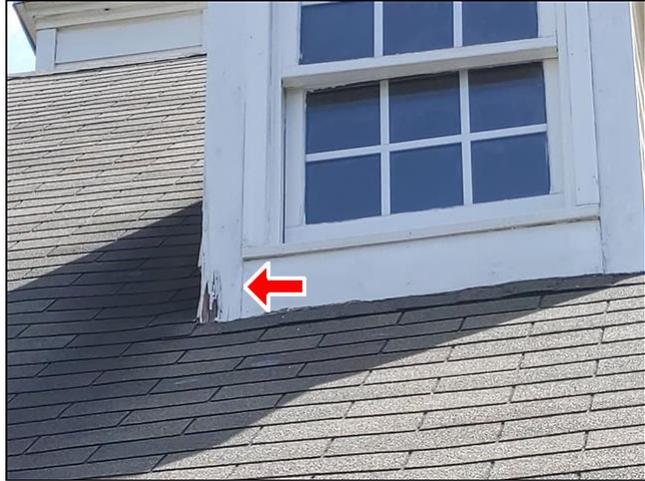
(2) Failing paint to the left side of dormer.

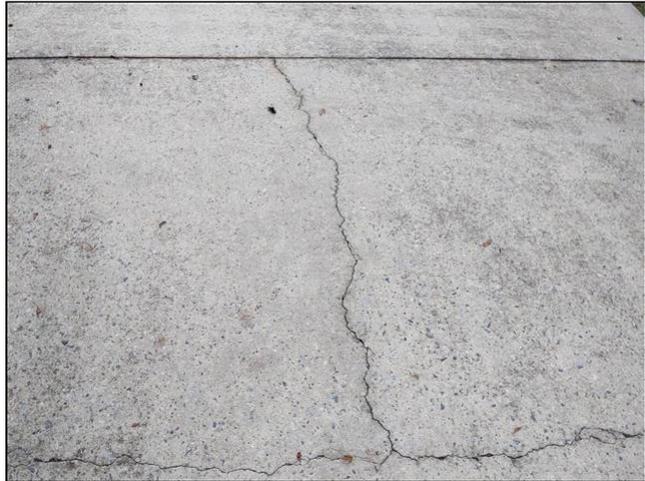
(1) Common settling cracks were observed on the driveway.

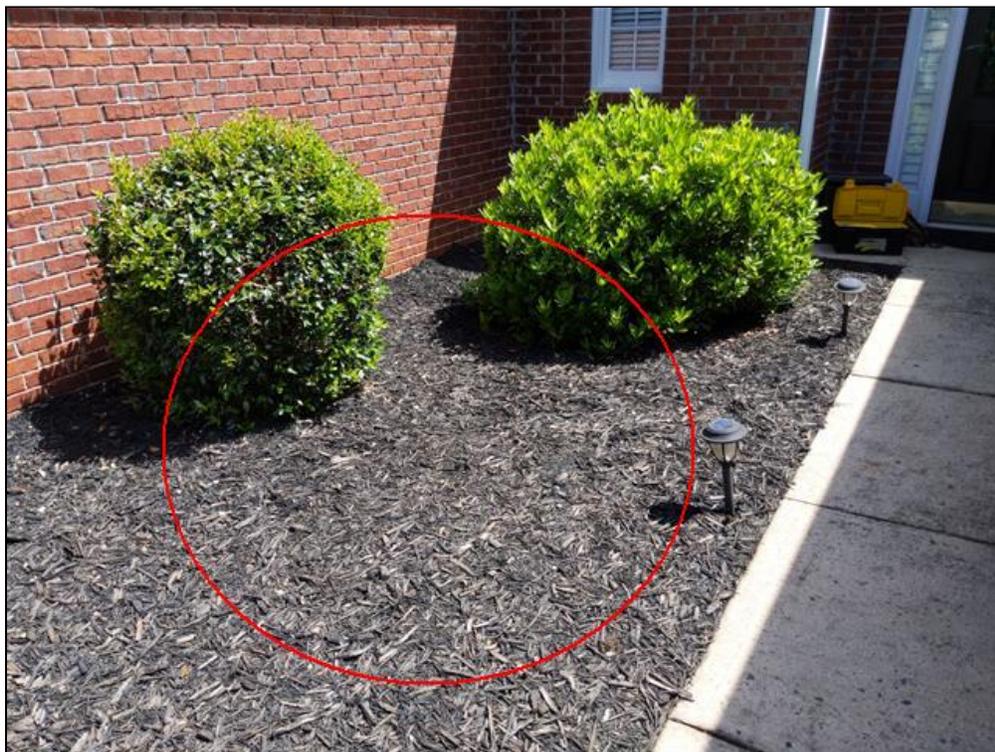
(2) There is a neutral to negative grade at the front of the house that may place excessive amounts of moisture up against the foundation. It is recommended to modify the grading to create a positive slope away from the house and foundation.

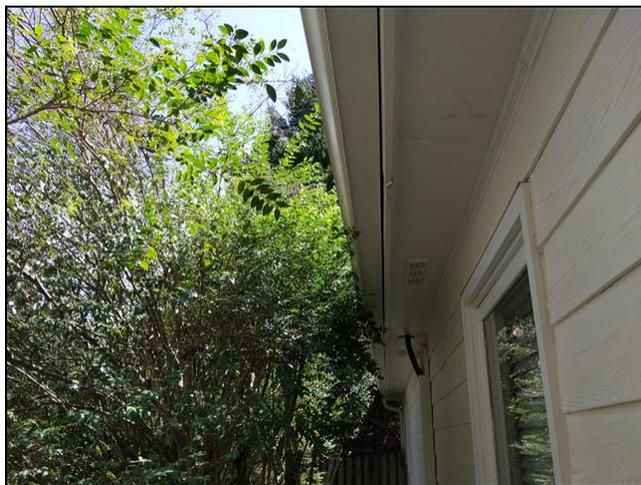
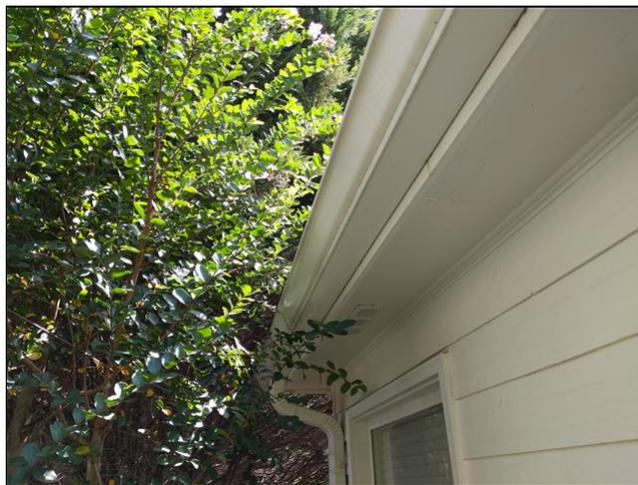
(3) All vegetation in contact with the house or roof should be cut back or removed.

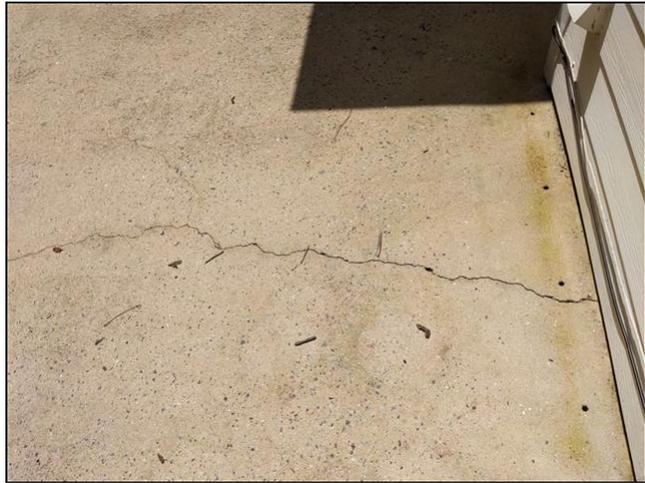
Common settling or curing cracks were observed on the back patio.

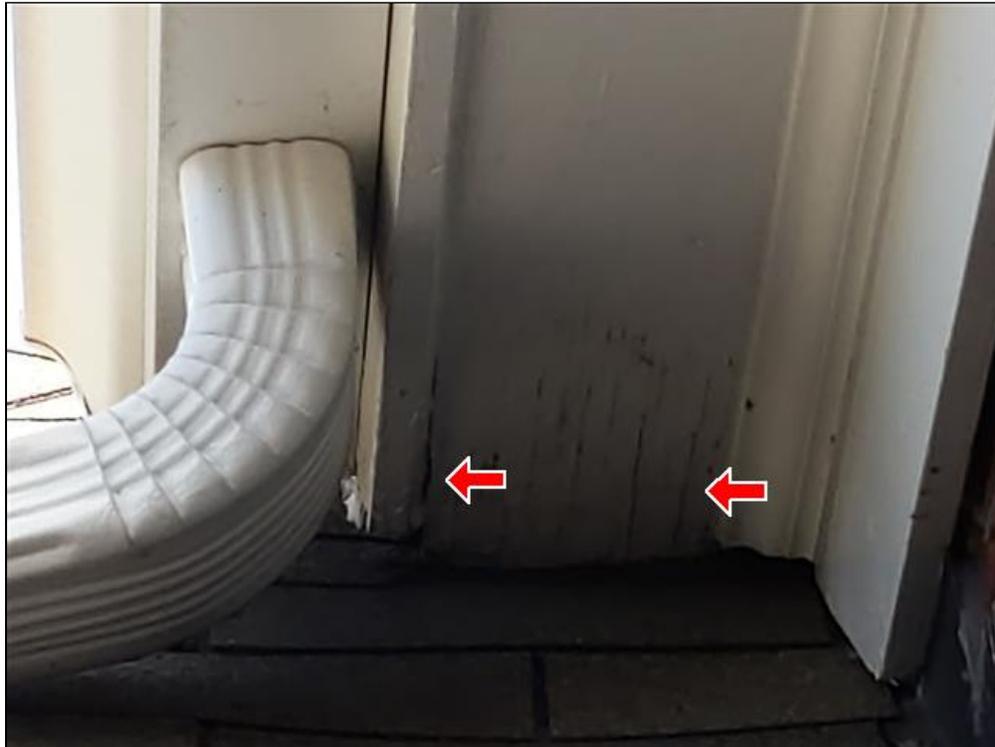
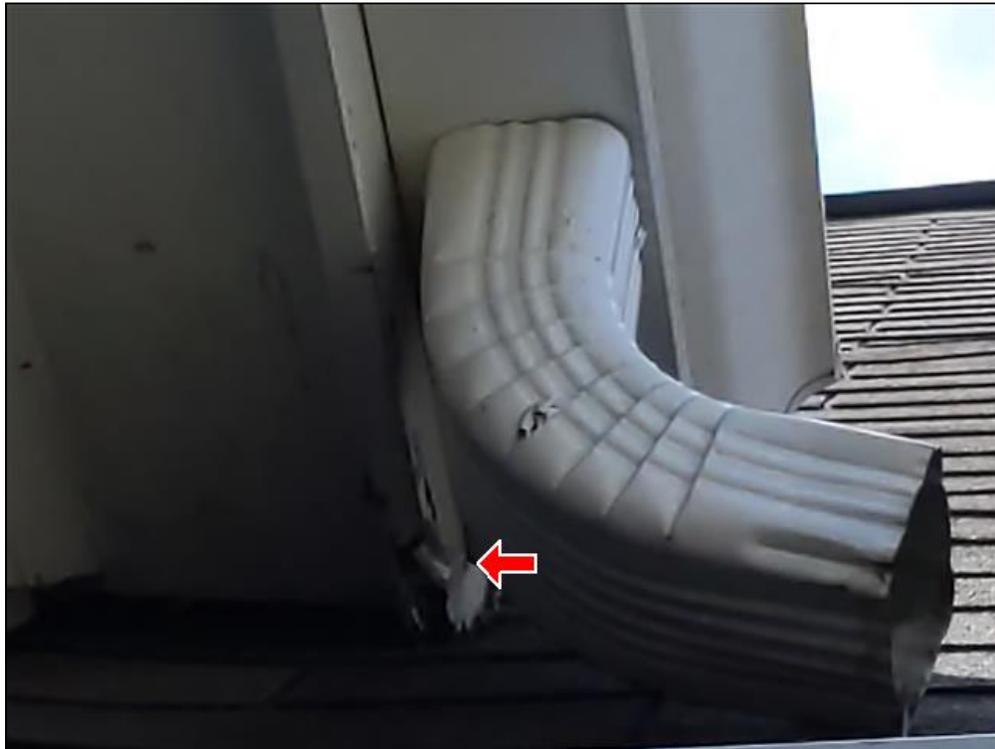
Wood rot to the soffit and fascia above the front door behind downspouts and front right near garage.

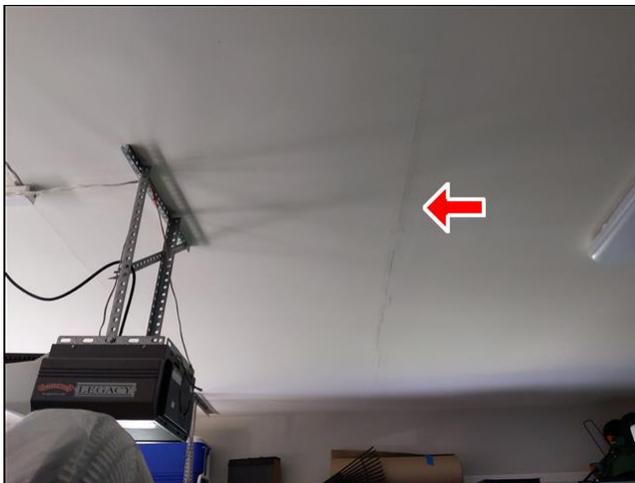
Cracking at the drywall joint line in the garage. Recommend qualified drywall contractor repair.

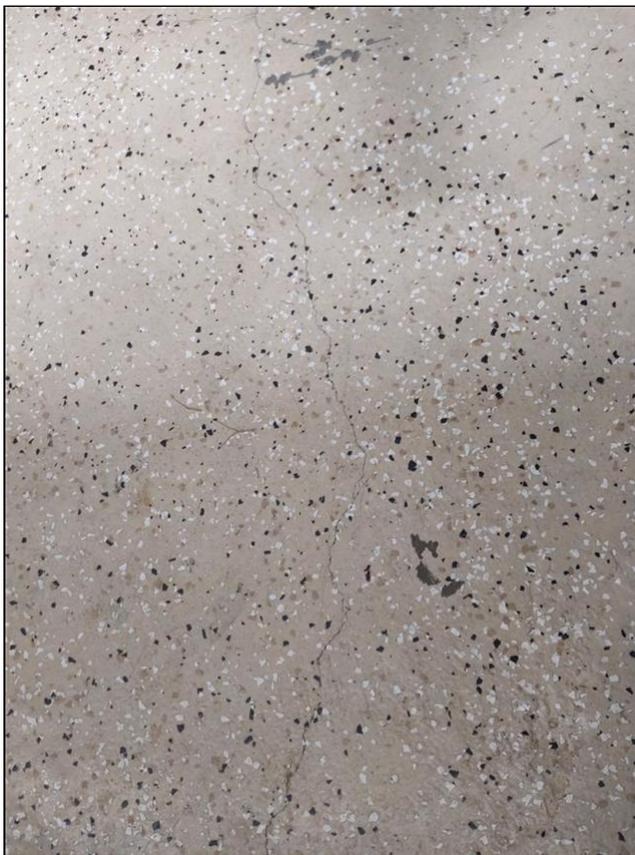
(1) Common curing or settling cracks were observed on the garage floor.

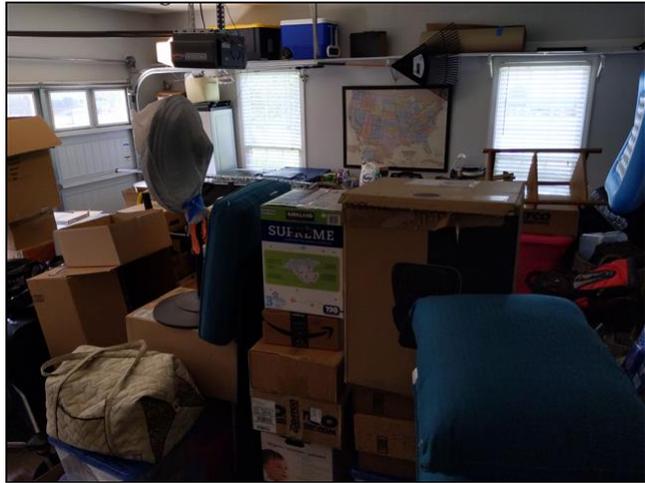
(2) I was unable to inspect most of the walls and floor of the garage due to storage.

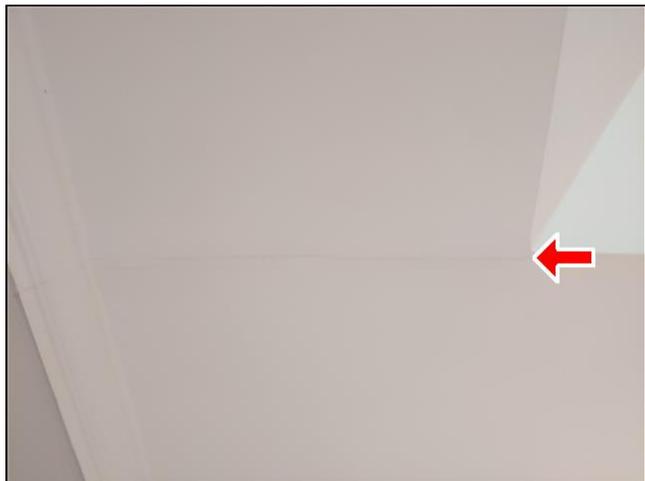
Common drywall cracking on the ceiling in the master. Recommend drywall contractor repair.

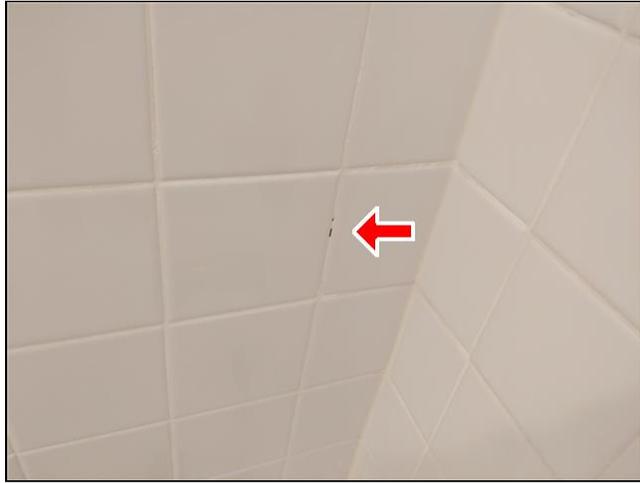
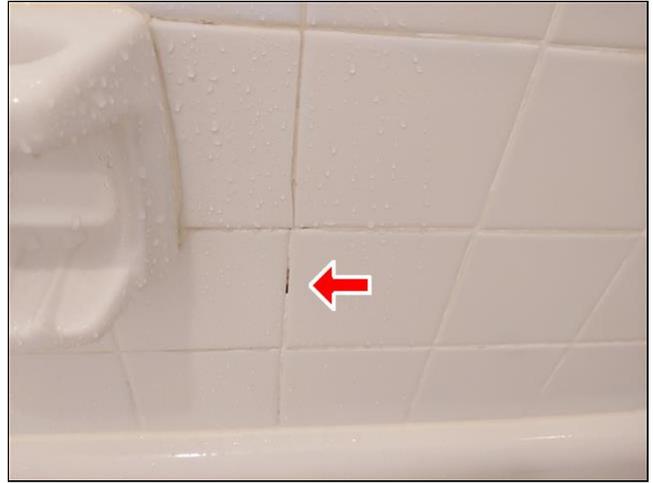
(1) Sealant needed in hallway bathroom shower.

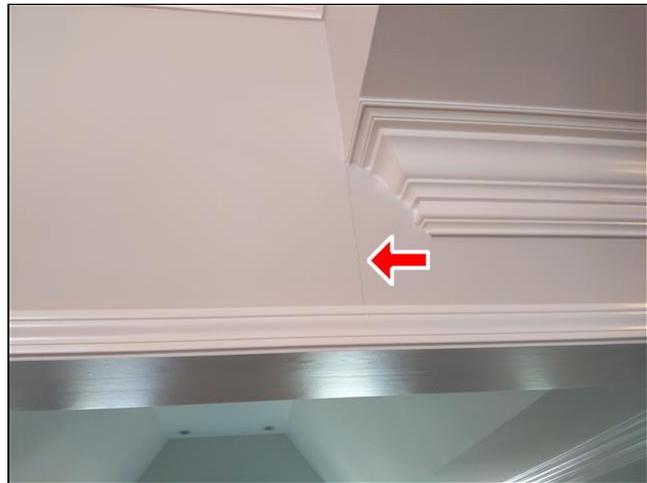
(2) Common drywall cracking at the entrance to the living room.
Recommend a drywall contractor repair.

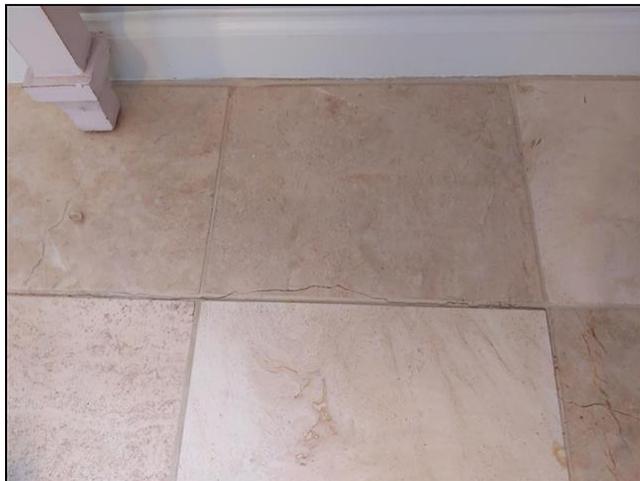
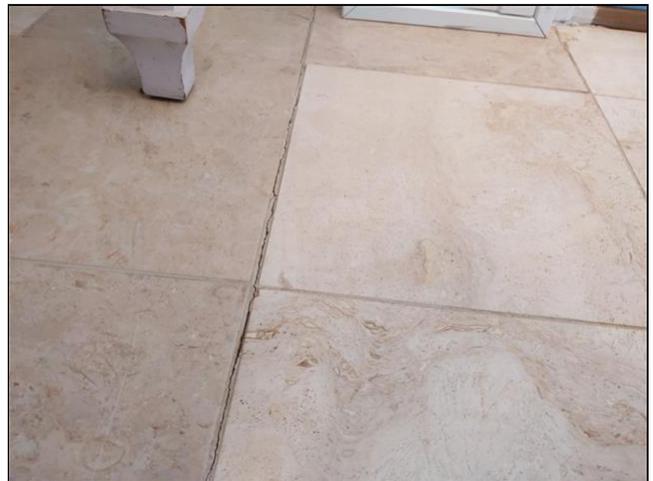
Cracking to tile and mortar in the foyer.

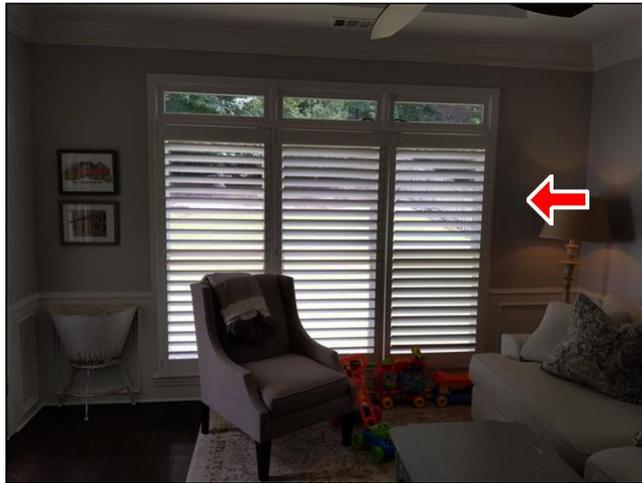
(1) The windows in the living room were stuck shut and should be repaired.

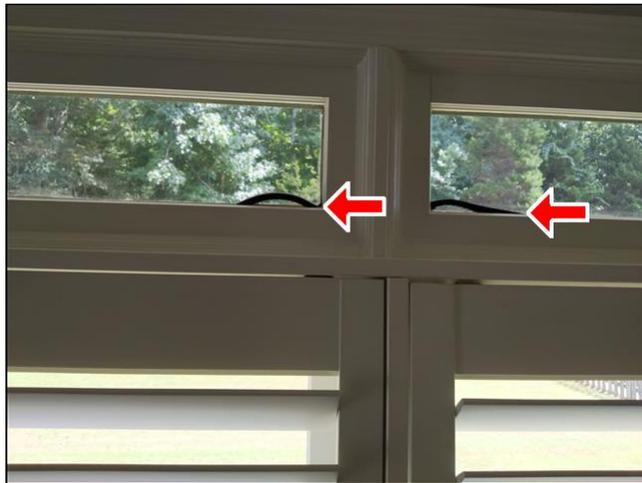
(2) Evidence of seals going bad in the living room windows. Recommend a qualified window contractor evaluate.

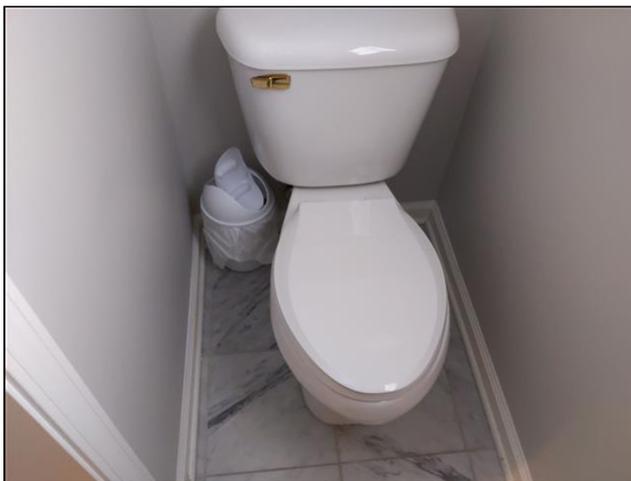
Loose toilet seat hallway bath.

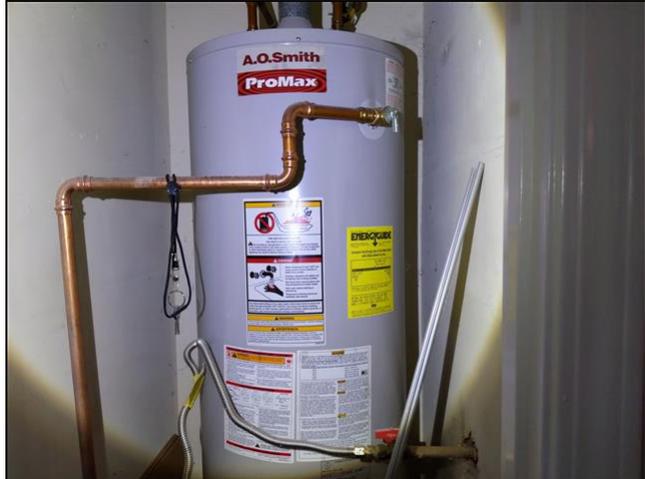
The water heater is 15 years old and at the end of its useful life. It may require replacement within the next 5 years.

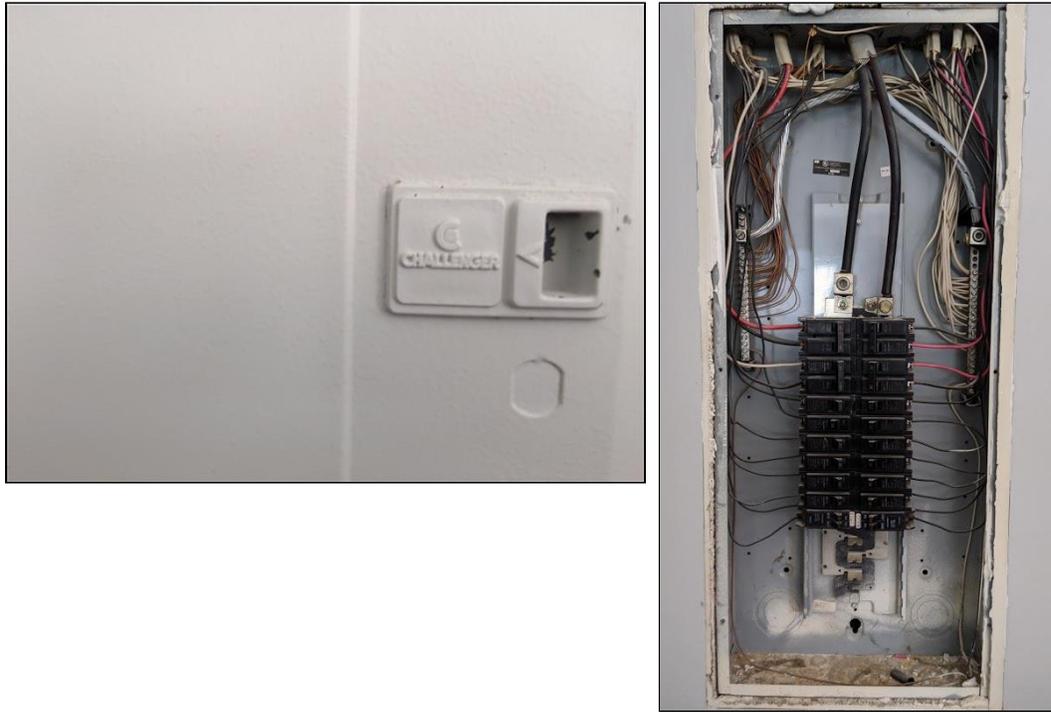
A Challenger-brand electrical panel was observed in the house and these breakers have the potential for overheating under normal conditions, creating a fire hazard. Have the panel further evaluated by a licensed electrician, knowing that replacement will likely be recommended.

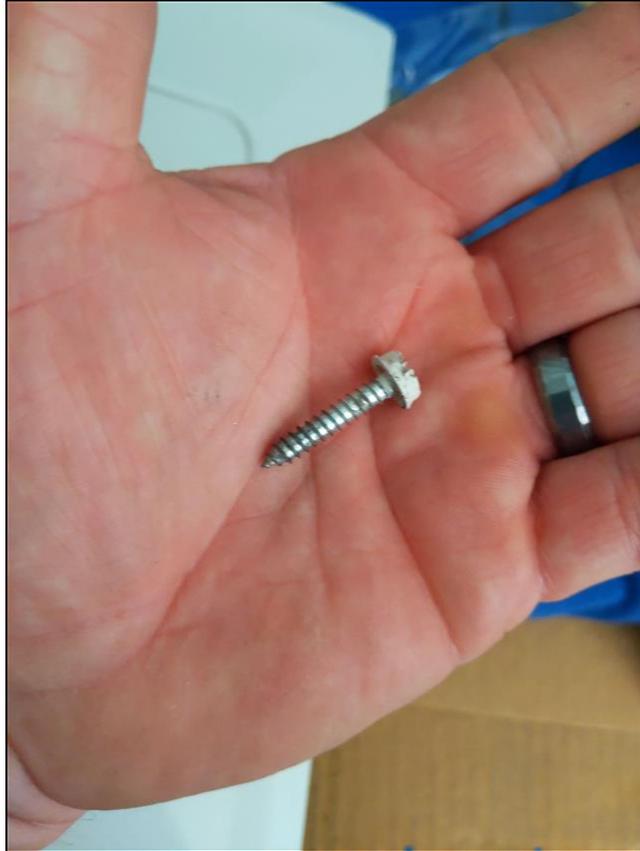
(1) Screws that have pointed tips are in use at the electrical panel cover, which is not recommended as they can puncture wires. Have replaced with the correct screws by a qualified electrician.

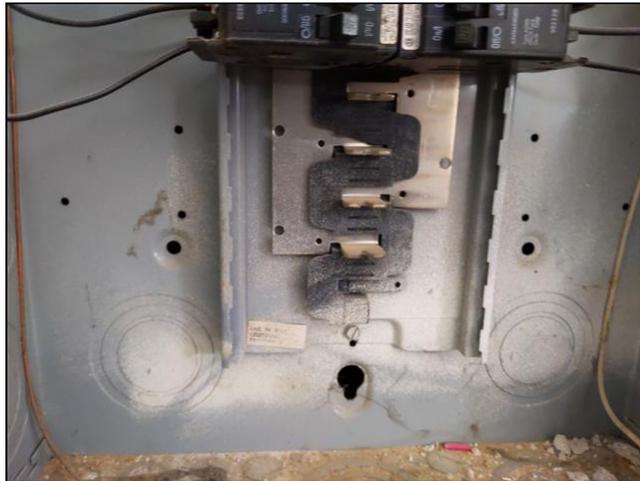
(2) A little bit of paint over spray was observed inside the electrical panel from when the house was built. However, there was no evidence this was having a negative impact.

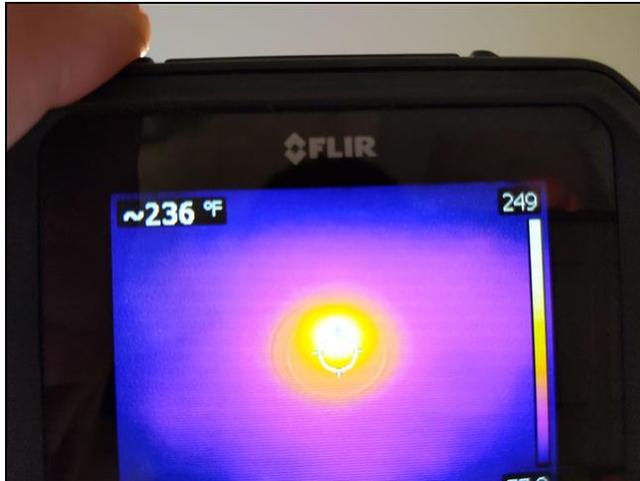
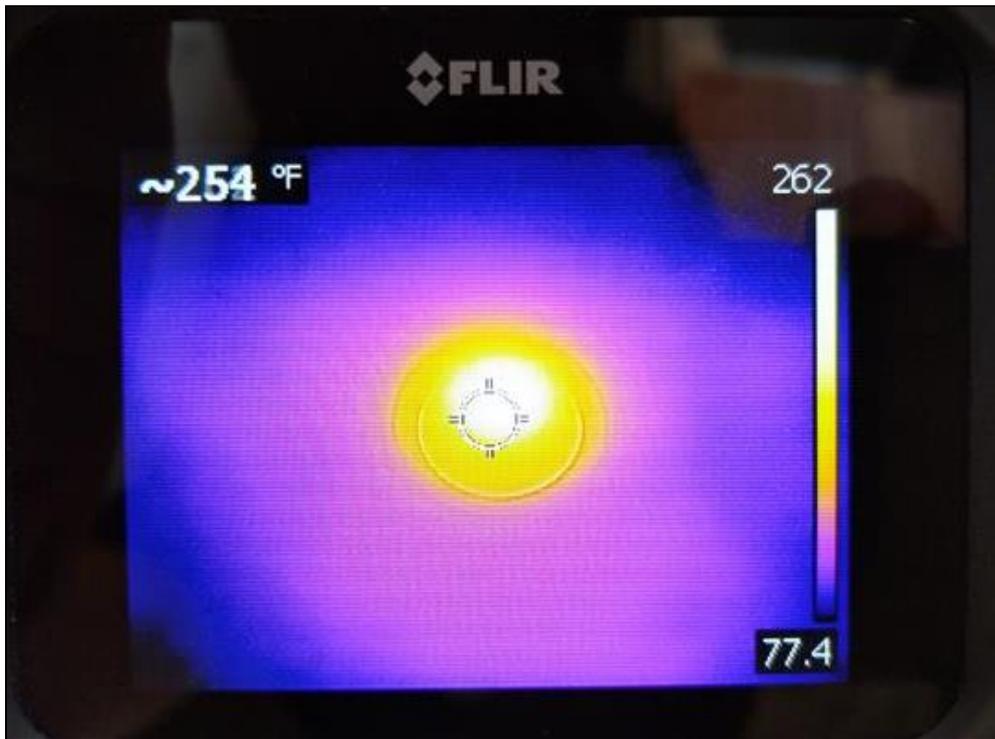
(1) The can lights in the kitchen are burning above the allowed maximum temperature which is 195 degrees. This may be a result of improper light bulbs. Recommend a qualified electrician repair.

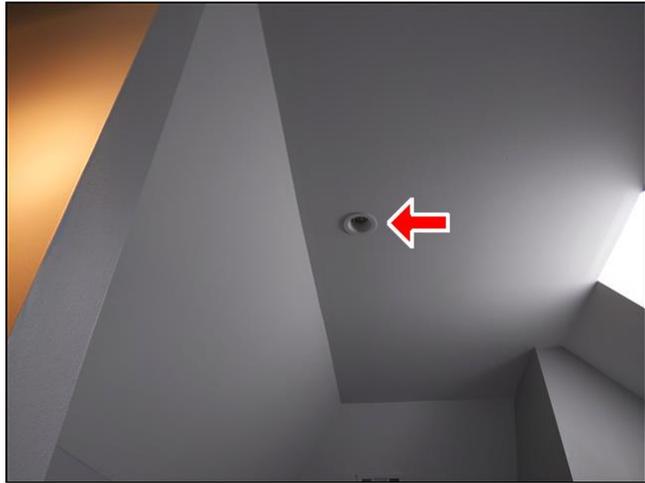
(2) Light in the master bathroom was not working at the time of inspection.

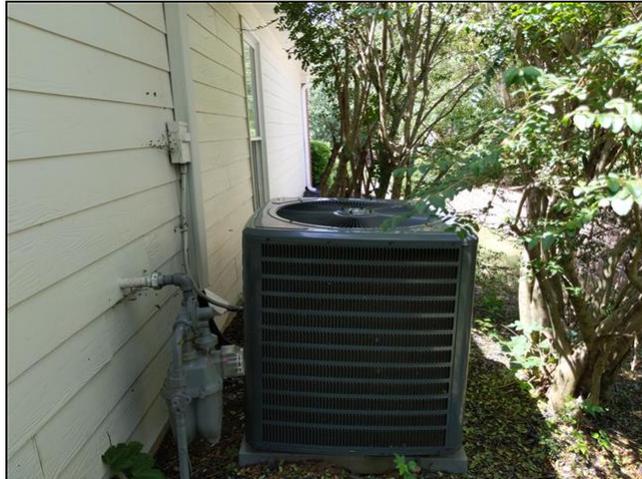
The A/C unit is very much off level which can affect compressor operation, lubrication and places excessive stress on the freon lines and connections. Have leveled by a licensed HVAC professional.

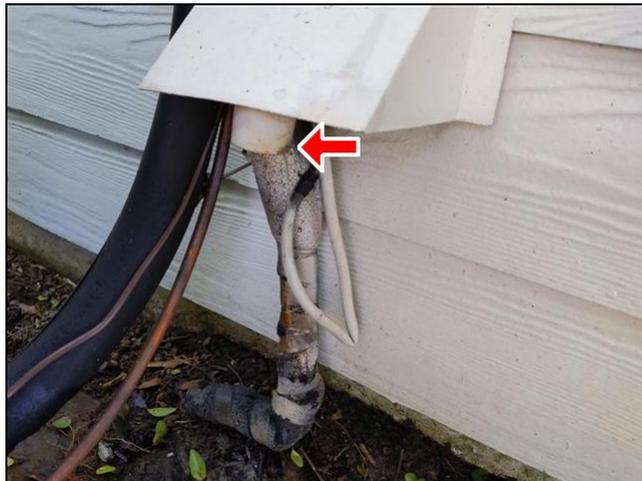
The exterior condensate drains should be extended to drain farther away from the house.

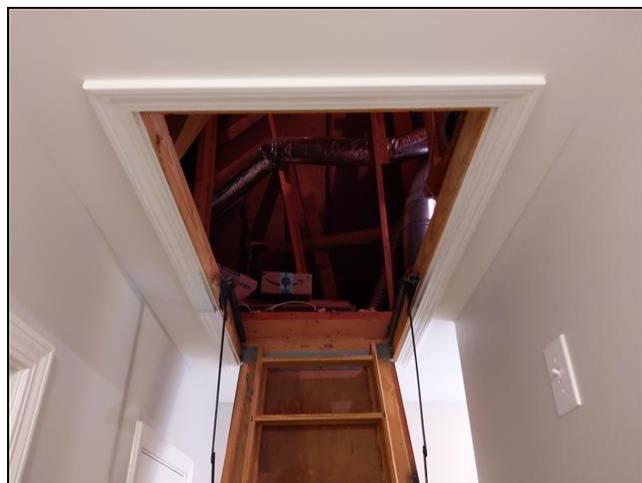
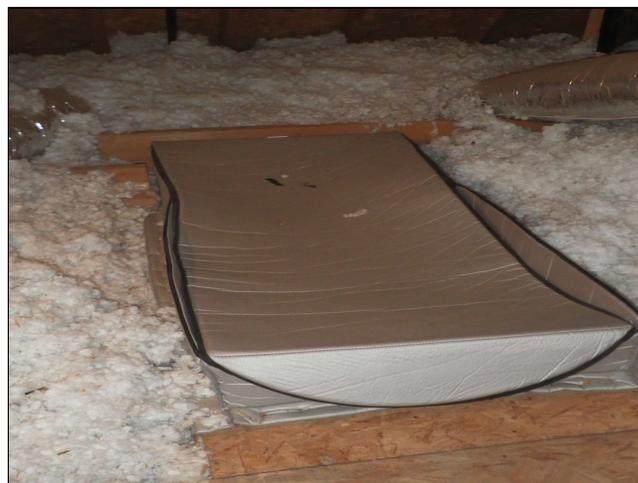
Attic cover

Insulation and weather stripping should be added to the attic pulldown ladder or the attic opening should be insulated with a cover.
