AccuSpect Home Inspections, Inc.

SUMMARY REPORT

Client: WU GA Properties LLC
Realtor: Jasmine Chang, Georgia Realty Brokers International
Inspection Address: 11139 Blackbird Ln, Alpharetta, GA 30022
Inspection Date: 10/11/2020 Start: 8:30 am End: 12:30 pm
Weather: Raining
Temperature: 70 Degrees
Inspected by: Gary Edge

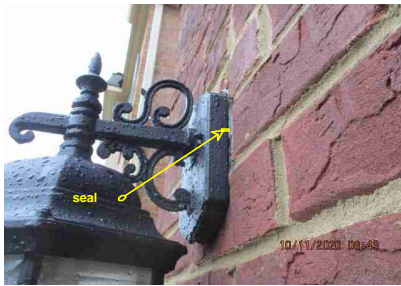
- 2.1 - The exterior light fixtures should be sealed/caulked at the wall to prevent moisture entry per the NEC 410.10.

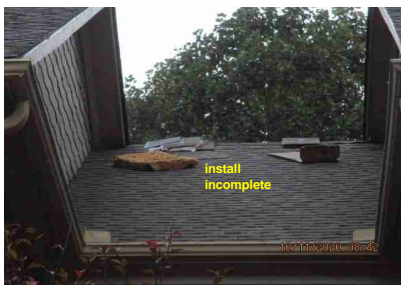
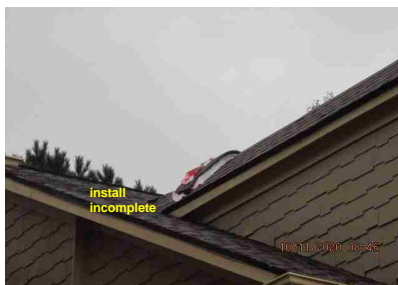
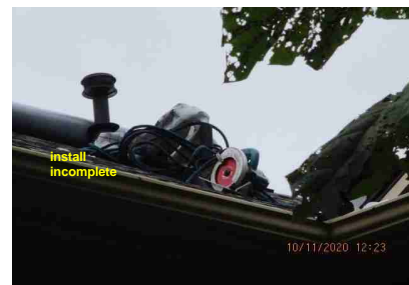
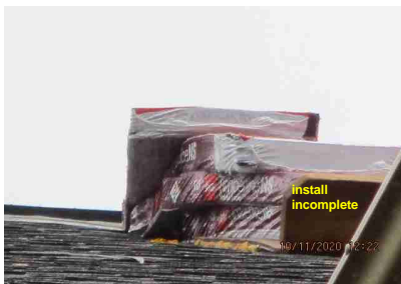
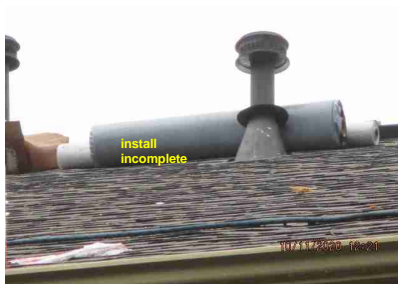
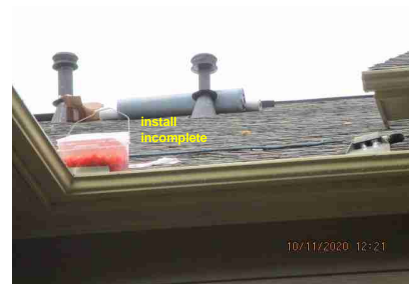
3.1 - There roof installation is incomplete. The inspector will return when the install is completed to assess the roof.

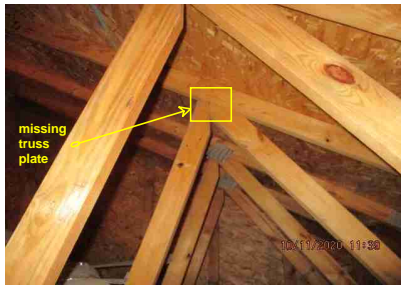
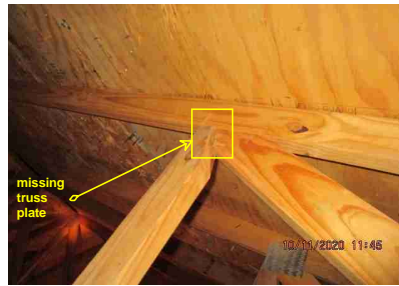
3.2 - There are two trusses in the attic which should be evaluated for repair by a registered structural engineer. Both are missing truss plates (gussets) where the webs meet the top chord.

1. The first truss is the one which passes between the furnaces.
2. The second truss is third from the left side of the attic.

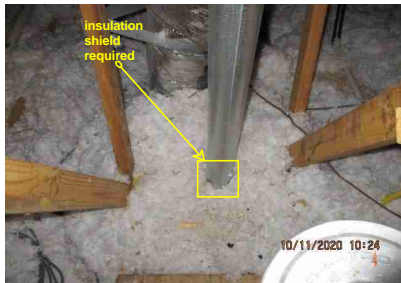
- 3.3 - The water heater vent should have an insulation shield where it passes through the attic insulation, and terminate no less than 2 inches above the insulation. This was required by the 2000 IRC G2425.4 at the time of construction. One should be installed by a licensed mechanical contractor.

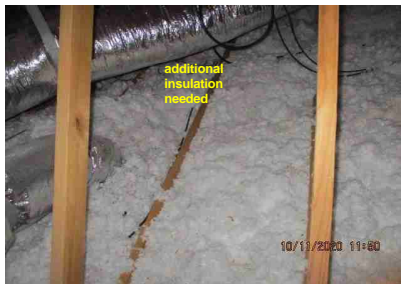
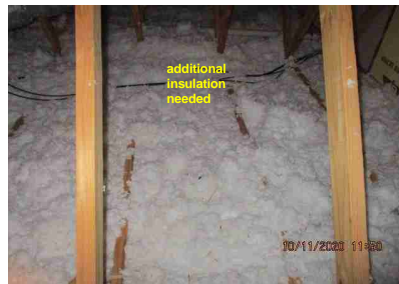
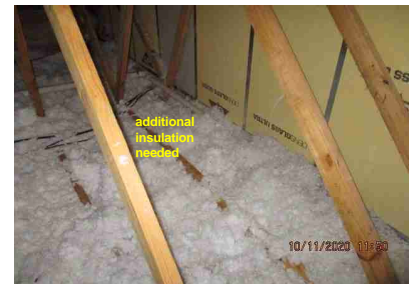
- 3.4 - The depth of insulation appears to be aprox. 8" There are deeper areas and also areas with less than 8 inches. This does not meet the depth (12") required for R-38. A qualified insulation contractor should evaluate and increase the depth of insulation to obtain R-38.

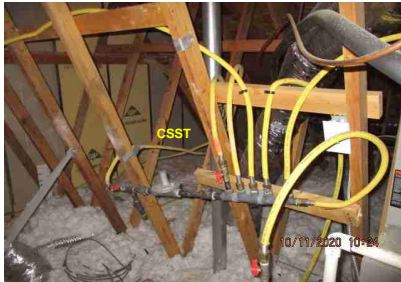
- 5.1 - The CSST (corrugated stainless steel tubing) gas piping system should be bonded directly to the electrical service grounding electrode system per the IRC G2411.1.1 and the manufacturers installation instructions by a licensed electrician. This is a safety requirement for lightening protection of the thin walled tubing to prevent perforations due to arcing . The bonding jumper shall connect to a metallic pipe or fitting, between the point of delivery and the first downstream CSST fitting (at the meter). The bonding jumper shall not be smaller than AWG 6 copper wire or equivalent.

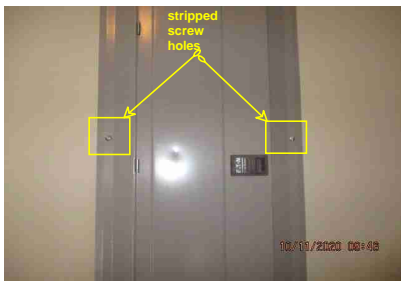
- 5.2 - The exterior cover of the garage sub-panel has two stripped screw holes,

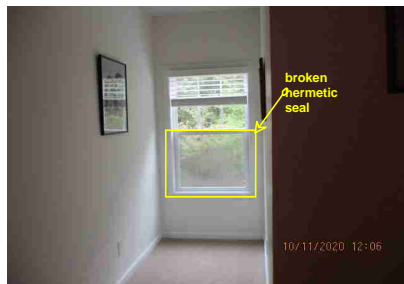
- 10.2 - The window in the upstairs right rear bedroom has a lower pane with a broken hermetic seal, which should be replaced by a qualified glass or window contractor.

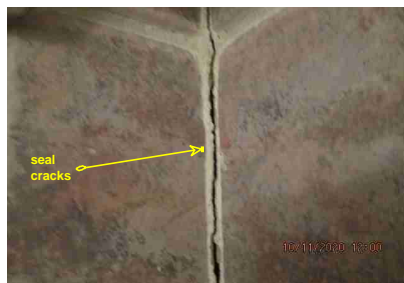
11.1 - There are cracks in the grout-joint in the left rear corner of the shower enclosure in the guest bathroom adjacent the left front bedroom. This should be sealed to prevent moisture damage.

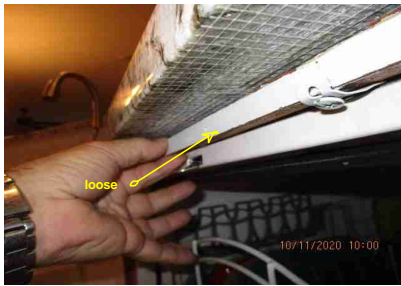
19.1 - The wood strip which holds the dishwasher in place is loose under the counter top. This should be secured in place.

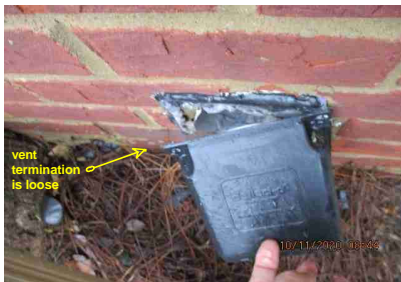
19.2 - The dryer vent termination is loosened at the outside wall and should be secured and sealed.
