Report: 1000-ambrose-ave home inspection

1000 Ambrose Ave
Alpharetta, GA 30022

October 6, 2020

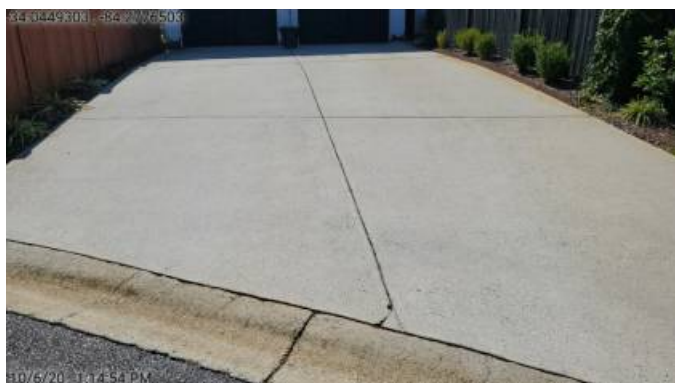
Cracks noted are typical. Typical cracks include normal shrinkage of the concrete. Recommend applying a sealant or seal all cracks to prolong service life of the driveway.

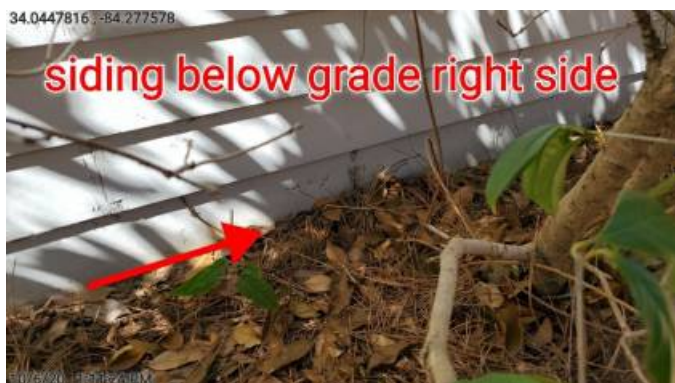
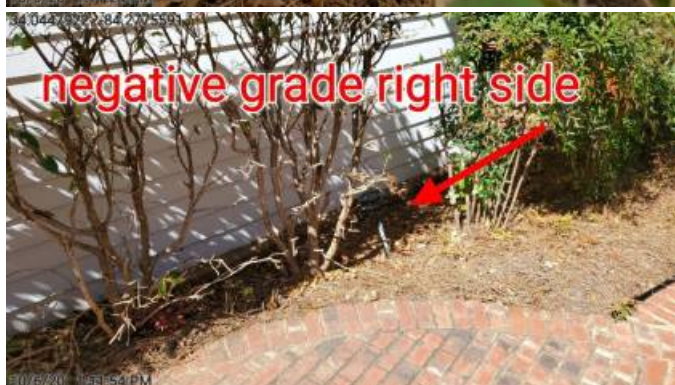
Ground was in contact with the siding on the right side of the home. Grade should be 6 inches below any wood / siding materials. Concrete should be 2 inches below any wood / siding materials. This condition may be conducive to termites and water entry into the home.

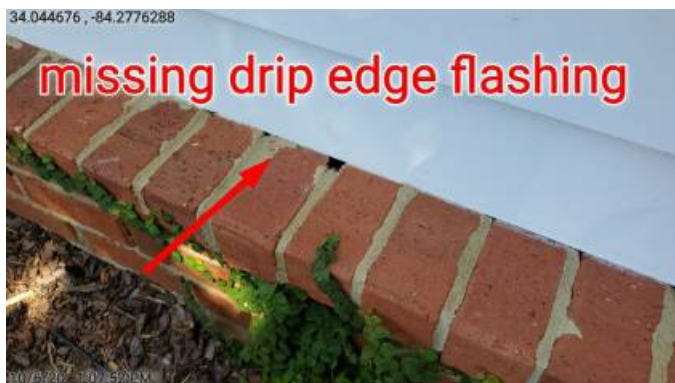
3.3 Flashing & Trim:

The home is missing the drip edge flashing where the siding meets the brick ledge. Recommend the installation of flashing between the two materials or ceiling the top edge of the brick ledge to help prevent water penetration behind the siding system.

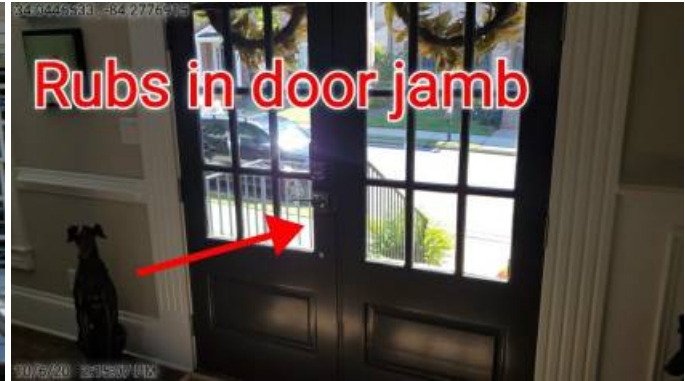
The door sticks or rubs in the door jamb. Recommend adjustments to the door and / or jamb for proper operation of the door.

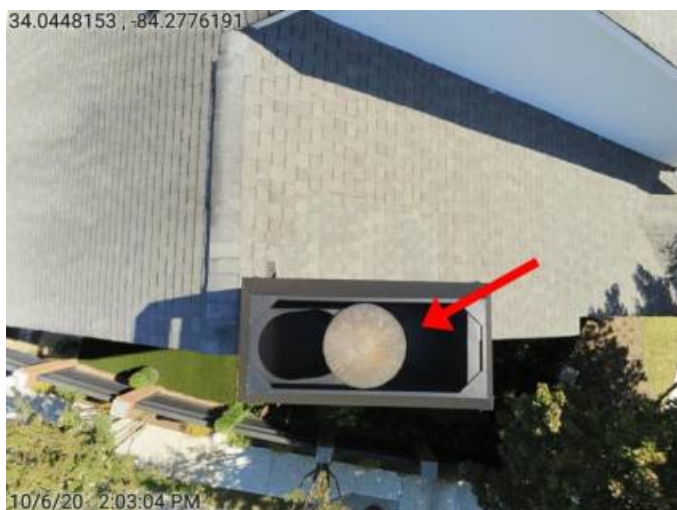
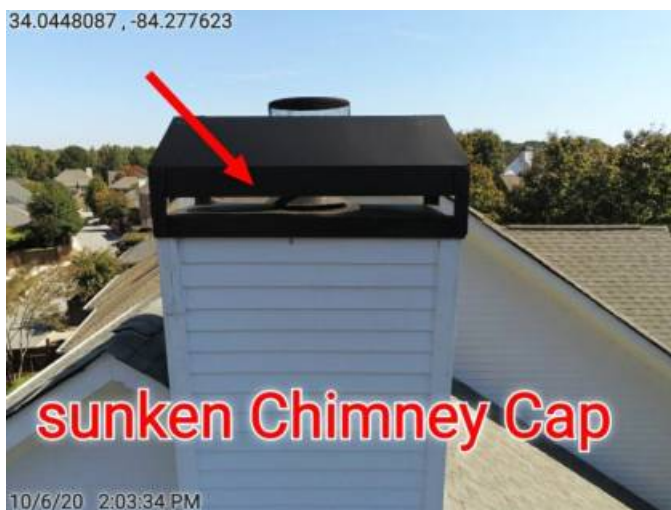
There appears to be water entering the chimney chase around the flue at the chimney cap or some other penetration in the cap. This is evidenced by water staining noted in the top portion of the fire box. Recommend sealing the penetrations in the chimney cap to help prevent further water penetration and ensure a proper slope on the chimney cap.

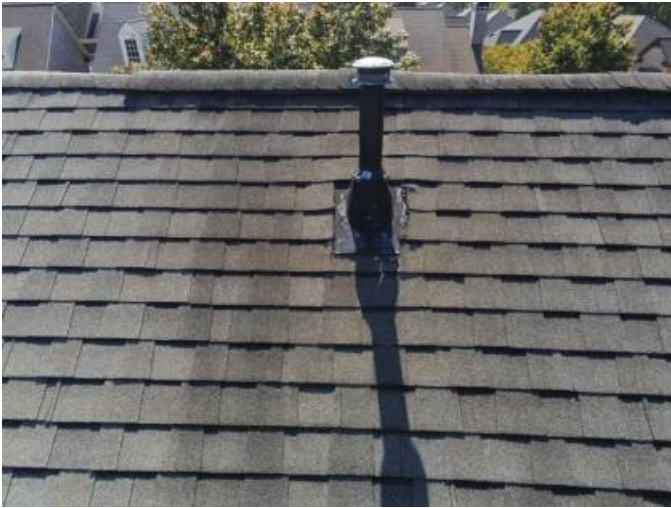
Repairs were noted around plumbing boots and roof flashing. This would indicate previous leaks. Repairs of this nature are temporary in nature. Dry at the time of the inspection. Monitor condition.

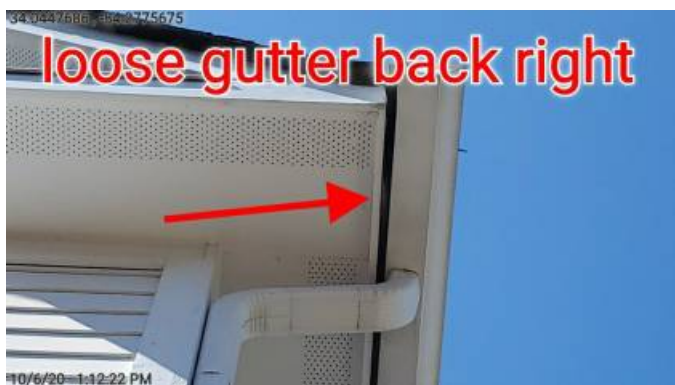
Gutters are loose and pulling away from the fascia at one or more locations around the home. Recommend securing the gutters to the fascia to promote water flow to the downspouts.

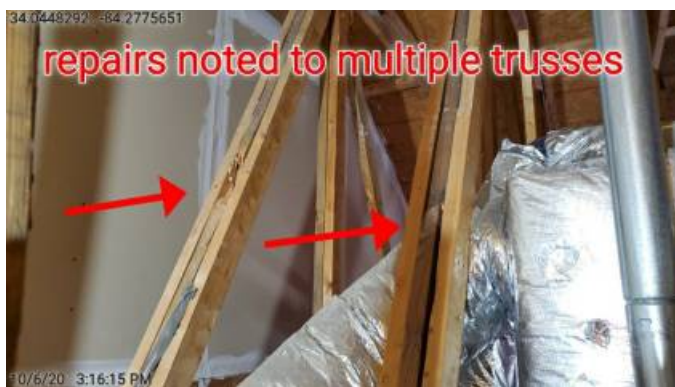
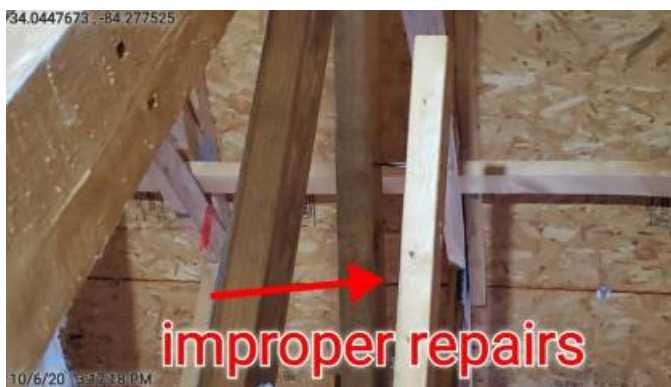
4.12 Structure Condition: ☐ ☐ ☒ ☐ Repairs were noted to at least two trusses in the attic space around the first floor furnace. The repair on one section of the truss is loose and no longer effective. Recommend new Repairs by a licensed framing contractor.

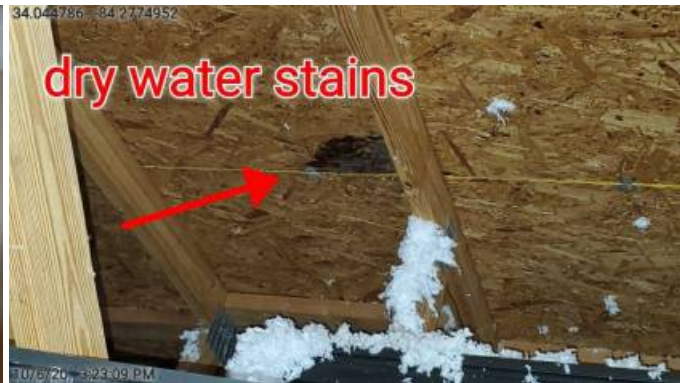
4.13 Moisture: ☐ ☐ ☐ ☒ Dry water staining was noted on the framing. This appears to be from a previous leak on the roof.

Water stains above the master bedroom closet correspond with the repairs and staining on the ceiling of the same closet. All areas were tested with a moisture meter and showed no moisture at the time of the inspection. Recommend inquiring with the current homeowners as to the nature of any previous repairs and

any warranty that may transfer to the new owners.

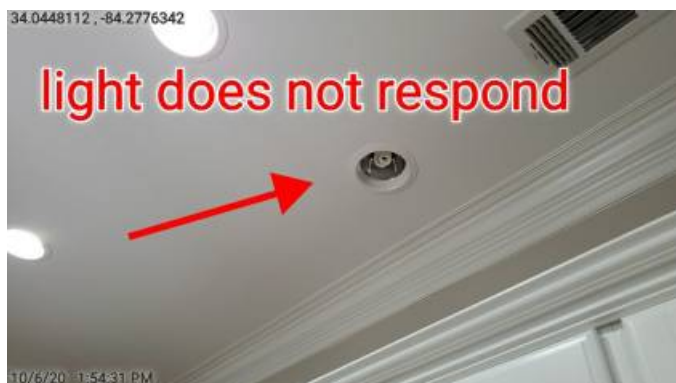
The ceiling light installed in this room did not function using the wall switch. The inspector did not determine if the switch is bad or if the light bulb is bad. Recommend replacing the light bulbs to test the fixture for proper operation. If bulb replacement does not correct the problem there may be an issue with the wiring / switch / fixture.

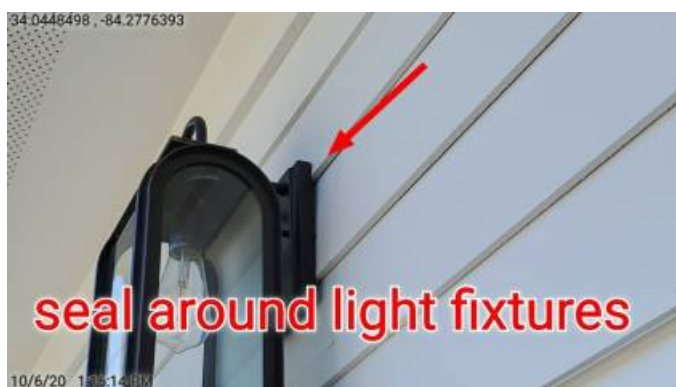
The exterior light fixtures are not caulked / sealed to the home allowing water to run behind the fixture and siding. Recommend caulking around the light fixtures to prevent water penetration.

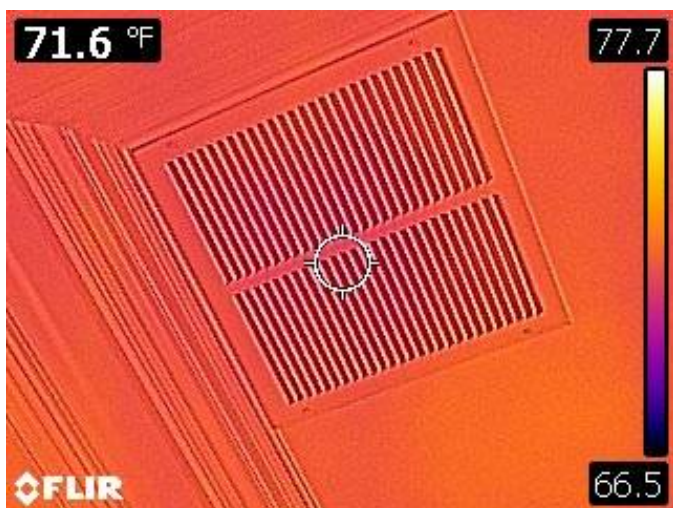
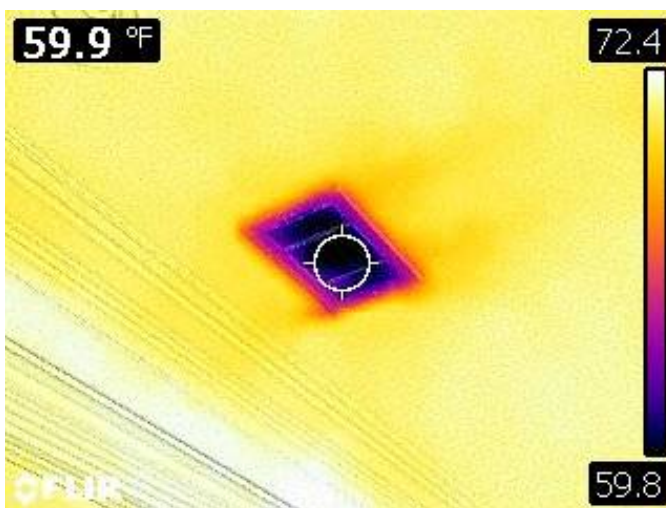
6.4 Air Temp Drop: ☐ ☐ ☒ ☐ 12 F Cooling not adequate. The temperature drop should fall between 14 and 21 degrees. The tested unit does not fall within this range. This could be the result of loss of refrigerant or poor operation on the equipment. Recommend repairs / replacement by a licensed HVAC technician.

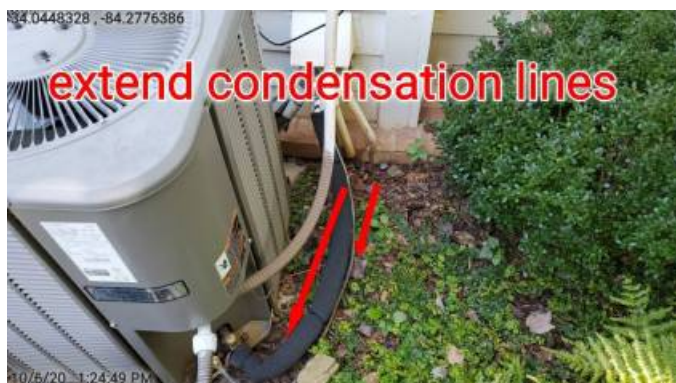
The condensation line terminates behind the AC unit and / or directly next to the foundation. This may cause erosion in the area and affect the foundation over time as well as cause the AC unit to lean. Recommend extending the condensation line a minimum of 4 - 6 feet from the foundation to prevent further erosion / damage.

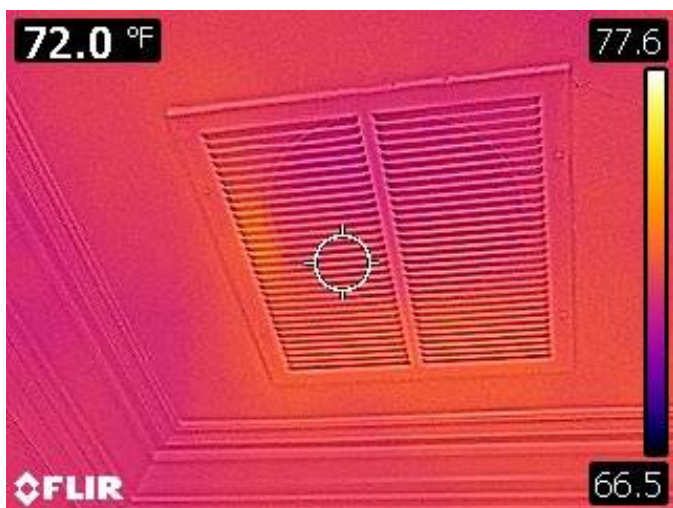
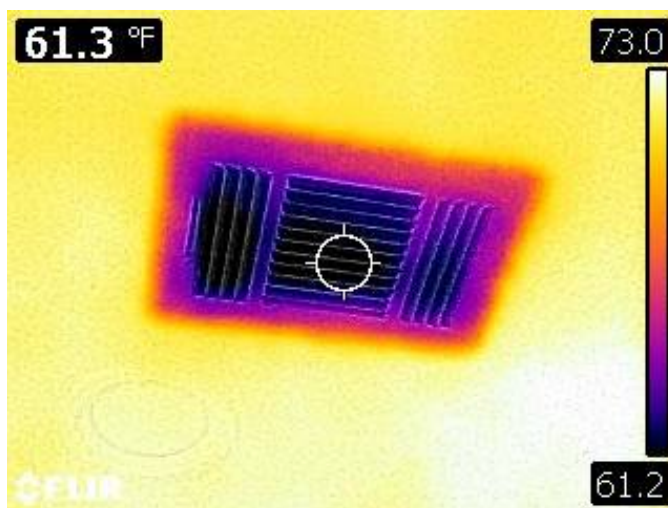
6.10 Air Temp Drop: ☐ ☐ ☒ ☐ 11 F Cooling not adequate. The temperature drop should fall between 14 and 21 degrees. The tested unit does not fall within this range. This could be the result of loss of refrigerant or poor operation on the equipment. Recommend repairs / replacement by a licensed HVAC technician.

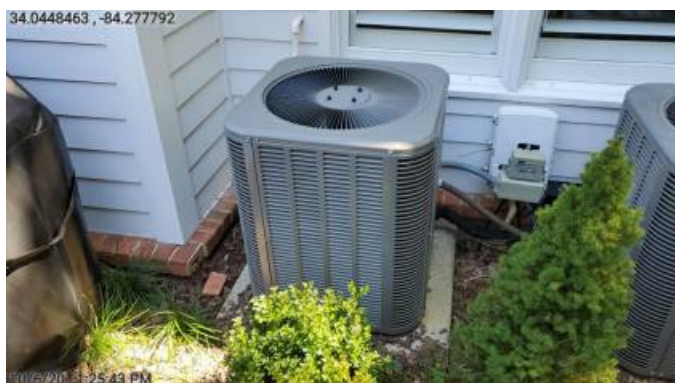
Unit is not producing an adequate air temperature drop.
 Recommend further evaluation and repairs by a qualified HVAC technician.

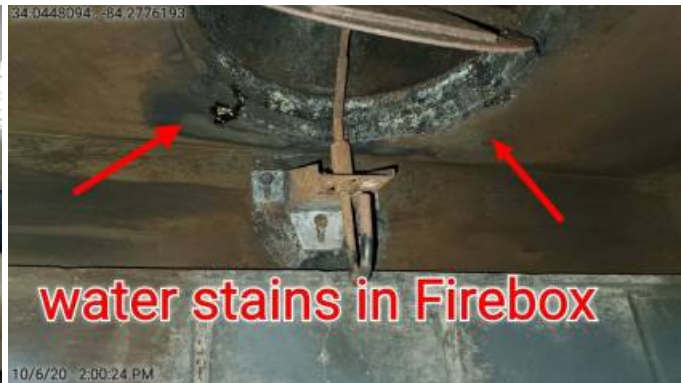
Water staining was noted at the top of the firebox around the flue. This may be an indication of water leakage around the flue and chimney cap. Recommend a licensed chimney specialist further evaluate and make any repairs necessary to the chimney cap to help prevent future water penetration.

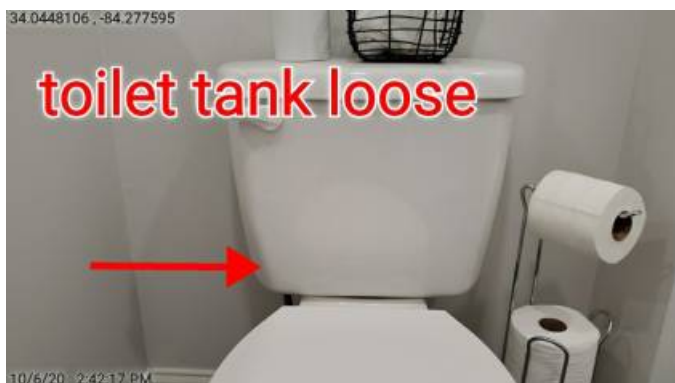
The tank was installed incorrectly. The tank Hardware is missing the nut and washer directly below the tank. Recommend reinstalling the tanks buy a licensed plumbing contractor.

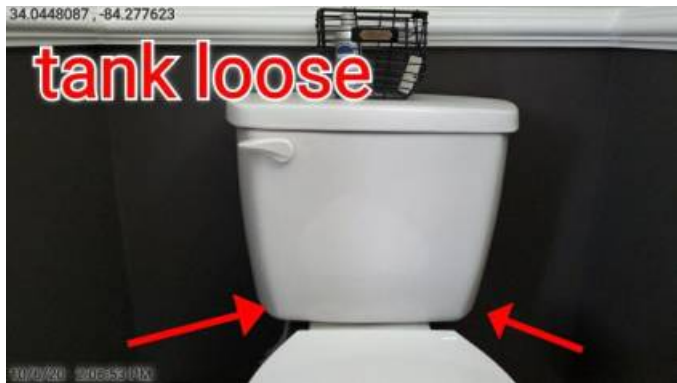
The tank was installed incorrectly. The tank Hardware is missing the nut and washer directly below the tank. Recommend reinstalling the tanks buy a licensed plumbing contractor.

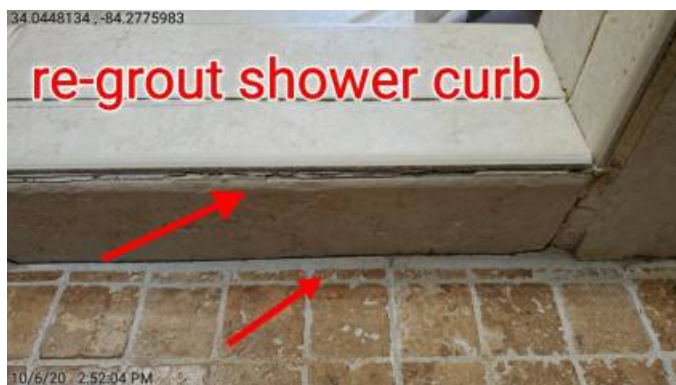
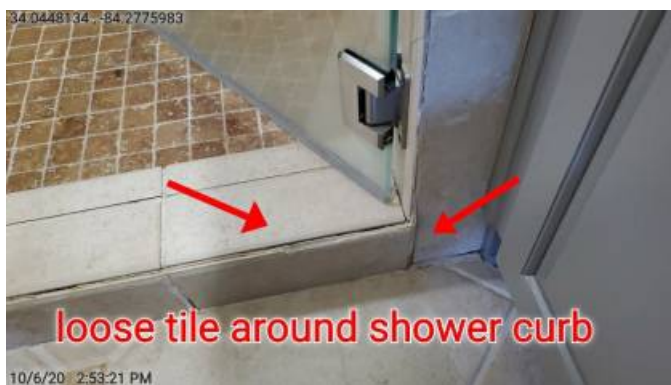
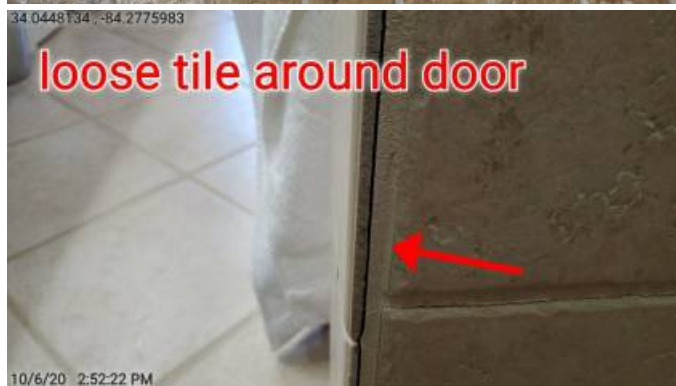
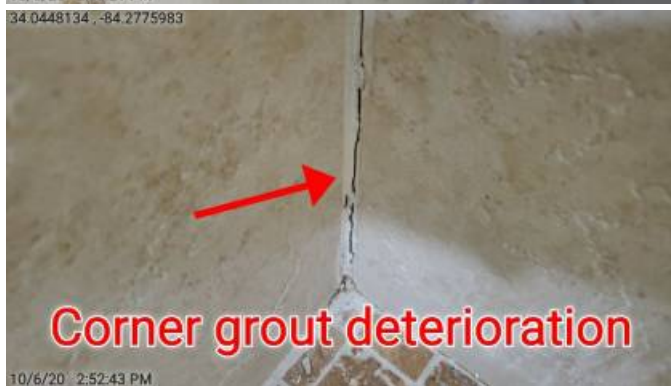
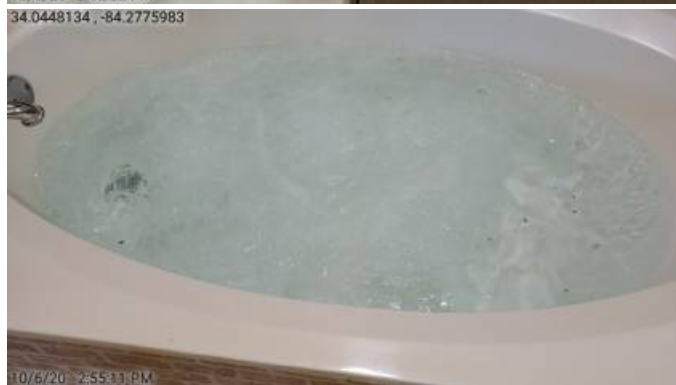
Loose tile and damaged grout noted around the shower curb below and around the shower door. This may indicate some water penetration below the tile surface. Recommend repairs to the tile in the door area by a licensed tile contractor.

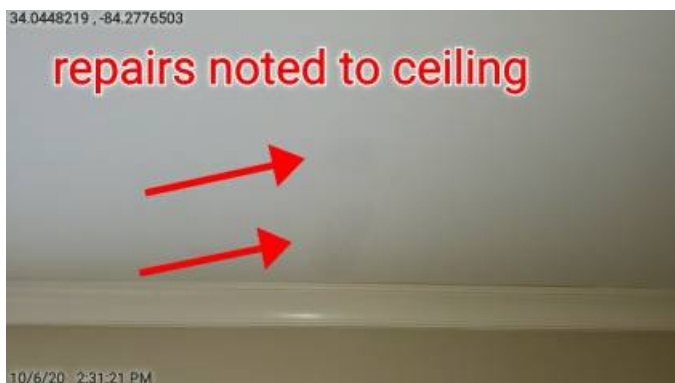
Repairs noted to the ceiling in this room. Recommend inquiring with the current homeowners as to the nature of the repairs and monitor condition.

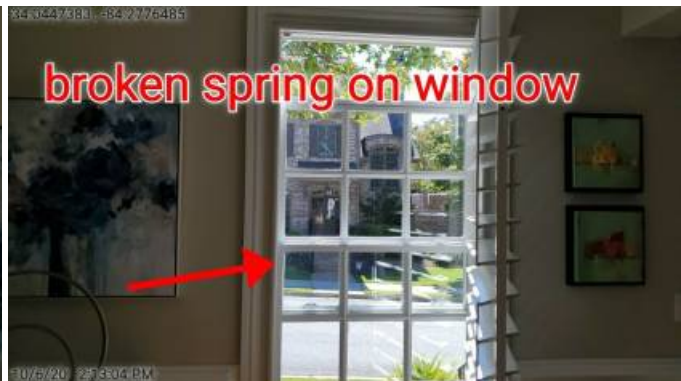
The spring or slide that holds the window in the up position is nonfunctional or damaged in some way. It needs to be replaced or repaired for proper operation of the window.

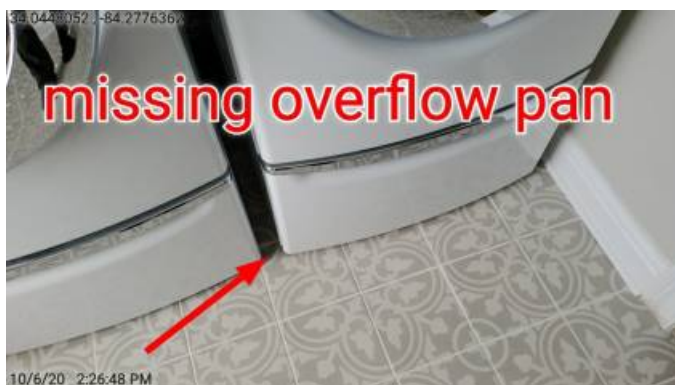
The overflow pan below the washing machine is missing. Recommend installing an overflow pan as a safety precaution.

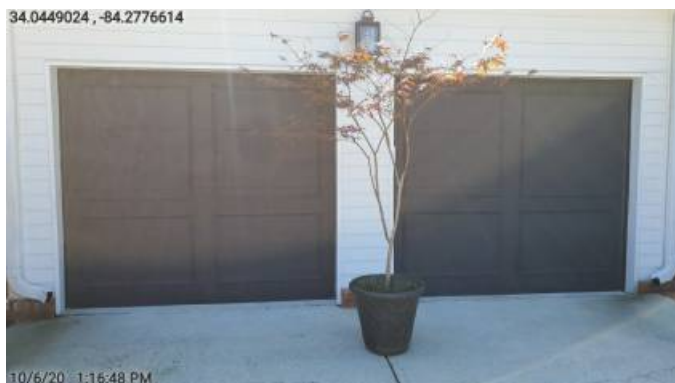
Water damage noted around the base of one or more of the garage door jams. Recommend repairs or replacement to the affected material.

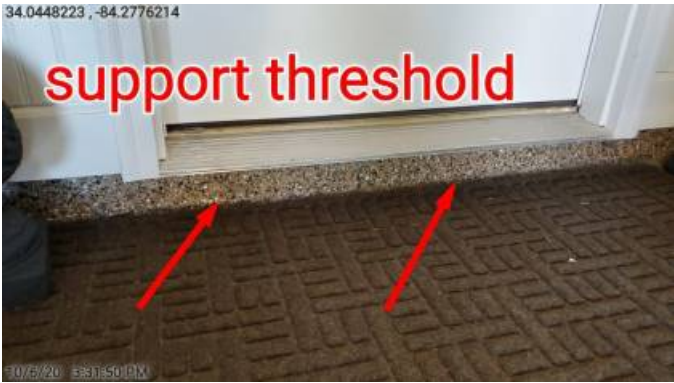
threshold and caulking between the blocking and threshold for proper support and seal of the door to help prevent future water penetration.

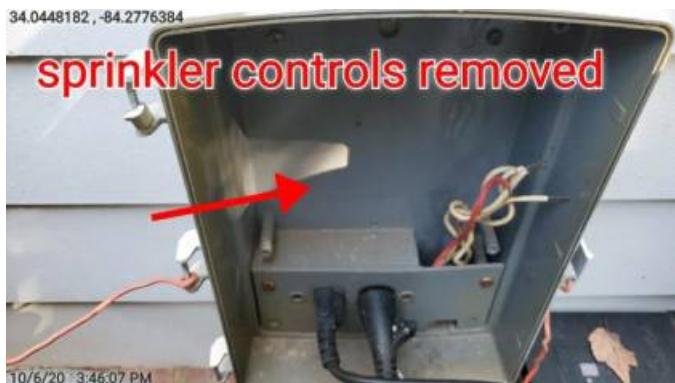
The sprinkler control panel has been removed. All Zone wires are loose and not connected inside the sprinkler control box on the left side of the home. Recommend the installation of a control panel and testing by a licensed irrigation specialist.
