Inspection Report

Property Address:
1575 Spinnaker Dr
Alpharetta GA 30005

Champia Real Estate Inspection, LLC

Date: 10/9/2020	Time: 02:00:00 PM	Report ID: 42821
Property: 1575 Spinnaker Dr Alpharetta GA 30005	Customer: Alexis Seton	Real Estate Professional: Kim Rowe Chapman Hall (Atlanta)

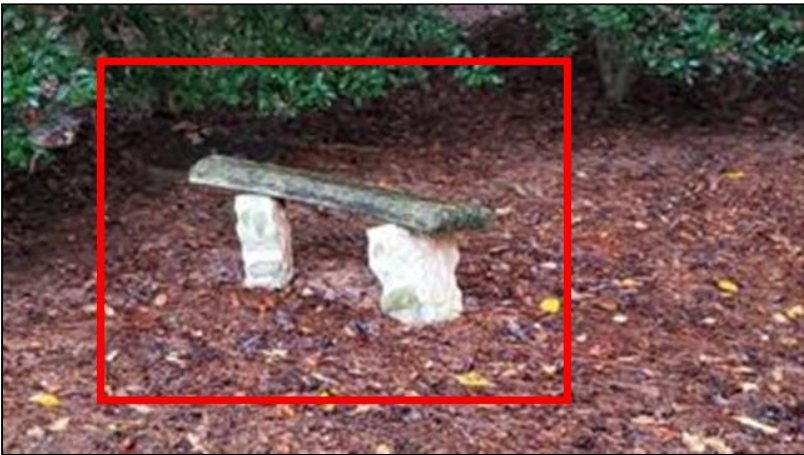
1.0 rear

1.0 Damaged bench noted at rear of property. Repair/Replace as necessary to ensure proper operations and improve safety.

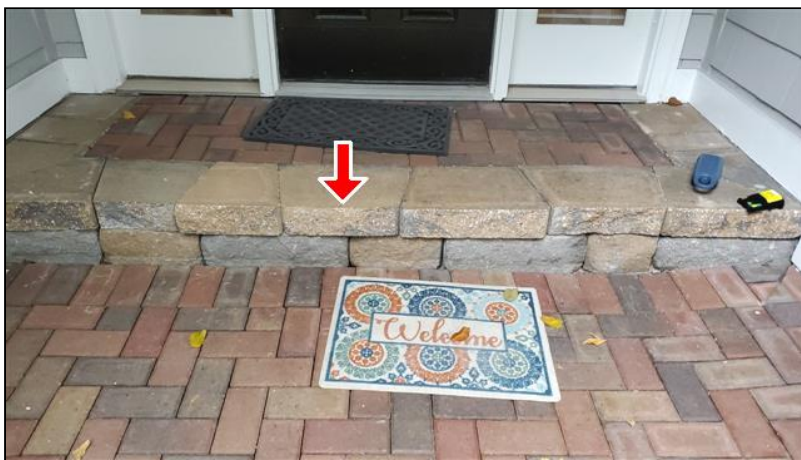
1.1 front porch

1.1 Uneven riser height noted at front porch stairs. NOTE: Risers should be consistent in height; not to exceed 7 3/4". Adjust as necessary to avoid trip hazard.

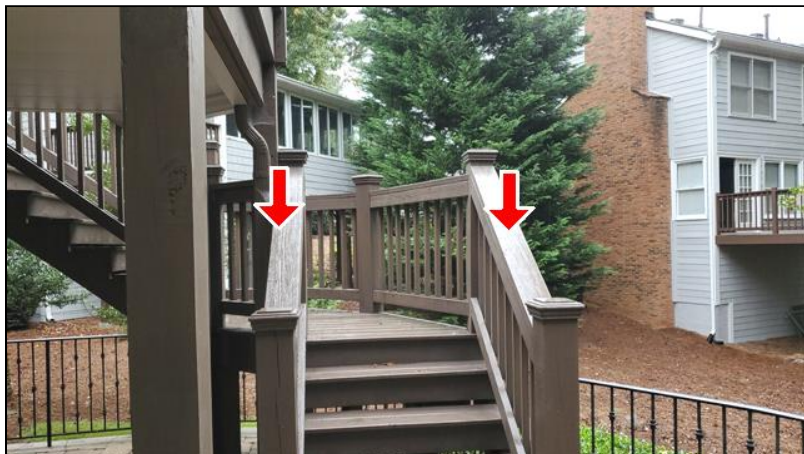
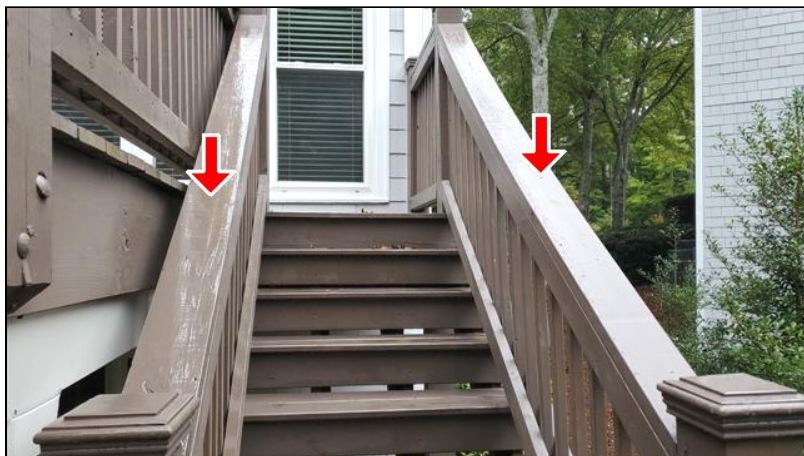
1.2 rear deck

1.2 (1) Handrail not graspable at rear deck stairs. NOTE: Handrails should be graspable. Install as necessary to improve safety. Recommend consult with a licensed general contractor for further information.

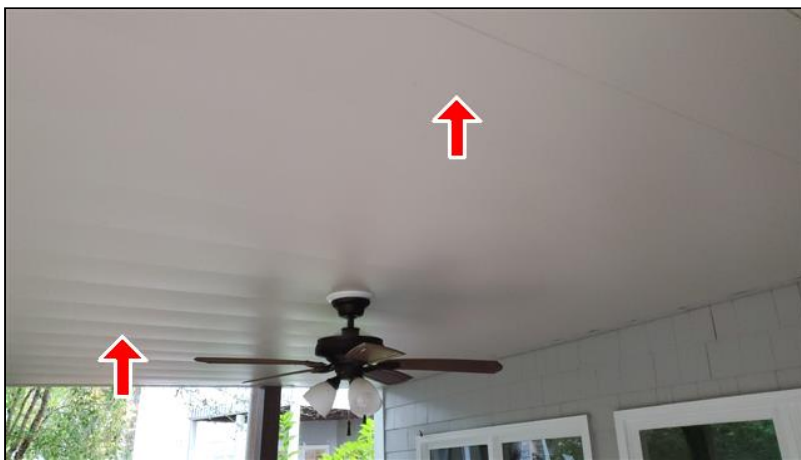
1.2 rear deck

1.2 (2) NOTE: Deck structure below rear deck is covered and not visible. Unable to inspect structure. Monitor and repair as necessary.

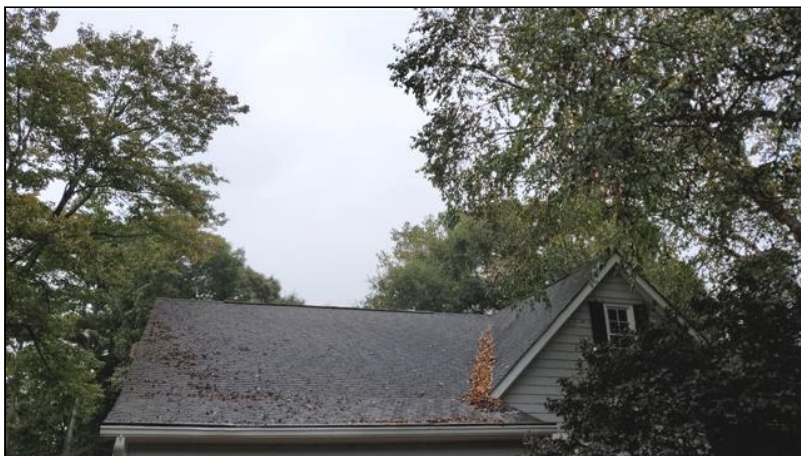
1.3 front, left, right

1.3 (1) Leaning trees and overhanging branches noted at front, left and rear. Remove/trim trees/branches as necessary to avoid hazard to occupants, damage to the roof and exterior. Recommend consult with a qualified tree contractor for further information.

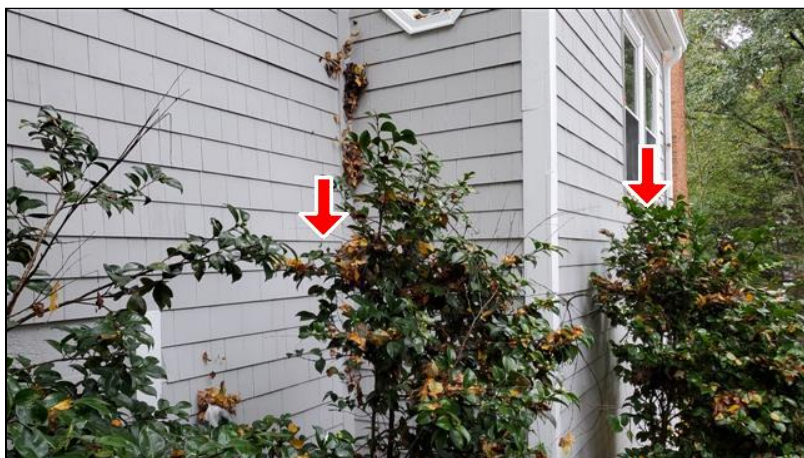
1.3 right

1.3 (2) Shrubs against the exterior noted left and right. Recommend to maintain a distance of 6" to avoid damage to the exterior, animal and moisture entry. Recommend consult with a qualified landscape contractor for further information.

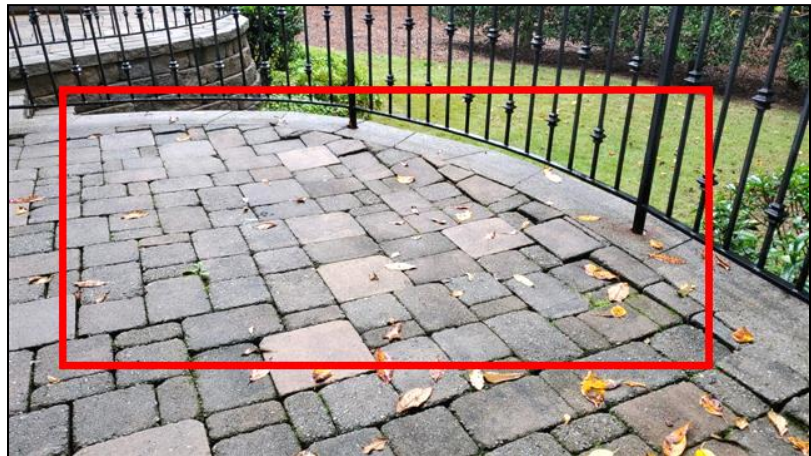
1.4 rear patio

1.4 Signs of erosion noted at rear brick patio and front porch. Repair as necessary to avoid further damage. Recommend consult with a licensed general contractor for further information. Refer to images for specific locations.

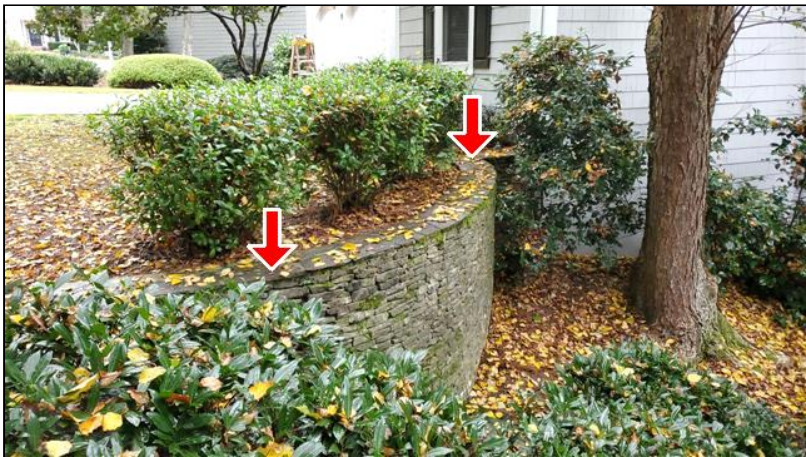
1.6 front right

1.6 Missing guard rail noted at front right retaining wall. NOTE: Distances of 30" and higher should be protected by guardrails. Install guardrails as necessary. Recommend consult with a licensed general contractor for further information.

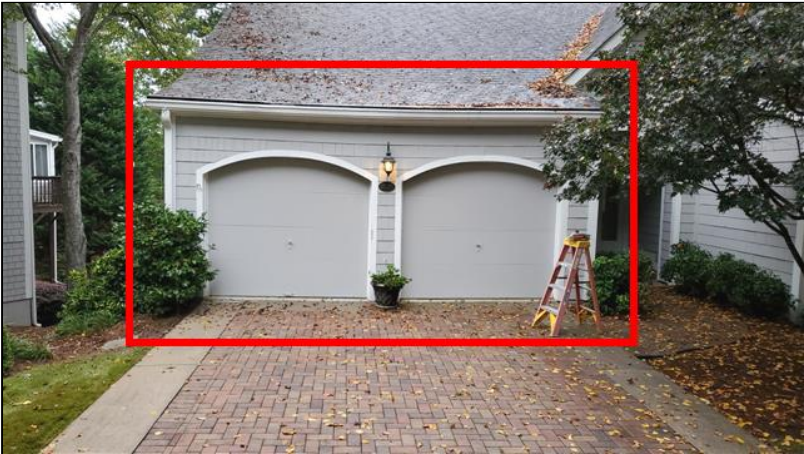
2.0 front

2.0 Sag noted at front left garage.
Recommend further evaluation by a
licensed structural contractor for further
evaluation.

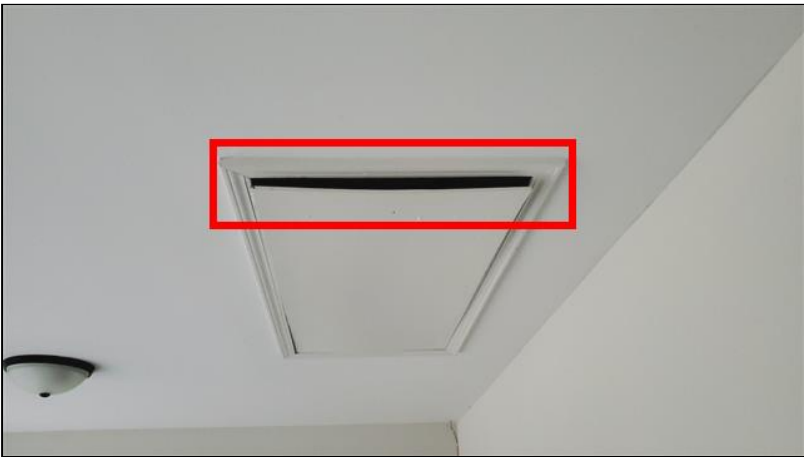
3.0 garage

3.0 Access cover does not close tight. Adjust/repair as necessary to ensure proper operations. Recommend service by a licensed general contractor.

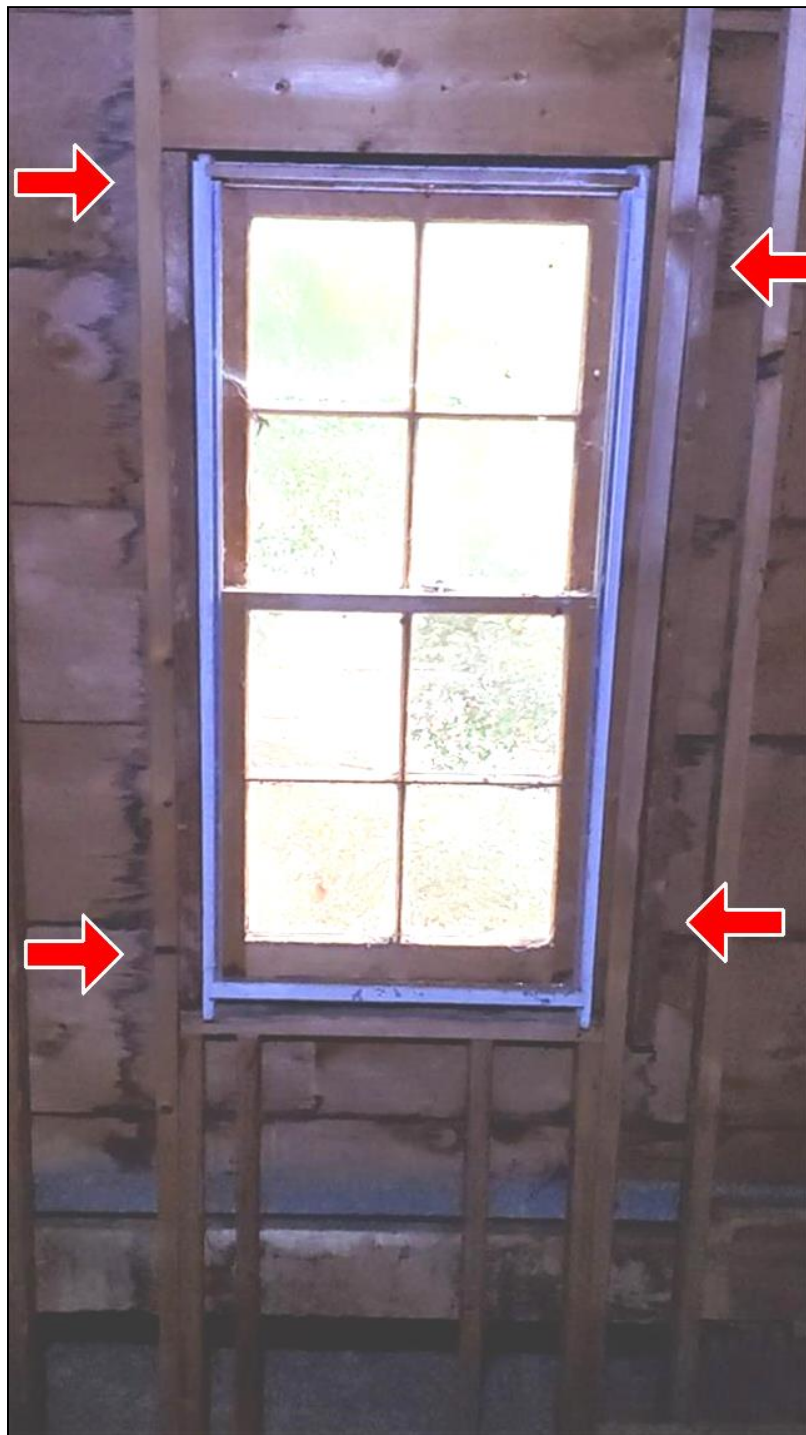
3.1 attic front

3.1 (1) Signs of moisture entry noted at front right and left in attic. Recommend further evaluation by a qualified roof contractor.

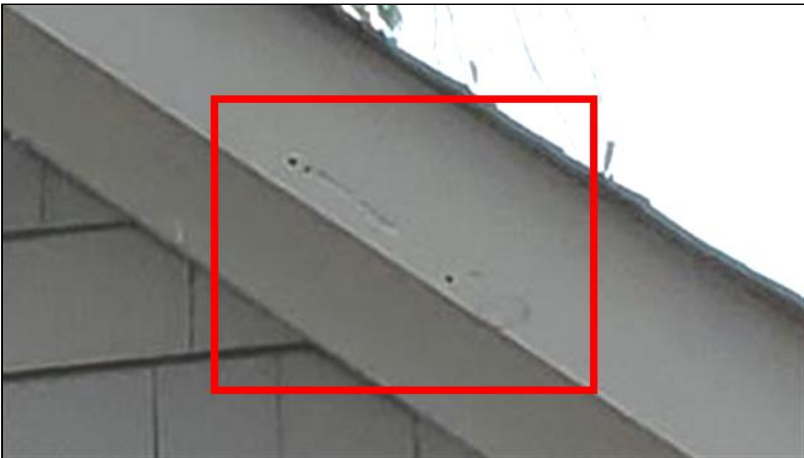
3.1 front

3.1 (2) Signs of wood destroying organism activity noted at front roof line. Recommend to consult with a qualified pest and wildlife exclusion contractor

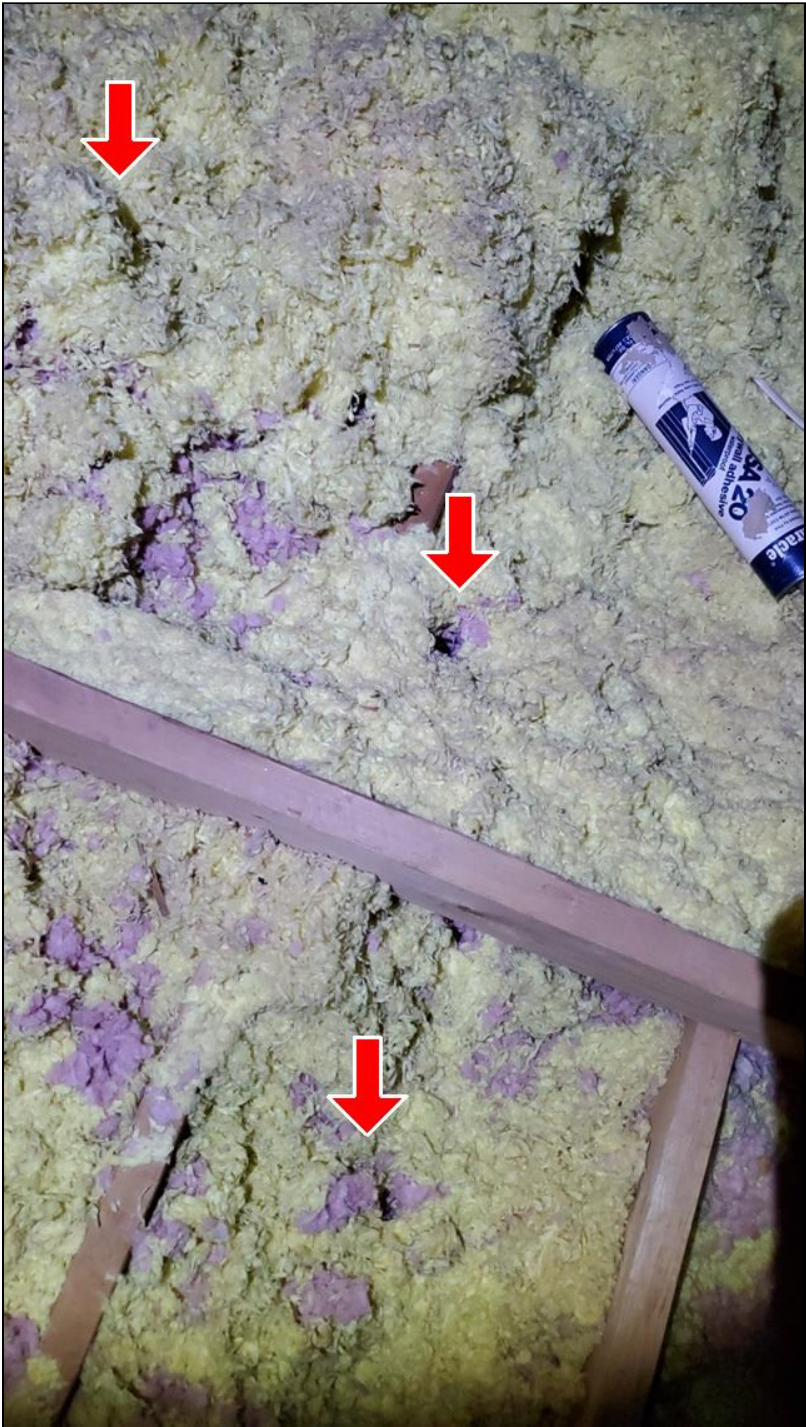
3.4 attic

3.4 Signs of animal activity noted in the attic (tracks, burrow holes). Recommend to consult with a qualified pest and wildlife exclusion contractor.

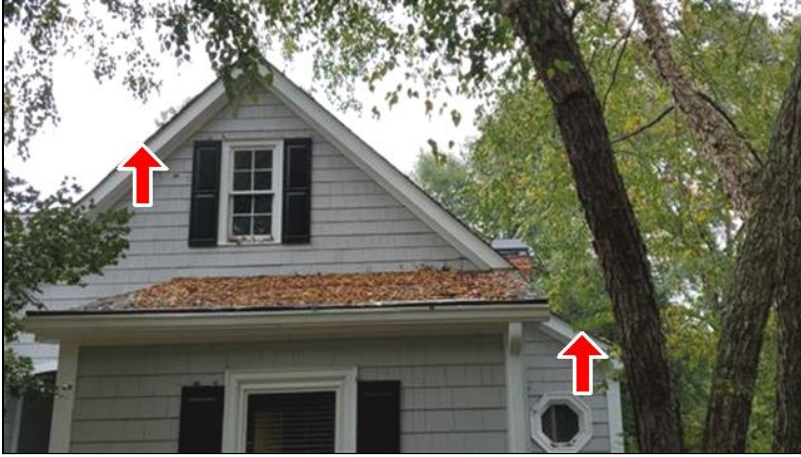
3.6 front

3.6 Missing drip flashing noted at roof lines. NOTE: Drip flashing should be installed at roof-to-facia intersections to protect the facia. Recommend consult with a qualified roof contractor for further information.

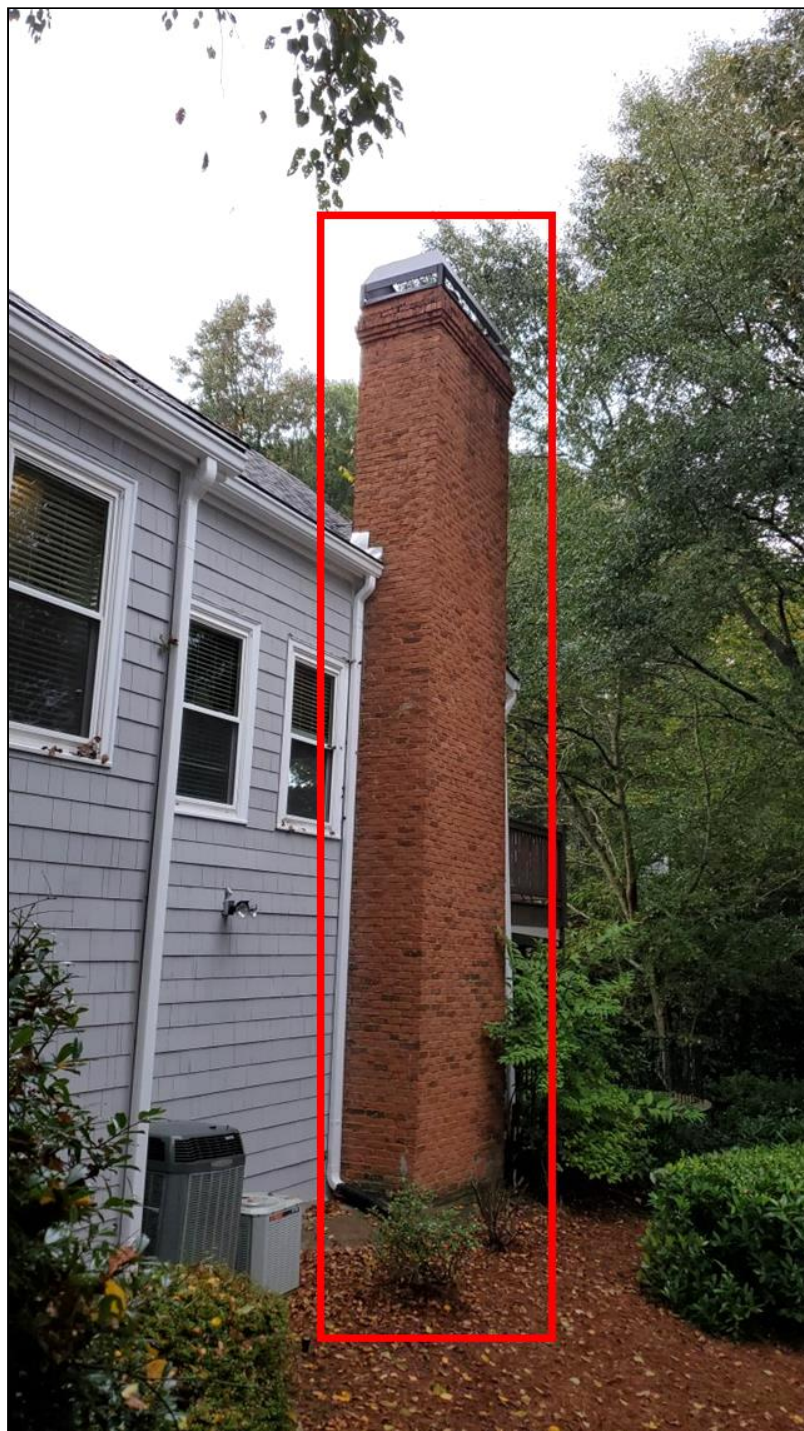
3.7 right

3.7 NOTE: It is recommended that the purchaser have the fireplace and chimney further evaluated by qualified chimney sweep for compliance with current fireplace/chimney construction and safety standards.

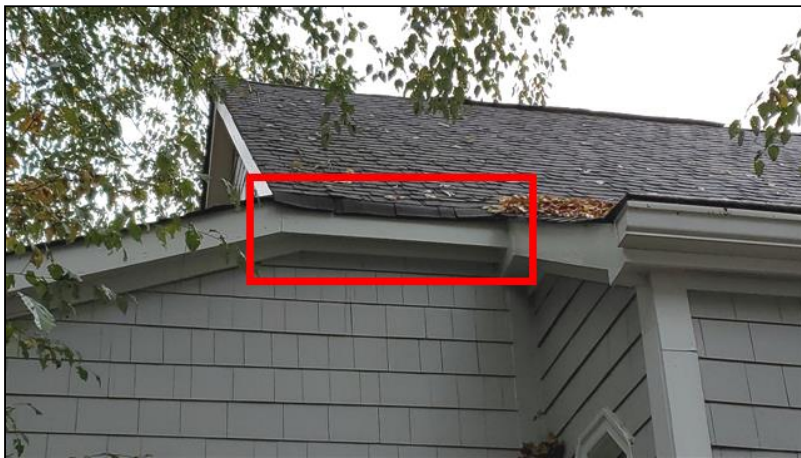
3.8 right

3.8 (1) Missing gutter noted right front. Recommend to install gutters and downspouts to improve rain run-off management.. Recommend consult with a qualified gutter contractor for further information.

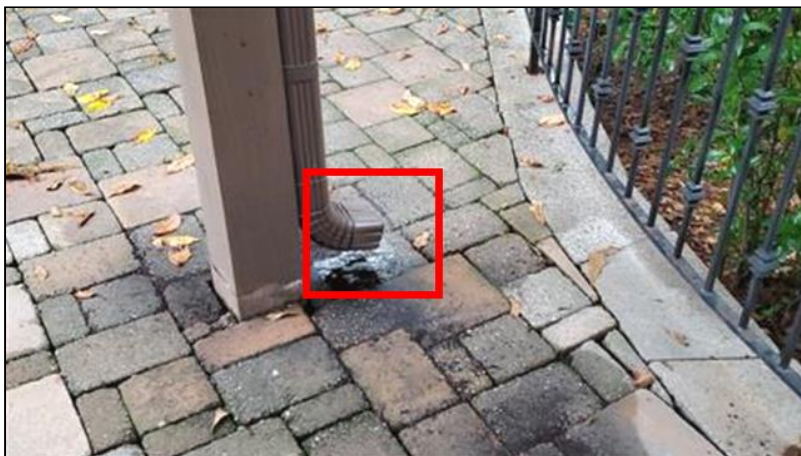
3.8 rear patio

3.8 (2) Recommend to direct downspout discharge away from the foundation. Noted at rear right. NOTE: At least 5 ft. Recommend service by a qualified landscape contractor.

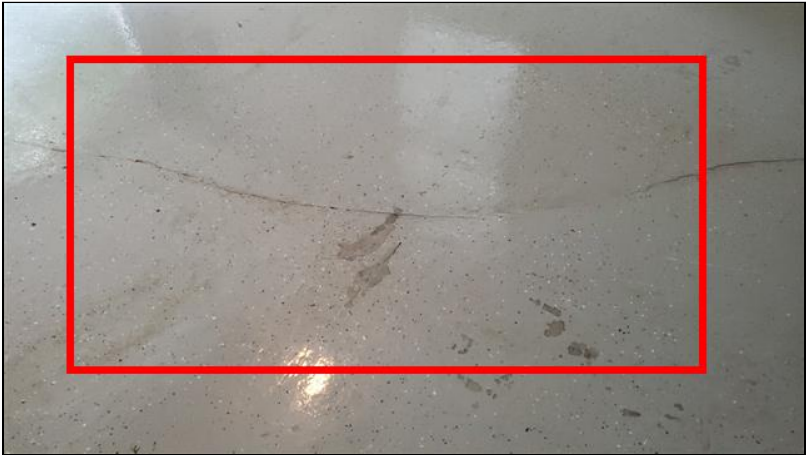
4.2 garage

4.2 Damage/Cracks/Sagging noted at garage flooring. Recommend further evaluation by a qualified structural contractor.

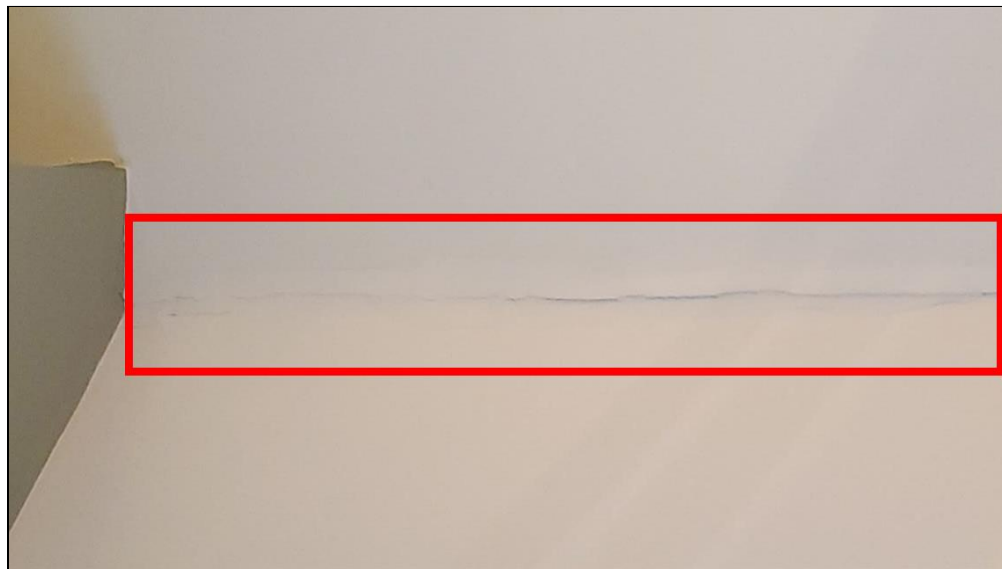
5.0 1st floor dining room

5.0 (1) Damage/Crack noted at 1st floor dining room ceiling. Repair/Seal/Paint as necessary to avoid further damage.

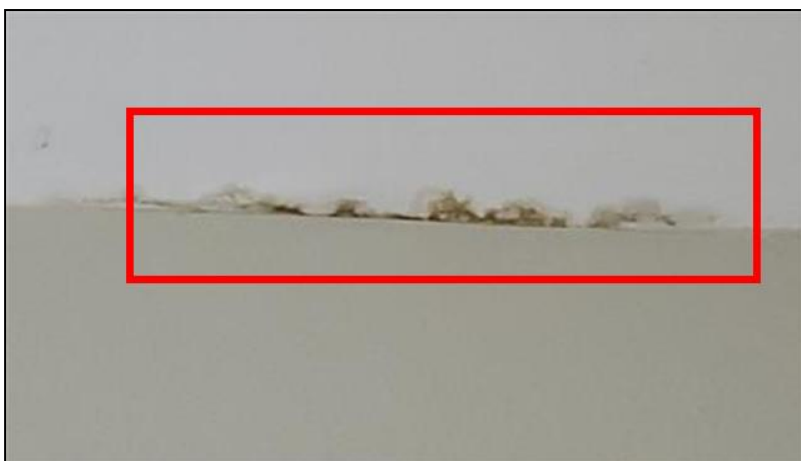
5.0 bsmt open area closet

5.0 (2) Signs of prior moisture stain noted at desk in basement. Repair/Seal/Paint as necessary.

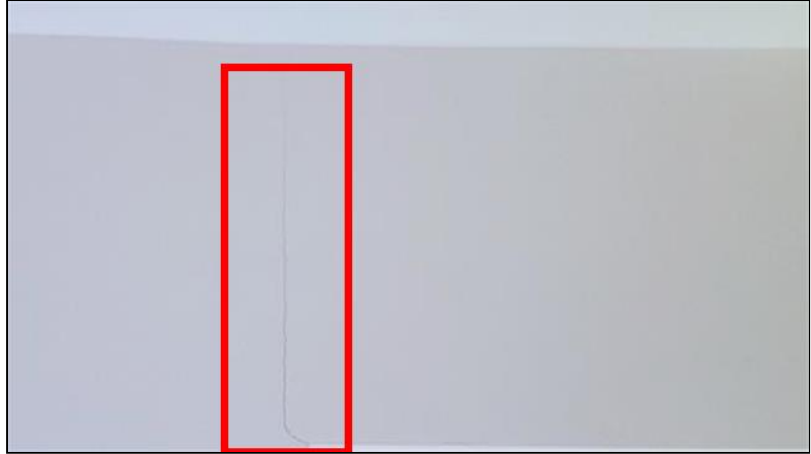
5.1 bsmt front left bdrm

5.1 Damage/Crack noted at basement front left bedroom. Repair/Seal/Paint as necessary to avoid further damage. Recommend consult with a licensed general contractor for further information.

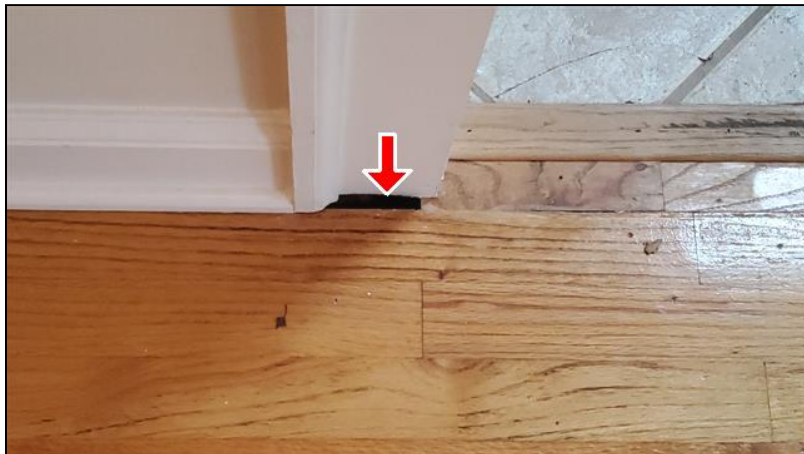
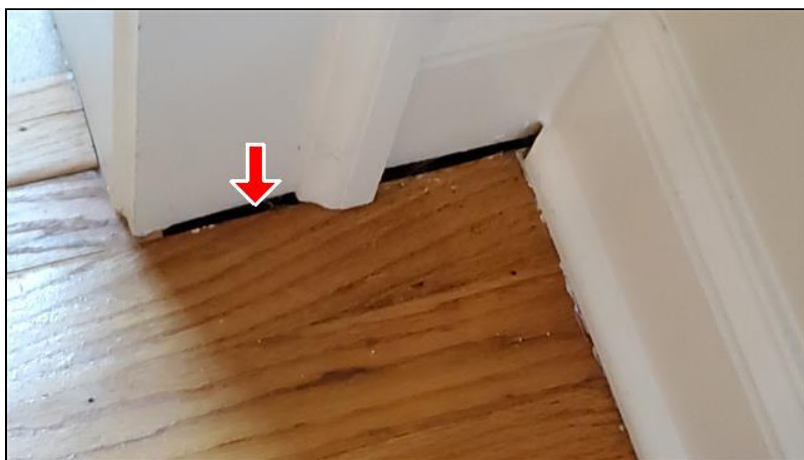
5.2 1st floor family room

5.2 (2) Gaps noted at 1st floor family room flooring to wall intersection. Repair/Seal as necessary to ensure proper operations.

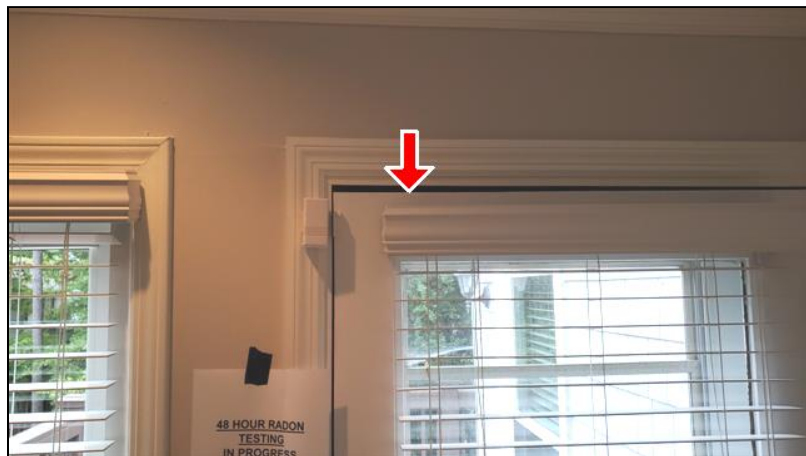
5.4 1st floor mstr bdrm

5.4 (1) Uneven/Gap noted at 1st floor master bedroom door. Repair/Adjust as necessary to ensure proper operations.

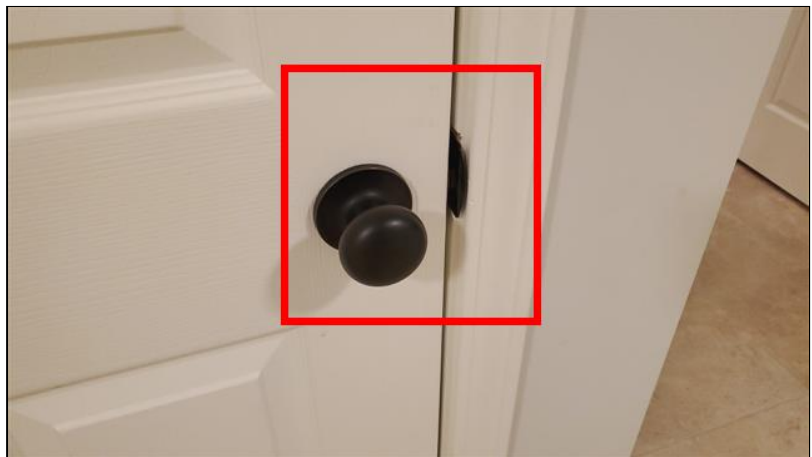
5.4 bsmt mechanical

5.4 (3) Doors at basement mechanical closet do not latch. Adjust as necessary to ensure proper operations.

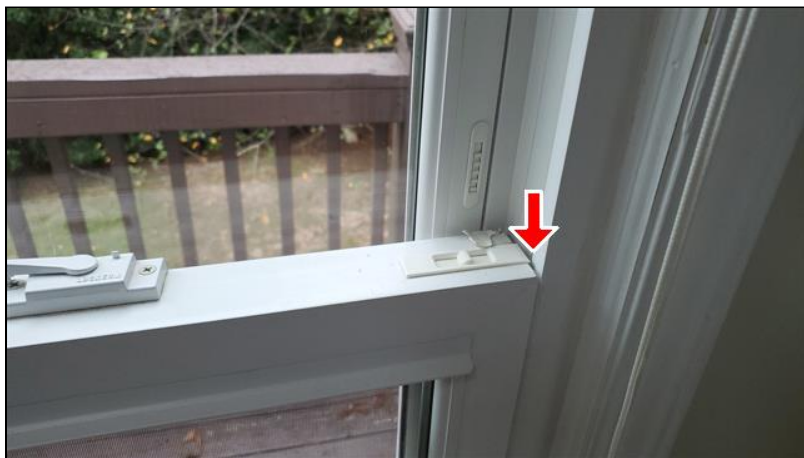
5.5 kitchen breakfast

5.5 (1) Damaged tilt feature noted at several windows. Repair/Replace as necessary ensure proper operations. Refer to images for specific locations. Recommend further evaluation by a licensed window contractor.

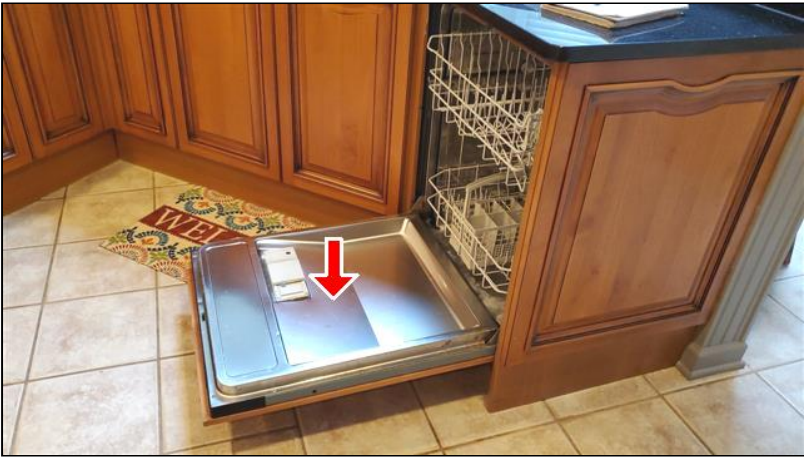
6.0 kitchen

6.0 Dishwasher door not operating properly noted at 1st floor kitchen. Repair/Adjust as necessary. Recommend consult with a qualified appliance contractor for further information.

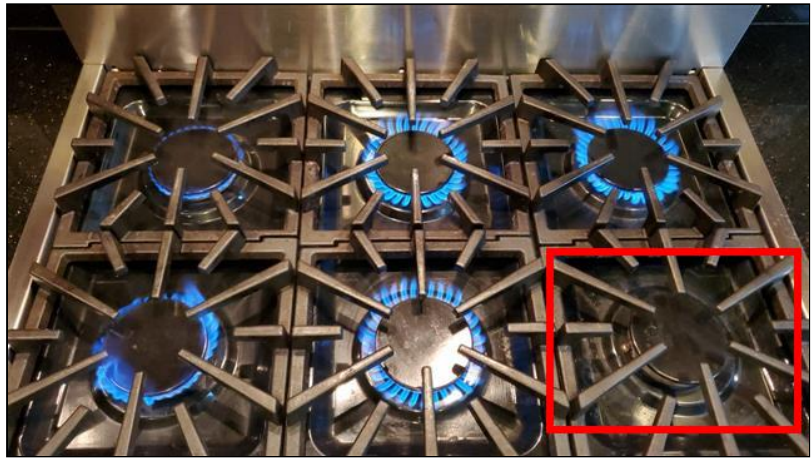
6.2 kitchen

6.2 (1) The front right burner at the kitchen range did not operate. Recommend service.

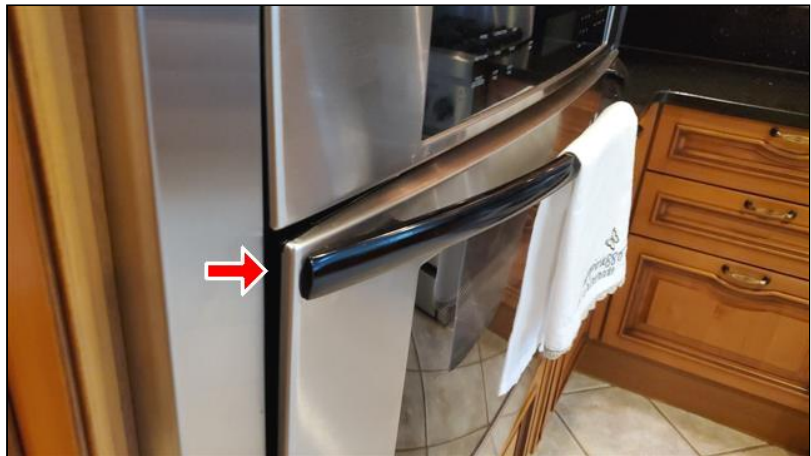
6.2 kitchen

6.2 (2) Oven door not closing properly. Repair/Adjust as necessary to ensure proper operations.

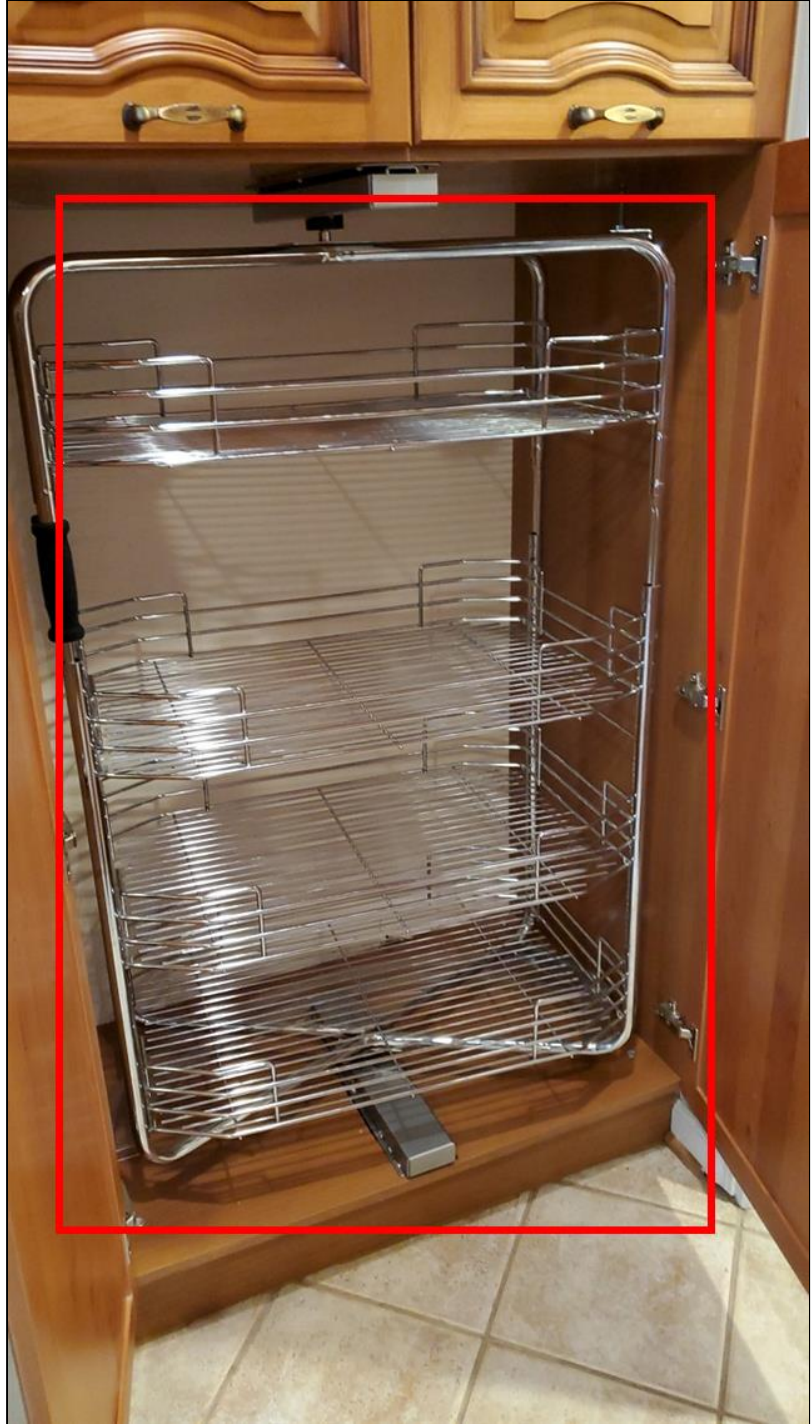
6.6 kitchen

6.6 (1) Cabinet rack not operating properly. Repair/Secure as necessary to ensure proper operations.

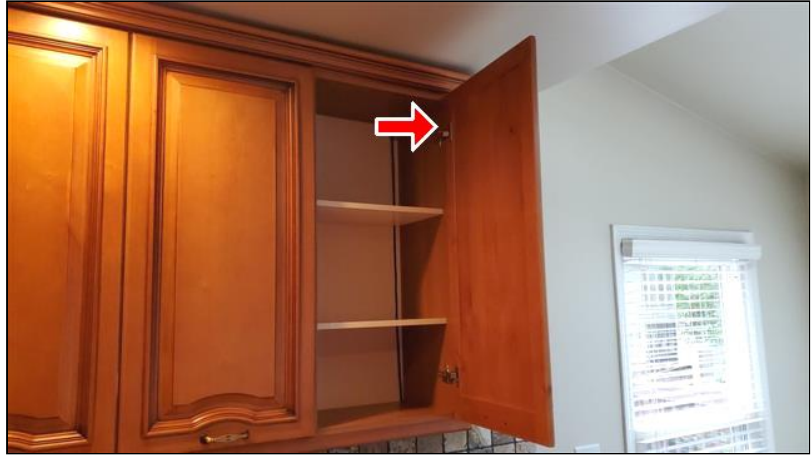
6.6 kitchen

6.6 (2) Cabinet door not open/close properly noted at 1st floor kitchen. Repair/Adjust as necessary to ensure proper operations.

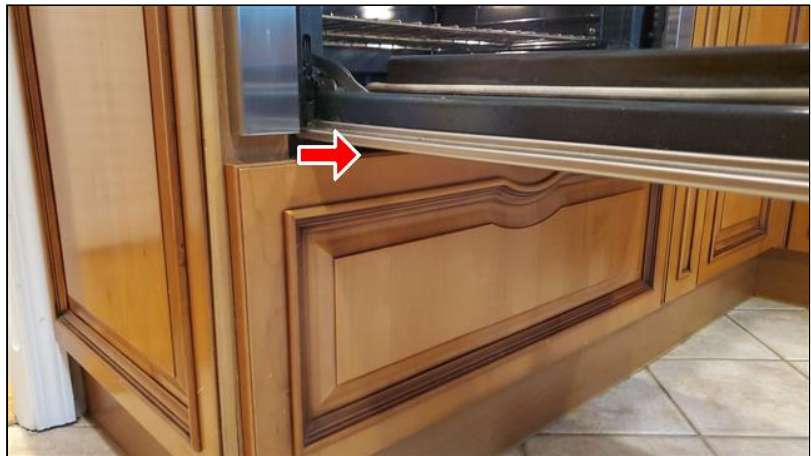
6.6 kitchen

6.6 (3) Oven door scrubs on bottom cabinet drawer when open/close. Adjust as necessary to ensure proper operations.

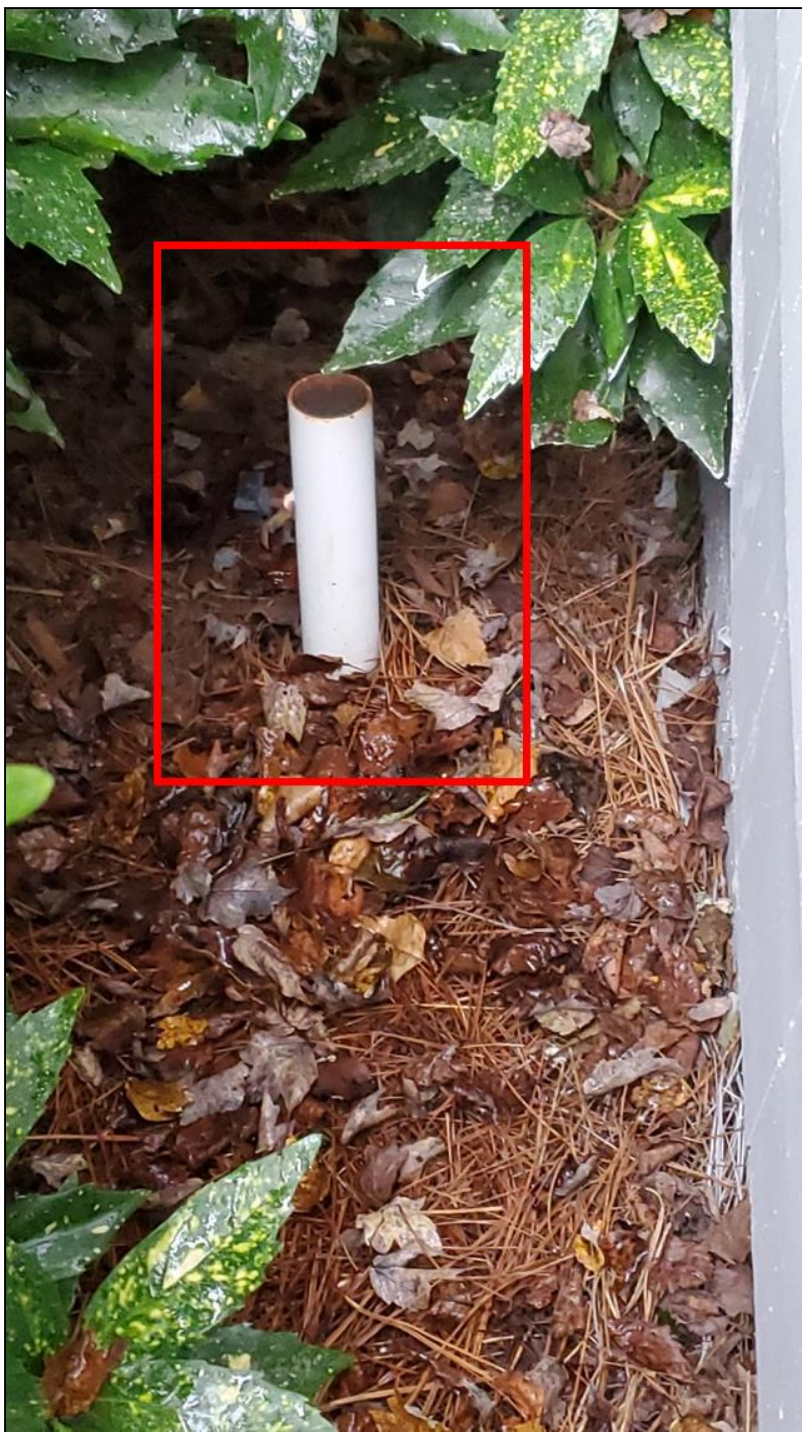
7.0 left

7.0 NOTE: Unidentified pipe noted at left of property. Recommend consult with seller for further information.

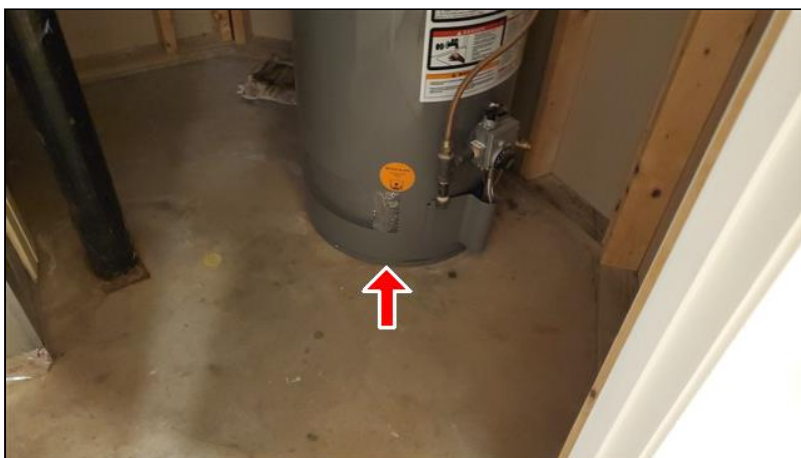
7.4 bsmt mechanical closet

7.4 NOTE: Missing drain pan noted at water heater. Recommend to install a drain pan/catch pan with moisture sensor to minimize risk of flood damage. Refer to manufacturers guidelines.

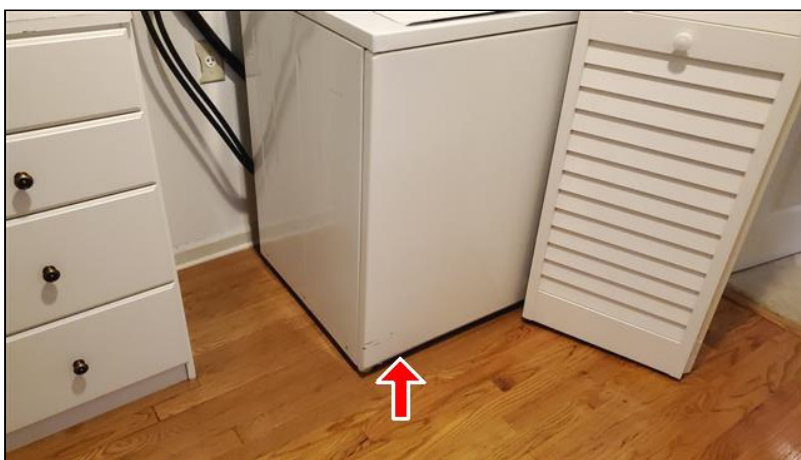
7.5 1st floor laundry room

7.5 Missing catch/drain pan noted at laundry (for washer). Recommend to install/connect a suitable pan (with moisture sensor) to minimize risk of flooding.

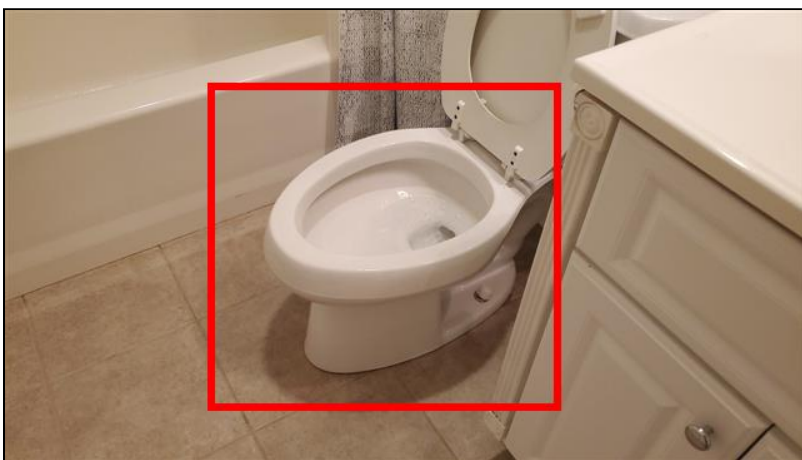
7.6 bsmt lavatory

7.6 (1) Loose toilet bowl noted at 1st floor and basement lavatory. Reset toilet bowl with approved sealing material (i.e. wax ring) and secure as necessary.

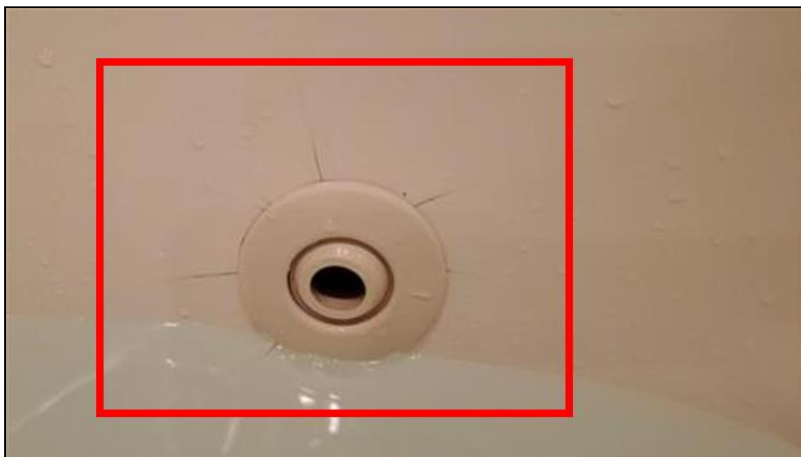
7.6 1st floor mstr lavatory tub

7.6 (2) Damaged jacuzzi tub jet noted at 1st floor master bedroom lavatory. Repair/Replace as necessary to ensure proper operations and further damage.

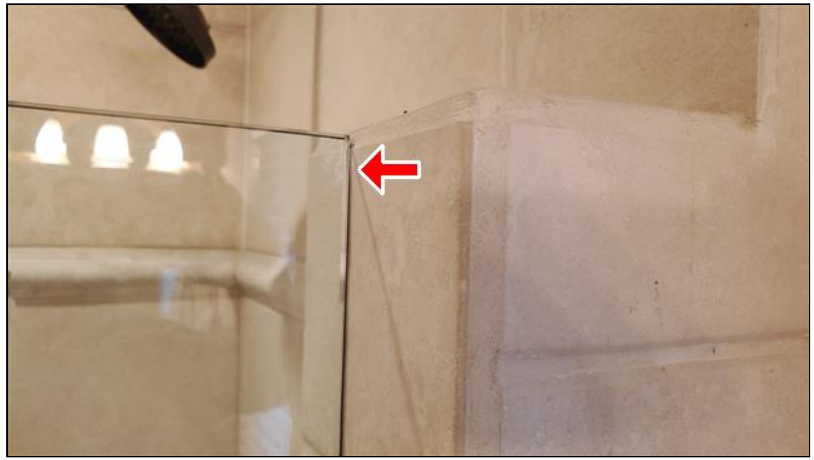
7.6 1st floor mstr lavatory shower

7.6 (3) 1st floor master lavatory shower door scrubs. Repair/Adjust as necessary to ensure proper operations.

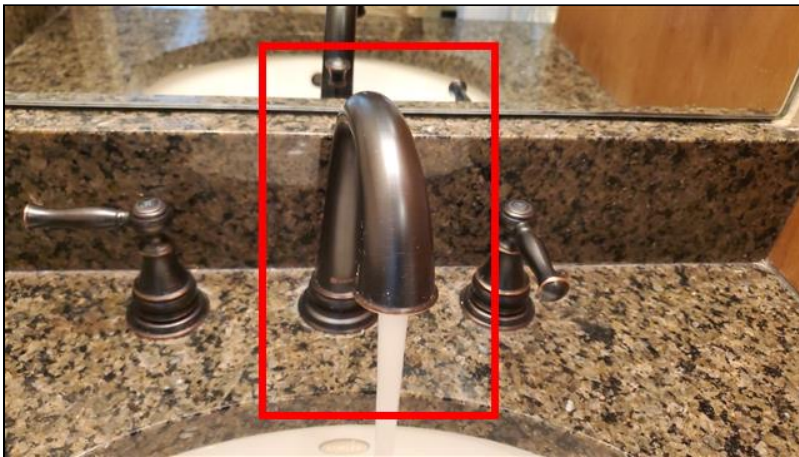
7.6 1st floor mstr lavatory sinks

7.6 (4) Loose faucets noted at 1st floor master lavatory sinks. Repair/Secure as necessary to ensure proper operations.

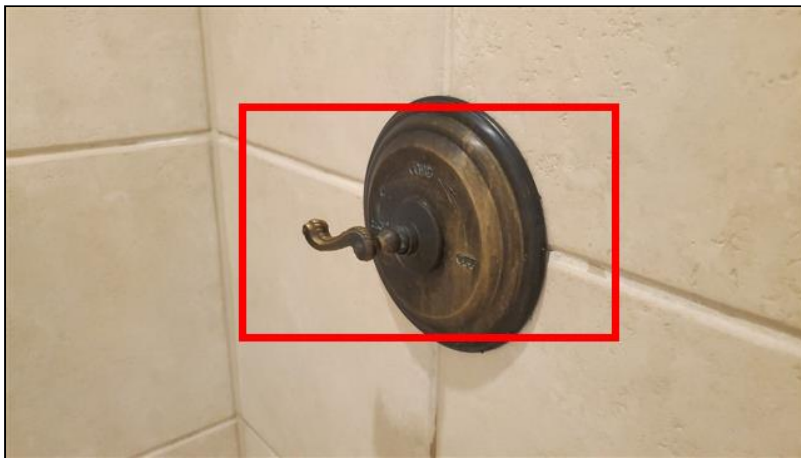
7.6 1st floor mstr lavatory

7.6 (5) 1st floor master lavatory shower valve not operating properly (not adjusted to cold setting). Repair/Adjust/Replace as necessary to ensure proper operations.

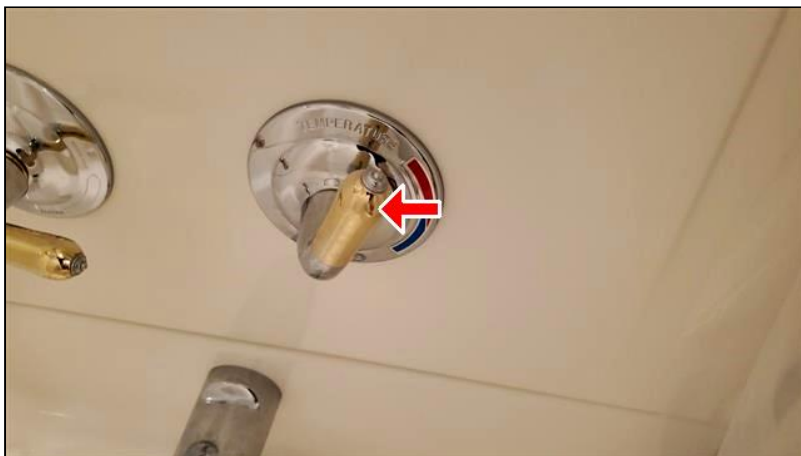
7.6 bsmt lavatory shower/tub

7.6 (6) Looser handle noted at basement lavatory shower/tub valve. Repair/Secure as necessary to ensure proper operations.

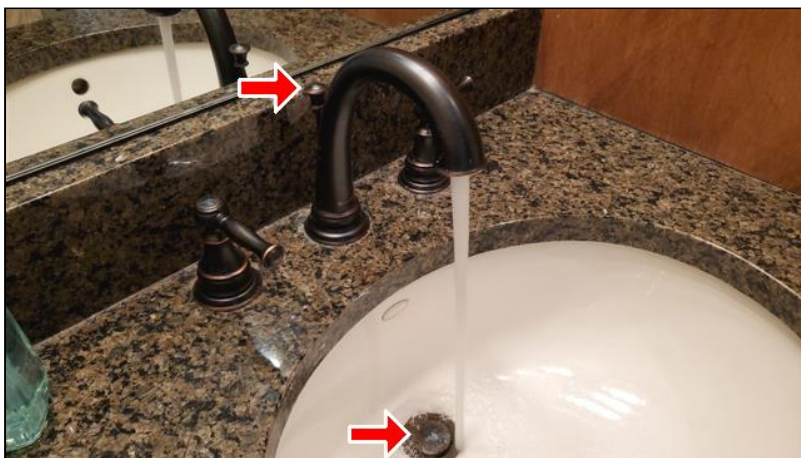
7.6 1st floor mstr bdrm lavatory left sink

7.6 (7) Stopper not operating at 1st floor master lavatory left sink. Repair/replace as necessary to ensure proper operations.

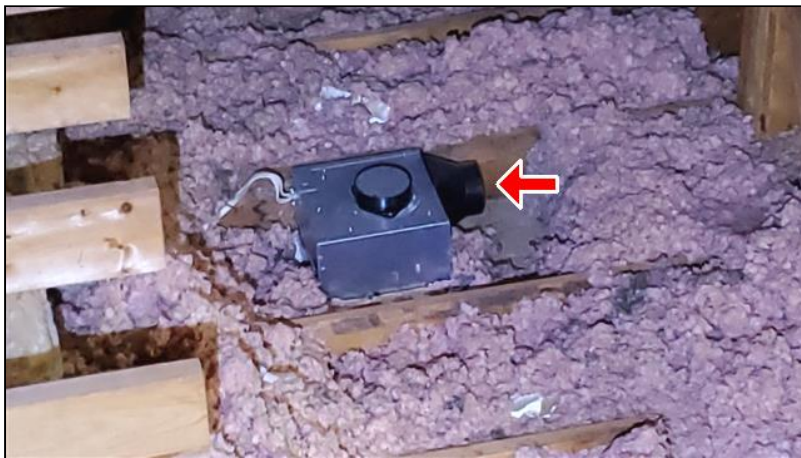
7.7 attic

7.7 Bathroom vent terminates in the attic. NOTE: Vents should terminate to the exterior to avoid humidity built-up in the in the attic. Repair as necessary to ensure proper venting operations. Recommend consult with a licensed general contractor for further information.

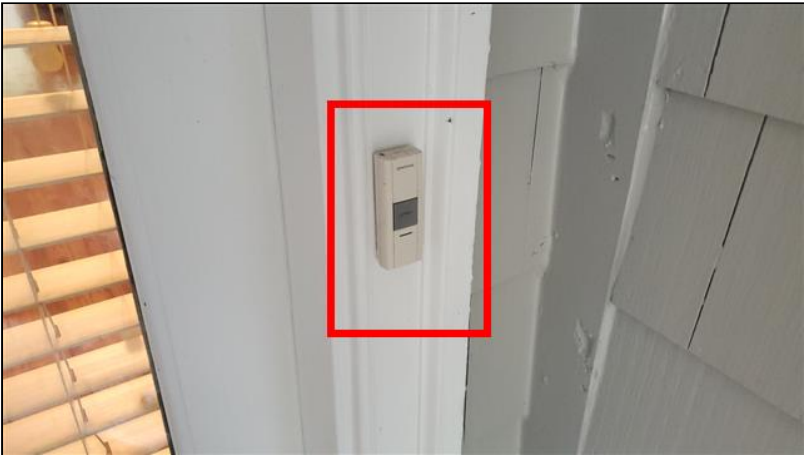
8.0 1st floor front

8.0 Doorbell did not operate at time of inspection. Repair/Replace as necessary to ensure proper operations.Recommend consult with a licensed electrical contractor for further information.
