Inspection Report

Property Address:
1575 Spinnaker Dr
Alpharetta GA 30005

Champia Real Estate Inspection, LLC

Date: 10/9/2020	Time: 02:00:00 PM	Report ID: 42821
Property: 1575 Spinnaker Dr Alpharetta GA 30005	Customer: Alexis Seton	Real Estate Professional: Kim Rowe Chapman Hall (Atlanta)

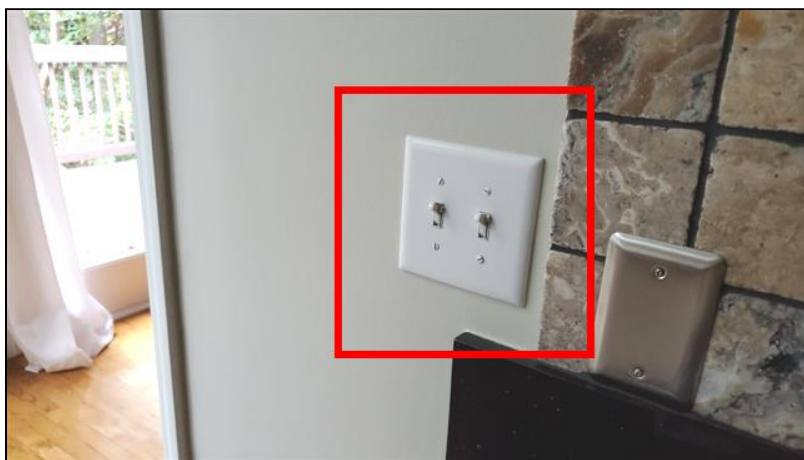
8.4 kitchen

8.4 (2) Functionality of numerous light switches were not readily determined or apparent. Recommend to consult with owner for explanation/clarification.

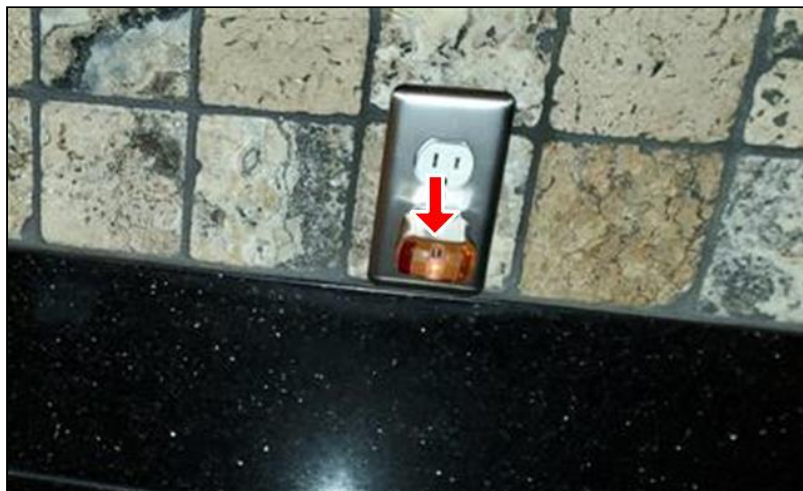
8.5 kitchen

8.5 (1) Open ground noted at kitchen receptacles. Repair/replace as necessary to ensure proper operations. Recommend to consult with a licensed electrical contractor for further evaluation..

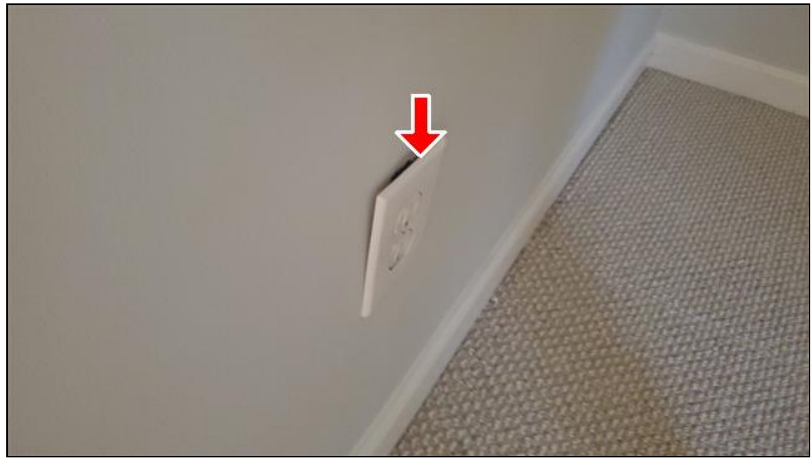
8.5 bsmt left rear room

8.5 (2) Loose receptacle noted at basement left rear room. Repair/Secure as necessary to ensure proper operations.

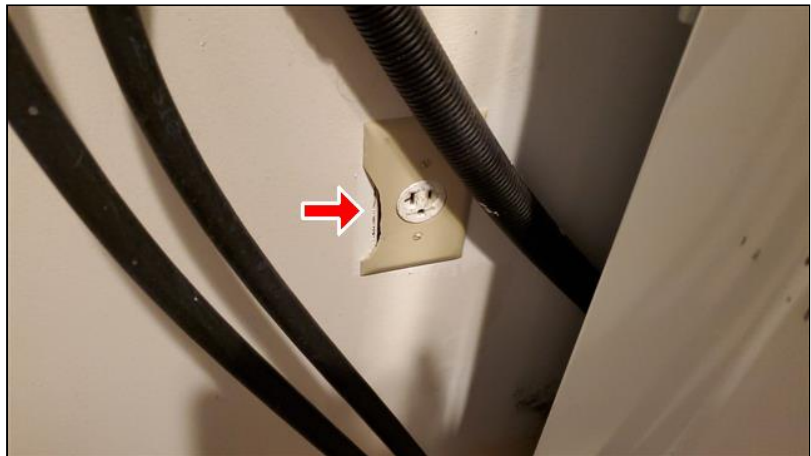
8.5 1st floor laundry room

8.5 (3) Damage cover noted at 1st floor laundry room receptacle. Replace as necessary to improve safety.

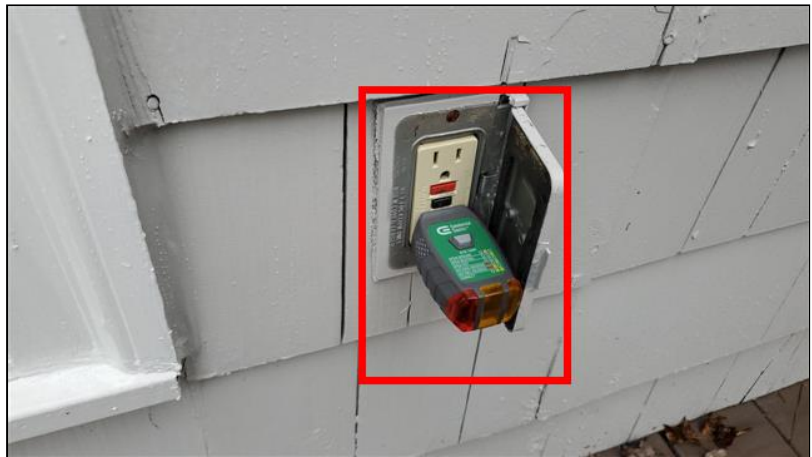
8.6 rear deck

8.6 (2) No power noted at the rear deck receptacle. Repair/Replace as necessary to ensure proper operations.

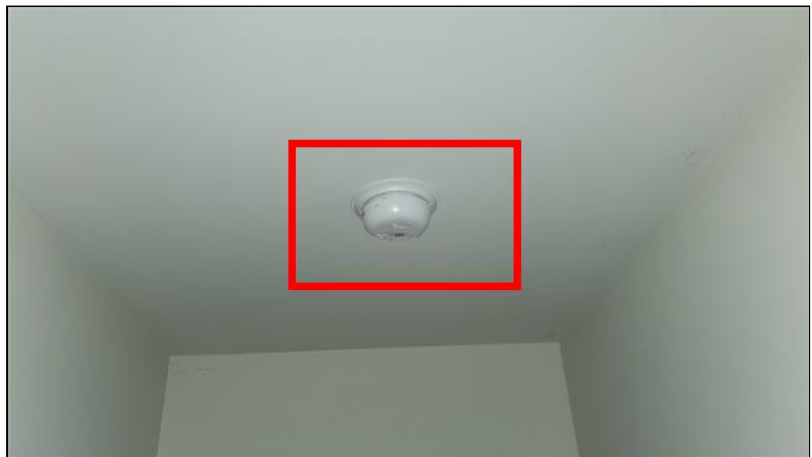
8.8 1st floor front hallway

8.8 NOTE: Recommend to upgrade the smoke alarm system to include smoke alarms at each level, each bedroom area and each bedroom. Install a carbon monoxide detector in each bedroom area. Establish routine testing; per manufacturers guidelines.

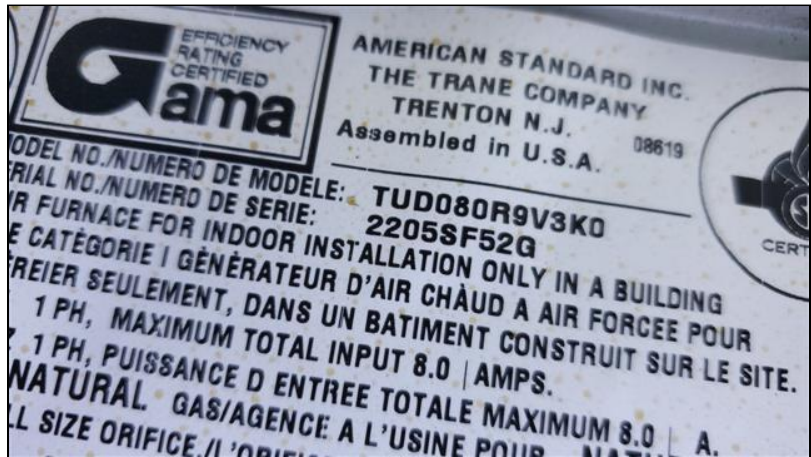
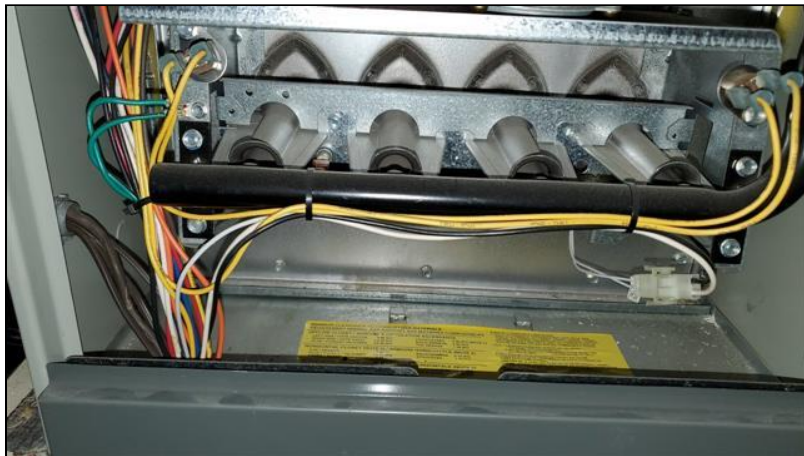
9.0 bsmt 1st floor

9.0 (1) The serial number of the 1st floor furnace indicates a year of manufacture in 2002 and is 18 years old.
NOTE: The typical life expectancy of furnaces is 15 - 20 years. Recommend service/evaluation by a licensed HVAC contractor.

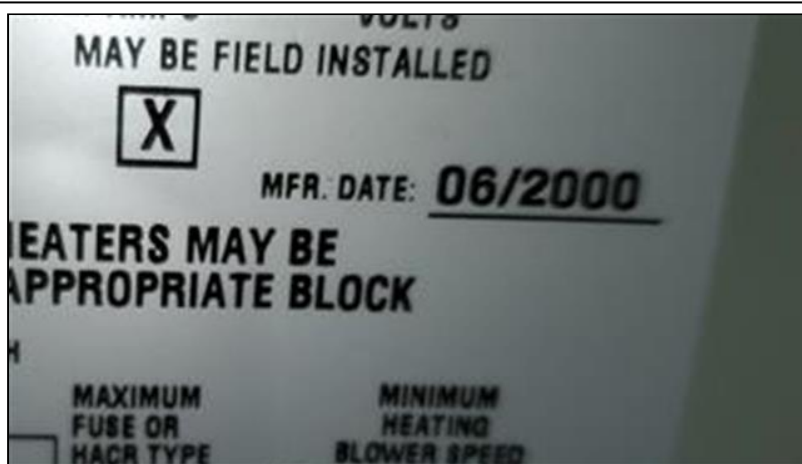
9.0 bsmt hp

9.0 (2) The serial number of the basement furnace indicates a year of manufacture in 2000 and is 20 years old. NOTE: The typical life expectancy of furnaces is 15 - 20 years. Recommend service/evaluation by a licensed HVAC contractor.

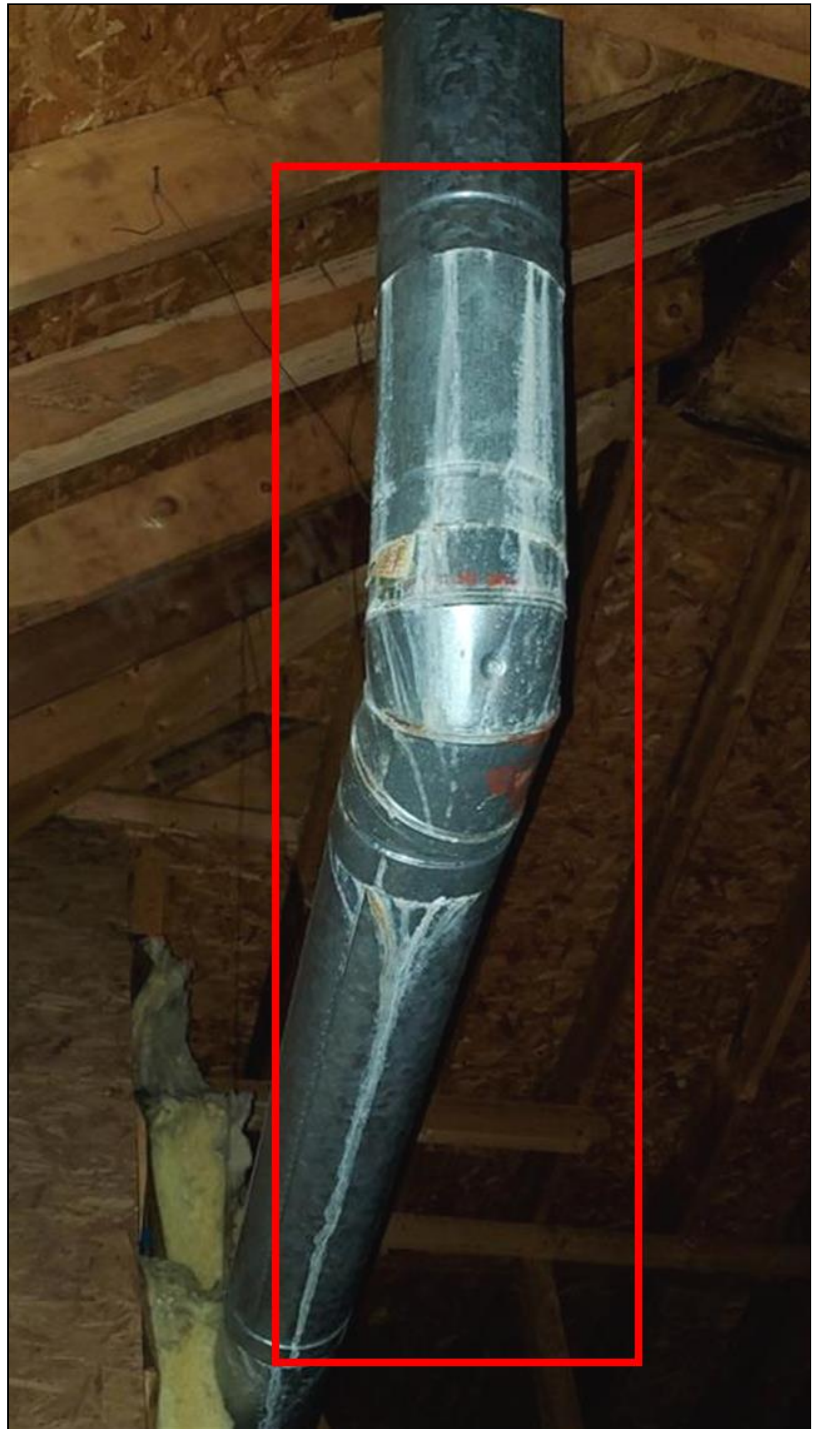
9.0 attic

9.0 (3) Damage/Rust/Signs of moisture entry noted at flue pipe in attic. Repair/ Replace as necessary to avoid further damage. Recommend consult with a licensed HVAC contractor for further information.

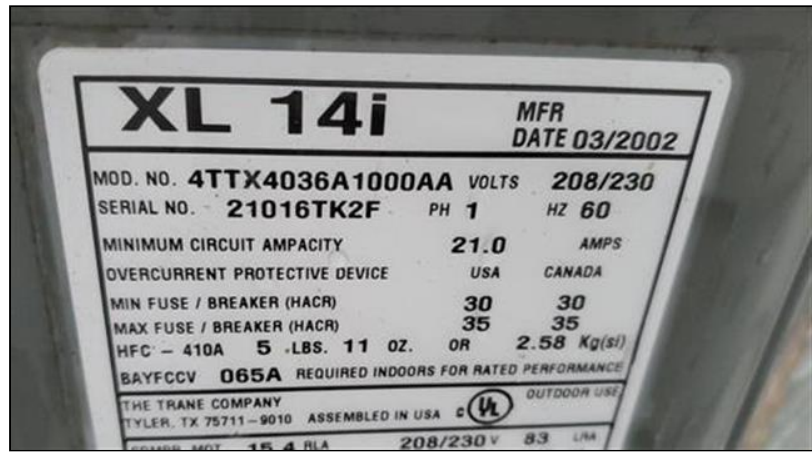
9.4 right

9.4 (1) The serial number of the 1st floor air conditioning unit indicates a year of manufacture in 2002 and is 18 years old. NOTE: The typical life expectancy of condensers in the Southeast US is 15 - 20 years. Recommend service/evaluation by a licensed HVAC contractor.

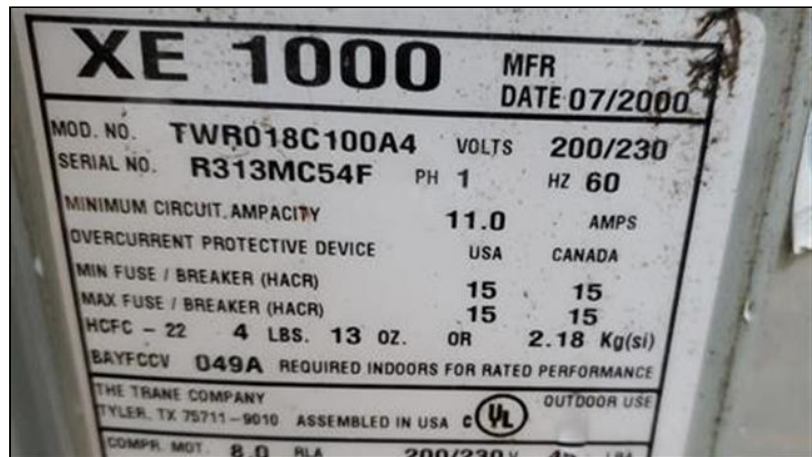
9.4 right

9.4 (2) The serial number of the basement air conditioning unit indicates a year of manufacture in 2000 and is 20 years old. NOTE: The typical life expectancy of condensers in the Southeast US is 15 - 20 years. Recommend service/evaluation by a licensed HVAC contractor.

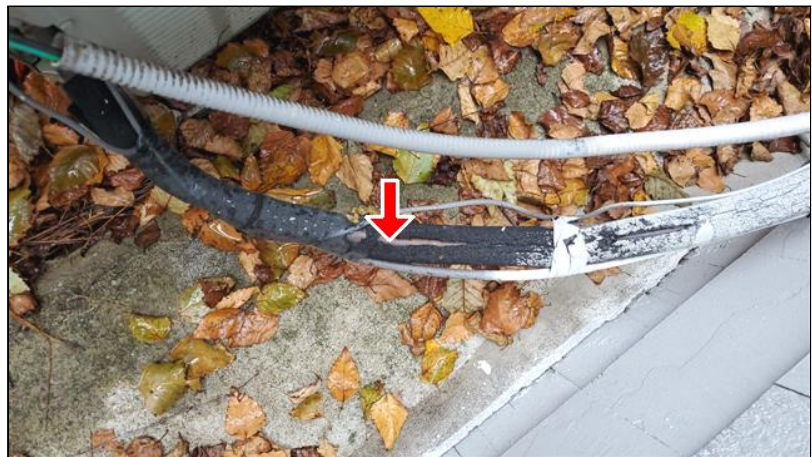
9.4 right

9.4 (3) Missing/deteriorating insulation noted at the AC unit line set. Amend/repair/replace insulation to avoid built-up of condensate on the line exterior.

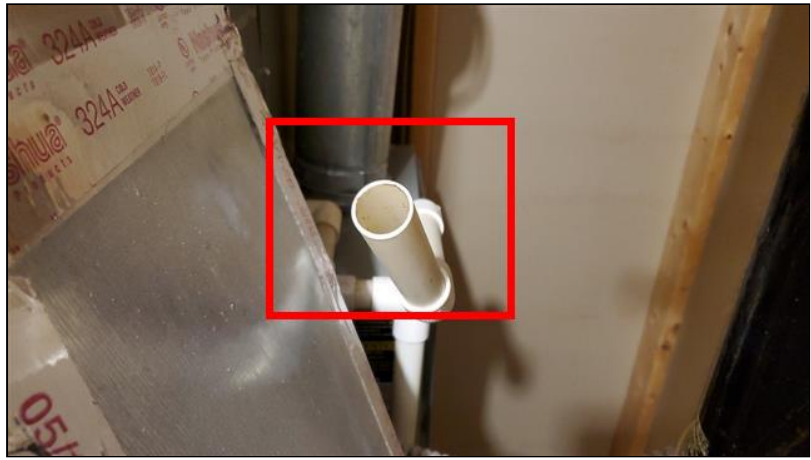
9.4 bsmt

9.4 (4) Missing cap noted at 1st floor air handler condensation drain line. Recommend to install cap to avoid the escape of conditioned air.

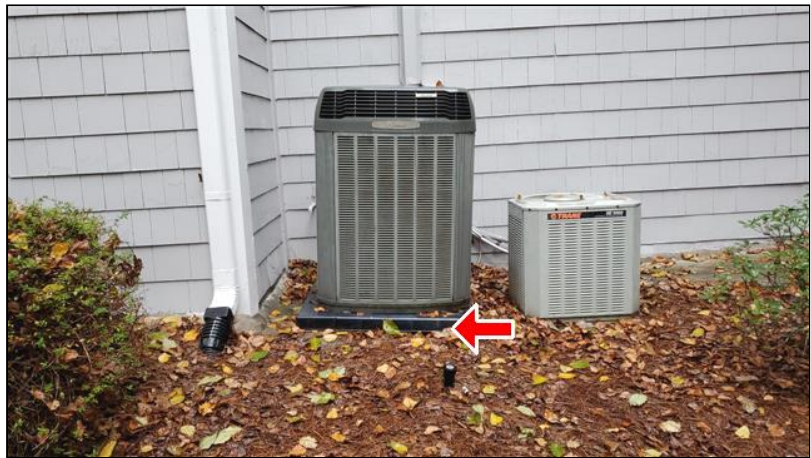
9.4 right

9.4 (5) Leaning AC unit noted at the condenser pad. NOTE: Typically AC units should be installed level. Refer to (AC unit) manufacturer guidelines and adjustments/repairs as necessary.

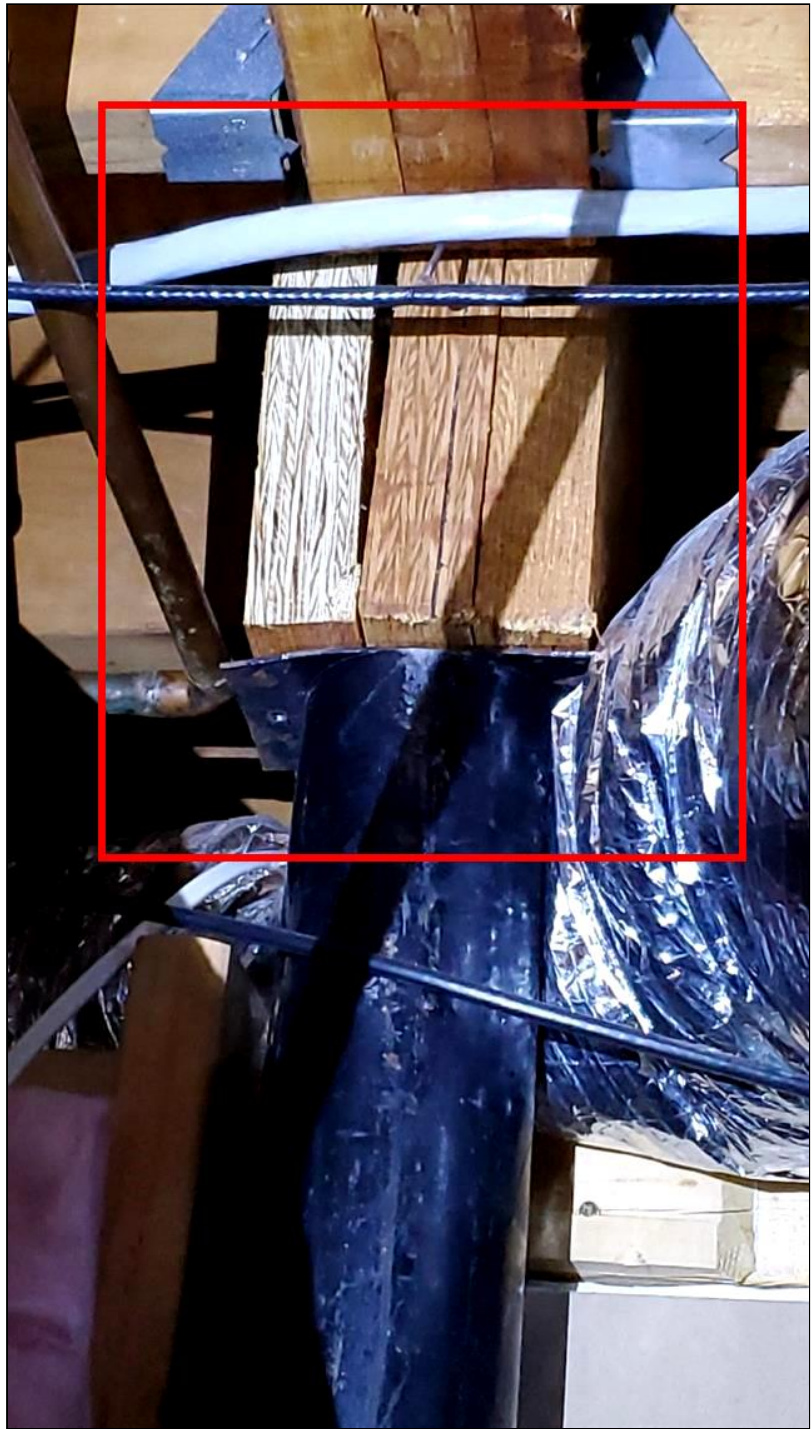
10.3 bsmt

10.3 NOTE: Prior repairs noted at floor structure in basement unfinished. Recommend consult with seller for further information. Recommend consult with a qualified structural contractor for further information.
