# Building Inspection Report

9375 Scott Rd, Roswell, GA 30076

9/11/2020

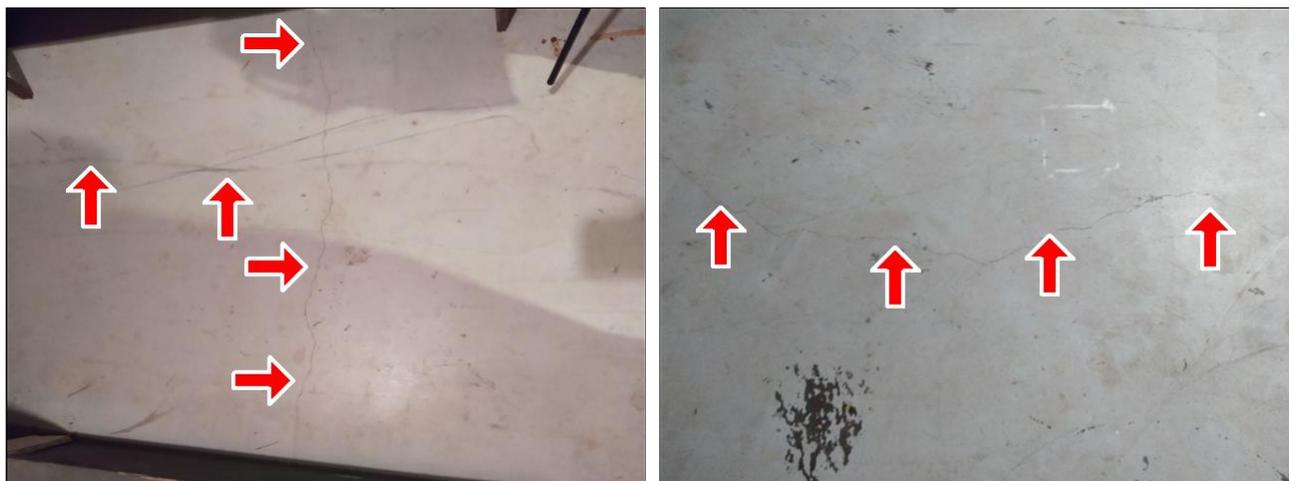
### 1.4 Structural: Slabs

**Repair, Monitor:** Fairly typical concrete settlement cracks were noted in the basement slab. The cracks should be grouted and sealed to limit moisture and radon infiltration and then monitored for future movement.

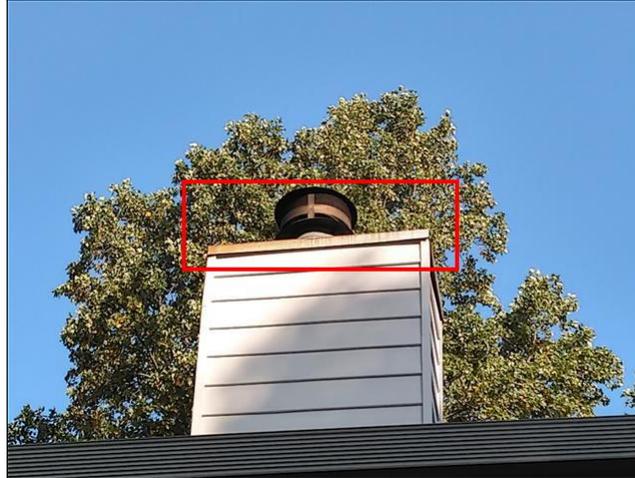
**Monitor, Future Repair:** *The metal rain pan for the fireplace flue is rusting noticeably and may need replacement in the near future. Painting the pan with a rust prohibitive paint would prolong the life of this component.*

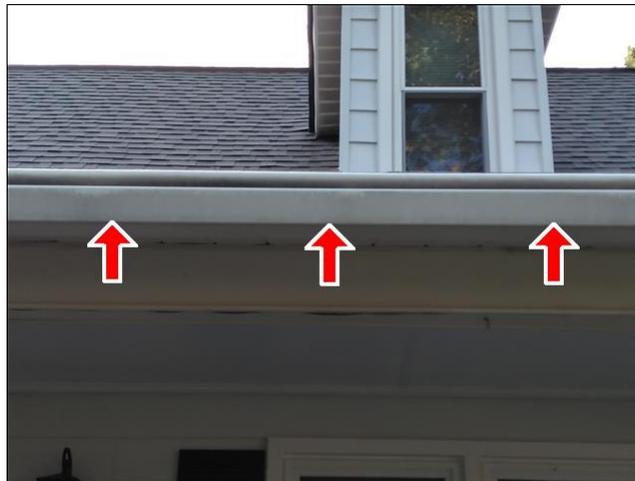
### 2.3 Roofing: Gutters / Downspouts

**Monitor, Possible Repair:** *The gutters show signs of leaks and possible overflows as evidenced by stains on the gutters, cornice and fascia. The gutters should be monitored in a heavy rain to determine if the sizing, capacity, and configuration of the gutters is appropriate for proper handling of the water runoff from the roof. If they do not perform properly, recommend consulting with a qualified guttering contractor for possible improvement and/or replacement that may be needed.*

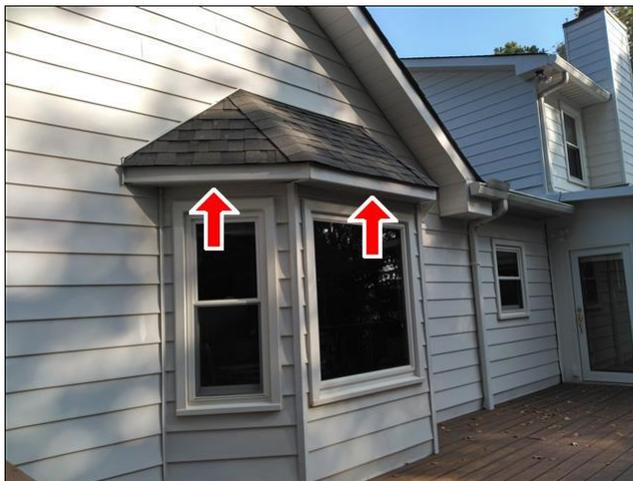
**Improve:** All of the downspouts should be piped away from the foundation so that they discharge water at least ten (10) feet from the house or into an underground drainage system to prevent moisture infiltration into the basement and settlement of the foundation. Recommend using smooth wall piping as opposed to the black ribbed piping, which is more prone to blockages. Storm water should be encouraged to flow away from the building at the point of discharge.

**Improve:** It is recommended that a gutter and downspout (or discharge spout) be installed around the edge of the bay roofing to avoid letting water run over the front face of the wood trim and windows, which poses a risk for future wood rot and leaks.

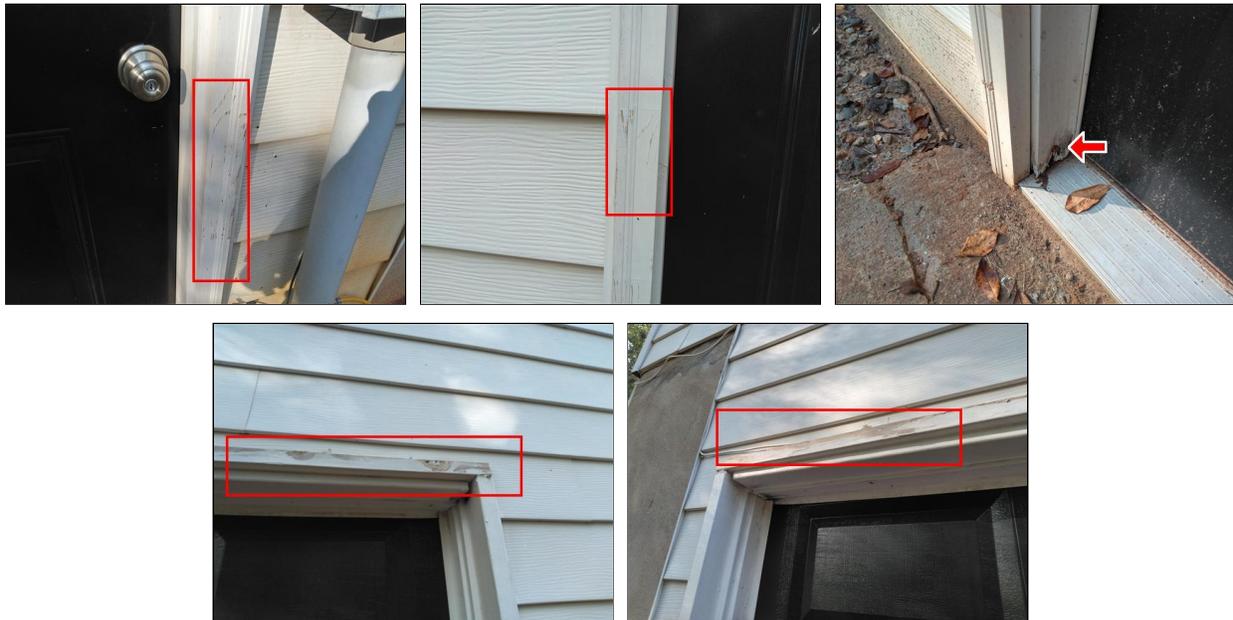
**Monitor, Future Repair:** The window and door frames, sashes, and panels will need painting and caulking in the near future for proper protection against rot and decay as indicated by peeling paint on these components. The windows will also need glazing repairs. Remove all peeling paint and apply two good coats of exterior alkyd paint. Repair or replace all damaged wood as needed.

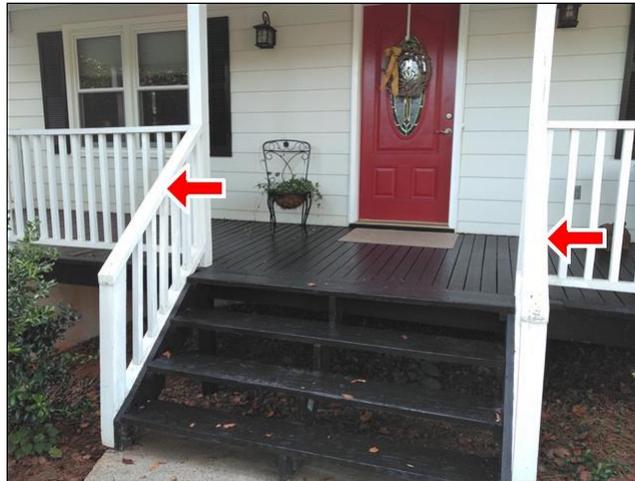
**Repair, Safety Issue:** The handrails as noted at the front do not meet current safety standards for proper grasping of the top of the rail. The hand grip portion of the rail should have a minimum width of 1 1/4" and a maximum width of 2 5/8", which should be improved as needed for proper grasping of the rails.

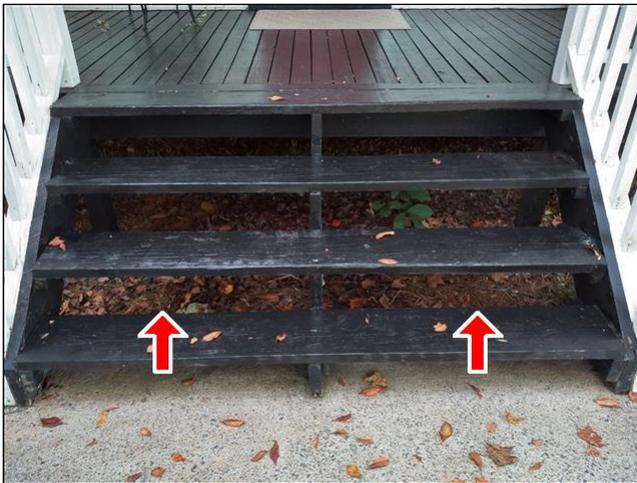
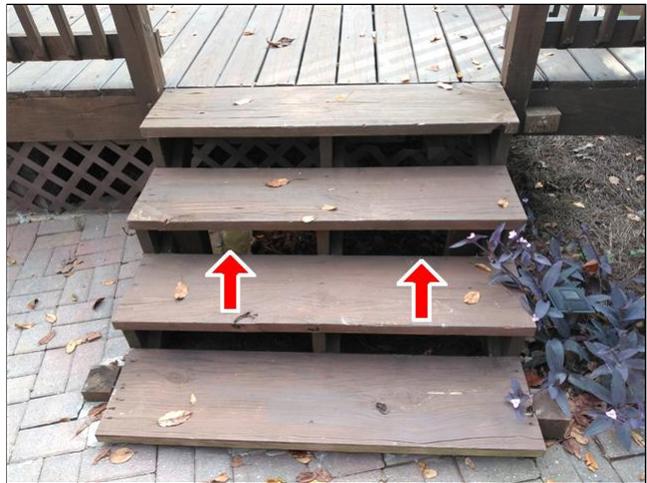
**Repair, Safety Issue:** Openings between stairs treads at the front and rear are not allowed to be greater than 4" as recommended for child safety.

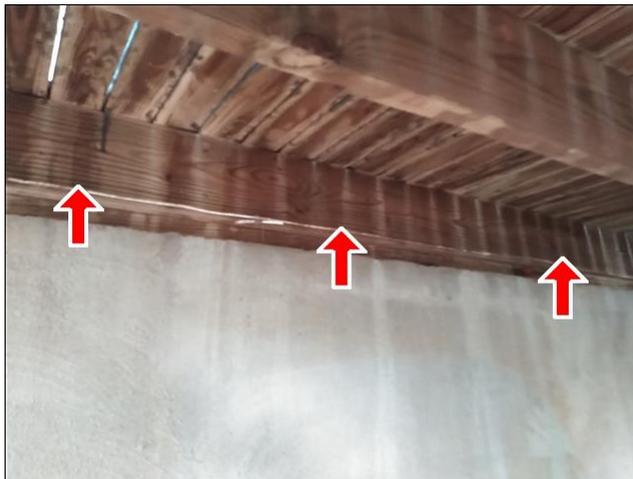
**Repair, Safety Issue:** The front porch ledger band appears to be only nailed to the structure of the house. This ledger should instead be bolted to the structure for proper support. This condition if not repaired, may cause the deck to pull away from the house possibly causing injury to occupants. Immediate repair is strongly recommended.

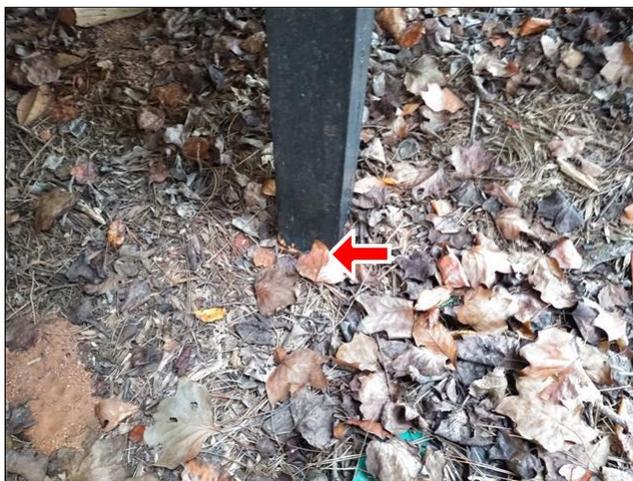
**Repair:** The grade is in contact with the base of the support wood posts for the front porch, which can cause moisture and termite damage in the future. Recent studies have shown that even pressure treated wood can rot over time due to constant contact with the soil. Make sure the footings for the posts are in place and extend at least 2" above the ground to keep the bottoms of the posts dry and free from soil contact.

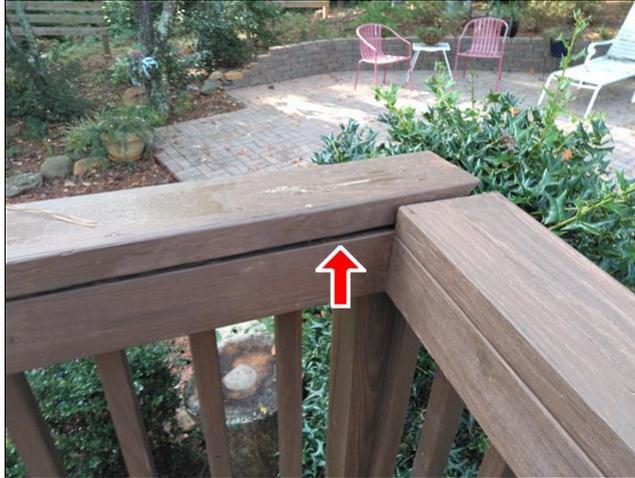
**Repair:** Loose and warped deck boards as noted at the railing should be re-secured with wood screws for a better and longer lasting attachment.

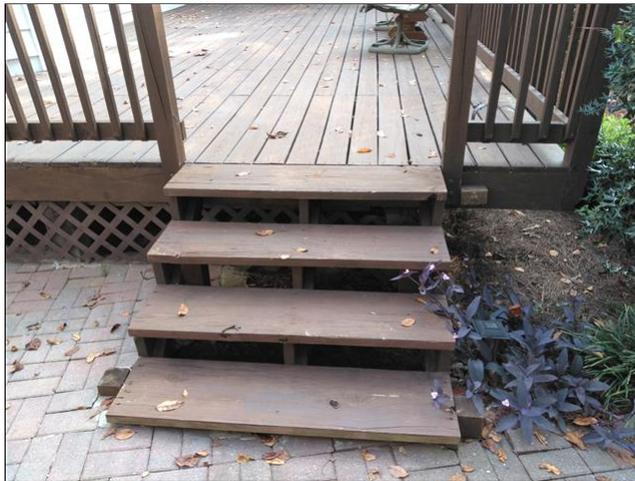
**Improve, Safety Issue:** Recommend installing a handrail at the exterior steps located at the rear deck for improved safety. Current safety standards recommend a handrail for steps of four (4) or more risers.

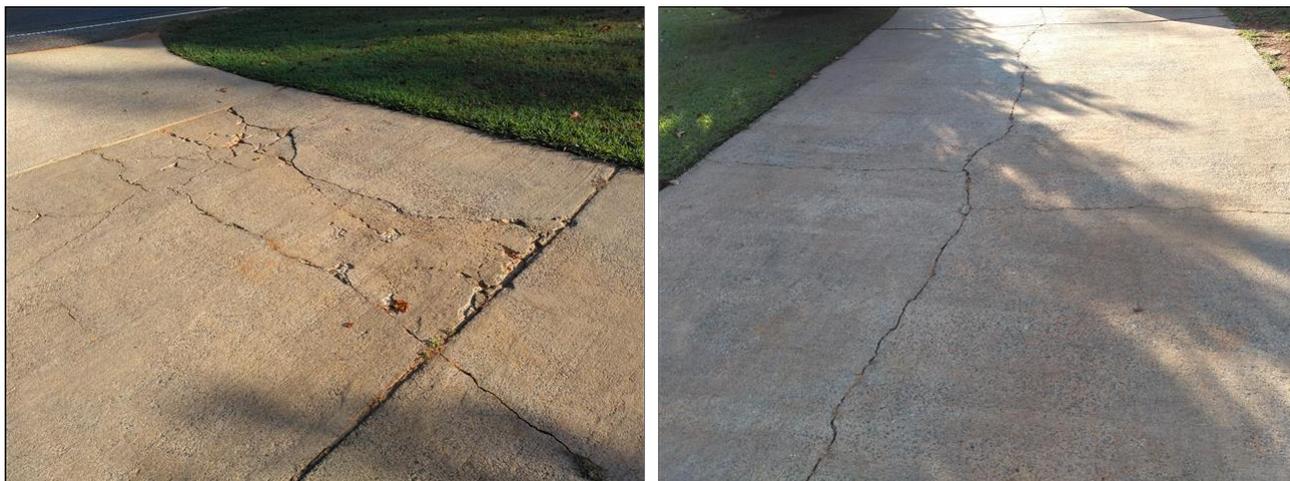
### 3.8 Exterior: Driveway / Sidewalks

**Monitor, Future Repair:** *The driveway has heaved and cracked in some areas as noted and will need repair or replacement in the future.*

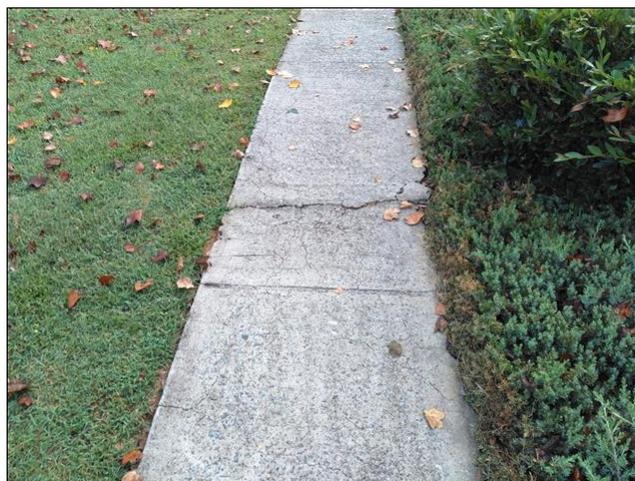
**Improve, Safety Issue:** The walkway as noted at the front presents a trip hazard and should be altered as needed for improved safety.

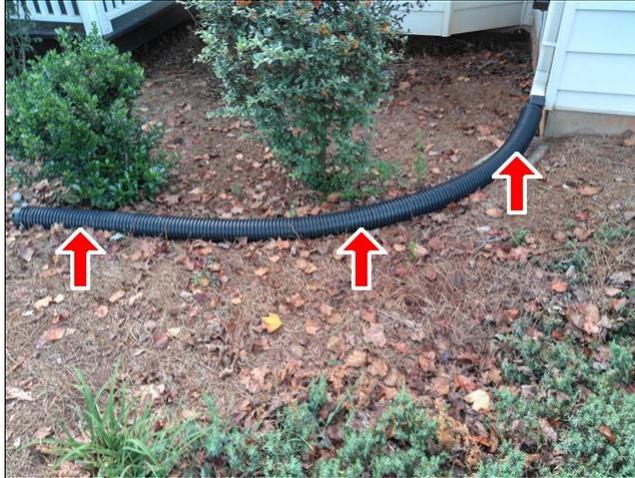
### 3.10 Exterior: Lot / Drainage

**Improve, Monitor:** The downspout piping as noted should be buried and properly sloped away from the house to prevent damage to the piping and to insure that storm water does not collect next to the foundation. The "ribbed" pipelines as noted are more prone to blockages than smooth wall piping. These should be monitored for proper flow and flushed on a regular basis to prevent obstructions in the lines.

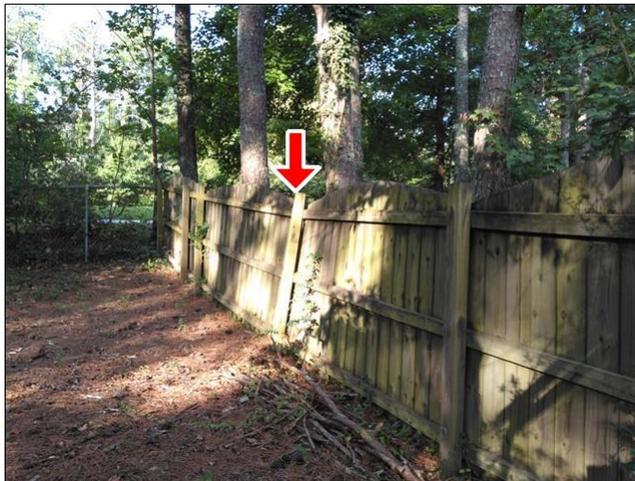
**Monitor, Future Repair:** Some of the wood fencing components are in poor condition. Replacement of these will ultimately be necessary.

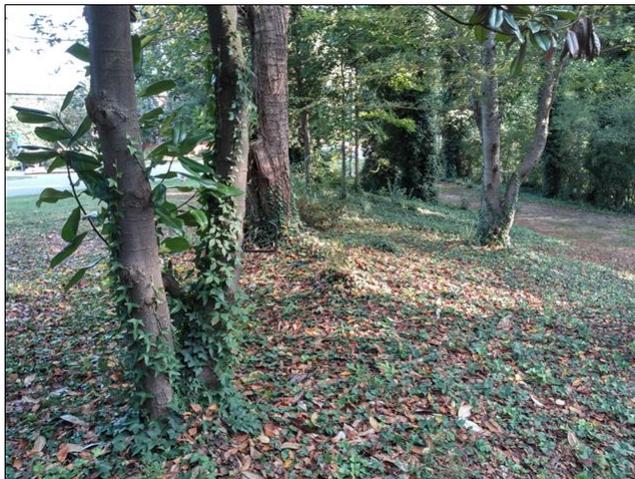
**Improve:** Ivy and other vegetation growing on trees as noted, should be removed to prevent future damage to the trees.

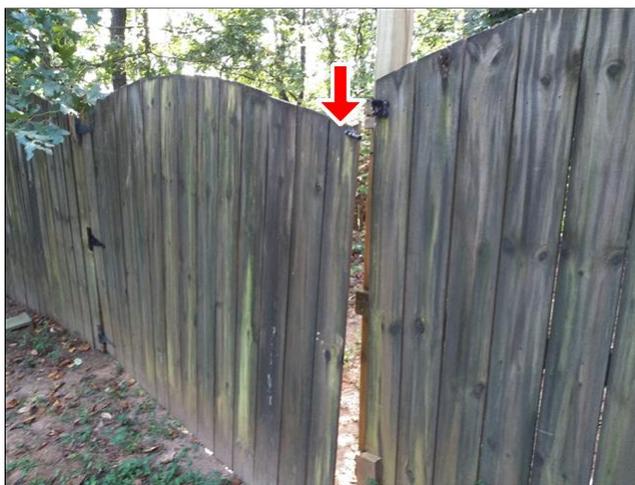
**Improve:** The wood fencing should be power-washed and then painted or stained to improve durability and protection against further weather damage.

**Improve:** The gate and/or latch mechanism needs adjustment to function properly.

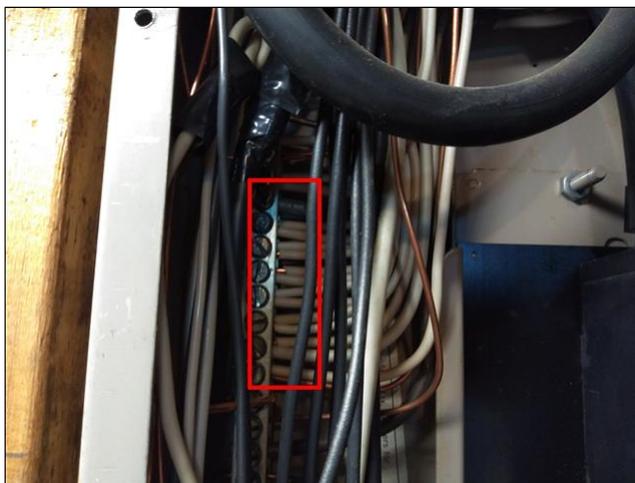
**Repair:** Neutral wires that are doubled up on one slot of the buss bar as noted in the panel should be separated and installed in separate slots as needed to prevent poor connections.

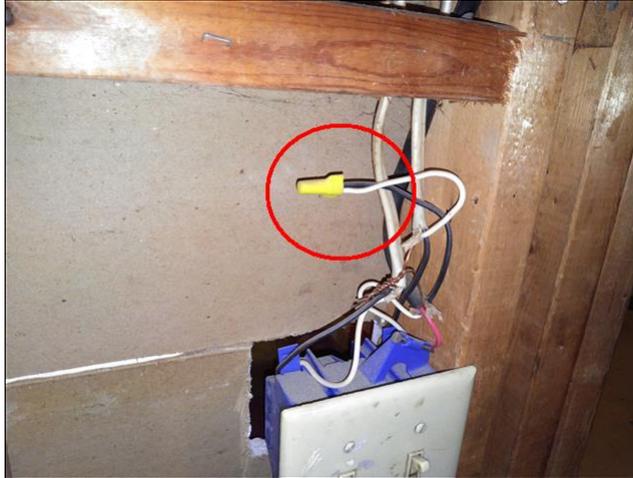
**Repair:** Improper electrical connections as noted in the basement should be repaired. All electrical connections should be made with wire nuts and installed inside junction boxes fitted with cover plates to minimize shock and fire hazards.

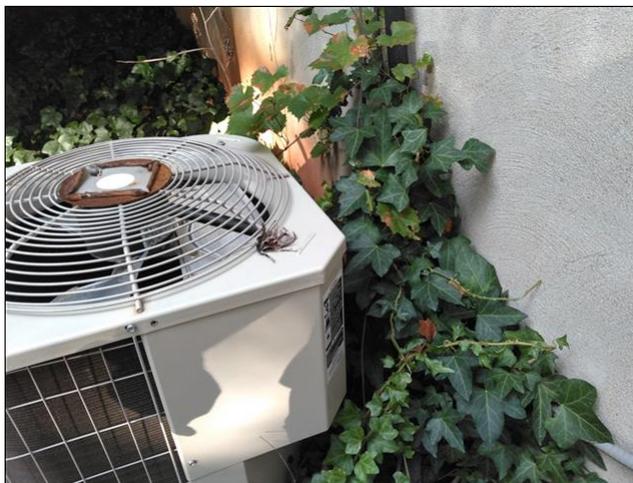
**Repair:** *Vegetation and soil in the vicinity of the outdoor unit of the air conditioning system should be cut back and removed for proper air flow and to prevent moisture damage to the units. There should be at least 3" clearance between the soil and base of the unit. Make sure these are properly supported and kept level at all times for proper operation of the fan motor and compressor.*

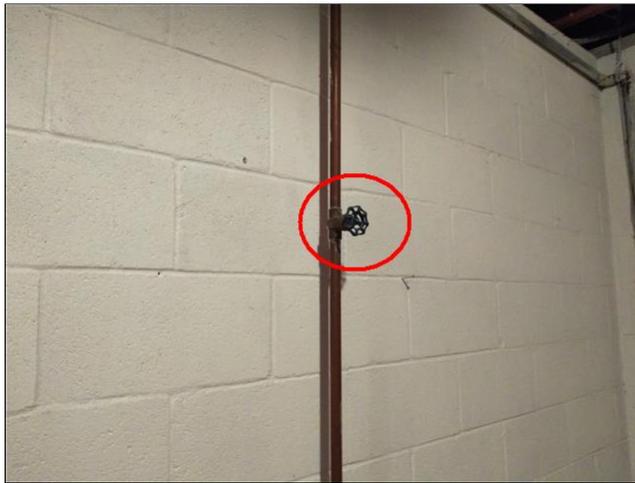
**Improve:** The main whole house water shut-off valve appears to be located front foundation wall (confirm with seller) and should be labeled for proper identification. The shut-offs for the outside hose faucets should also be properly labeled for future access. We recommend shutting off the water when leaving the house for extended periods of time.

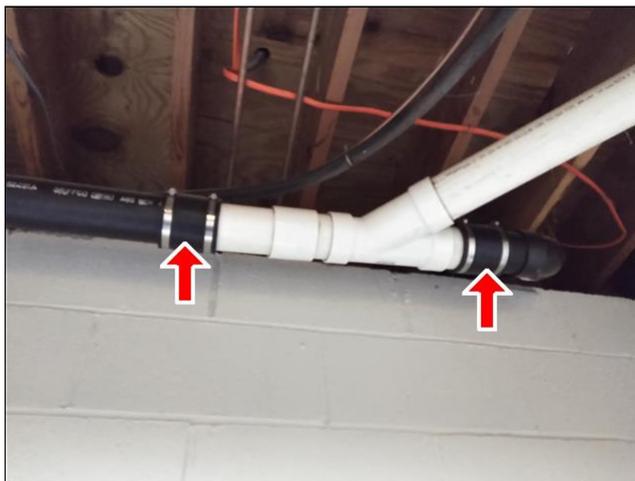
**Monitor, Improve:** The "Fernco" type connections as noted in the basement are prone to blockages and leakage and should be replaced as needed with proper smooth wall connections for improved performance.

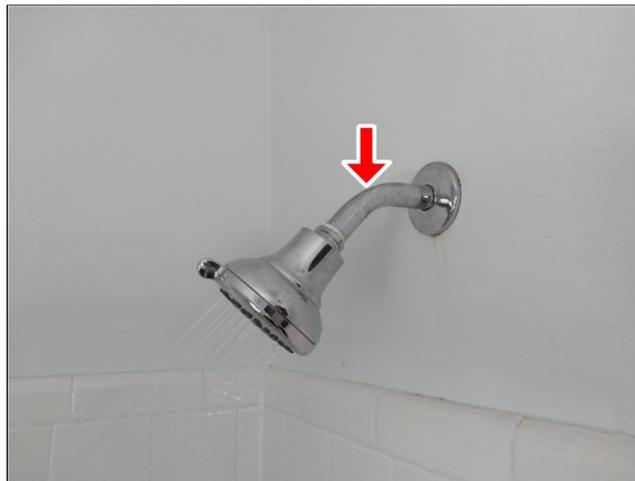
**Repair:** The shower head piping is loose in the wall as noted at the guest bathroom. This condition may cause future leaks in the piping. The piping should be properly secured and the escutcheon plate caulked and sealed to prevent moisture intrusion behind the tile.

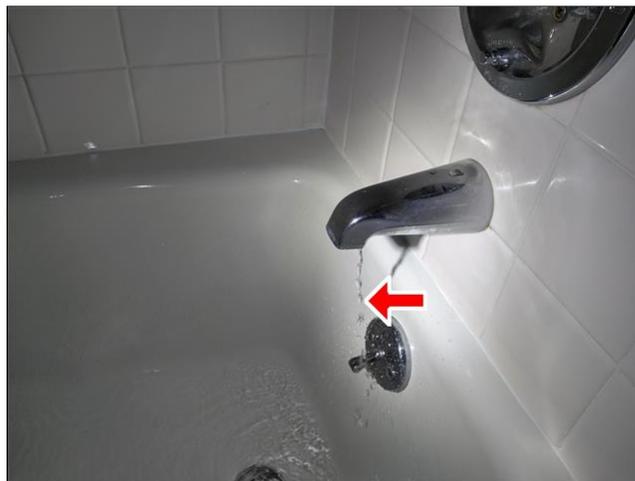
**Repair:** The shower diverter at the guest bathtub does not completely divert all of the water to the shower head, which should be improved as needed for proper function.

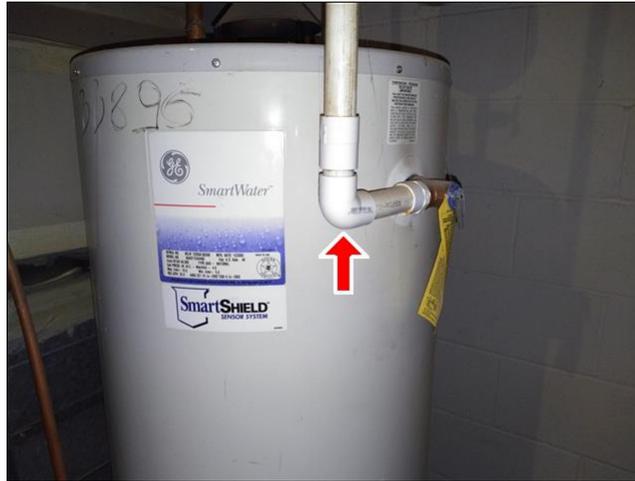
**Repair, Safety Issue:** Current safety standards require a "bleeder" valve when the discharge piping for the TPR (Temperature and Pressure Relief) valve does not drain by means of gravity. This device should be added as needed to drain water build up in the lines, which can cause damage to the TPR valve.

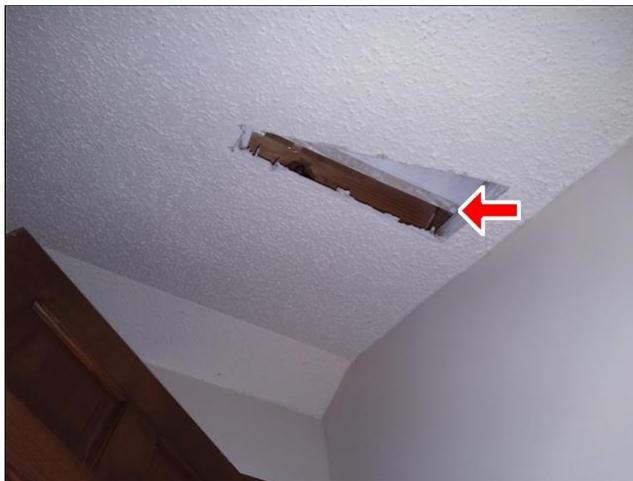
**Repair:** Damage and/or holes were noted in the ceilings as noted in the basement stairway, which should be repaired and repainted.

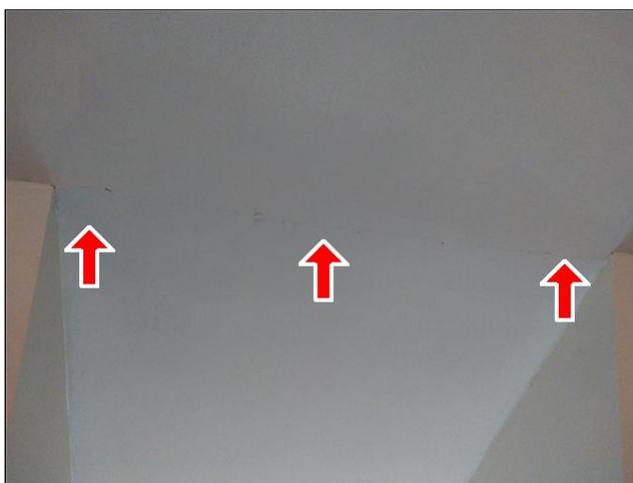
**Improve, Monitor:** Minor cracks in the ceiling as noted in the left guest bedroom should be patched and monitored for further movement.

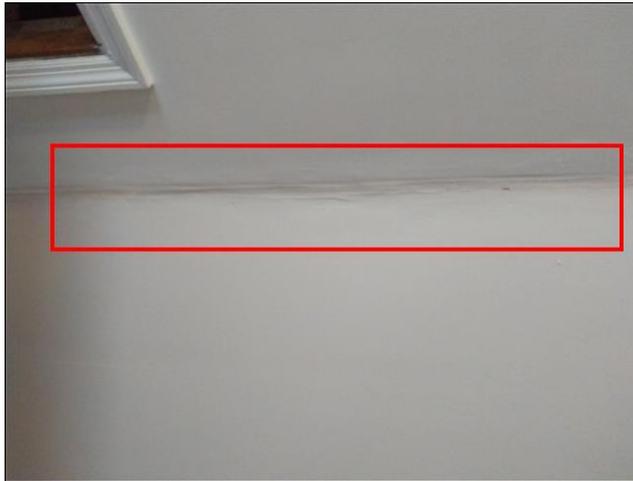
**Monitor:** Previous damage was noted in ceilings at the right guest bedroom, which has been repaired. Consult with seller concerning history of past leaks or settlement here.

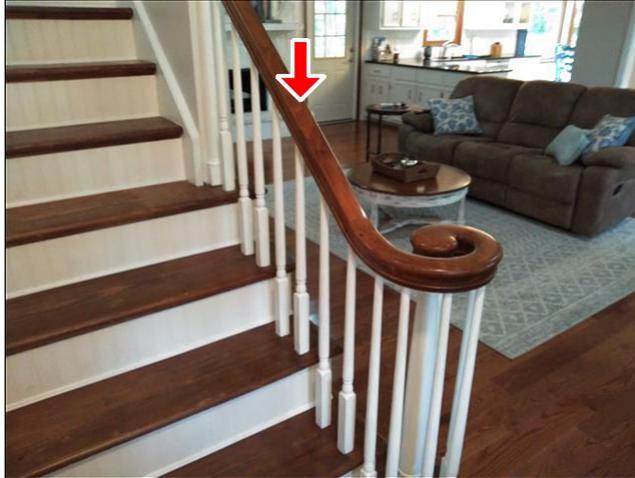
**Repair, Safety Issue:** *The railing for the main stairway is loose and unstable and needs strengthening and repair for proper safety.*

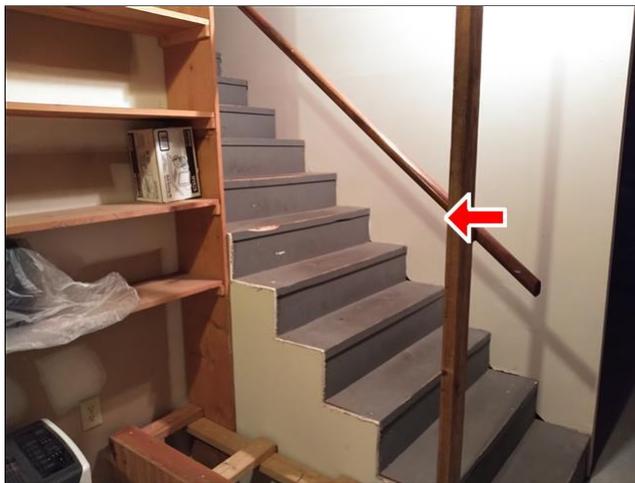
**Repair, Safety Issue:** The openings at the stairway to the basement are large enough to allow a child to fall through. This condition should be improved by adding a railing with pickets (with openings no greater than 4") as needed for proper safety.

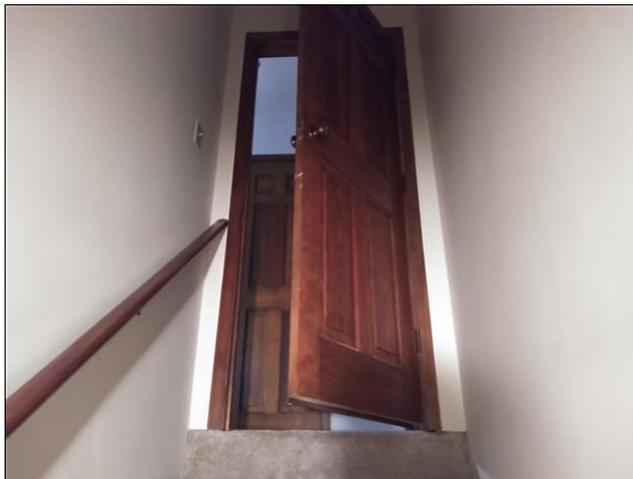
**Improve, Safety Issue:** The door at the top of the stairwell should open away from the stairs to prevent tripping hazards. It is recommended that this door be altered for improved safety.

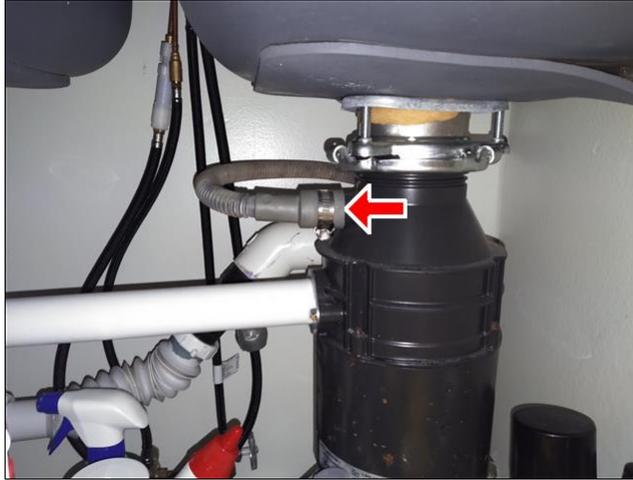
**Monitor, Improve:** The dishwasher drains into the disposal under the kitchen sink, which may cause water to back up into the sink periodically. Relocating this line to its own drain would alleviate this problem.

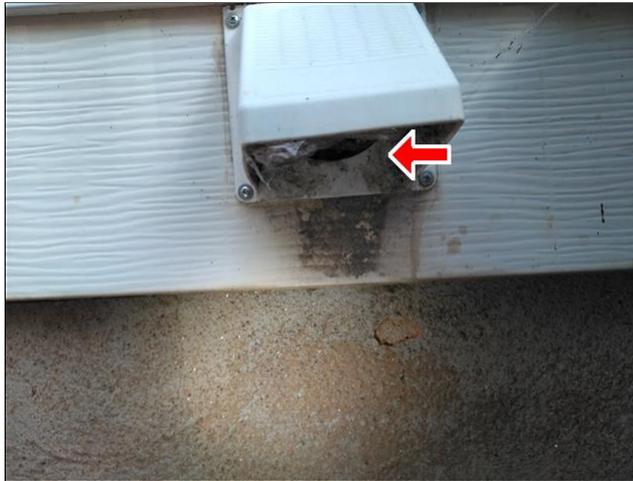
#### 10.6 Appliances: Dryer / Washing Machine

**Repair, Safety Issue:** *The clothes dryer exhaust vent pipe appears clogged with lint and should be cleaned. Blocked piping can cause damage and possible fires at the dryer element.*
