Inspection Report

1745 Hawk View Ct
Cumming GA 30041

Dana Inspection Services, Inc.

Date: 10/15/2020	Time: 01:00:00 PM	Report ID: 101520TC11
Property: 1745 Hawk View Ct Cumming GA 30041	Customer: Seamus McGrath	Real Estate Professional: ann-marie Sharp keller williams

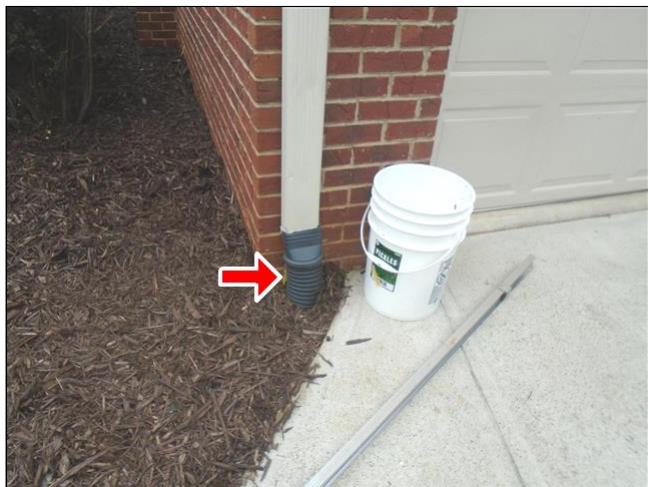
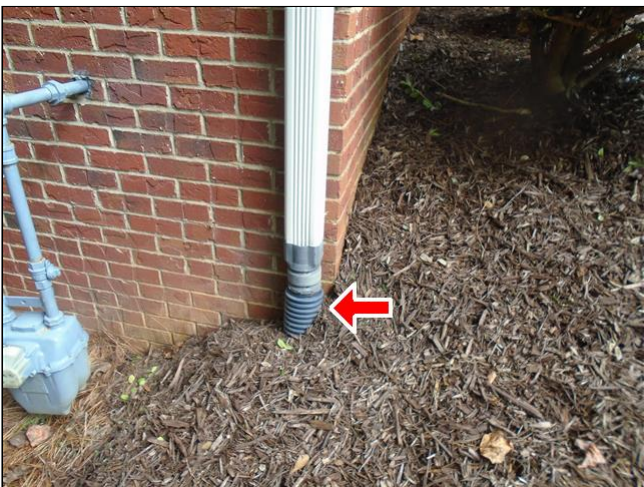
- 1
- In-ground downspout drains were observed around the house and are not tested. Monitor for signs of improper drainage during rain.

In-ground downspout drains were observed around the house and are not tested. Monitor for signs of improper drainage during rain.

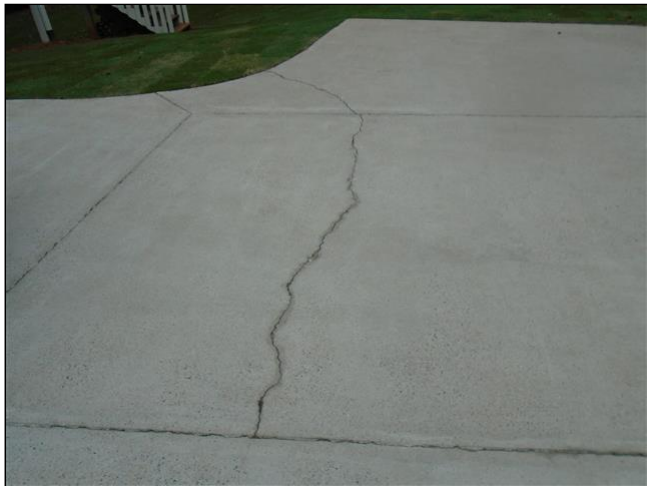
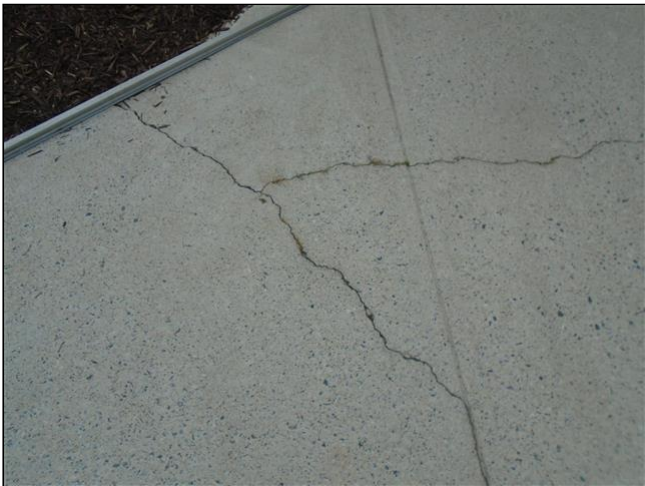
- 2
- Common settling cracks were observed on the driveway.

Common settling cracks were observed on the driveway.

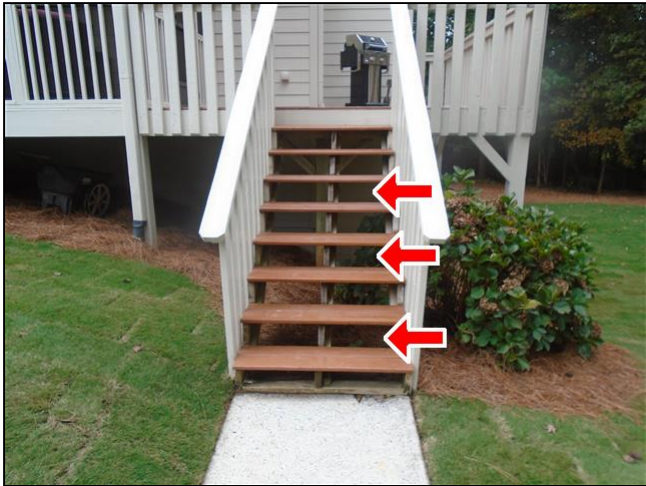
Rear of house

- 1 Gaps between the deck steps should be covered to have less than 4" exposed.

Gaps between the deck steps should be covered to have less then 4" exposed.

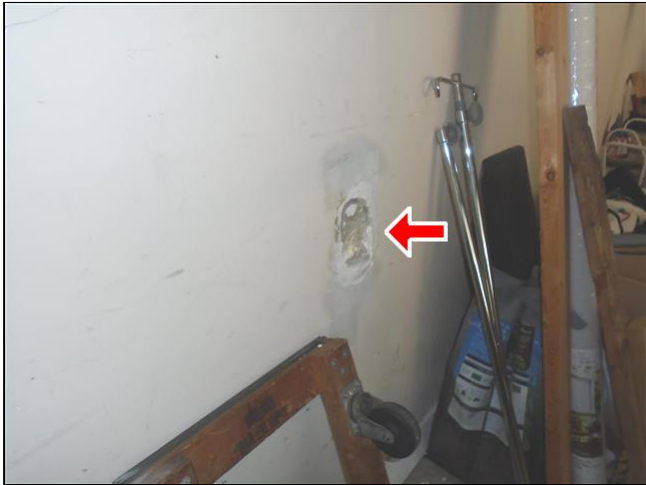
Garage

- 2 Damaged drywall was observed at the rear wall of the garage. The area did not show any signs of elevated moisture when tested. Recommend repairs as needed by a qualified contractor.

Damaged drywall was observed at the rear wall of the garage. The area did not show any signs of elevated moisture when tested. Recommend repairs as needed by a qualified contractor.

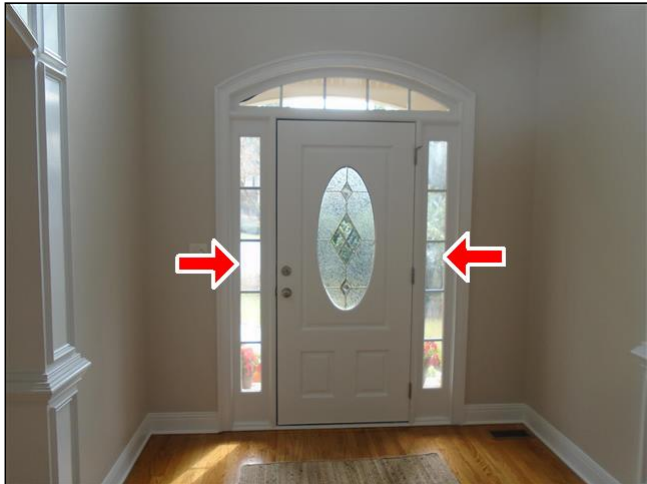
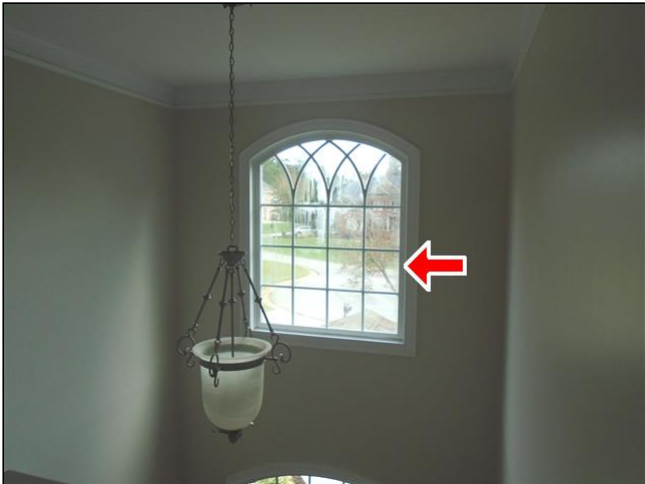
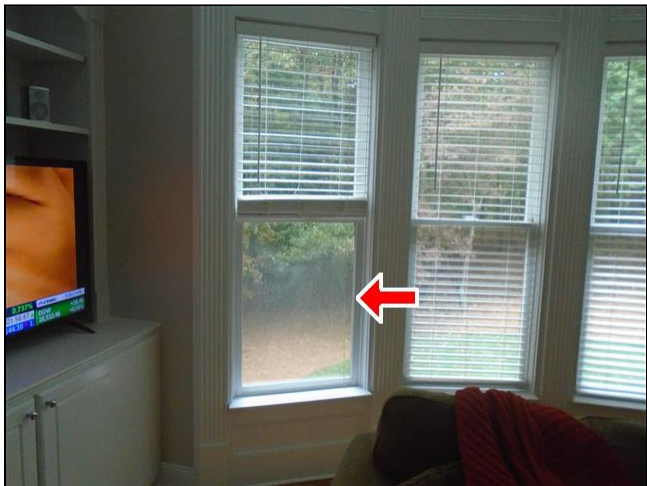
(1) Several double double-pane windows are fogging over due to a bad seal between the panes of glass. These locations include: the side lights by the front entry door, the upper fixed window in the foyer, and the left rear lower window in the great room. Have the windows further evaluated for replacement by a qualified window contractor.

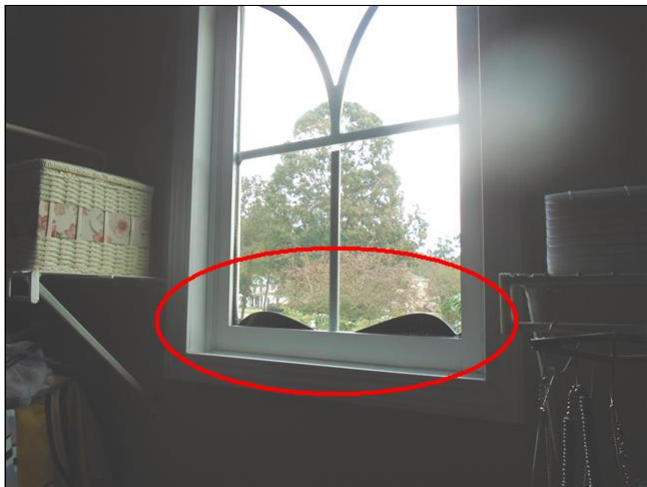
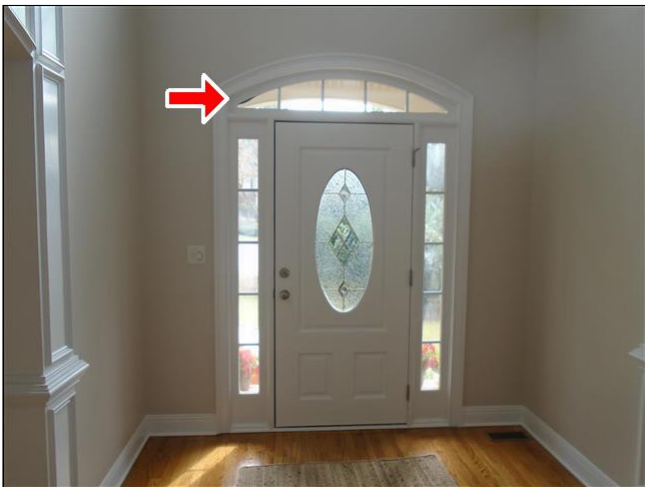
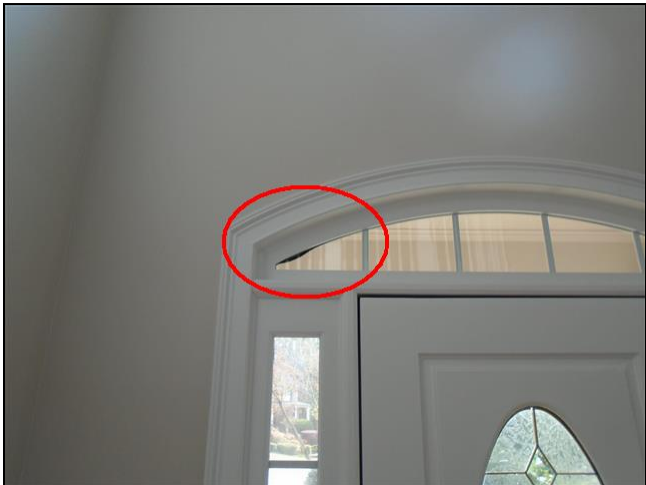
(2) Two windows were observed to have rubber seals that are loosening due to expansion and contraction. This does not affect the window other than being unsightly but can cause fogging. These locations include: the master bathroom closet and the small window above the front entry door. Have further evaluated for replacement by a qualified window contractor.

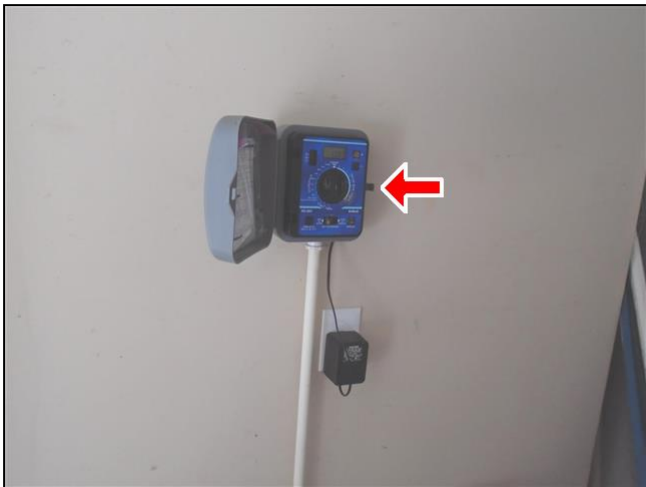
Garage

- 3 A irrigation system control panel was observed in the garage, but is a specialized component that was not tested. Contact the seller to provide information on how it operates or have evaluated by a qualified irrigation professional.

A irrigation system control panel was observed in the garage, but is a specialized component that was not tested. Contact the seller to provide information on how it operates or have evaluated by a qualified irrigation professional.

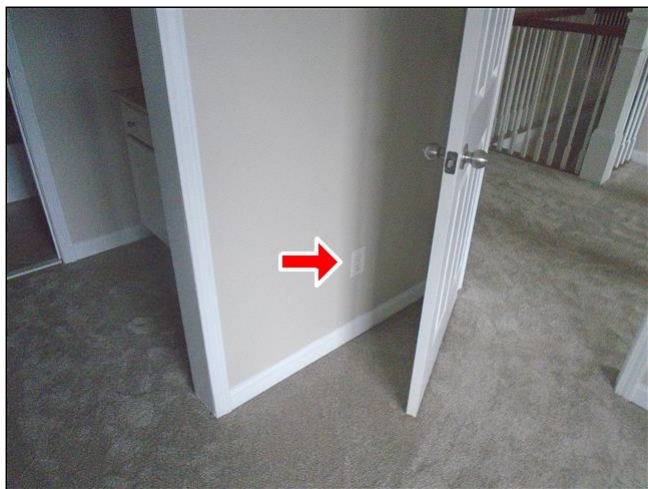
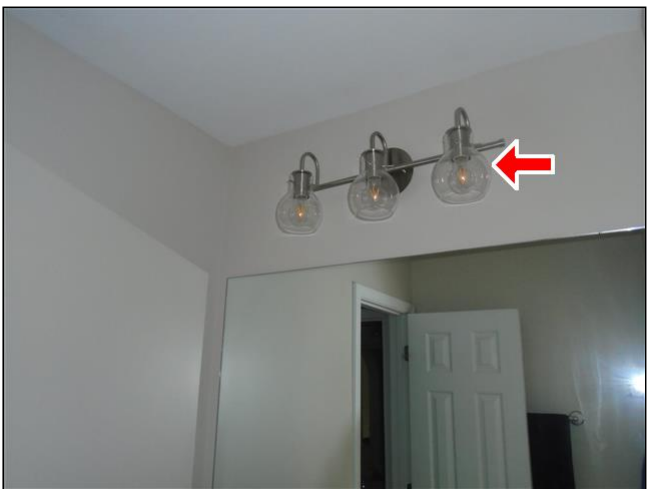
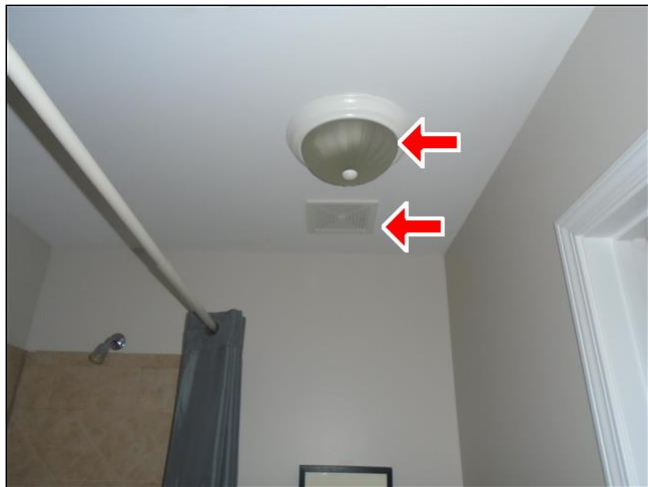
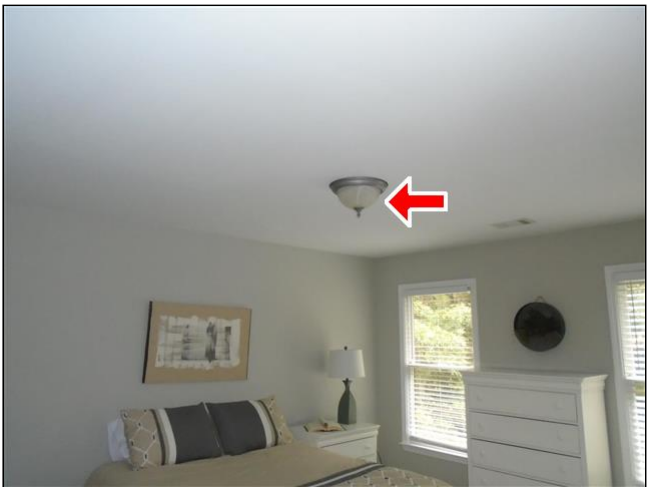
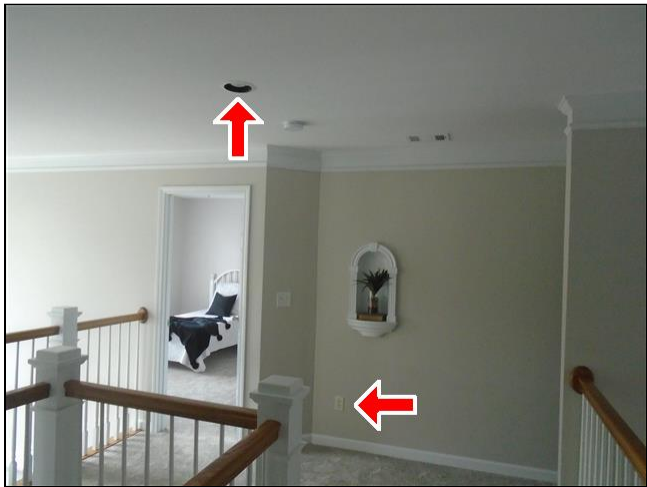
- 6 Several of the electrical outlets and lights at the left end of the 2nd floor were without power when tested. This is likely related to the arc fault breaker issues listed below. This affected the front left bedroom, the Jack-n-Jill bathroom, the left rear bedroom, and the hallway lights and an outlet.

Several of the electrical outlets and lights at the left end of the 2nd floor were without power when tested. This is likely related to the arc fault breaker issues listed below. This affected the front left bedroom, the Jack-n-Jill bathroom, the left rear bedroom, and the hallway lights and an outlet.

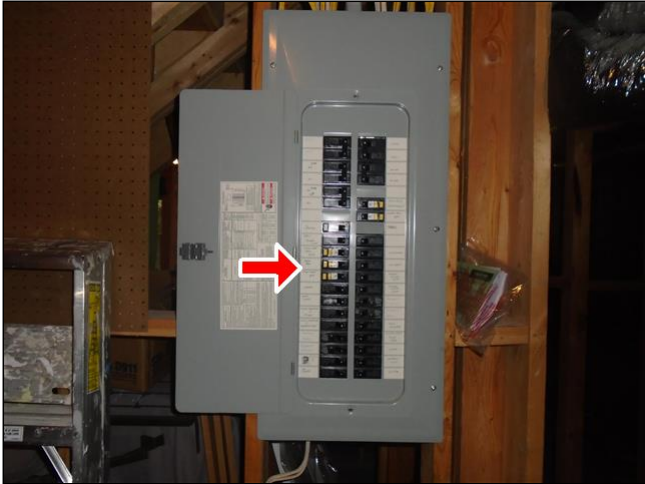
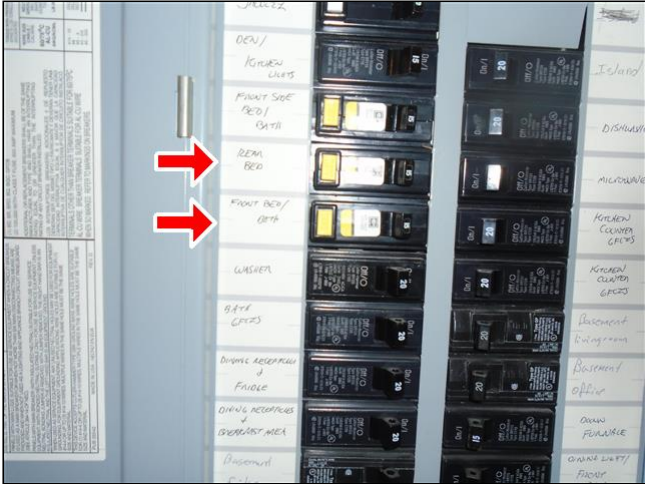
- 7 Two arc fault breakers in the electrical panel did not function properly when tested. One labelled "front bed/bath" did not trip consistently. One labelled " rear bed" tripped, but would not reset. Recommend further evaluation by a qualified electrician for replacement as needed.

Two arc fault breakers in the electrical panel did not function properly when tested. One labelled "front bed/ bath" did not trip consistently. One labelled " rear bed" tripped, but would not reset. Recommend further evaluation by a qualified electrician for replacement as needed.

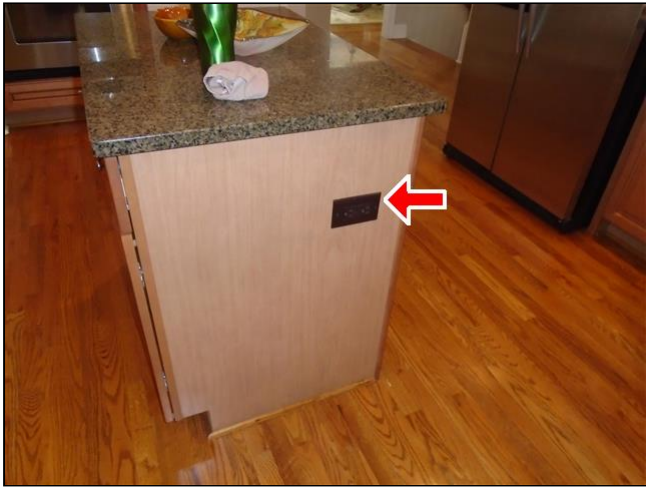
Kitchen

- 8 The kitchen island GFCI outlet no longer trips when tested, indicating that the GFCI protection is no longer operational and posing an increased safety risk. The outlet should be replaced.

The kitchen island GFCI outlet no longer trips when tested, indicating that the GFCI protection is no longer operational and posing an increased safety risk. The outlet should be replaced.

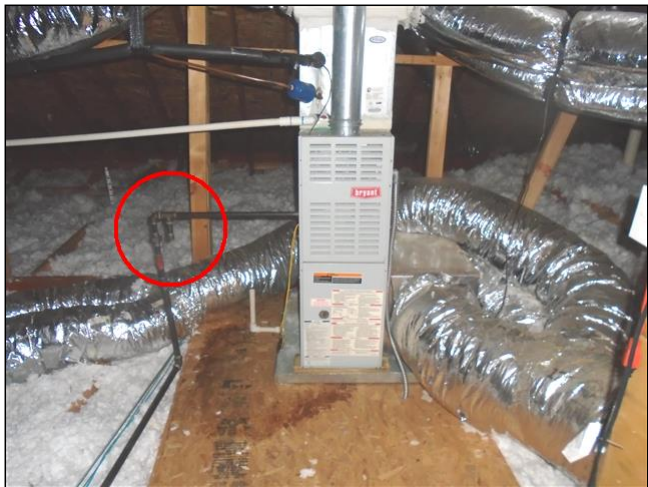
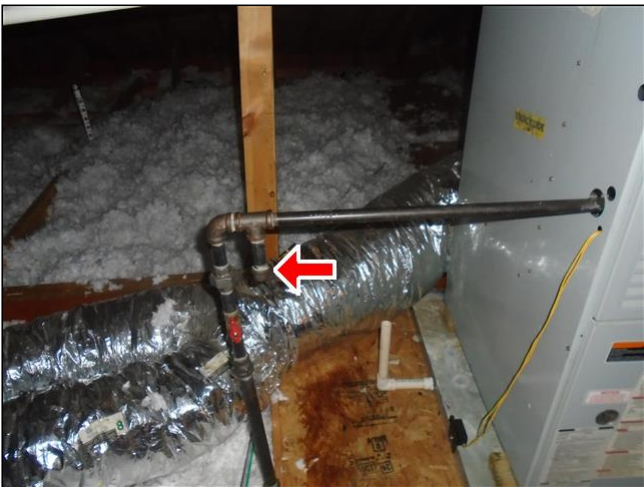
- 9 The requirement for sediment traps for gas appliances has changed since the house was built, and the existing sediment trap in the attic is no longer considered adequate. However, this will not have any negative impact and can be changed at some point in the future.

The requirement for sediment traps for gas appliances has changed since the house was built, and the existing sediment trap in the attic is no longer considered adequate. However, this will not have any negative impact and can be changed at some point in the future.

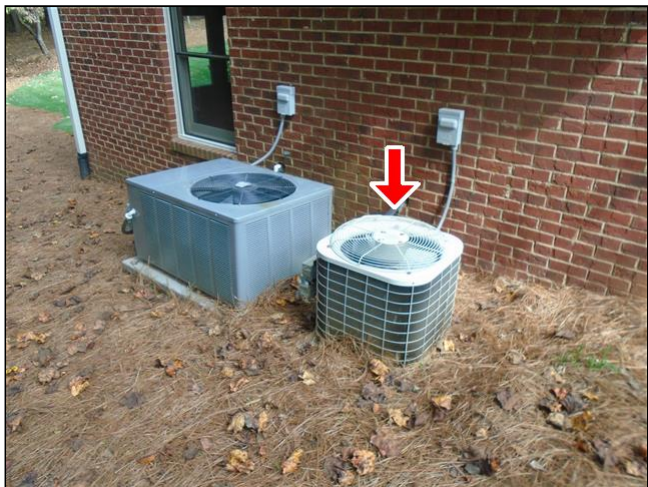
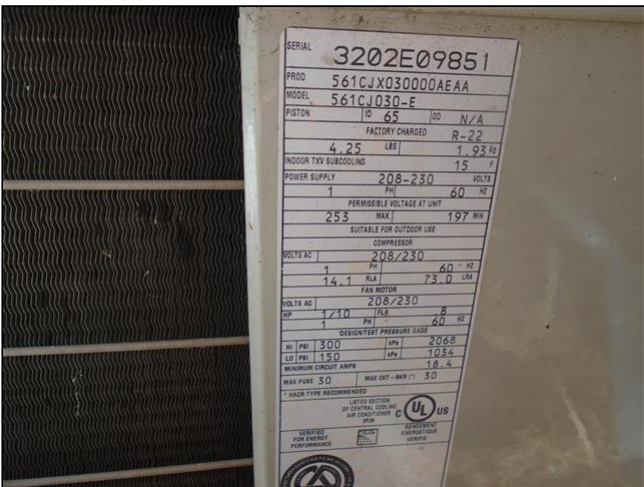
- 4 The A/C condensing unit serving the main floor level is 18 years old and at the end of its useful life. This may require repair or replacement within the next few years.

The A/C condensing unit serving the main floor level is 18 years old and at the end of its useful life. This may require repair or replacement within the next few years.

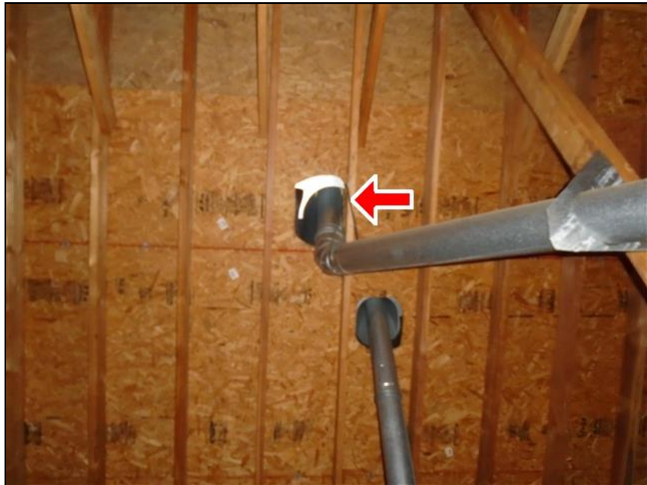
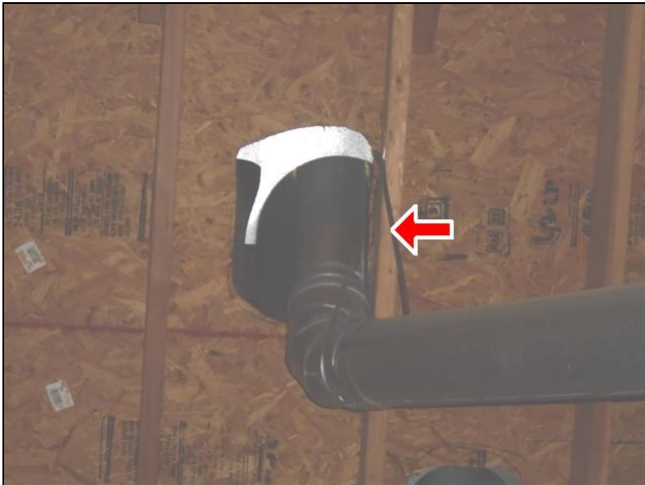
- 10 The furnace exhaust duct (from basement) is in contact with the roof decking and rafter inside attic, which is considered a fire hazard. Have repaired to have at least a 1" gap created.

The furnace exhaust duct (from basement) is in contact with the roof decking and rafter inside attic, which is considered a fire hazard. Have repaired to have at least a 1" gap created.

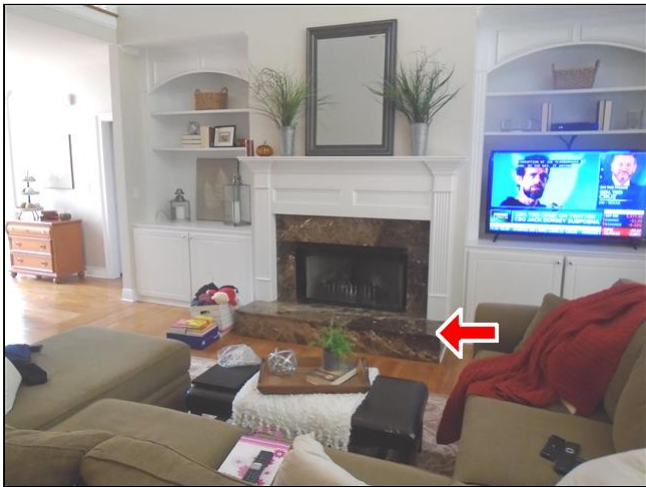
Great room

Contact the owner to confirm there is a key for the gas fireplace log lighter. The fireplace was tested for gas flow and was found to be operable.

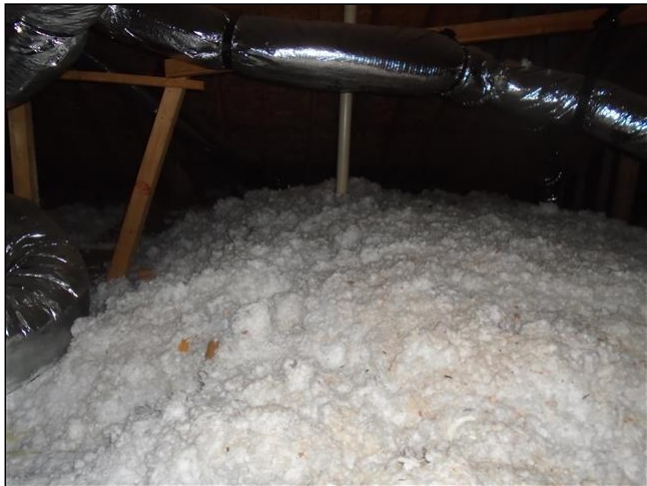
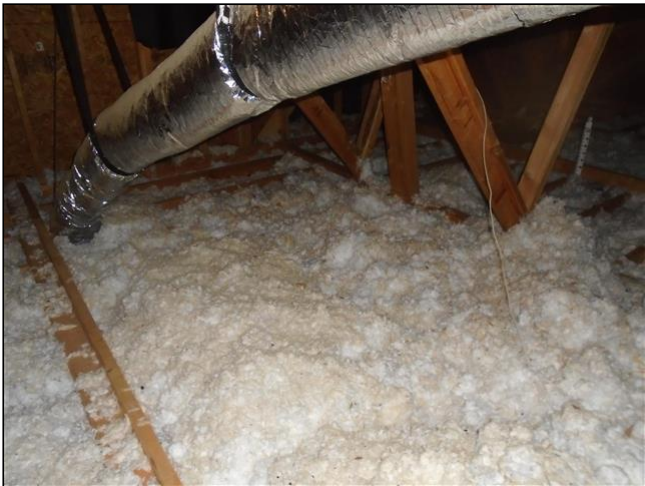
- 12 Signs of rodent burrowing were observed inside the attic insulation. Although a common problem, this should be further evaluated and treated by a qualified exterminator or wildlife control professional. The best fix for this would be having the exterior of the house sealed, which is called Exclusion.

Signs of rodent burrowing were observed inside the attic insulation. Although a common problem, this should be further evaluated and treated by a qualified exterminator or wildlife control professional. The best fix for this would be having the exterior of the house sealed, which is called Exclusion.

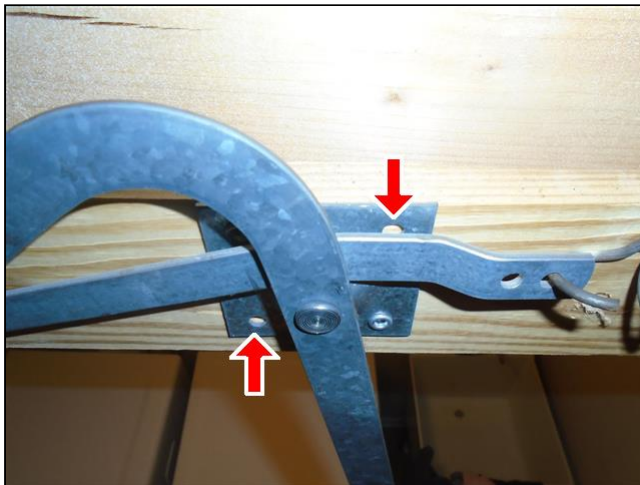
Attic ladder (example)

(1) Nails are missing at the attic ladder hinge pivot hardware.

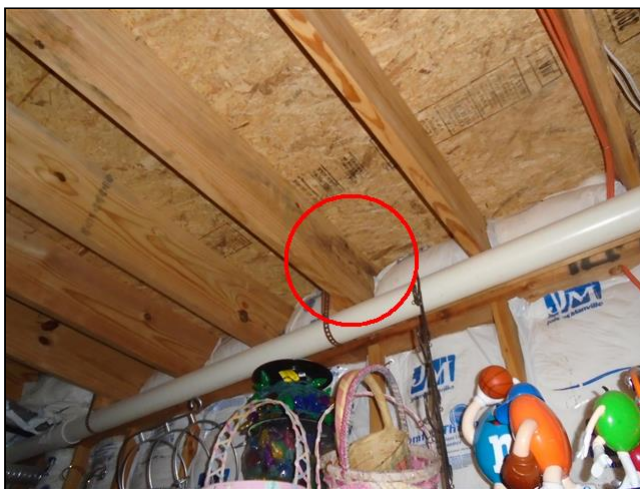
Front left basement

(2) A mold-like substance was observed on a floor joist near the front left basement. Although common, if mold is a concern for you the living space should be further tested for cross contamination by a qualified mold testing professional and removed as needed.
