The Cornerstone Inspection Group

Building Inspection Report

2170 Country Ridge Road, Alpharetta, Georgia 30004

9/15/2020

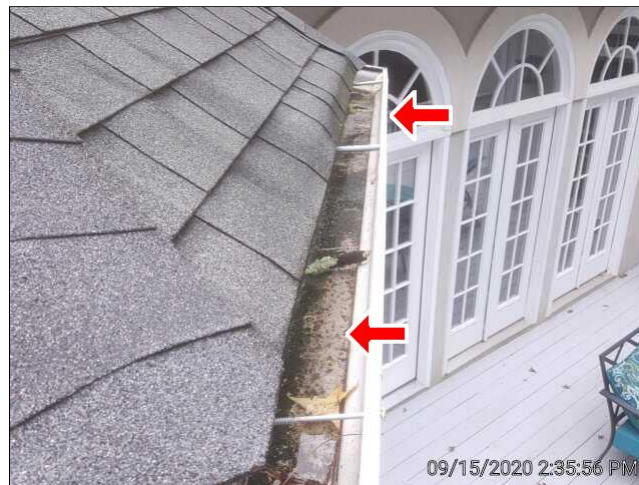
2.3 Item 1(Picture) water in gutters

Repair: The gutters and downspouts require cleaning and realignment by a qualified gutter contractor to avoid spilling roof runoff around the building and into the cornice - a potential source of water entry and damage. Debris should also be removed from the roofing to reduce the risk of leaks and early roof wear. All leaks and joints in the gutters should be caulked and sealed. All loose gutter nails should be re-driven into the fascia board. The cornice and fascia boards behind the gutters should be checked for damage. Check all underground piping, where present, for blockages to insure that they are also draining properly.

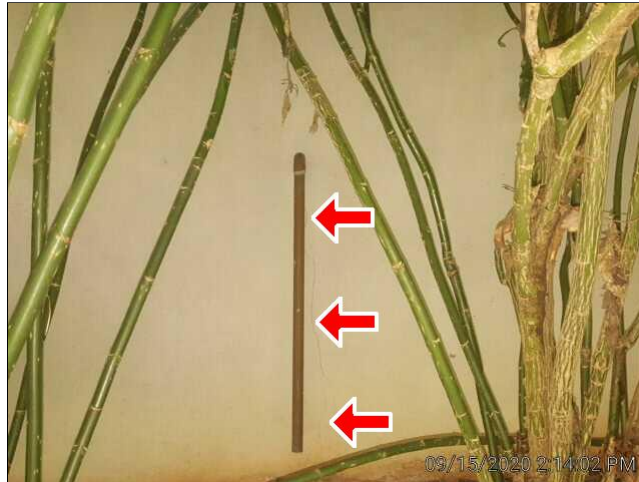
3.3 Item 4(Picture) left side

Monitor, Possible Repair: Grade contact with hard coat stucco was noted around the perimeter of the house. This condition could possibly pose a termite risk, especially if there is foam backing board behind the stucco that is touching the ground or if voids exist in the lath which can provide pathways for termites. Contact your termite exterminator to determine if repair work is required such as cutting the stucco back from the grade. Make sure your home is protected with a structural repair bond.

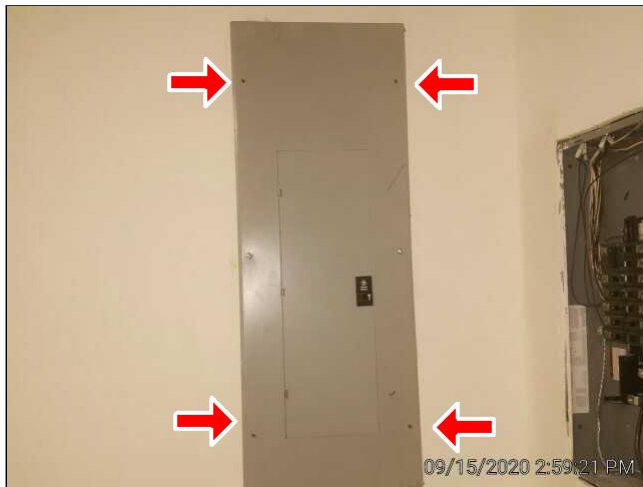
4.2 Item 5(Picture)

Monitor, Possible Repair: It appears that circuit breakers have been installed in the main electrical panel that are of a type that do not match with the manufacturer of the panel (marked with orange dots). This condition can cause the breakers to be uneven and loose, which can lead to poor electrical connections. Have the electrician assess this condition and replace all miss-matched breakers as necessary.

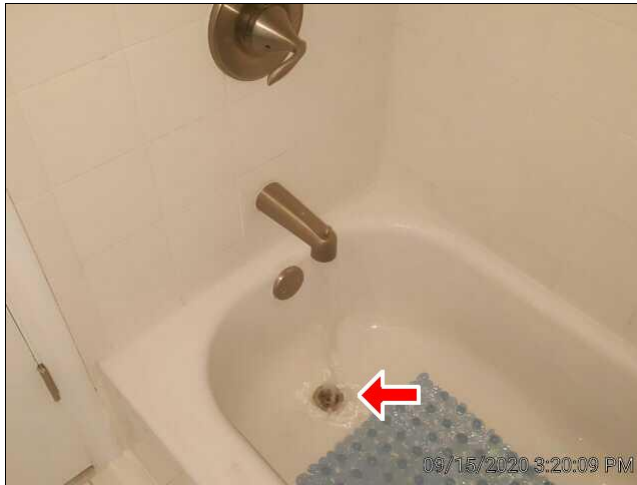
7.5 Item 2(Picture)

Repair: The tub in the master bathroom is loose at the floor. This condition may cause future leaks in the piping. The tub should be properly secured to prevent movement and damage to pipes under the tub.

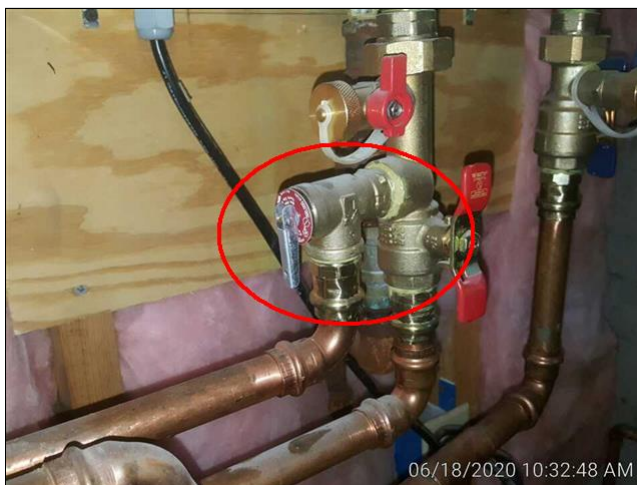
7.7 Item 1(Picture)

Monitor, Possible Repair: There was no expansion tank or valve visible near the tankless water heater located in the basement. Expansion devices are typically required to prevent the back up of hot water into the potable drinking water system and to prevent excessive pressure build-up in the piping systems. Some experts have contended that an expansion tank is not required for a tankless water heater. Recommend consulting with a qualified plumber concerning the need for this device and have installed as necessary.

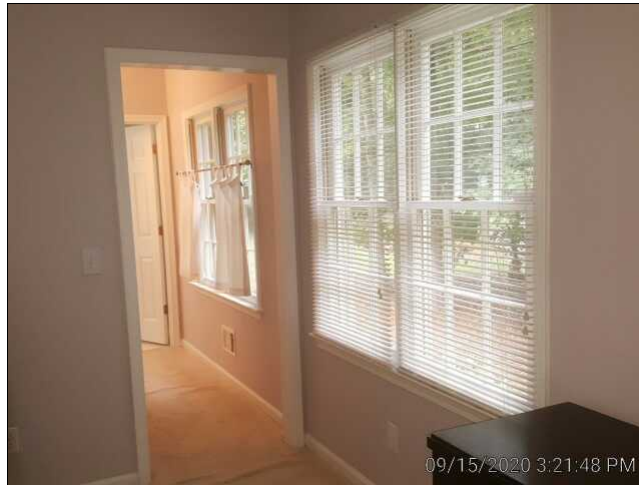
9.2 Item 3(Picture) left side bedroom

Repair: "Fogged" glass was noted, which should be replaced. This condition is typically caused by damaged seals around the perimeter of the insulated glass, which in turn allows condensation to develop between the panes. All damaged glass panels in this area should be replaced by a qualified glass replacement contractor to prevent further moisture damage to wood components and for proper visibility through the glass. The contractor should inspect all other insulated panels in the house for additional condensation that may be occurring in the glass. Other windows may be fogged but cannot be positively determined until the glass is cleaned.

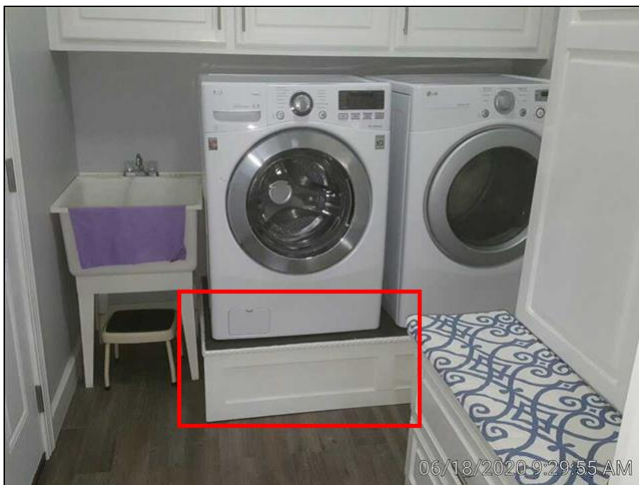
10.6 Item 1(Picture)

Improve, Safety Issue: The flexible clothes dryer exhaust vent pipe behind the dryer should be replaced with rigid smooth wall piping where possible to prevent lint build-up in the line which can cause damage and possible fires at the dryer element.
