Atlanta Property Inspections HOME INSPECTION REPORT

9610 Rod Road, Alpharetta, GA 30022

Inspection prepared for: Nick Alexander

Date of Inspection: 9/29/2020 Time: 1:30 PM

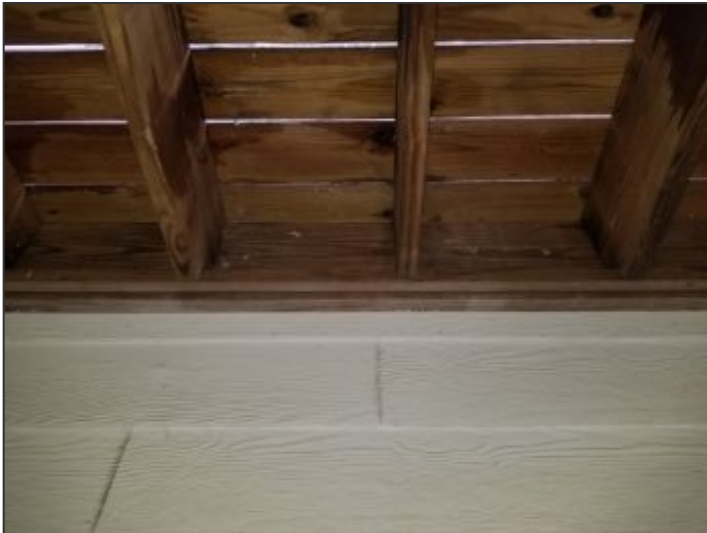
• No deck ledger flashing is visible where the right side deck attaches to the house. This flashing is required by local building code to prevent water entry into this house wall connection. Correction is recommended by a professional deck contractor so that the entire deck is fully flashed at the house wall.

Missing flashing at right side deck attachment

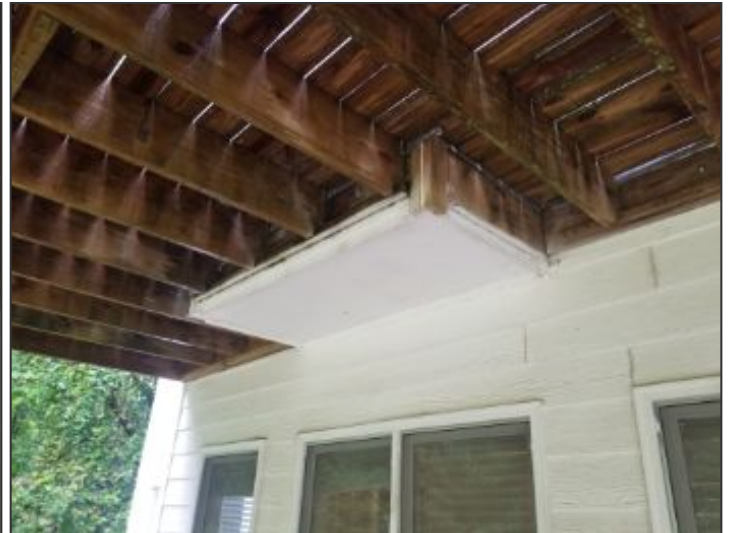
• The deck ledger board is anchored to the chimney which is no longer allowed in newer building codes; the chimney is not framed or rated for this type of structural attachment. Although there are no signs of any structural stress at this location during this limited visual inspection, it is recommended that vertical support be installed below the deck to chimney connection, to relieve the chimney of any additional future stress.

Deck attached to chimney cantilever surface

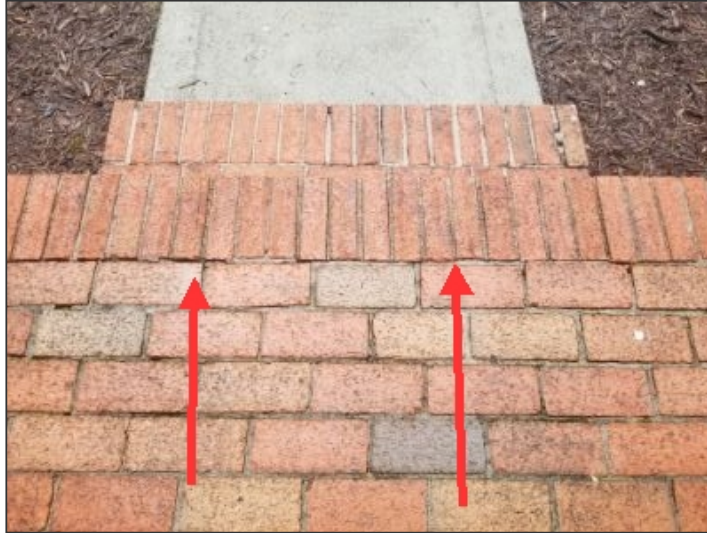
• Several loose bricks were found at the front edge of the porch (see photo). Repair is recommended to fully secure all loose bricks at the front porch.

Loose bricks at edge of front porch

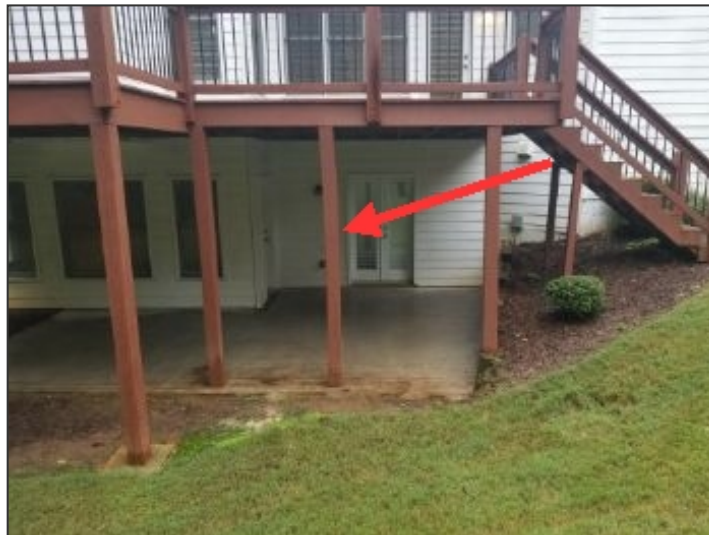
- **A support post is slightly bowed at the right side deck (see photo). Continue to monitor this support post, future replacement may be needed.**

Bowed support post at rear deck

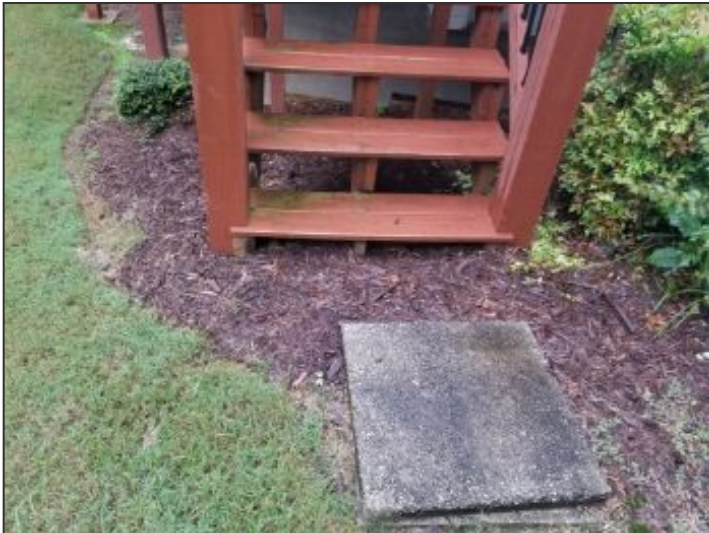
- Wood steps are present at the rear deck.
- Wood railings are present at the rear deck steps.
- The wood support posts below the deck stairs are loose and no supporting the stringers as intended (see photo). Further evaluation and repair is recommended by a professional deck contractor.
- No stairway landing is present at the bottom of the rear deck stairs as required (see photo); correction is recommended so that a minimum 3 foot landing is present on the ground.
- Inadequate support was noted below the bottom of the deck stairway; the stringers are not supported by a concrete footing as required. Correction is recommended by a professional deck or stairway contractor so that the steps are terminating onto a properly sized, poured concrete footing.

**No landing below rear deck stairs**

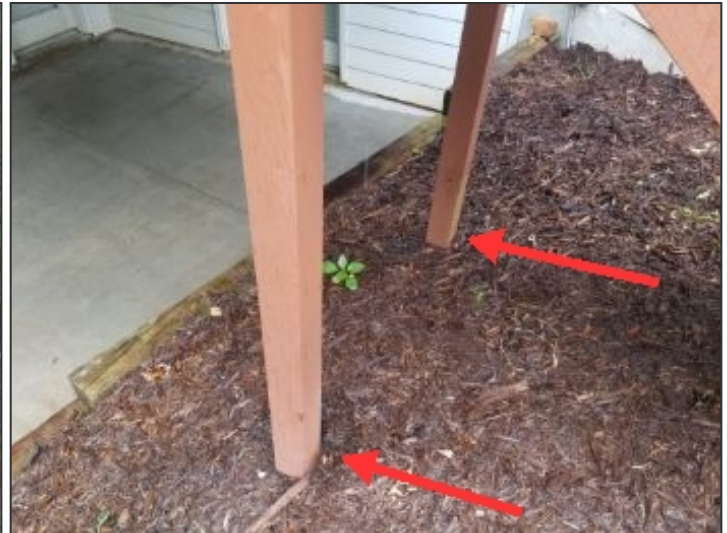
**Loose vertical support posts below stairs**

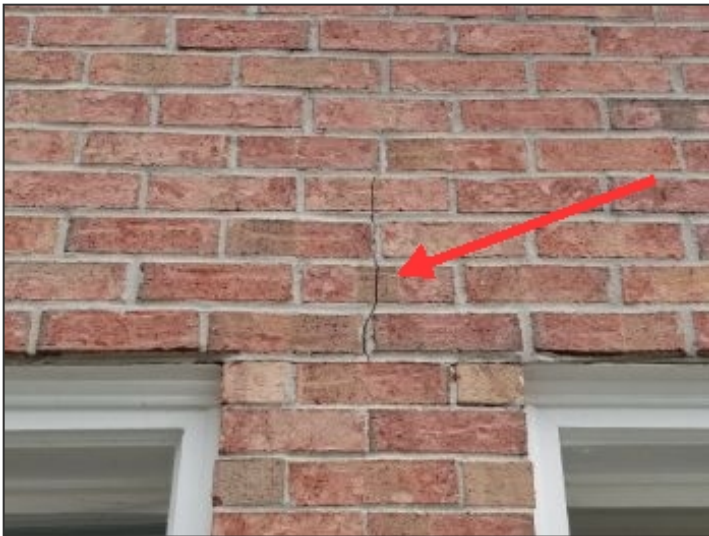
• **Minor cracks were observed in the brick veneer at the front living room / office wall, below the window, and above the center garage narrow wall (see photos). This type of crack is not considered to be structurally significant and is most often a minor concern. Continue to monitor for any changes in crack length and width, future repairs may be needed.**

Brick crack above center garage narrow wall

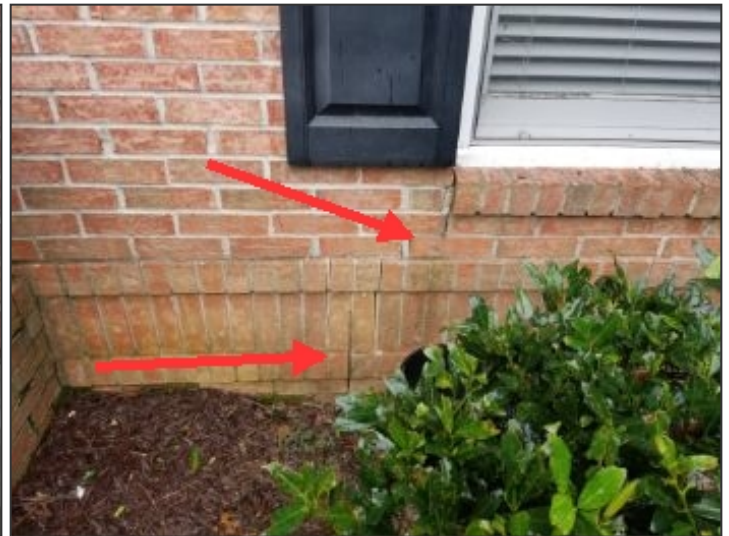
Brick crack at front living room / office window

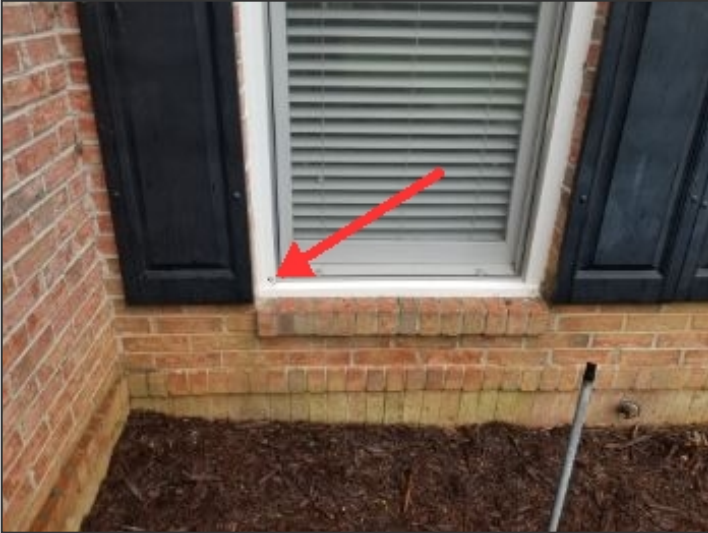
• **Damaged wood trim was noted at the following exterior locations (see photos):**

Damaged wood trim at left corner of dining room window

Replacement of the affected wood trim is recommended.

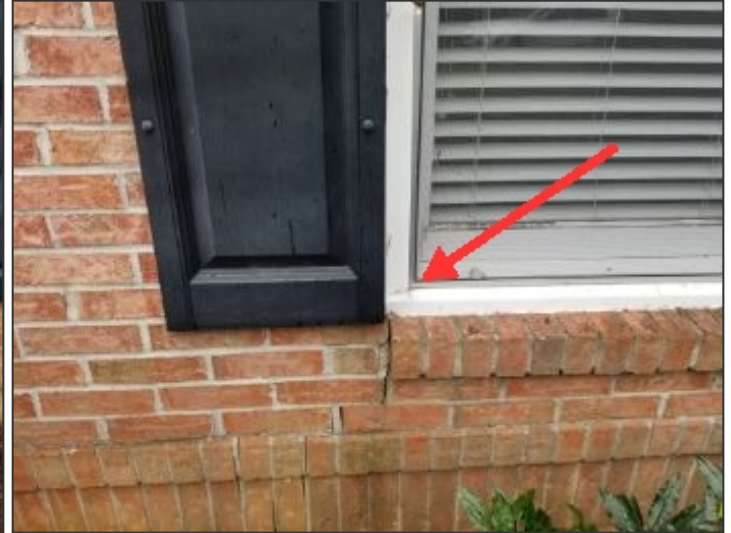
Damaged wood trim at front living room / office windows

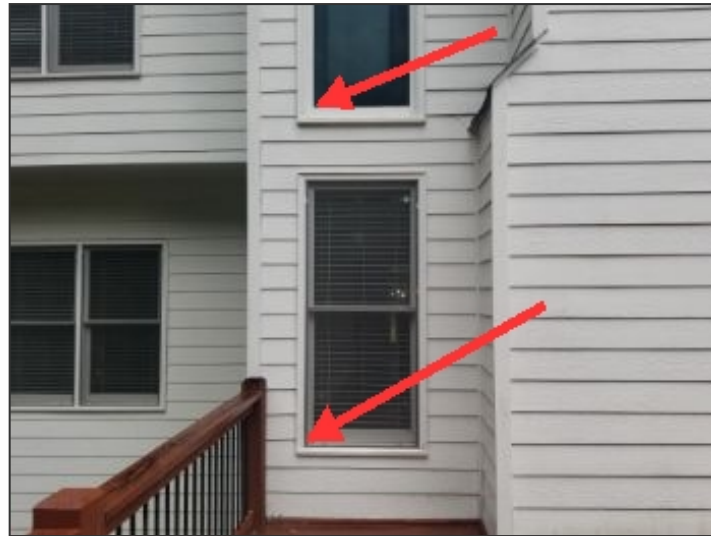
Damaged wood trim at rear family room windows

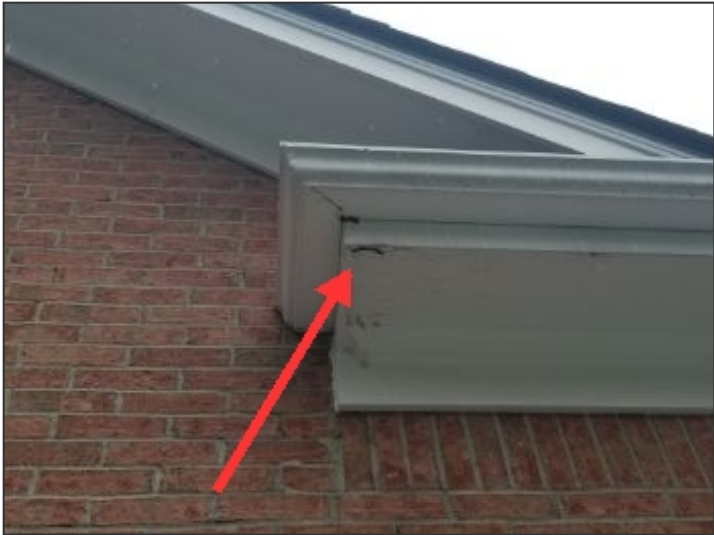
• Damaged wood was observed at the fascia board located at the left roof above the front overhead garage door and chewed fascia boards were noted at the right side roof above the AC units (see photos). Replacement of the damaged wood is recommended by a professional contractor.

Damaged fascia at left side garage roof

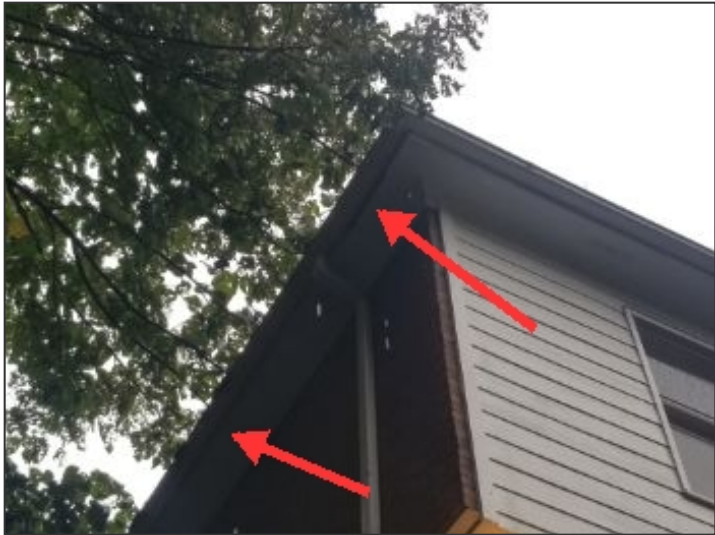
Chewed fascia boards at rear right side roof

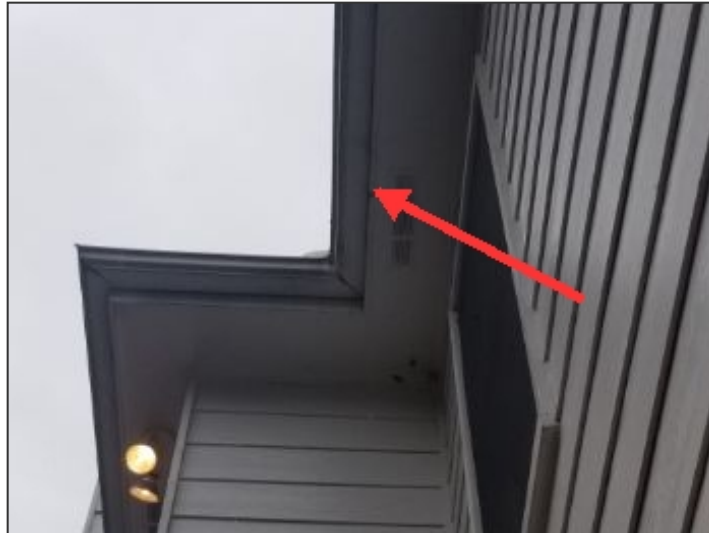
• **There are signs of improper shingle overlap into the rear gutter to the right of the chimney (see photo). Water was leaking from the fascia board behind the gutter at this location during recent rains. Further evaluation and repair is recommended by a professional roofing contractor.**

Improper shingle overlap into gutter at rear roof - water flow behind gutter

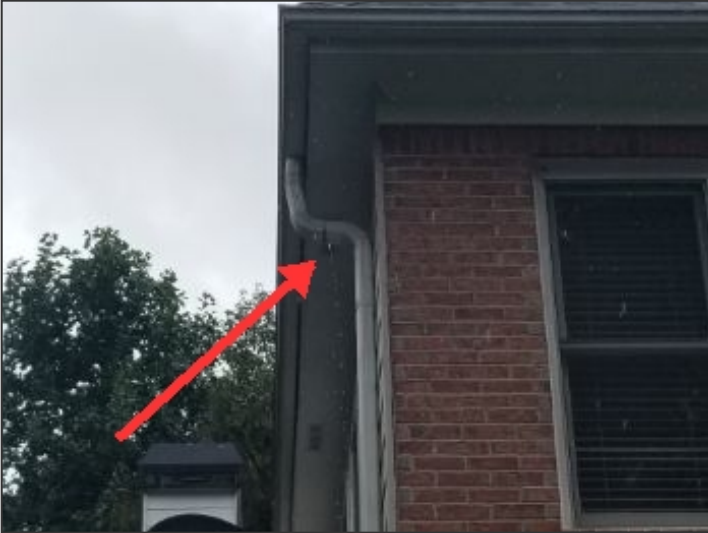
- A downspout leak was noted at the rear left master corner roof (see photo); further evaluation and repair is recommended.

Rear corner downspout actively leaking

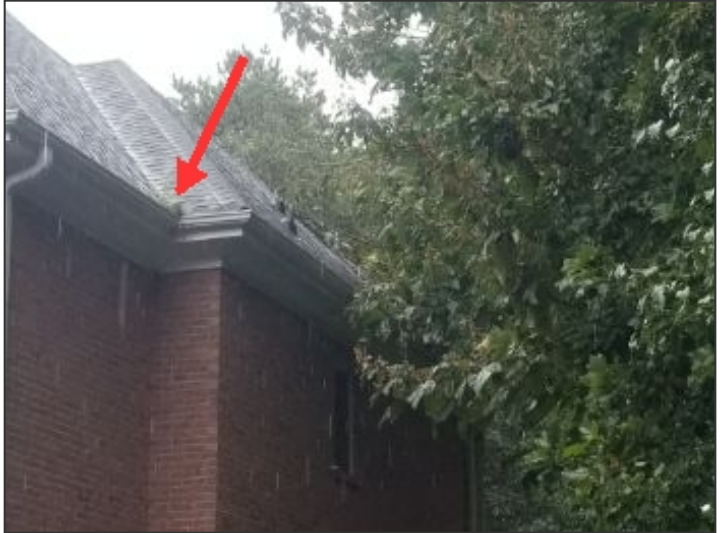
- The gutters are full of debris at the right side roof with visible vegetation growing from the gutter (see photo). Gutter cleaning is recommended so that the gutters can drain correctly.

Gutter debris at right side roof

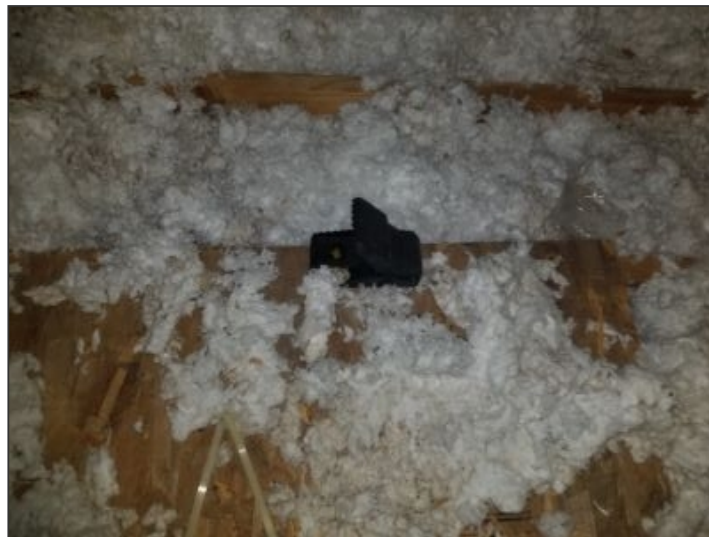
• Rodent traps were observed in the attic which is an indication of rodent activity (see photo).

Rodent traps in attic

• Due to the evidence of rodent activity noted above, it is recommended that client ask the home seller for any available disclosure information regarding rodent activity and any efforts to correct this condition. If there is no history of documented rodent exclusion work, it is recommended that further evaluation be conducted by a professional wildlife control contractor to determine the full extent of rodent exclusion needs and costs. All potential rodent entry access points should be sealed to prevent future rodent entry. In addition, any trees or tree limbs that are near the roof that may be contributing to rodent activity on the roof and in the attic should be removed. In many cases, this type of repair can develop into a major expense depending upon the amount of work needed.

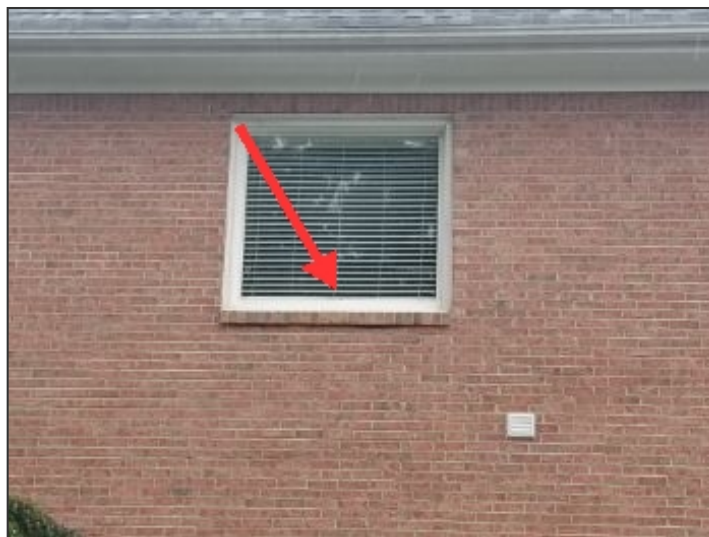
• Water damage was noted to the window frame at the foyer window, master bathroom window, and the two front living room windows (see photo). The damaged frame is difficult to repair and may require full window replacement. Further evaluation is recommended by a professional window contractor to determine the full extent of repair or replacement needs and costs.

Damaged window frame at master tub window

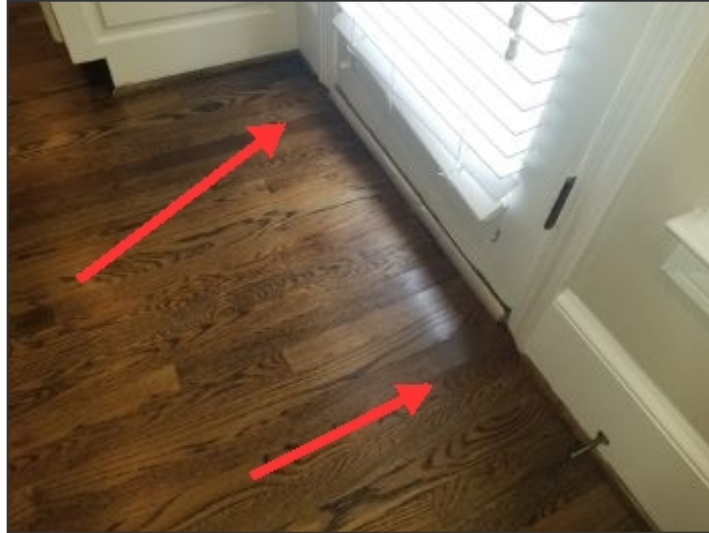
• The hardwood flooring at the deck entry, the refrigerator location, and in front of the dishwasher has suffered some minor moisture damage (see photo). This condition is most often caused by the doorway being inadequately sealed and or previous leaks at these locations. Further evaluation is recommended by a professional hardwood flooring contractor to determine the full extent of repair needs and costs - some or all of the flooring may need to be sanded and refinished which could develop into a major expense. In addition, the source of the moisture should be evaluated and corrected.

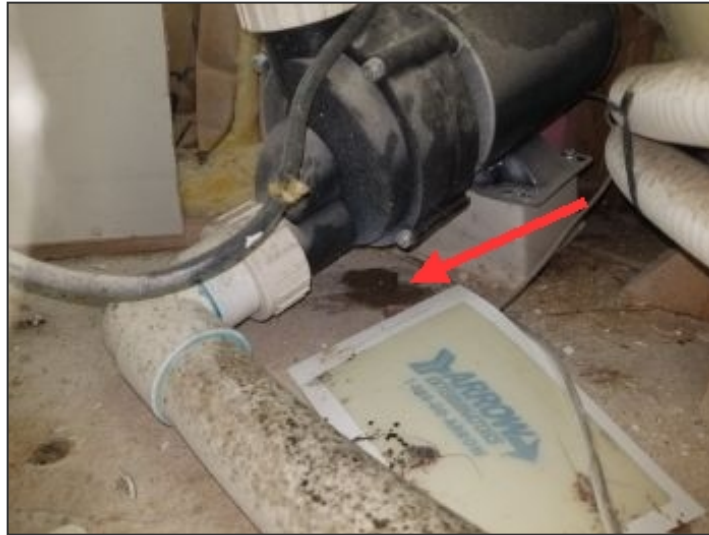
• An active leak was found at the jetted tub motor or piping (see photo). The jetted tub test was stopped. Further evaluation and repair is recommended by a professional plumber.

Active leak at master jetter tub motor during testing

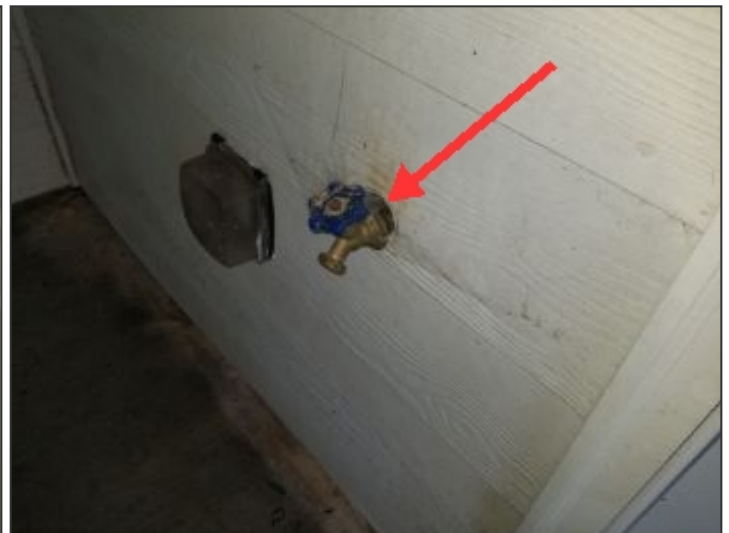
- A loose and unsealed hose bib was found at the rear basement patio wall (see photo). Correction is recommended to fully secure and seal the hose bib to the exterior wall.

Loose and unsealed hose bib at rear basement wall

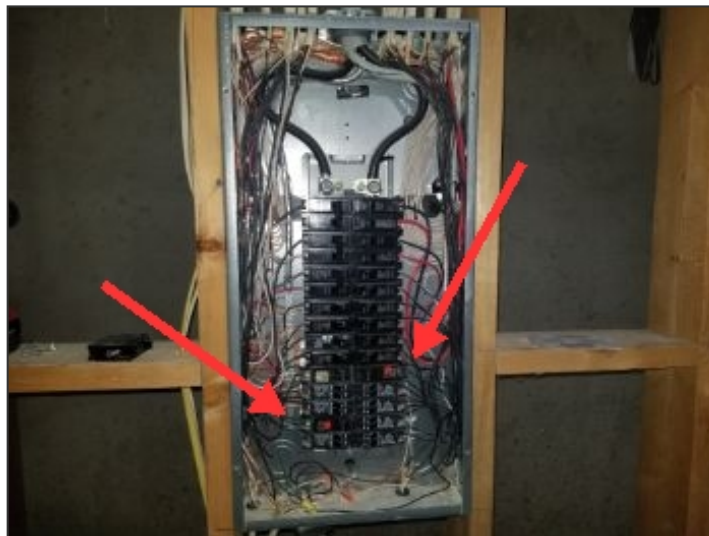
• Improper wiring was noted at the three of the lower tandem 20 amp circuit breakers and is indicated by red stickers. The circuits incorrectly have 14 gauge wires which does not meet the safety requirements of the National Electric Code. The minimum wire size for 20 amp circuits is a 12 gauge wire. Further evaluation and correction is advised by a licensed electrician to meet the safety requirements of the NEC.

Improper wire size at breakers inside panel box

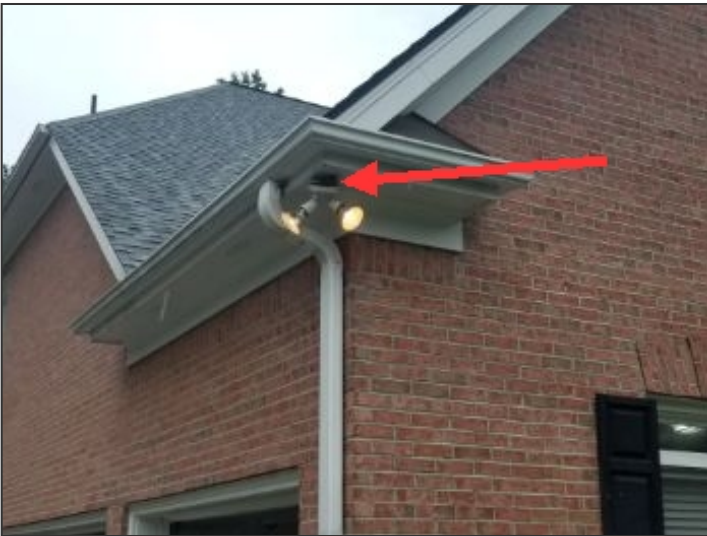
• A loose and hanging light fixture was noted at the front garage corner roof (see photo); repair is recommended to fully secure the loose light.

Loose light fixture at front garage corner roof

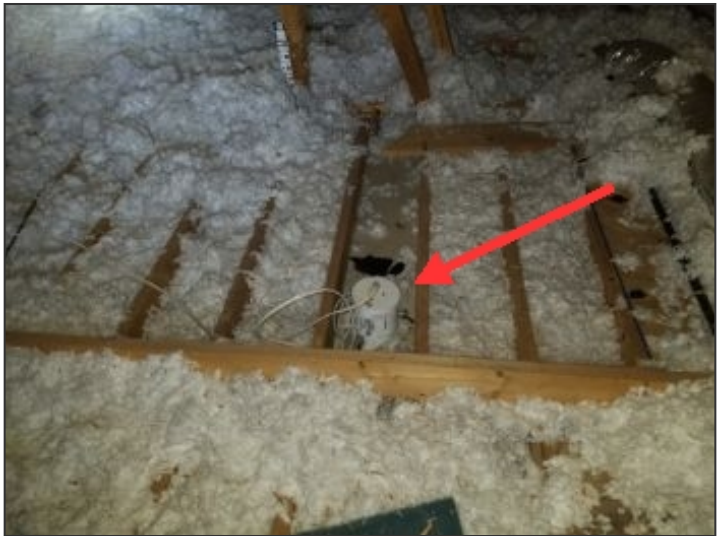
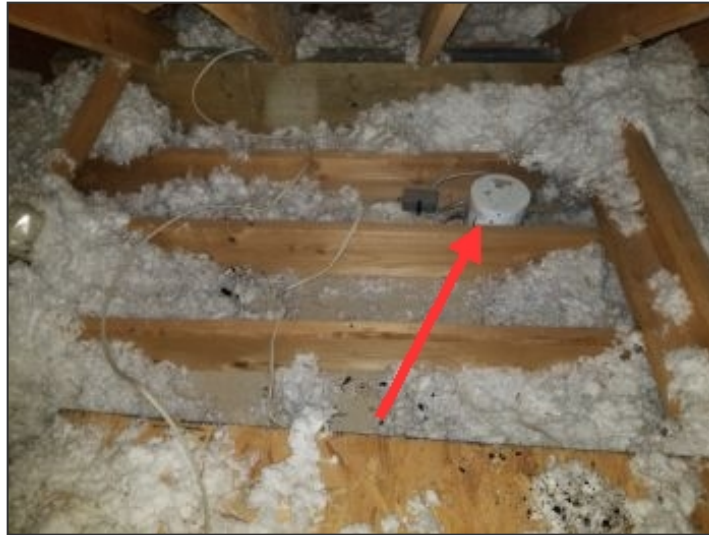
• Incorrect electrical was noted at two of the recessed lights in the attic floor (see photo) - the lights do not appear to be rated for insulation contact in attic installations (Type I/C). Some of the light fixtures have a printed label listing a fire / heat warning requiring a 3 inch clearance between the light and the insulation to prevent the light from overheating (most recessed lights now have a built-in cut off feature when the light overheats causing the light to turn off). This is the incorrect type of light fixture for this attic location. If recessed lights are to be installed in the attic, they must be IC type which are double walled and rated for insulation contact. Two repair options are available: 1. Replace the existing lights with the correct I/C type that will not overheat OR 2. Install a metal baffle around the perimeter of the light so that insulation can be moved up against the baffle without light fixture contact.

Improper can lights in attic floor above family room

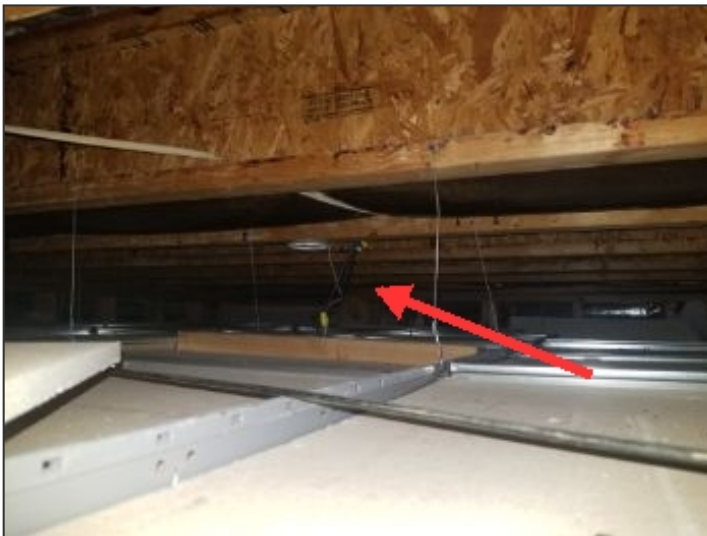
• **Incorrect Electrical:** Exposed wire splices were found in the basement drop ceiling above the fan locations (see photos). The wiring splice is required by the National Electric Code (NEC) to be enclosed in a properly sized and covered junction box for fire safety. Correction is recommended to meet the safety requirements of the NEC.

Exposed wire splice above rear basement ceiling fan

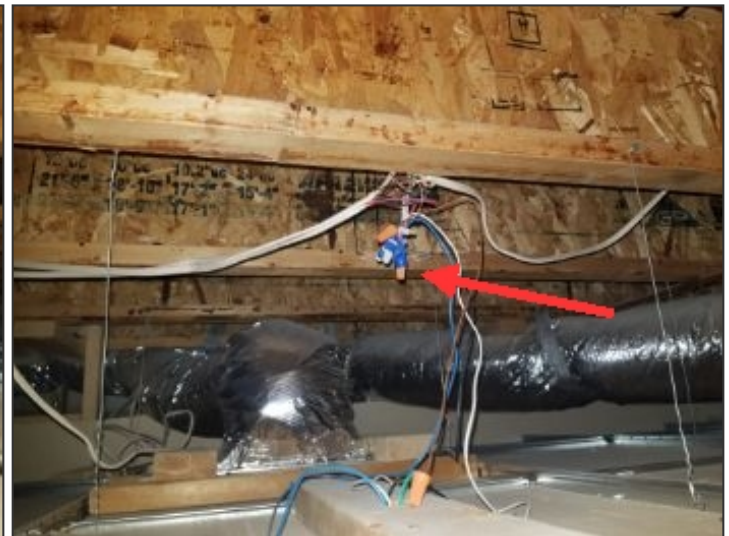
Exposed wire splice above front basement ceiling fan

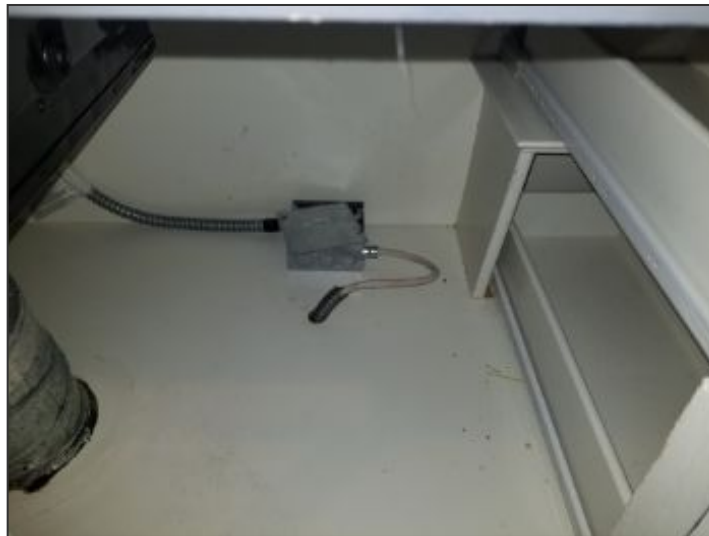
• A floor mounted junction box has been installed inside the kitchen cabinet below the cooktop which is not recommended (see photo). This condition can allow water to enter the junction box if a leak or spill occurs creating an unsafe condition. It is recommended that junction box be relocated to the side wall of the cabinet instead. Correction is advised by a licensed electrician.

Floored junction box below cooktop
