Home Inspection Report

90 Foxridge Ct
Marietta, GA 30067

INSPECTION REPORT SUMMARY

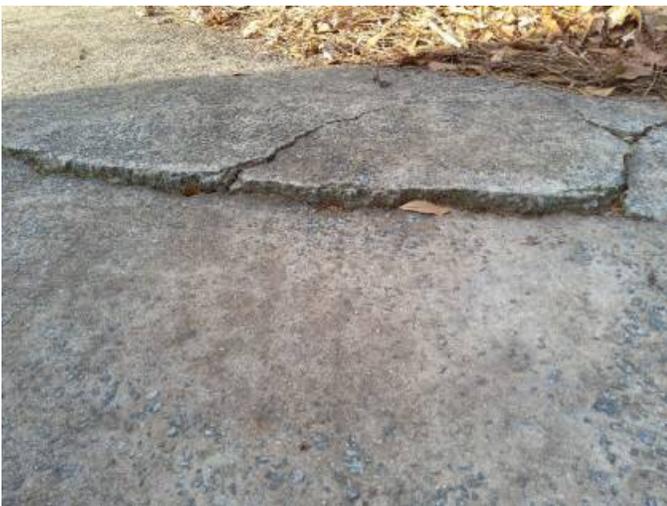
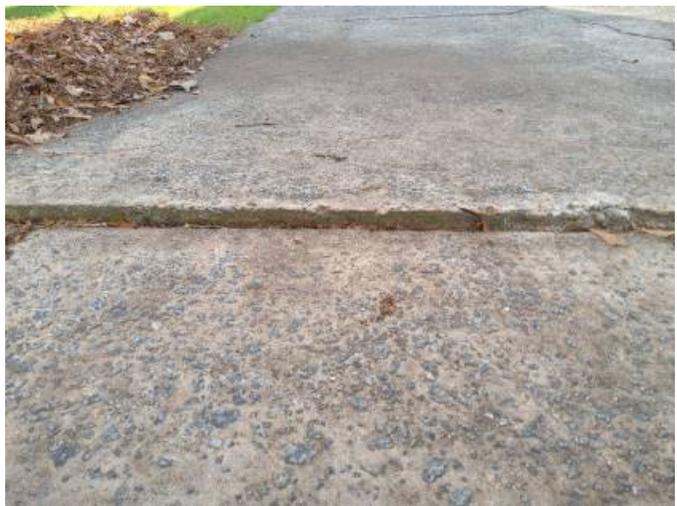
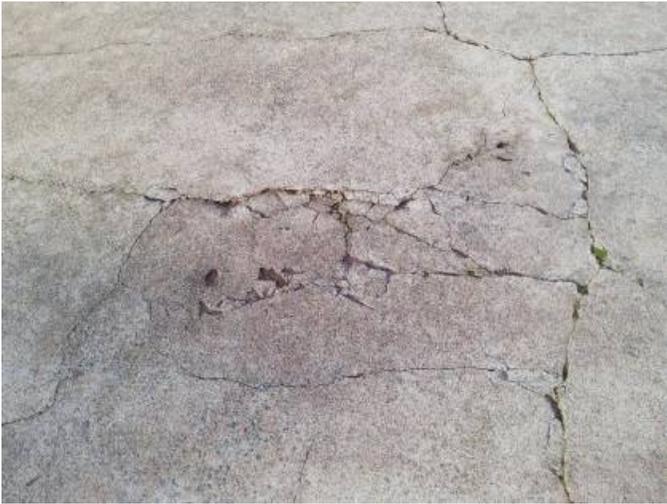
1. - There is heaving or settling in the driveway. This creates a trip hazard. Repair is recommended for safety.

Driveway Condition: **Action** - There is heaving or settling in the driveway. This creates a trip hazard. Repair is recommended for safety.

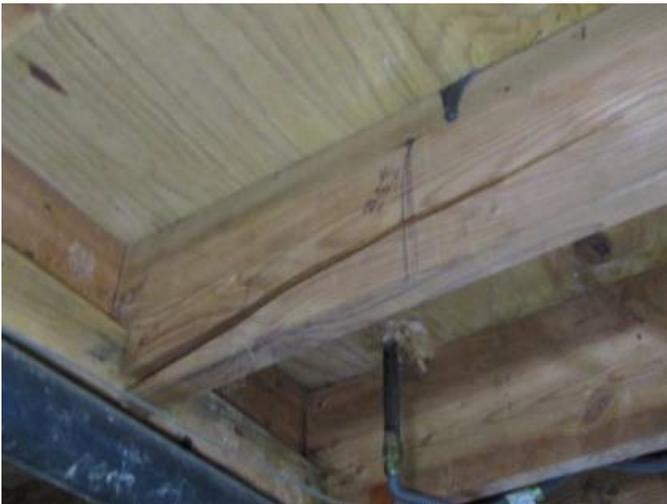
2. - There is a cracked floor joist in the right rear of the basement. Recommend repair by a qualified contractor.

Framing Condition: **Action** - There is a cracked floor joist in the right rear of the basement. Recommend repair by a qualified contractor.

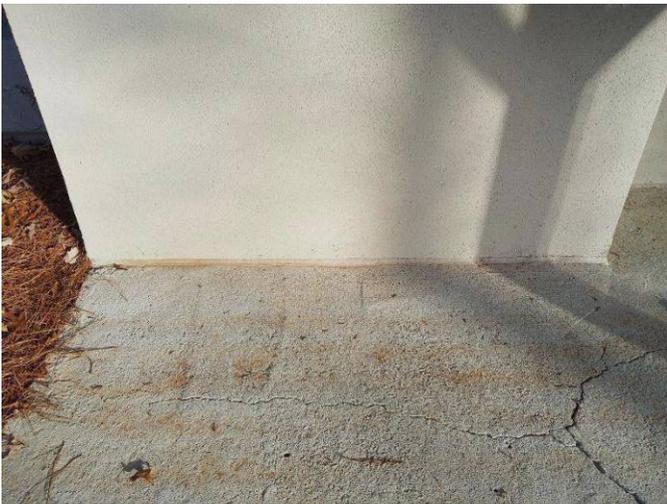
Siding Condition: **Action** - The foam board behind the stucco siding is in contact with the ground on the rear of the chimney.
- Some of the joints where wood trim meets the stucco siding have gaps in the caulk.
- There is not a flashing above the garage door trim.
- Repairs were noted at several areas of the stucco siding.
- There are water stains on the basement ceiling at several locations.
Not all locations are listed here or are shown below. Recommend having the stucco siding evaluated by a qualified stucco contractor or stucco inspector. Repair and seal as needed.

the foam goes all the way to the bottom

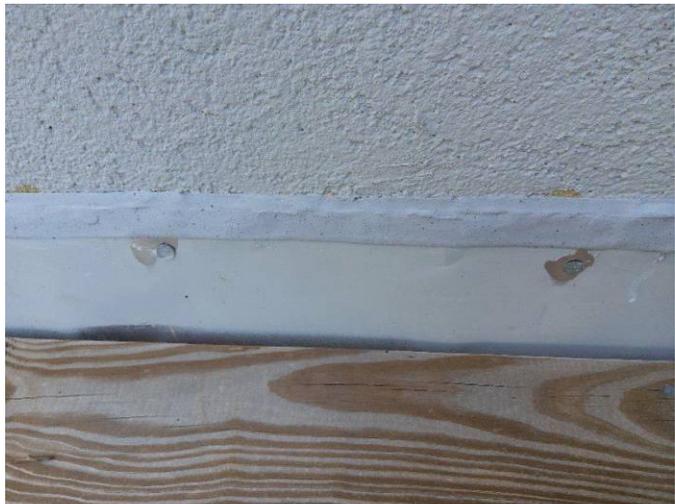
nail heads on the flashing are not sealed

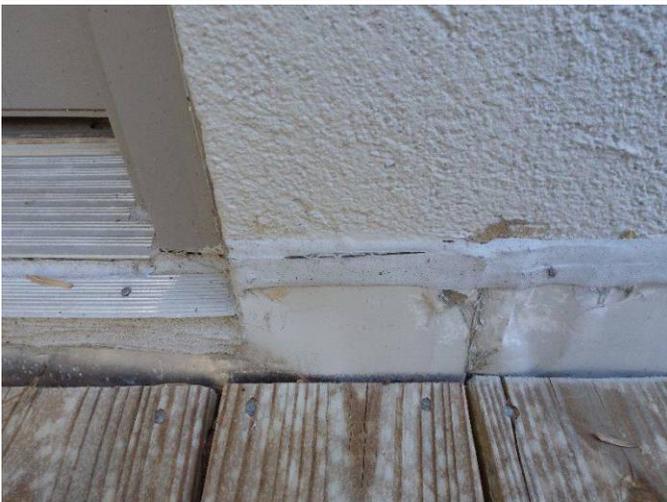
gaps in the caulking at the deck

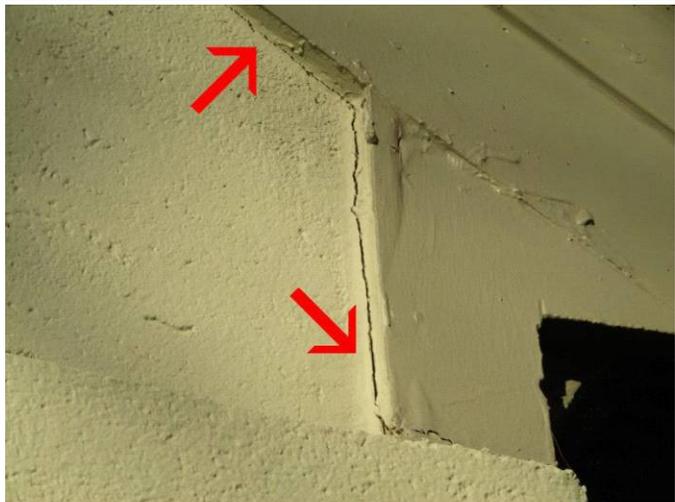
example of gaps in the caulking

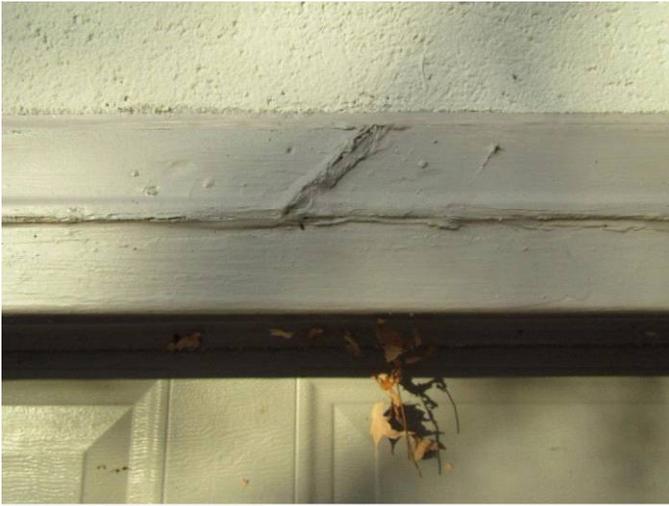
no flashing above the garage door

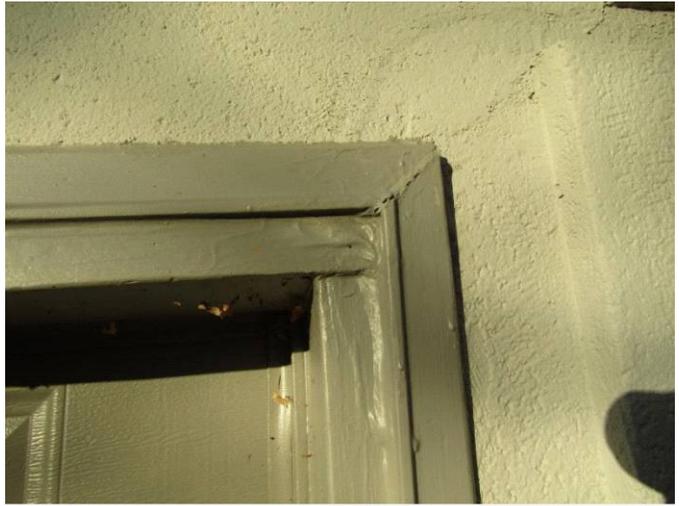
the garage door trim is deteriorating

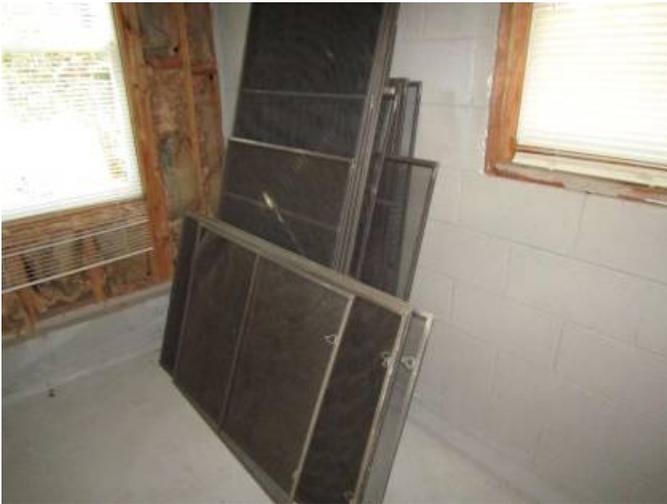
Comments: **Attention** - The window screens are not installed. I could not determine if all are present and in good condition.

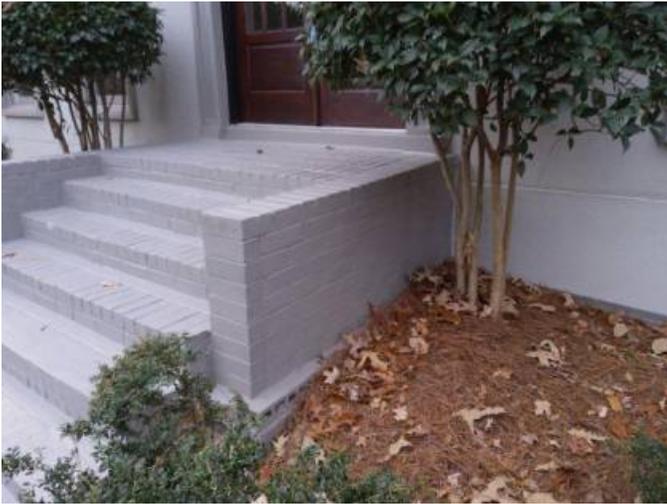
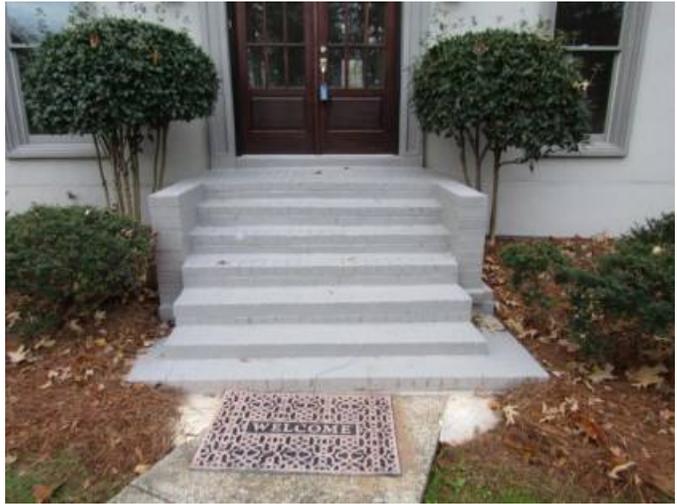
Railings: **Attention** - There are no railings on the front porch. This was not required at the time the home was built. However, because the height above ground is over 30", railings are recommended for safety.
- There is not a handrail on the front porch stairs. Stairways with four or more risers should have a handrail installed for safety. This was not required at the time the home was built. Recommend installing a railing for safety.

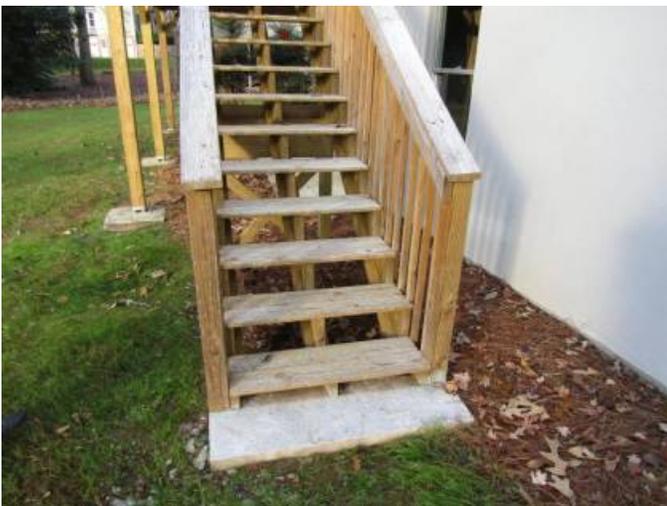
- There is not a graspable railing on the deck stairway. A graspable railing is required on at least one side.
- There is not a proper landing at the bottom of the deck stairway. The landing should be flat and level, the same width as the stairway and 36" long in the direction of travel. Repair by a qualified contractor is recommended for safety.

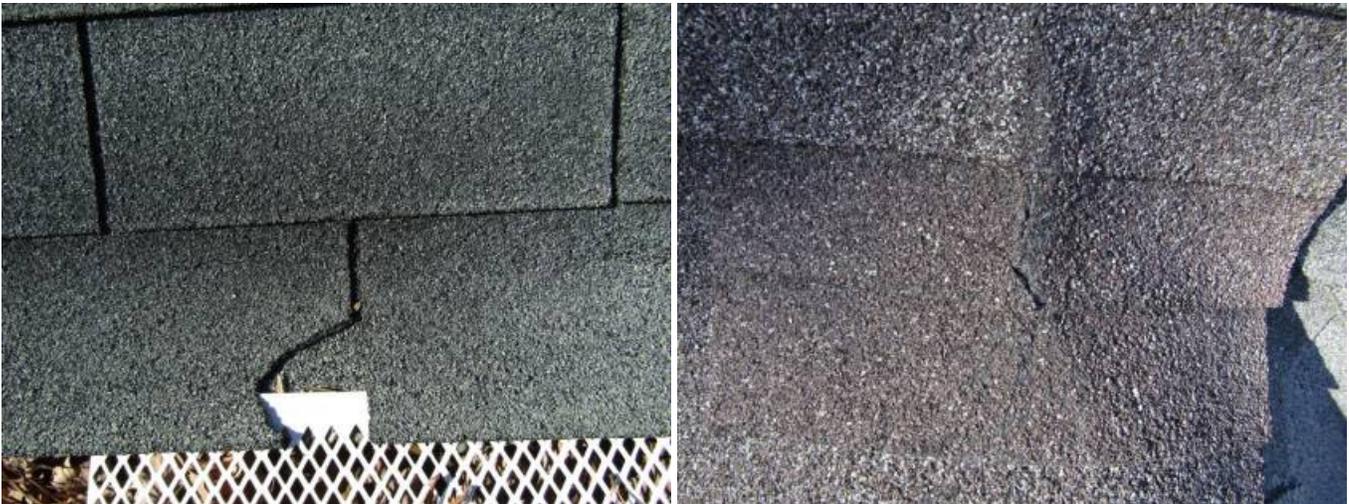
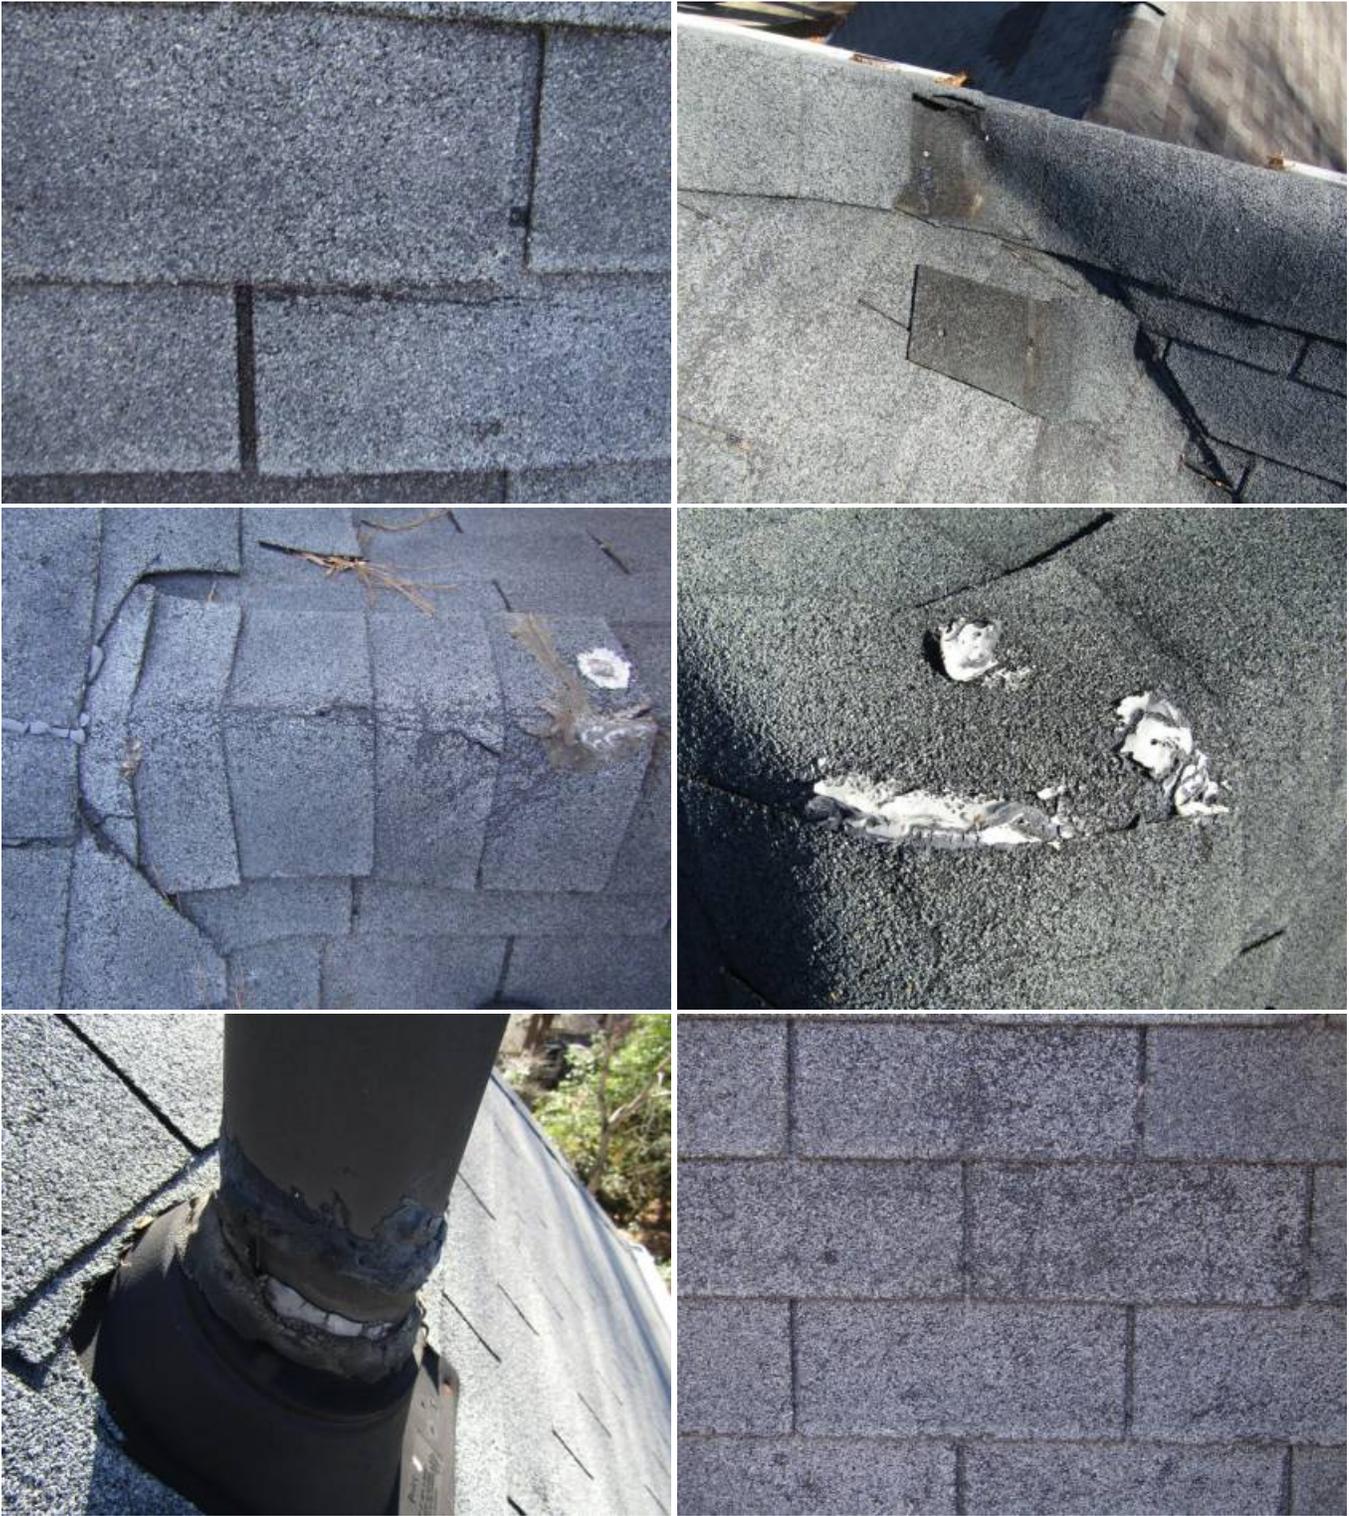
Condition of Roof: **Action** - Damaged shingles were noted at the several locations.
- There are gaps in the sealant at the vent penetrations.
- There is water staining in several locations of the attic.
Not all locations are shown below. Recommend having a licensed roofing contractor evaluate the roofing system and repair as needed.
Budget for replacement of the roofing within the next 3 to 5 years.

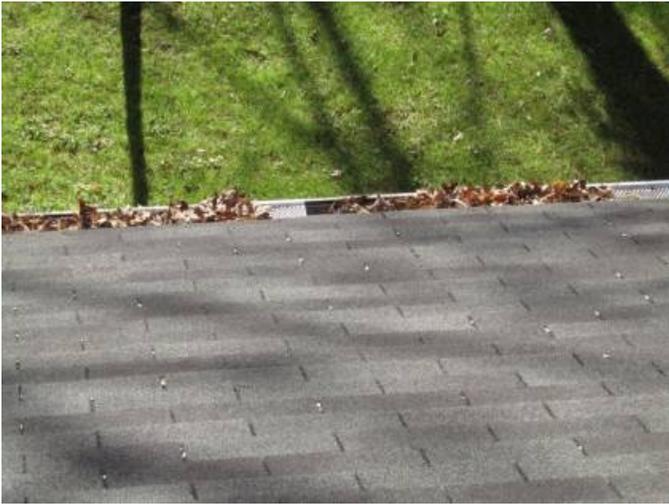
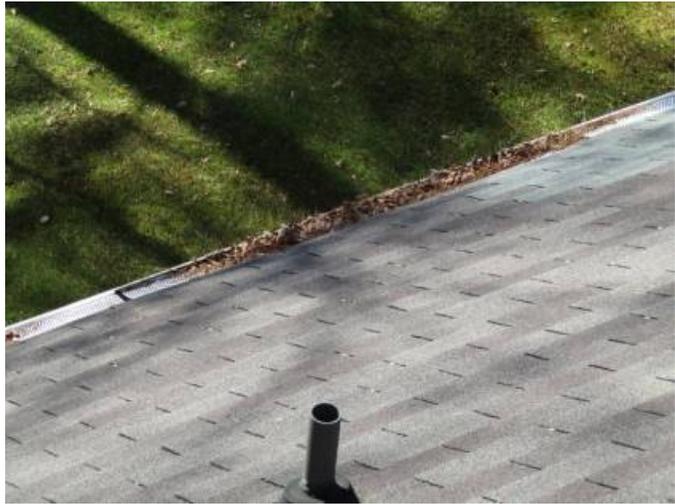
Attention - Loose and missing gutter screens were noted in several locations. Recommend replacing all missing covers to prevent clogging of the gutters.

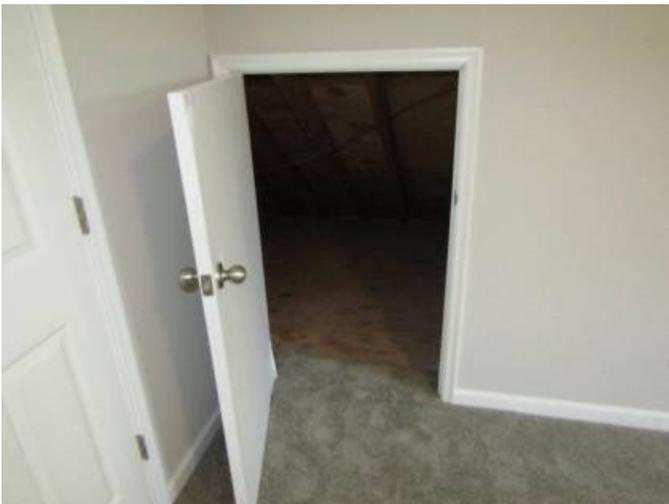
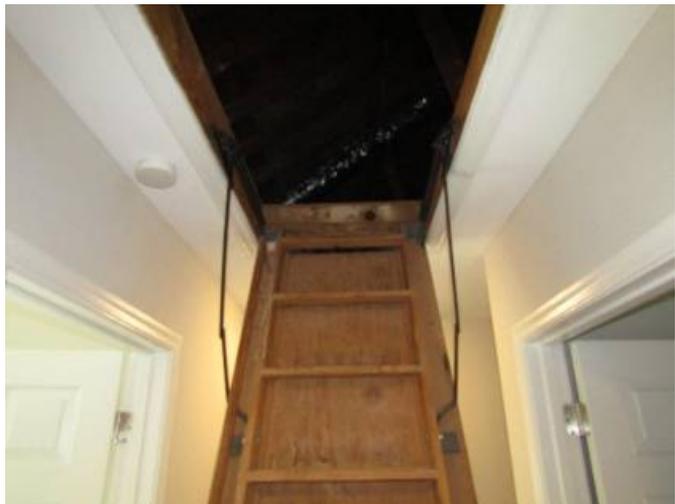
Condition of Access: **Attention** - Recommend installing a lock on the attic access door for safety of children.
- Weather stripping and insulation are not installed on the attic access ladder. This was not required at the time the home was built. Recommend installing insulation and weather stripping for improved energy efficiency.

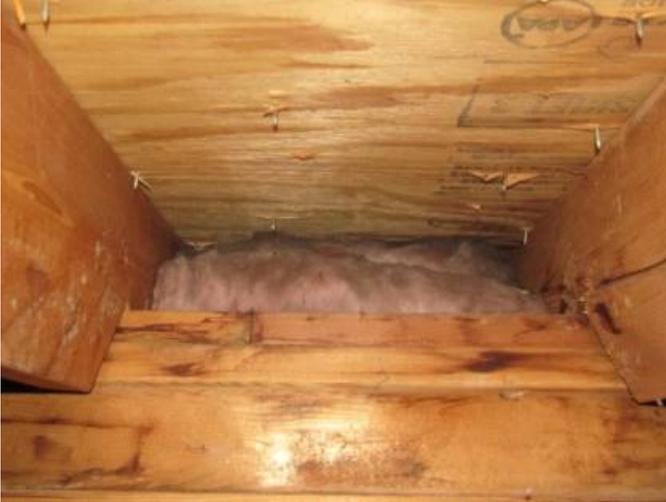
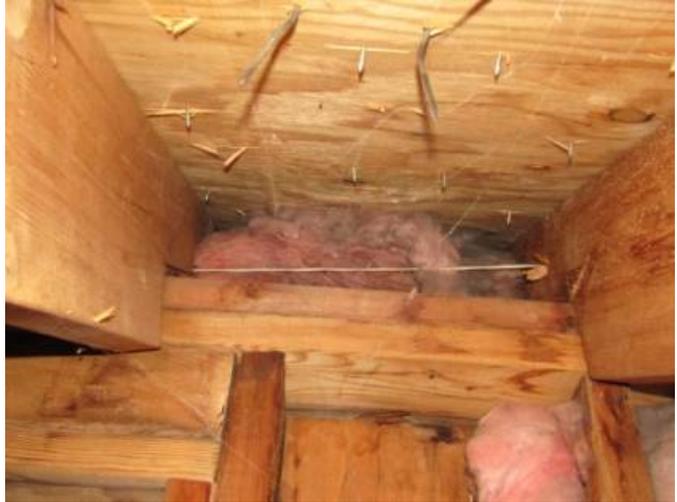
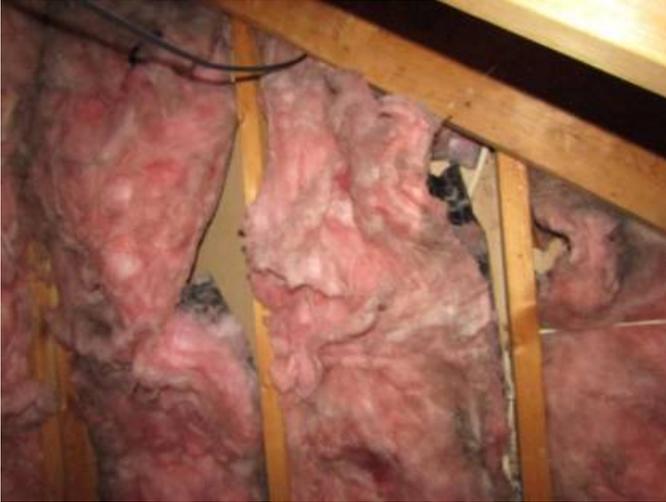
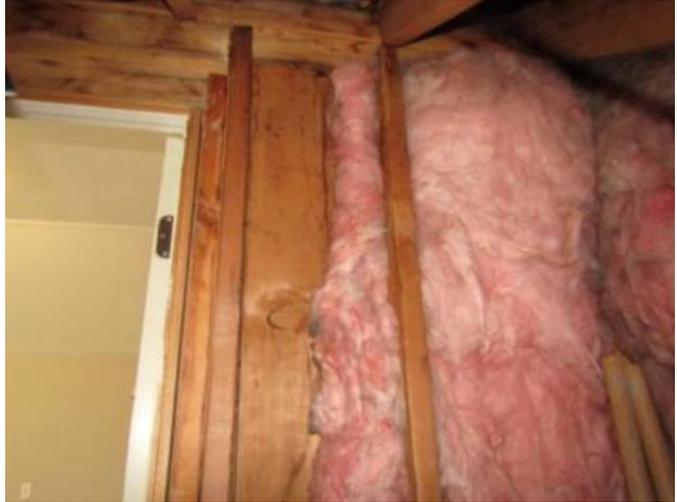
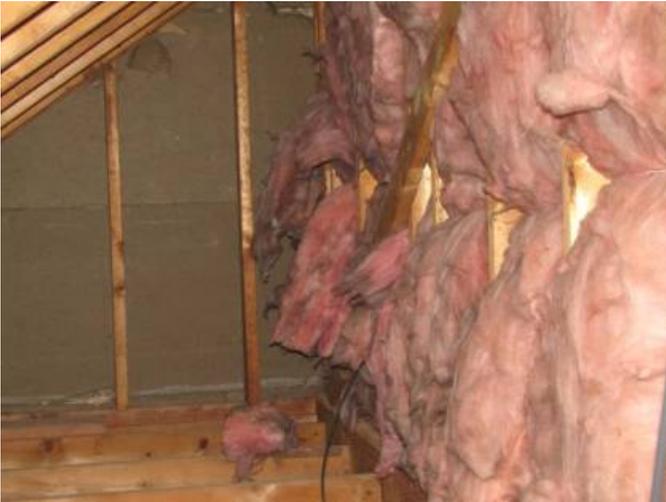
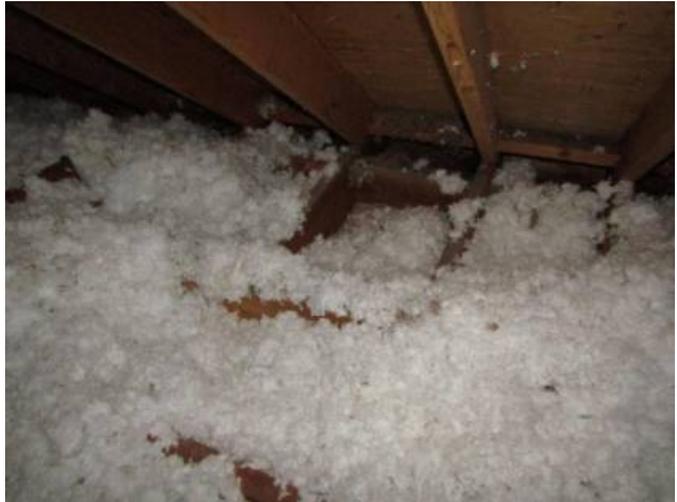
Condition of Insulation: **Action** - The insulation between the rafters above the angled ceiling of the bonus room is tight against the roof decking. This blocks off air flow that is needed to cool the roof and upper attic area. Recommend installing baffles to provide space for air flow.
- Missing insulation and loose insulation was noted in several locations of the attics. Not all locations

are shown below. Recommend replacing the insulation for energy efficiency.

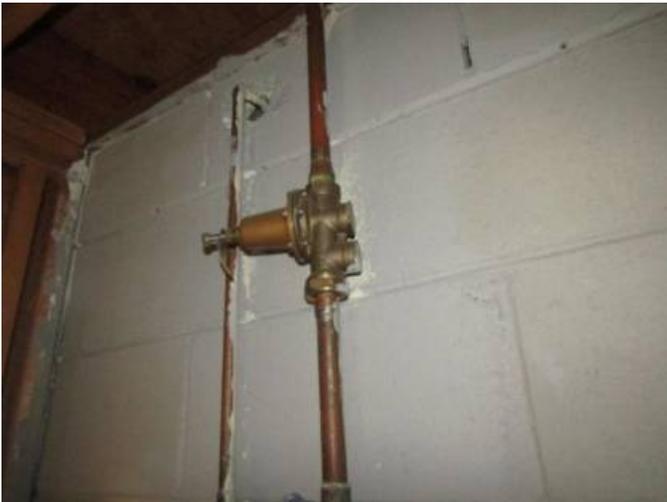
Action - There is not a grounding jumper installed at the water pressure regulator to allow the electrical ground to be intact. Recommend having a jumper installed for safety.

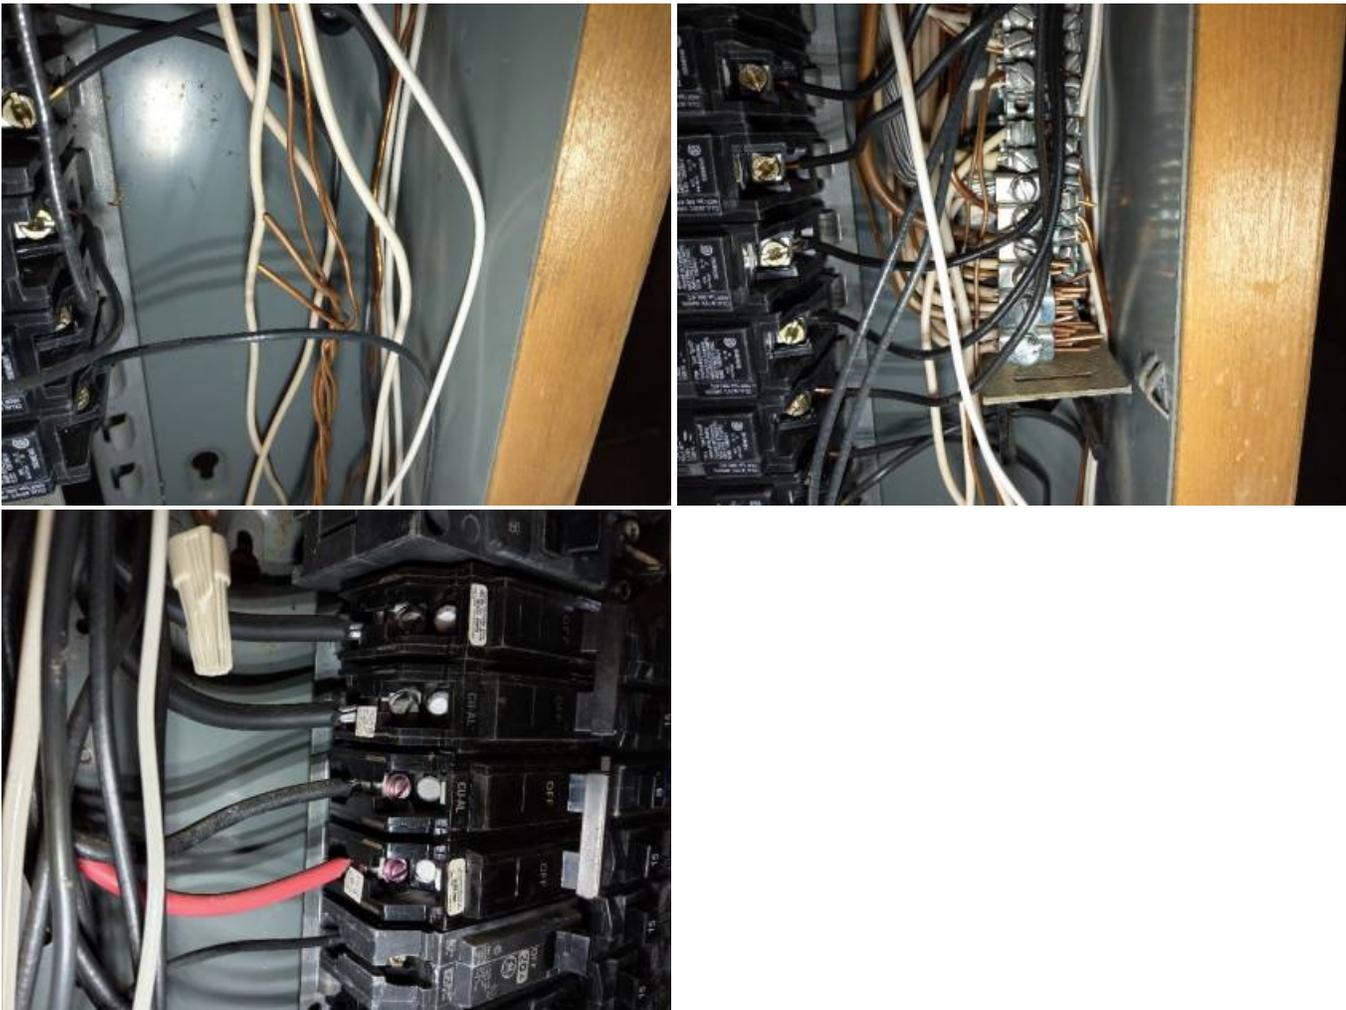
10. - Some of the grounding conductors are not attached to the terminal bar.
 - Anti-oxidant paste was missing on the aluminum wire connections in the panel box. This prevents corrosion and overheating.
 - FYI: There is more than one wire installed in the terminals on the neutral bar in the electrical panel. This was allowed by the panel manufacturer and building standards at the time the home was built. The NEC does not require upgrading this to current code standards.Recommend having the electrical panel evaluated by a licensed electrician and repaired as needed.

Recommend having the electrical panel evaluated by a licensed electrician and repaired as needed.

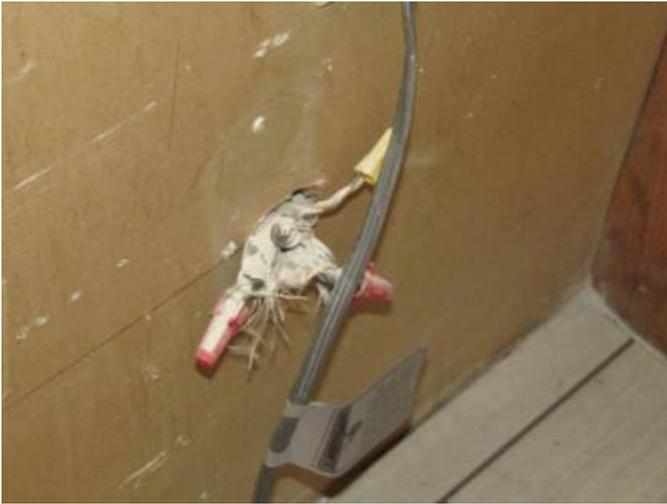
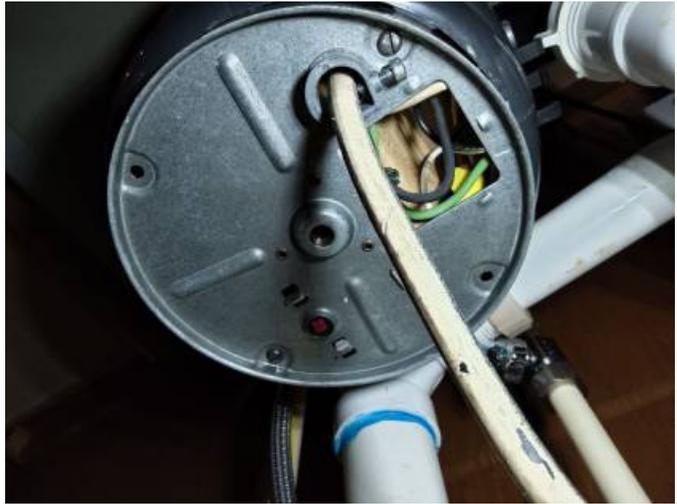
- Action** - There is an exposed live wire behind the kitchen range. This is a short/fire hazard.
- The cover is missing from the junction box on the bottom of the garbage disposal. This leaves exposed live wires.
 - The connector for the cord at the bottom of the garbage disposal is the wrong type, therefore it will not hold the cord in place.
- Repair by an electrician is recommended for fire safety.

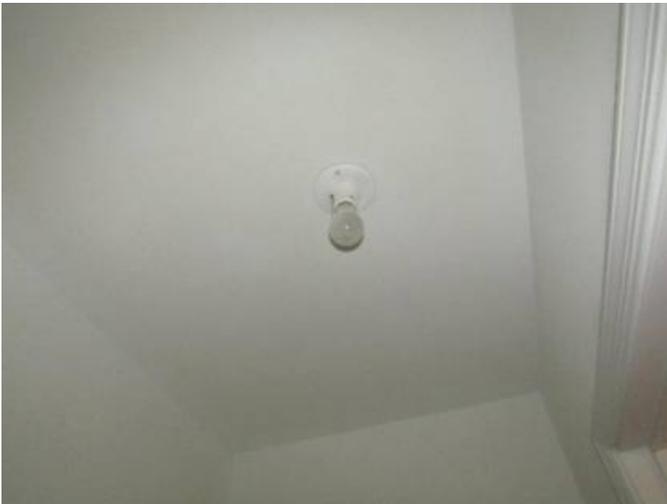
Interior Lighting: **Attention** - Exposed light bulb fixtures in closets are considered to be a fire hazard because stored items could come in contact with the bulb. Recommend replacing them with enclosed fixtures.

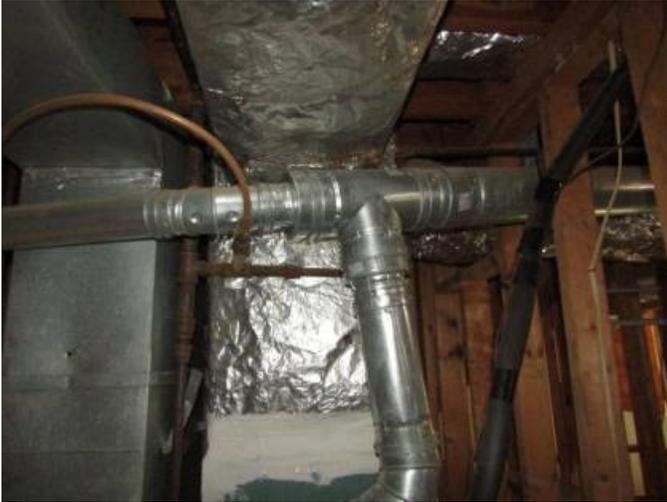
Flue Pipe: **Action** - The flue for the water heater is connected downstream of the furnace flue. Smaller BTU gas appliances must be connected upstream of larger BTU appliances. Repair by a licensed plumber or HVAC contractor is recommended.

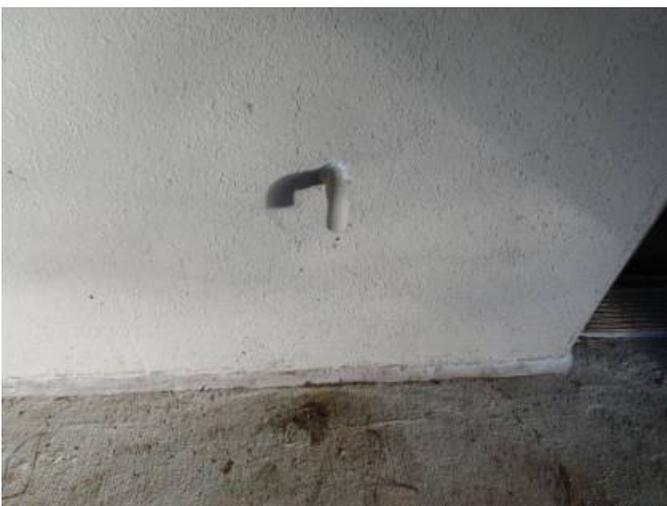
Relief Valve Drain Pipe: **Action** - The discharge pipe for the water heater pressure relief valve does not extend to within 6" of the ground as required. The pipe should be extended close to the ground to prevent a scald hazard.

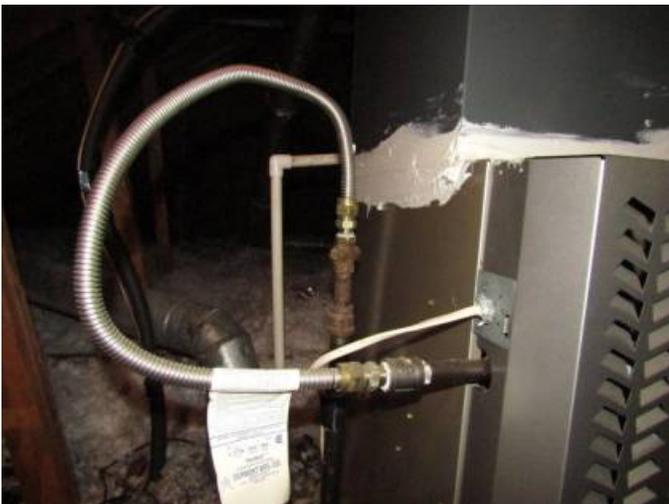
Piping Condition: **Action** - There is not a sediment trap on the gas line for the upstairs furnace. A sediment trap is required to help prevent clogging of the gas regulator.
- There is a gas leak at the gas meter on the exterior of the home. Repair by a licensed plumber is recommended.

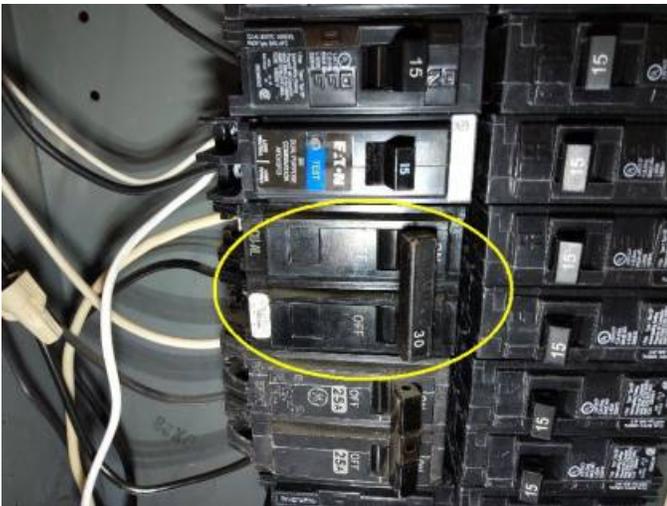
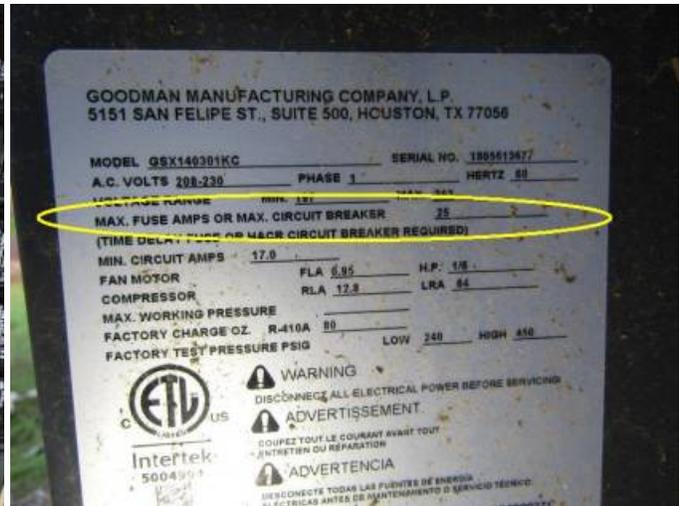
Power: **Action** - The circuit breaker is the wrong size for the air conditioning condenser. The manufacturer requires a maximum 25 amp breaker, a 30 amp breaker is installed now. Recommend having a HVAC contractor or an electrician replace the breaker with the proper size.

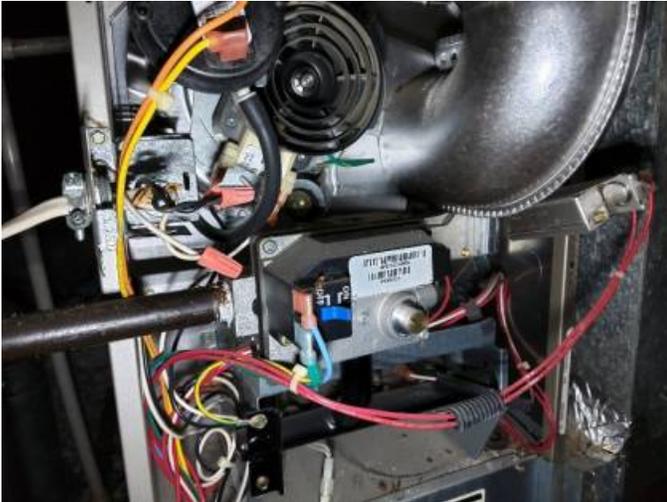
Action - The cover is not installed on the electrical junction box inside the upstairs furnace. This leaves open electrical connections in the same compartment with the gas regulator and burners. Recommend having a HVAC contractor repair for safety.

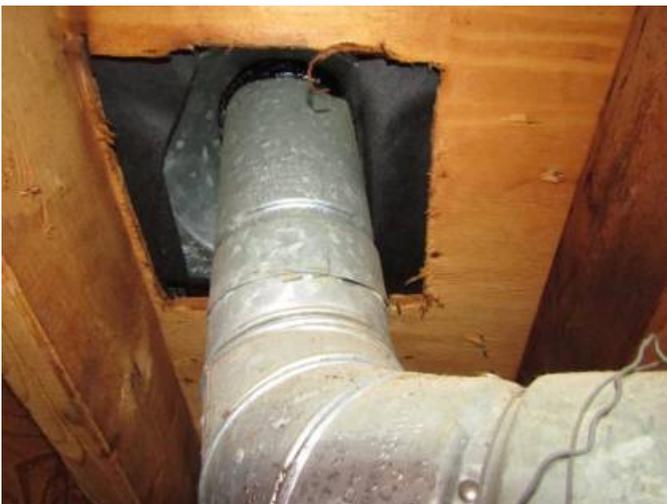
Flue: **Action** - The flue pipe for the furnace is in contact with roofing materials in the attic. The flue requires at least a 1" clearance from combustible materials. Recommend cutting the materials away from the flue to provide the proper clearance for fire safety.

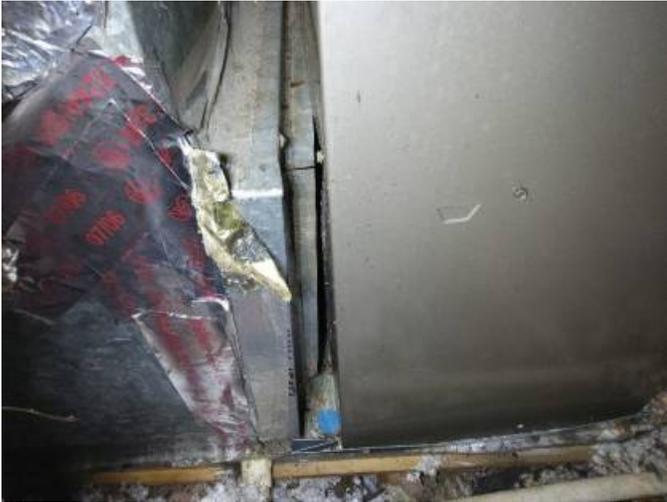
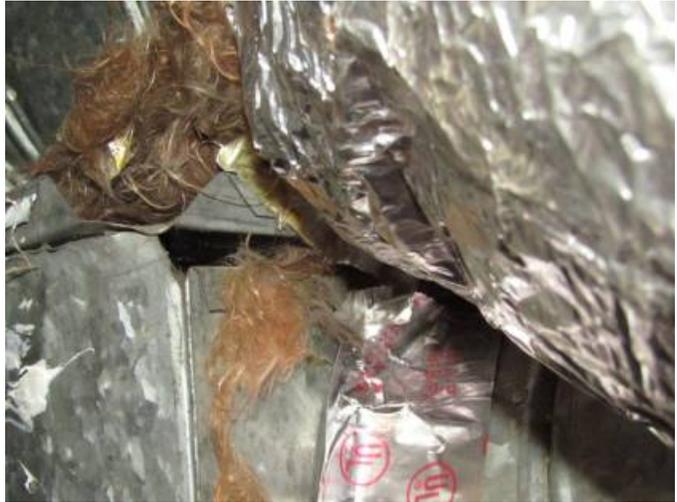
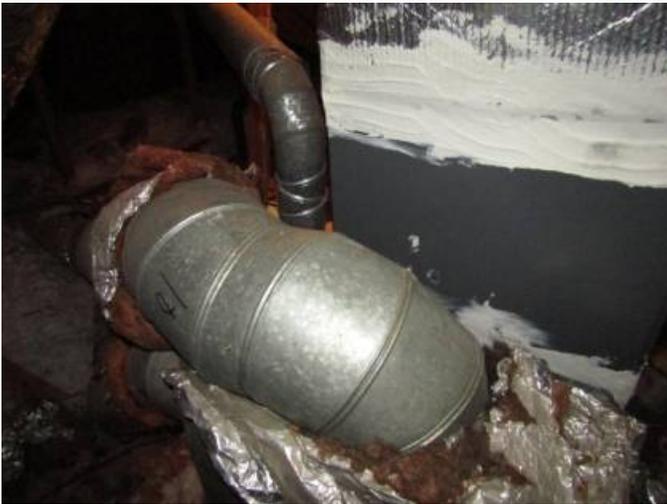
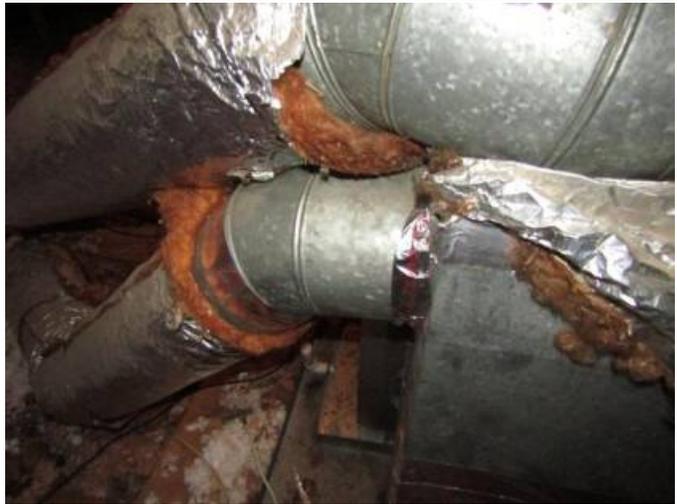
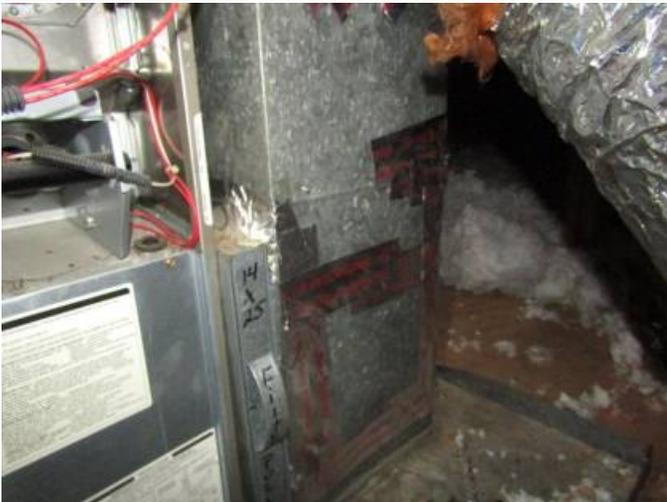
Action - The return plenum in the attic is disconnected from the side of the furnace and has gaps at the seams. This allows the HVAC system to draw air in from the attic.
- Some of the ducts in the attic are not insulated. The efficiency of the heating and air conditioning systems is reduced due to heat loss or gain. Installing insulation on the ducts is recommended. Recommend having a HVAC contractor evaluate the ducts and repair as needed.

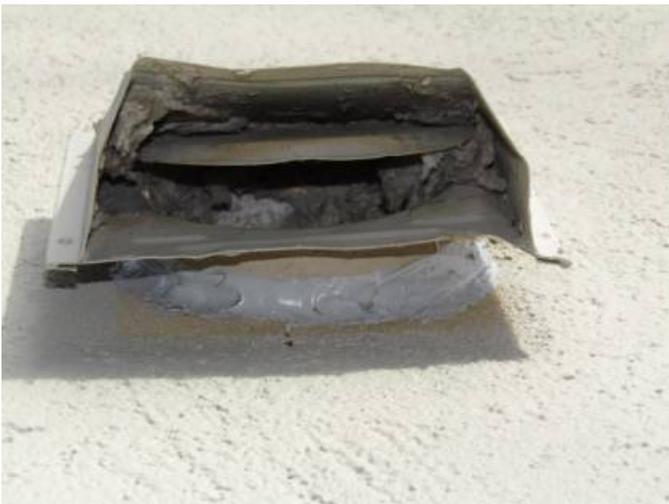
Dryer Vent: **Action** - The dryer vent is full of lint and the damper in the hood on the exterior of the home that keeps animals out does not close off. A vent clogged with lint or a nest is a fire hazard and can cause longer drying time for clothes. Recommend cleaning the vent pipe and repairing the hood to close off.

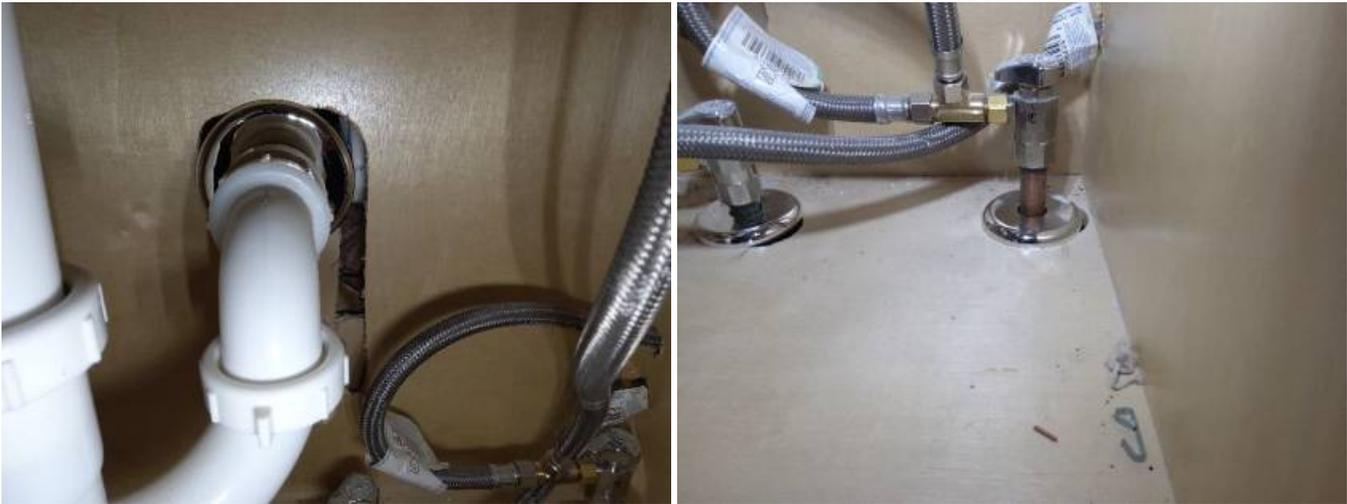
Cabinets: **Attention** - There are gaps at the pipes on the back and the bottom of the master bathroom vanity cabinet. These can be filled with low expanding foam.

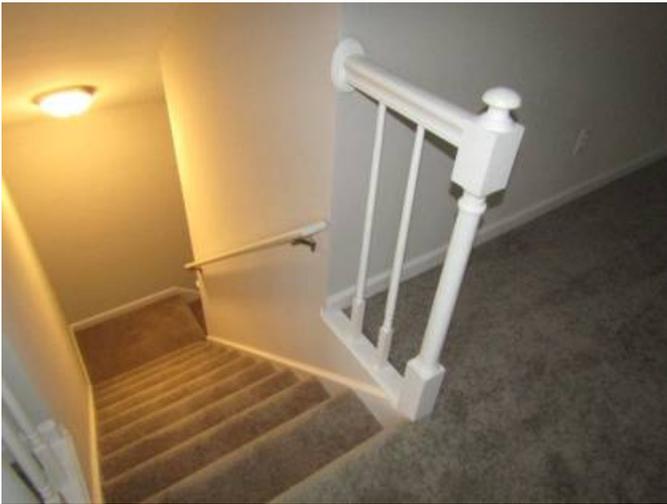
- Doors:** **Attention** - The door for the powder room binds on the frame when opening. Recommend adjusting or planing the door to close properly.
- The doors for the bonus room, master bedroom, left rear bedroom, left rear bedroom closet, and middle front bedroom closet drag on the carpet. Recommend trimming the bottom of the doors to avoid damage.
- Walls:** The visible walls are in satisfactory condition.
- Ceilings:** The ceilings are in satisfactory condition.
- Flooring:** **GOOD NEWS:** The hardwood flooring was recently refinished and should provide years of service.
- Stairway:** **Attention** - The handrail in the rear stairway does not extend the full length of the steps. This creates a fall hazard. Repair is recommended for safety.

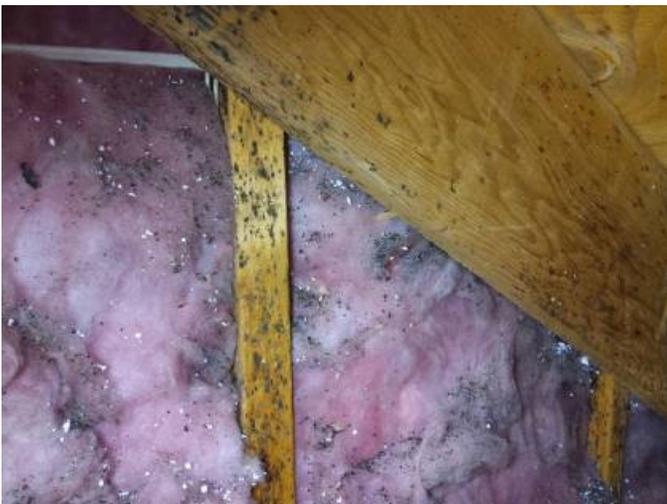
- Animals or Insects:** **Attention** - Evidence of insect activity was noted in the attic off of the bonus room.

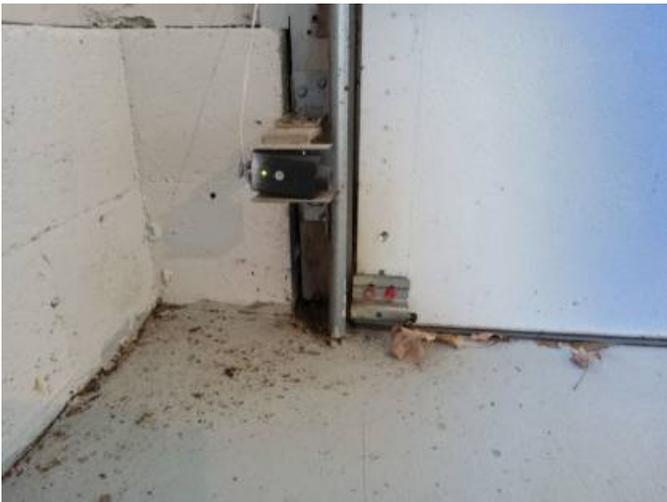
- Type:** Attached two car garage.
- Vehicle Door:** **GOOD NEWS:** The overhead garage door is made of metal, which lasts longer and requires less maintenance than a wood door.
- Vehicle Door Condition:** The overhead garage door is in satisfactory condition and is functional.
- Door Opener:** **Action** - The safety sensors for the garage door opener are installed too high. According to the manufacturer, the lens is required to be no less than 4" to no more than 6" above the floor. Recommend lowering the sensors for the safety of children.
- The down force of the safety reverse system on the garage door opener did not reverse when tested.
Adjustment is recommended so that it will reverse with less force required.

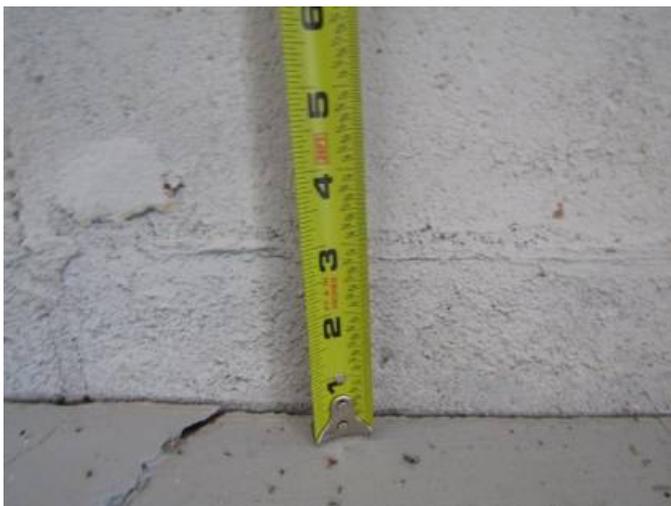
Floor: **Action** - Settlement and cracks noted in the concrete floor of the garage. There are gaps or hollow areas under the concrete. The floor has settled 3" in some locations. Recommend having a structural engineer or foundation contractor evaluate the garage floor. Repair as needed.

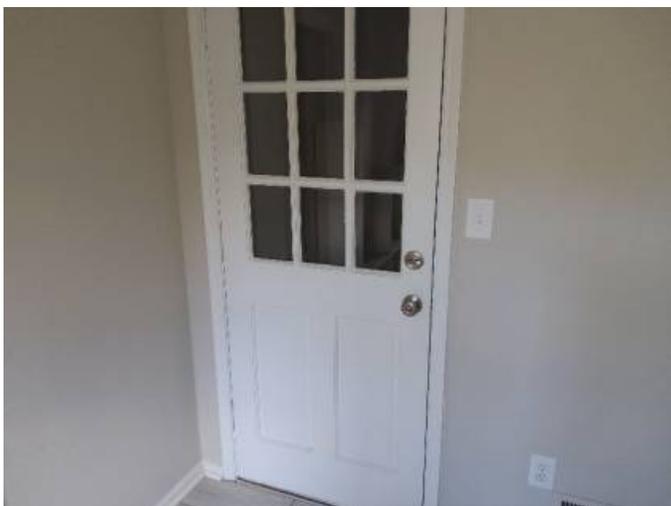
Door to Home: **Attention** - The door separating the garage from the home is not a fire rated door. this was not required at the time the home was built. For safety, recommend replacing it with a metal exterior door without glass.
