Home Inspection Report

90 Foxridge Ct
Marietta, GA 30067

INSPECTION REPORT SUMMARY

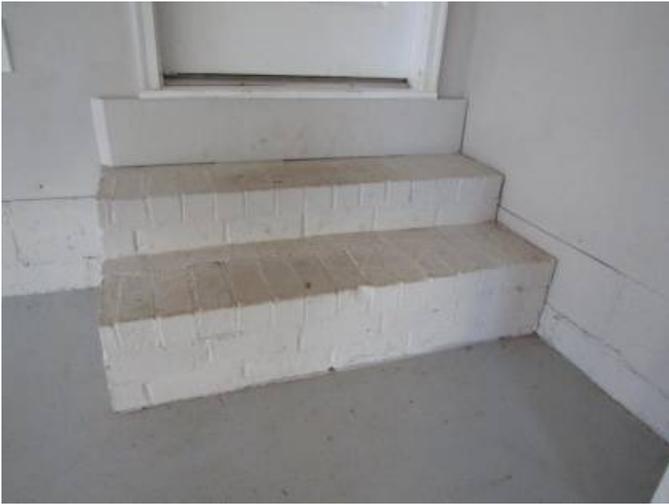
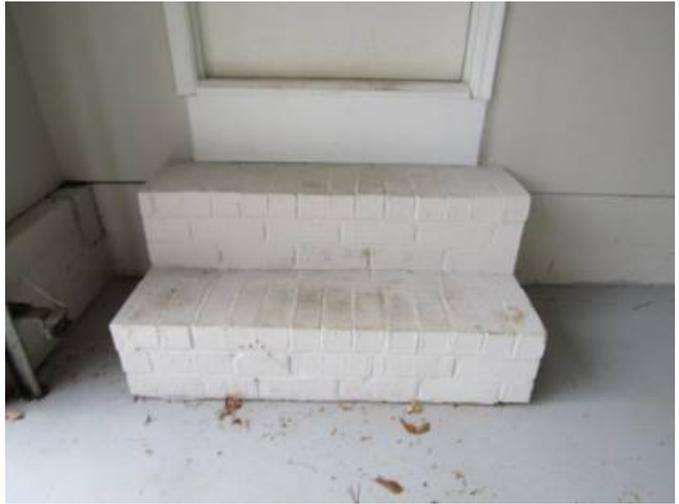
Stairs: **Attention** - The steps on the garage stairways are too high for safety, they are 10 inches high. The maximum height allowed is 8 inches.
- The steps from the garage to the home do not have equal rise.
