# Your Inspection Report

3091 Verdun Drive  
Atlanta, GA 30305

**INSPECTION DATE:**  
Monday, October 28, 2019

RE: Report No. 31811, v.2  
3091 Verdun Drive  
Atlanta, GA  
30305

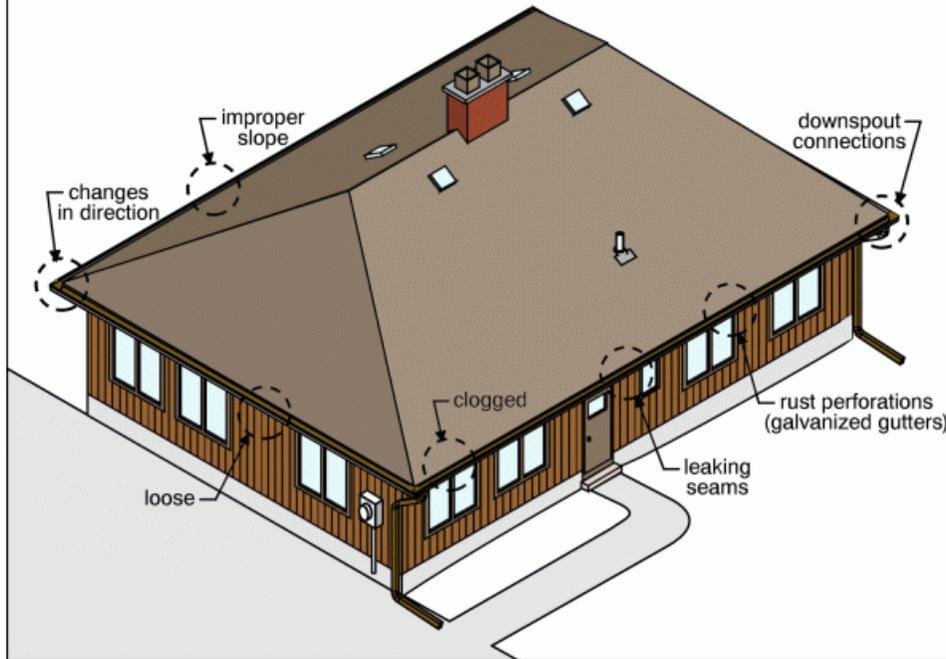
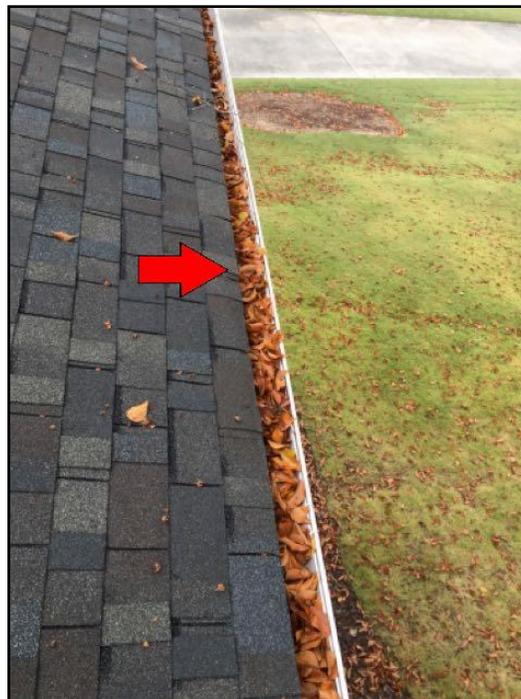
- 1. **Condition:** • Clogged
- Location: Throughout Exterior
- Task: Clean
- Time: As Soon As Possible
- Cost: Regular Maintenance Item

3. Clogged Location: Throughout...

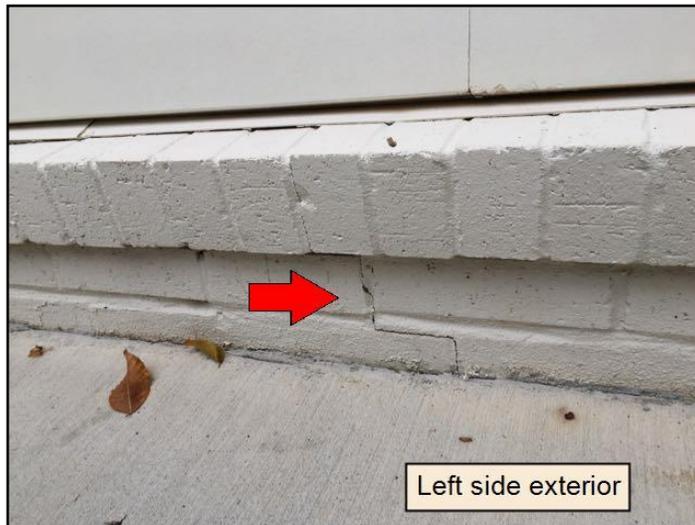
2. Condition: • Mortar deterioration

4. Mortar deterioration Task: Point repairs b...

Task: Point repairs by qualified mason at areas of deterioration

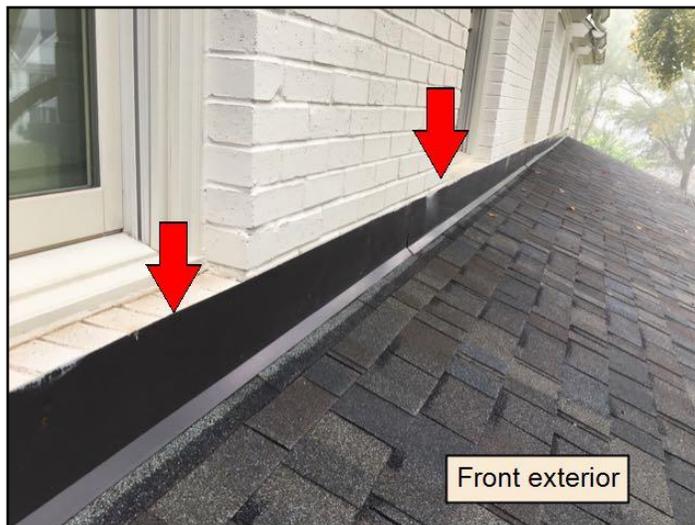
3. Condition: • Caulking needed at seams

5. Caulking needed at seams Task:...

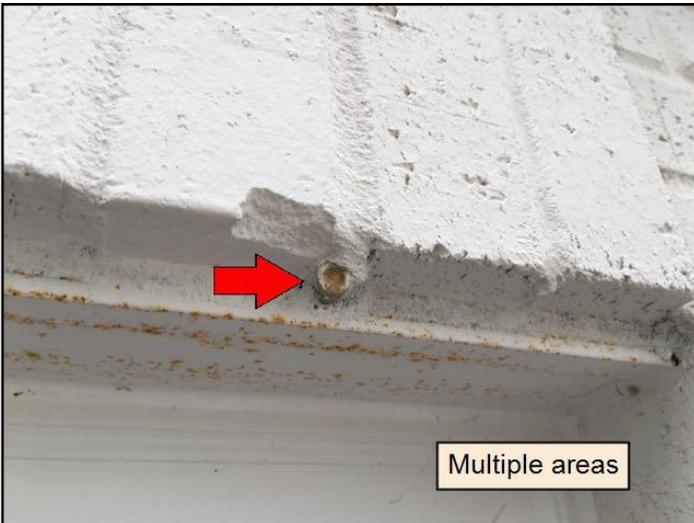
4. Condition: • Weepholes missing/ineffective

6. Weepholes missing/ineffective Task: Consul...

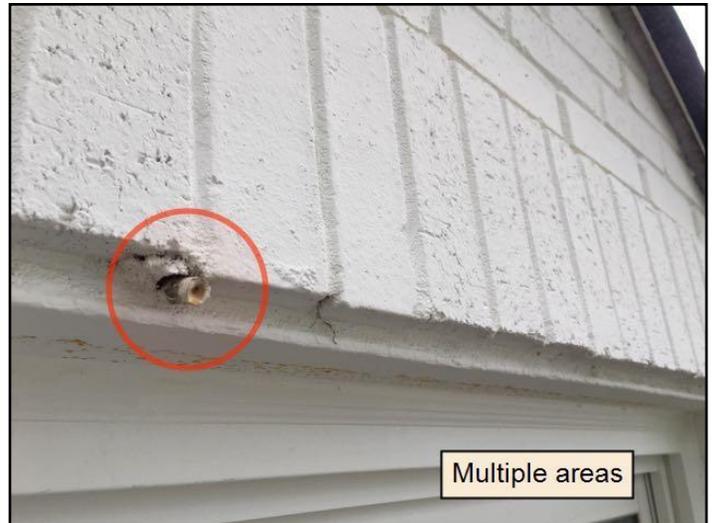
7. Weepholes missing/ineffective Task: Consul...

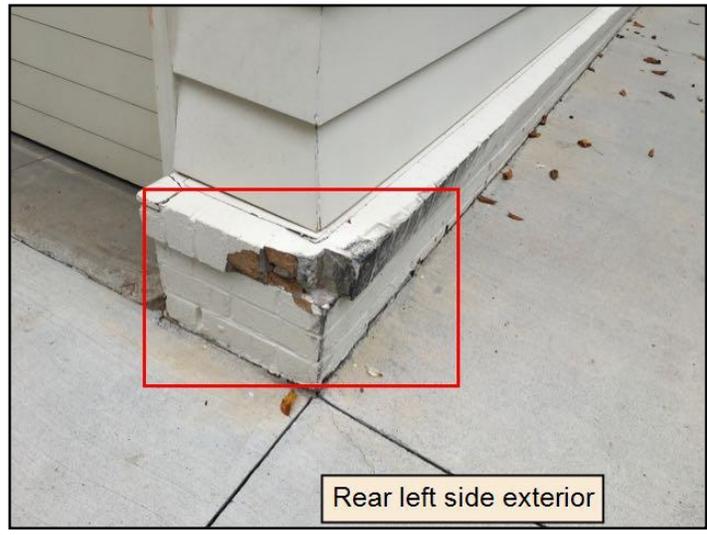
**5. Condition:** • Mechanical damage

8. Mechanical damage Task: Repair Time:...

Task: Repair

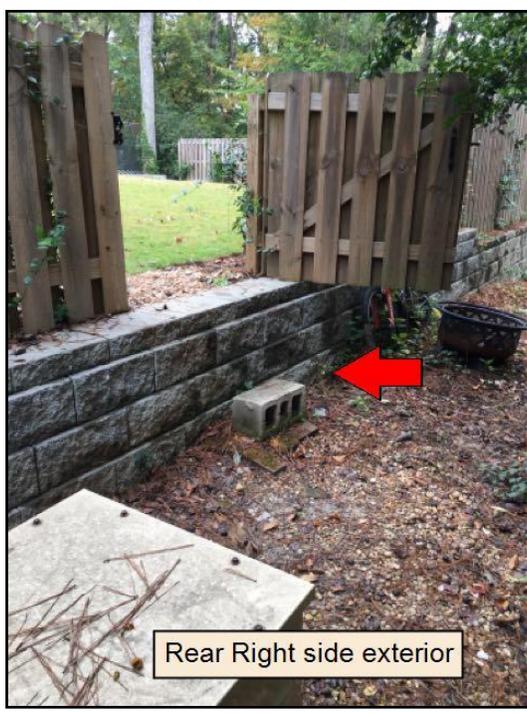
9.

**6. Condition:** • Missing stairs  
**Task:** Provide  
**Time:** Immediate  
**Cost:** Depends on the preferred remedy of repair

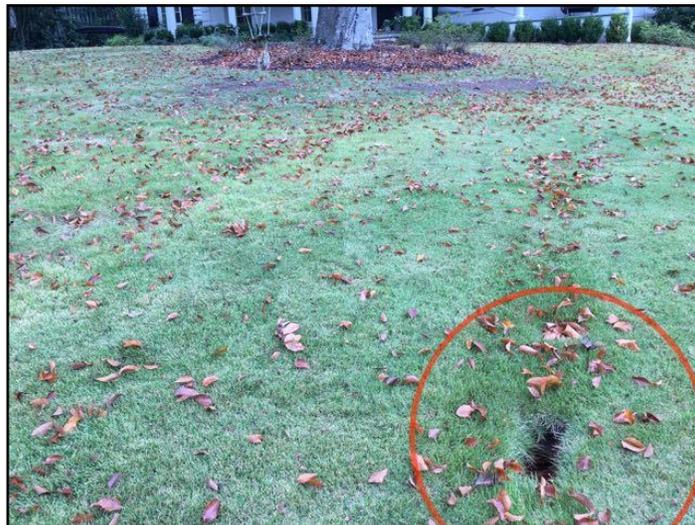
10.

**7. Condition:** • Abandoned water meter box (missing cover) in front yard

**Task:** Be Advised / cover

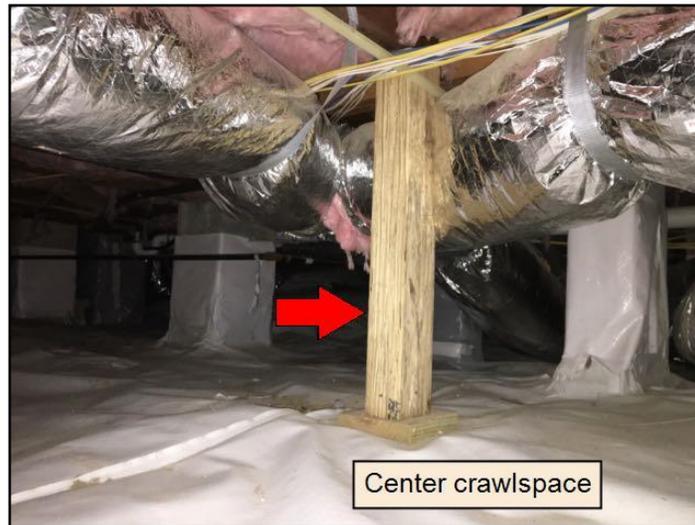
#### **8. Condition:** • Temporary Supports

Although there are no issues with the temporary or supplemental supports installed in the crawlspace, this is usually done in response to some type of movement or settling and as a temporary corrective measure. Although there were no issues noted that were a concern at the time of inspection, it is recommended that a qualified contractor install more permanent supports that are properly secured at the top and bottom.

11. Temporary Supports Task: Repair as...

Task: Repair as needed

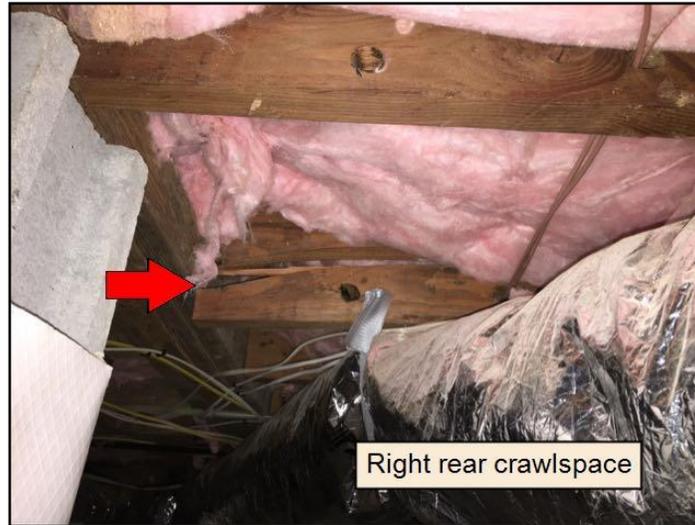
#### **9. Condition:** • [Split or damaged](#)

12. Split or damaged

Task: Repair

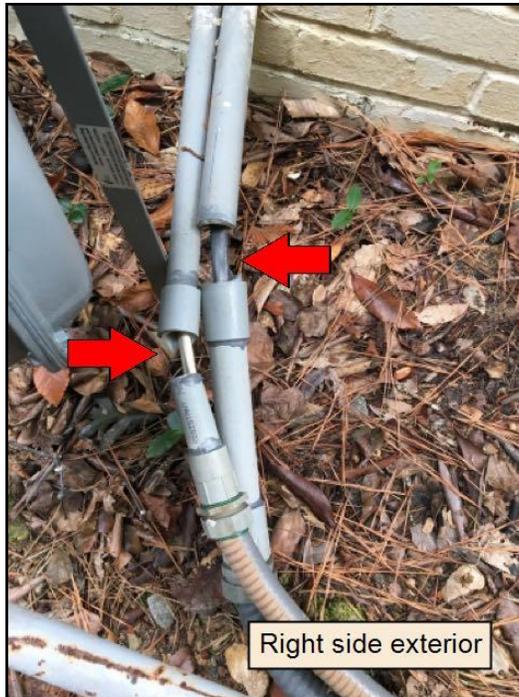
**10. Condition:** • Conduit needed

Conduit repair needed at generator

14. Conduit needed Task: Provide Time:...

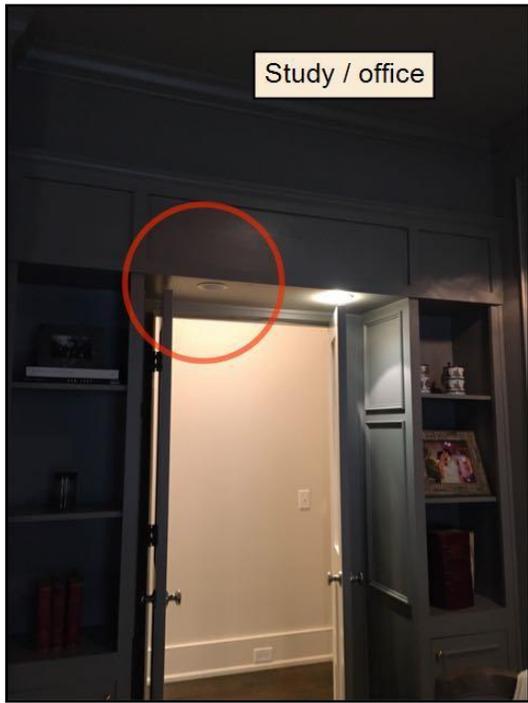
Study / office

**11. Condition:** • Inoperative

This is most likely blown bulbs and recommend confirming operation from the seller.

15. Inoperative Task: Repair Time:...

Task: Repair

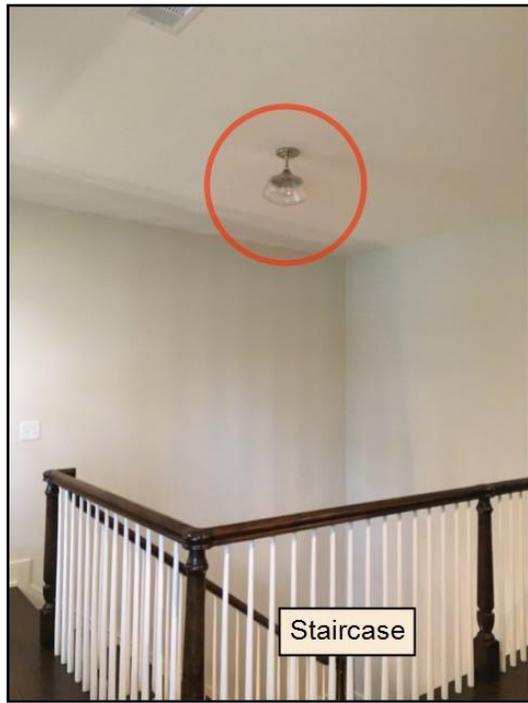
Staircase

16. Inoperative Task: Repair Time:...

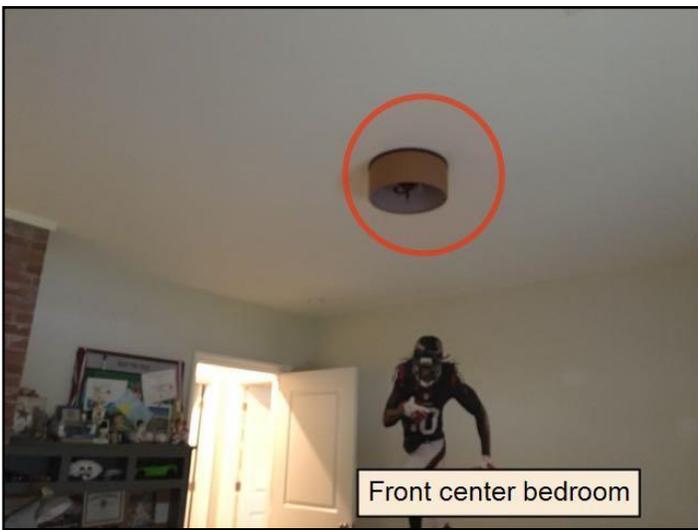
Front center bedroom

17. Inoperative Task: Repair Time:...

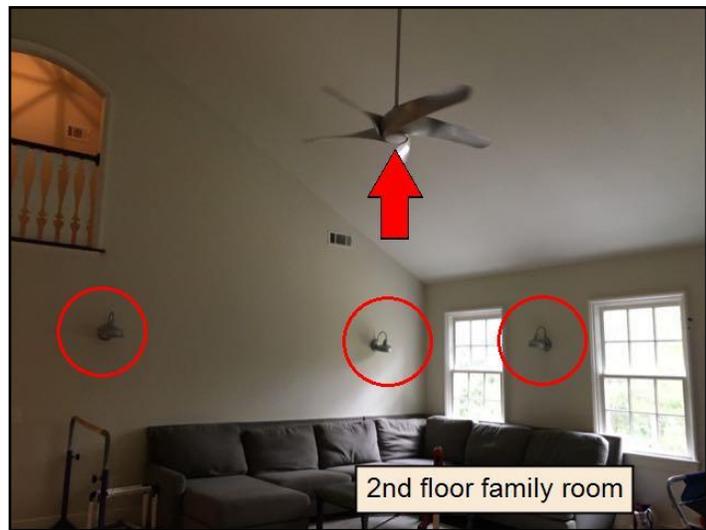
2nd floor family room

18. Inoperative Task: Repair Time:...

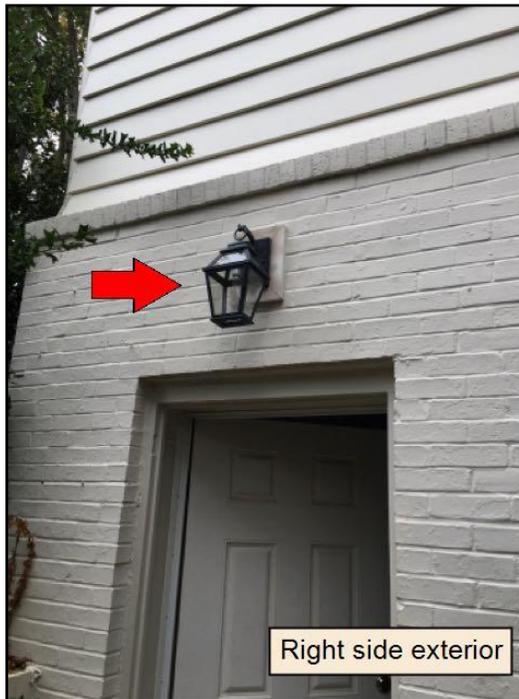
19. Inoperative Task: Repair Time:...

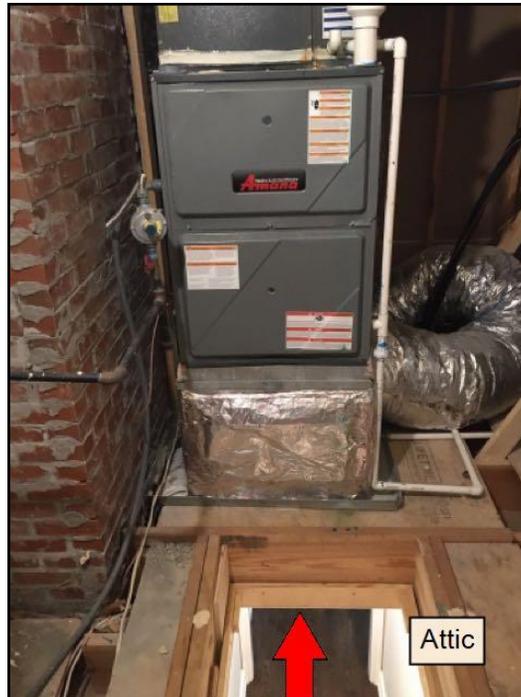
**12. Condition:** • Poor Access

Poor working space in front of furnace

22. Poor Access Task: Improve access to the...

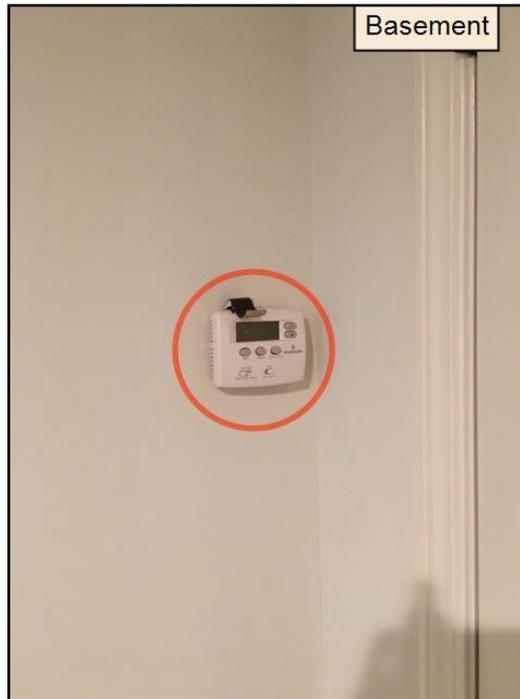
**14. Condition:** • Inoperable

23. Inoperable

Task: Repair or replace

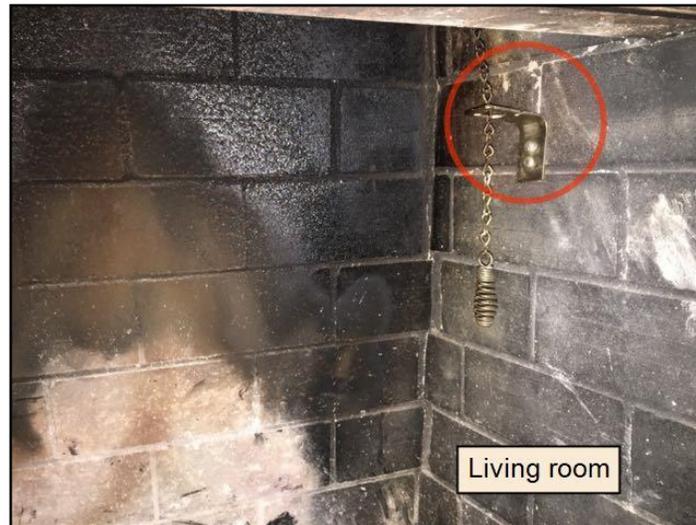
24.

**16. Condition:** • Damper chain bracket is loose

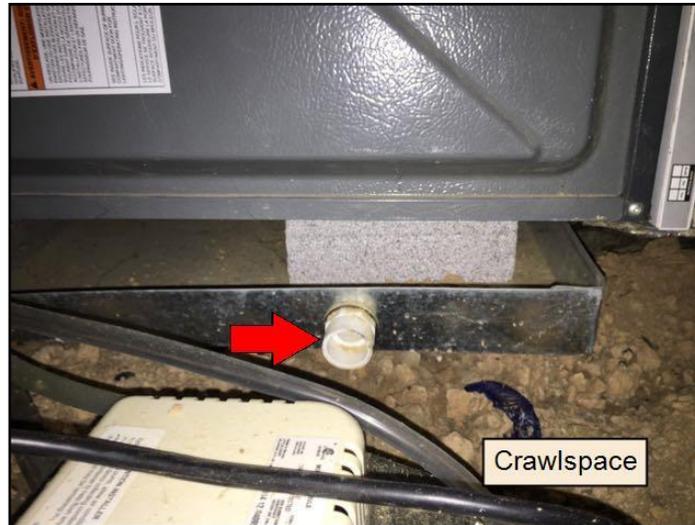
**17. Condition:** • Drip pan missing plug and float switch or auxiliary pan drain line to exterior

27. Missing cap / drain line

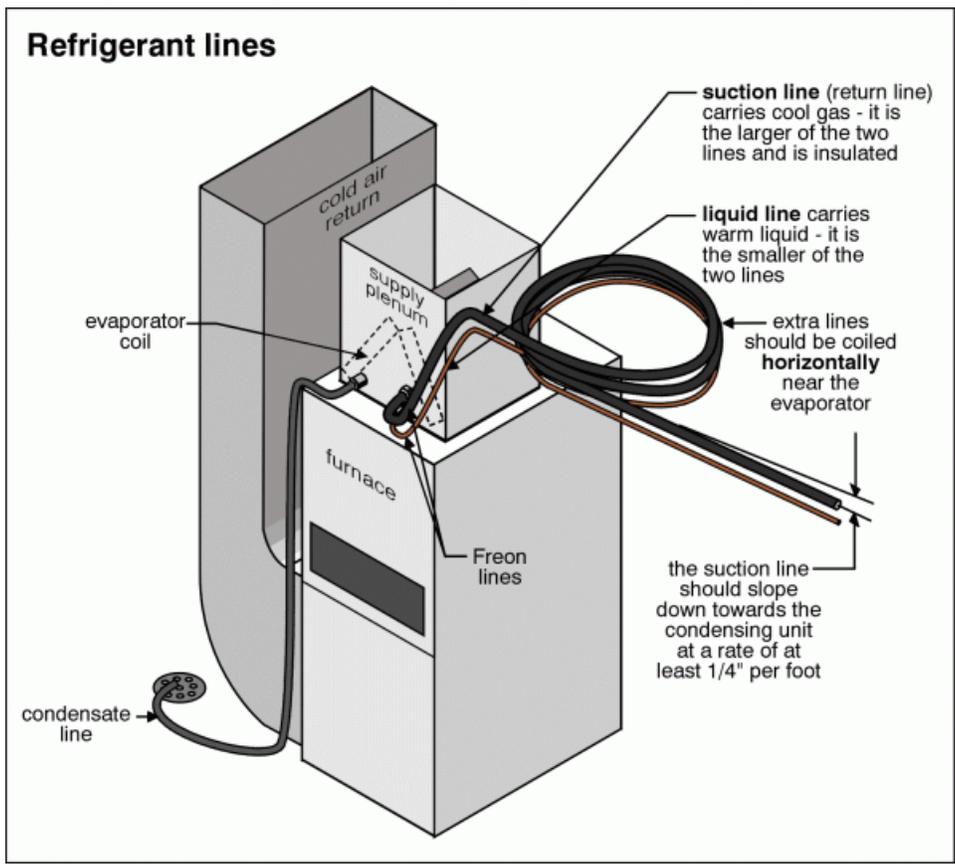
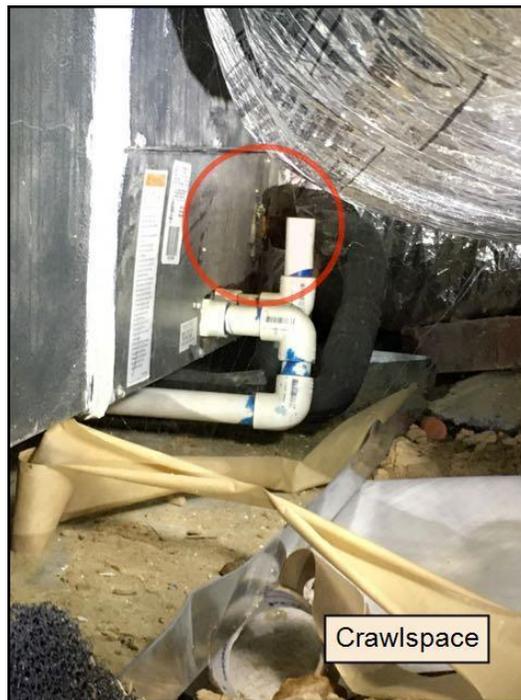
**18. Condition:** • Missing Insulation

28. Missing Insulation Task: Insulate or wrap...

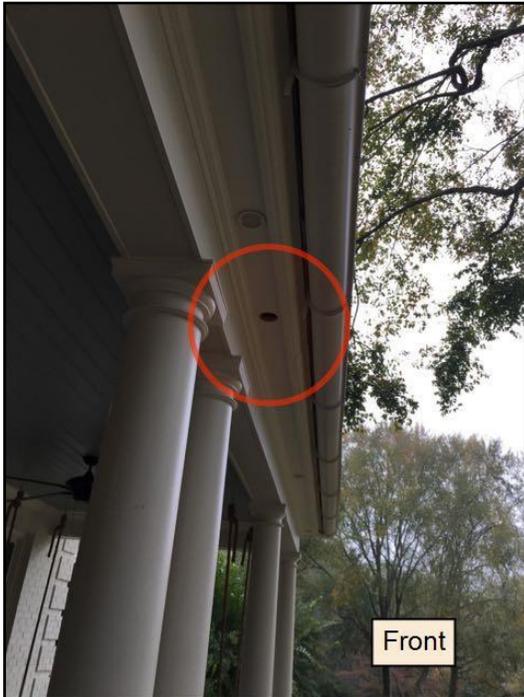
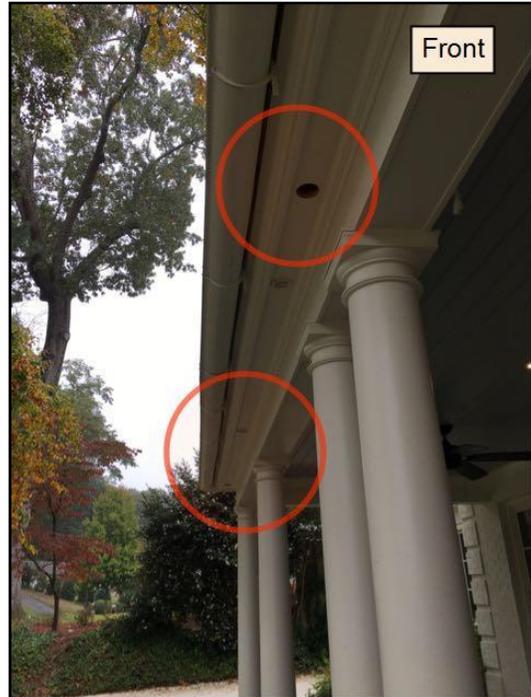
**19. Condition:** • Soffit vents missing covers

30. Missing pieces

31. Missing pieces

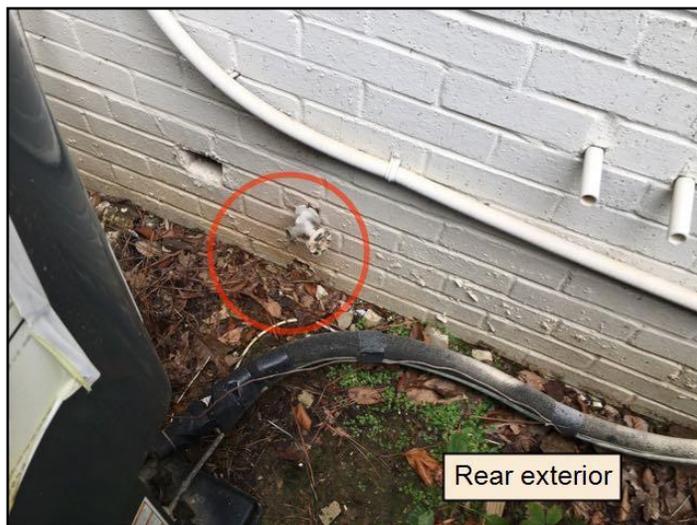
**21. Condition:** • [Inoperative](#)

**32. Inoperative**

**Task:** Be advised

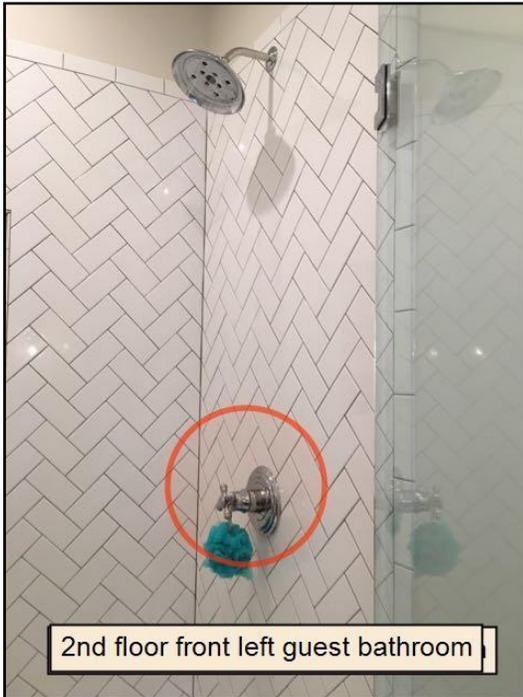
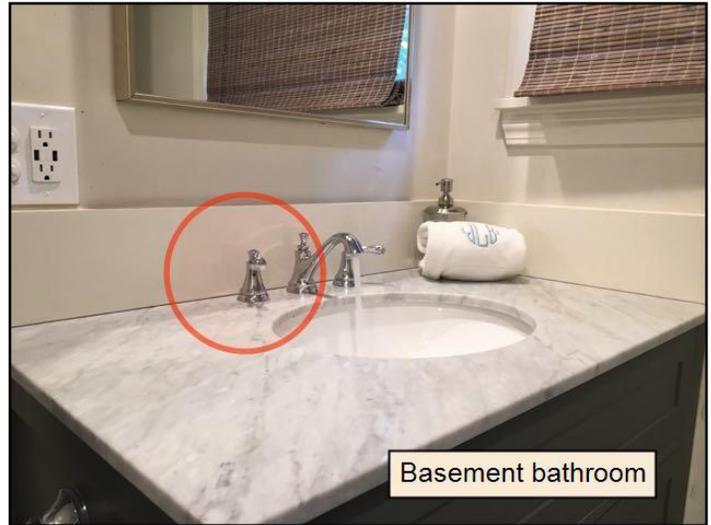
**22. Condition:** • Loose

33. Loose Task: Secure Time: Immediate Cost:...

34. Loose Task: Secure Time: Immediate Cost:...

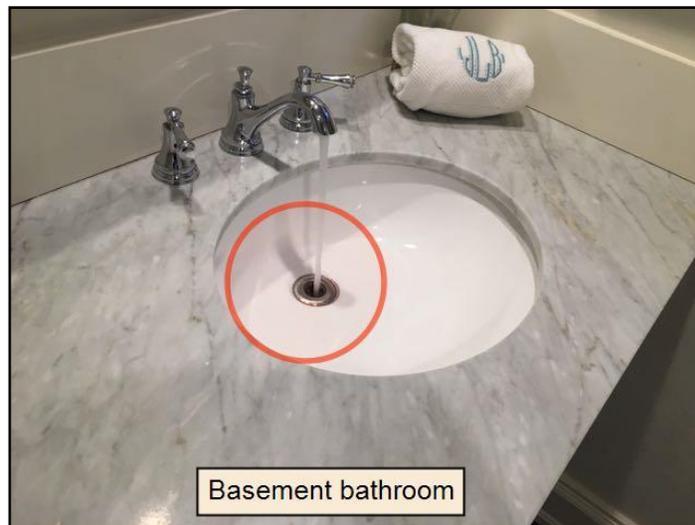
23. Condition: • Drain stop missing

35. Drain stop missing

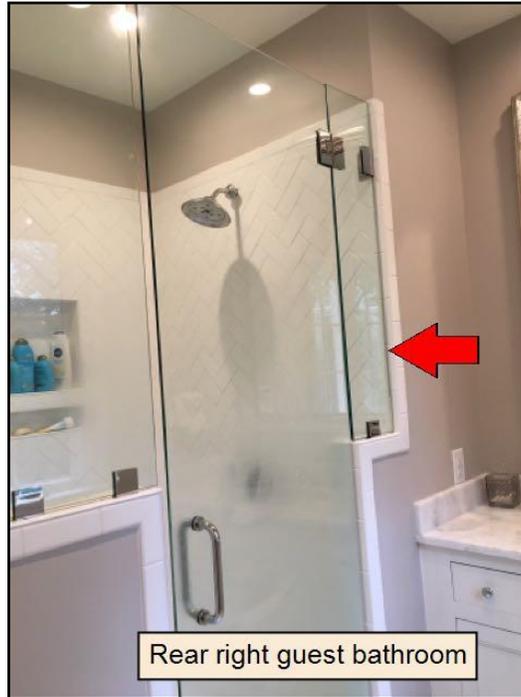
24. Condition: • Loose shower panel

**36. Loose panel**

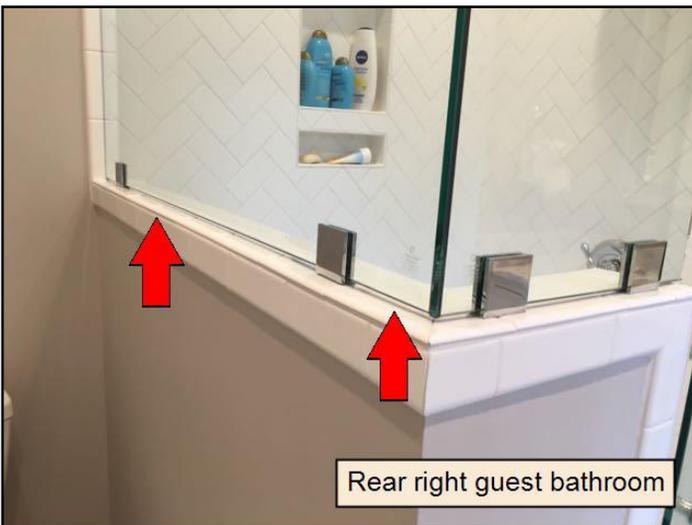
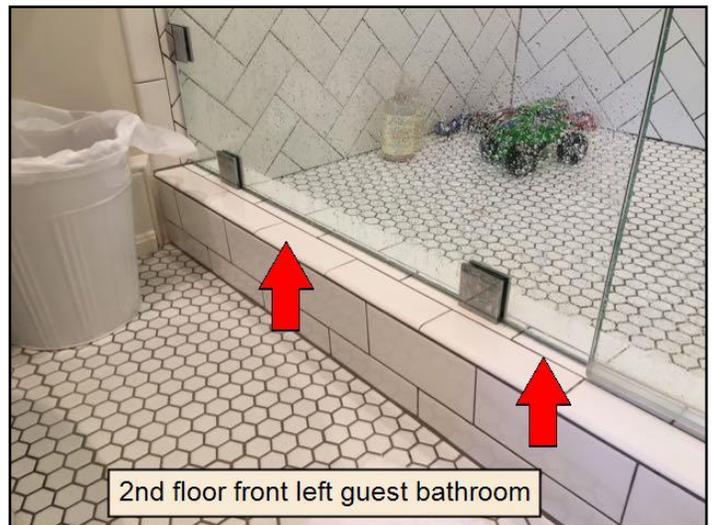
**25. Condition:** • Caulking/Grout missing and or deteriorated

**37. Caulking/Grout missing and or...**

**38. Caulking/Grout missing and or...**

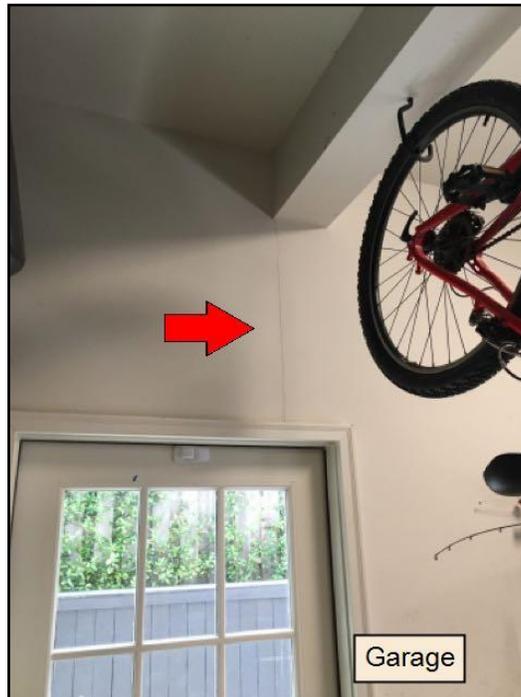
**26. Condition:** • Typical Flaws

41. Typical Flaws Task: Be Advised and...

Cosmetic repairs can be done and should be considered part of ongoing homeowner maintenance.

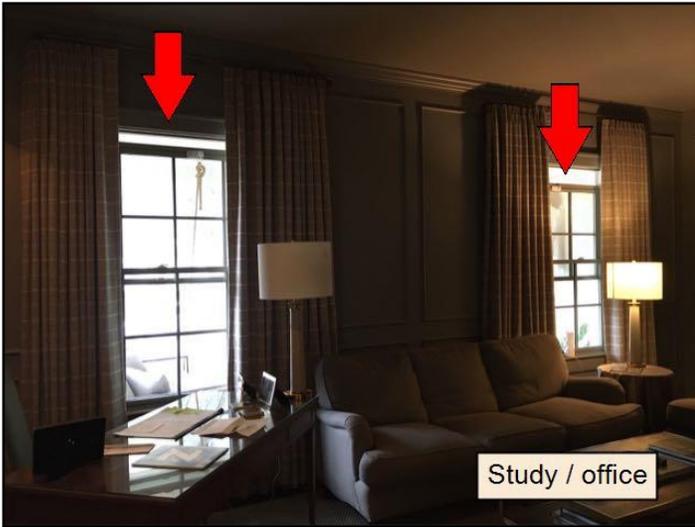
Study / office

**27. Condition:** • Top panel will not remain closed when unlocked

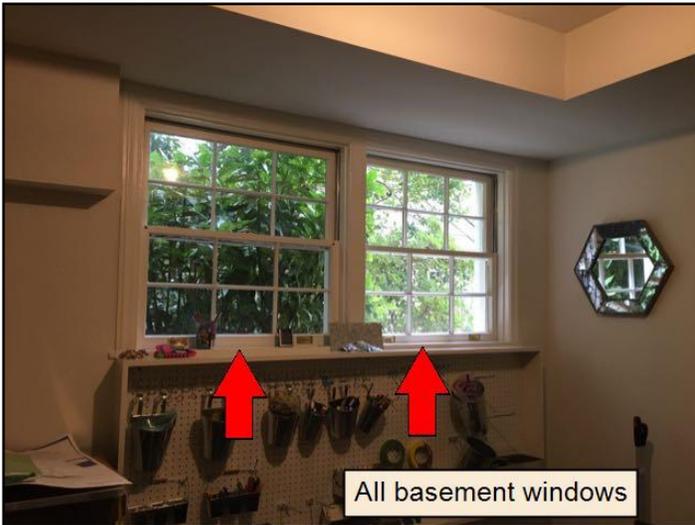
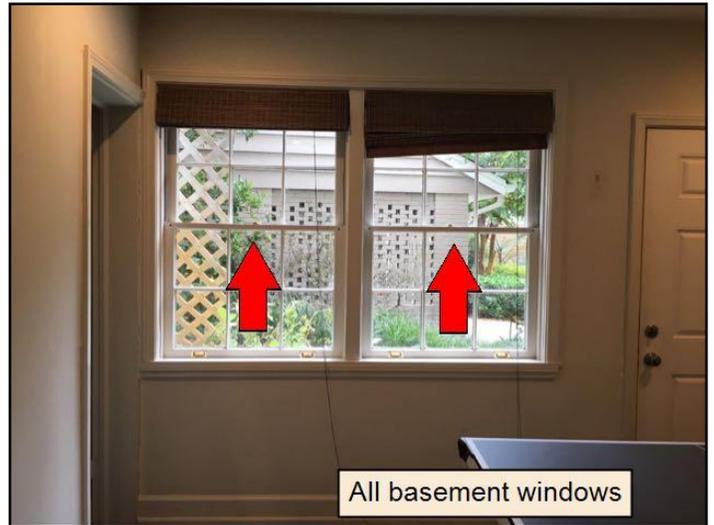
All basement windows

**28. Condition:** • Windows Inoperative

44. *Windows Inoperative Task: Be Advised Time...*

45. *Windows Inoperative Task: Be Advised Time...*

Task: Be Advised

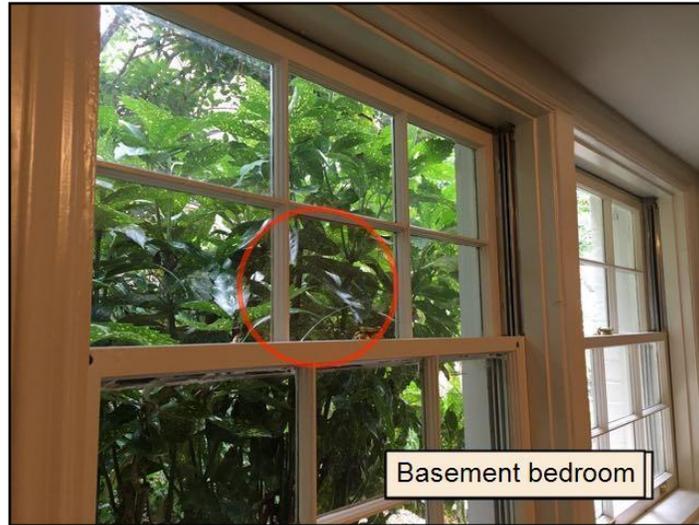
**29. Condition:** • Cracked Glass

46. Cracked Glass Task: Repair Time: As Soon...

Task: Repair

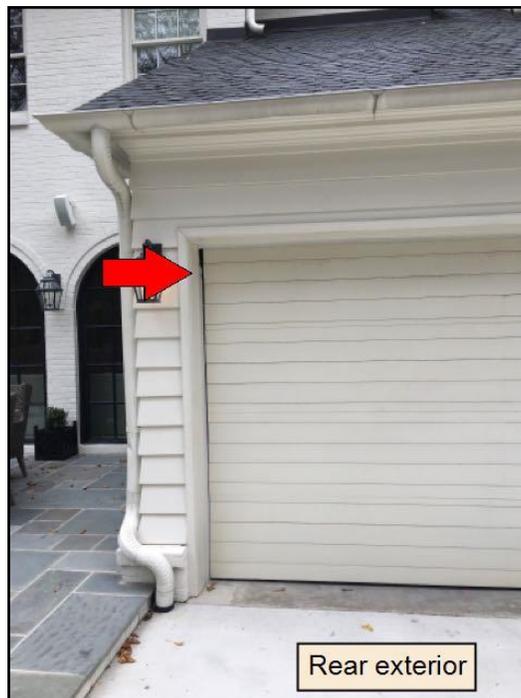
**30. Condition:** • Weather Stripping Needed

47. Weather Stripping Needed Task:...

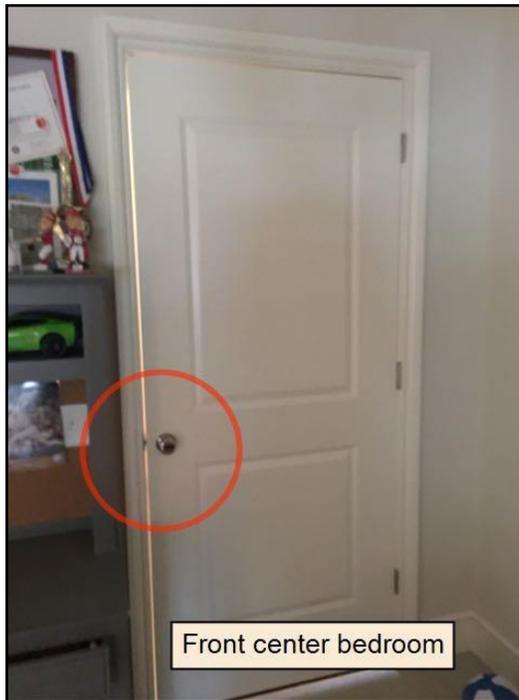
**31. Condition:** • Does Not Latch Properly

48. Does Not Latch Properly Task: Adjust Time...

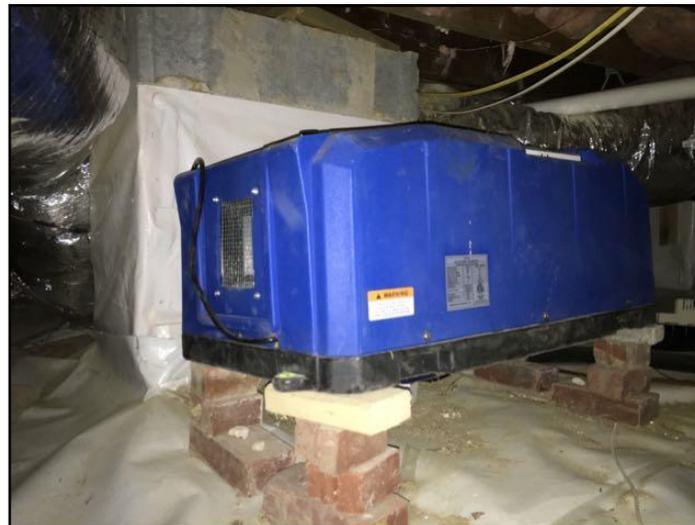
49.

**32. Condition:** • Dehumidifier In crawlspace

**Task:** Be Advised

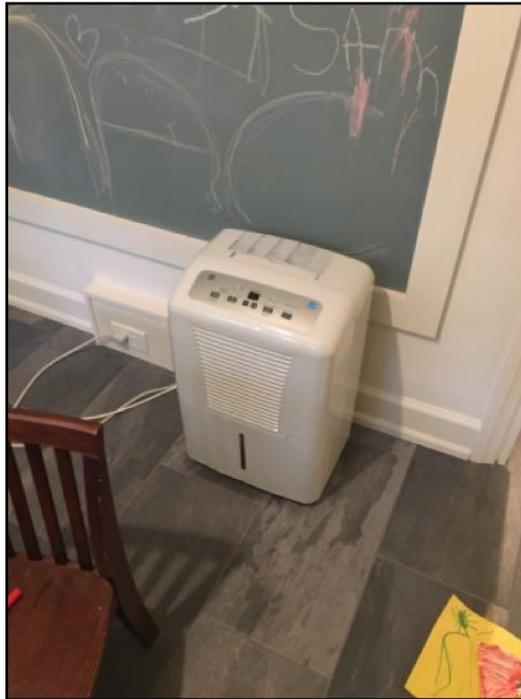
**33. Condition:** • [Dehumidifier in basement](#)

50. Dehumidifier in basement

**Task:** Be Advised / Request disclosure

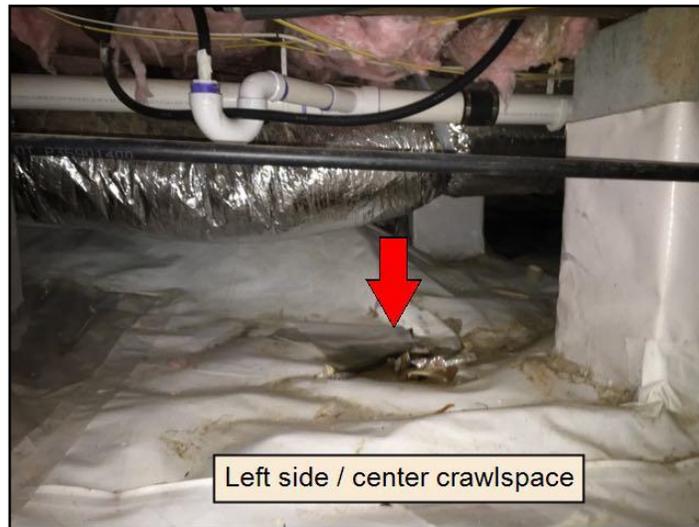
34. Condition: • [Water on floor](#)

51. Water on floor

Task: Be Advised
