Home Inspection

A Limited Building Analysis Letter

Commissioning Party/ Reference:	Andrew and Stacy Fotos 2295 Saxony Trace Alpharetta, GA 30005
Date and time of this analysis:	December 31, 2109 at 8:54 a.m. to 12:20 p.m.
Weather Conditions:	Sunny/44°F and windy
Water pipes/drain pipes (primary):	Copper/PVC
Water heater:	50-gallon gas-fired
HVAC:	Gas fired <i>Category 1</i> units
Electrical amperage/wire type):	Est. 400, (2)200 amperes/subpanel/Copper wiring
Roof cover (shingles):	Asphalt architectural grade shingles with an estimated 12 years of useful life remaining. Raised seam metal panels on the front elevation are in good condition.
Siding:	Brick, cement board and stone
Porch/deck:	Front (open)/Elevated rear decks
Visible framing:	Conventional wood framing, I-Joists, no steel framing is visible
Date of construction:	Date given 2014
Orientation:	The orientation is from the perspective of facing the front door from the left side elevation.
Photos:	Limited number

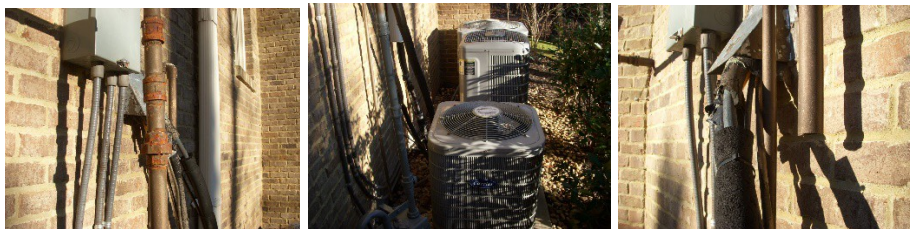
7. Rusty gas pipe at the outside supply is required to be protected against corrosion; buff and paint.
8. Three air conditioning units located at the right side elevation were not tested by inspector as outside ambient air temperature is unfavorable. I strongly recommend acquiring a 1-year appliance warranty to ensure start up in the spring.

9. Condenser/breaker compatibility and correct sizing was not confirmed. The panel index did not account for or ID the AC units. Unit 1(20 ampere); 2(40 ampere); 3(35 ampere). Before closing, match the panel breaker with the breaker size (Maximum/Minimum) listed on the specification plate on each of these condensing units.

10. Lineset insulation is damaged and part is missing; repair as necessary.
11. All drain pipes need to terminate not greater than 6" above the dirt line and extended outward not less than 5' to move the discharge away from the foundation.

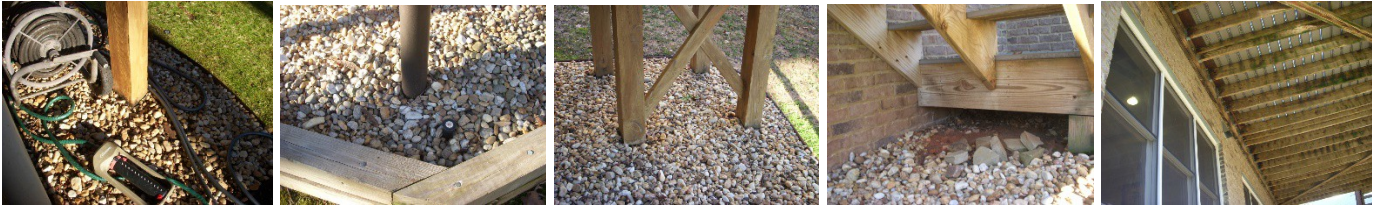
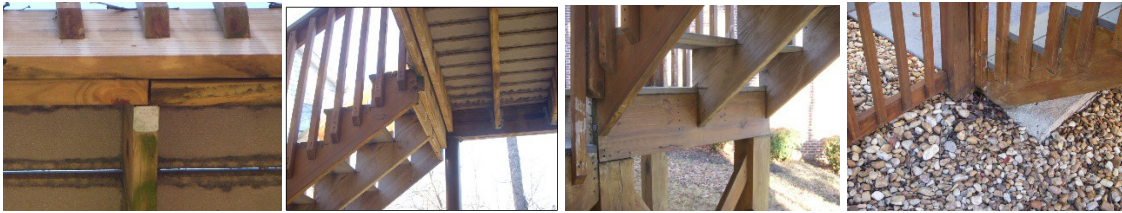
12. Deck posts (wood and steel) are in contact with dirt. Remove posts from dirt and pour an appropriately sized (to code) concrete footing, leaving the top of the footing not less than 2" above the grade line.

13. The lower deck landing should have a post and footing installed and not rely on physical attachment to the house with metal fasteners.
14. The upper deck flashing detail is questionable and shows deterioration. It performs its intended function, but monitor this location for penetration of storm water in the future.

15. The outside rim joist on the long span of the deck is spliced between support posts. This means that the deck is not fully supported vertically with a double member. In essence, this deck may not be capable of sustaining a 40/lb. per sq. ft. live load. You are encouraged to correct this condition before closing and before using this deck for family/friend gatherings.

16. The upper inside end of the high deck step stringer appears unsafe and should have a post and footing support installed to carry the live and dead loads. These steps may break loose from the deck and collapse if not repaired. Unsafe!

17. A horizontal brace is needed to provide addition support at the bottom end of the high deck step stringers where they meet the mid-landing.
18. High deck steps stringers, lower section, are in contact with dirt. These stringers need raising above the dirt line and placed on a poured concrete pad.

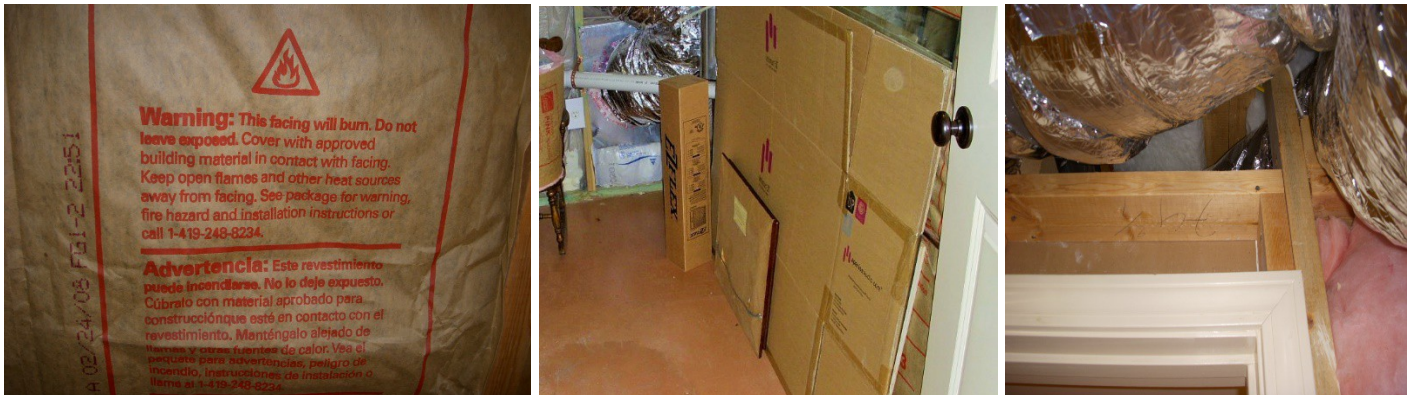
19. The PVC drain pipe against the water heater vent pipe connector requires not less than a 1" clearance.
20. **All** paper facing on insulation and other combustible paper products need removing from the mechanical room; unsafe confection...fire hazard.
21. The mechanical room ceiling is not firestopped or draft stopped. Seal these openings with code approved firestopping material before closing.

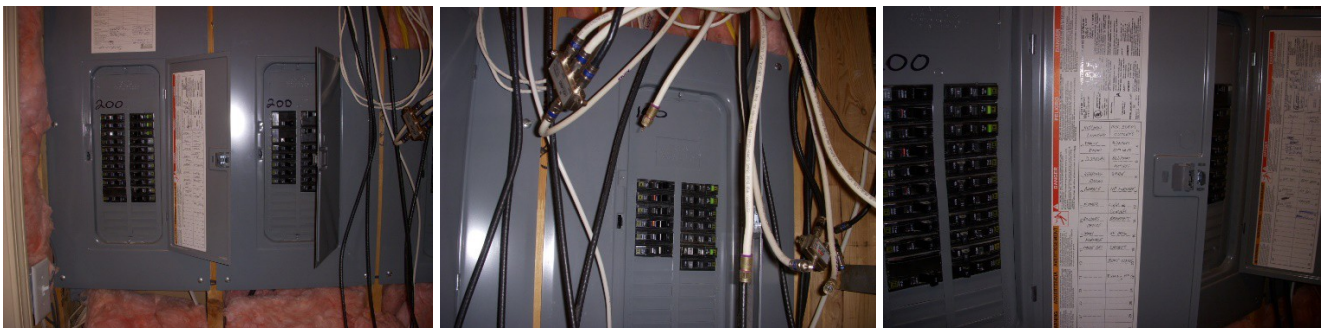
22. Repeat, electrical breakers to circuit wires need correct labeling.

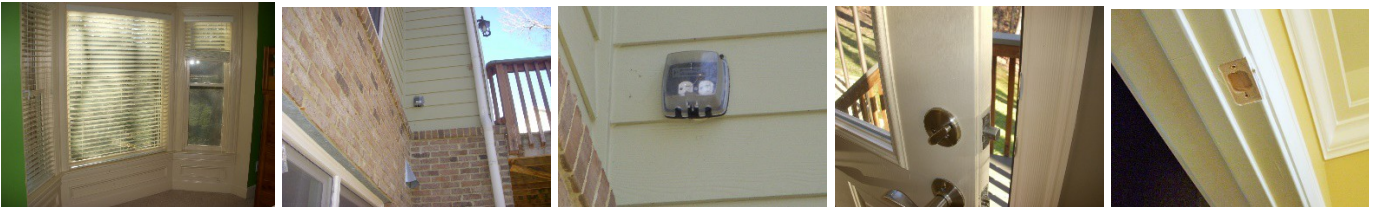
23. **Basement bedroom, green, does not have an openable 5.0 sq. ft. net clear egress window for fire rescue.** The present openable window has a 3.7 sq. ft. net clear egress opening.
24. All windows used for light and ventilation in habitable rooms must be free of easy opening. Free all windows that are stuck shut or painted shut, and also those windows that do not fully open.
25. Outside electrical receptacle 14' above the outside grade line was not tested. It would be good if the seller engages an electrician to check this outlet for functionality before closing. GFCI receptacles are prone to fail (not trip) even when new. Monitor all GFCI regularly using a proper testing device. Replace all units that do not pass the trip test.
26. Door to upper deck deadbolt needs adjusting for easy operation.
27. Closed door strike plate is missing, upper bedroom.

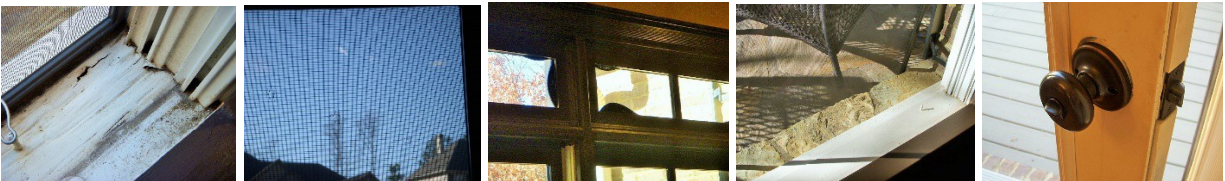
28. Wood rot is highly visible at the right side looking out of the office window.
29. Office window screen has three holes.
30. Office window transom has a pushed out seal that cannot be repaired. Replacement of the window is strongly recommended before the condition grows worse.
31. One window screen in the dining room is not set in place, and one window is missing at the front porch.
32. Adjust the loose knob on door to the upper deck/great room.

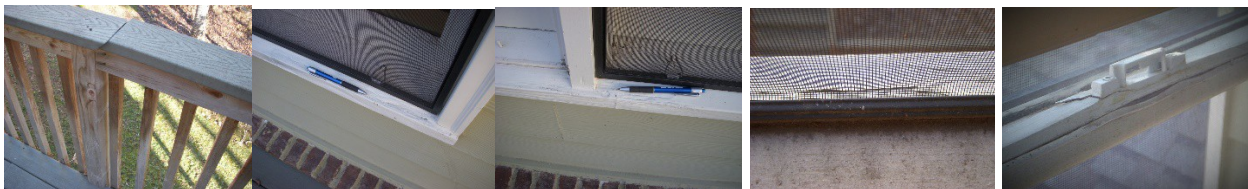
33. The upper deck top cap is loose at an intermediate rail post. The screw on the right cap is not screwed into the 2x4 top rail.
34. Window ledge has significant wood rot at the base of the 4-part window assembly above the high deck. The rot is noticeable especially in the ledge at window base 1-2, and right of window base 4.
35. House paint is beginning to peel off the woodwork at window ledges. Care must be taken to protect the wood from the elements and eventual rot.
36. Upper right front bedroom window has a damaged sash where the window lock is broken loose.

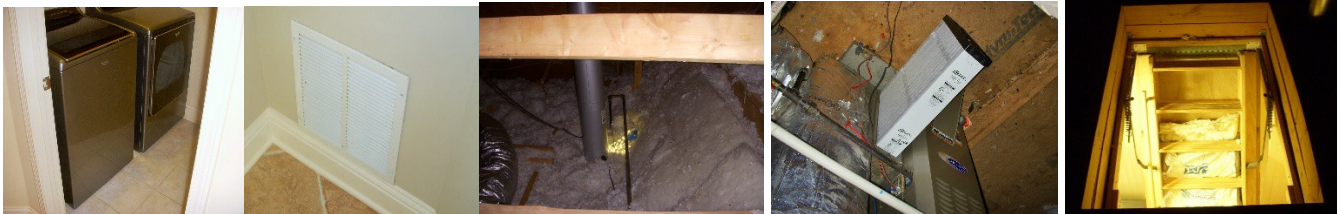
37. There is not a utility catch pan under the clothes washer, and a discharge pipe is not installed to connect a pan. A pan and pipe is strongly recommended to prevent water damage to the house should washer overflow and leakage occur.

38. There is no evidence of a gas connection in the event a gas clothes dryer is preferred. However, a gas supply pipe can be installed through the ceiling in the laundry room.

39. Jetted tub motor access openings are required to be large enough to access the tub motor for service and repair. The motor under the master bathtub does not meet this requirement.

40. There is no reasonable explanation for “cord lights” to be lying on the attic floor next to a furnace vent pipe.
41. It appears the furnaces were last serviced on 5-18-19. However, I recommend cleaning and servicing the furnaces before closing, and cleaning professionally all air ducts.

42. The thermostat wire lying in the passageway to the attic furnace is a trip hazard. This set of wires need routing of the passageway and work space at the furnace. To leave these wires in place could result in the wires being ripped from the furnace.

43. A protective railing should be installed across the furnace end of the walk board and along the right side of the access opening; though not a code requirement.
