# Inspection Report

**Property Address:**  
3127 Lenox Rd NE, Unit 41  
Atlanta GA 30324

<b>Date:</b> 1/14/2020	<b>Time:</b> 12:15 PM	<b>Report ID:</b>
<b>Property:</b> 3127 Lenox Rd NE, Unit 41 Atlanta GA 30324	<b>Customer:</b> Jeanette Brummell	<b>Real Estate Professional:</b> Alex Dallas Preferred Choice Realty

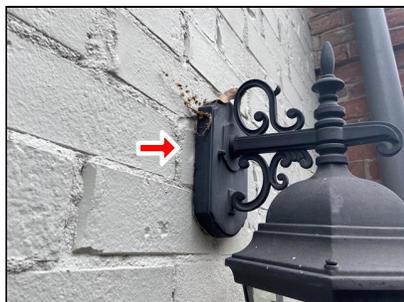
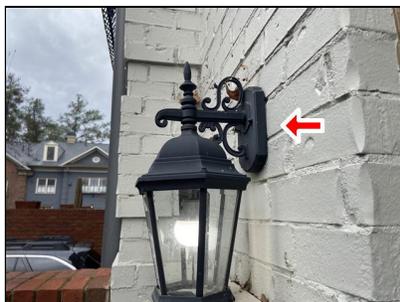
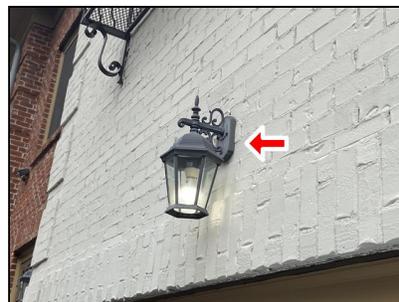
-The bases of the exterior light fixtures installed next to the exterior doors around the perimeter of the house should be sealed where they meet the brick siding to prevent water entry into the wall cavity and wiring connections.

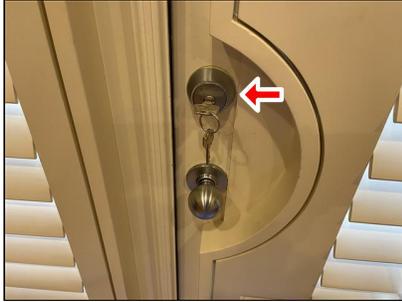
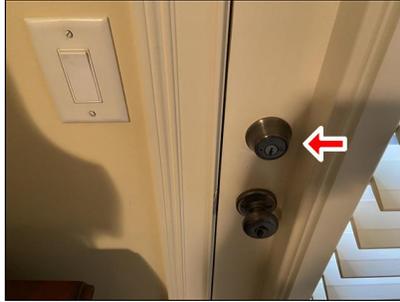
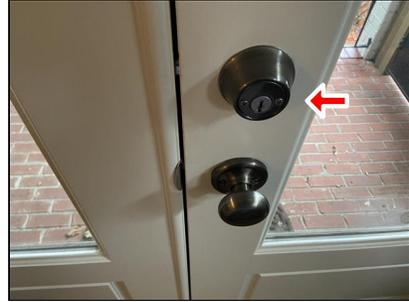
-It is recommended that the keyed dead bolts installed on the exterior doors be replaced with dead bolts that do not need a key to exit for emergency escape purposes.

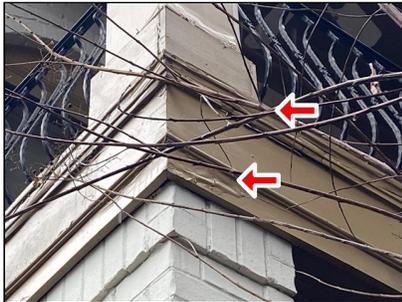
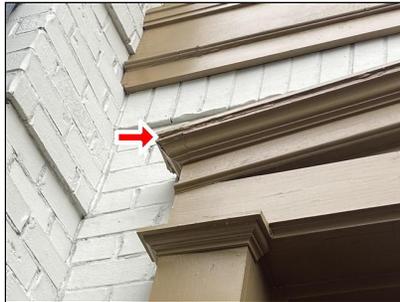
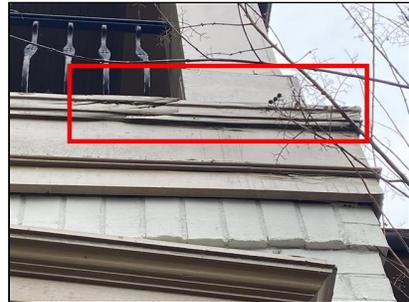
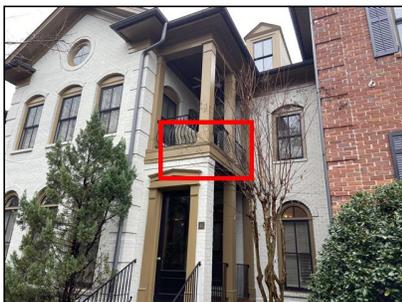
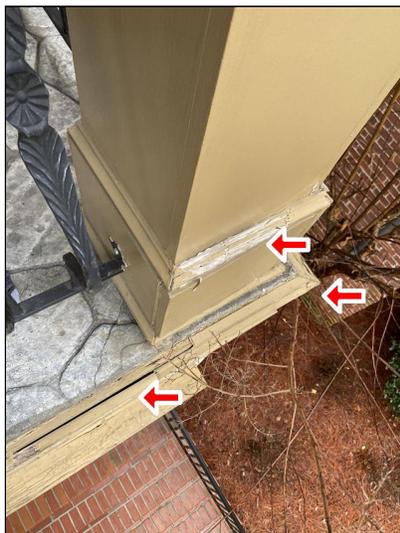
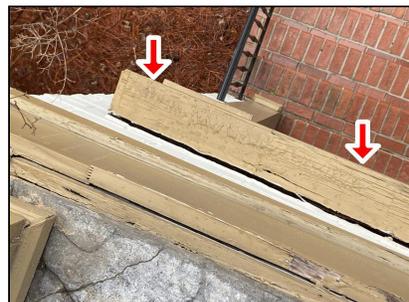
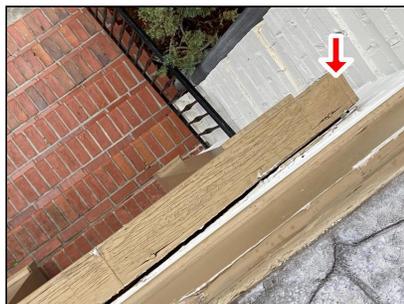
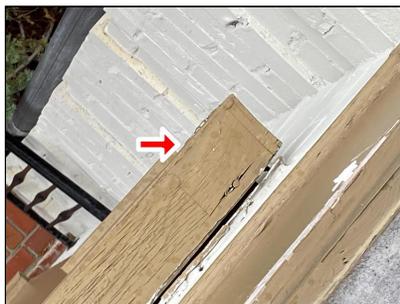
-Properly repair or replace water damaged wood at the front right corner of the upper balcony. The tree limbs/branches making contact with the wood at this area may be the cause. Have these limbs removed. Repair or replace water damaged wood trim along the top of the front porch (see photos).

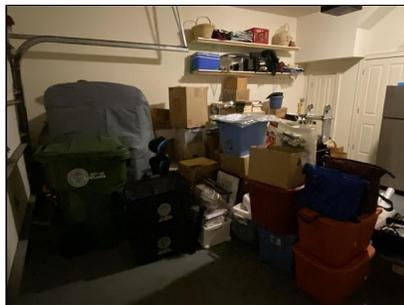
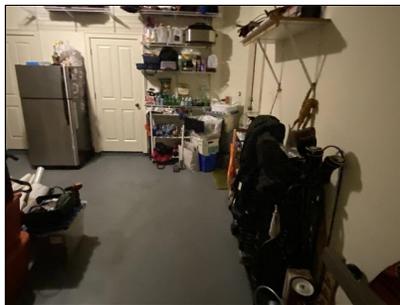
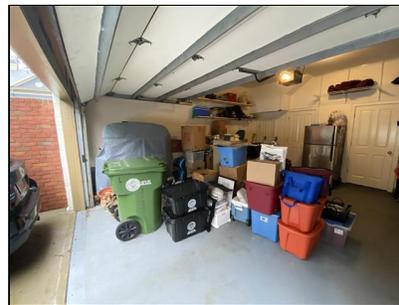
-The garage inspection was limited due to a large amount of stored items being in the garage at the time of the inspection. No problems were noted at the accessible areas.

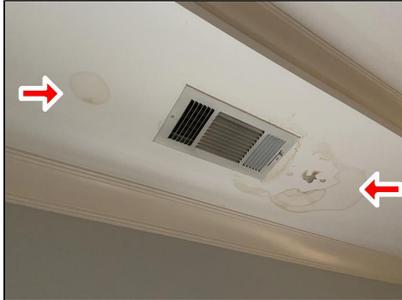
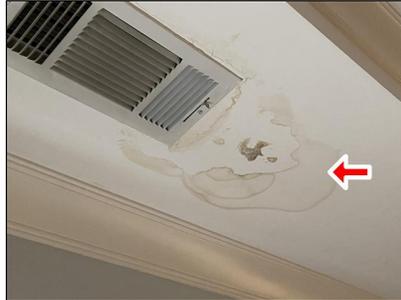
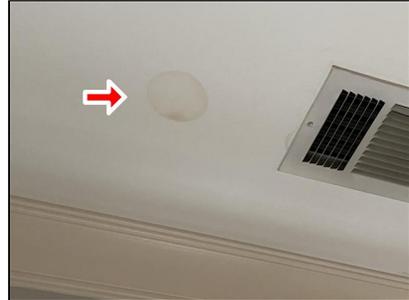
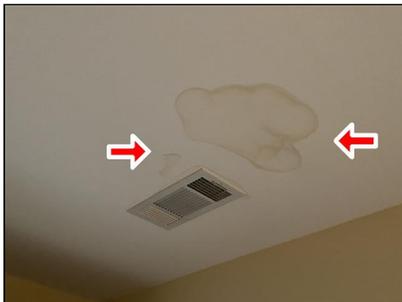
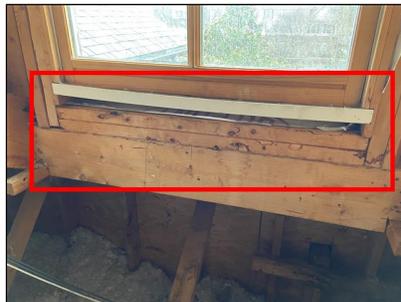
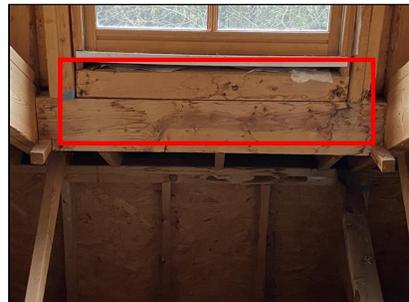
-Water stains and evidence of roof leaks on the drywall ceiling at the rear of the sitting area of the master bedroom. Water stains and evidence of leaks also on the drywall ceiling at the front of the front right bedroom. Upon further inspection water stains and evidence of previous leaks were noted on the framing at the bottom of the dormer windows right above these areas. All stains were dry and as per the sellers property disclosure the HOA repaired/ replaced the dormer windows and this fixed the problem.

-Water stains and evidence of roof leaks on the drywall ceiling at the rear of the sitting area of the master bedroom. Water stains and evidence of leaks also on the drywall ceiling at the front of the front right bedroom. Upon further inspection water stains and evidence of previous leaks were noted on the framing at the bottom of the dormer windows right above these areas. All stains were dry and as per the sellers property disclosure the HOA repaired/replaced the dormer windows and this fixed the problem.

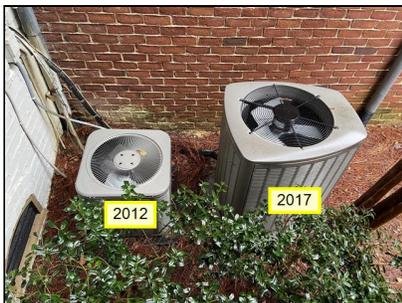
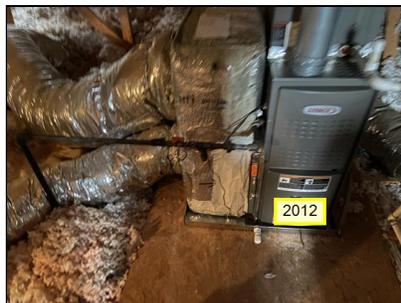
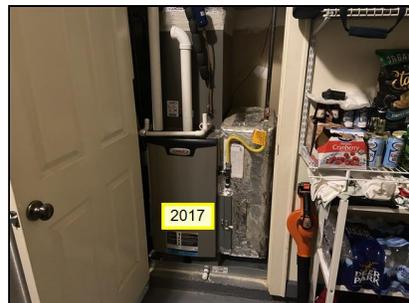
(1) -The heating and cooling units for the main level are 3 years old and the heating and cooling units for the upper level are 8 years old. The heating and cooling systems for both levels were tested for a short period of time during the inspection and they were working; however, much of an HVAC system is concealed from view during a normal home inspection and our inspection is basic in scope. As per the labels/stickers on the units the systems have been periodically serviced and no problems were noted at the time of the inspection.

(2) -The sediment trap installed on the gas pipe where it connects to the attic unit is installed according with the building requirements when the house was built. Those requirements have changed with the time and few gas companies are now requiring that this sediment trap be updated to meet new code requirements.

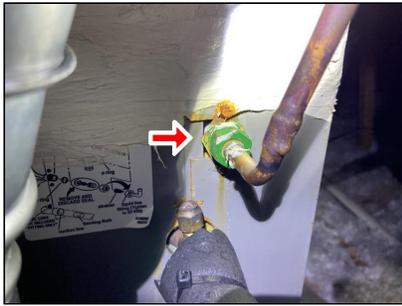
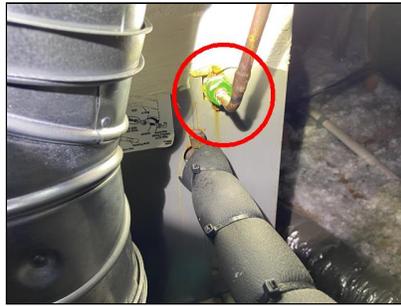
(3) -Minor condensation leaks were noted on the refrigerant pipe where it connects to the attic unit. Have an HVAC contractor evaluate to make repairs as needed.

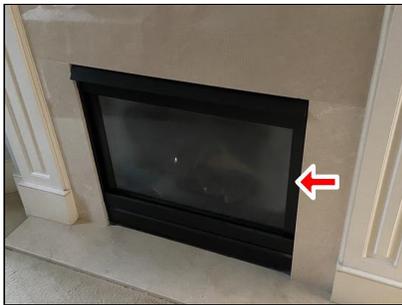
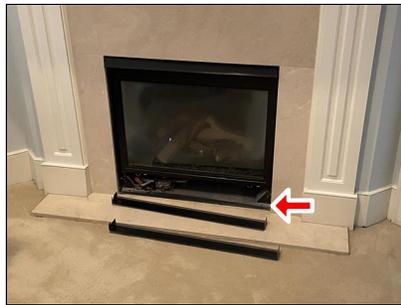
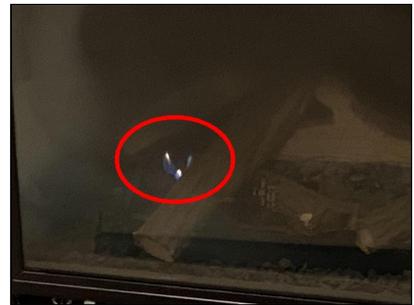
-The pilot light for the fireplace at the sitting area of the master bedroom was on but this fireplace did not operate when it was tested. Have it repaired or replaced. The glass on this fireplace is fogged and should be replaced.

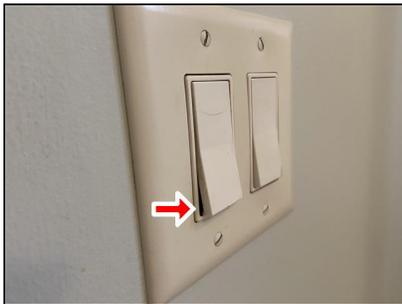
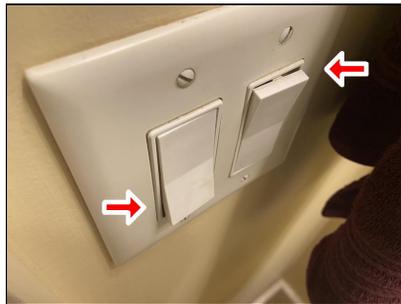
-Wall switches at the master bathroom and the wall switches at the main level half bathroom are broken and they should be replaced.

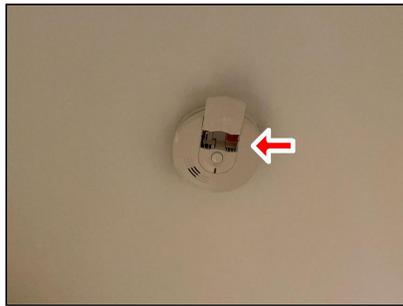
7.7 Item 1(Picture)

(2) -Replace missing batteries on the smoke detector at the upper level.

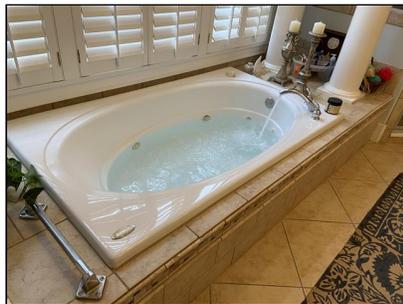
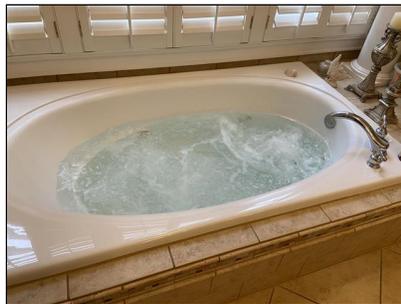
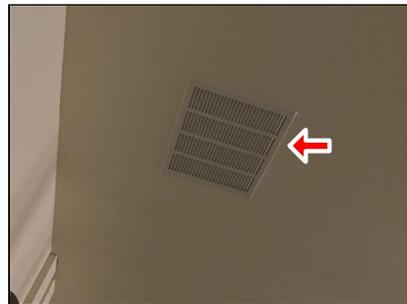
(1) -The jacuzzi motor at the master bathroom was tested and it was working. No leaks or problems were noted on the garage ceiling under this tub after the motor was tested. The access panel to the motor on the ceiling was not cut and it could not be removed.

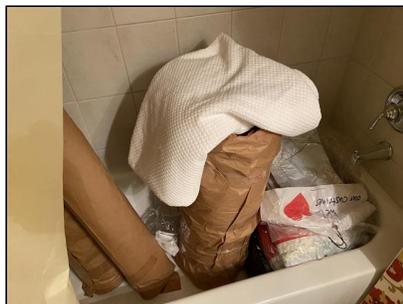
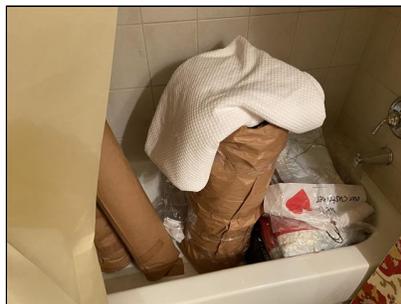
(2) -Due to stored items on the front left bedroom bathroom tub, this tub could not be tested. Have the seller ascertain that it is functional and leaks free.

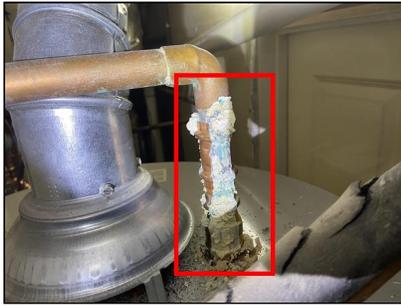
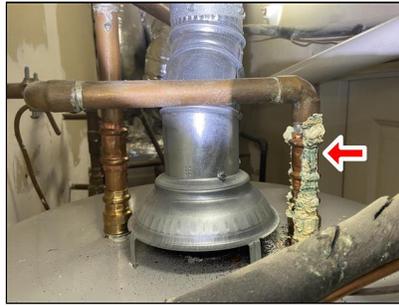
(3) -Rust and evidence of leaks on the water pipe above the water heater (see photos). Have a plumber repair.

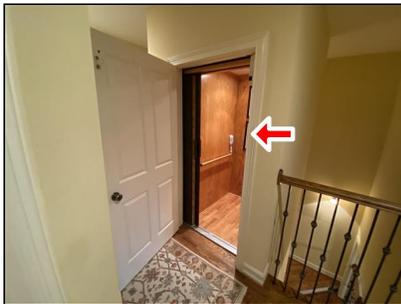
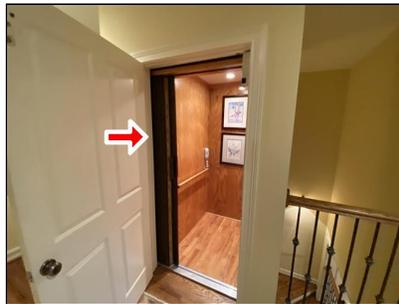
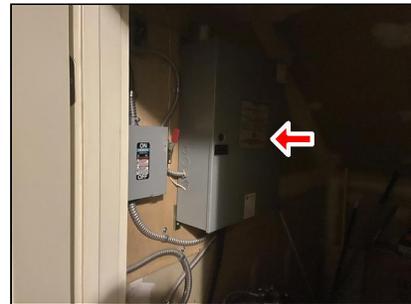
-The elevator was tested couple times during the inspection and it was working.

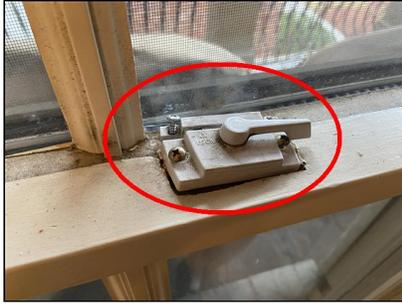
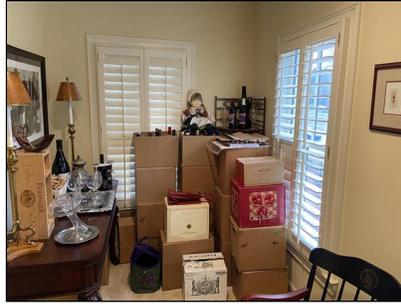
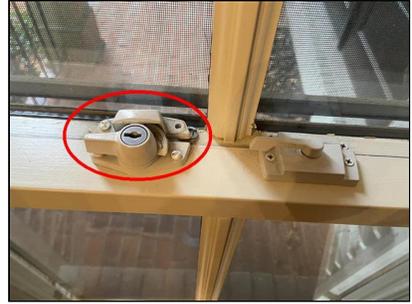
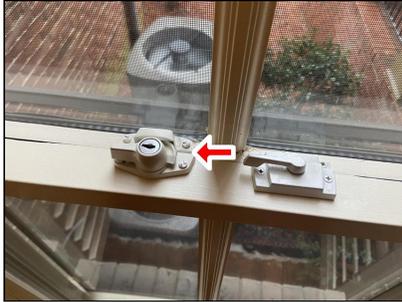
-Sash lock at the front right bedroom bathroom window is broken and needs to be replaced. The front dining room windows were locked and they could not be tested. Windows are emergency exits. It is recommended that these locks be removed. The windows at the front right of the front left bedroom were blocked and they were not tested.
