Inspection Report

**Property Address:
554 Vinings Estate Dr SE
Mableton GA 30126**

Inspector: Brandon Williams

**Residential Inspector of America
3276 Buford Drive, Ste. 104-306
Buford, GA 30519
770.476.4963**

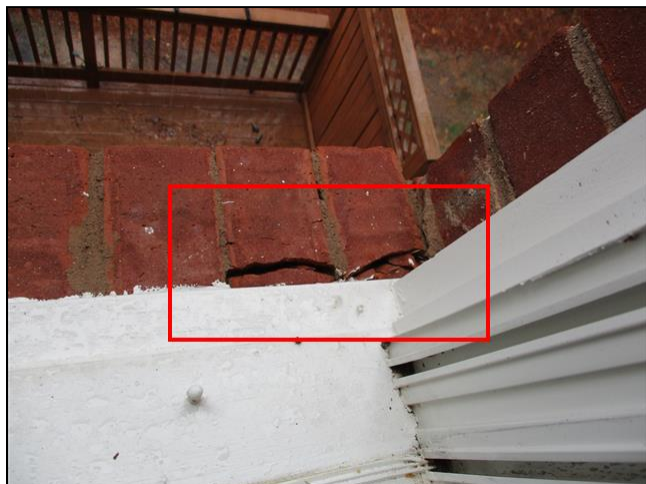
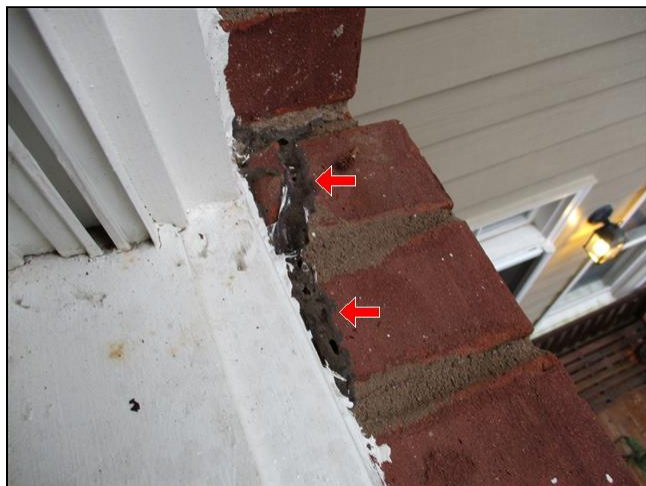
(2) Cracks found in the brick veneer/sill at several windows around the home. See photos for examples. Have a brick mason evaluate brick window sill areas and make all repairs/replacements as needed

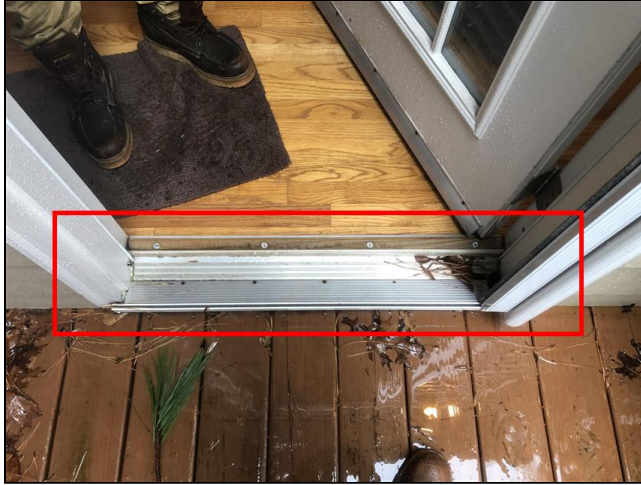
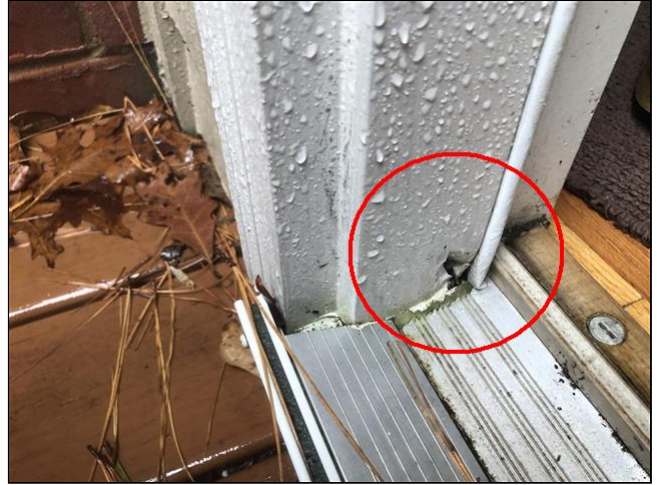
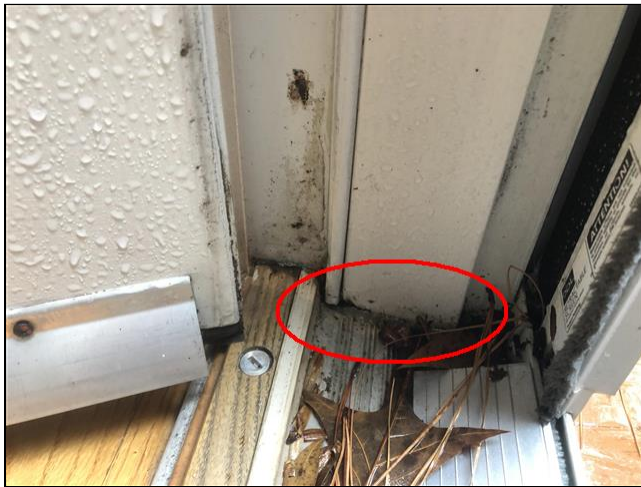
🔧 (2) Minor rot damage on the lower part(s) of the rear deck door. Repair or replace damaged wood. See photo(s). This is a common area for damage and will need to be maintained. This is a common area for damage and will need to be maintained. Damage appears to be due to the valley type shape that the sliding screen door threshold creates and traps water in this area.

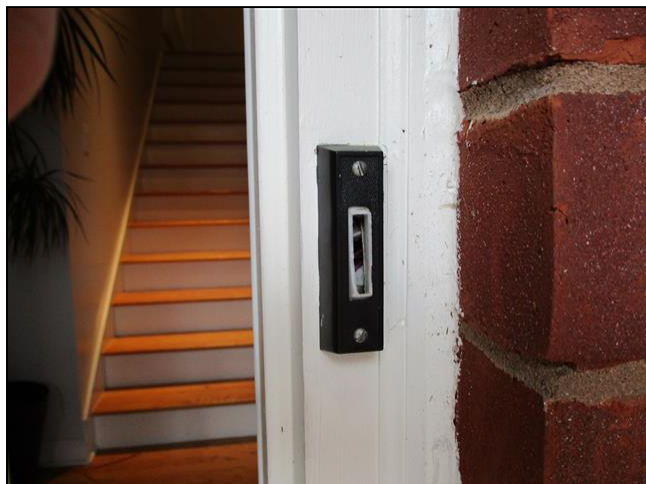
1.2 Item 4(Picture)

(3) Door bell for the front door is functioning at time of inspection. Door bell button is broken, recommend replacement..

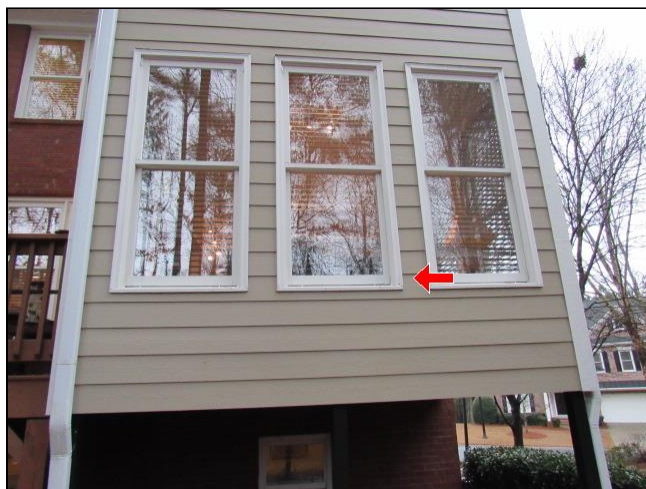
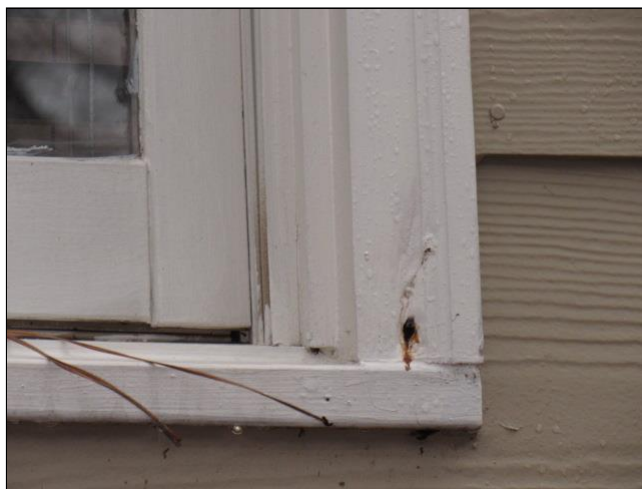
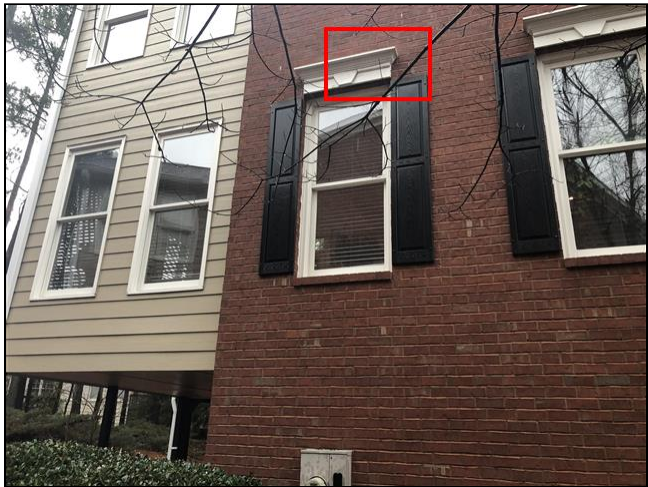
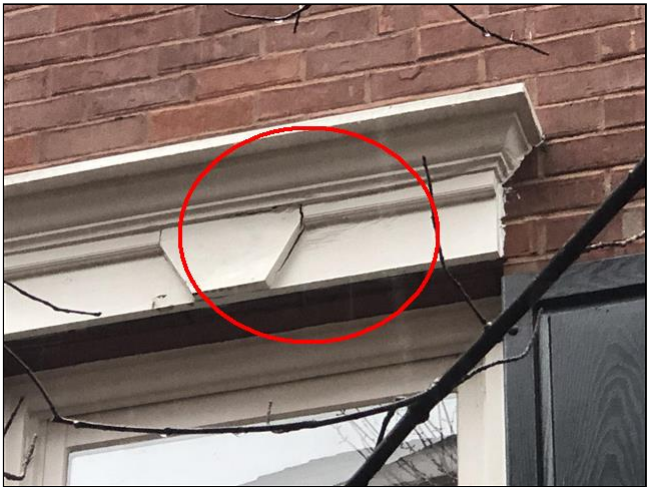
🔧 (1) Water damaged wood found on rear main level sitting room window and right side trim over window. Have contractor evaluate and have all damaged wood replaced. Extent of damage behind siding, if any, is not visible and is not known. See photos for locations

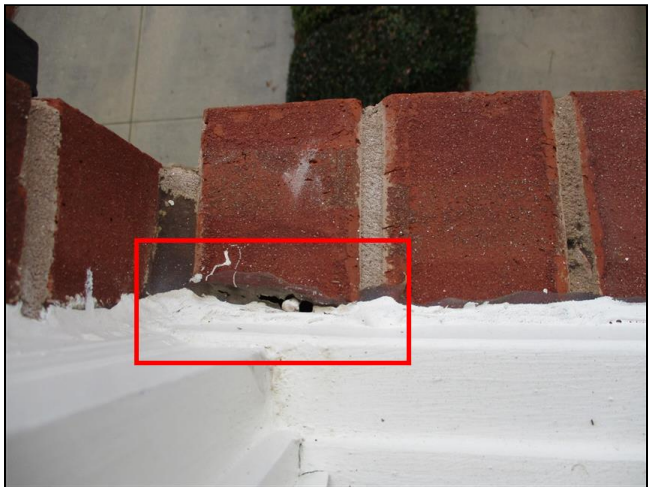
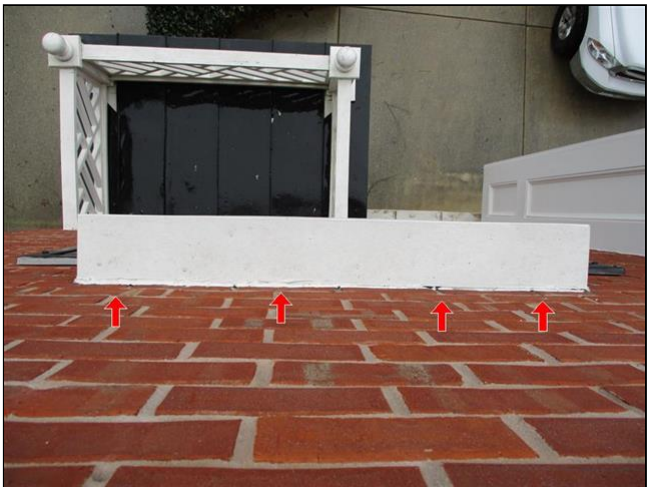
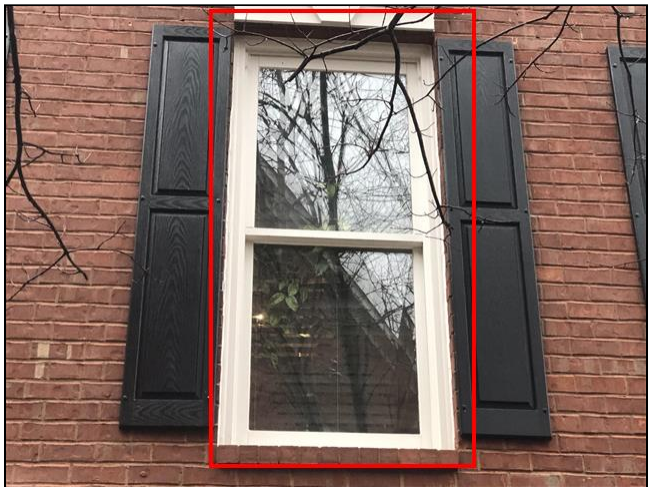
(2) As part of general maintenance it is recommended to seal the exterior trim around windows to the brick veneer to prevent any possible water or air leaks.

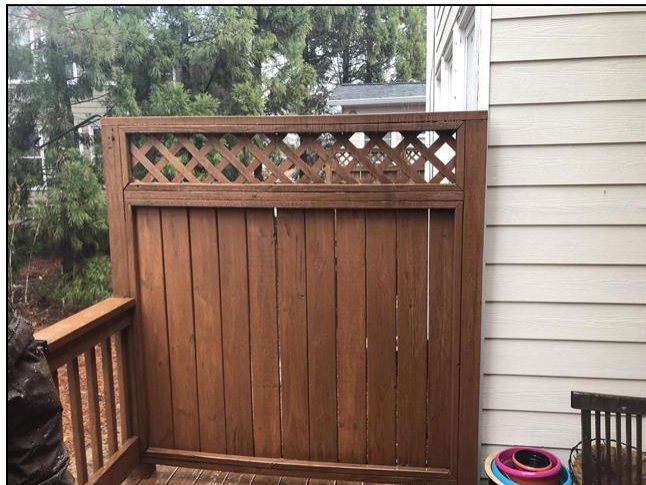
1.4 Item 1(Picture)

🔧 (2) Guard rail/fence on rear deck is loose and need additional bracing and/or fasteners to reduce the amount of movement on the rails. See photo for location.

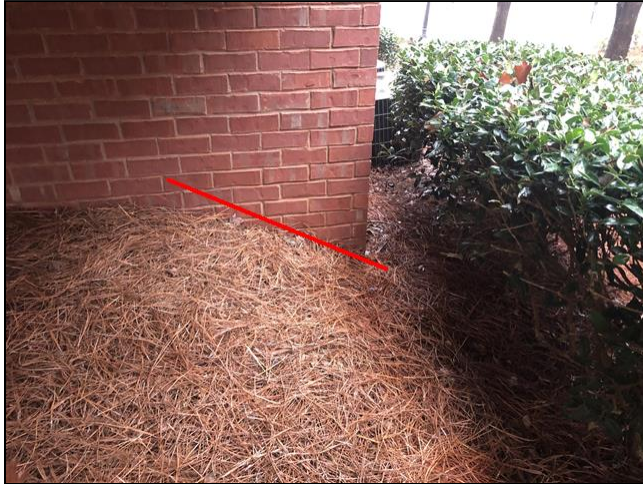
1.5 Item 1(Picture)

the foundation area during conditions not present during the inspection. Poorly graded soil can lead to water intrusion into the foundation areas. See photo(s). Buyer should resolve all concerns prior to closing.

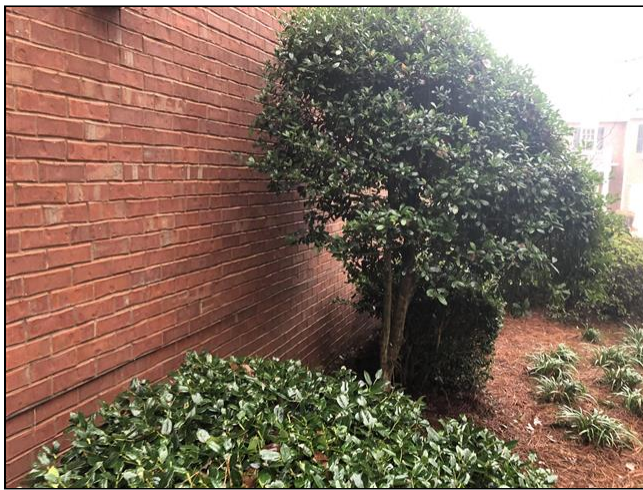
1.5 Item 2(Picture)

(2) Trim vegetation away from house siding. It is best to have a clear path around the house.

The tree limbs that are in contact with roof or hanging near roof should be trimmed.

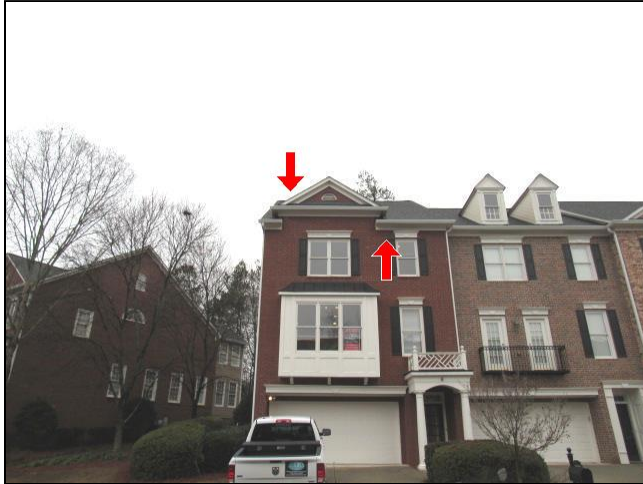
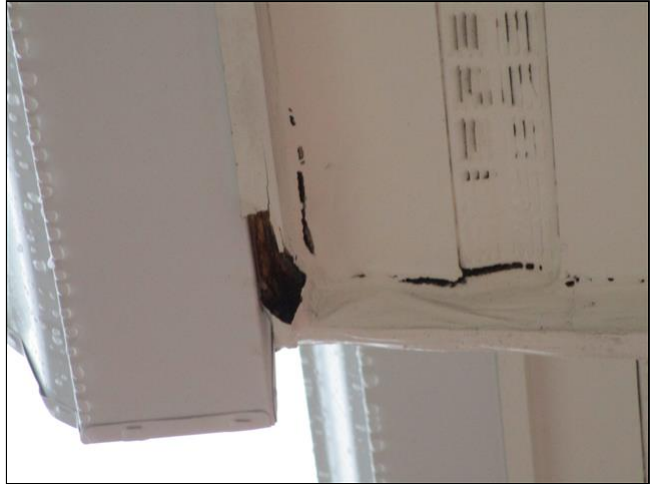
Water damage found on soffit and fascia trim at two areas at the front of the home. See photos for locations. Have contractor evaluate all soffit/fascia and have all damaged wood replaced.

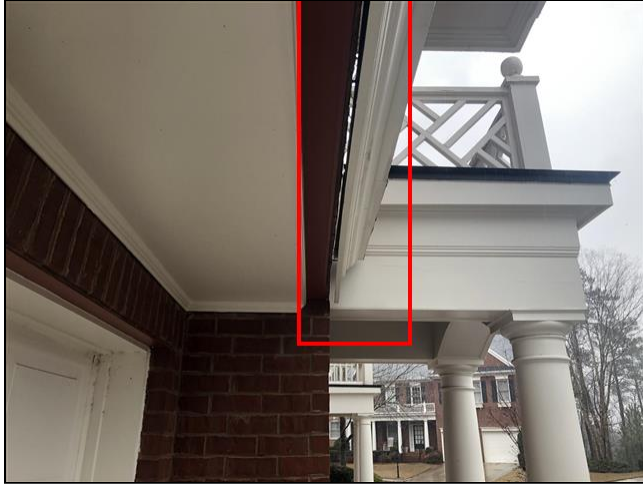
1.7 Item 1(Picture)

Secure loose trim board over the garage door opening seen in photo

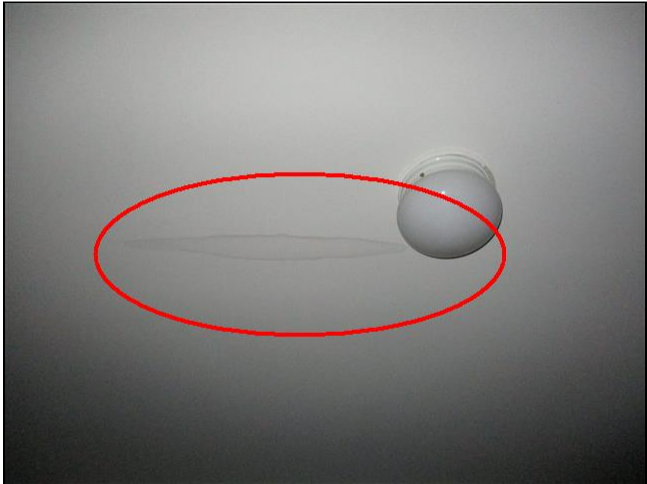
2.0 Item 1(Picture)

Old water stain found on the ceiling in the garage. Stains were not wet at time of inspection, but conditions may change and stains may become wet again. Buyer should resolve all concerns prior to closing.

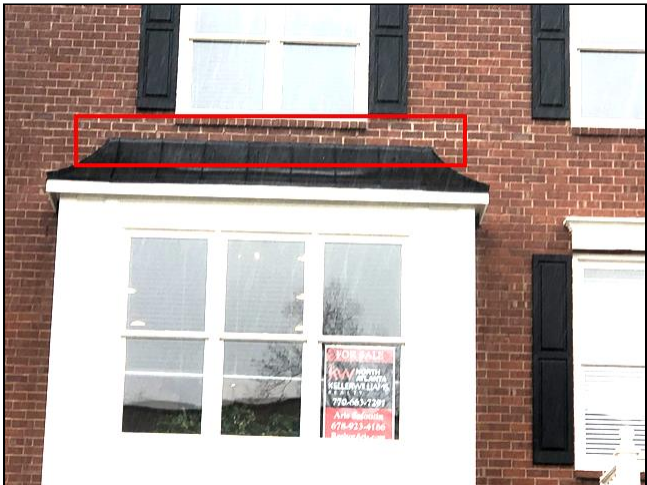
4.1 Item 1(Picture)

(1) Metal roof to brick junctions needs to be maintained to prevent leaks into the wall cavity. Metal roofs tend to pull away from the brick and water can leak into gaps.

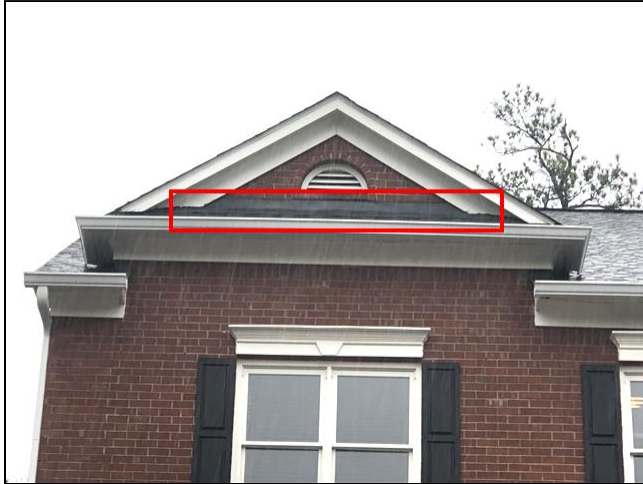
4.1 Item 2(Picture)

(2) Metal flashing to brick wall seal needs to be maintained to prevent leaks into the wall cavity. Metal flashing tend to pull away from the brick and water can leak into gaps.

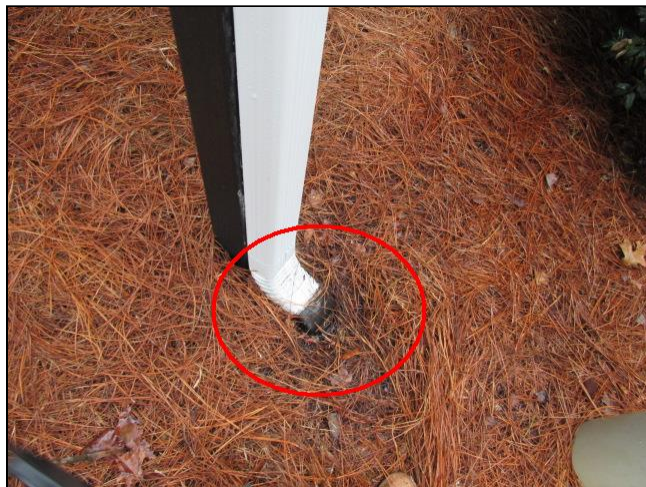
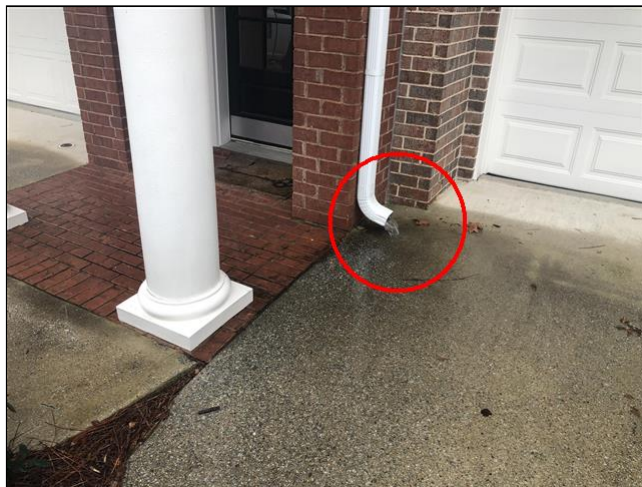
Have owner point out location of the outlets of the buried down spout extensions. They should come to daylight and the ends were not found.

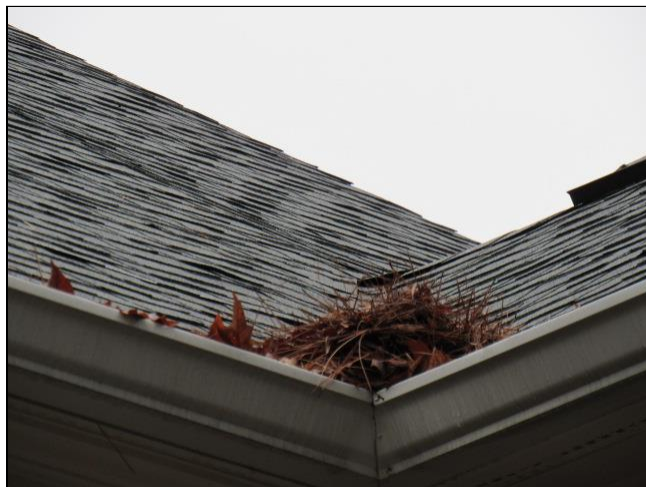
4.3 Item 3(Picture)

🔧 (2) The gutters are full of debris in areas and needs to be cleaned. The debris in gutters can also conceal rust, deterioration or leaks that are not visible until cleaned, and I am unable to determine if such conditions exist.

Gutter guards are recommended over the gutters to prevent leaves from clogging gutters. Over flowing gutters often cause water damage on siding and trim, and cause water entry into walls and basements.

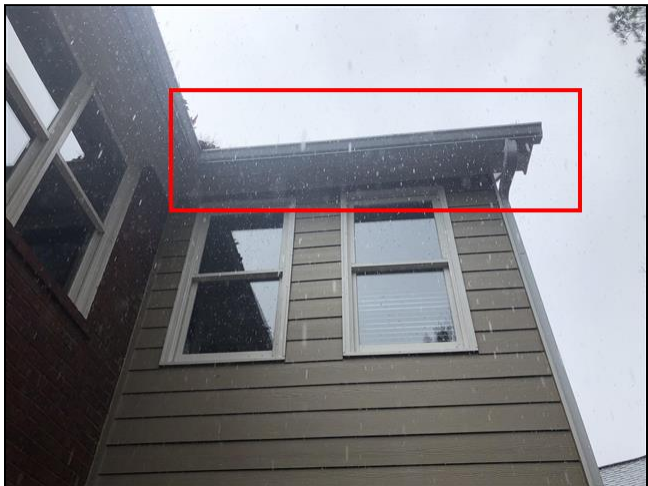
4.3 Item 4(Picture)

🔧 (3) Gutter over rear deck is full of debris and overflows when raining, have cleaned and ensure it is properly sloped towards the downspout.

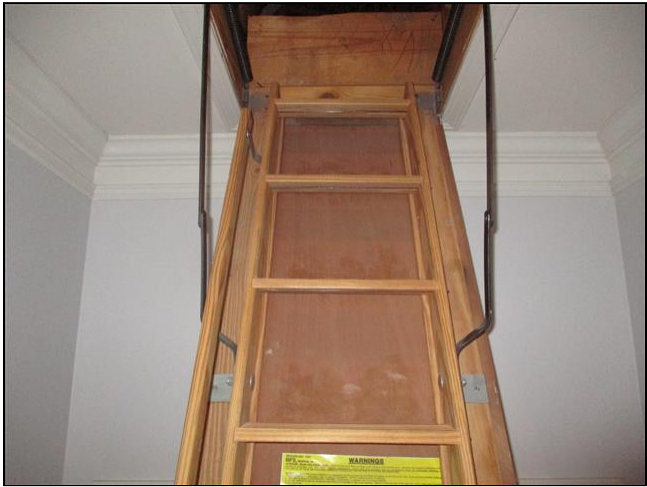
5.0 Item 1(Picture)

Weather strip and insulation of some type (recommend foam board insulation) needed over the attic pull down steps.

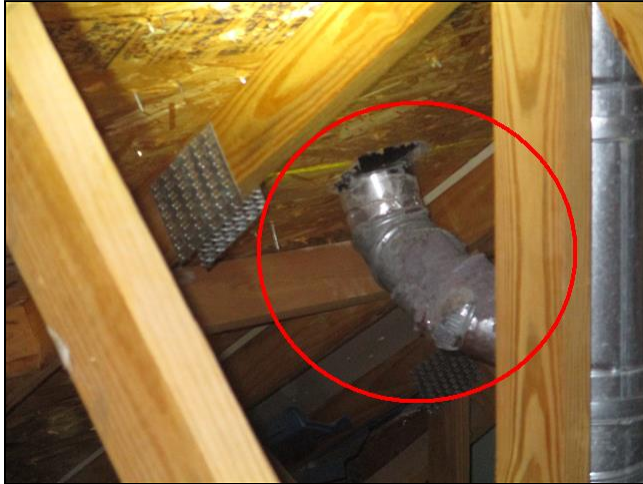
5.4 Item 1(Picture)

Dryer vent in the attic was detached at the roof, lint build up noted. Have dryer vent pipe cleaned and reattached

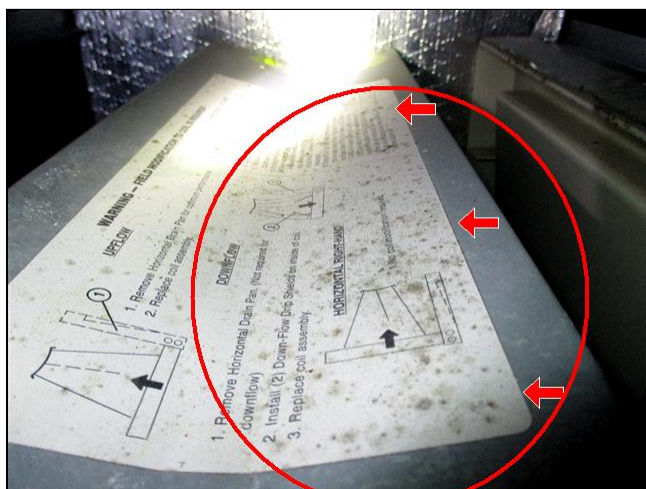
6.0 Item 3(Picture)

🔧 (4) Minor mold growth found in the interior of the air handler. See photo for example. Have hvac tech evaluate and treat/remove

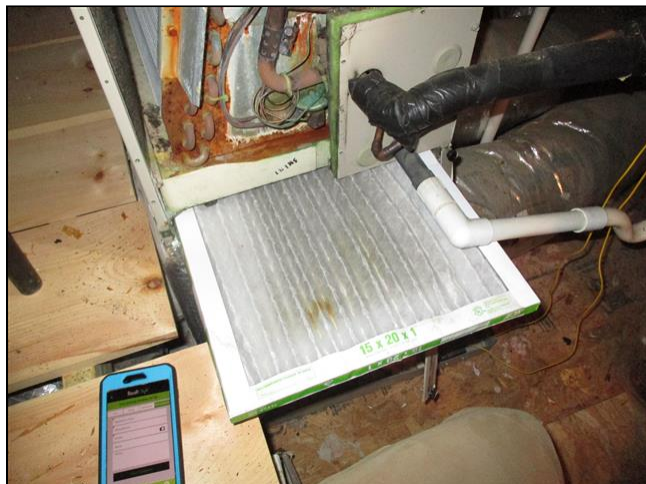
6.2 Item 1(Picture)

Basement filter is the washable type and is ready to be cleaned. These filters should be cleaned about once a month

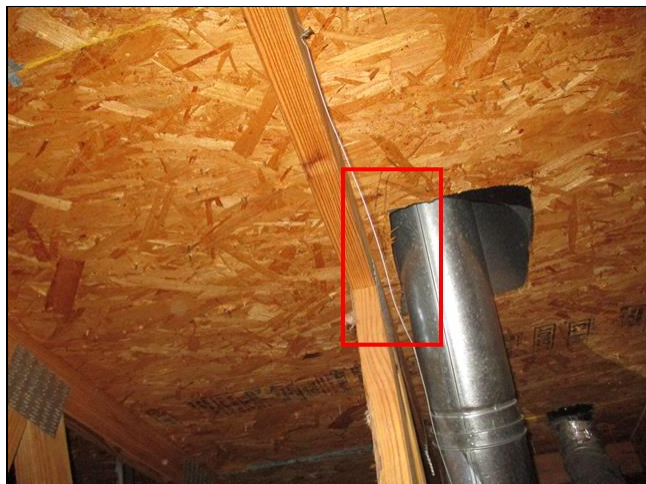
6.4 Item 1(Picture)

(1) Gas vent pipe in photo is too close to combustible material. At least one inch clearance is needed for this type of vent pipe. Have hvac tech correct.

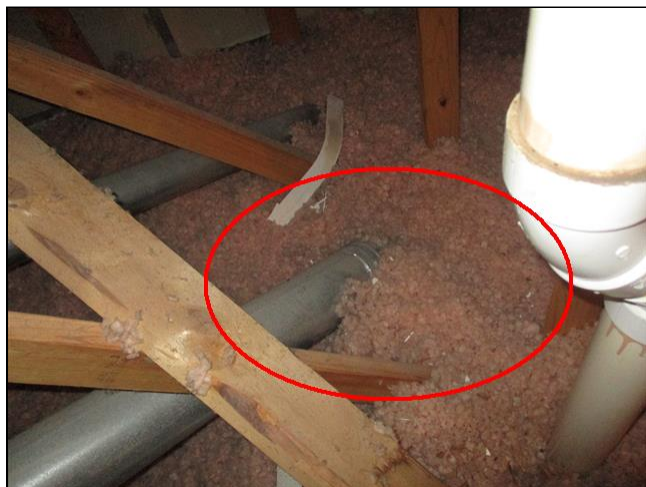
6.4 Item 2(Picture)

- 🔧 (2) The insulation is resting against the gas exhaust flue pipe in the attic. Hot spots can develop when insulation is against the pipe and cause fires. Move insulation away or install an insulation/heat shield around the pipe

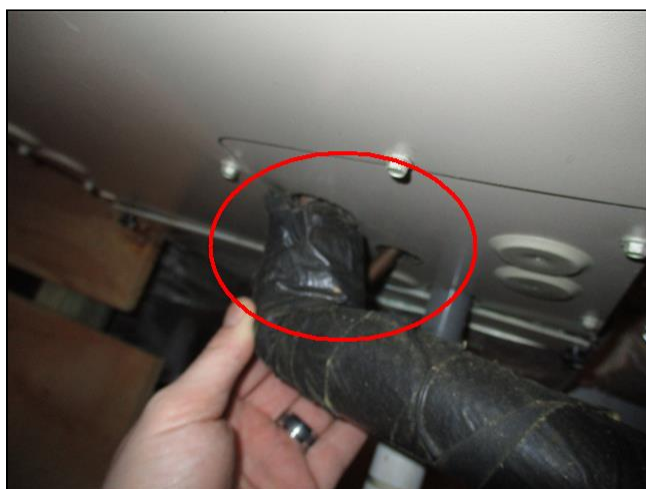
6.7 Item 1(Picture)

- 🔧 (1) Seal the holes in the evaporator coils where the A/C lines enter the unit in the attic and basement.

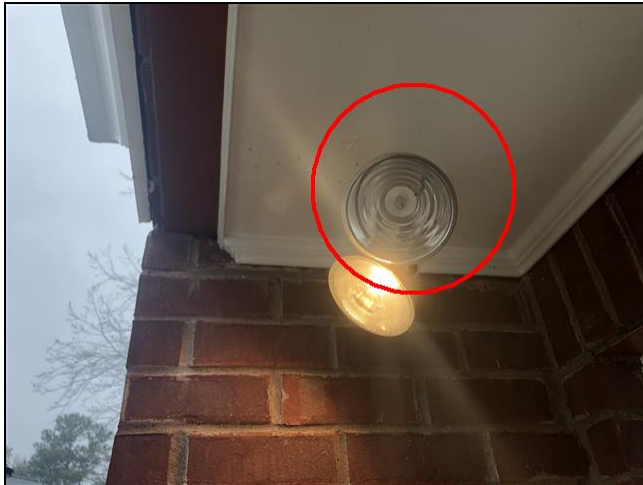
7.4 Item 1(Picture)

(2) Replace damage flood light by garage door

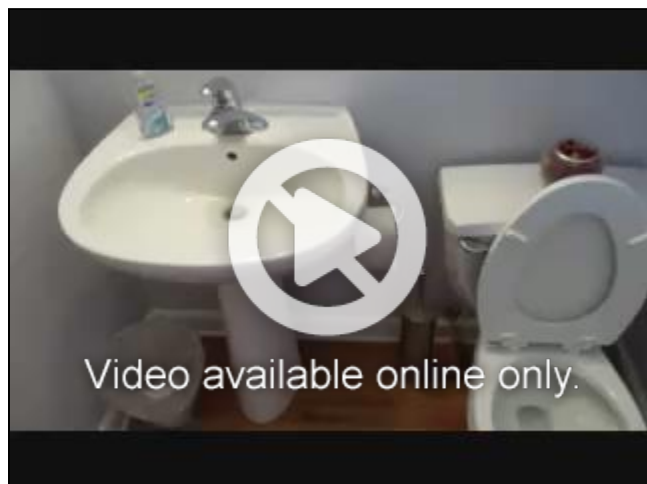
8.1 Item 2(Video)

🔧 (2) The half bath sink faucet was continuously dripping at time of the inspection. It is believed that some of the internal parts of the faucet are failing. Have plumber evaluate and repair/replace as needed. See video

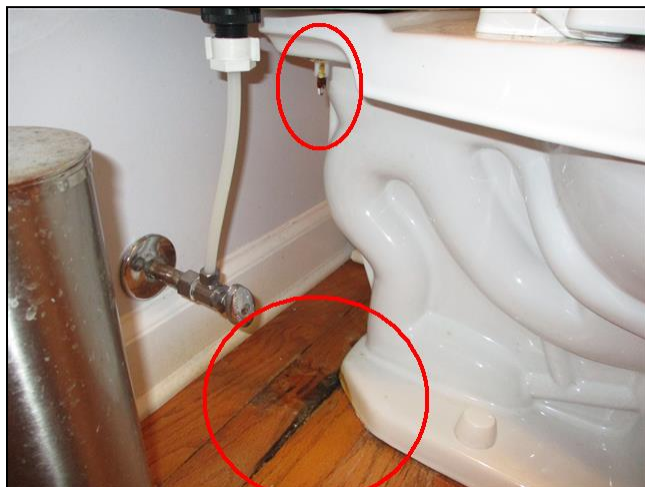
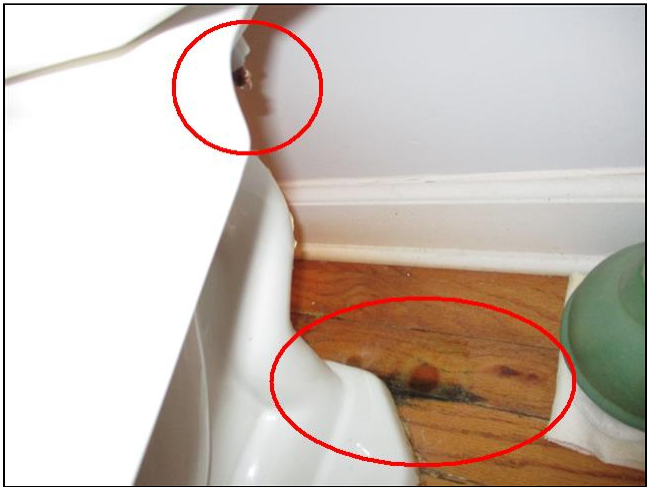
🔧 (1) Active leak at both tank bolts on the main level half bath toilet. These are dripping onto the hardwood flooring below and has caused some minor damage. Have plumber repair the leaking tank bolts, then have a qualified contractor evaluate flooring and repair/replace as needed

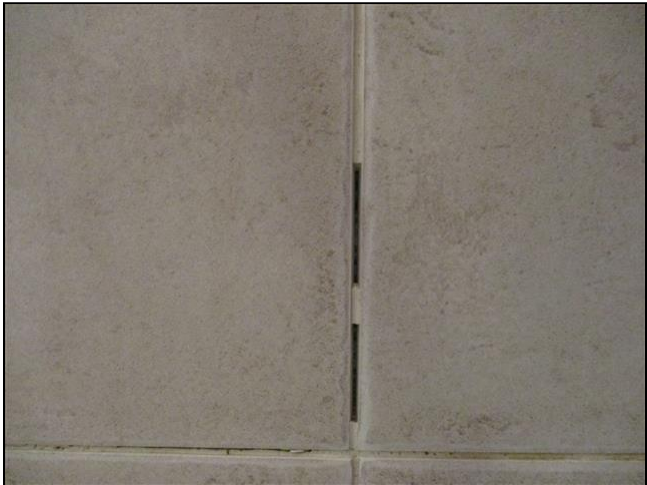
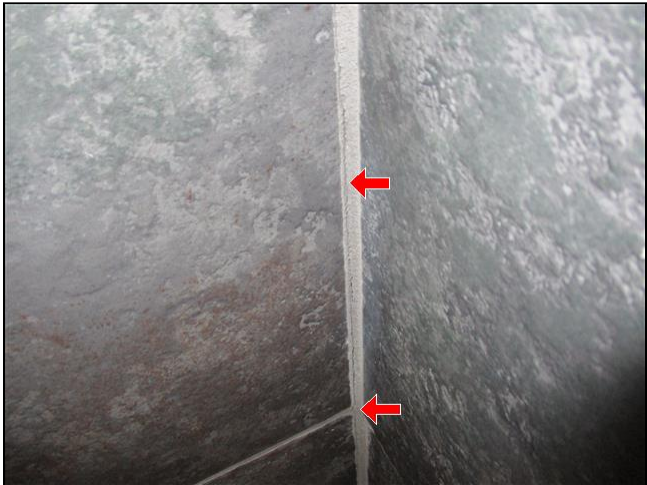
🔧 (2) Touch up grouting needed between tiles in master bath and basement shower stalls. Water can enter into the tile and get into wall. Condition of framing behind tiles in baths is unknown.

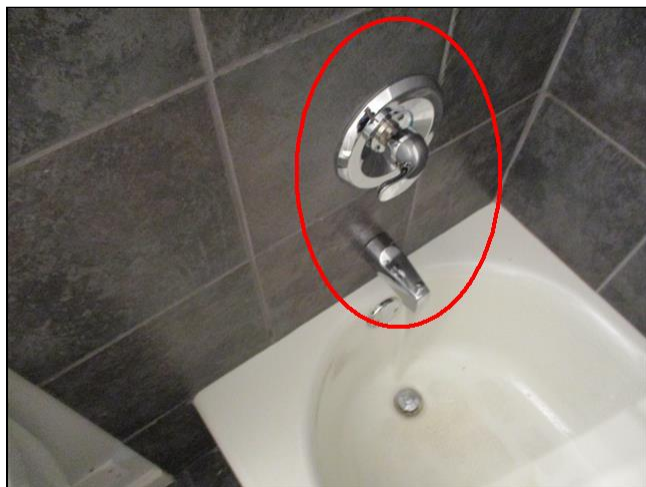
8.2 Item 8(Picture)

(3) Seal gaps around plumbing fixtures in shower stalls to help prevent water entry into the wall cavity behind.

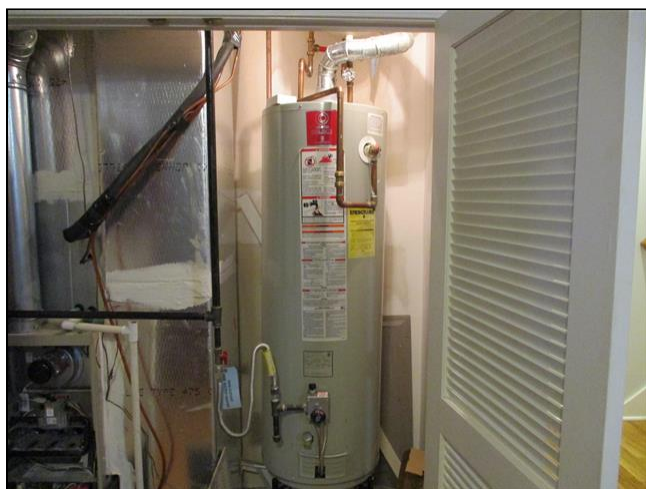
8.3 Item 1(Picture)

🔧 (1) Water heaters generally last about 10-12 years before needing replacement. Current water heater works and makes hot water but will likely need replacement in the near future due to its age. Unit 2002 model

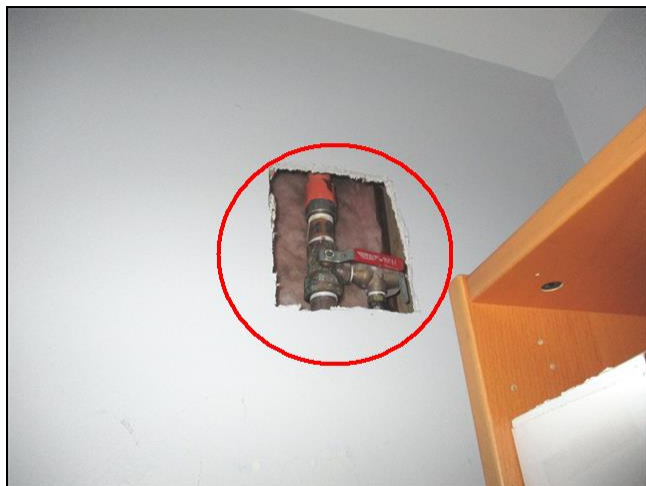
8.4 Item 2(Picture)

🔧 (2) The main water shut off to the sprinkler system in the rear righty basement closet appears to be in the off position. Confirm with current owner if they were the one to turn this off. If not, it is recommended to have a sprinkler company evaluate the system for any hidden defects

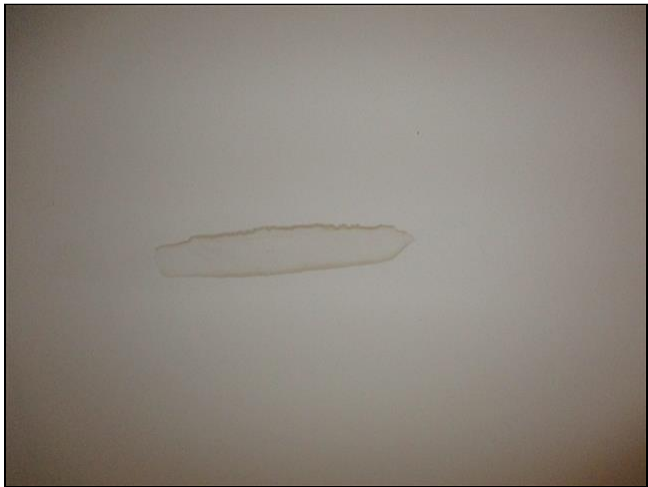
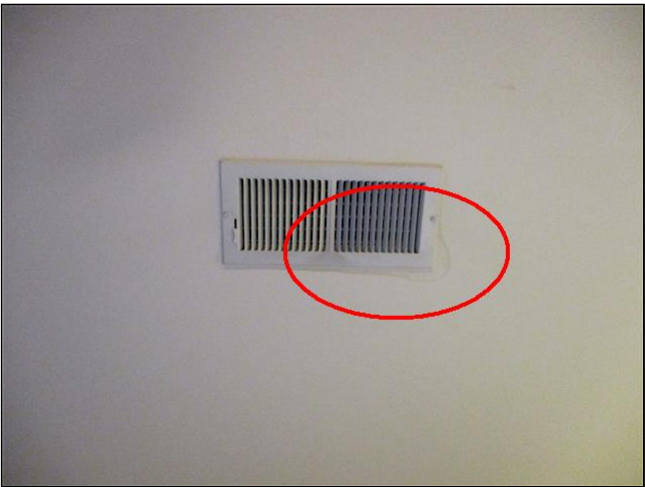
(2) Old water stains found on master bedroom ceiling from past leaks. Stains were not wet at time of inspection, but conditions could change and leaks could become active again. Before stains are sealed and painted over, buyer should resolve all concerns prior to closing. See photo(s).

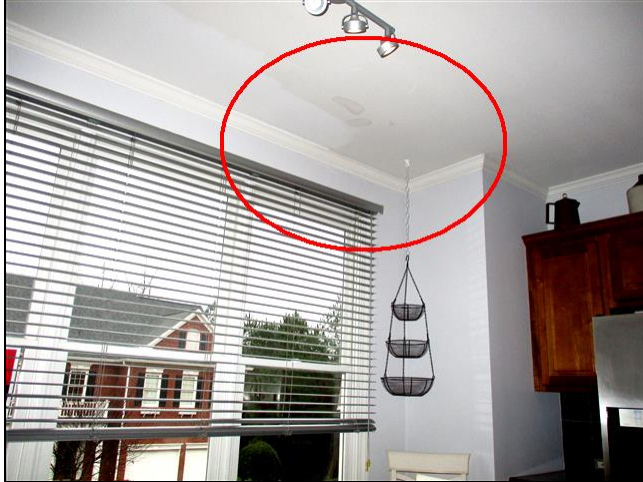
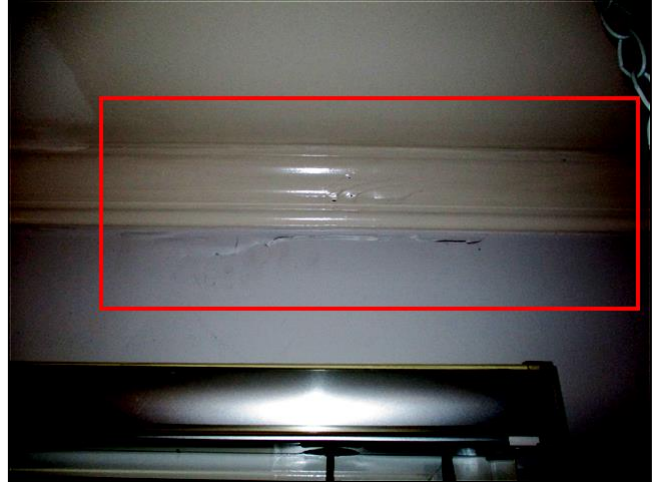
(3) Water staining and minor damage noted in the drywall ceiling and molding at the front kitchen dining nook. All stained areas were dry at the time of the inspection when tested with a moisture meter, but conditions could change and the leaks could become active again in the future. Staining and past water entry is believed to have entered into home through deteriorated sealant at the metal roof to brick wall junction on the exterior of the area. Sealant at this roof to wall junction was in good condition at the time of the inspection. Have any concerns resolved prior to closing

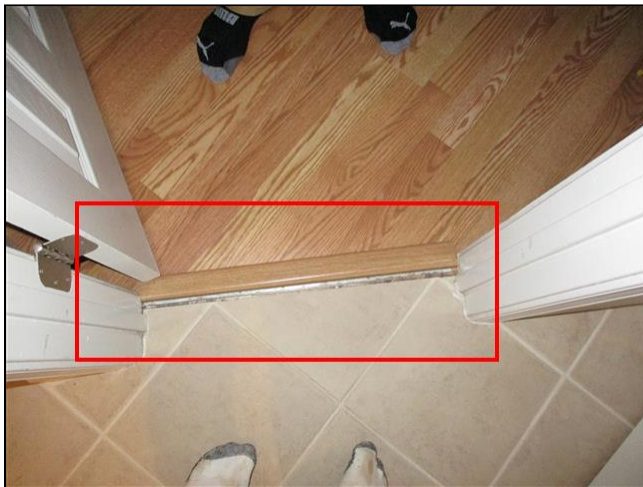
9.2 Item 1(Picture)

Secure loose flooring transition piece between the master bathroom and the master closet. See photo

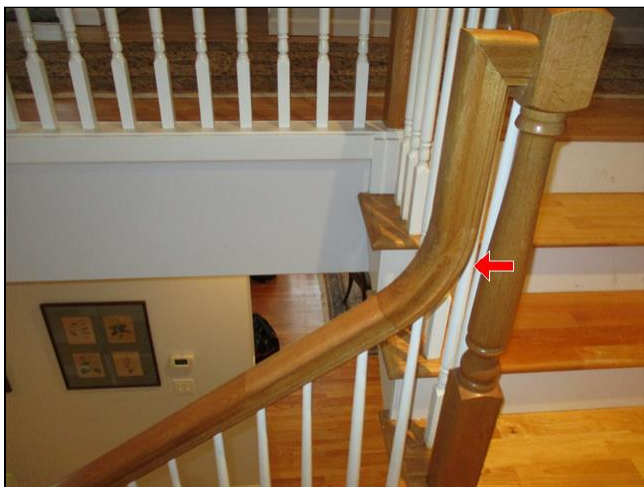
9.3 Item 1(Picture)

Minimal movement on guardrails at steps seen in photos. Have secured as much as possible.

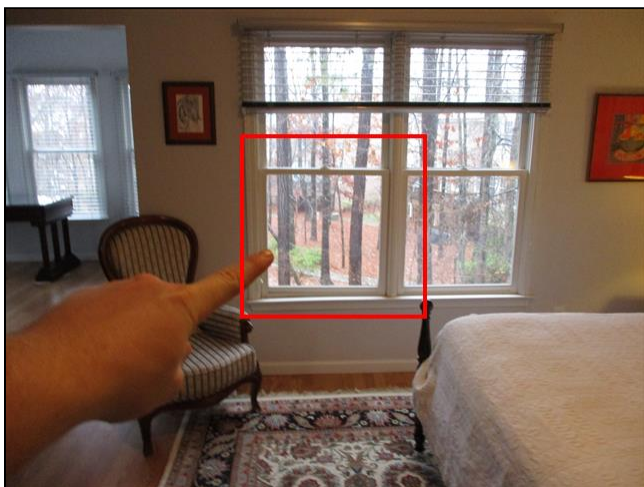
9.5 Item 1(Picture)

🔧 (1) The rear master bedroom window sash, seen in photo, is out of alignment and does not close all the way or lock. Have a window contractor evaluate and repair
