## HOME INSPECTION

01/13/20

5477 Woodsong Trail  
Dunwoody, GA 30338

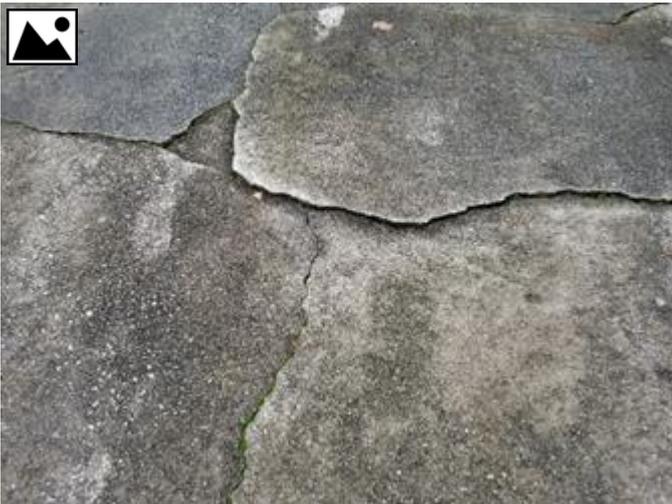
Issue The driveway has cracked and settled/heaved. Cracks may permit moisture to enter, which may cause further damage. Uneven walking surfaces may cause someone to trip and fall.
- Location Front
- Action *Repair and seal the driveway.*

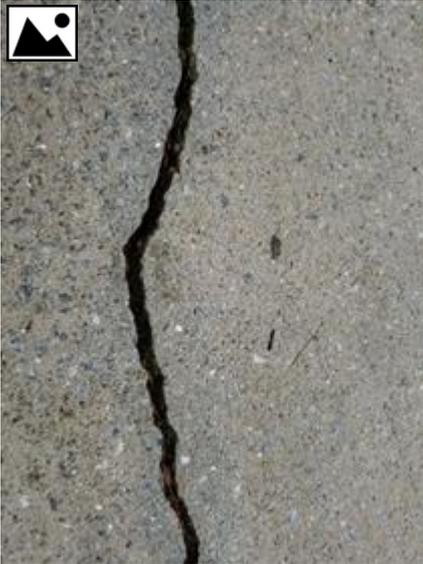
Issue The walk has cracked and settled/heaved. Cracks may permit moisture to enter and cause further damage. Uneven walking surfaces may cause someone to trip and fall.
- Location Front
- Action *Repair and seal the walk.*

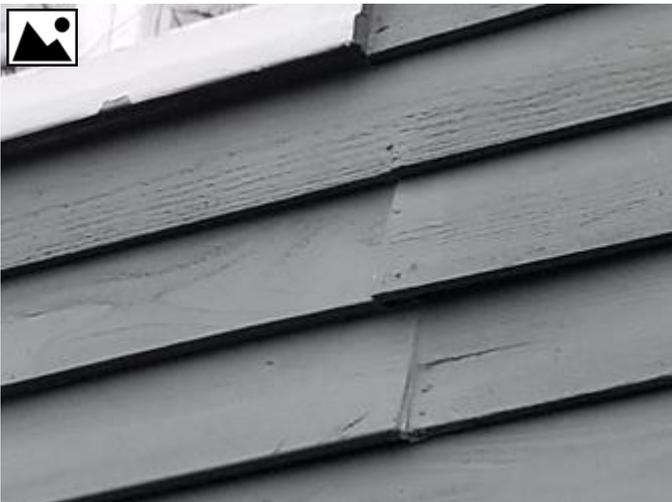
Issue There is loose siding. This permits moisture to enter. There may be hidden damage behind the siding.
- Location Right side, rear
- Action *Repair or replace the siding and repair any damage which may be revealed.*

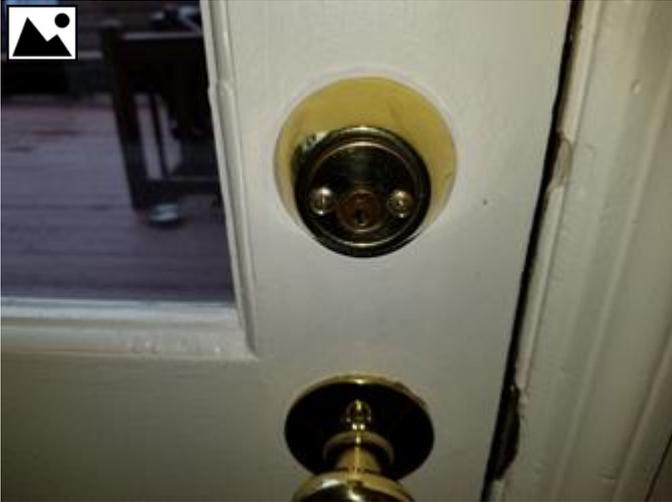
Issue There is a double-keyed deadbolt lock at the door. This is a safety concern if the key is damaged or missing during an emergency.

Action *Replace the door hardware with a single key locking mechanism.*

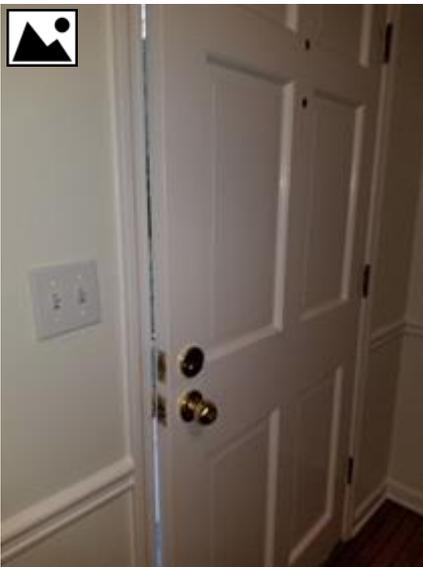
Issue The door does not fit and seal properly within frame. This permits energy loss and moisture intrusion.

Action *Repair or replace the door.*

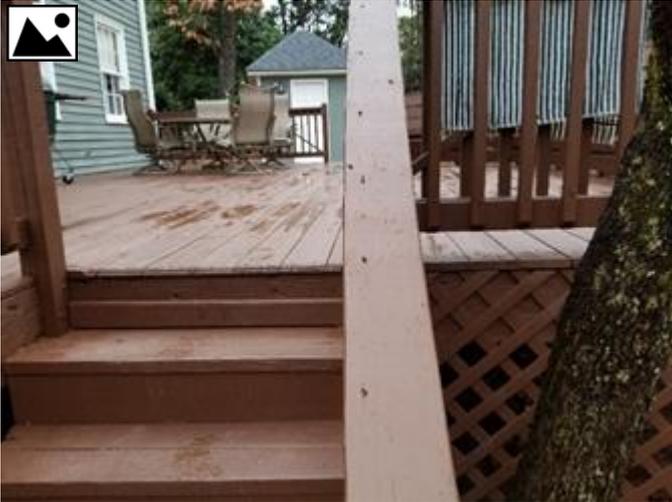
- 04 The handrail does not have a "graspable" profile, which may prevent a firm grip. This is contrary to accepted practices. This is a safety concern. **Location:** Rear. *Repair or replace the handrail.* [19](#)

Action *Repair or replace the handrail.*

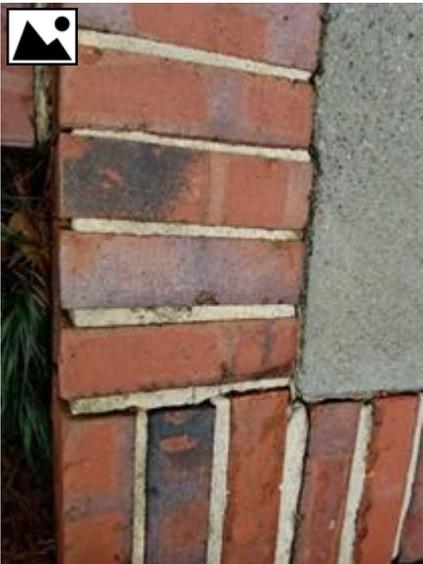
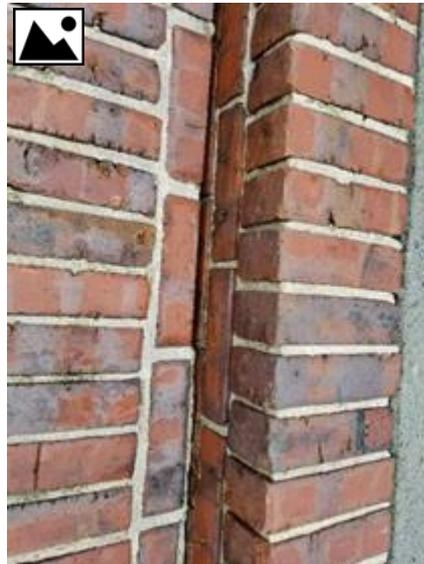
Issue The mortar joints are deteriorated. This permits water penetration into the structure and may lead to further damage.

Action *Repair the mortar joints.*

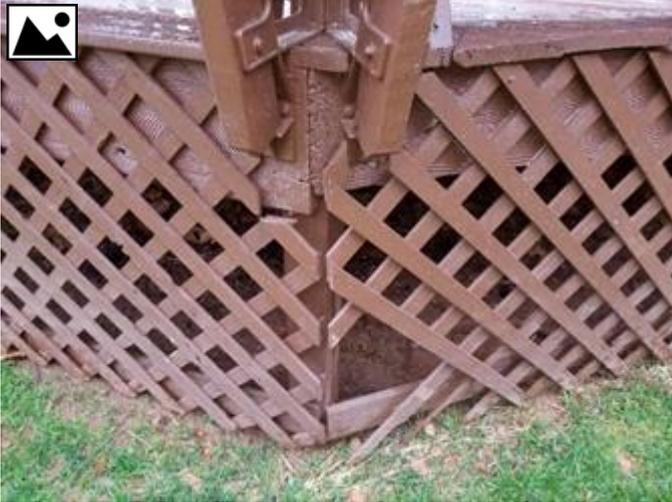
- Issue The posts are 6x4. Current code requires 6X6 posts.
- Location Rear
- Action *Replace the posts with 6X6 posts as needed.*

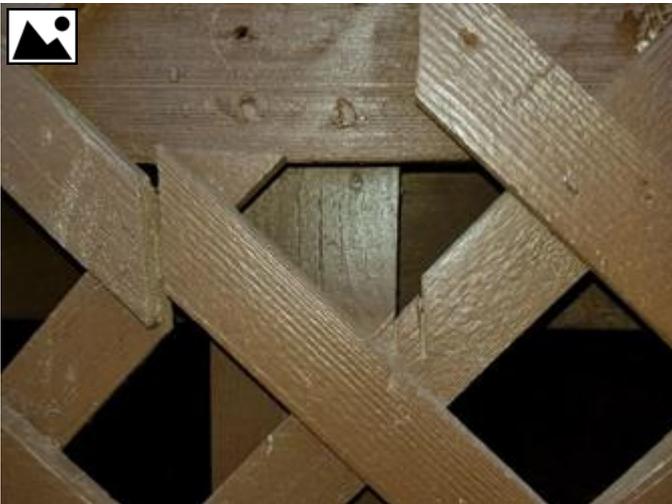
- Issue The beams are attached to the sides of the posts. This can effect the integrity of the structure.
- Location Rear
- Action *Install posts under the beams.*

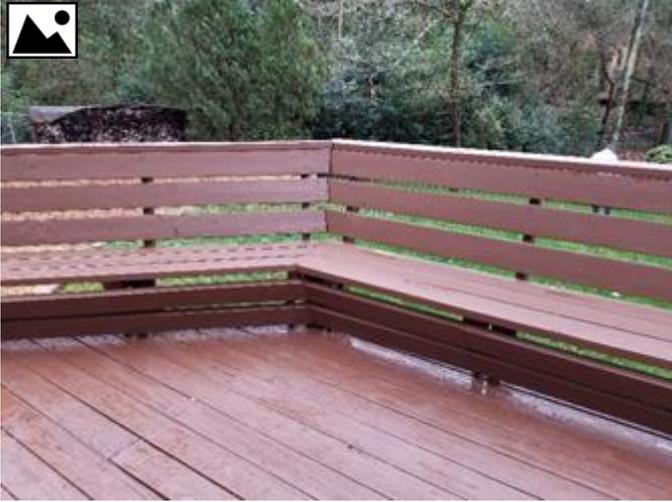
- 🔍 Issue The balusters are installed with a ladder effect. This is a safety issue..  
Location Rear  
Action *Install horizontal balusters.*

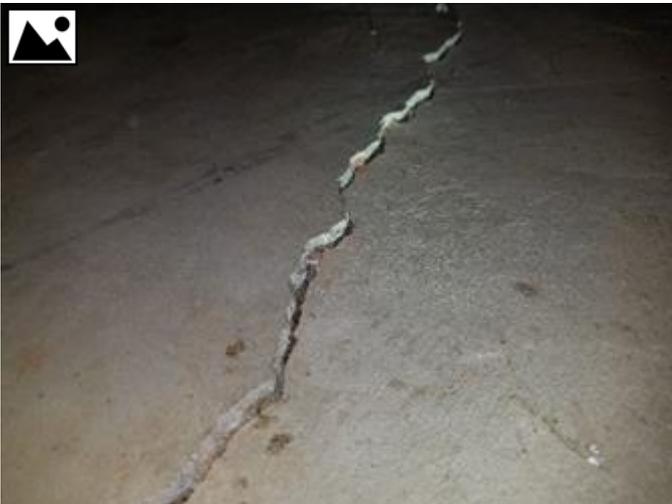
- X** Issue There is a significant crack in the foundation that exhibits displacement. This means that the two sides of the crack are not in the same plane and that the foundation has settled unevenly.
- Location Crawl space floor
- Action *Hire a contractor for an evaluation and to provide repairs as needed.*

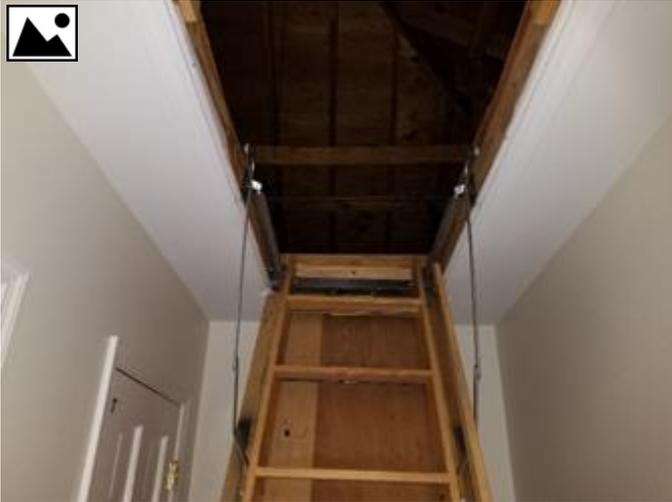
Issue The seal or insulation at the attic access is inadequate. This permits energy loss and permits moisture to enter the attic.
- Location Main Home
- Action *Repair or replace the seal and add insulation as needed.*

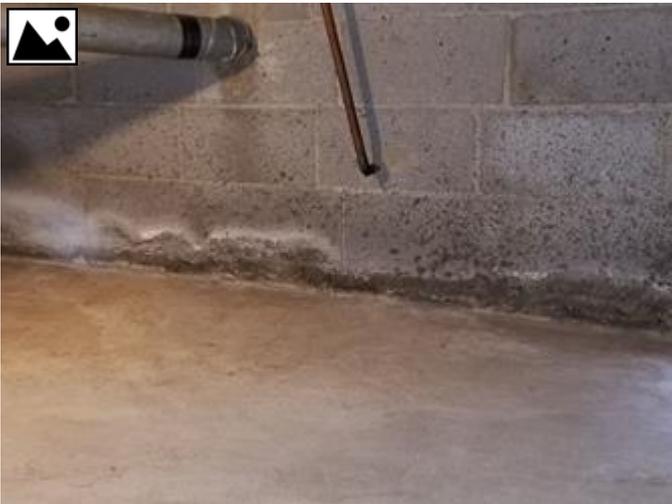
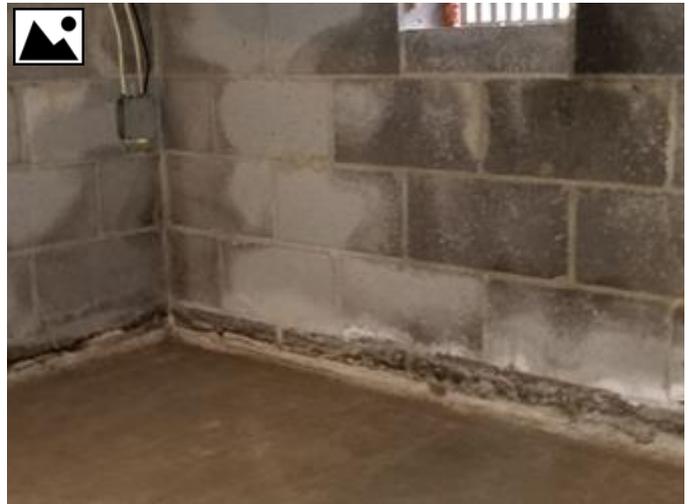
Issue There is efflorescence in the crawl space. These white crystalline deposits indicate moisture penetration. This is conducive to mold formation and damage.
- Location Main Home
- Action *Hire a contractor for an evaluation and to make repairs or upgrades as needed.*

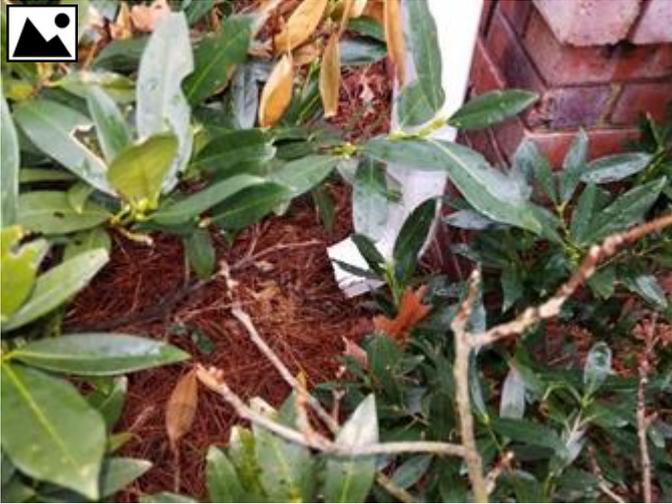
- 31 The downspout extension is missing. Downspout extensions are required to carry away roof run-off water from the foundation. **Location:** Front. *Install downspout extensions as needed.* [27](#)

Action *Install downspout extensions as needed.*

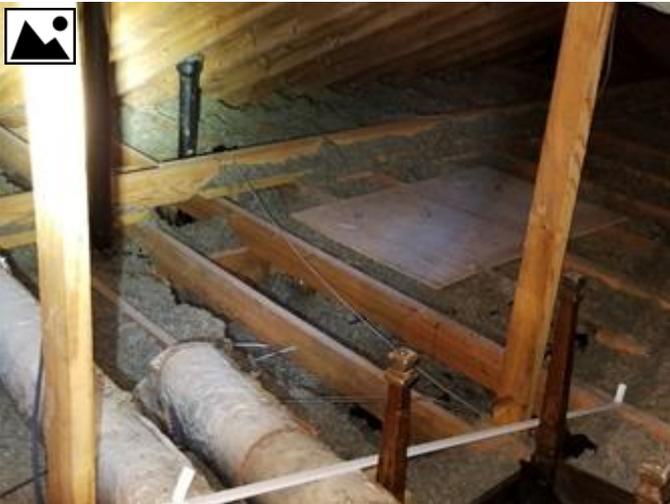
Issue      The level of attic insulation is considered inadequate by today's standards.  
Location Multiple Locations  
Action      *Install additional insulation in accordance with local guidelines.*

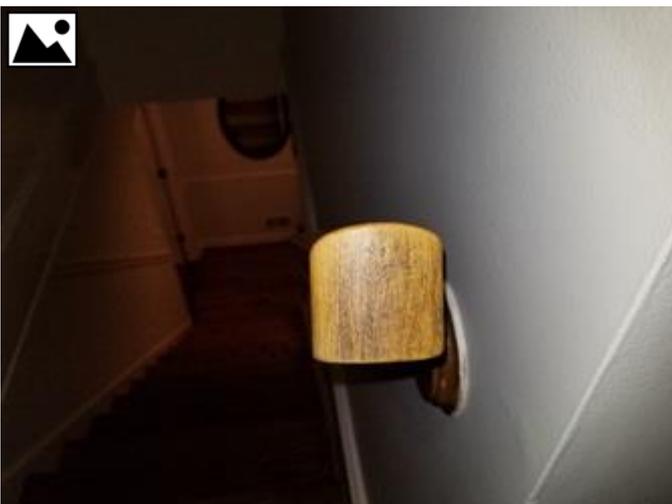
Issue The handrail does not have a return back to the wall. This is a safety concern.
- Location Front
- Action *Add a handrail return back to the wall.*

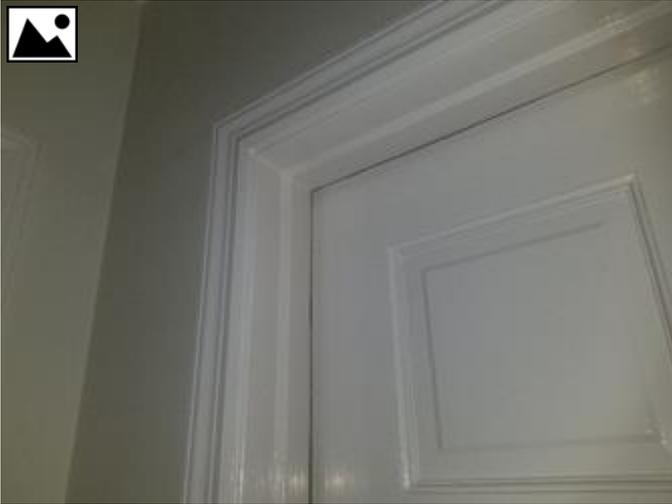
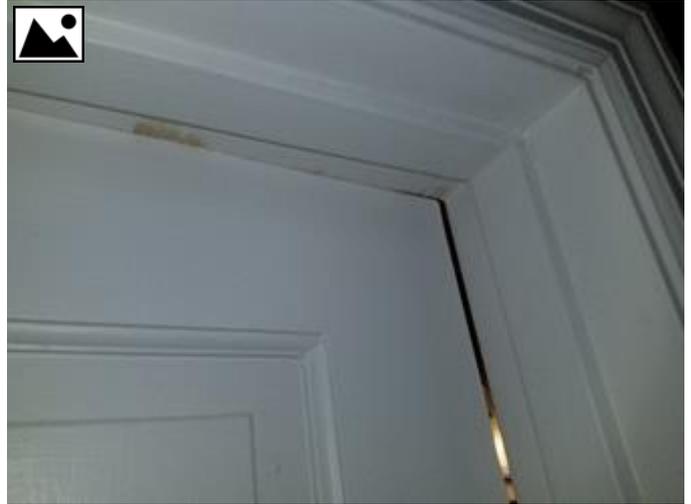
Issue The door does not fit properly within frame. It is binding and/or has large gaps. This affects its function.
- Location Right front bedroom, master bathroom
- Action *Adjust or replace the door.*

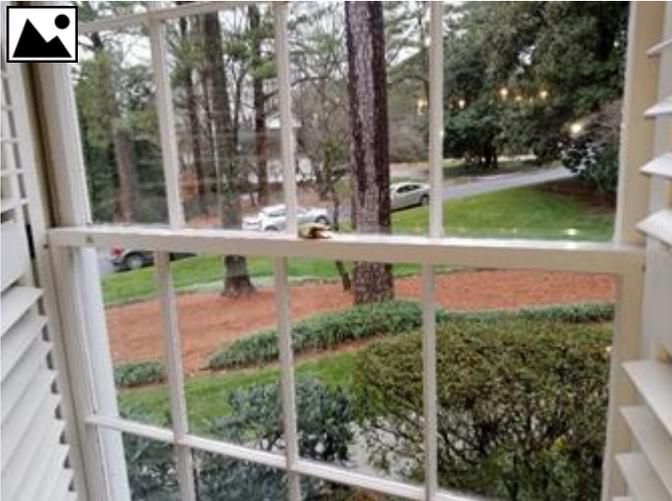
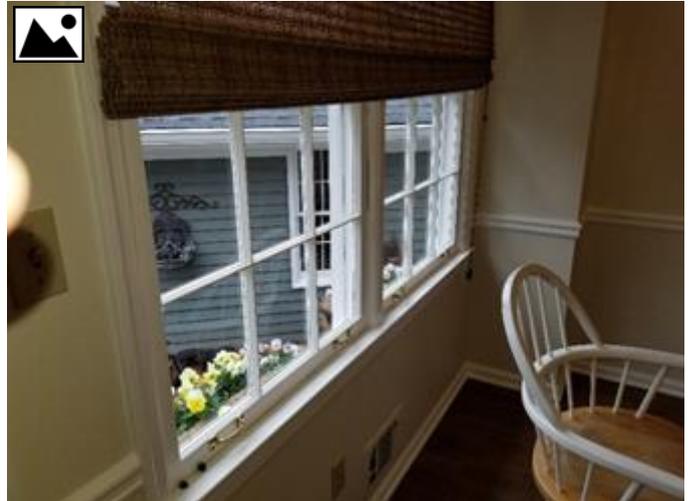
Issue The window is painted/stuck shut. This affects proper function.
- Location Kitchen, family room
- Action *Remove the paint or repair the window as needed for proper operation.*

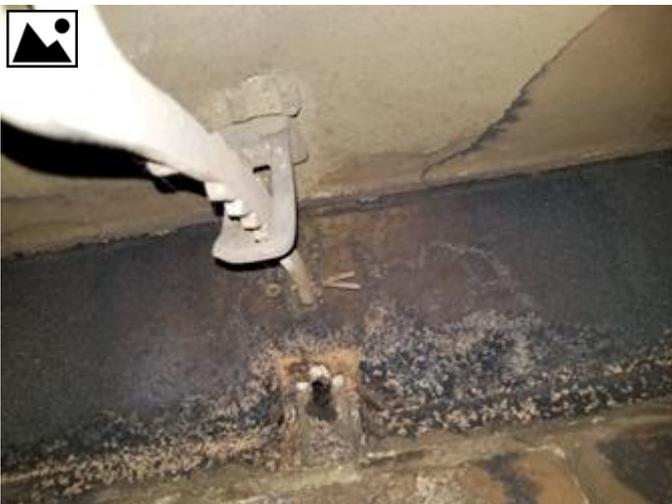
- 🔧 Issue The fireplace has an operable damper without a clamp that prevents the damper from closing completely. This is a safety concern.  
Location Family Room  
Action *Install a damper clamp.*

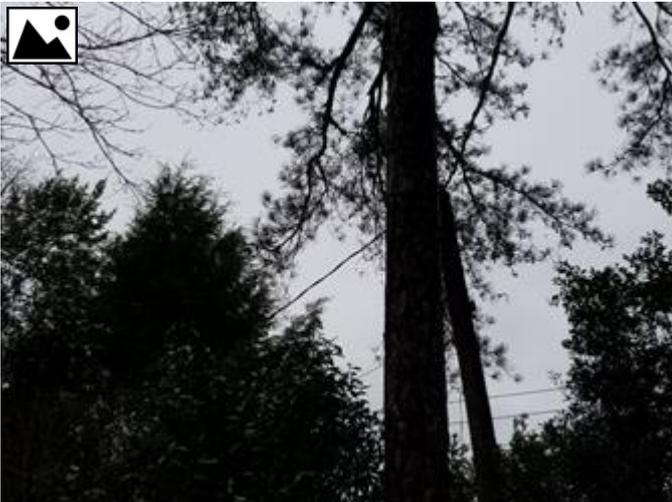
- Issue The entrance cable is in contact with tree limbs. This is a safety hazard.
- Location Front
- Action Hire a contractor to remove the tree limbs.

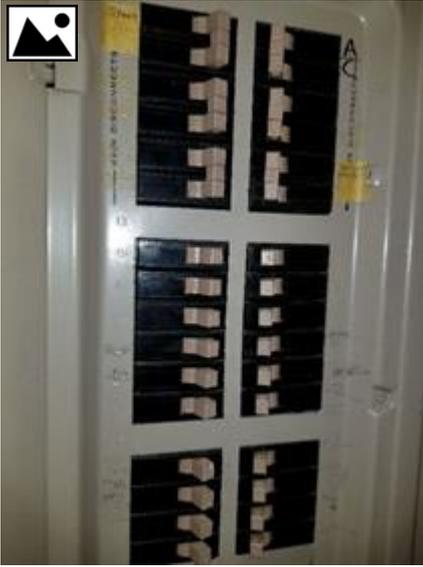
- 13 The electrical panel requires more than 6 breakers to turn off all the power to the home, which is contrary to accepted practice. This is a safety hazard. **Location:** Laundry Room. *Hire an electrician to evaluate the panel and to make required repairs.* [34](#)
- 14 The electrical panel is not labeled or is only partially labeled. All panels must be completely labeled correctly to indicate which circuits the breakers or fuses serve. **Location:** Laundry Room. *Label the panel.* [34](#)

Action *Hire an electrician to evaluate the panel and to make required repairs.*

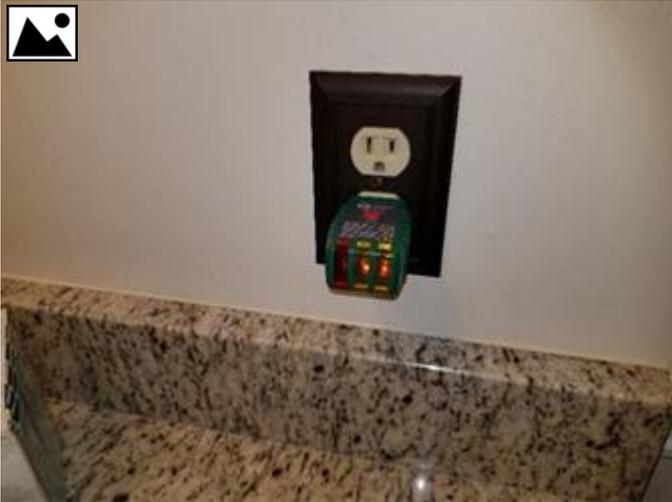
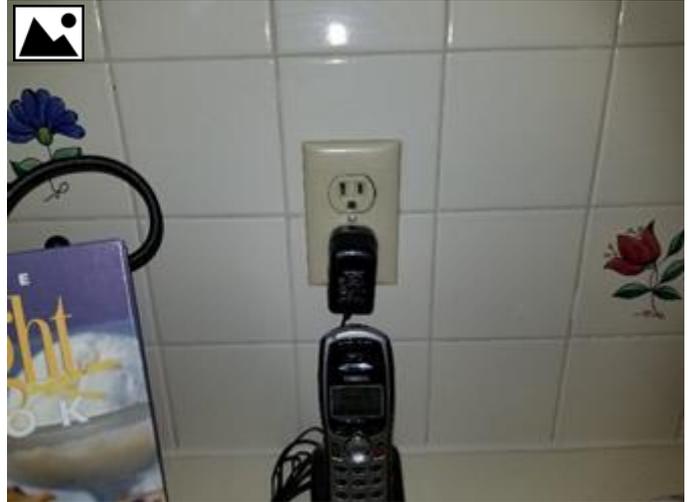
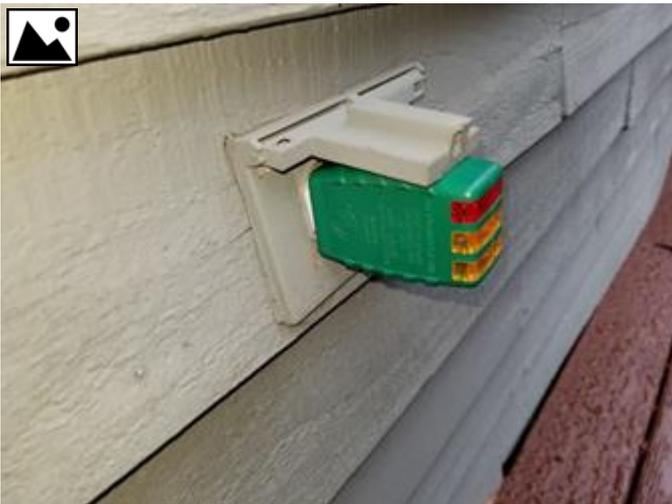
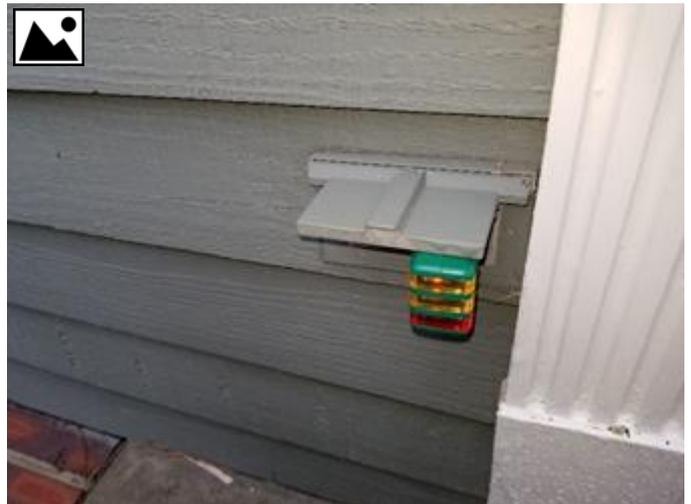
- 15 There is a standard receptacle installed in a location that currently mandates a GFCI device. While this may not have been required at installation, it is a safety concern. **Location:** Half bathroom, kitchen, exterior. *Hire an electrician to replace the receptacle.* [35](#)
- 16 There is an opening between the cover plate and the wall . This is a shock hazard. **Location:** Hall bathroom, master bathroom. *Hire an electrician to evaluate and repair as necessary.* [36](#)

**Action** Hire an electrician to replace the receptacle.

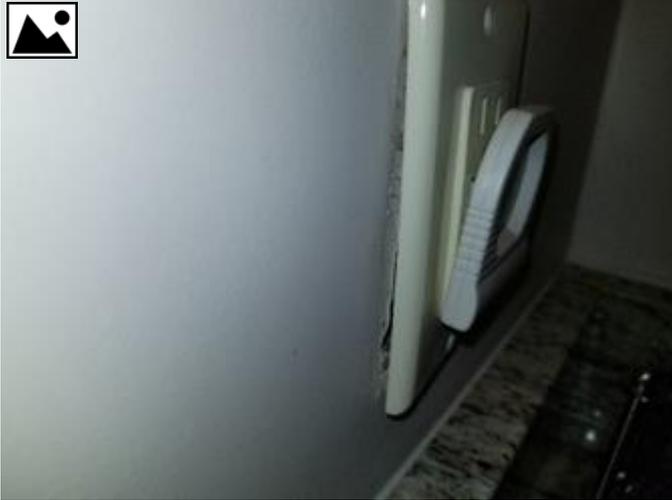
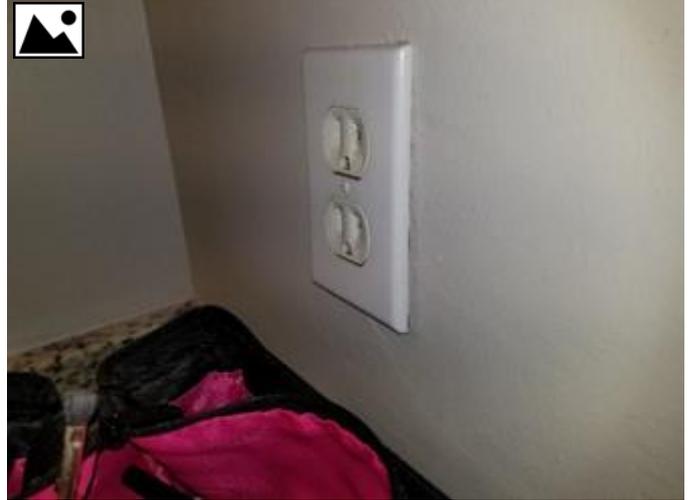
- ⚡ Issue There is an opening between the cover plate and the wall . This is a shock hazard.
- Location Hall bathroom, master bathroom
- Action Hire an electrician to evaluate and repair as necessary.

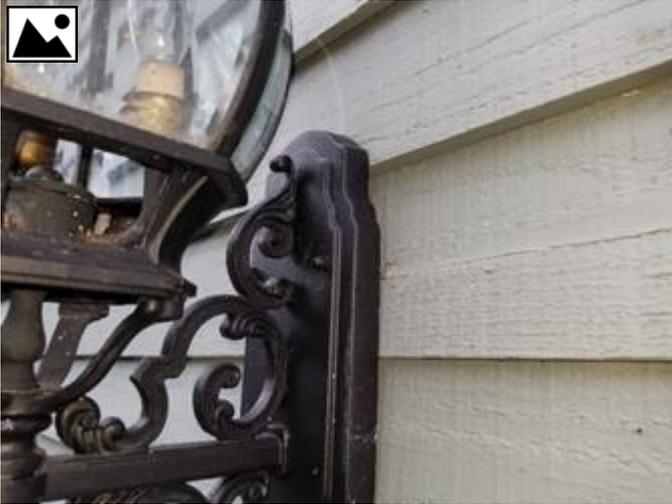
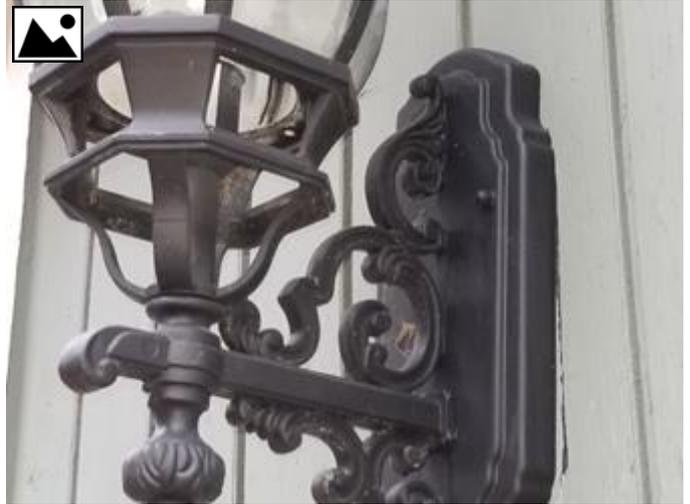
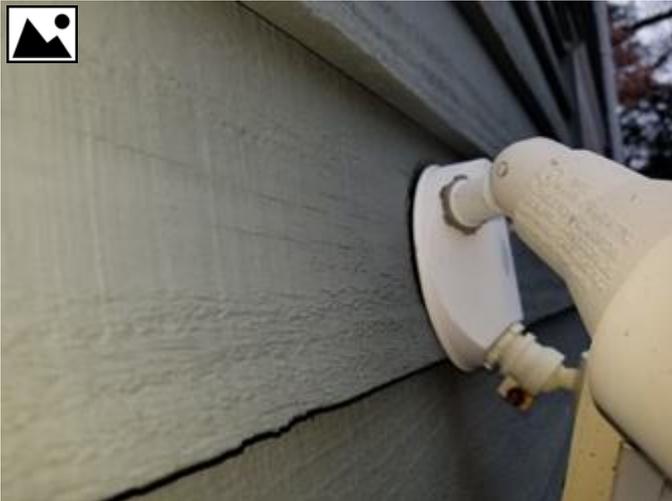
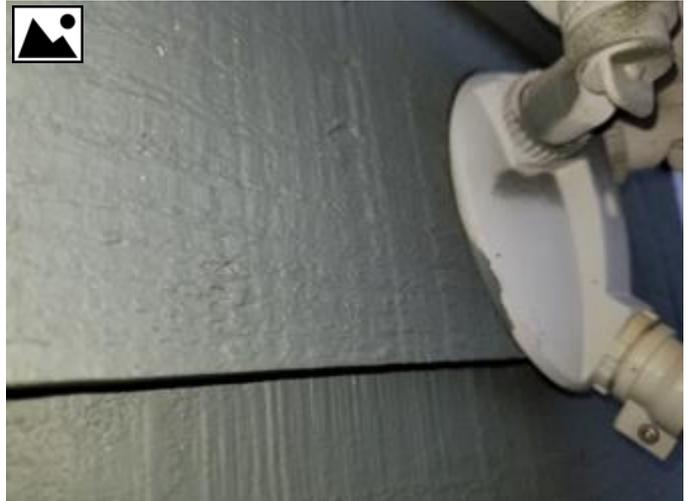
- X** Issue The exterior lamp bases are not sealed to the siding. This can allow for water penetration.
- Location Front door, rear door, shed, garage
- Action Seal around the bases.

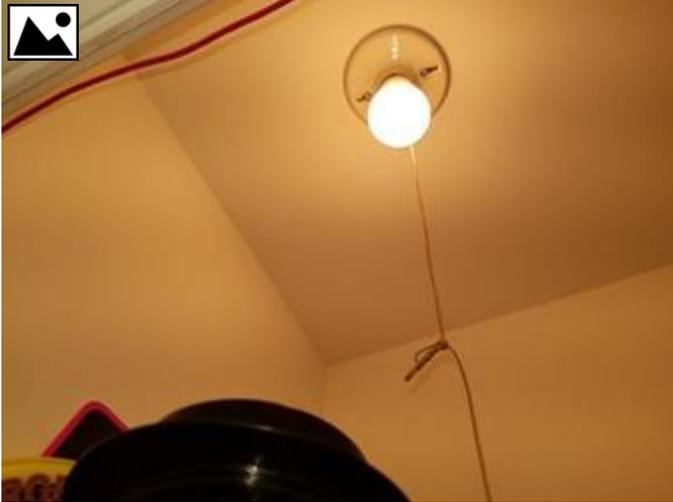
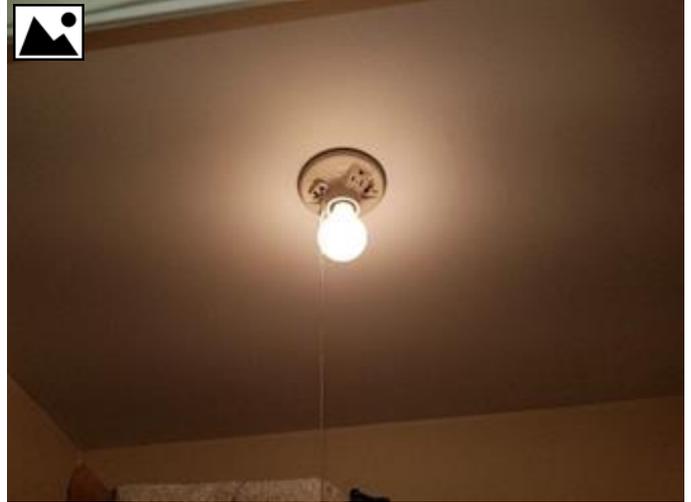
- ⚡ Issue The light bulb is exposed. This is a safety concern.  
Location Hall closet, front left bedroom closet  
Action *Repair or replace the fixture.*

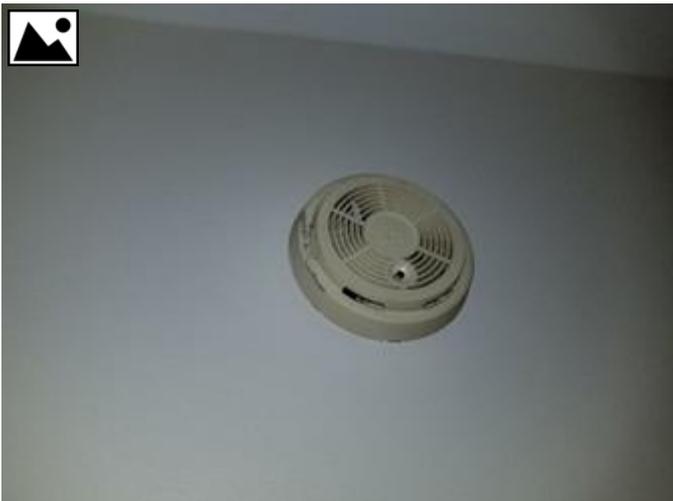
- ⚡ Issue Smoke detectors are missing. There should be at least one functional smoke detector on each level of the house. Some jurisdictions require a detector within 15 feet of or inside each bedroom. This is a safety hazard.  
Location First floor hall, all bedrooms  
Action *Install smoke detectors as needed to comply with local requirements.*
- ⚡ Issue The smoke detectors are 10+ years old and beyond their life expectancy. This is a safety hazard.  
Location Upstairs hall  
Action *Replace the smoke detectors.*

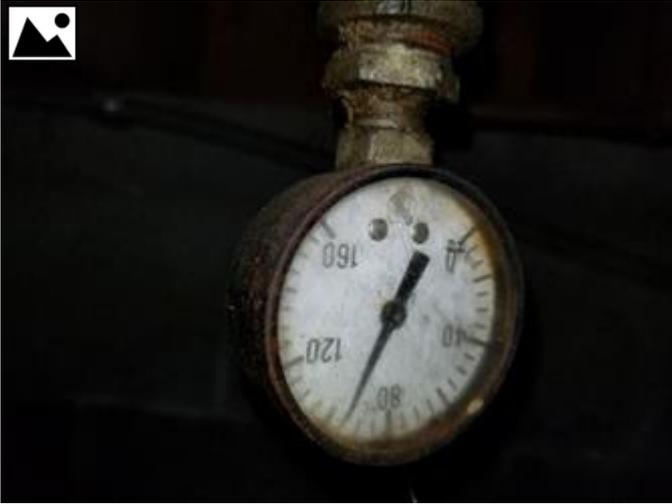
- X** Issue The water pressure is too high. Pressure higher than 80 psi may cause pipes, valves, and faucets to fail prematurely.
- Location Crawl Space
- Action *Hire a plumber to evaluate the water system and to make required repairs.*

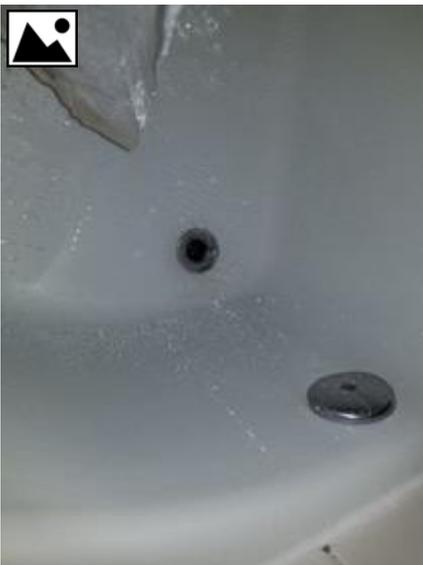
- X** Issue The tub/shower stopper is damaged or missing. This affects proper function.
- Location Master Bathroom
- Action *Replace the stopper.*

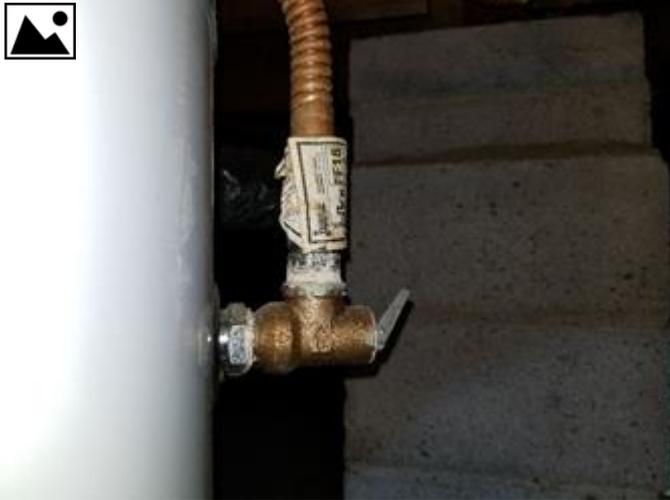
Issue The water heater's Temperature Pressure Relief Valve (TPRV) extension pipe is routed upwards, which may prevent the valve from opening. This is a safety hazard.
- Location Crawl Space
- Action *Hire a plumber to replace the TPRV extension pipe.*

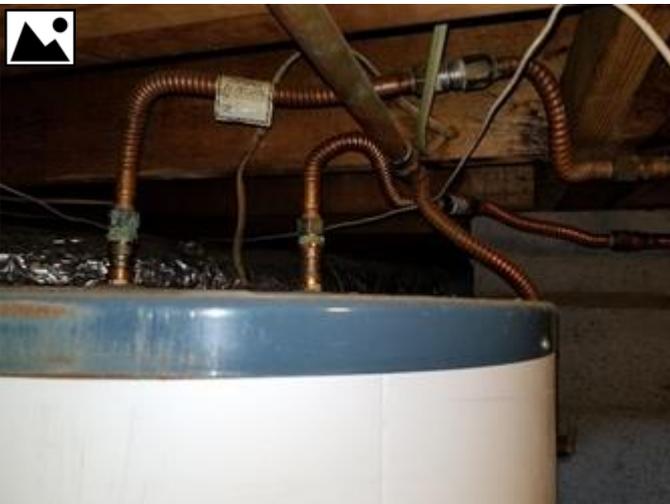
Issue The water heater lacks an expansion tank or valve. This is a safety hazard.
- Location Crawl Space
- Action *Hire a plumber to install a tank or valve.*

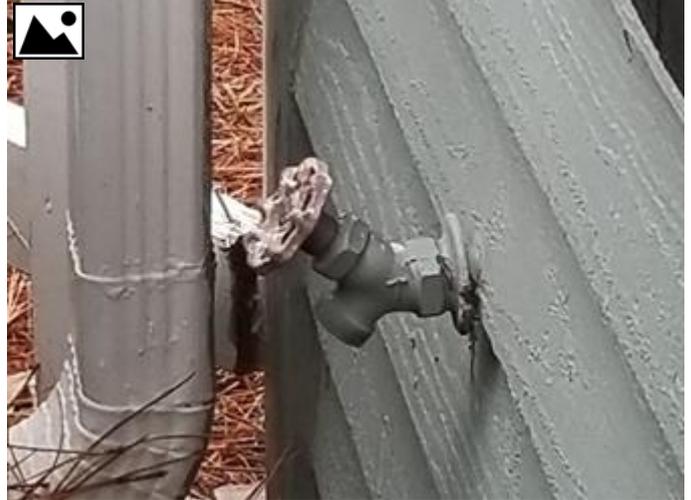
- 23 The hose faucet is missing an anti-siphon device, which is designed to prevent contaminated water from entering house's potable water supply. This is a safety concern. **Location:** Multiple Locations. *Install an anti-siphon device.* [45](#)

**Action** *Install an anti-siphon device.*

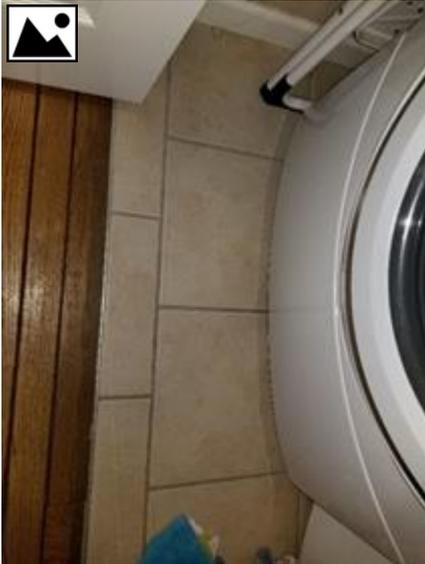
- X** Issue The washing machine does not have a drip pan. Washers above finished areas should be installed on a draining catch pan to prevent water damage if the appliance leaks.
- Location Laundry Room
- Action *Install a draining drip pan.*

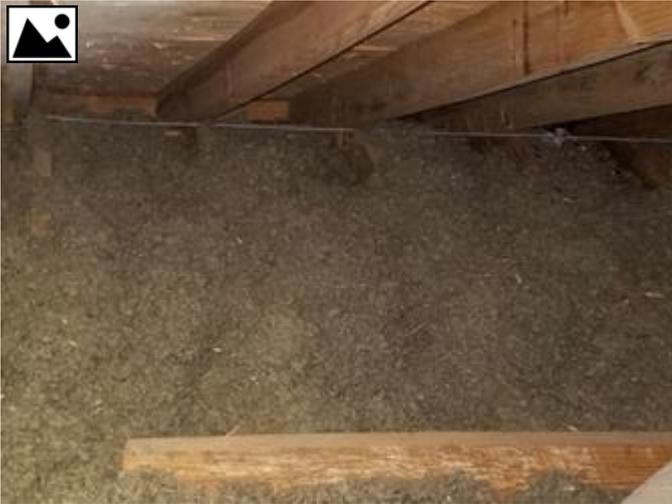
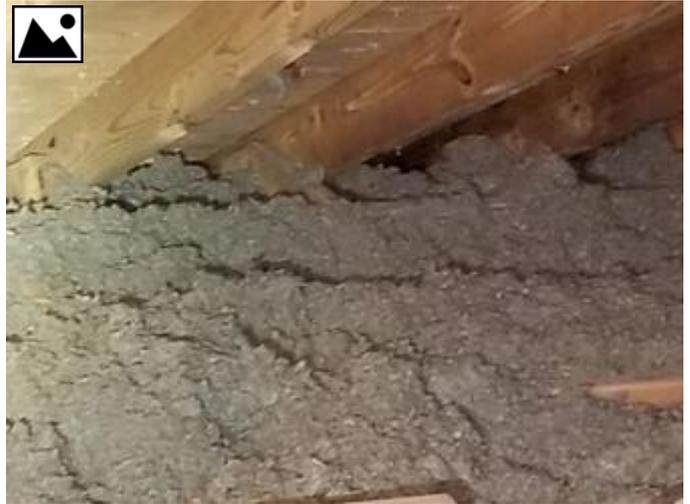
- Issue There is evidence of rodent activity within the home. This is a health and safety concern.
- Location Attic
- Action *Hire a specialist for an evaluation and to make required repairs.*
