Home Inspection  
for  
Craig and Jennifer Sloan Wudi  
4315 Orleans Court  
Alpharetta, GA 30004

# HOME INSPECTION REPORT

HOME AND STUCCO INSPECTIONS, INC.

4315 Orleans Court  
Alpharetta, GA 30004

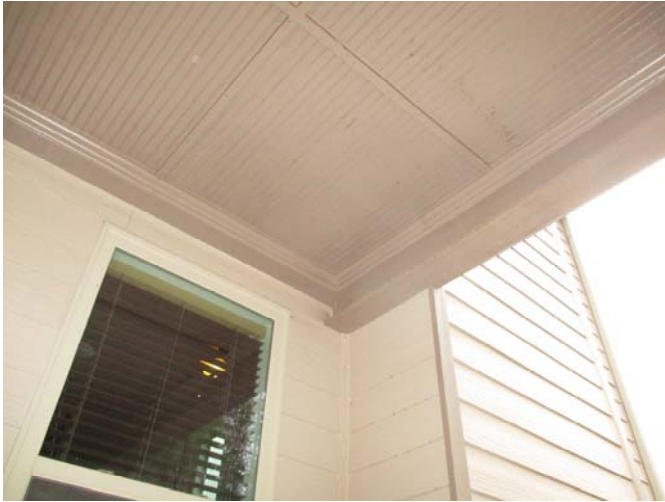
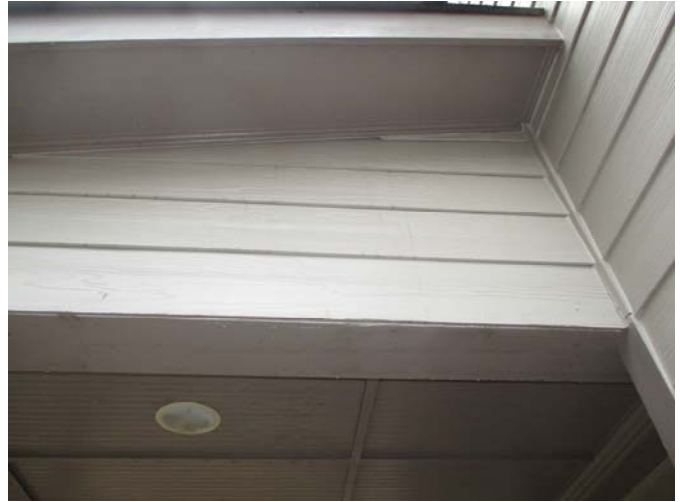
Active moisture stains were present on the siding, horizontal trim and paneling on the ceiling located below the left side of the roof above the covered patio on the back of the home.

Active moisture stains were present on the siding and horizontal trim on the ceiling located below the left side of the roof above the covered patio on the back of the home.

1. Active moisture stains were present on the siding, horizontal trim and paneling on the ceiling located below the left side of the roof above the covered patio on the back of the home (see photos). The roof flashing is torn behind the vertical trim on the right side of the chimney chase located above the left, front corner of the covered patio on the back of the home, which is allowing moisture entry under the shingles during rains (see photo). A licensed roofer should remove the shingles on the left side of the roof above the covered patio to allow for evaluation of the roof flashing, roof decking and rafters and repair as needed. An extension should also be installed on the downspout located above the left, front corner of the covered patio roof on the back of the home to help divert water away from chimney chase (see photo).

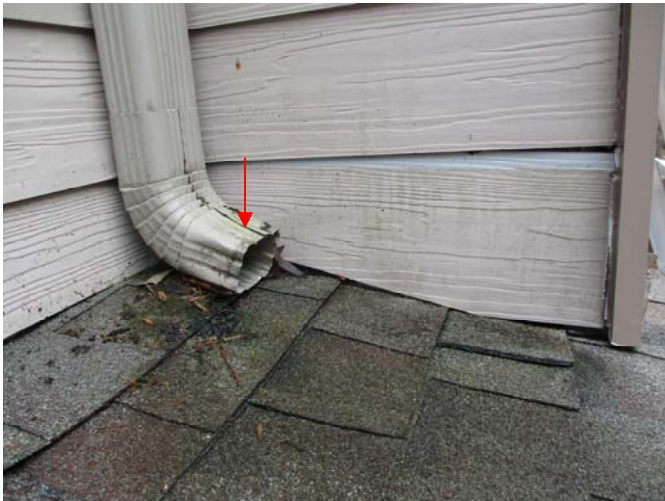
The roof flashing is torn behind the vertical trim on the right side of the chimney chase located above the left, front corner of the covered patio on the back of the home, which is allowing moisture entry under the shingles during rains.

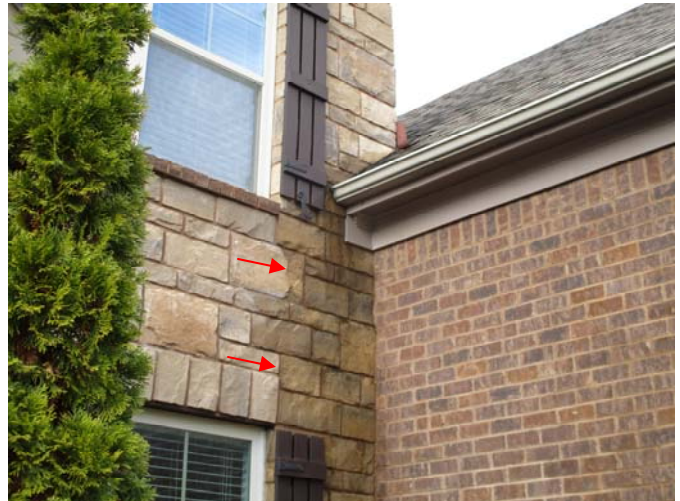
Active moisture stains were present on the stone cladding below the roof termination located above the right, front corner of the formal dining room.

2. Active moisture stains were present on the stone cladding below the roof termination located above the right, front corner of the formal dining room (see photo). Swelling and moisture stains were also present on the wainscoting located around the outlet in the right, front corner of the formal dining room (see photo). A licensed roofer should evaluate and install counter and kick-out flashing on the exterior of the stone cladding located along the roofline above this roof termination to help prevent water from draining between the gutter and the stone cladding during rains. The inside of the gutter and downspout located above the left wall of the garage should be cleaned and this area monitored in the future during rains.

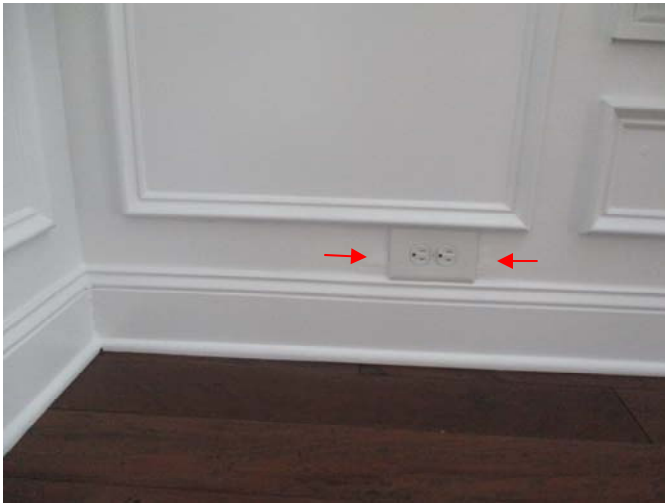
Swelling and moisture stains were present on the wainscoting located around the outlet in the right, front corner of the formal dining room.

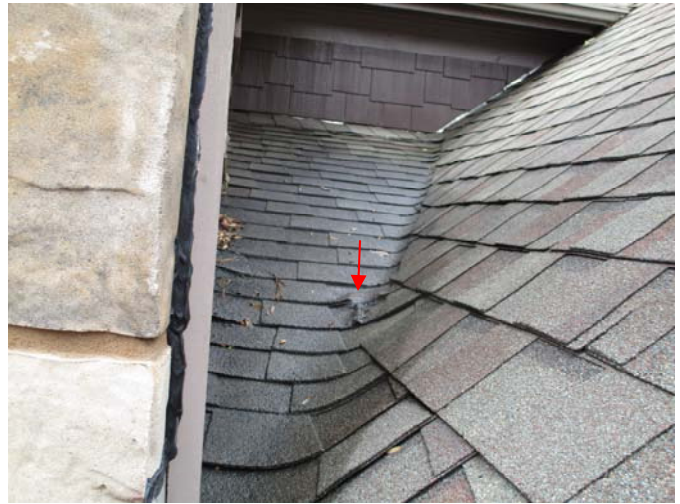
The shingles located at the bottom of the roof valley outside the right wall of the front, center bedroom are raised and have been sealed with roofing tar.

3. The shingles located at the bottom of the roof valley outside the right wall of the front, center bedroom are raised and have been sealed with roofing tar (see photo), unsealed toe board nail holes were present in the shingles above some of the gutters around the perimeter of the home (see photo for example) and several exposed nail heads were present in the upper rows of shingles on the roof located above the covered patio on the back of the home (see photo for example). A licensed roofer should evaluate and replace the damaged shingles outside the right wall of the front, center bedroom and seal all toe board nail holes and exposed nail heads in the shingles as needed to help reduce the risk of future leaks.

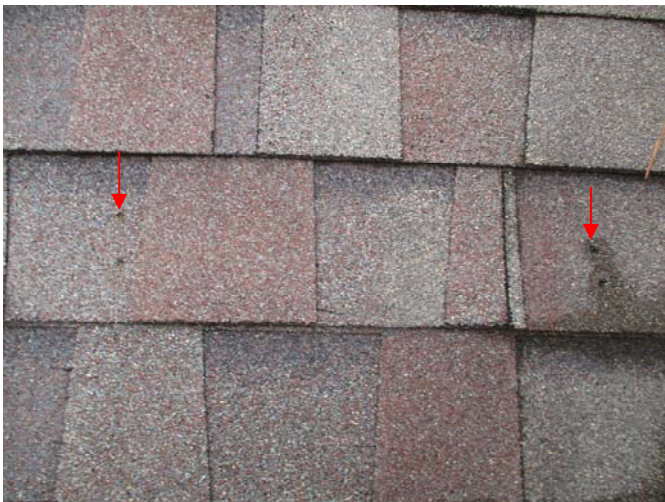
Unsealed toe board nail holes were present in the shingles above some of the gutters around the perimeter of the home.

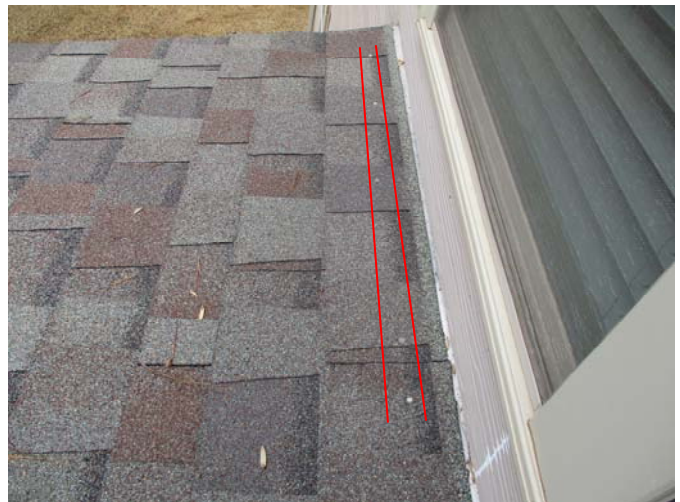
Several exposed nail heads were present in the upper rows of shingles on the roof located above the covered patio on the back of the home.

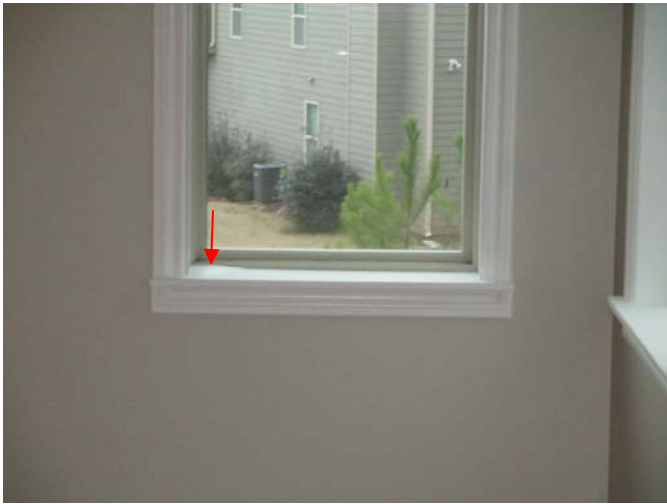
The interior sill is swollen below the left side of the upper, right window in the left wall of the family room (. . .)

4. The interior sill is swollen below the left side of the upper, right window in the left wall of the family room (see photo). Please consult with the homeowner about previous moisture entry in this area. A qualified contractor should evaluate the exterior of this window and the flashing above this window and repair as needed to prevent future water entry.

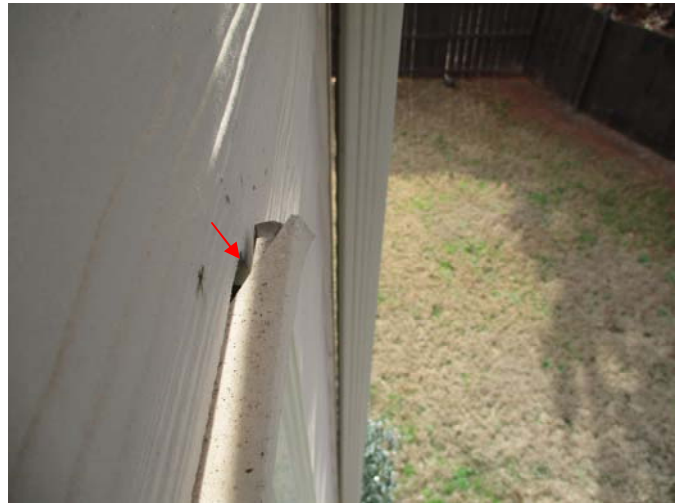
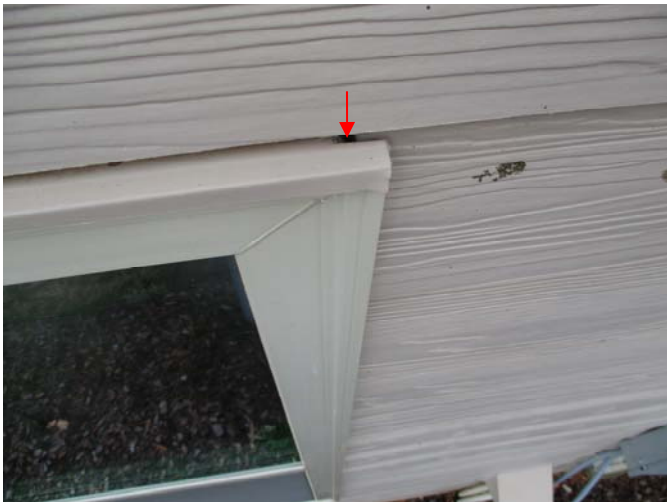
The header flashing is damaged at the upper corners of several windows in the siding portion of the home, which is a source of water entry behind the siding during rains.

5. The header flashing is damaged at the upper corners of several windows in the siding portion of the home, which is a source of water entry behind the siding during rains (see photos for examples). A qualified contractor should evaluate the flashing above all windows in the siding portion of the home and seal/replace as needed.

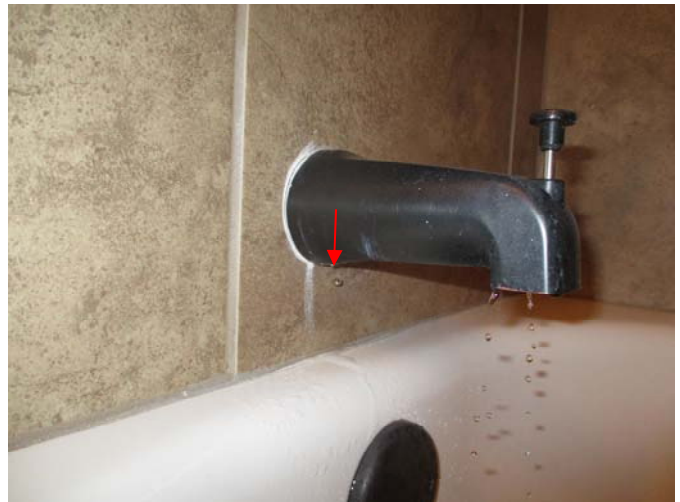
Water leaks out from the bottom of the tub faucet in the right, upstairs bedroom bathroom when the showerhead is engaged.

8. Water leaks out from the bottom of the tub faucet in the right, upstairs bedroom bathroom when the showerhead is engaged (see photo). A licensed plumber or qualified contractor should evaluate this faucet and repair as needed.

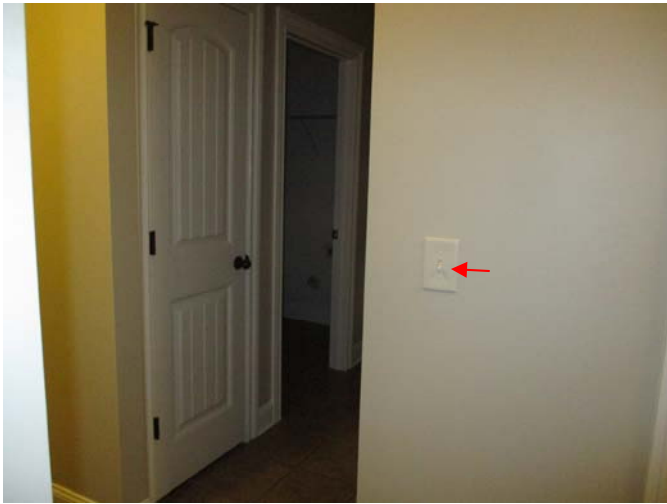
A licensed electrician or qualified contractor should replace the defective light switch located on the right side of the hallway leading to the laundry room.

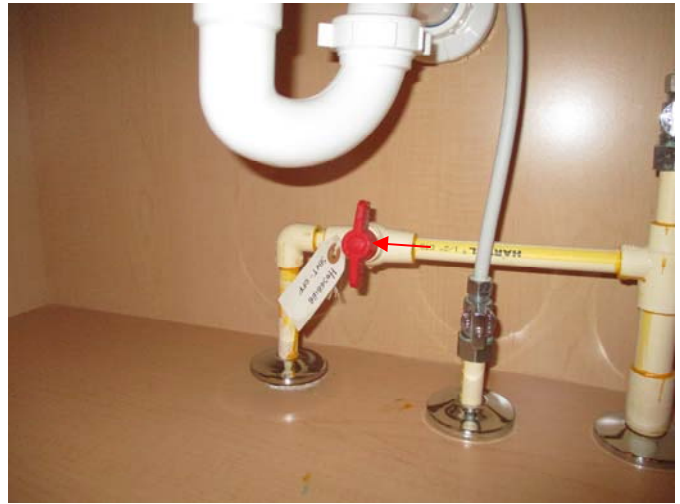
The shut-off valve on the waterline for one of the exterior water spigots was turned-off inside the cabinet below the sink in the center bathroom in the upper level of the home prior to the start of the inspection.

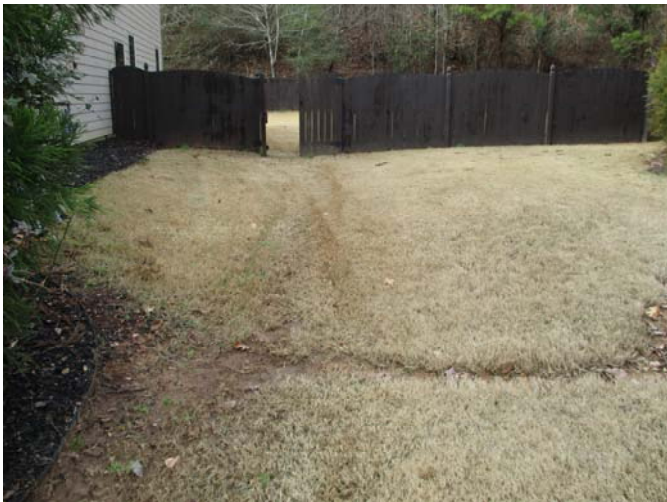
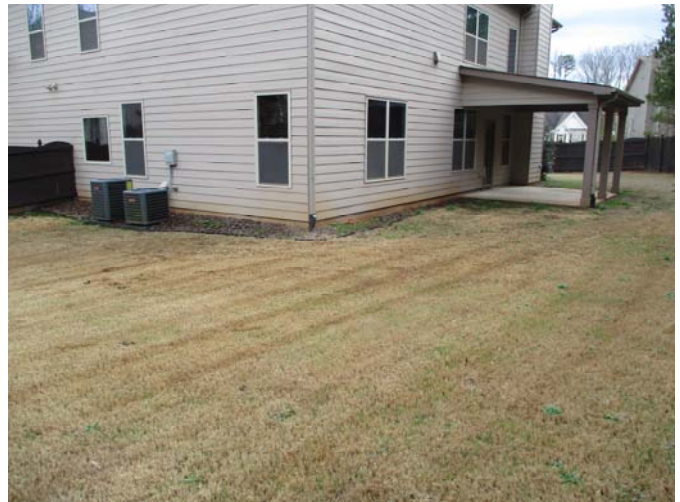
The sod/soil along the swale on the right side of the home was very soft and saturated at the time of the inspection.

The sod/soil along the swale around the back of the home was very soft and saturated at the time of the inspection.

1. Trim all tree limbs and bushes away from the exterior of the home and shingles as part of routine maintenance.
2. The sod/soil along the swale on the right side of the home and along the swale around the back of the home was very soft and saturated at the time of the inspection (see photos). Standing water was also present inside the left, front corner of the fence on the left side of the home at the time of the inspection (see photo). A qualified landscaping contractor should evaluate these areas to suggest the proper repair.

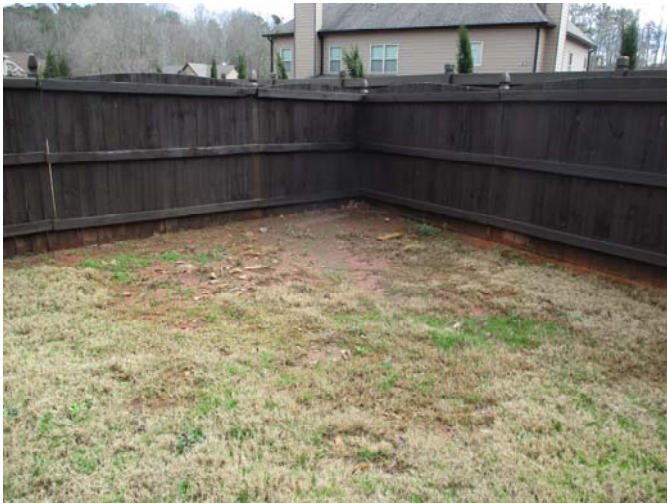
Standing water was present inside the left, front corner of the fence on the left side of the home at the time of the inspection.

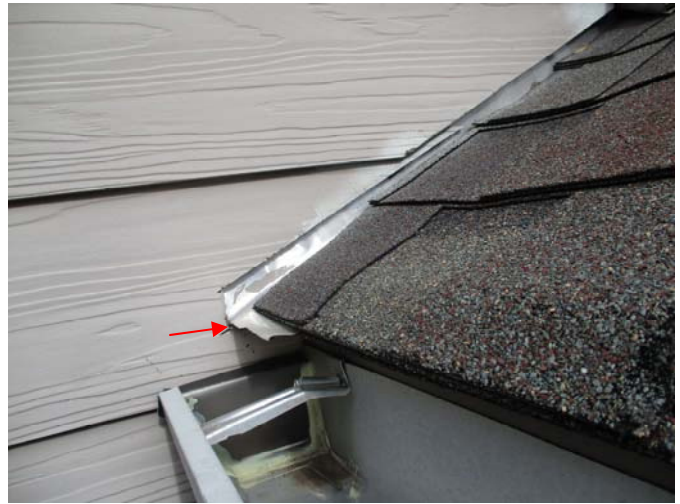
A licensed roofer should install kick-out flashing at the roof termination located above the gutter on the right and left sides of the chimney chase to prevent water from draining between the gutter and the siding during rains.

3. A licensed roofer should install kick-out flashing at the roof termination located above the gutter on the right and left sides of the chimney chase to prevent water from draining between the gutter and the siding during rains (see photo) – (Ref.: Mfr's installation instructions for HardiePlank Lap Siding).

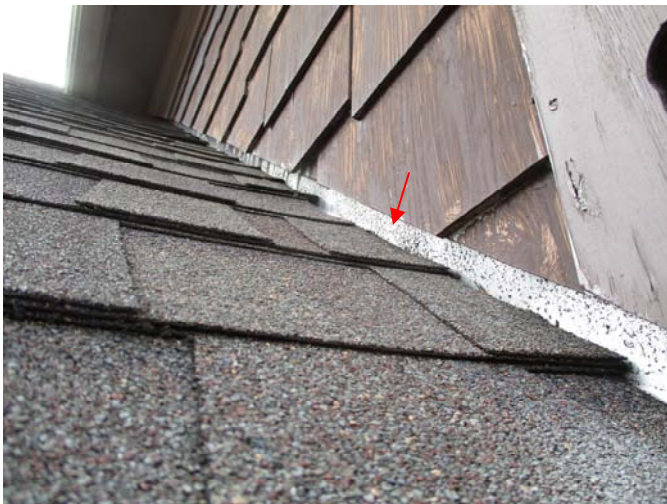
Counter flashing rather than step flashing was installed along the rooflines on the home.

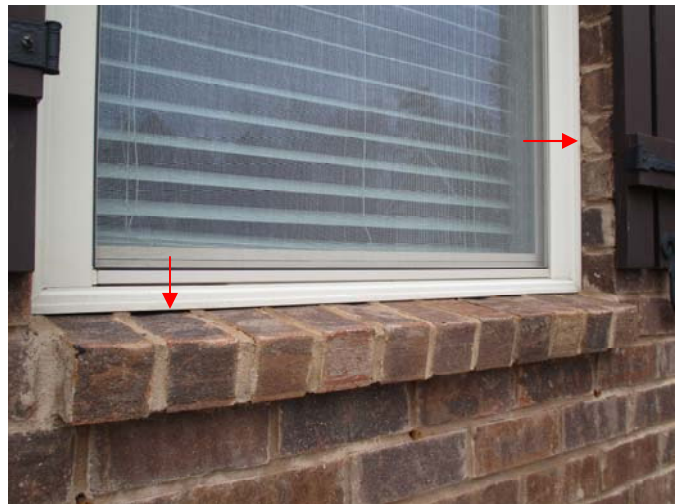
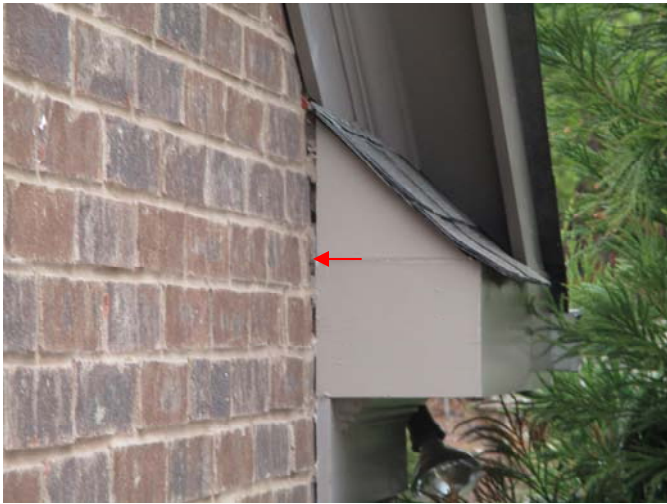
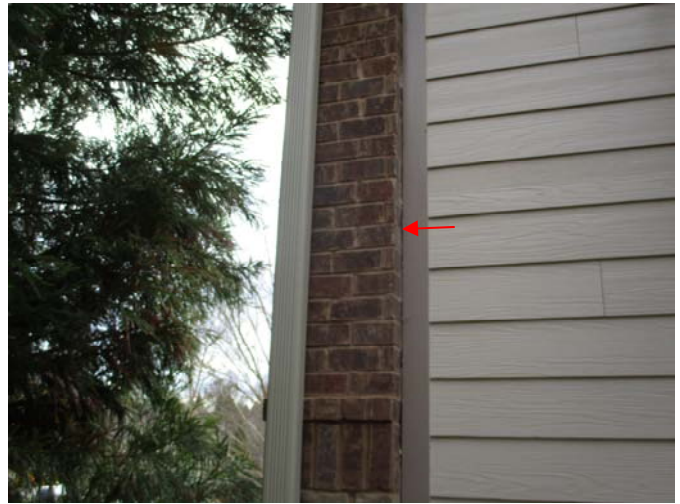
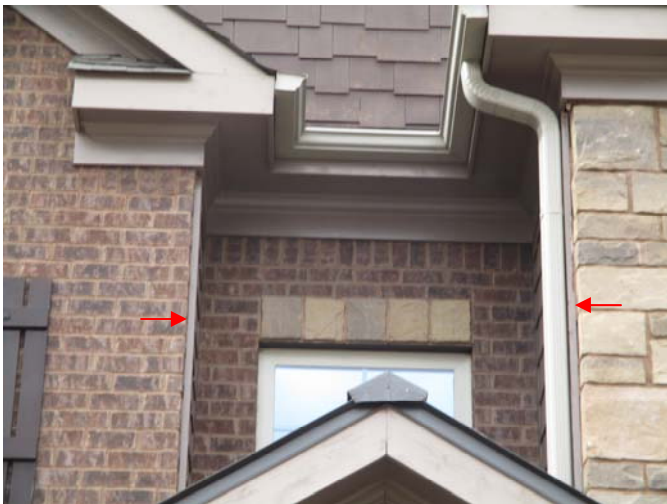
Caulking is needed around the perimeter of the second floor windows on the front of the home.

Caulking is needed along the sides of the gable returns on the front of the home.

Caulking is needed along the vertical trim at all brick transitions on the home.

5. Caulking is needed around the perimeter of the second floor windows on the front of the home, along the sides of the gable returns on the front of the home and along the vertical trim at all brick transitions on the home (see photos).

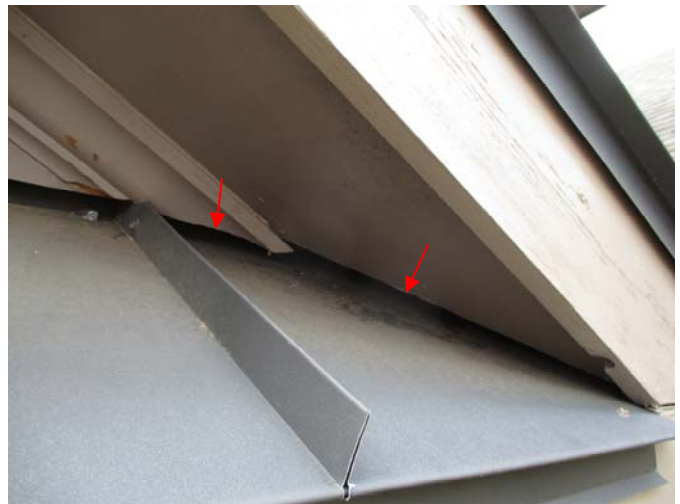
A qualified contractor should seal the construction gap under the soffit located below the right side of the gable on the front porch roof to help prevent future insect/rodent entry.

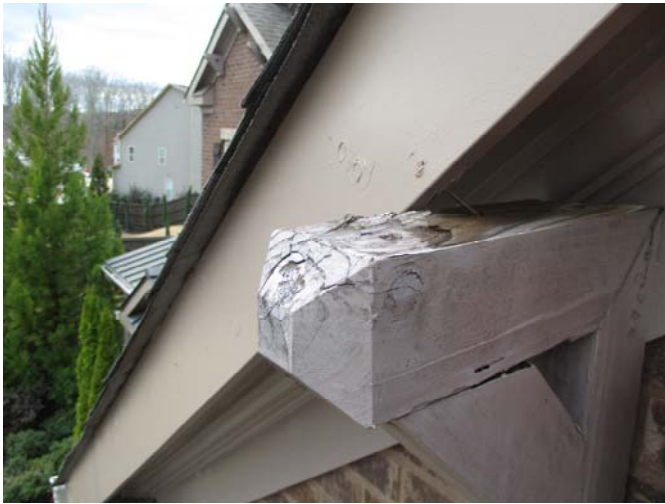
Updated paint is needed on the decorative beams located along the gables on the front of the home.

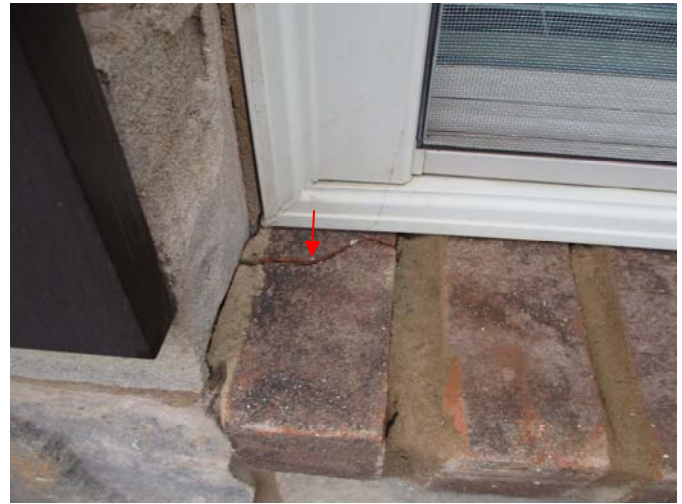
A qualified contractor should seal the cracked brick below the left side of the windows in the front, center bedroom to help prevent future moisture entry.

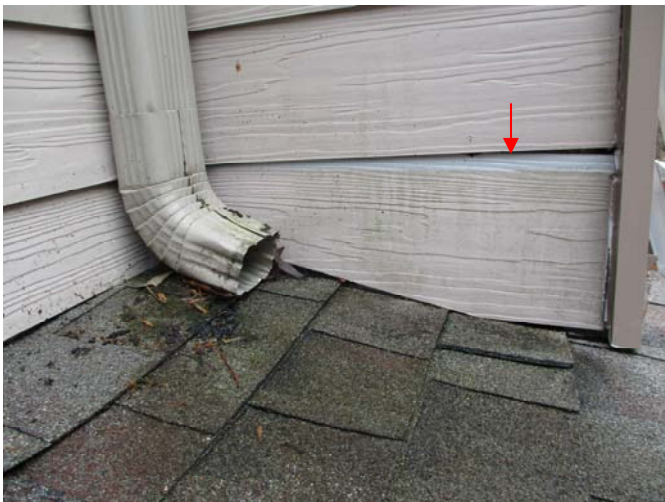
A qualified contractor should secure the displaced, lower piece of siding on the right side of the chimney chase located above the left, front corner of the roof above the covered patio on the back of the home.

10. A qualified contractor should secure the displaced, lower piece of siding on the right side of the chimney chase located above the left, front corner of the roof above the covered patio on the back of the home (see photo).

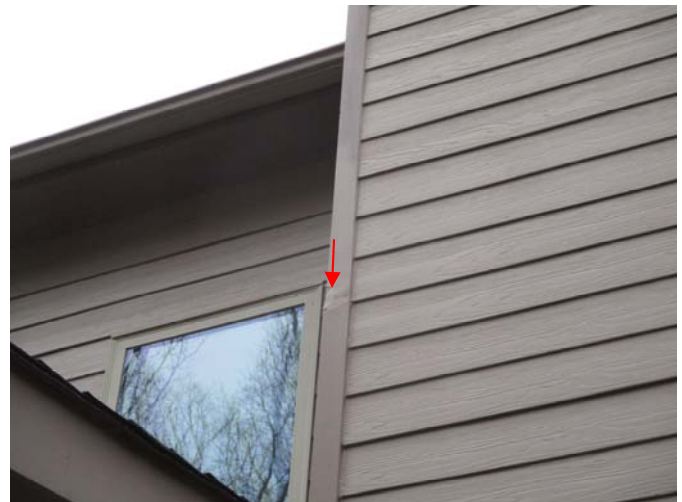
Moisture damage was present at the vertical trim midway-down the right side of the chimney chase.

11. Moisture damage was present at the vertical trim midway-down the right side of the chimney chase (see photo). A qualified contractor should evaluate and replace the damaged wood as needed.

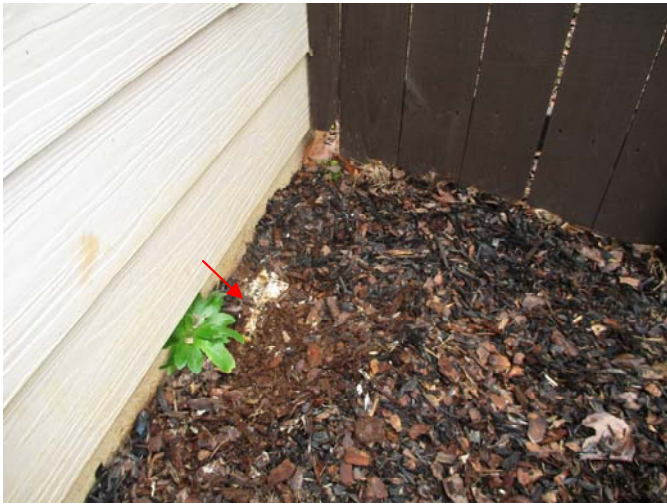
The a/c condensate drainlines terminate along the foundation in front of the fence on the right side of the home.

15. The a/c condensate drainlines terminate along the foundation in front of the fence on the right side of the home (see photo). Recommend installing extensions on these drainlines to help divert water away from the foundation. The insides of these drainlines should also be cleaned by a licensed hvac contractor to ensure proper waterflow.

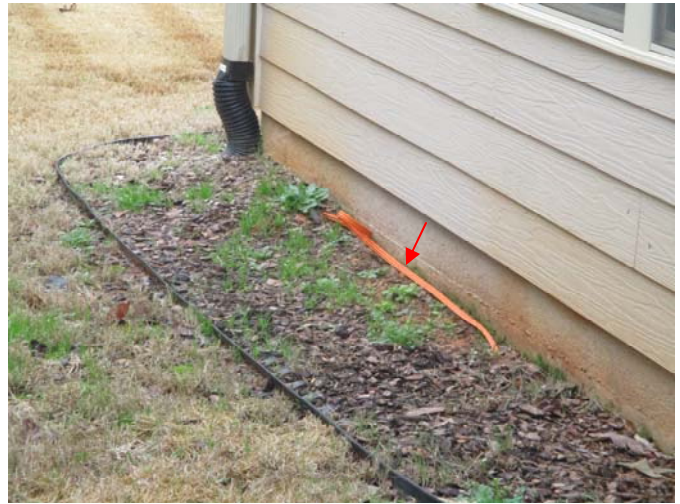
Please consult with the homeowner about the buried/exposed, orange wiring running along the foundation around the rear portion of the home.

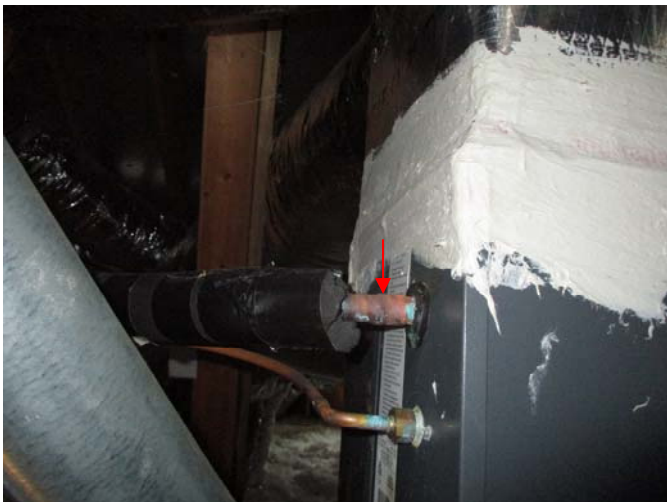
Additional insulation is needed around the refrigerant return line exiting each a/c evaporator coil in the attic to prevent condensation from dripping into the furnaces during the operation of the a/c units.

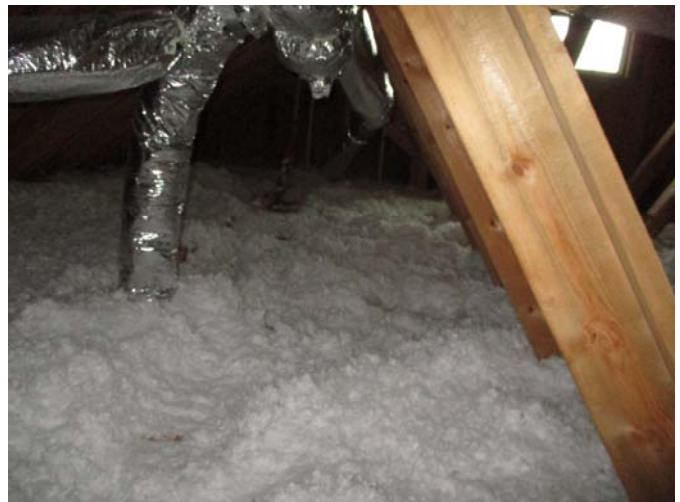
Re-distribute the blown-in insulation in the floor of the upper attic to provide consistent coverage which will help increase efficiency.
