Atlanta Property Inspections, Inc.

HOME INSPECTION REPORT

2464 Canopy Glen, Marietta, GA 30066
Inspection prepared for: Ron Brown
Date of Inspection: 1/10/2020 Time: 1:30 PM
Age of Home: 15 Years Old (2005) Size: 6690 SF
Weather: Cloudy, 60 Degrees, Dry Soil

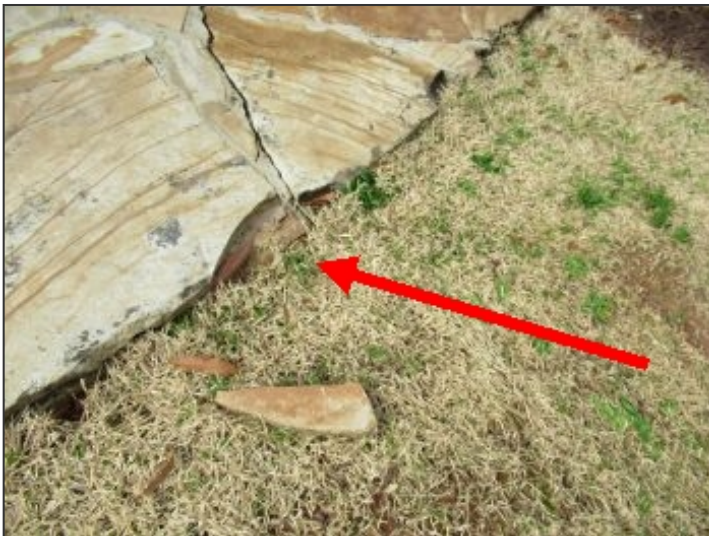
- **Several stones are damaged along the edge of the front sidewalk (see photo). In addition, many stones at the right side yard are damaged and loose with damaged mortar joints between the stones (see photo). Further evaluation and correction is recommended by a professional stone contractor.**

Damaged stones at front sidewalk

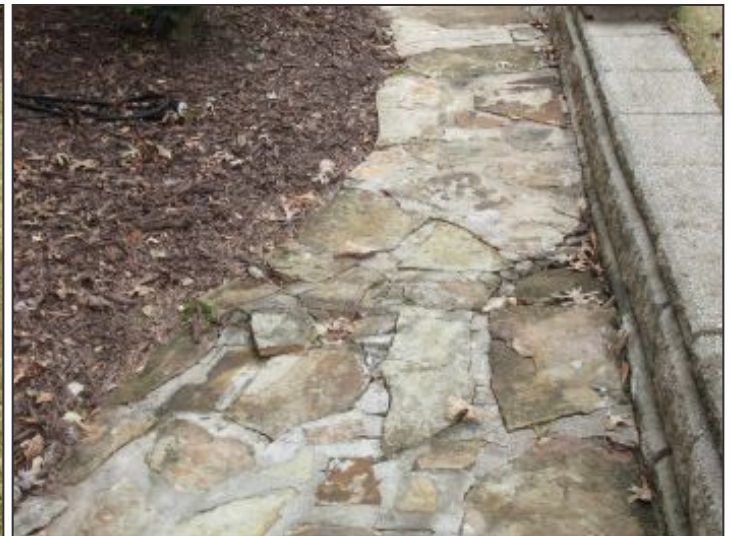
Damaged stones at right yard sidewalk

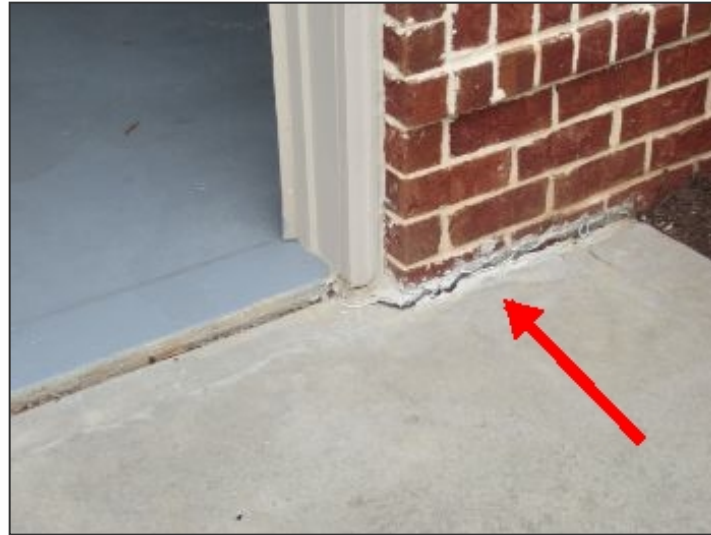
- The driveway has dropped and settled slightly near the front corner of the garage (see photo). The concrete movement does not appear to be significant; continue to monitor for any changes in concrete elevation at this location. Future repairs may be needed.**

Driveway has dropped slightly at garage

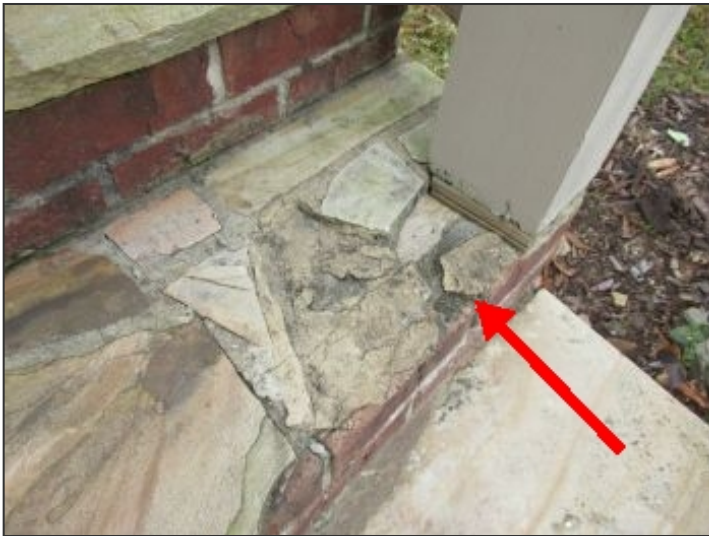
- Brick steps are present at front porch
- Wood steps are present at the rear deck
- **The rear deck exterior steps appear serviceable; no concerns were noted.**
- **The front brick stairs have settled and shifted approximately 1/4 - 1/2 inch; the front side of he stairway has several cracks in the brick (see photo). Further evaluation is recommended by a professional brick mason to determine the full scope of repair needs and costs.**

Damaged stones at front porch steps

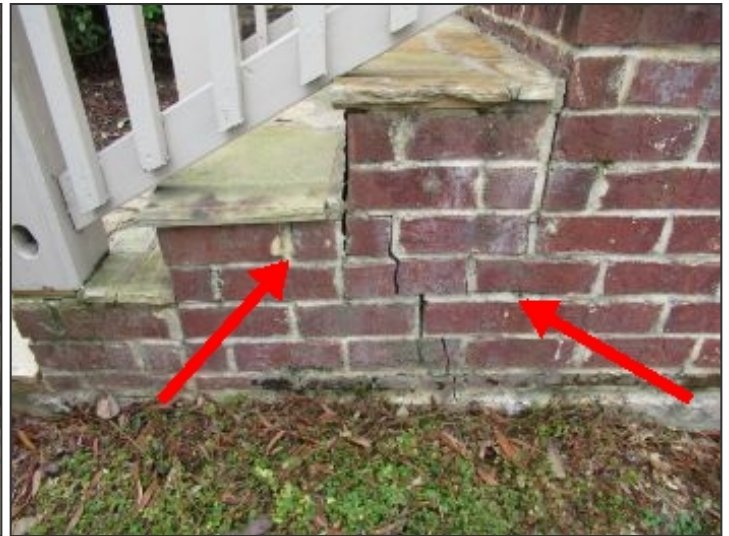
Brick movement at front steps

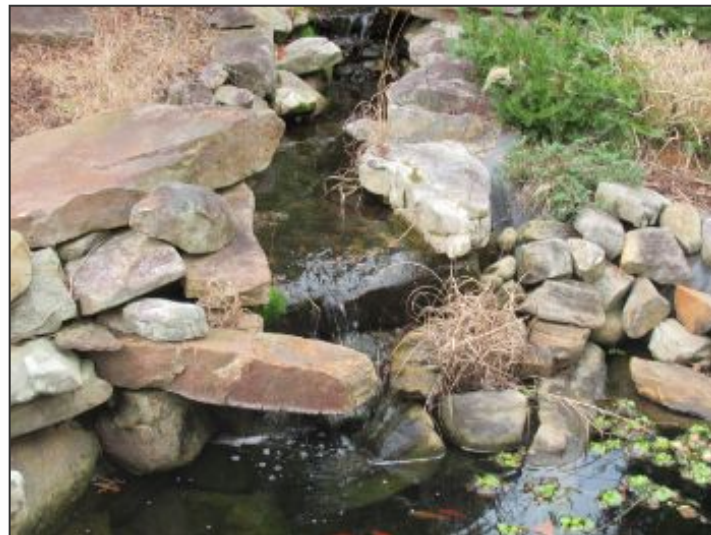
FURTHER EVALUATION RECOMMENDED: WATER FEATURE
 The rear yard water pond and its components are not within the scope of this inspection. Further evaluation is recommended.

Rear yard water pond not inspected

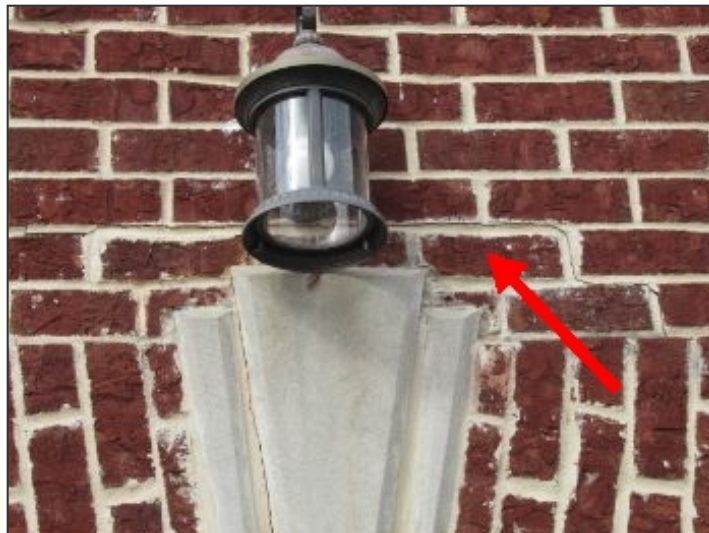
• **Minor cracks were observed in the brick veneer above the center of the two car garage door (see photo). This type of crack is not considered to be structurally significant and is most often a minor concern. Continue to monitor for any changes in crack length and width, future repairs may be needed.**

Small crack at brick above garage doorway

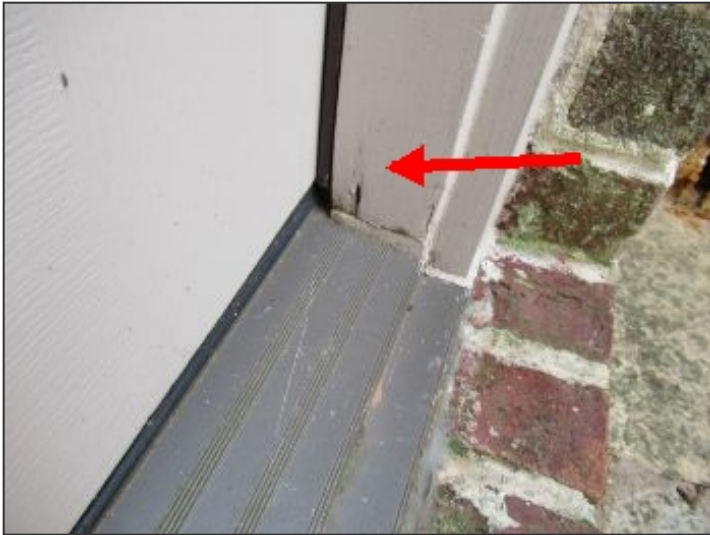
Minor wood damage at basement door

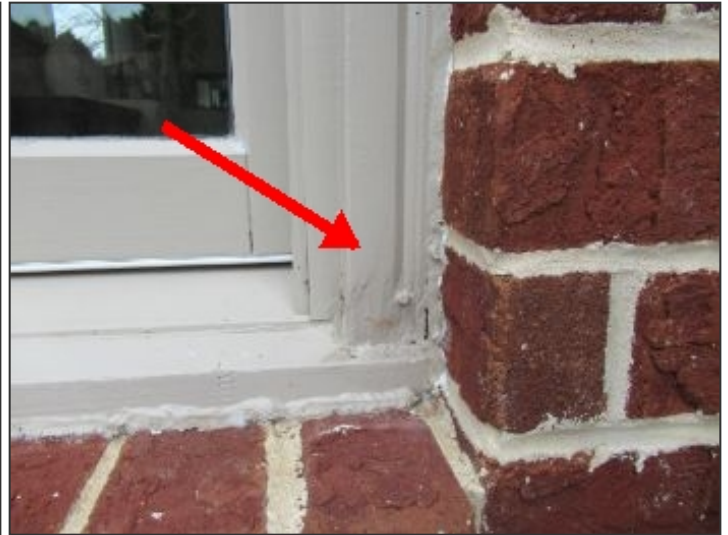
- 1. **Minor damaged wood trim was noted at the rear kitchen keeping room window (see photo). Replacement of the affected wood trim is recommended.**
- 2. **Damaged wood trim was noted at the exterior door jamb of the basement entry door - both sides are affected (see photo) door just above the threshold. Replacement of the damaged wood is recommended.**

Minor trim rot at rear kitchen keeping room window

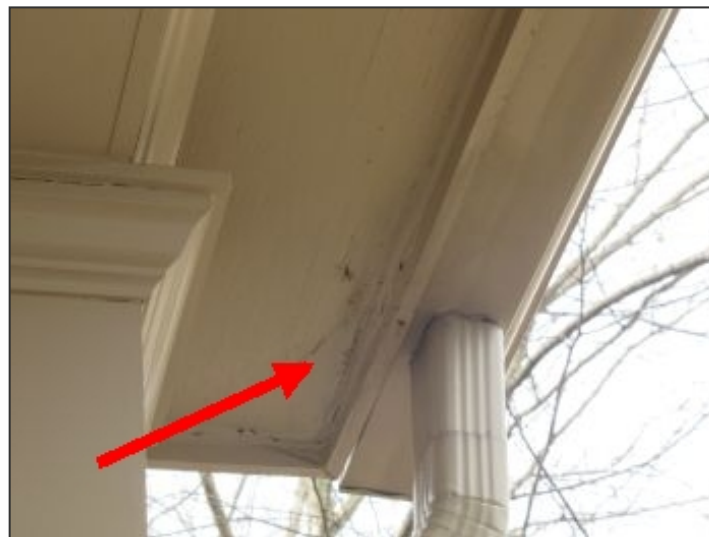
• **Damaged wood was observed at the soffit board located at the right corner of the front porch roof (see photo). Replacement of the damaged wood is recommended, further evaluation is recommended to determine the source of the water damage and to make necessary repairs.**

Damaged wood soffit at front porch roof

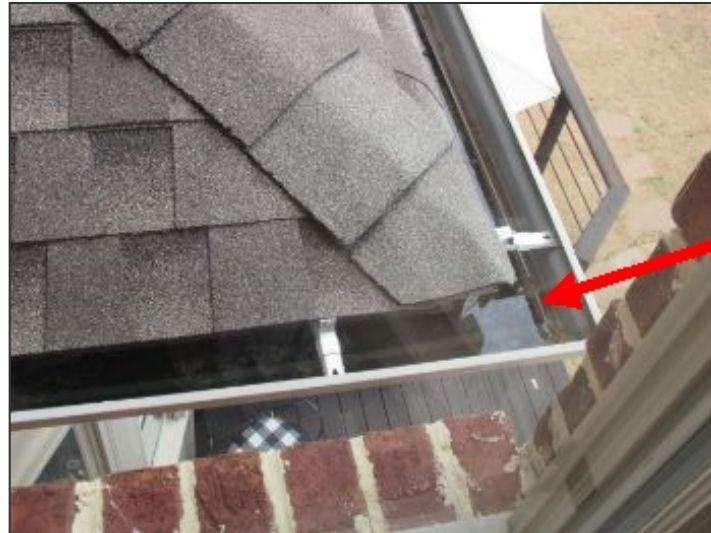
• **A gutter is improperly sloped above the family room bay windows and is holding water - can be seen from the left master bedroom window (see photo). Repair / adjustment is recommended so that the gutter is properly sloped and water flows to the downspout.**

Gutter holding water above family room windows

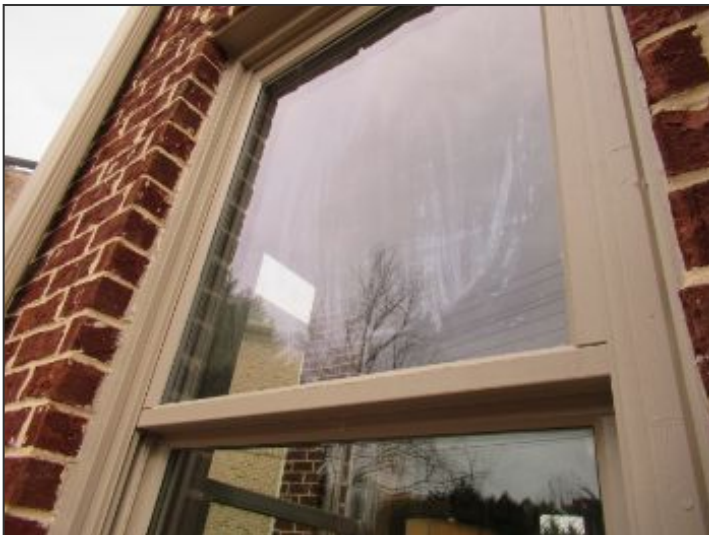
Defective window at rear kitchen keeping room

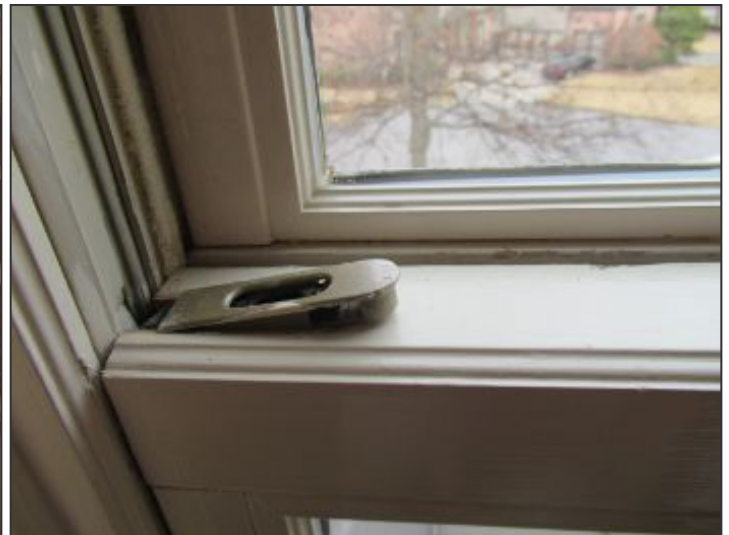
4. Defective / missing tilt latches were noted at the front bedroom window over the dining room and one front dining room window (see photo); repair is recommended.

Broken window tilt latch

Due to these concerns, further evaluation is recommended by a professional widow repair / replacement contractor to determine the full scope of repair needs and costs.

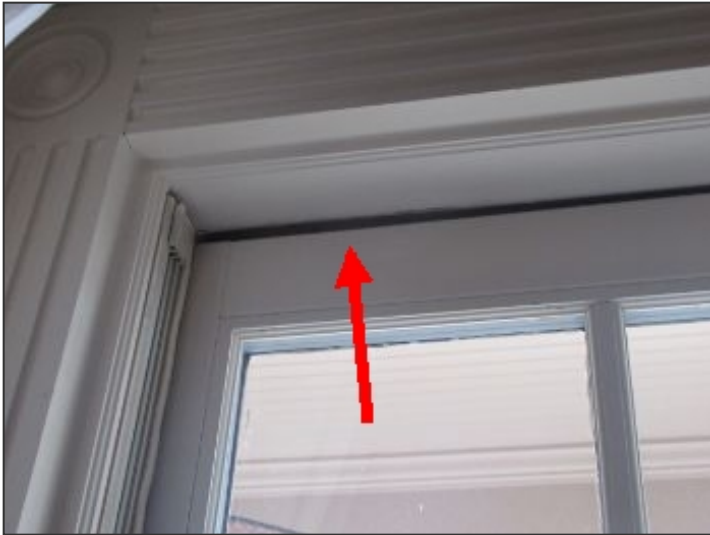
Dining room window not fully closed

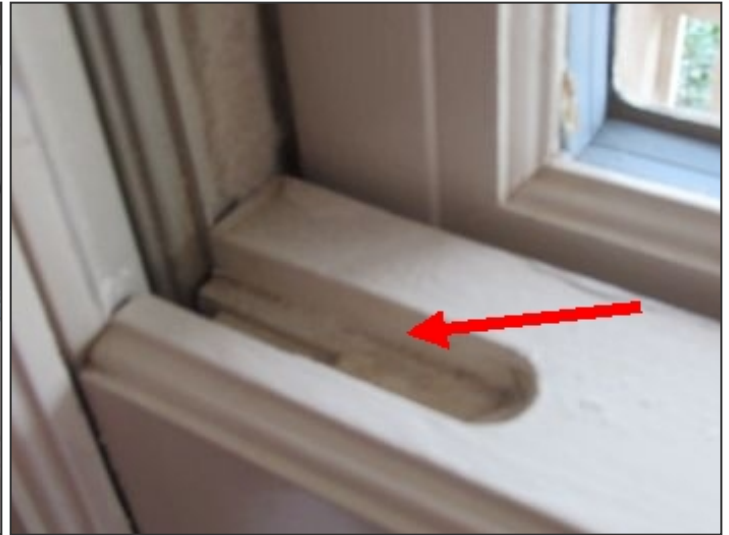
Missing tilt latch

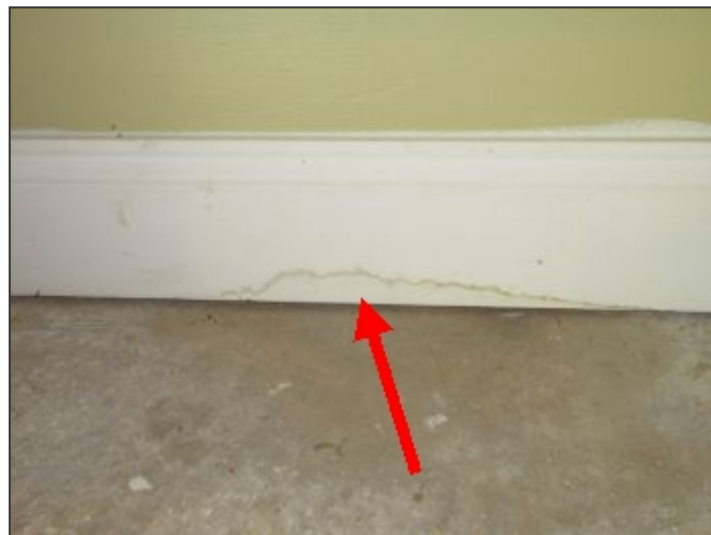
A water stain was observed at a baseboard in the basement below the main water cut off (see photo). This is an indication of an active or previous leak. Ask seller for full disclosure information regarding this leak. The stained area was tested with a moisture meter and was found to be dry. Continue to monitor, future repairs may be needed.

Water stain at baseboard below main water cut off

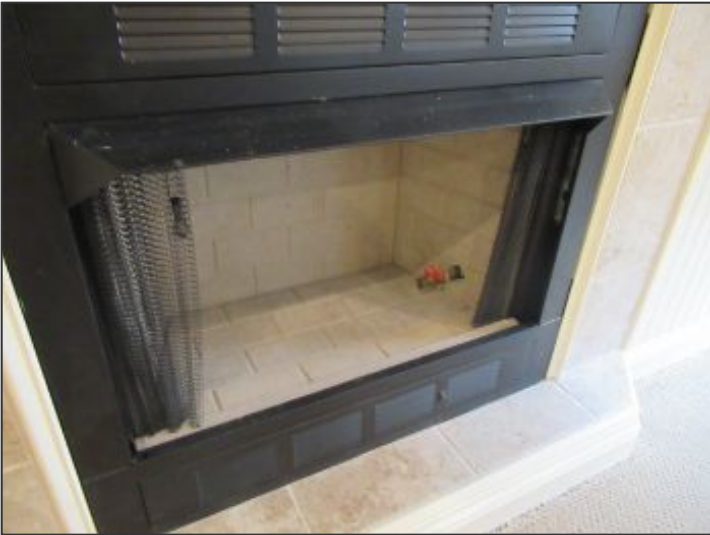
<p>Page 28</p>	<p>FIREPLACE:</p>	<ul style="list-style-type: none"> • BASEMENT FIREPLACE: 1. The fireplace gas logs have been removed (see photo). Replacement of the gas logs is recommended by a professional fireplace contractor. 2. The gas supply line is open and is not capped or sealed; correction is recommended. • KITCHEN KEEPING ROOM: The gas logs will not ignite manually, only the pilot light comes on. There was no gas valve outside the fireplace, the controls had to be accessed through the floor of the firebox. Further evaluation is recommended to determine the full scope of repair needs and costs. • DEN FIREPLACE: The gas log set appears to be too large for this size firebox and incorrectly extends too far out of the firebox, the gas logs need to be replaced with the correct size log set. This condition can lead to poor performance and possible improper venting of the gas log set. Further evaluation is recommended by a professional fireplace contractor to determine the full extent of repair needs and costs.

Basement fireplace logs have been removed

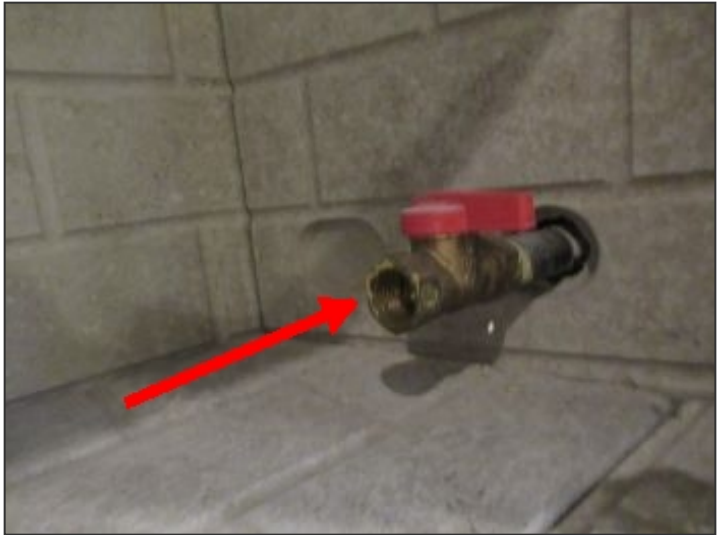
Open gas line at basement fireplace

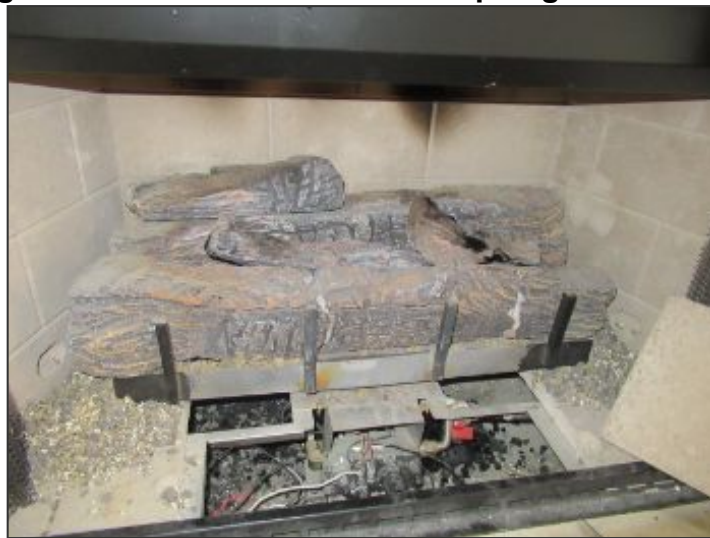
Unable to light kitchen keeping room fireplace

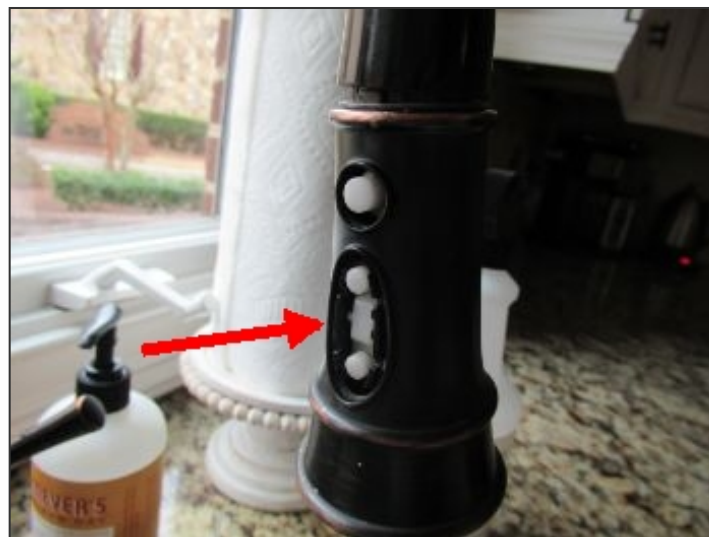
• **The kitchen sink faucet diverter buttons are missing (see photo). Repair / replacement is recommended.**

Diverter buttons missing

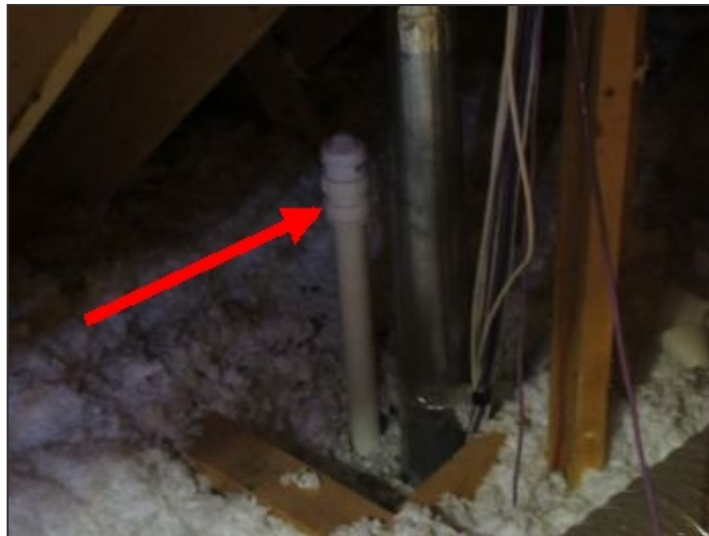
• **A strange odor is present at the master closet laundry room area during testing of the water fixtures in the bathroom. This condition may be caused by an improperly vented studor vent in the attic directly above this location. Further evaluation is recommended by a professional plumber to determine the full scope of repair needs and costs, if any.**

Studor vent above master closet laundry room

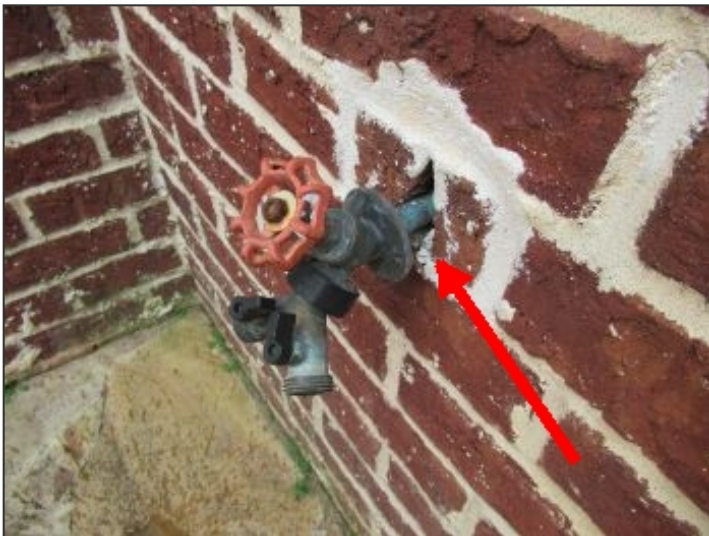
• An exposed supply pipe was noted at the exterior basement doorway (see photo). This condition is a potential freeze concern in the winter. Correction is recommended by a professional plumber.

Basement door hose bib projects too far outside wall

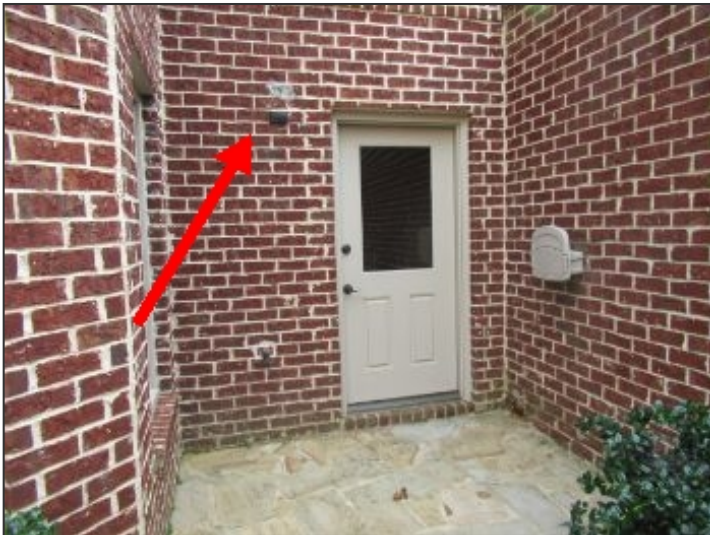
No exterior light above basement entry door

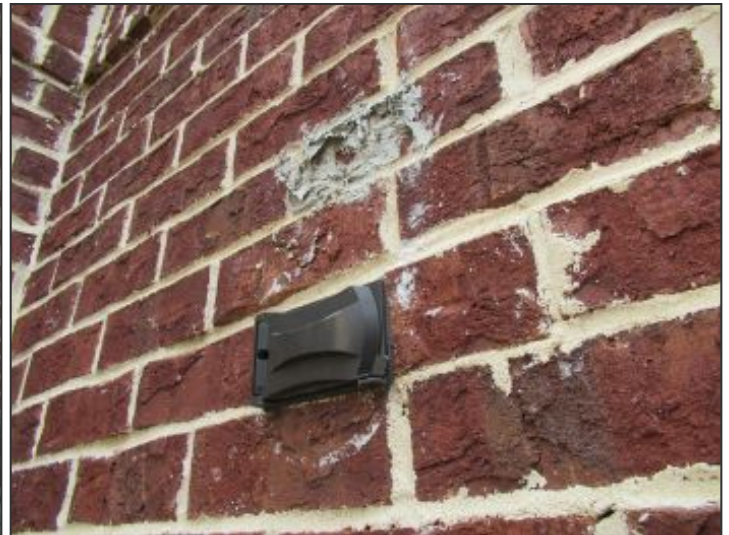
Basement doorway light removed

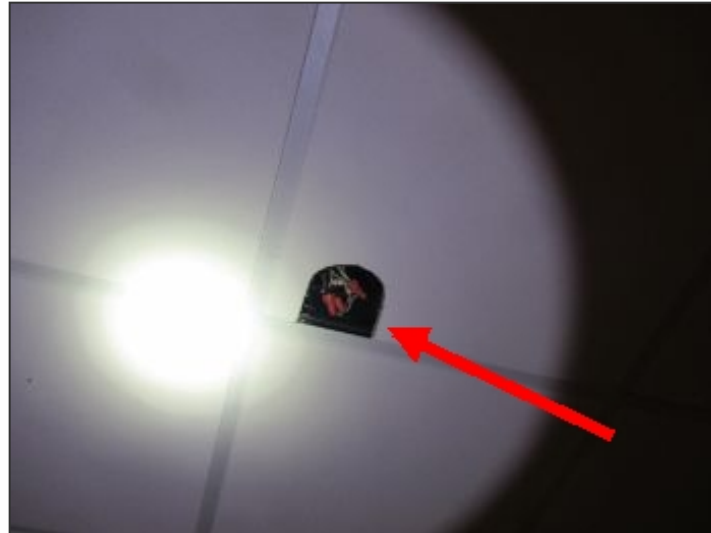
• Missing light fixtures and exposed wires were noted at the basement room with the electrical panels (see photo). Replacement of the missing light fixtures is recommended.

Missing light at basement ceiling

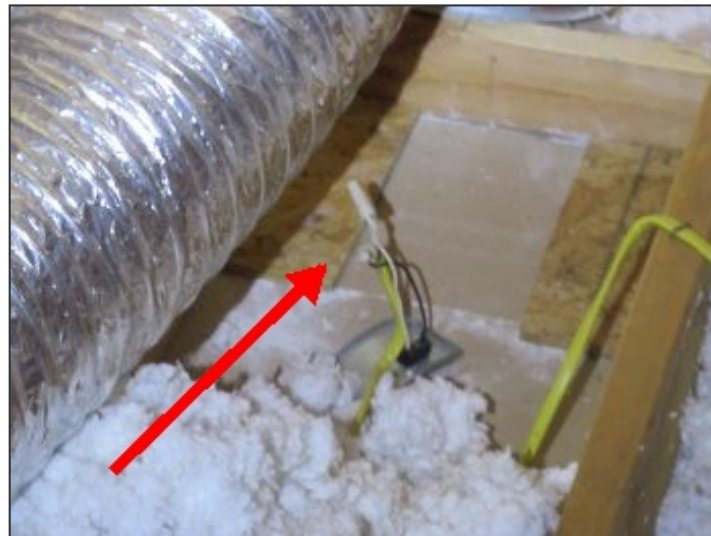
• **Incorrect Electrical:** An exposed wire splice was noted at the attic above the master shower (see photo). The wiring splice is required by the National Electric Code (NEC) to be enclosed in a properly sized and covered junction box for fire safety. Correction is recommended to meet the safety requirements of the NEC.

Wiring splice in attic above master shower

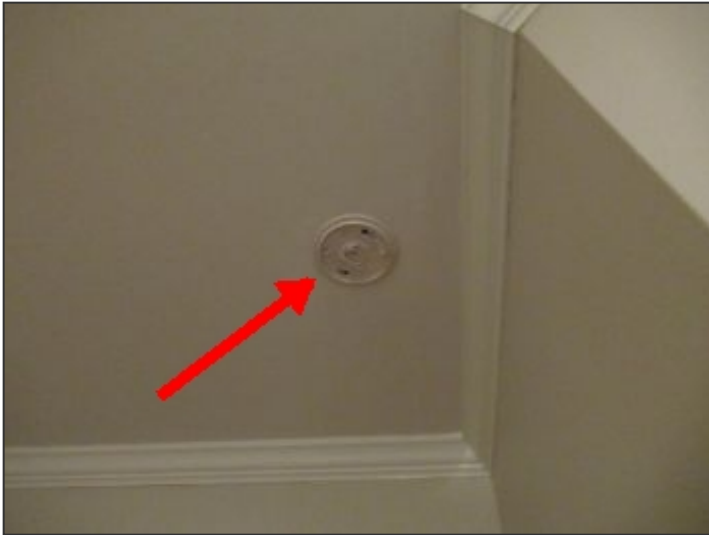
• The bedroom located at the basement does not have a smoke detector within 10 feet of the bedroom door; the smoke detector has been removed (see photo). Correction is advised to meet this fire safety requirement.

Smoke detector removed in basement

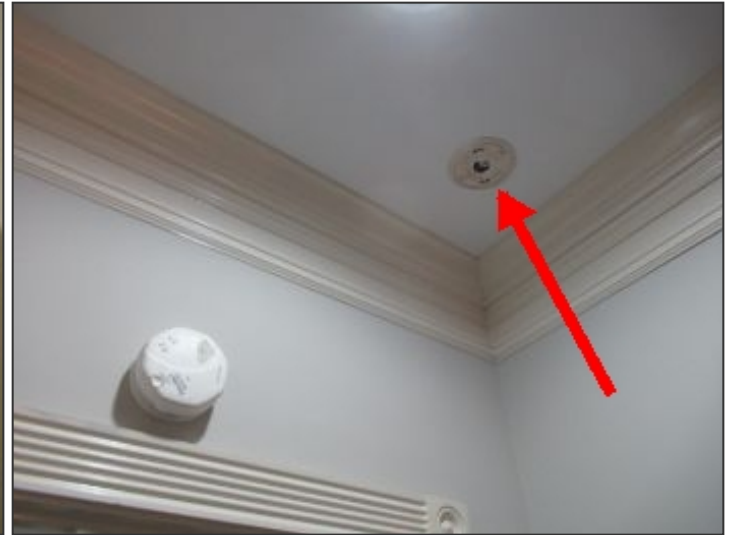
Smoke detector removed near master bedroom

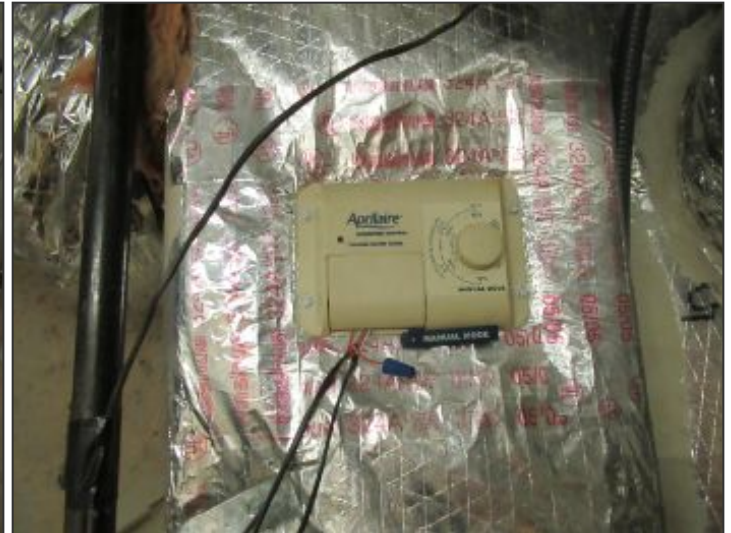
Humidifier not inspected
