**BPG Inspection Services**

**5390 Glenbrooke Trail  
Dunwoody GA 30338**

Client(s): Mulrane  
Inspection Date: 1/3/2020  
Inspector: Kevin Carey ,

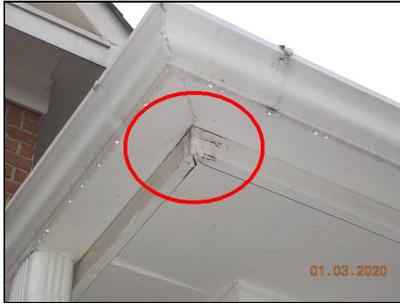
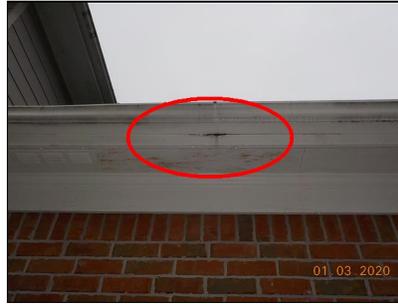
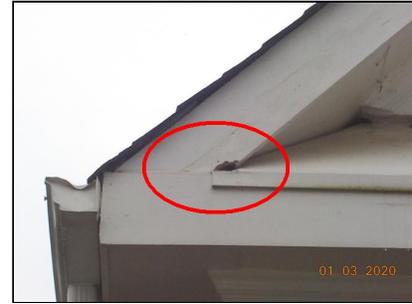
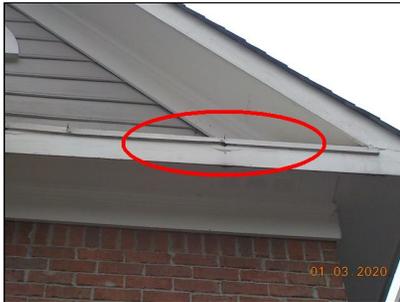
- ☒ 4. **SERVICE / REPAIR:** Wood rot and deterioration of the fascia board noted. Have a professional contractor evaluate and eliminate the cause and repair damage to fascia boards. Locations: **Front, right side**

Wood rot and deterioration of the fascia board noted.

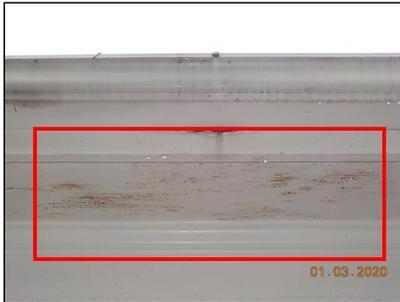
- ❌ 5. **SERVICE / REPAIR:** Wood rot and deterioration noted in the soffit. This often indicates problems with a roof leak or overflowing gutters. Have a professional contractor evaluate the cause and repair affected areas and eliminate cause of moisture intrusion. Location: **Right side**

Wood rot and deterioration noted in the soffit.

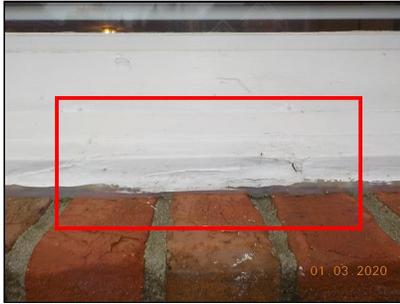
- ❌ 6. **SERVICE / REPAIR:** Wood rot and deterioration are present. Evaluate all areas and replace/repair all wood rot to the extent found to prevent further damage to any area. All replacement wood should be primed on all sides, caulked and painted as required. Any damage on the exterior wall or trim that allows openings into the wall cavity or interior can cause significant water damage over time if not repaired. Location: **Front window frame**

Wood rot and deterioration are present.

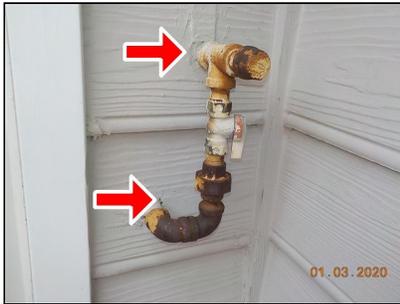
- ❌ 7. **SERVICE / REPAIR:** Metallic piping or tubing is exposed to corrosive action or oxidation/rust, such as soil condition or moisture, Piping should be protected in an approved manner. Recommend cleaning the pipe with a metal brush and painting with a rust inhibitor. Location: **Rear-at the chimney**

Recommend cleaning the pipe with a metal brush and painting

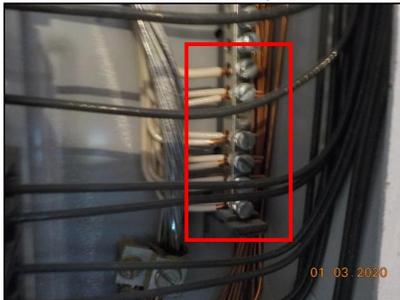
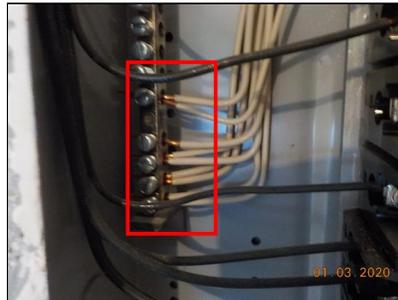
- ❌ 8. **SAFETY / HEALTH:** The neutral (white) wires are doubled under the same lugs inside the electrical panel. Although the manufacturer of this panel may allow the doubling of ground wires, the doubling of neutral wires is prohibited in most cases due to potential for loose contact. Would recommend having reviewed and corrected by an electrician for safety.

The neutral (white) wires are doubled under the same lugs

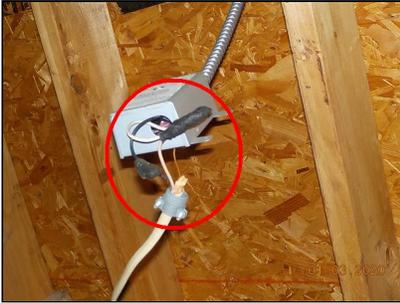
- ❌ 9. **SAFETY / HEALTH:** Improper wiring noted. All electrical splices and terminations should be inside of an approved junction box with cover plate for safety. Recommend a licensed electrician to evaluate the condition and correct. Location: **Attic-at the roof vent fan**

All electrical splices and terminations should be inside of an approved junction box

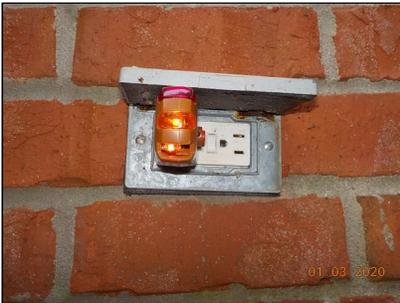
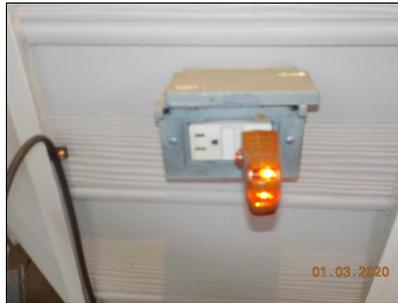
- ❌ 10. **SAFETY / HEALTH:** GFCI device failed to trip when tested with pocket tester or when test button was used. While it will still appear to function, it does not provide the required level of safety. Required to be GFCI protected at this location. Replacement with a functional GFCI is necessary by qualified electrician. Locations: **Exterior-front porch, screened porch**

GFCI device failed to trip when tested

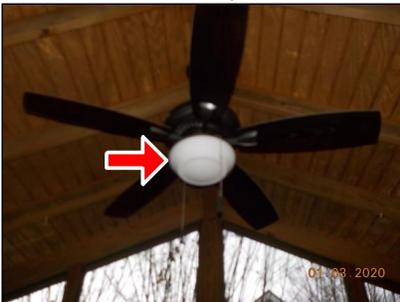
- ❌ 11. **SERVICE / REPAIR:** Inoperable light noted. Replace bulbs and verify that the fixture is operational. If not, consult an electrician for repairs. Location: **Screened porch**

Inoperable light noted.

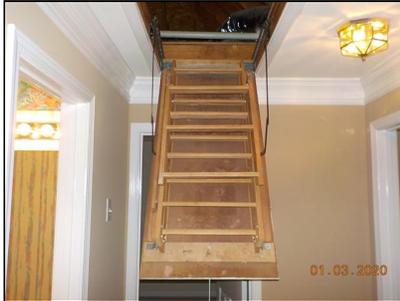
- ❌ 12. **SERVICE / REPAIR:** Attic pull down stair is not substantially weather tight when closed. Have the unit modified (weather stripped / insulated) as necessary to control energy loss. One option is to provide an insulated cover that fits over the stairs when retracted to reduce heat loss in the winter.

Attic pull down stair is not substantially weather tight when closed.

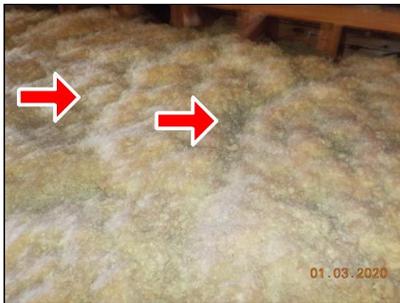
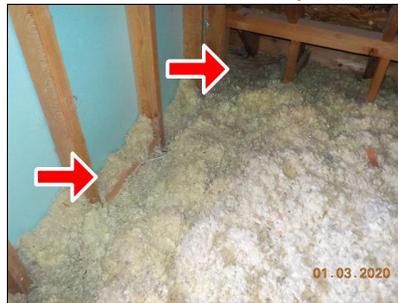
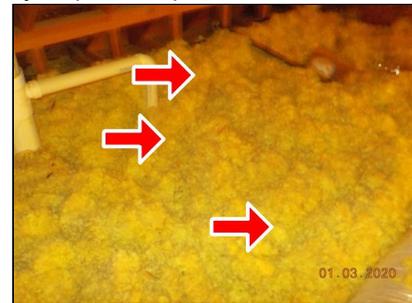
- ❌ 13. **SERVICE / REPAIR:** Signs of past rodent activity noted in the **attic**. Tunnels, trails and matted insulation noted in both attic areas. Recommend further evaluation and service performed by a qualified pest control contractor.

Tunnels, trails and matted insulation noted

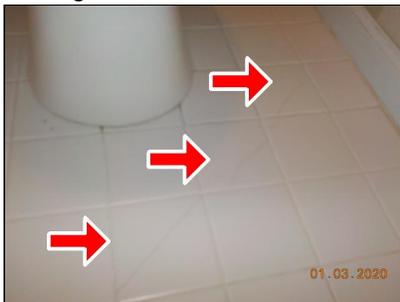
- ❌ 14. **SERVICE / REPAIR:** Cracked floor tiles noted. Have a professional flooring contractor evaluate and replace damaged tiles. Location: **Master bathroom**

Cracked floor tiles noted.

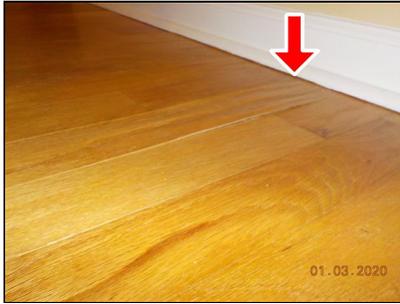
- ❌ 15. **SERVICE / REPAIR:** Damaged area of flooring noted. Have a professional flooring contractor evaluate and repair or replace the flooring as needed. Location: **Kitchen/breakfast area**

Damaged area of flooring noted.

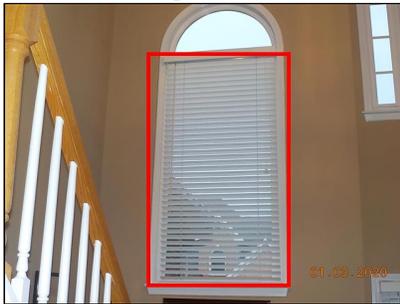
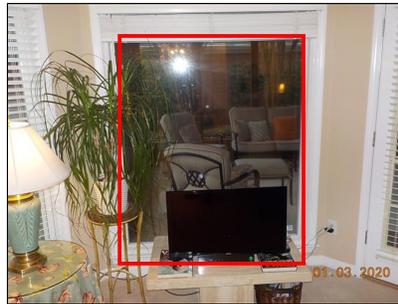
- ❌ 16. **MAJOR DEFECT:** Condensation and / or hazing was noted between insulated window panes. The thermopane insulated glass has lost its vacuum seal and may eventually completely cloud over. Broken seals also reduce the original insulation value of the window. (Dirty windows should be cleaned to assure that conditions do not exist in other units and were not obvious at time of inspection.) Recommend replacement of all damaged windows listed plus any others throughout house that may be identified by glass service. Locations: **Front entry-at the stairway, kitchen sitting room/den**

Condensation and / or hazing was noted between insulated window panes.

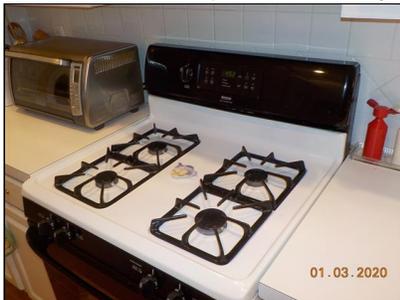
- ❌ 17. **SAFETY / HEALTH:** A hold down device is necessary for the stove to prevent it from being tipped over when the door is open. Typically this involves a bracket around the stove foot or a chain from the back of the stove to the wall. Install as required for safety.

Missing anti-tip device noted.

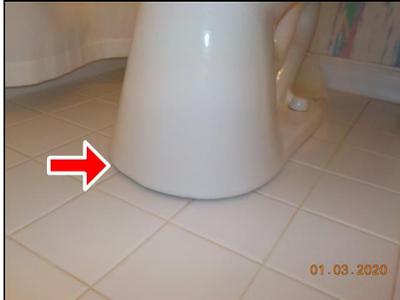
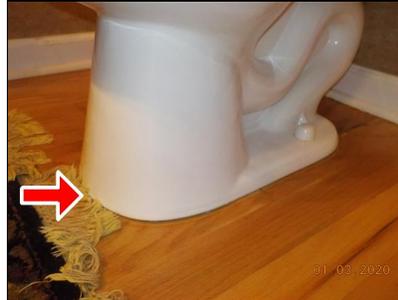
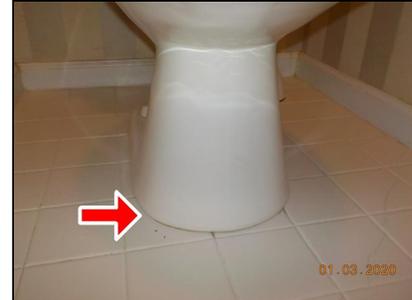
- ❌ 18. **SERVICE / REPAIR:** Toilet should be sealed between the base and floor as required. This helps protect below the unit from contaminants and better holds the unit in place to avoid rotating. The plumbing code also requires caulking fixtures to their mounted surfaces. Location: **All 3 bathrooms** Note: Recommend using clear caulk on darker floor surfaces

Toilet should be sealed between the base and floor

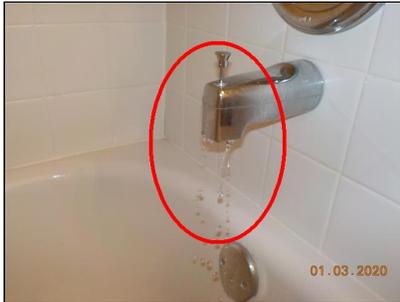
- ❌ 19. **SERVICE / REPAIR:** Shower diverter does not seal completely when engaged. This will result in a weaker flow to the shower head. Recommend correct to prevent water loss and allow normal use of shower. Location: **2nd floor bathroom**

Shower diverter does not seal completely when engaged.

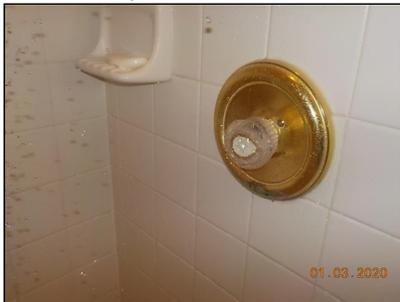
- ❌ 20. **SAFETY / HEALTH:** Reversed hot and cold plumbing noted at the shower fixture. The valve does not stop properly. This can result in scalding if unfamiliar with this condition. Recommend correct as required for hot to be on the left position. Location: **Master bathroom**

Reversed hot and cold plumbing noted at the shower fixture.

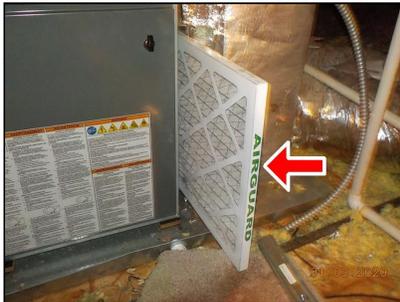
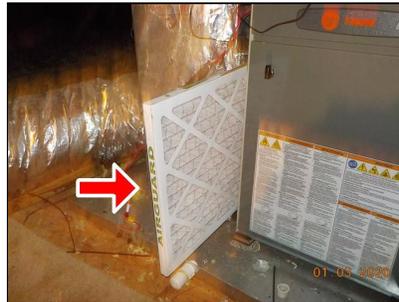
31. **GENERAL NOTE:** Recommend changing the filter at move-in. Recommend changing filter every two to three months thereafter. Use a good quality, pleated filter that is rated MERV-8 or better. The filter size is: 16 x 25 x 1

Recommend changing the filter at move-in.

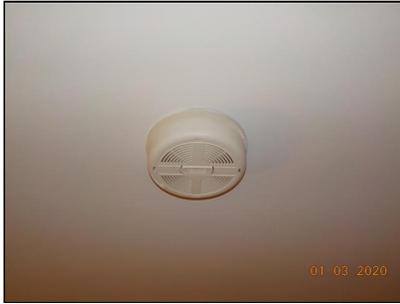
33. **RECOMMENDED UPGRADE:** Older model smoke detectors noted. Manufacturers recommend the replacement of smoke detectors every ten years due to the declining sensitivity of the internal sensors.

Older model smoke detectors noted.
