Echota Home Inspections, Inc
P.O Box 17771
Atlanta, Georgia 30316

1953 Willa Way
Decatur, Georgia 30032

Echota Home Inspections, Inc

07:52 December 25, 2019

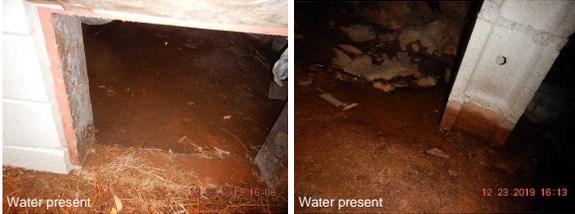
5. Main Crawl Space Unable to Inspect: 80% - Debris., Water., Mud., Deteriorated radiant barrier on floor joist.
6. Main Crawl Space Moisture Penetration: Water present - A qualified contractor is recommended to evaluate and estimate repairs

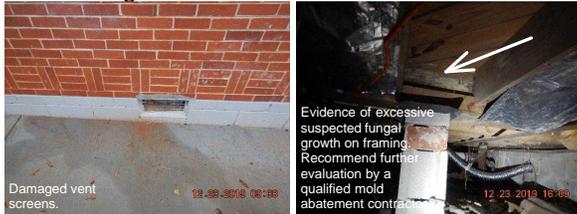
7. Main Crawl Space Ventilation: Vents - Evidence of excessive suspected fungal growth on framing. Recommend further evaluation by a qualified mold abatement contractor., Damaged screens/covers, suspected rodent intrusion.

Vents at grade level, left elevation.
