# Property Re Inspection Report

Property address: **7060 Amberleigh Way  
Duluth GA 30097**

Inspection date: **Wednesday, January 8, 2020**

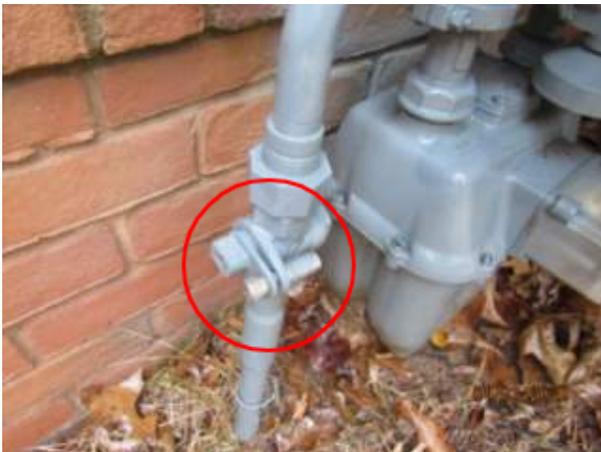
**Photo 1-1**

1) **i** The natural gas service was turned off. As a result, some appliances such as water heater(s), forced air furnace(s), gas fireplace(s), stove(s), range(s) and/or gas supply lines weren't fully evaluated. The inspector was unable to test for gas leaks.

The natural gas was turned on at time of the re inspection

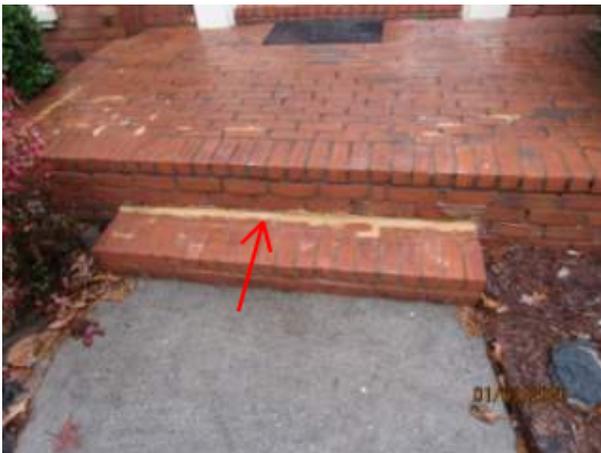
**Photo 4-1**

Risers for stairs at one or more locations were higher than 7 3/4 inches and posed a fall or trip hazard. Risers should be 7 3/4 inches or shorter. At a minimum, be aware of this hazard, especially when guests who are not familiar with the stairs are present. Recommend that a qualified contractor repair per standard building practices.

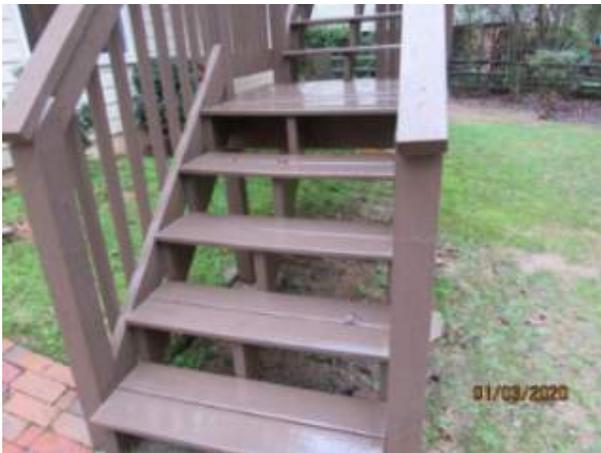
**Photo 5-1**

Large gaps at stair risers were found. This is a potential safety hazard for children (e.g. falling, getting stuck in gaps). Recommend that a qualified contractor repair as necessary to eliminate large gaps in stairs at elevations over 30 inches high. For example, by installing boards for risers.

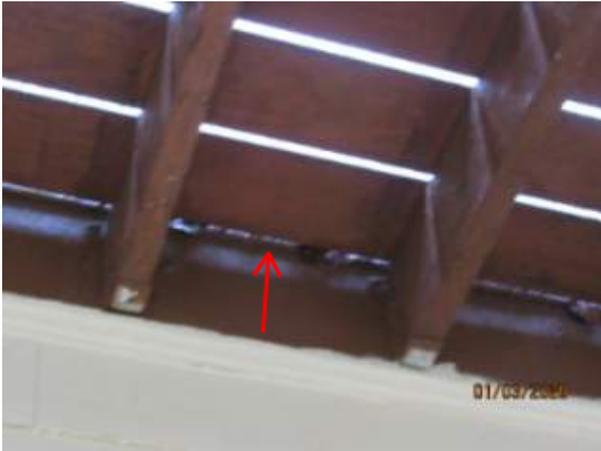
**Photo 6-1**

6) 🛠️💧 Flashing appeared to be missing from above one or more deck or porch ledger boards, or could not be verified. Missing flashing at this location can cause moisture to accumulate between the ledger boards and the building. Fungal rot may occur in this area and cause the ledger board fasteners to fail. The deck may separate from the building in this event. This is a potential safety hazard. Recommend that a qualified contractor install flashing above ledger boards per standard building practices. For more information, visit: <http://www.reporthost.com/?LB>  
<http://www.reporthost.com/?SD>

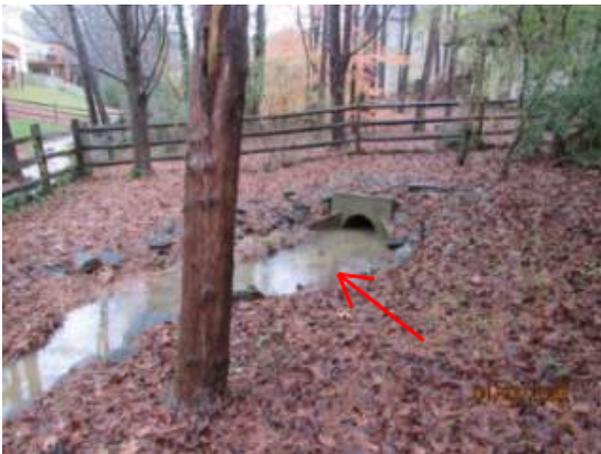
**Photo 7-1**

7) 🛠️📍 Located in the rear of the property is a culvert drain for the storm drains. The path that the water takes to the creek is clogged with debris causing the water to back up. Recommend a qualified contractor evaluate and make the necessary repairs.

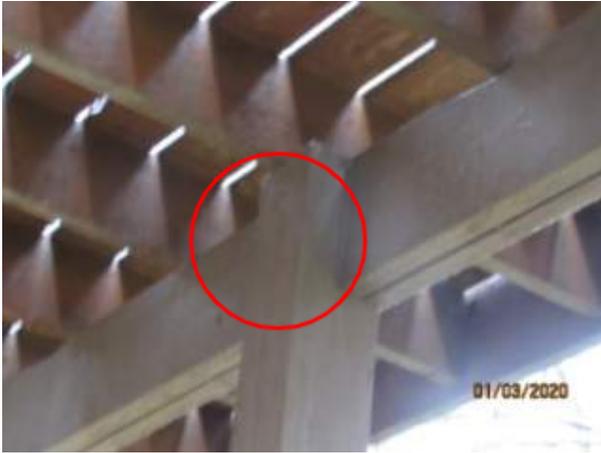
**Photo 8-1**

8) 🛠️📍 The support beams for the deck sit on top of a cut out in the 6x6. There are no carriage bolts or lag bolts securing the beams to the post. Recommend a qualified contractor evaluate and make the necessary repairs.

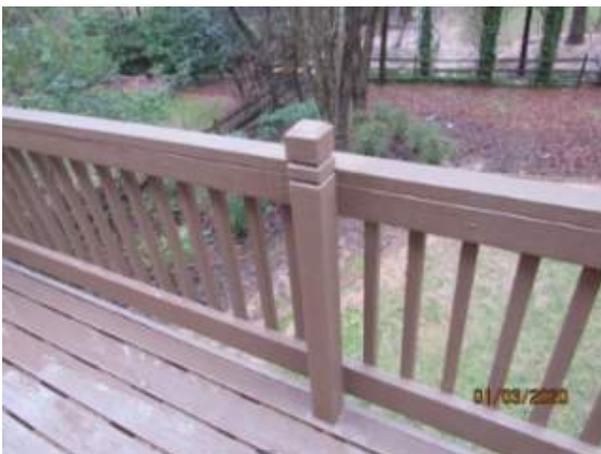
**Photo 9-1**

9) 🛠️🔍📄 Handrails at one or more flights of stairs were loose. This is a safety hazard. Recommend that a qualified person repair as necessary.

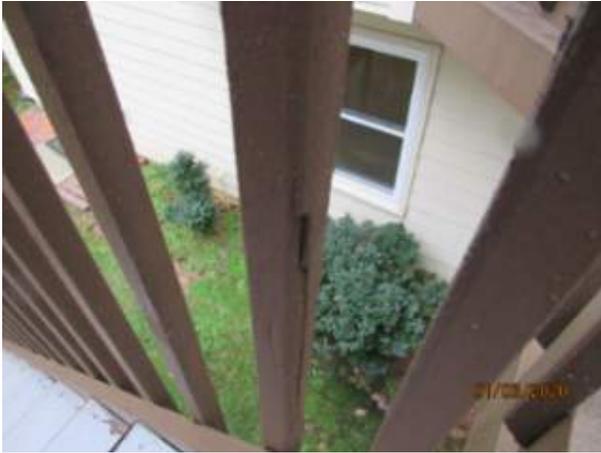
**Photo 10-1**

10) 🛠️🔍📄🚧 Fungal rot was found in railings at one or more sets of exterior stairs. Fungal rot in some stair components may pose a safety hazard. Recommend that a qualified person evaluate and repair as necessary. All rotten wood should be replaced.

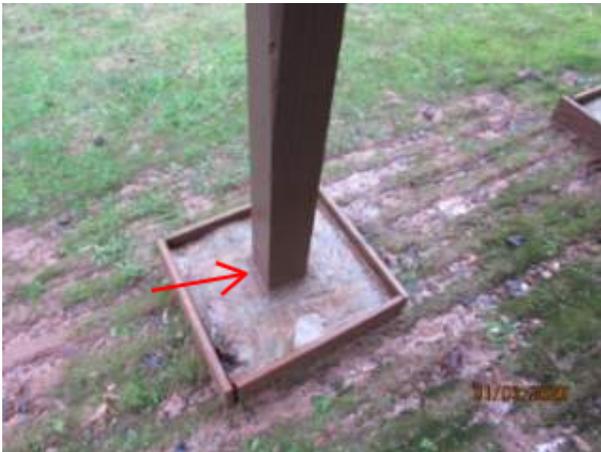
**Photo 11-1**

**11)** 🛠️💧 Wooden support posts for the deck or porch were resting directly on concrete piers or footings below. Water may wick up into the support post ends and result in elevated levels of moisture in the wooden support post ends. This is a conducive condition for wood-destroying organisms. Support posts should rest in metal brackets above concrete piers or footings, or should be separated from the concrete below by impervious membranes such as composition shingle scraps. Even if posts are made of treated wood the cut ends may not have been field-treated, leaving little or no preservative at the post center. Recommend that a qualified contractor repair per standard building practices. For example, by installing composition shingle scraps between the posts and the concrete below.

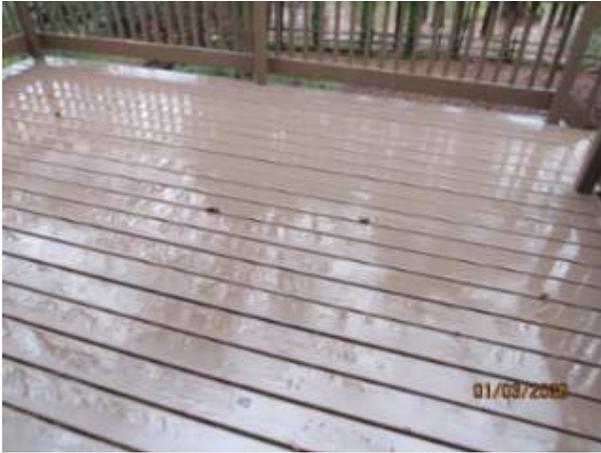
**Photo 12-1**

One or more decks and/or porches appear to be painted with a thick paint called Deck Restore. Deck Restore is a product that is designed to mask the wood not allowing the wood grain to show. It is marketed as a thick paint product for wood decks that are outside of conventional restoration. In many cases, it is used to cover or mask significant damage to deck boards rather than replacing them. The inspector was unable to determine the condition of many areas of the deck and/or porch because of this. The client should also be aware of the class action lawsuit regarding one manufacturer of this product. Bubbling, peeling and premature deterioration of the finish can cause moisture to become trapped in the wood causing rot/deterioration. Click on the link below for more information on this product and the class action lawsuit. <https://www.deckstainhelp.com/class-action-lawsuit-against-rust-oleum-deck-restore/>

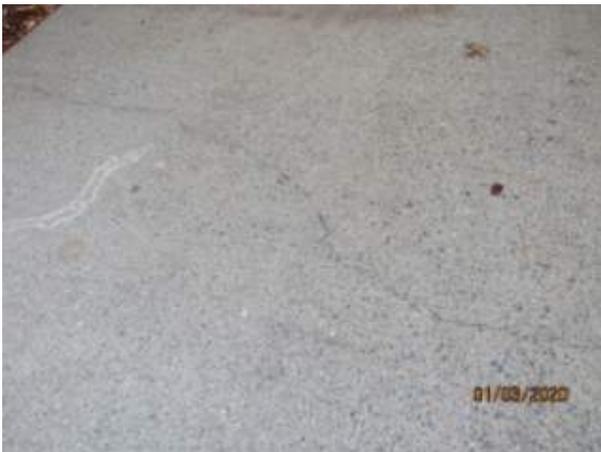
**Photo 13-1**

Minor deterioration (e.g. cracks, holes, settlement, heaving) was found in the driveway, but no trip hazards were found. The client may wish to have repairs made for cosmetic reasons.

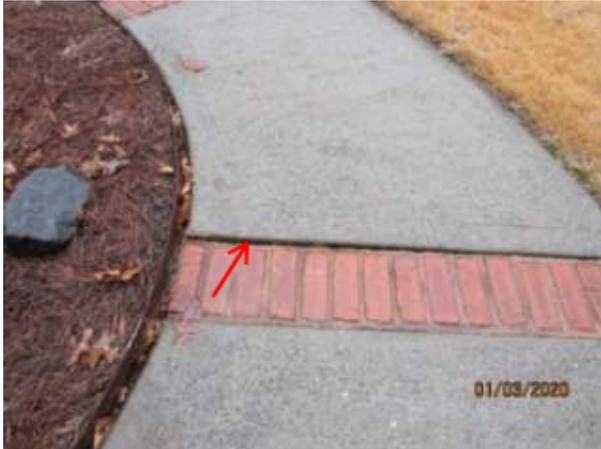
**Photo 14-1**

Minor deterioration (e.g. cracks, holes, settlement, heaving) was found in sidewalks or patios, but no trip hazards were found. The client may wish to have repairs made for cosmetic reasons.

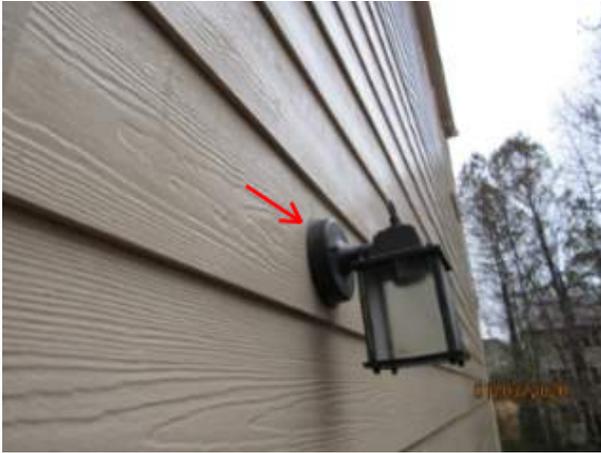
**Photo 15-1**

One or more wall-mounted exterior light fixtures have wiring that's subject to water intrusion due to caulk not being installed around the light fixture's back plate. Caulk should be applied around the perimeter of back plates where missing. A gap should be left at the bottom for condensation to drain out.

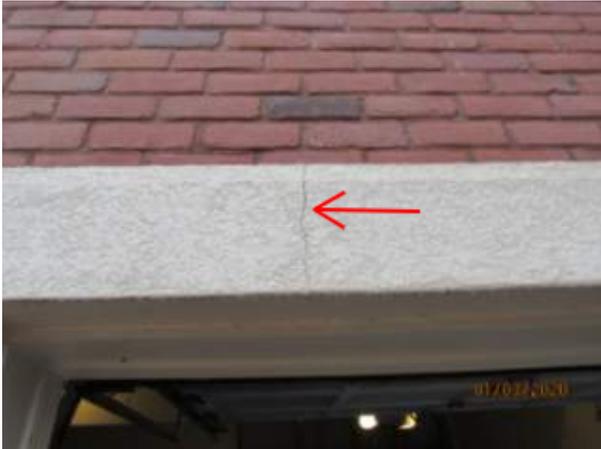
**Photo 16-1**

**16)** 🛠️ 🔍 ⓘ 💧 Cracks, deterioration and/or damage were found in one or more areas of the expanded foam insulation system (EIFS) exterior finish. In damp climates, moisture can enter cracks or damaged areas and further deteriorate the finish. Also, the wall behind the finish can become damaged from moisture intrusion. Note that areas behind the finish are inaccessible and excluded from this inspection. Recommend that a qualified contractor evaluate and make repairs and/or replace the EIFS siding as necessary.

For an additional fee, our office can schedule a stucco inspection with one of our certified stucco specialists. This inspection would include non-invasive wall scanning along with minor moisture probing to determine the overall condition of the stucco, including the potential to expose hidden moisture trapped behind the wall.

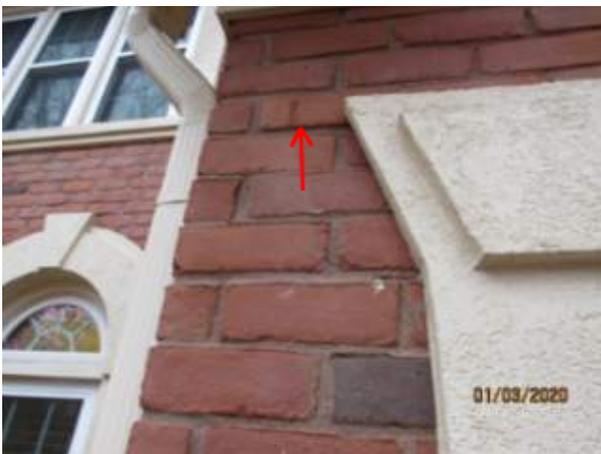
**Photo 17-1**

**17)** 🔧🔍 Minor cracks or deterioration were found in one or more sections of brick veneer. A qualified contractor should evaluate and make repairs as necessary, such as repointing mortar to prevent water intrusion and further deterioration in the future.

Above garage doors

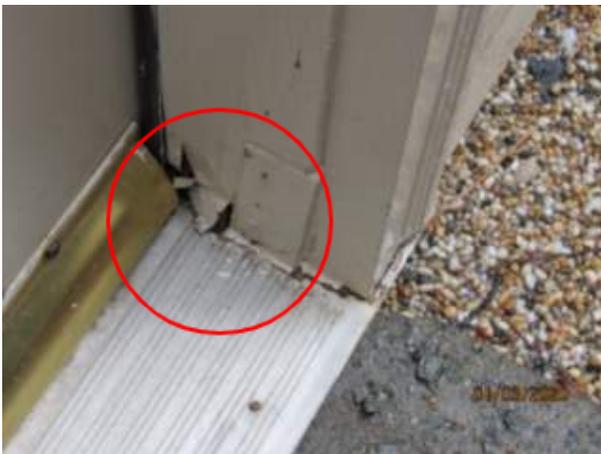
**Photo 18-1**

Fungal rot was found at one or more door jambs. Conductive conditions for rot should be corrected (e.g. wood-soil contact, reverse perimeter slope). Recommend that a qualified person repair as necessary. All rotten wood should be replaced.

Possible location left side door and basement door.

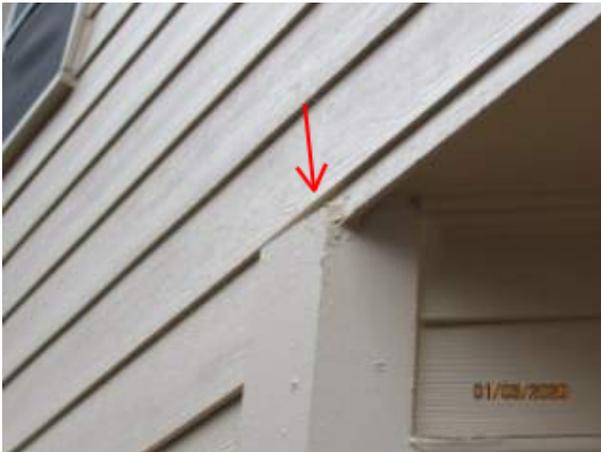
**Photo 19-1**

**19)** 🛠️ ⓘ 💧 One or more sections of horizontal trim boards had no "Z" flashing installed above them where they met siding. "Z" flashing should be installed above these boards to reduce the chance of leaks between the trim and siding. Without this flashing, caulk and paint must be diligently maintained, or water can enter wall cavities and cause rot and possible structural damage. Recommend that a qualified contractor install flashing above horizontal trim boards where missing and per standard building practices. Note that when trim or siding is removed to install flashing, damaged wood may be found and additional repairs may be needed.

Possible location rear elevation

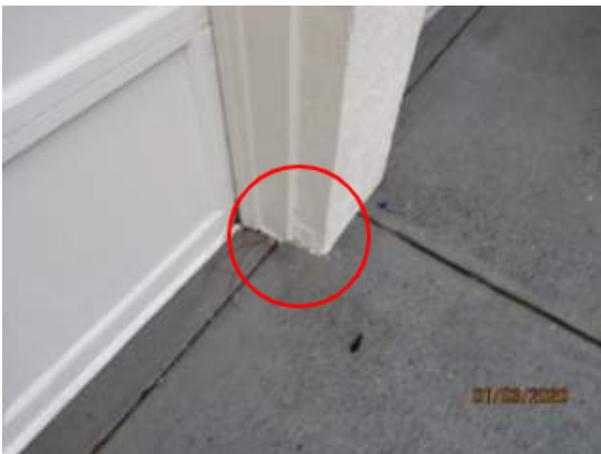
**Photo 20-1**

**20)** 🛠️ sections of siding and/or trim were . Recommend that a qualified person repair, replace or install siding or trim as necessary.

Possible location front elevation

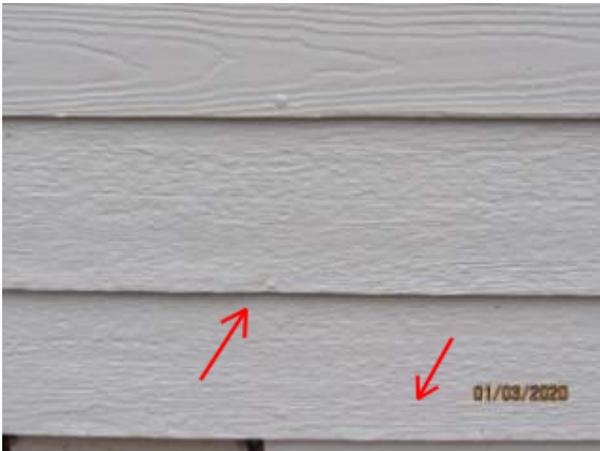
**Photo 21-1**

**21)** 🛠️ ⓘ 💧 This property was clad with composition wood fiber siding. Many brands of this type of siding by different manufacturers are known to deteriorate and/or fail prematurely due to moisture penetration. Failure is typically visible in the form of swelling, cracking and

Some areas of siding on this structure show the symptoms described above, but it appears that the siding hasn't deteriorated to the point of needing replacement. Some manufacturers (Louisiana Pacific) recommend a repair process for this siding where affected areas are sealed with "Permanizer Plus", a flexible primer made by Pittsburgh Paint, followed by two coats of 100% acrylic latex paint. This sealant must be applied to the bottom edges using a brush. The face of the siding can be sprayed. The "Permanizer Plus" sealer isn't required for edges that aren't swollen, cracked or deteriorated, but the acrylic latex should still be brushed on these edges.

Possible location near basement door

At a minimum, recommend having a qualified contractor seal and repaint as described above, or by other methods specified by the siding's manufacturer. The client may wish to have a qualified contractor evaluate further to determine if some or all of the siding should be replaced.

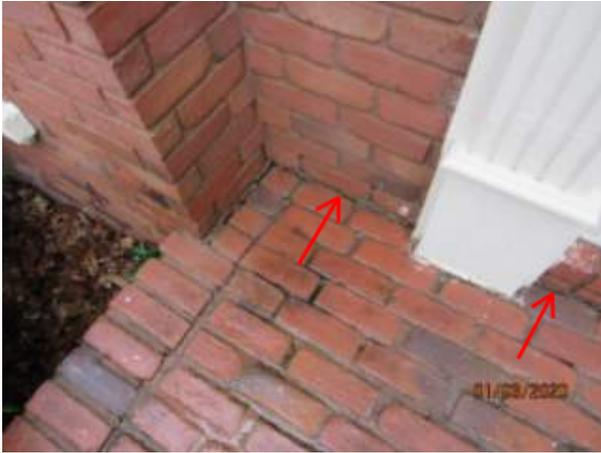
**Photo 22-1**

One or more holes or gaps were found in siding or trim. Vermin, insects or water may enter the structure. Recommend that a qualified person repair as necessary.

Possible location left side

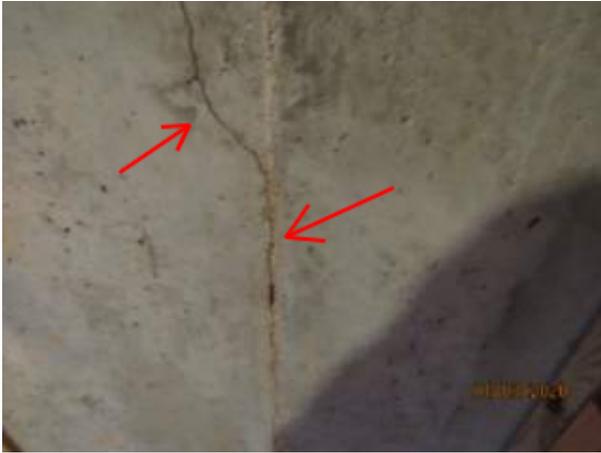
**Photo 23-1**

One or more minor cracks (1/8 inch or less) were found in the foundation. These didn't appear to be a structural concern, but recommend sealing them to prevent water infiltration and monitor them in the future. Numerous products exist to seal such cracks including hydraulic cement, non-shrinking grout, resilient caulks and epoxy sealants.

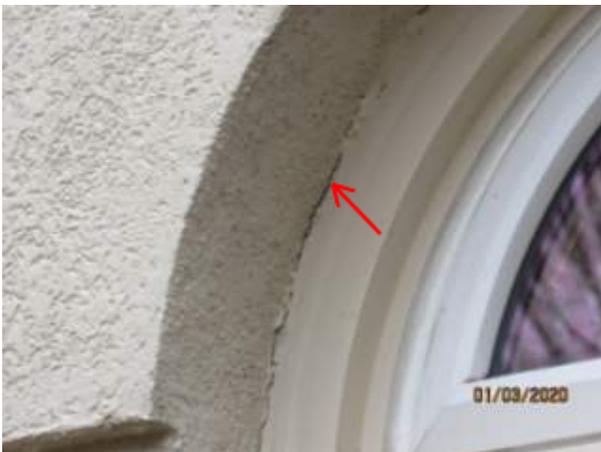
**Photo 24-1**

Caulk was deteriorated in some areas. For example, around windows and/or at siding butt joints. Recommend that a qualified person renew or install caulk as necessary. Where gaps are wider than 1/4 inch, an appropriate material other than caulk should be used. For more information, visit: <http://www.reporthost.com/?CAULK>

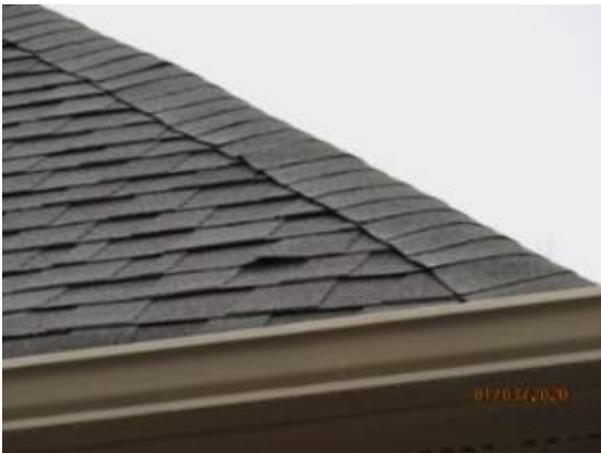
**Photo 27-1**

Some composition shingles were loose. Leaks can occur as a result. This is a conducive condition for wood-destroying organisms. Recommend that a qualified contractor repair as necessary. For example, by replacing shingles.

Front elevation

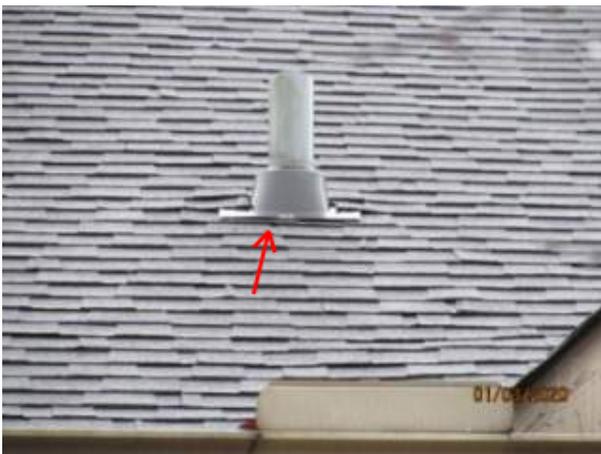
**Photo 28-1**

One or more rubber or neoprene pipe flashings were loose or lifting. Leaks can result from windblown rain. This is a conducive condition for wood-destroying organisms. Recommend that a qualified person repair as necessary to prevent leaks. For example, by nailing flashings down and sealing as necessary.

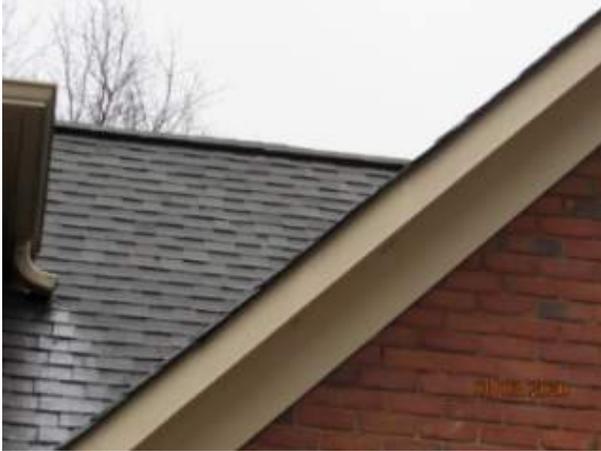
**Photo 29-1**

material (typically plywood or oriented strand board). This reduces the chance of fungal rot or deterioration from water damage in the roof sheathing. Recommend that a qualified contractor install drip edge flashings where missing and per standard building practices.

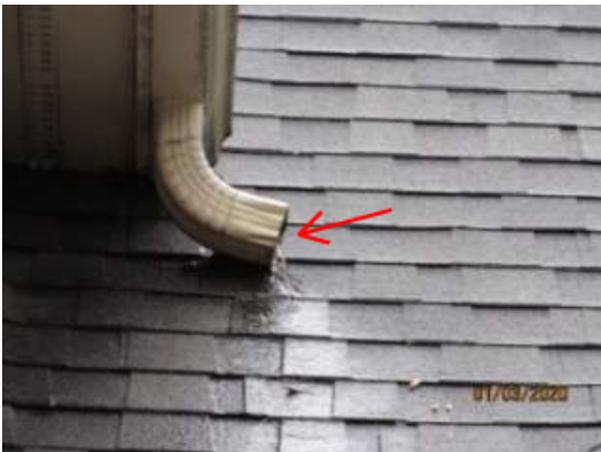
**Photo 30-1**

Downspouts that discharge onto the roof should be extended to discharge directly into the gutters below. This condition, if left unattended, can result in premature deterioration of the roofing under the end of the downspout.

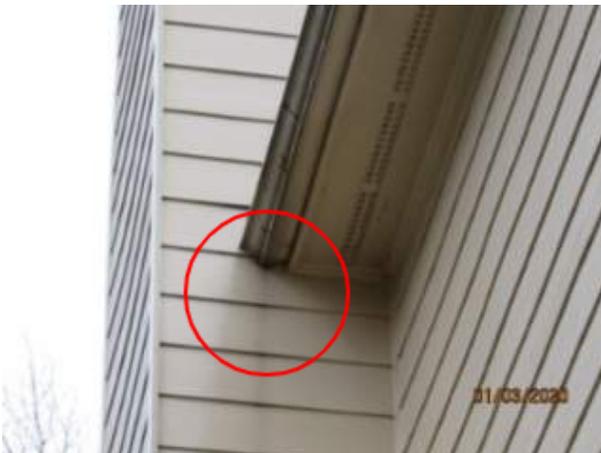
**Photo 33-1**

**33)** 🏠 ⓘ Stains were found at the front of one or more gutters and indicate that the gutters have overflowed. If they have overflowed, it's usually due to debris clogging gutters or downspouts. The inspector was unable to verify that the gutters and downspouts drained adequately due to lack of recent, significant rainfall. Monitor the roof drainage system in the future while it's raining to determine if problems exist. Then if necessary, recommend that a qualified person clean, repair or replace gutters, downspouts and/or extensions.

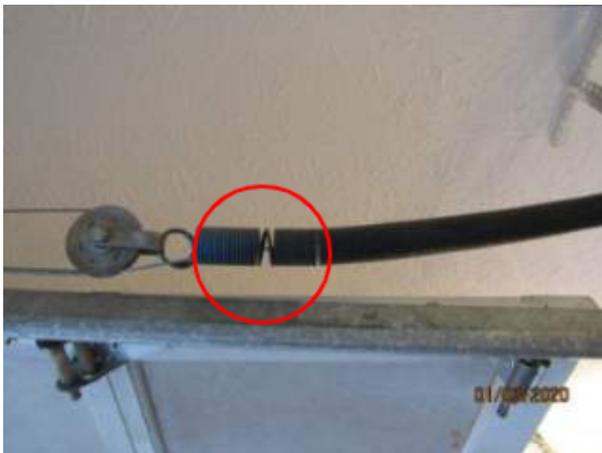
**Photo 36-1**

**36)** 🚑🔧📄 One or more extension springs supporting garage vehicle door(s) were stretched. This is an indication that the spring(s) have been weakened. Stretched extension springs are a potential safety hazard in the event that they break. The vehicle door could fall shut or a spring could strike someone nearby when it breaks. Recommend that a qualified contractor replace stretched extension springs.

Left door

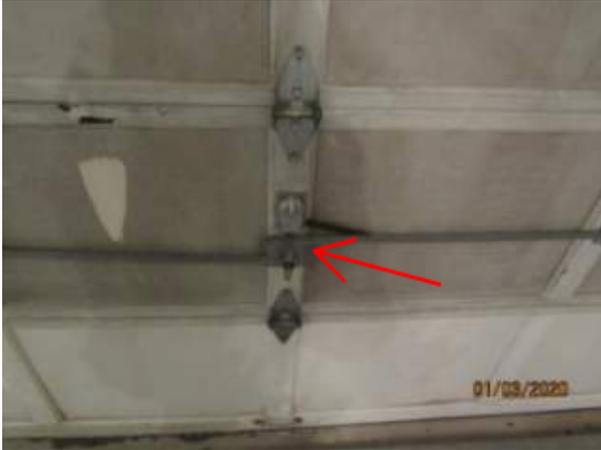
**Photo 38-1**

One or more garage vehicle doors had an automatic opener installed, and the manual lock mechanism on the door hadn't been permanently disabled. The automatic opener can be damaged, or injury can occur if the automatic door opener is operated with the manual lock engaged. A qualified person should disable or remove the lock mechanism per standard building practices.

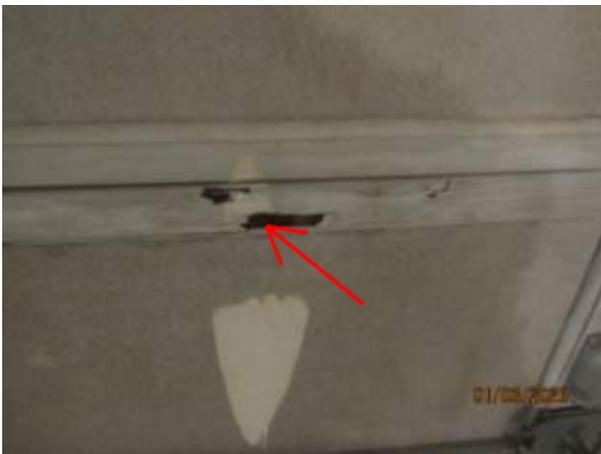
**Photo 39-1**

One or more garage vehicle doors were damaged or deteriorated. Recommend that a qualified contractor repair or replace door(s) as necessary.

Left side door

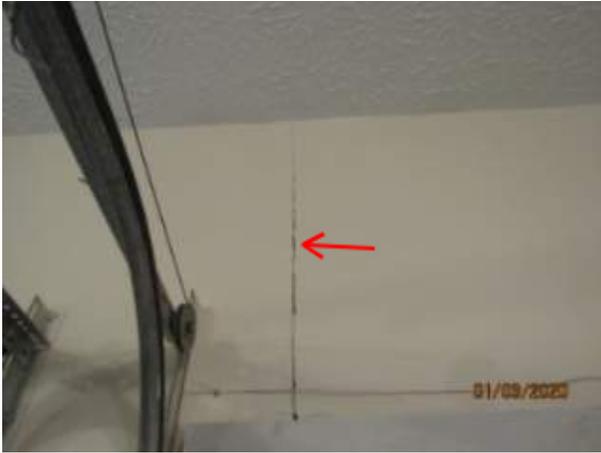
**Photo 40-1**

Stains were found in one or more ceiling areas. However, no elevated levels of moisture were found. The stain(s) may be due to past roof and/or plumbing leaks. Consult with the property owner and monitor the stained area(s) in the future, especially after heavy or prolonged rain. If elevated moisture is found in the future, then recommend that a qualified contractor evaluate and repair as necessary.

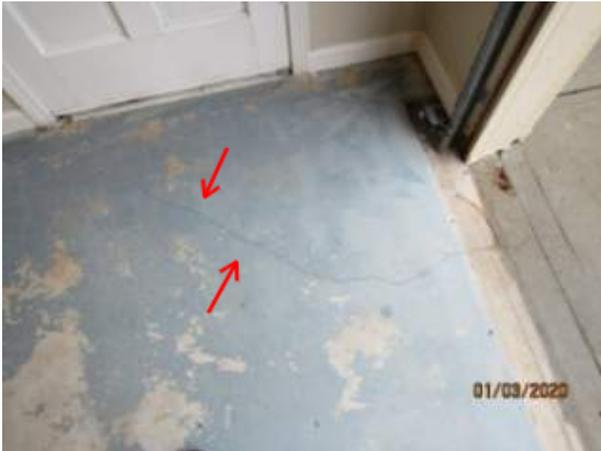
**Photo 41-1**

Minor cracks were found in the concrete slab floor. These are common and appeared to be only a cosmetic issue.

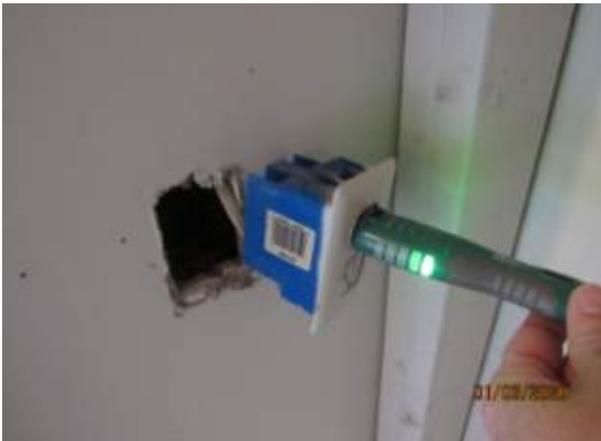
**Photo 44-1**

44) 🛠️🔍📄 One or more ground fault circuit interrupter (GFCI) receptacles (outlets) wouldn't trip with a test instrument at the garage. This is a potential shock hazard. Recommend that a qualified electrician evaluate and repair as necessary.

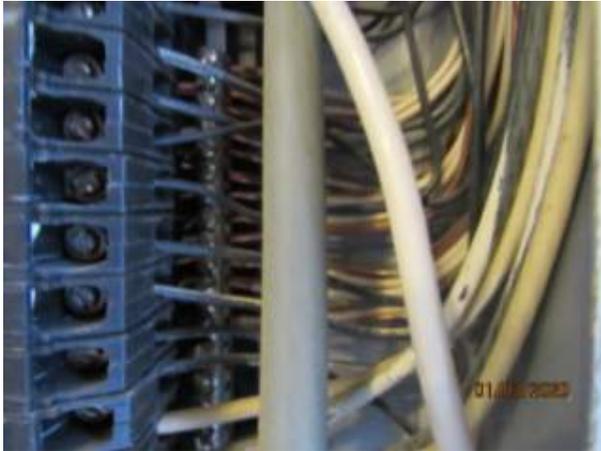
**Photo 45-1**

Neutral wires were doubled or bundled together under the same lug on the neutral bus bar in panel(s) #A. This is a potential safety hazard in the event that one of the circuits needs to be isolated during servicing. For one neutral to be disconnected, other neutrals from energized circuits sharing the same lug will be loosened. Power surges may result on the energized circuits and result in damage or fire. Also, multiple wires under the same lug may not be secure, resulting in loose wires, arcing, sparks and fire. Recommend that a qualified electrician repair per standard building practices. For more information, visit: <http://www.reporthost.com/?DTNB>

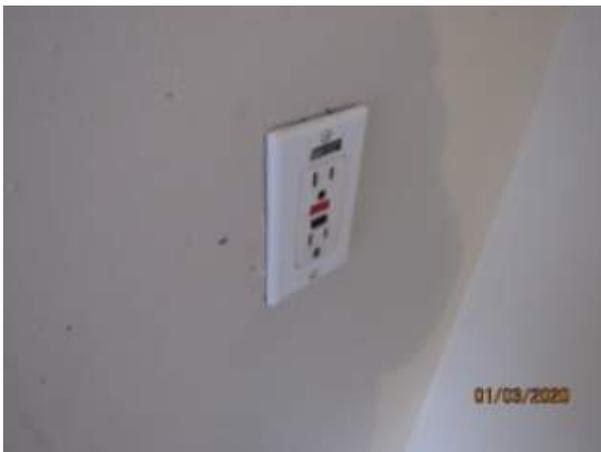
**Photo 47-1**

One or more electric receptacles (outlets) and/or the boxes in which they were installed were loose and/or not securely anchored. Wire conductors can be damaged due to repeated movement and/or tension on wires, or insulation can be damaged. This is a shock and fire hazard. Recommend that a qualified electrician repair as necessary.

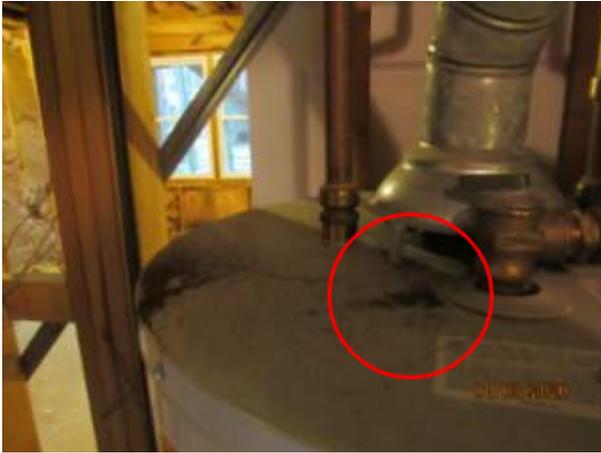
**Photo 55-1**

Black powder/soot observed on top of the water heater. Soot is carbon caused by the incomplete combustion of gas. The water heater needs to be serviced as soon as possible. Recommend a qualified contractor evaluate and make necessary repairs.

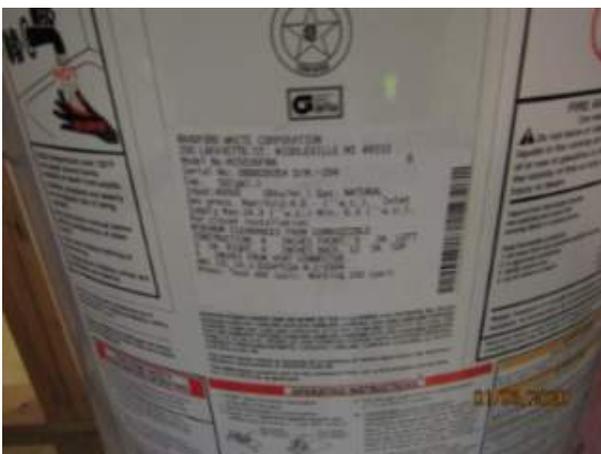
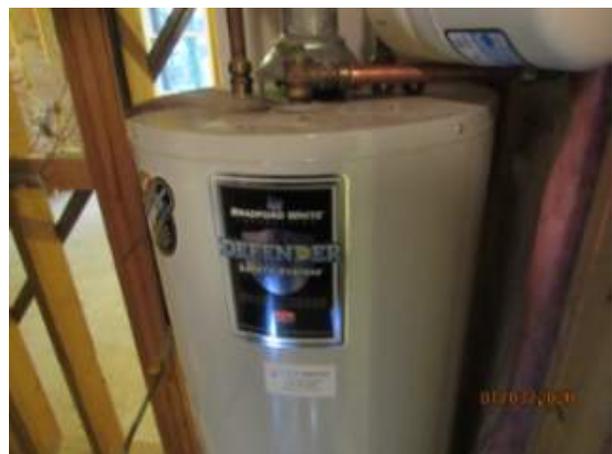
The estimated useful life for most water heaters is 8-12 years. This water heater appeared to be beyond this age and/or its useful lifespan and may need replacing at any time. Recommend budgeting for a replacement in the near future, or considering replacement now before any leaks occur. The client should be aware that significant flooding can occur if the water heater fails. If not replaced now, consider having a qualified person install a catch pan and drain or a water alarm to help prevent damage if water does leak.

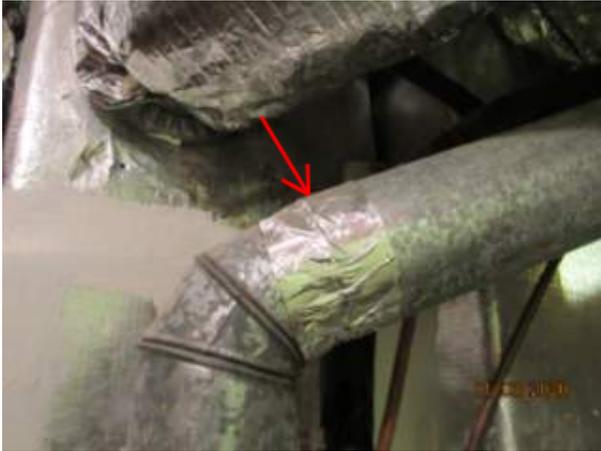
Photo 59-1

59) **i** Flue pipe sections or connections were substandard . This is a safety hazard due to the risk of carbon monoxide poisoning. A qualified contractor should evaluate and repair as necessary.

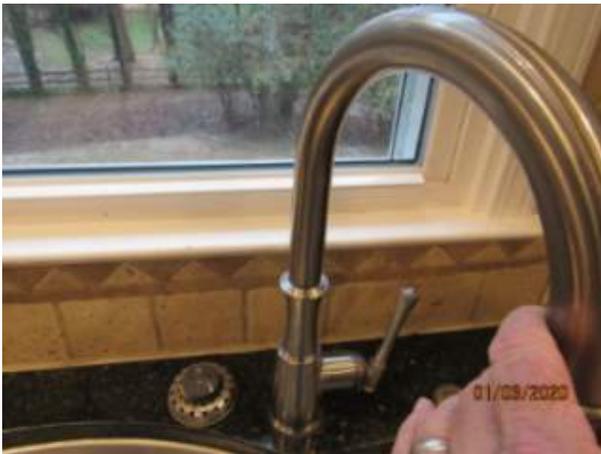
**Photo 63-1**

The sink faucet was loose. Recommend that a qualified person repair as necessary.

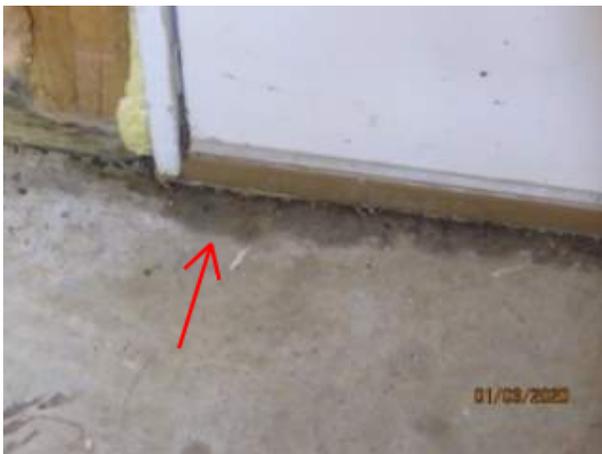
**Photo 71-1**

Ideally, water should not enter basements, but if water must be controlled after it enters the basement, then typical repairs include installing a sump pump.

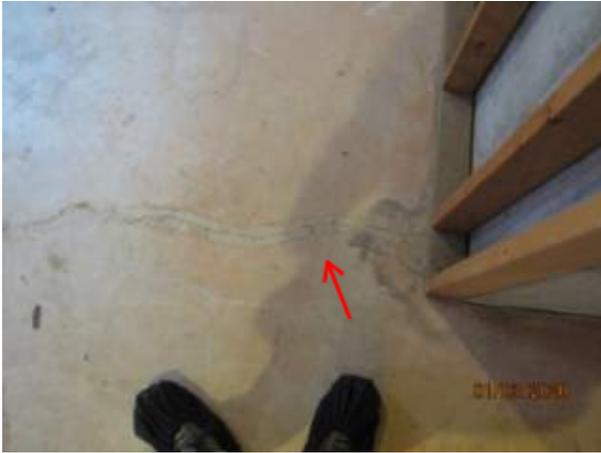
**Photo 72-1**

**72)** 🛠️📍📍 Minor deterioration (e.g. cracks, holes, settlement, heaving) was found in the basement slab, but no trip hazards were found. The client may wish to have repairs made for cosmetic reasons.

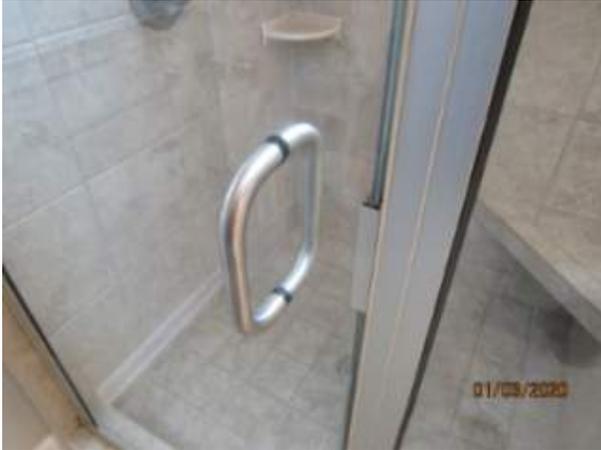
**Photo 74-1**

The handle for the shower door in the master bathroom is loose.

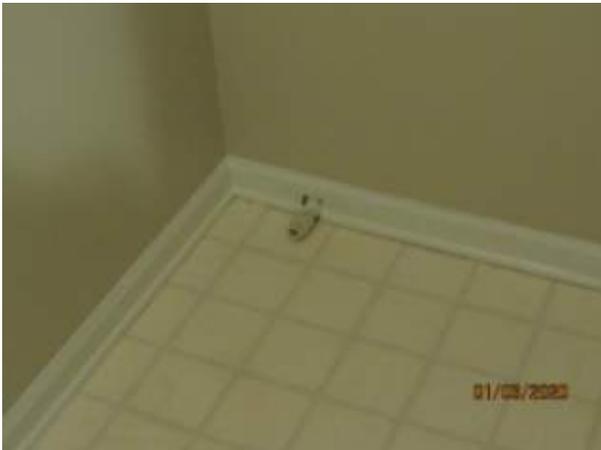
**Photo 75-1**

The laundry room is over or adjacent to finished living spaces and has no catch pan and drain installed. Recommend having a qualified contractor install a catch pan and drain to prevent water damage to finished interior spaces below if/when the washing machine develops a leak,

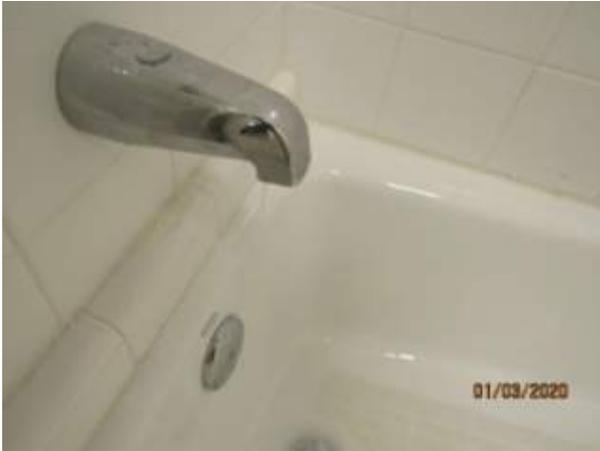
**Photo 76-1**

Diverter valve for the shower at location # was defective. Recommend replacing to prevent the wasting of water.

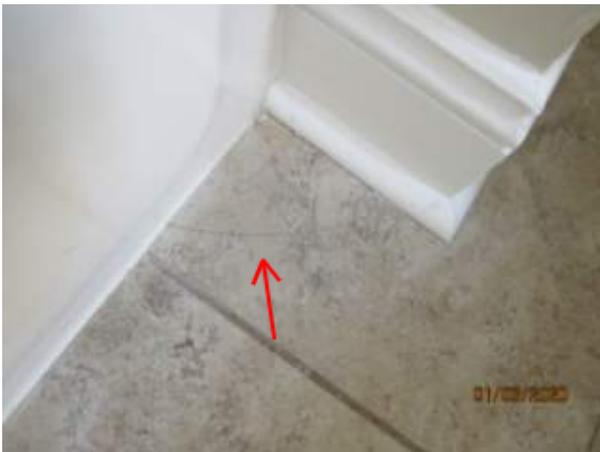
**Photo 77-1**

**77)** 🛠️ ⓘ 💧 Tile, stone and/or grout in the flooring at location(s) #B was deteriorated (e.g. loose or cracked tiles, missing grout) or substandard. Water can damage the sub-floor as a result. Recommend that a qualified contractor repair as necessary.

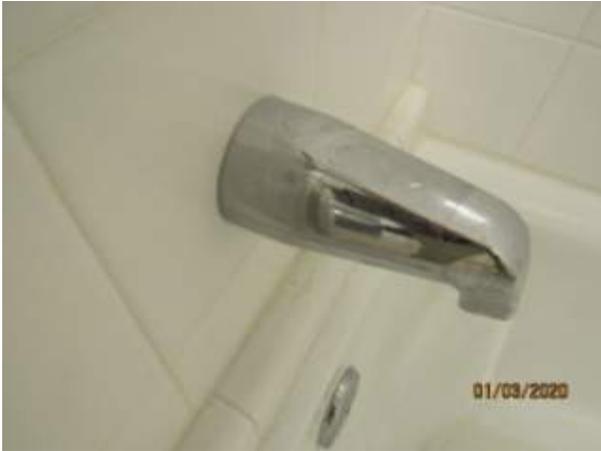
**Photo 78-1**

**78)** 🛠️ ⓘ 💧 Caulk was missing around the base of the bathtub spout, or there was a gap behind it, at location(s) #B and C. Water may enter the wall structure behind the bathtub. Recommend that a qualified person repair as necessary to eliminate the gap. For example, by installing or replacing caulk if the gap is small enough. For larger gaps, a shorter spout nipple or an escutcheon plate can be installed.

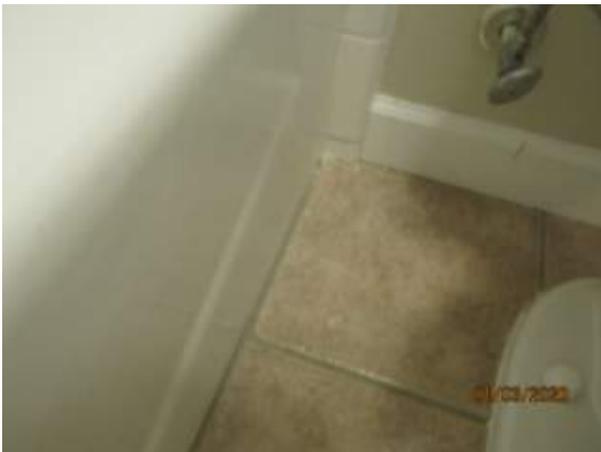
**Photo 79-1**

**79)** 🛠️ ⓘ 💧 Gaps, no caulk, or substandard caulking were found between the bathtub and the floor at location(s) #B. Water may penetrate these areas and cause damage. Recommend that a qualified person re-caulk or install caulking as necessary.

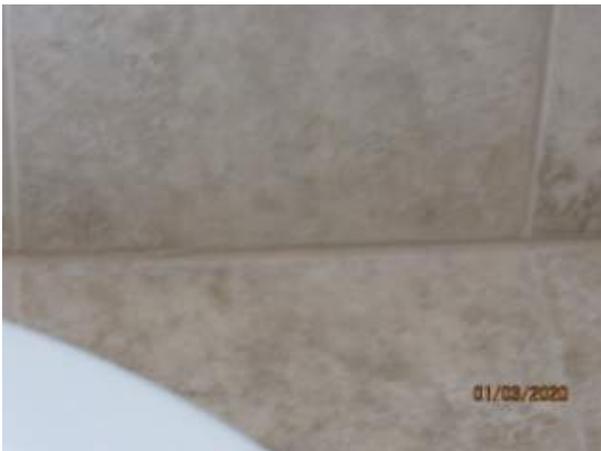
**80)** 🛠️ 💧 Tile and/or grout in the shower enclosure at location(s) #A were deteriorated (e.g. loose or cracked tiles, missing grout) or substandard. Water can damage the wall structure as a result. Recommend that a qualified contractor repair as necessary.

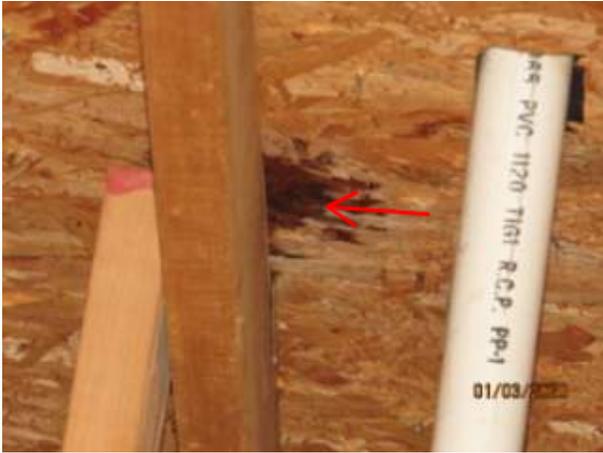
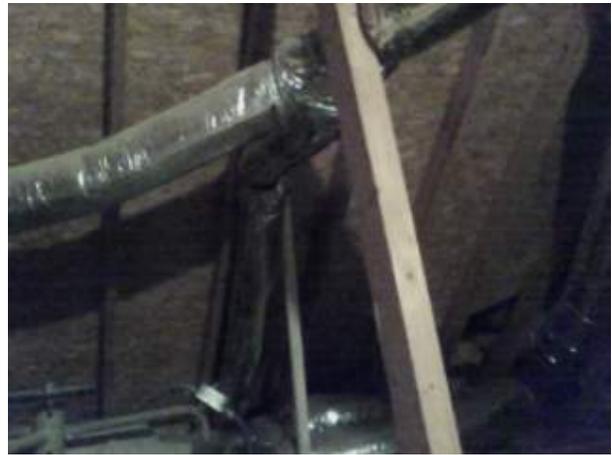
**86)** 🛠️ 🔍 ⓘ 💧 One or more areas of the roof structure were wet or had elevated levels of moisture at the time of the inspection. There appears to be an active leak in the roof or structure exterior. A qualified contractor should evaluate and repair as necessary.

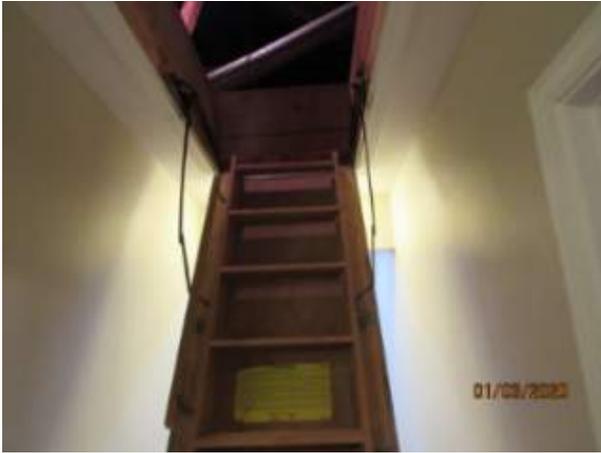
**Photo 88-1**

One or more attic access hatches or doors were not insulated, or had substandard insulation. Weatherstripping was also missing or substandard. Recommend installing weatherstripping and insulation per current standards at hatches or doors for better energy efficiency. For more information, visit: <http://www.reporthost.com/?ATTACC>

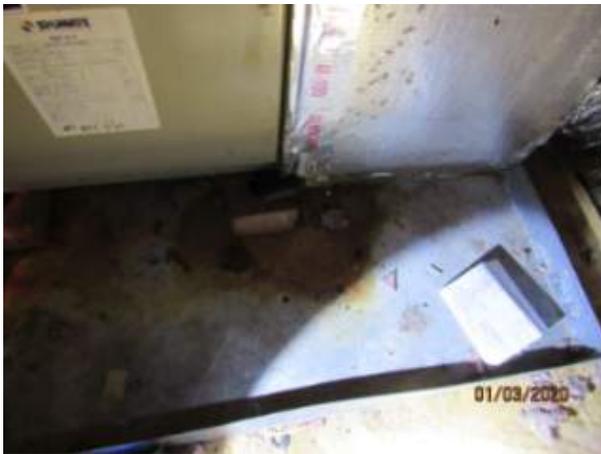
**Photo 91-1**

Lennox unit in attic

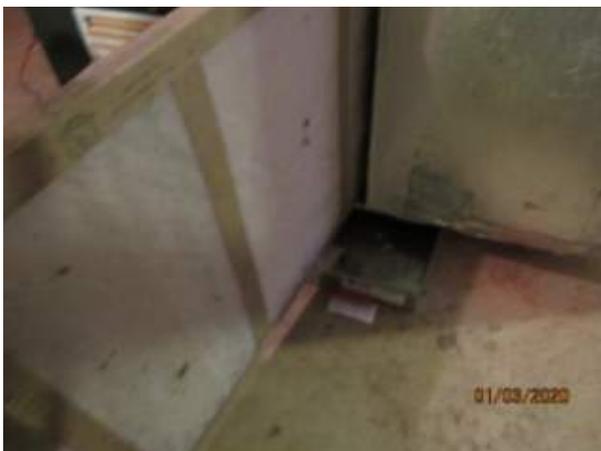
**Photo 92-1**

**92)** 🛠️📄📌📍 Recommend replacing or washing HVAC filters upon taking occupancy depending on the type of filters installed. Regardless of the type, recommend checking filters monthly in the future and replacing or washing them as necessary. How frequently they need replacing or washing depends on the type and quality of the filter, how the system is configured (e.g. always on vs. "Auto"), and on environmental factors (e.g. pets, smoking, frequency of house cleaning, number of occupants, the season).

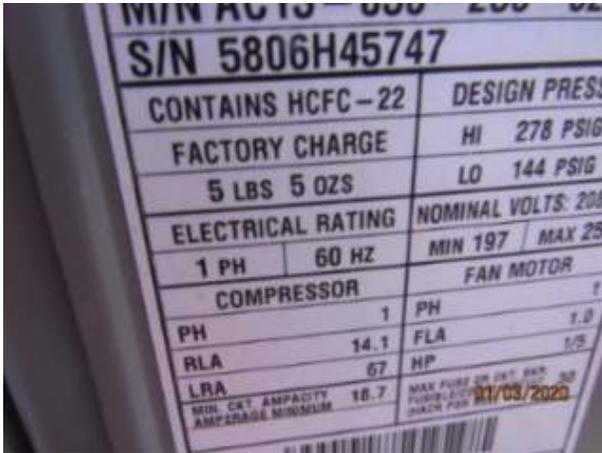
Photo 96-1

The a/c system appears to use R-22 as the refrigerant. This has been discontinued and by 2020 will likely no longer be available. Newer systems use 410-A refrigerant. Client should be aware of this and budget for replacement in the future. See the following link for more information. <http://www.startribune.com/does-your-air-conditioner-use-r-22-refrigerant-here-s-why-you-should-care/428178123/>

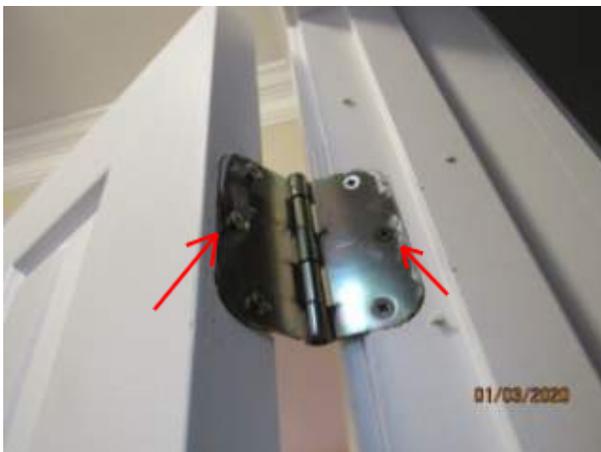
**Photo 99-1**

Closet door first floor

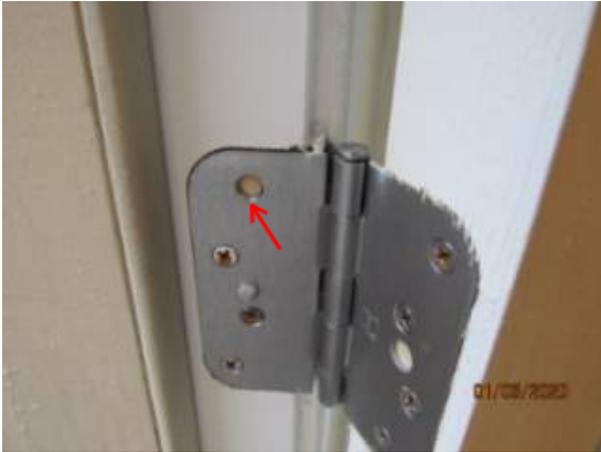
**Photo 100-1**

Hinges where missing screws.

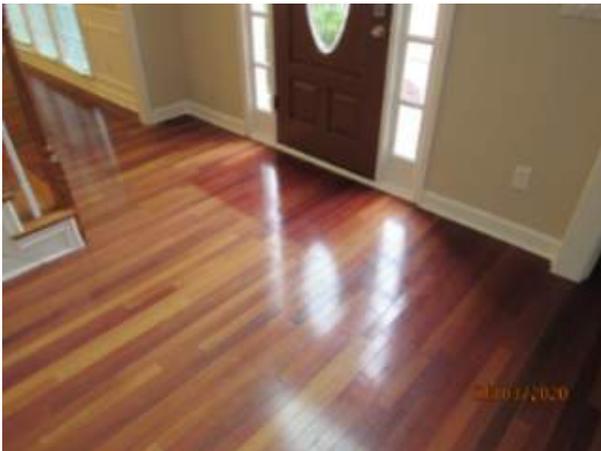
**Photo 101-1**

**101)** 🛠️ ⓘ Wood flooring in one or more areas was significantly worn, deteriorated or damaged. Recommend that a qualified contractor refinish wood flooring as necessary.

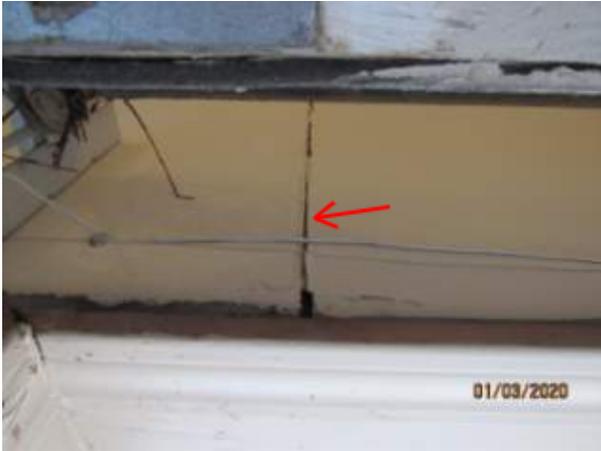
**Photo 102-1**

**102)** 🛠️ Minor cracks, nail pops and/or blemishes were found in walls and/or ceilings in one or more areas. Cracks and nail pops are common, are often caused by lumber shrinkage or minor settlement, and can be more or less noticeable depending on changes in humidity. They did not appear to be a structural concern, but the client may wish to repair these for aesthetic reasons. For recurring cracks, consider using an elastic crack covering product: <http://www.reporthost.com/?ECC>

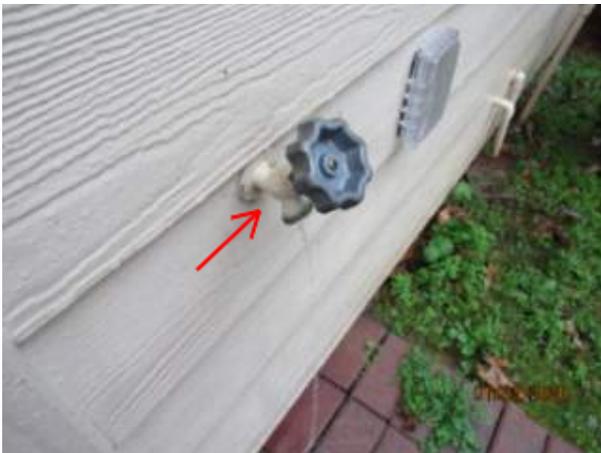
**Photo 104-1**

One or more hose bibs (outside faucets) appeared to be inoperable. No water flowed from the bib(s) when turned on. This may be due to a shut-off valve being turned off. Note that the inspector does not operate shut-off valves. Recommend consulting with the property owner about inoperable hose bibs, and if necessary have a qualified plumber make repairs.
