**Report:** 2225-blackheath-trce home inspection

# **Confidential Inspection Report**

## **2225 Blackheath Trce**

**January 9, 2020**

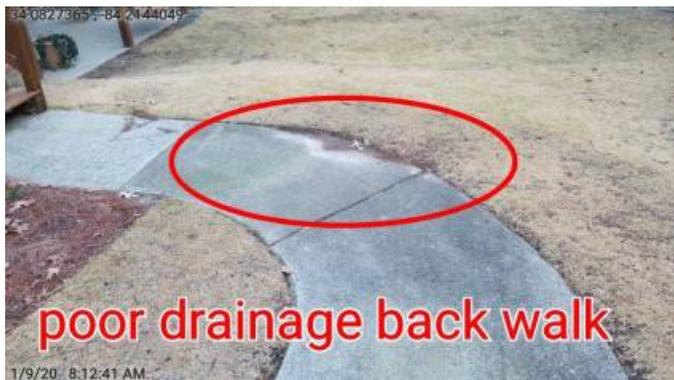
2.2 Walks:     Poor drainage is noted where the elevation of the walk way is below that of the adjacent ground which may cause water to pond on the walk way surface.

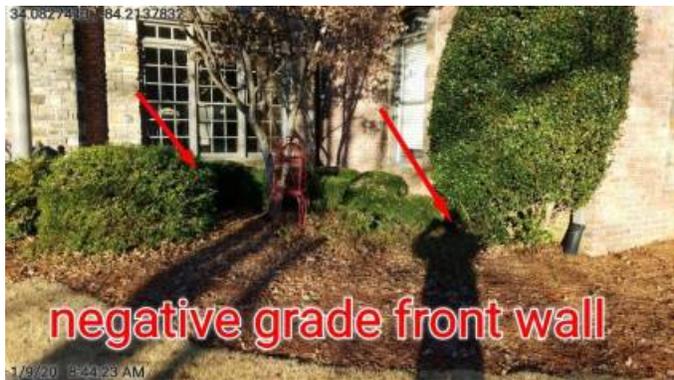
3. Grade at the foundation is negative at the left side of the home and front wall of the home. Correction is recommended. Pitch slope of soils away from foundation. Slope should fall away from the foundation at a minimum of 1/2 inch per foot and extend at least 10 feet away from the foundation

**R401.3 Drainage** - Surface drainage shall be diverted to a storm sewer conveyance or other approved point of collection that does not create a hazard. Lots shall be graded to drain surface water away from foundation walls. The grade shall fall a minimum of 6 inches (152 mm) within the first 10 feet (3048 mm).

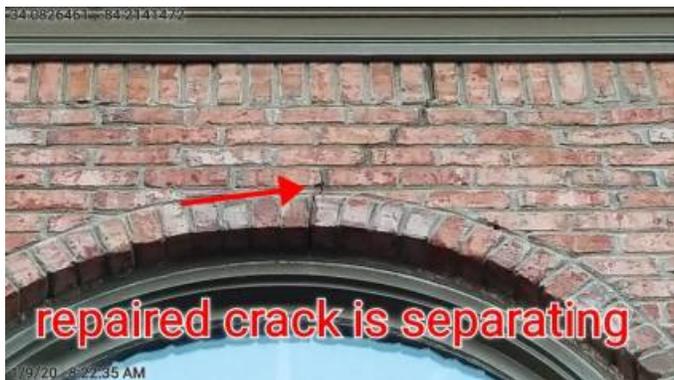
Repairs were noted to The Brick over the arched windows on the back of the home. The crack appears to be continuing separating after the repairs which would indicate continued settlement. Recommend inquiring with the current homeowners as to the nature of repairs and any warranties that may transfer to the new owners.

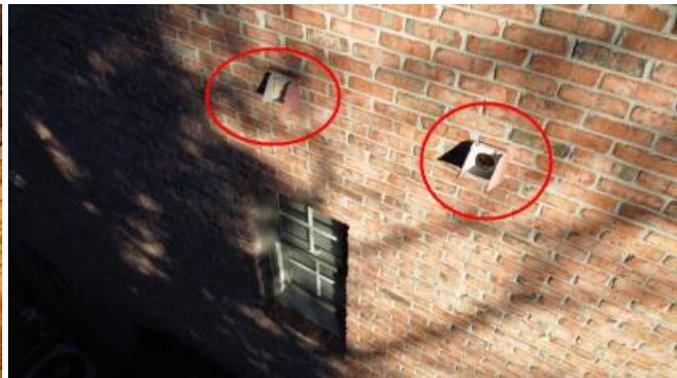
The two left side bathroom vent hoods are damaged and allowing water to enter behind the brick veneer. Recommend replacing both of the damaged vent hoods.

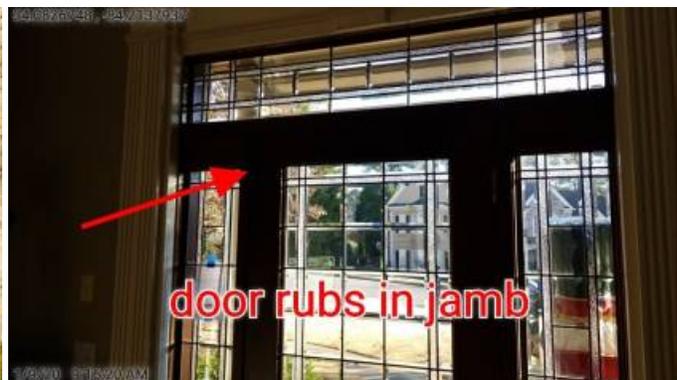
The door sticks or rubs in the door jamb. Recommend adjustments to the door and / or jamb for proper operation of the door.

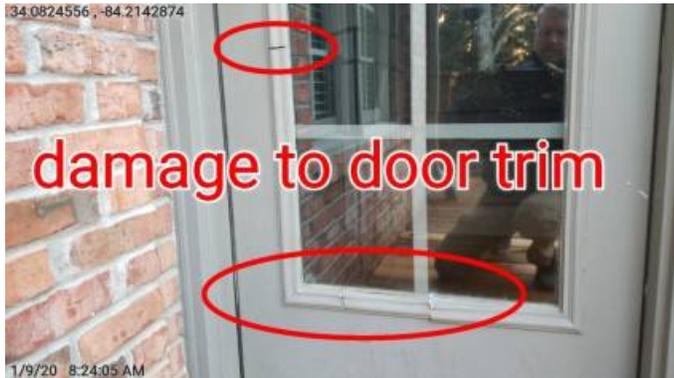
The door skin / trim is punctured or broken. It is no longer performing as intended.

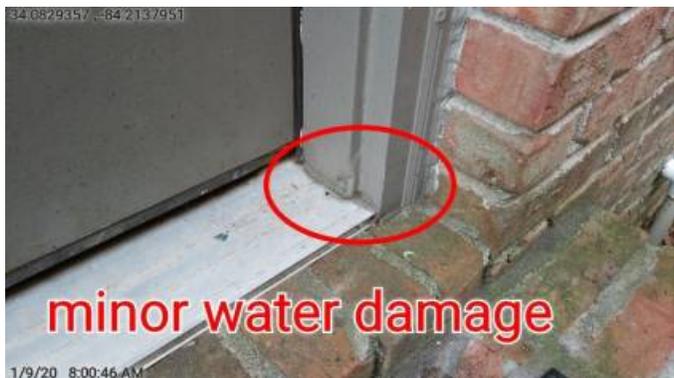
Water damage was noted at the lower portion of the doorframe. Recommend repairs to the soft spots and repaint to seal the trim and jamb.

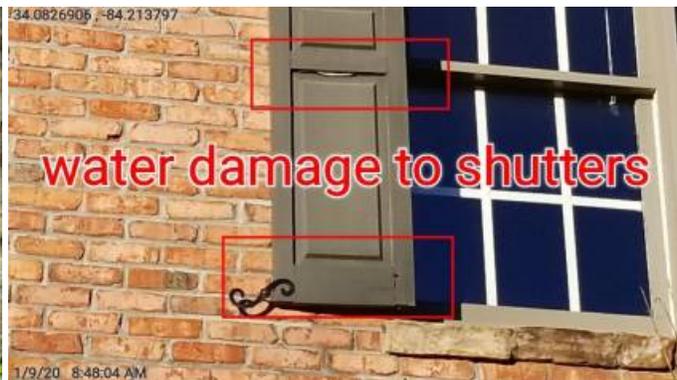
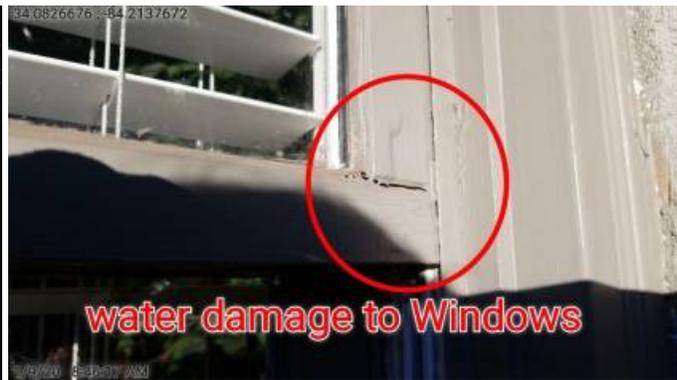
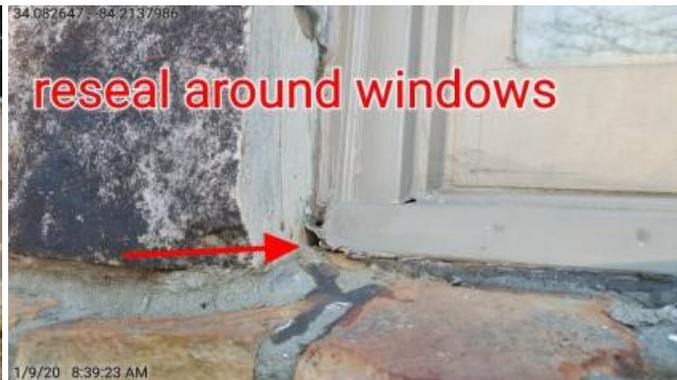
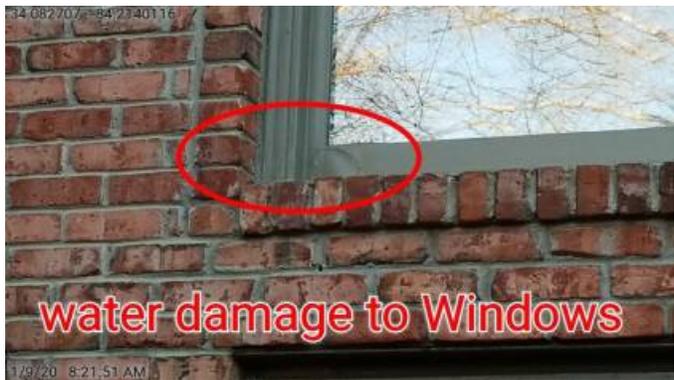
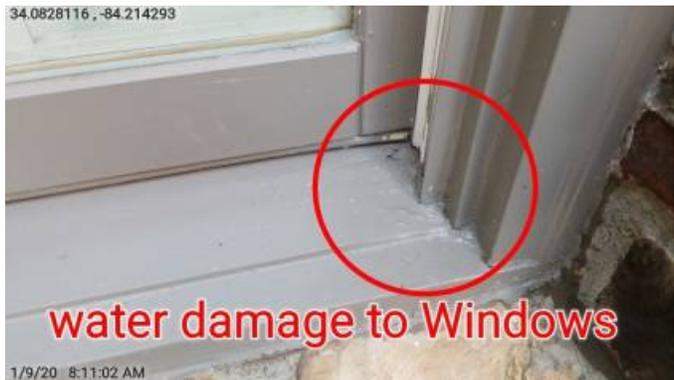
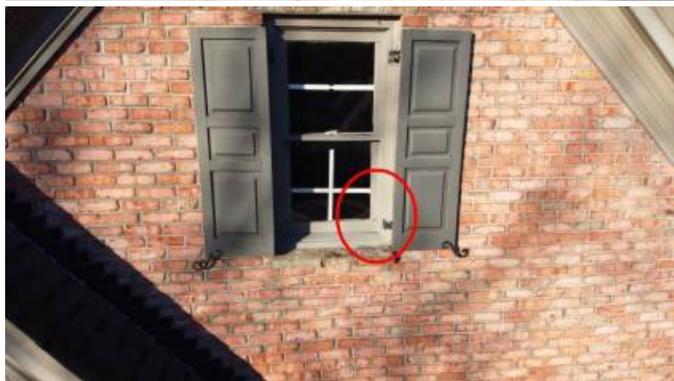
Water damage noted to one or more shutters around the windows. Recommend repairs or replacement of all affected window shutters.

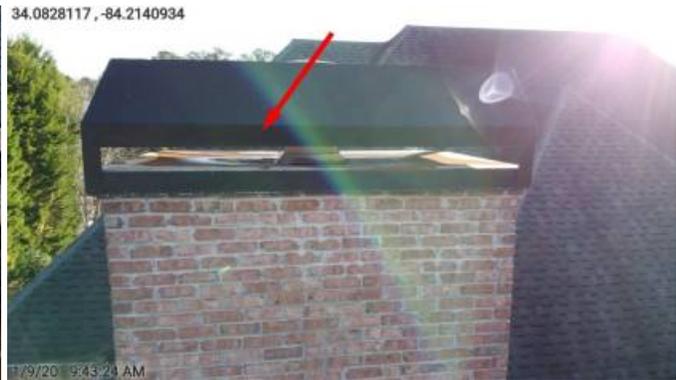
Standing water was noted on the top of the chimney cap due to an indentation in the metal. This will cause rusting and possible failure over time. Recommend adjusting the pitch on the cap to promote water flow off of the cap.

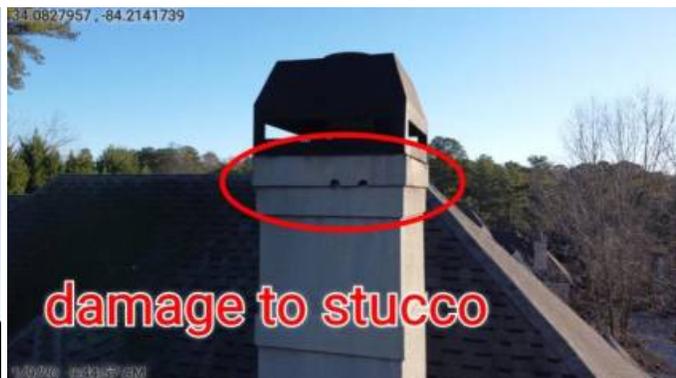
One or more sections of the siding on the chimney is damaged. It appears a woodpecker has damaged the area around the top of the chimney. Recommend a licensed siding contractor repair or replace all the affected siding on the chimney.

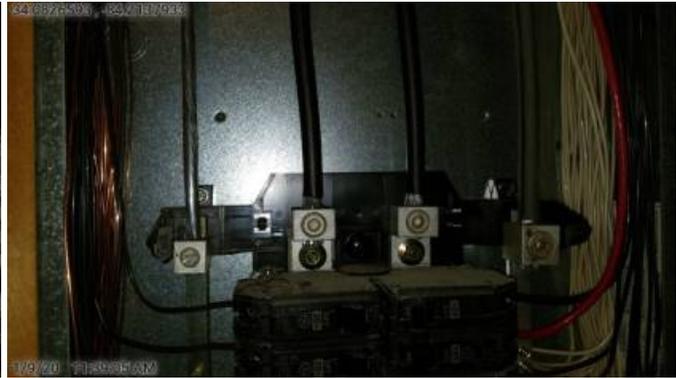
6.5 Entrance Cable Size:     2/0 Aluminum  
Anti-oxidant paste has been applied.

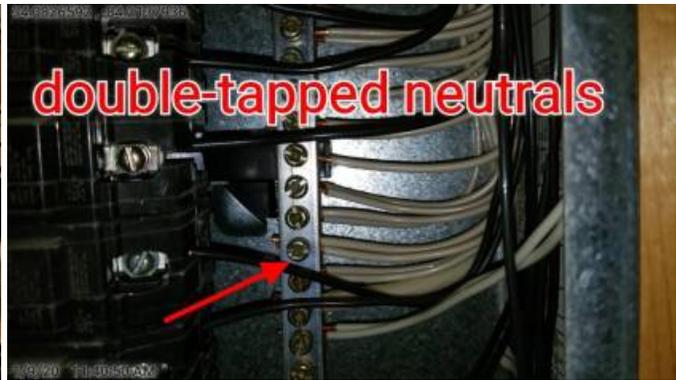
More than one neutral wire in the panel has been connected to a single termination screw where only one wire should be connected. Recommend a licensed electrician install each neutral wire on a dedicated terminal screw. **Please reference NEC 408.41**

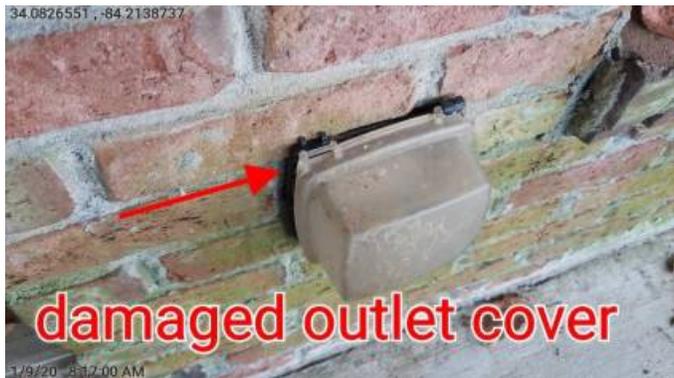
There is one or more outlet cover which is damaged. Recommend replacing the affected exterior outlet covers to protect the electrical outlet from the elements.

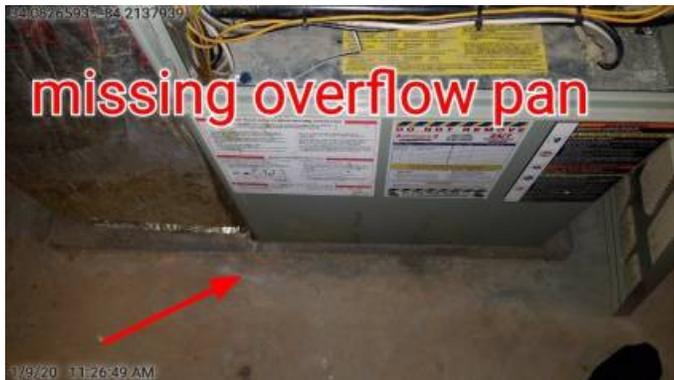
The system lacks general maintenance. Suggest cleaning / servicing burner compartment, blower motor, evaporator coil, pilot light, vent system and burners. Clear / service all condensation lines. Additionally, we recommend cleaning the duct work for improved indoor air quality.

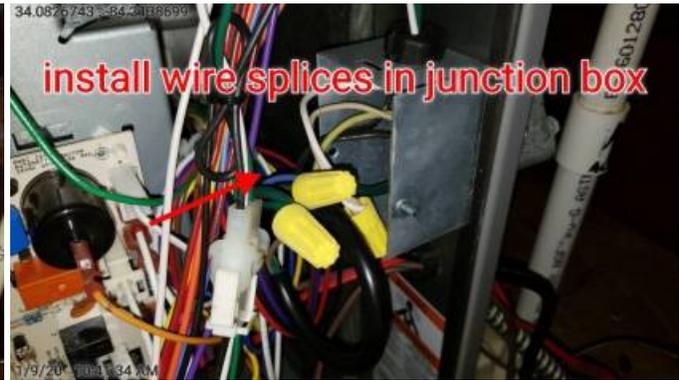
Missing the junction box and / or junction box cover located inside the burner compartment. All wire splices should be enclosed in an appropriate junction box. Recommend repairs by a licensed electrician.

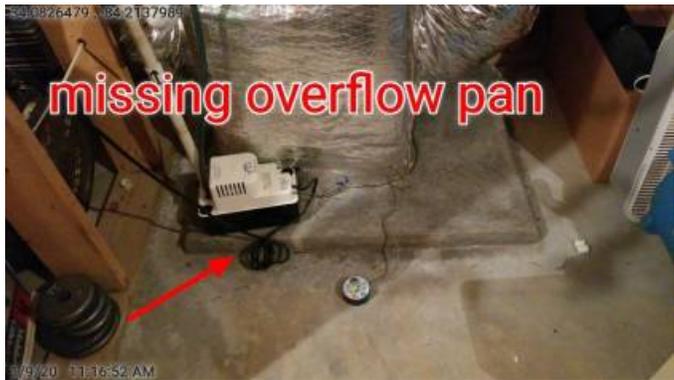
Furnace is an older unit that has a very limited service life.

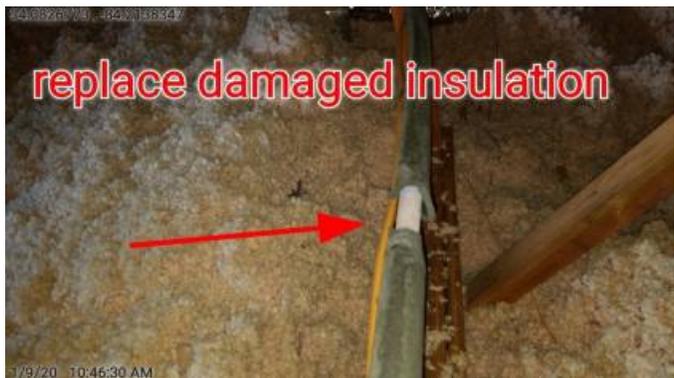
It is suspected that the insulation on the refrigerant line is damaged inside the wall where it travels from the attic to the left side wall. This is evidenced by water staining on the wall in the back left first floor bedroom. Recommend further evaluation and repairs by a licensed HVAC technician.

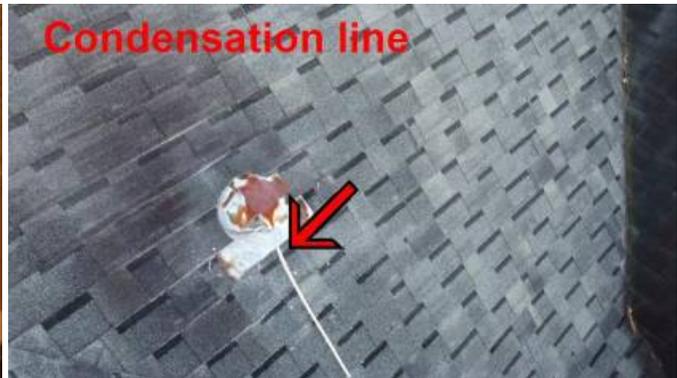
The condensation from the attic unit is pumped to a penetration in the roof around the dryer vent. This is an improper installation as the flexible condensation line may be pinched underneath the flashing, preventing the water to discharge correctly. This may result in water backing up into the attic. Recommend a licensed HVAC technician properly route the condensation line to the exterior of the home in an appropriate manner.

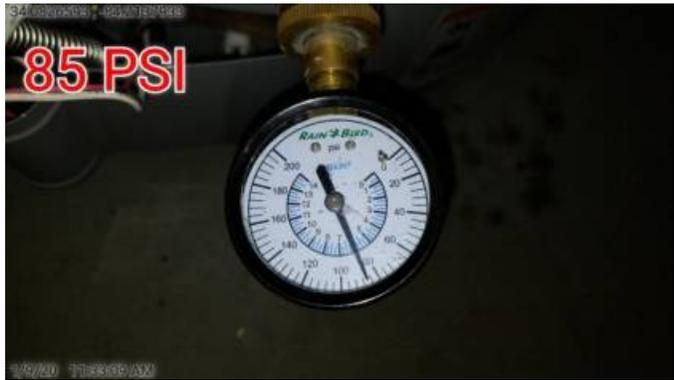
Water pressure was over 80 pounds per square inch and is considered excessive. Recommend adjusting the pressure on the system to below the 80 pound maximum. This may require the adjustment of the pressure regulator or replacement of a defective pressure regulator.

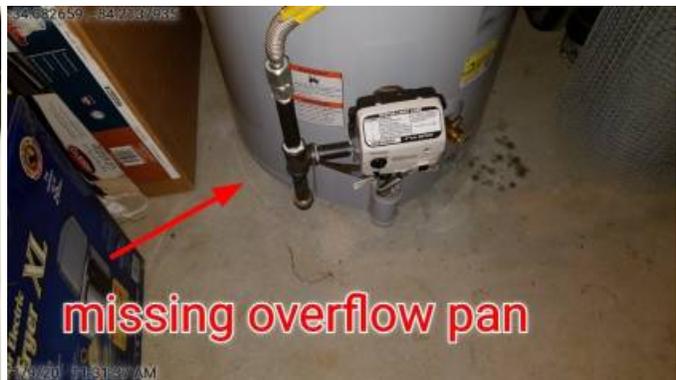
The water heater is missing the overflow pan below the unit. Recommend installing an overflow pan in case of a leak on the water heater or other plumbing emergency.

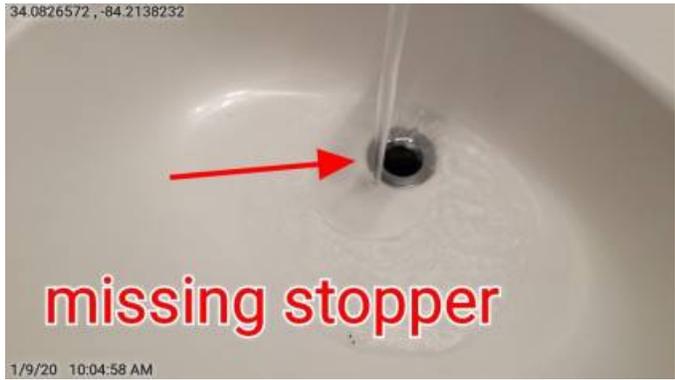
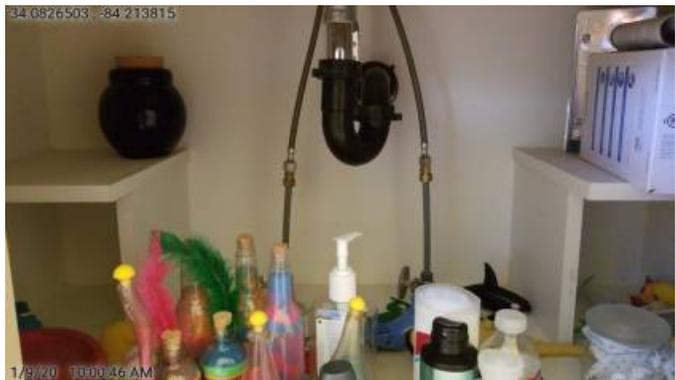
The stopper is missing in the sink. Recommend the stopper and all hardware be replaced for proper operation of the sink.

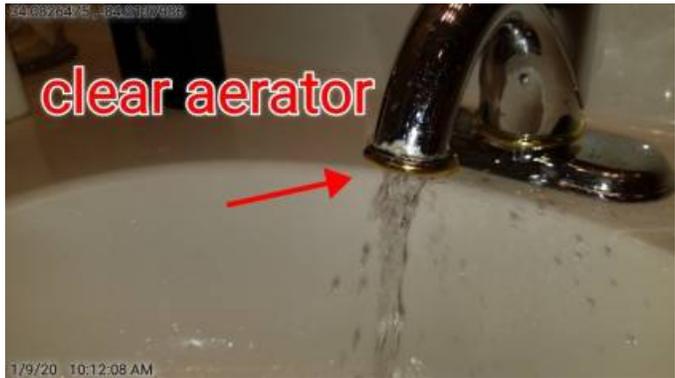
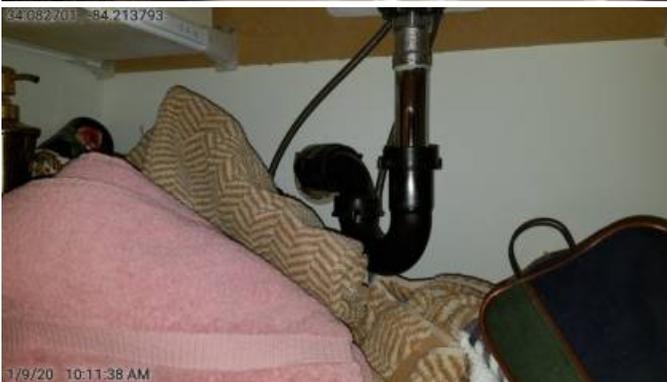
Recommend cleaning / clearing the faucet aerator for improved stream of water.

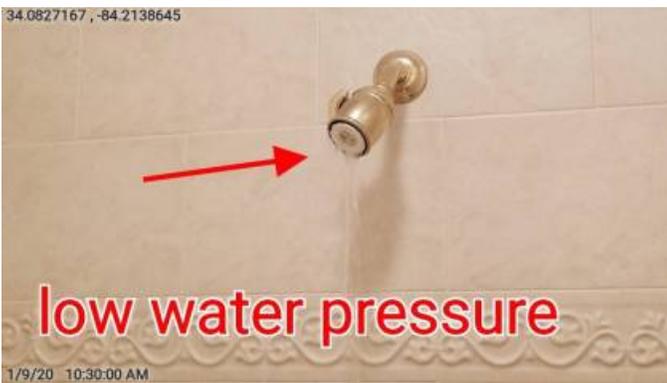
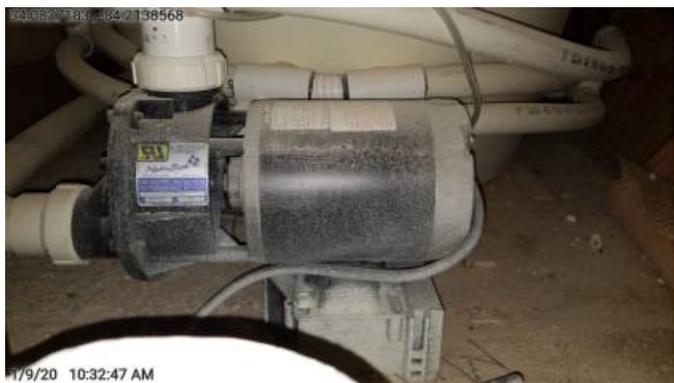
Low water volume is noted when two fixtures are operated simultaneously.

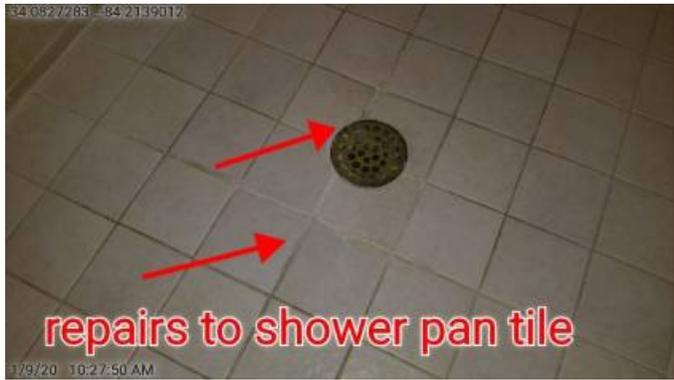
Repairs were noted to the shower pan tile around the drain. Caulking is only a temporary repair and does not provide for a permanent solution. Recommend inquiring with the current homeowners as to the nature of the repairs and any previous leaks as a result of the shower pan condition prior to repairs.

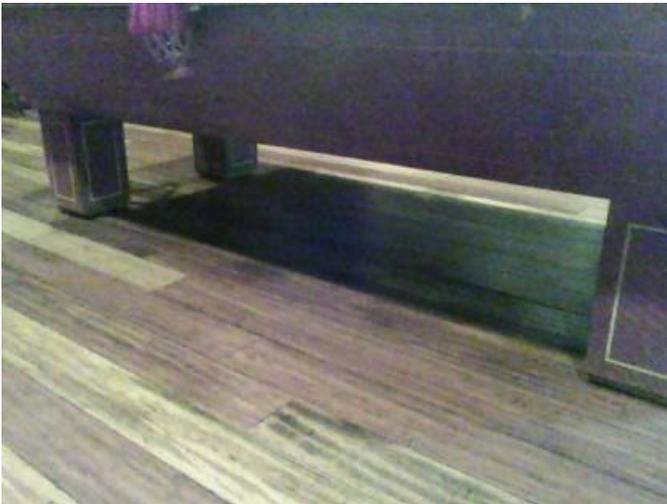
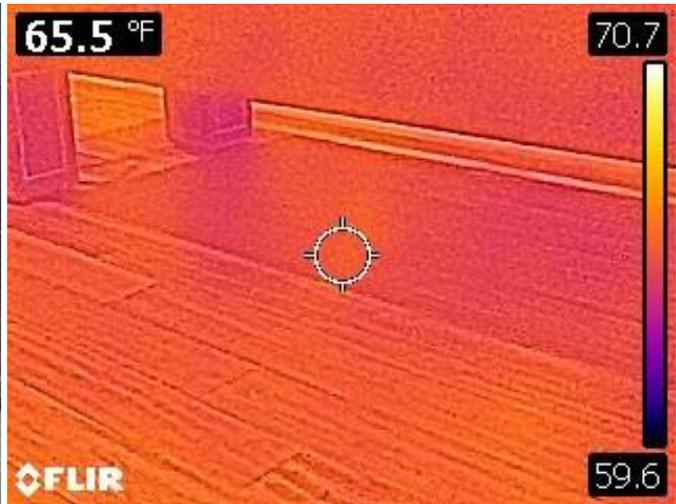
There was a leak reported in the discloser statement in this room. The floors appear to be dry at the time of the inspection. Recommend addressing the water management at the gutters along the back of the home and the flashing at the back of the deck to help prevent future water penetration.

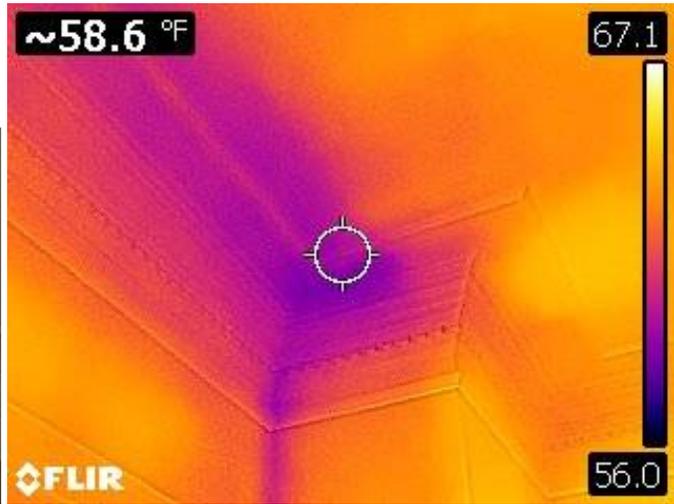
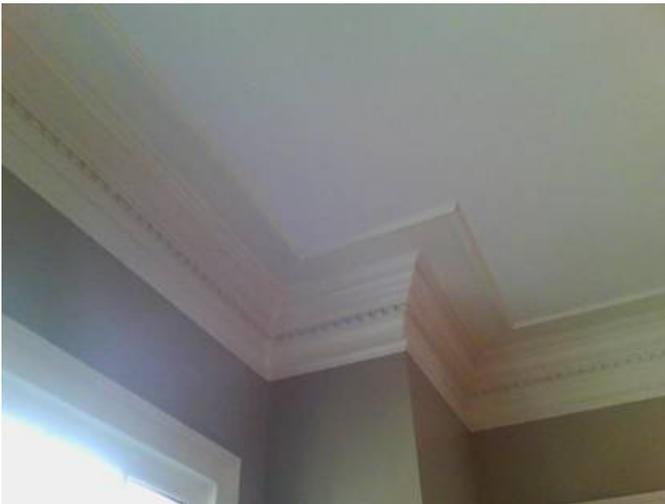
Repairs noted to the ceiling in this room. It appears there was a previous roof leak where the metal roof over the dining room windows separated from the exterior wall. Repairs were noted. Recommend inquiring with the current homeowners as to the nature of the repairs and monitor condition.

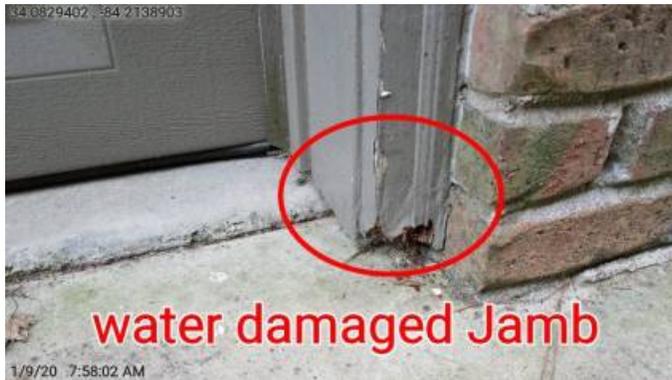
Water damage noted around the base of one or more of the garage door jambs. Recommend repairs or replacement to the affected material.

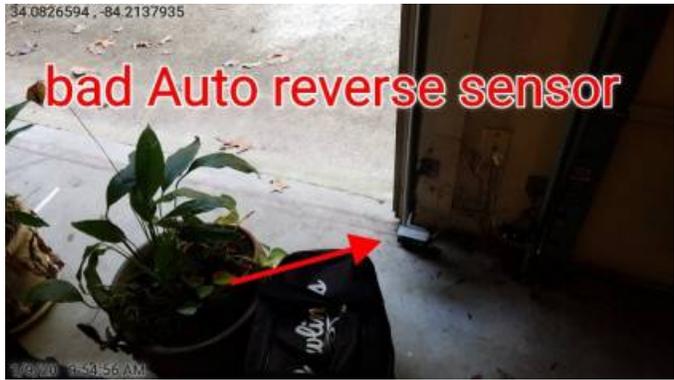
The auto reverse was not operational or missing the electric reverse sensors on the right side garage door directly adjacent to the interior of the home. Note: All overhead doors should have fully operational auto-reverse function as a safety precaution.
