Building Inspection Report

4047 Newhaven Circle, Atlanta, GA

Inspection Date:

1/21/2020

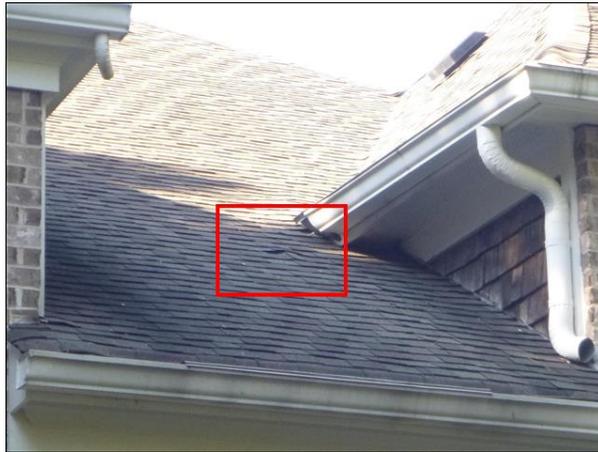
Repair: All "eyebrows" (shingles and/or decking that is lifted up by protruding or loose nails) as noted at the rear should be repaired by lifting the shingles and re-driving the nails into the decking and/or rafters. All holes in the shingles should be caulked and sealed.

1. **Repair:** All "eyebrows" (shingles and/or decking that is lifted up by protruding or loose nails) as noted at the rear should be repaired by lifting the shingles and re-driving the nails into the decking and/or rafters. All holes in the shingles should be caulked and sealed.
2. **Repair:** Split, loose or damaged ridge caps as noted at the left center require repair or replacement to prevent leakage.

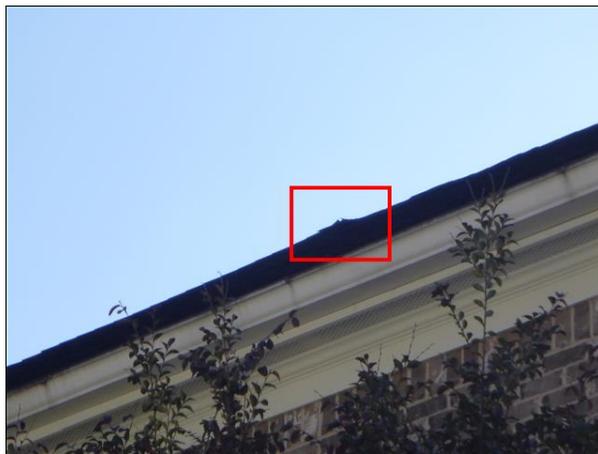
Repair: Split, loose or damaged ridge caps as noted at the left center require repair or replacement to prevent leakage.

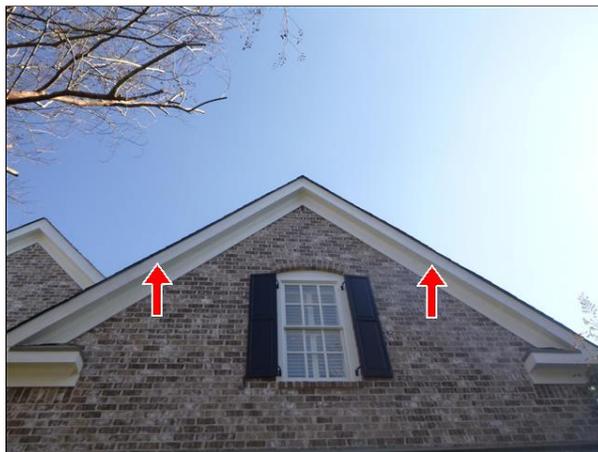
Improve: A drip edge flashing should be installed around the perimeter of the roof to ensure that water drains from the roof directly into the gutters. This flashing also helps protect the roof sheathing from damage at the eave.

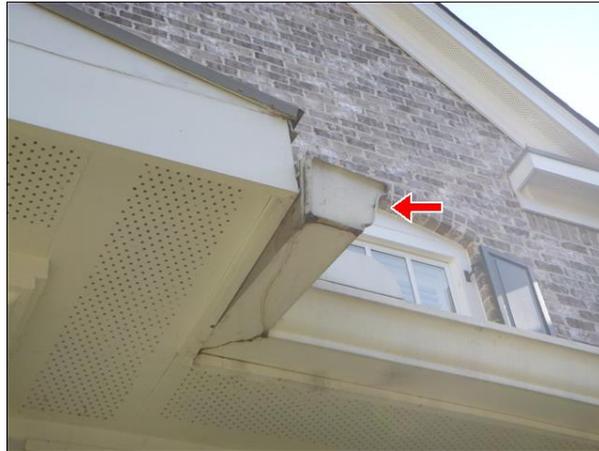
Repair: The gutter at the front entry is falling off the house and needs realignment by a qualified gutter contractor to avoid spilling roof runoff around the building and into the cornice - a potential source of water entry and damage. The cornice and fascia boards behind the gutters should be checked for damage. Check all underground piping, where present, for blockages to insure that they are also draining properly.

3. **Repair:** The gutter at the front entry is falling off the house and needs realignment by a qualified gutter contractor to avoid spilling roof runoff around the building and into the cornice - a potential source of water entry and damage. The cornice and fascia boards behind the gutters should be checked for damage. Check all underground piping, where present, for blockages to insure that they are also draining properly.
4. **Repair:** Leaks in the downspouts and gutters should be repaired by re-sealing the joints to prevent damage to the cornice. Have all connections inspected and repaired as necessary. The gutters and downspouts should also be checked for blockages and proper flow.

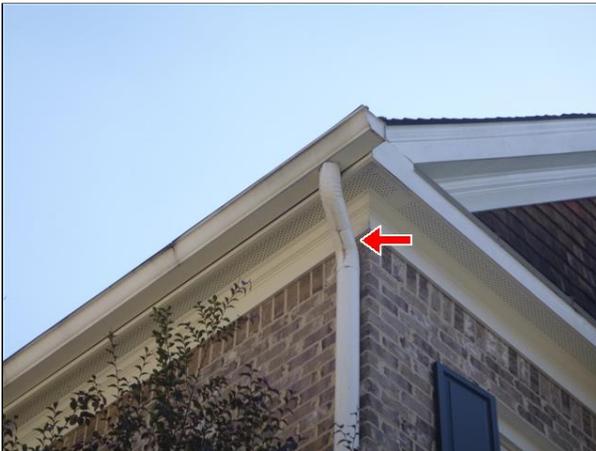
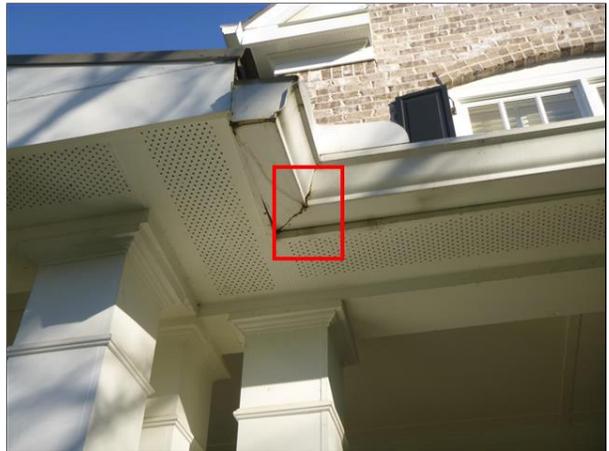
Repair: Leaks in the downspouts and gutters should be repaired by re-sealing the joints to prevent damage to the cornice. Have all connections inspected and repaired as necessary. The gutters and downspouts should also be checked for blockages and proper flow.

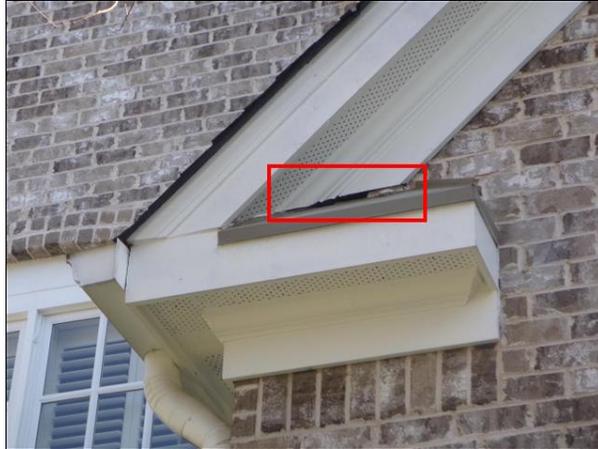
Repair: All outside openings into the structure as noted at the trim at the front should be properly sealed or screened by a qualified rodent control contractor to reduce the potential for vermin and/or insect infestations within the home. The contractor should inspect all exterior components of the home to insure proper protection.

5. **Repair:** All outside openings into the structure as noted at the trim at the front should be properly sealed or screened by a qualified rodent control contractor to reduce the potential for vermin and/or insect infestations within the home. The contractor should inspect all exterior components of the home to insure proper protection.

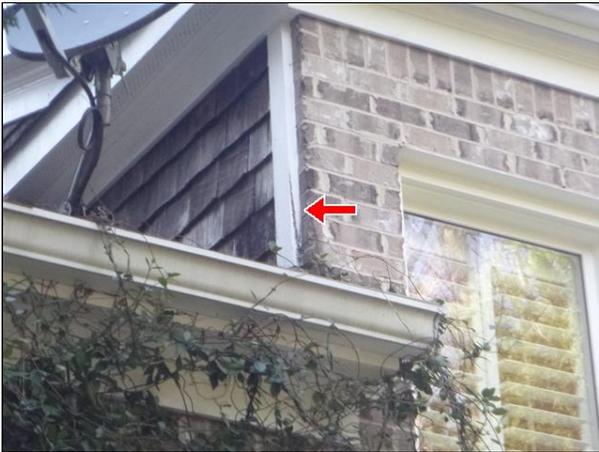
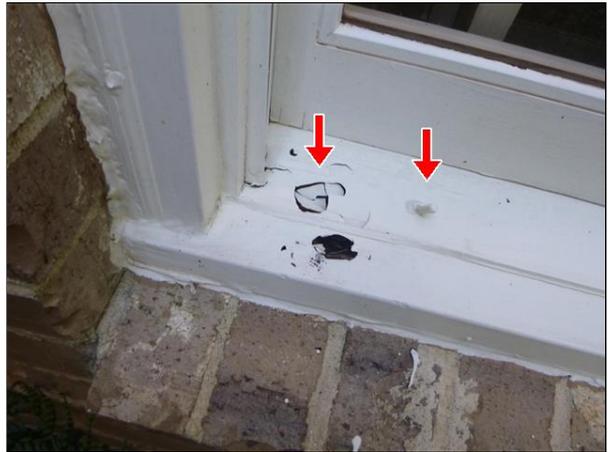
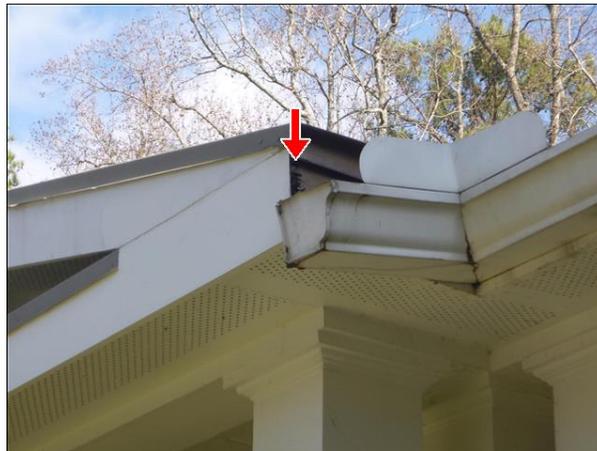
Repair: Signs of rot were observed at the trim at the rear roof the fascia at the front entry and at the rear family room window sill, which should be repaired by a qualified carpenter. Following repair of the damaged areas (which should be combined with exterior painting/maintenance) proper maintenance of the siding and wood trim and control of water from roof or surface runoff can avoid further damage. The carpenter should check all exterior wood components for further damage and repair as necessary.

6. **Repair:** Signs of rot were observed at the trim at the rear roof the fascia at the front entry and at the rear family room window sill, which should be repaired by a qualified carpenter. Following repair of the damaged areas (which should be combined with exterior painting/maintenance) proper maintenance of the siding and wood trim and control of water from roof or surface runoff can avoid further damage. The carpenter should check all exterior wood components for further damage and repair as necessary.

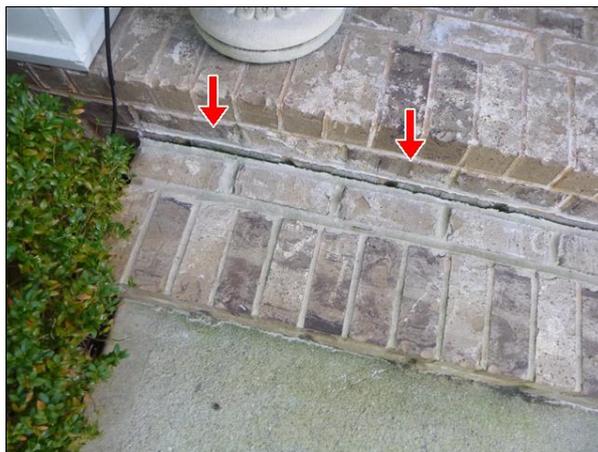
Repair, Monitor: The front steps have settled slightly exposing gaps in the brick. These openings should be grouted and sealed to prevent moisture intrusion and further deterioration of these components. These areas should then be monitored for future movement.

9. **Repair, Monitor:** The front steps have settled slightly exposing gaps in the brick. These openings should be grouted and sealed to prevent moisture intrusion and further deterioration of these components. These areas should then be monitored for future movement.

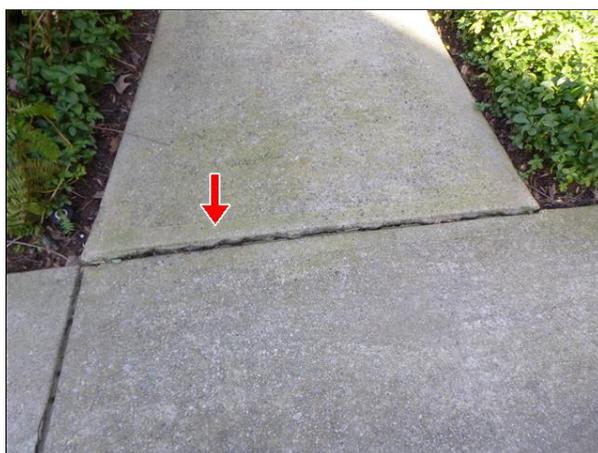
Improve, Monitor: Fairly typical concrete settlement cracks were noted in the driveway. The cracks should be grouted and sealed to limit moisture infiltration and then monitored for future movement.

Improve, Safety Issue: The walkway at the front presents a trip hazard and should be altered as needed for improved safety.

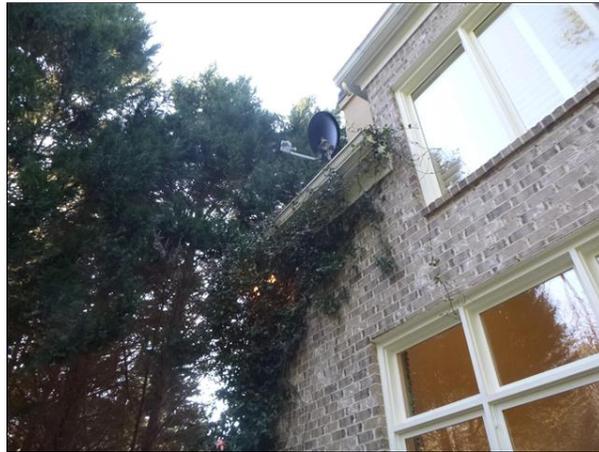
Improve: The shrubbery and vegetation growing on and near exterior walls should be kept trimmed away from siding, window trims, and the eaves to reduce risk of insect and water damage. Overhanging tree branches should be cut back to prevent future damage to the roofing and gutters and to prevent rodent infestations into the attic.

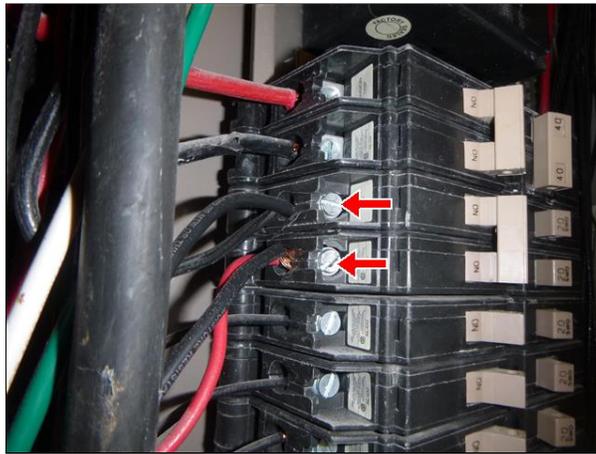
Repair: Wiring in the main distribution panel that is doubled up on one circuit breaker (referred to as "double taps") should be separated unless the breaker is designed to accept two wires (circuit(s) marked with orange dots). Otherwise, each wiring circuit should be connected to a separate breaker to prevent poor connections at the breakers.

10. **Repair:** Wiring in the main distribution panel that is doubled up on one circuit breaker (referred to as "double taps") should be separated unless the breaker is designed to accept two wires (circuit(s) marked with orange dots). Otherwise, each wiring circuit should be connected to a separate breaker to prevent poor connections at the breakers.

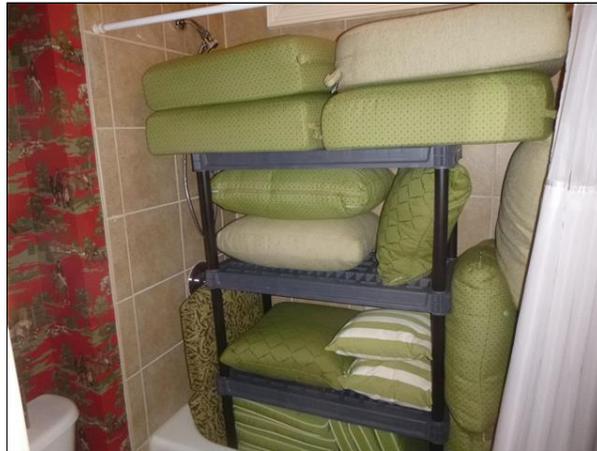
Monitor, Possible Repair: The main level bathtub/shower was blocked by storage and could not be tested. The storage should be removed and the fixtures tested for proper operation prior to closing.

15. **Monitor, Possible Repair:** The main level bathtub/shower was blocked by storage and could not be tested. The storage should be removed and the fixtures tested for proper operation prior to closing.

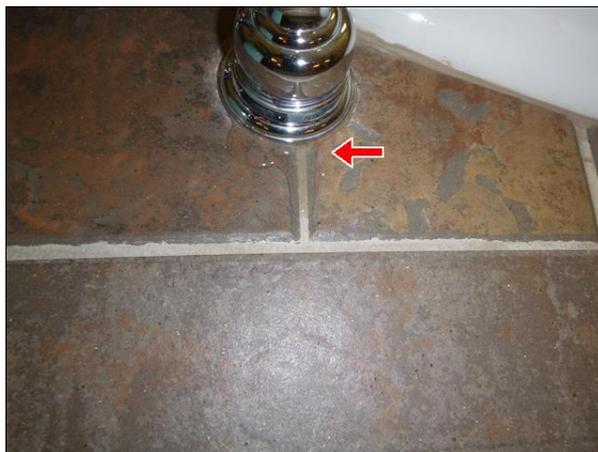
Repair: Some of the faucets leak as noted at the master tub handles. This typically indicates that washers inside the handles or valves need replacement.

18. **Repair:** Some of the faucets leak as noted at the master tub handles. This typically indicates that washers inside the handles or valves need replacement.

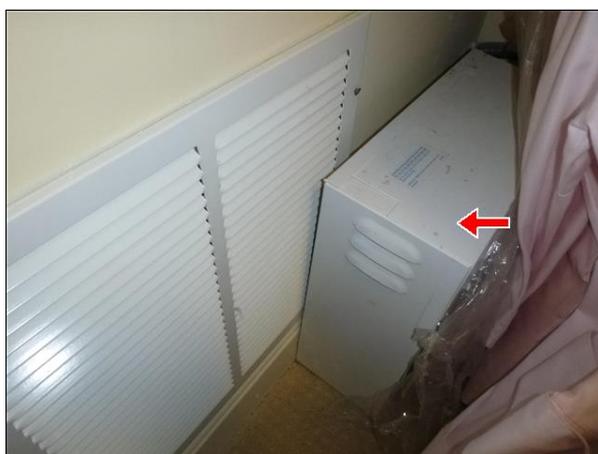
Monitor, Possible Repair: The steam unit located in the master shower did not respond to normal operating controls. Check with the seller concerning the proper operation of this component and repairs that may be needed. The unit may need replacement altogether.

Improve, Safety Issue: The whirlpool tub had signs of algae growth in the lines and needs cleaning and sanitizing before usage to prevent potential infections from the water. Consult manufacturer's recommendation for proper cleaning and upkeep.

Improve: Better access to the whirlpool motor should be provided. The existing access panel was blocked by the steam unit and was not readily accessible.

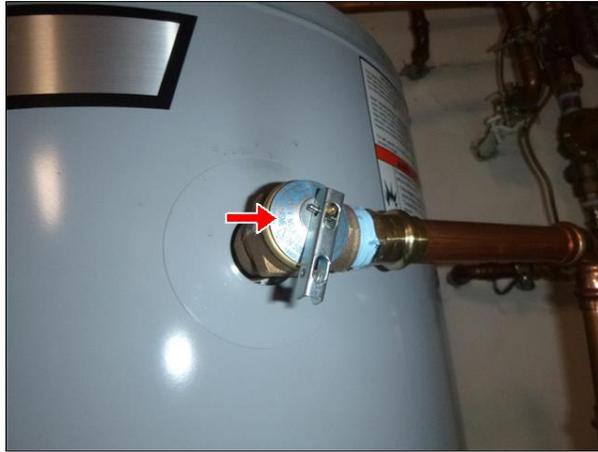
Monitor, Safety Issue: The Temperature and Pressure Relief (TPR) Valve serving the water heater is an important safety valve that protects the tank from explosion due to undue pressure build up in the tank. This valve was not fully tested and discharged during the inspection as these are required to be tested once a year by the occupant only. The valve should also be inspected once every three years by a licensed plumber to insure proper operation as also required by the manufacturer. Consult with the seller concerning such servicing and testing of device and have performed as needed.

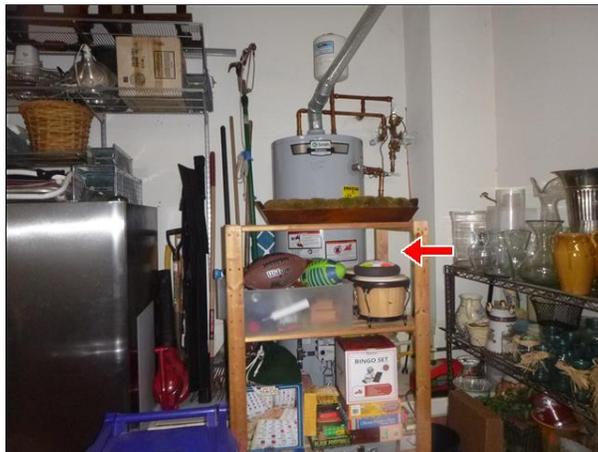
Repair, Safety Issue: Current safety standards require proper protection for water heaters in garages to protect the unit from vehicle damage. Recommend installing a metal pipe in front of the tank bolted to the slab for proper protection.

21. **Repair, Safety Issue:** *Current safety standards require proper protection for water heaters in garages to protect the unit from vehicle damage. Recommend installing a metal pipe in front of the tank bolted to the slab for proper protection.*
22. **Repair, Safety Issue:** *The water temperature at the faucets/showers was too high (120 Degrees is normal). This condition can cause scalding and is an inefficient use of energy. Recommend adjusting the thermostat on the water heater to the correct settings for proper safety.*

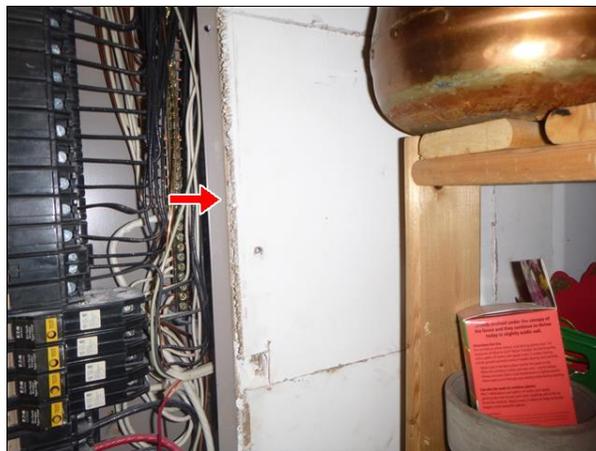
Monitor: Evidence of previous patching and repairs was detected at the right garage wall, the garage ceiling and the kitchen ceiling. Consult with the seller concerning the nature of these repairs and monitor for future activity.

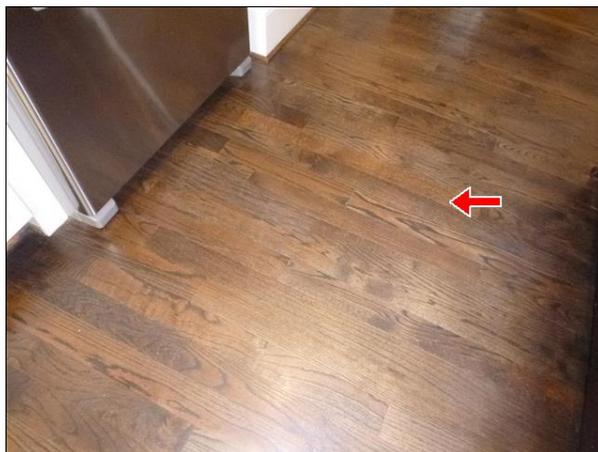
Improve, Monitor: Warped hardwood floors were noted at the kitchen, which typically indicates previous moisture in the area. This area should be monitored for future dampness and further warpage and repaired as necessary (possibly by re-sanding and re-staining).

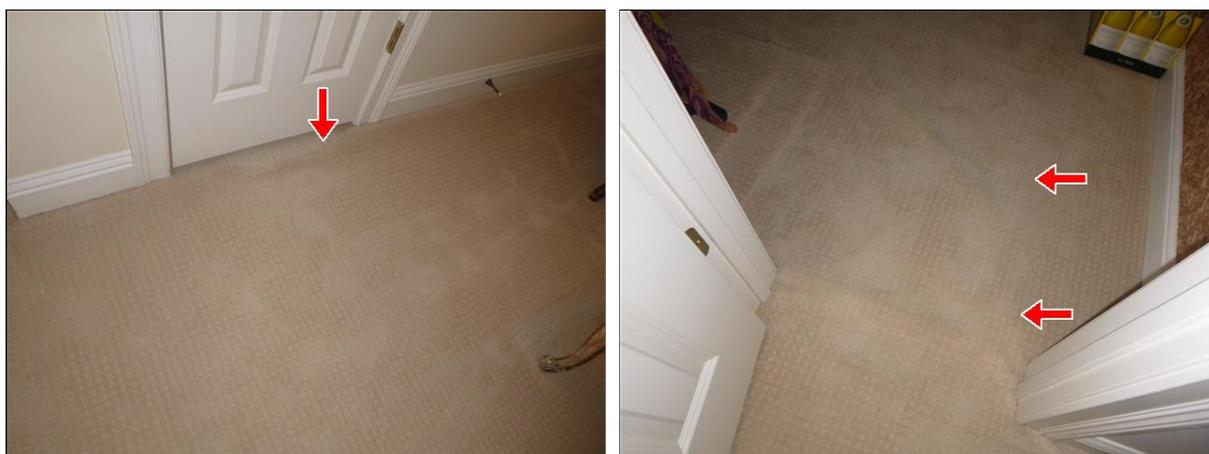
Improve: Loose carpet as noted at the right front bedroom and right front bedroom closet should be re-stretched and cleaned.

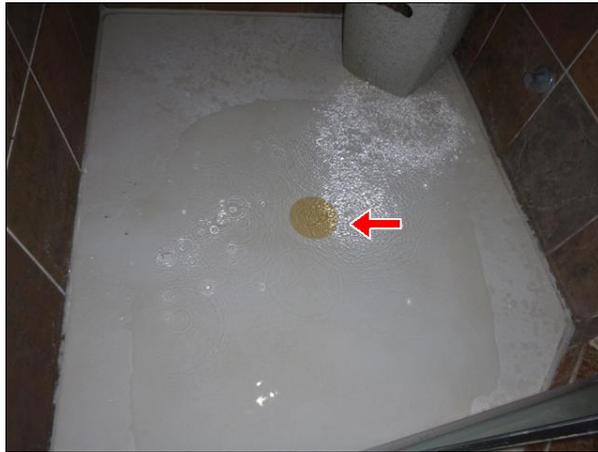
Monitor: The shower stall located in the master bathroom was tested with a standing water test (drain line plugged and the stall filled with water to a depth of 1" - 2") to determine if leaks might be present in the shower pan. While no evidence of leakage was noted at the time of the inspection, this does not preclude that leakage will be experienced in the future. Leakage that may be occurring may not be evident until the day after the inspection. The ceilings/floor system below the shower should be monitored for future leakage and the pan repaired or replaced as needed.

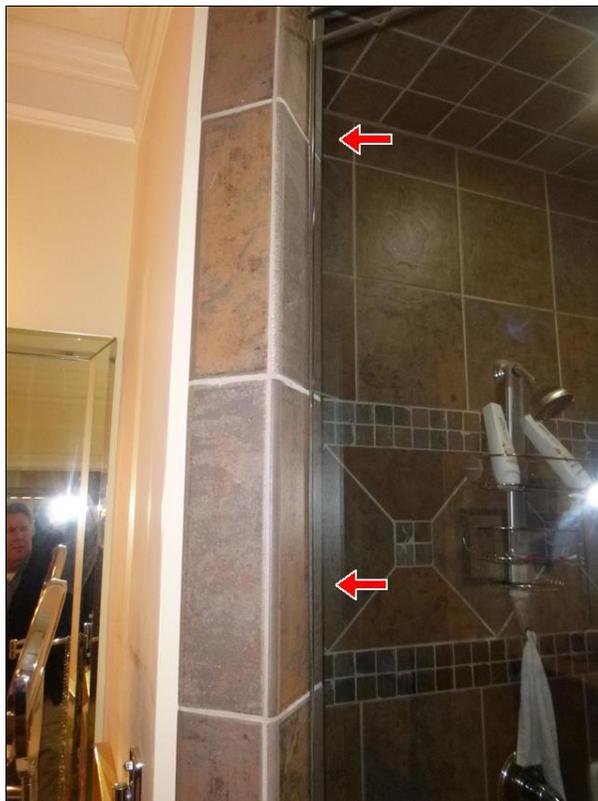
Repair: The shower door in the master bathroom needs adjustment for proper operation and to prevent leakage around the door.

23. **Repair:** *The shower door in the master bathroom needs adjustment for proper operation and to prevent leakage around the door.*
