Atlanta Property Inspections

HOME INSPECTION REPORT

786 Gardenside Circle, Marietta, GA 30067
Inspection prepared for: Kayla Meyer
Date of Inspection: 1/24/2020 Time: 9:30 AM
Age of Home: 20 Years Old (2000) Size: 1600 SF
Weather: Overcast / Light Rain, Wet Soil, 45 - 50 Degrees

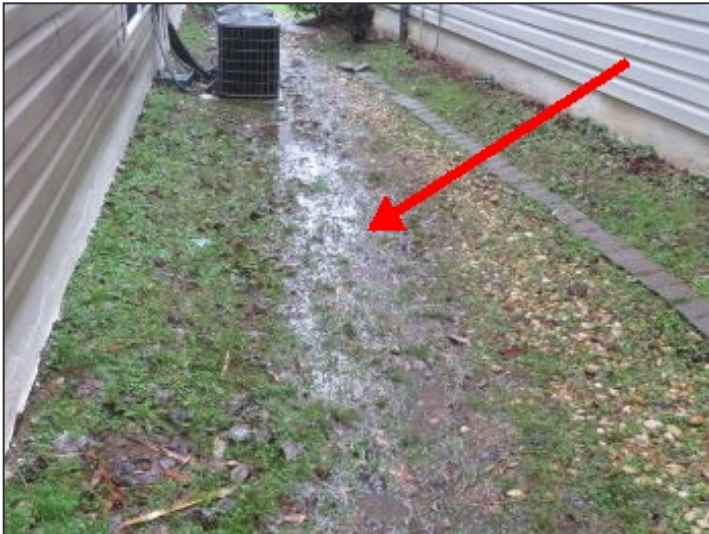
Drainage concerns were noted at the rear right corner yard and at the left side yard (see photos). Excessively muddy conditions and some standing water were observed. Drainage improvements are recommended at these locations. It was also noted that an underground drain is present at the rear right yard, but the water level inside of the drain is very high, which is an indication that the drain is not operating normally. Further evaluation is suggested by a landscaping professional to determine the full scope of repair needs.

Standing water at left side yard

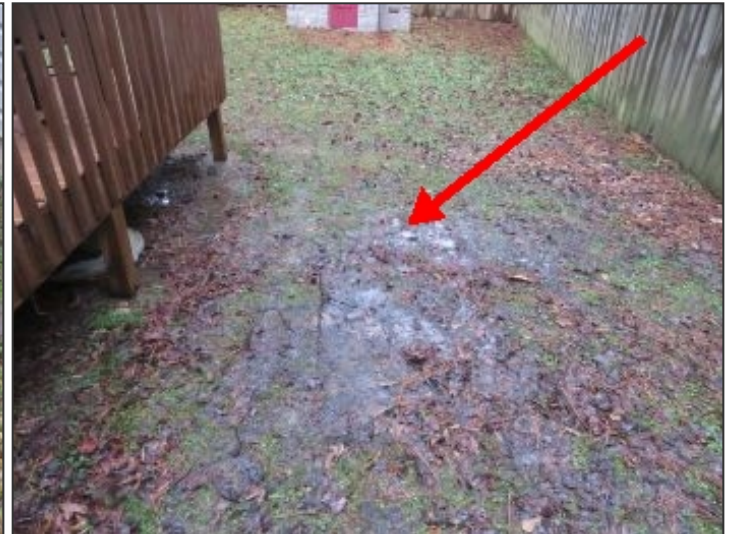
Standing water and excessively muddy conditions at rear right yard

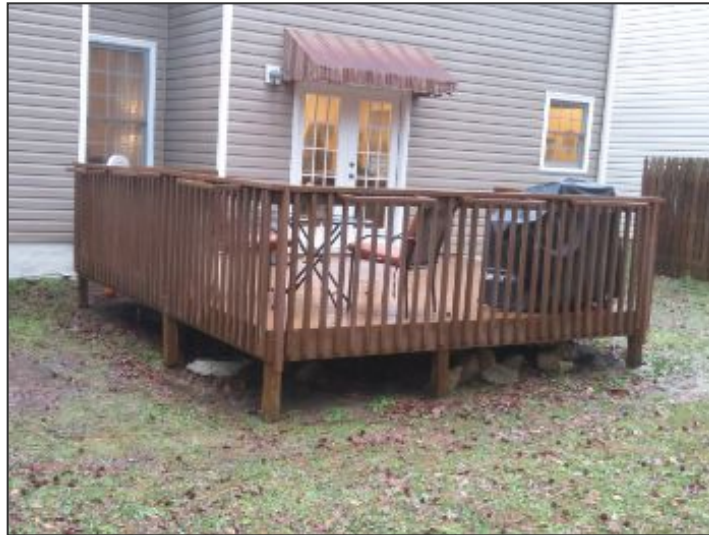
• **LIMITED INSPECTION:** The underside of the deck is not fully visible for inspection due to low clearances from the ground. The inspector is unable to inspect the deck anchorage system, the deck ledger flashing or the deck joists.

Wood deck at rear

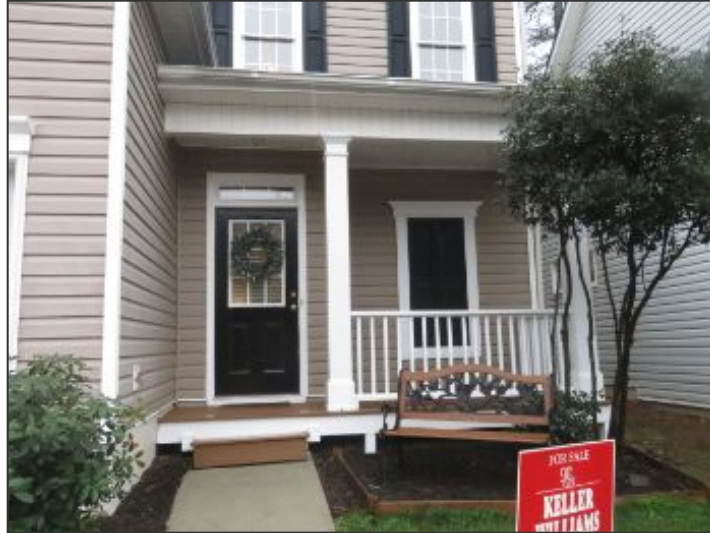
• **LIMITED INSPECTION:** The underside of the porch is not fully visible for inspection due to low clearances from the ground. The inspector is unable to inspect the porch anchorage system, the ledger flashing or the joists.

Wood porch at front entry

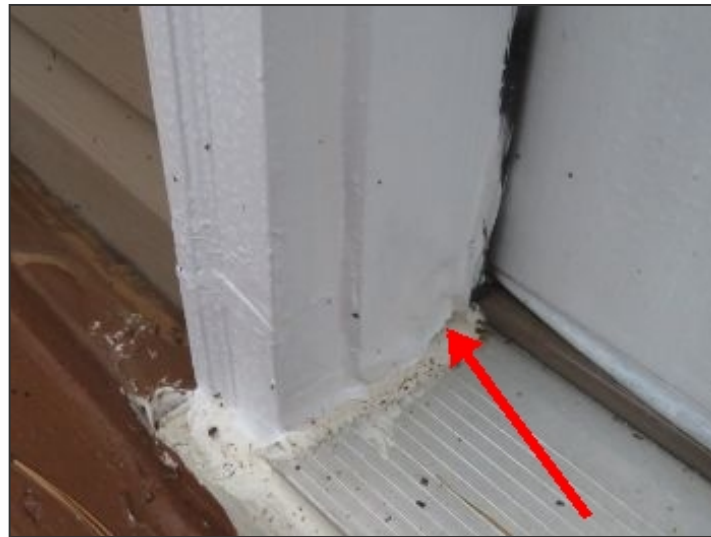
• Damaged wood trim was noted at the exterior door jamb of the deck entry door just above the threshold (see photo). The damaged area appears to have been repaired using a wood filler, which is not considered a long term repair. Replacement of the damaged wood is recommended.

Damaged trim and wood filler repair at deck door jamb

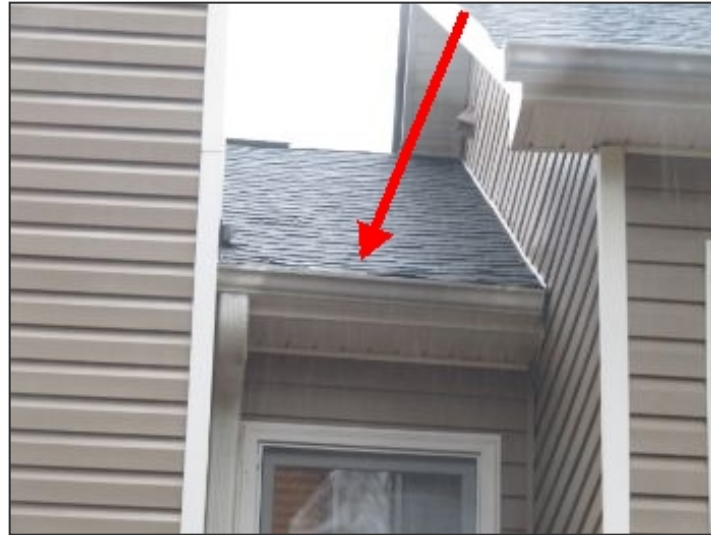
• **A gutter is improperly sloped at the rear roof to the right of the chimney and is holding water (see photo). Repair / adjustment is recommended so that the gutter is properly sloped and water flows to the downspout.**

Gutter improperly sloped at rear roof near chimney

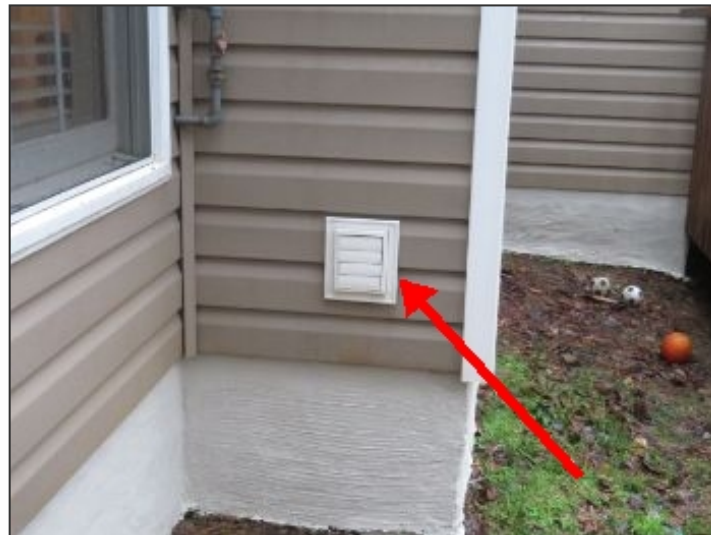
• **An improper fresh air vent cover was noted at the lower chimney - the cover present is designed for exhaust purposes only (see photo). Replacement of the cover with the correct screened and hooded type is recommended.**

Improper fresh air vent cover at chimney

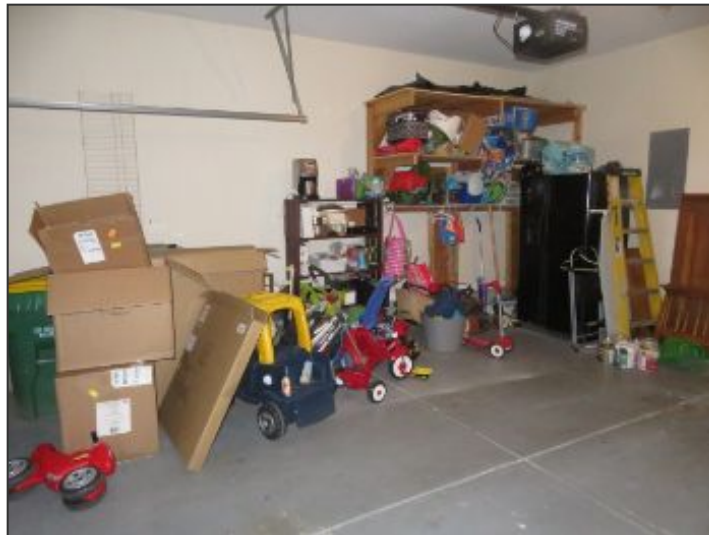
- **An attached two car garage is present.**
- **The garage appears serviceable. The garage floor has adequate slope to the outside and the garage walls and ceilings appear to be in good condition.**
- **Storage obstructions in the garage restrict full visibility of the floor and lower walls, unable to fully inspect (see photo). Further evaluation is recommended after the storage items have been removed.**

Storage obstructions in garage

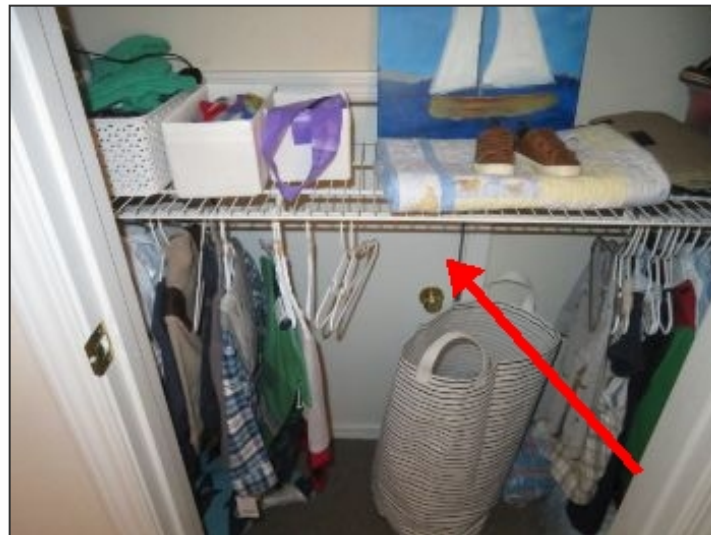
- **The attic is accessible by a pull down ladder.**
- **A partial attic space is present at the front corner guest bedroom closet.**
- **The partial attic space door was found to be blocked by built in shelving in the closet and could not be opened (see photo). We are unable to inspect this area for framing, roof leaks, wiring, rodents, etc. Further evaluation / inspection of this attic is recommended after access has been provided.**

Unable to access partial attic space - entry door obstructed by shelving

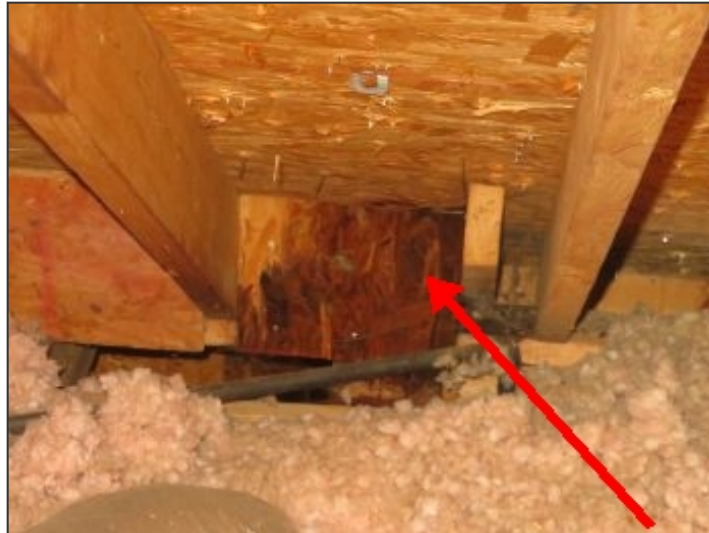
- **Evidence of an active roof leak was observed in the attic at the right side of the chimney; this observation is based on wet water stains on the roof decking (see photo). This condition appears to be an active roof leak - due to this concern, further evaluation is recommended by a professional roofer to determine the full scope of repair needs and costs.**

Active leak in attic at chimney - wet stains present

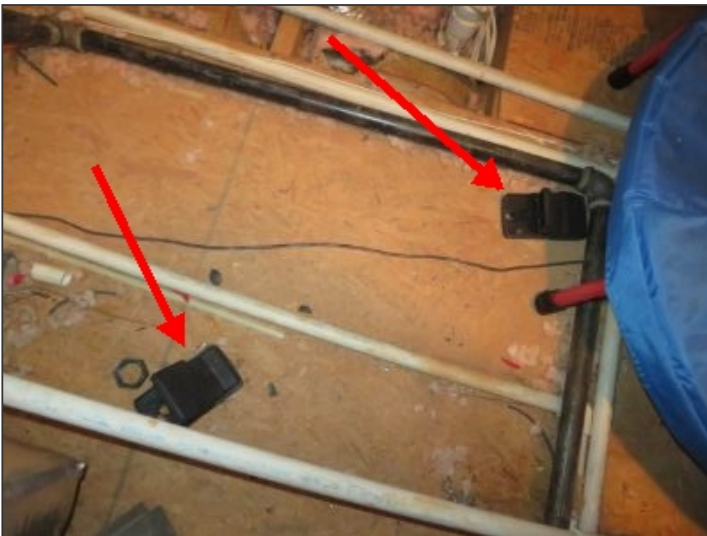
- Disturbed attic insulation was noted in the attic along with visible rodent trails in the insulation.
- Rodent traps were observed in the attic which is an indication of rodent activity.

Rodent traps in attic

- Due to the evidence of rodent activity noted above, it is recommended that client ask the home seller for any available disclosure information regarding rodent activity and any efforts to correct this condition. If there is no history of documented rodent exclusion work, it is recommended that further evaluation be conducted by a professional wildlife control contractor to determine the full extent of rodent exclusion needs and costs. All potential rodent entry access points should be sealed to prevent future rodent entry. In addition, any trees or tree limbs that are near the roof that may be contributing to rodent activity on the roof and in the attic should be removed. In many cases, this type of repair can develop into a major expense depending upon the amount of work needed.

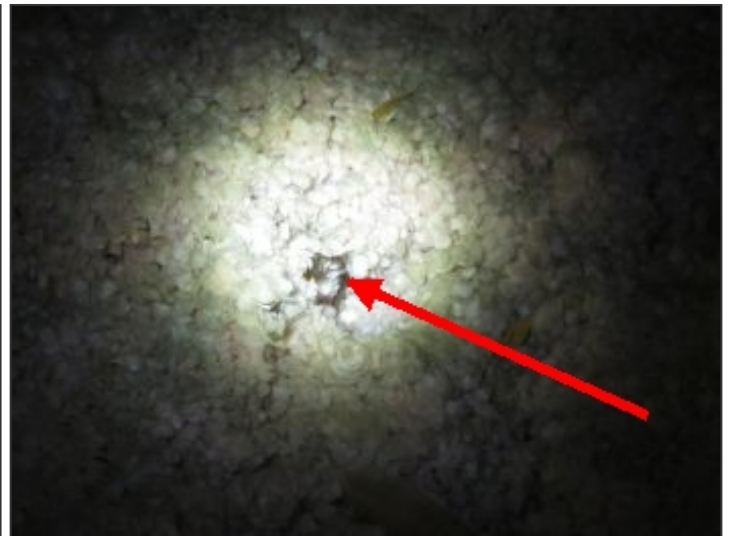
Rodent tunnels in attic insulation

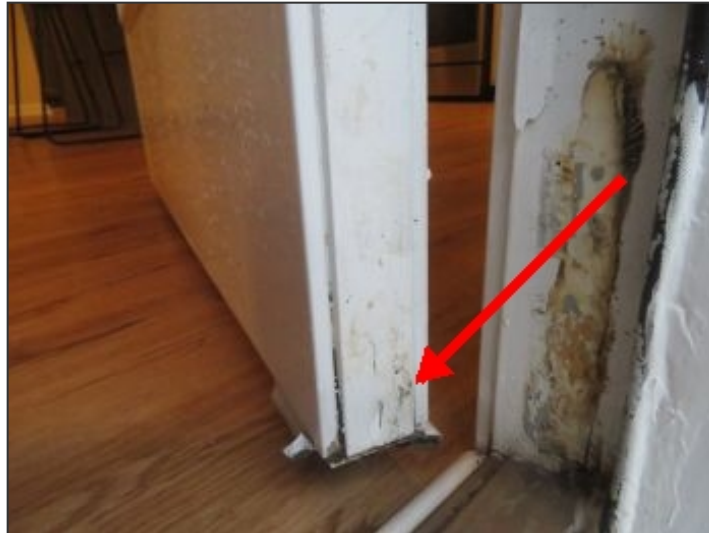
• Minor water damaged wood was noted to the lower inside corner of the door at the rear deck entry (see photo). Further evaluation is recommended by a professional door contractor or qualified carpenter to determine the full extent of repair or replacement needs and costs.

Minor damaged wood at deck entry door

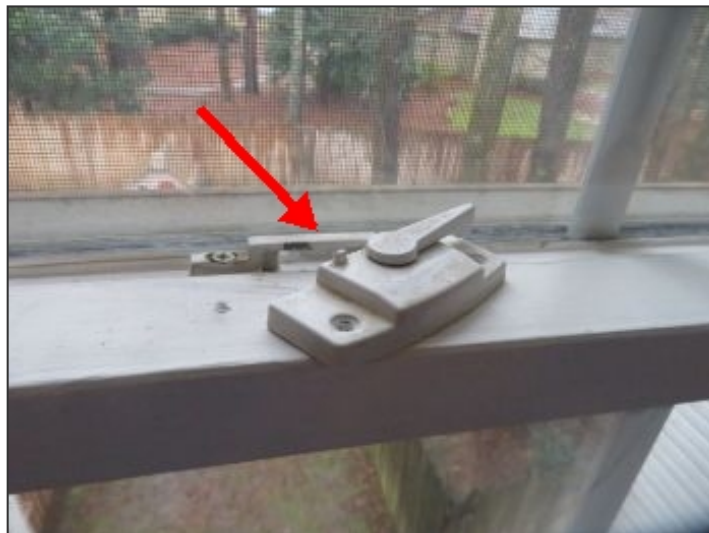
- The windows are wood framed windows with double pane glass.
- The overall condition of the windows is OK except as noted below:
 - **UNABLE TO FULLY INSPECT:** Nearly all of the windows are stuck closed and appear to be painted shut; we were unable to open, operate and fully inspect these windows. Correction is recommended so that all windows are fully functional, particularly for emergency egress in bedrooms if needed.
 - A loose lock was noted at the rear right window in the guest bedroom above the family room. Repair or replacement of the lock is recommended.

Loose lock at rear right guest bedroom window

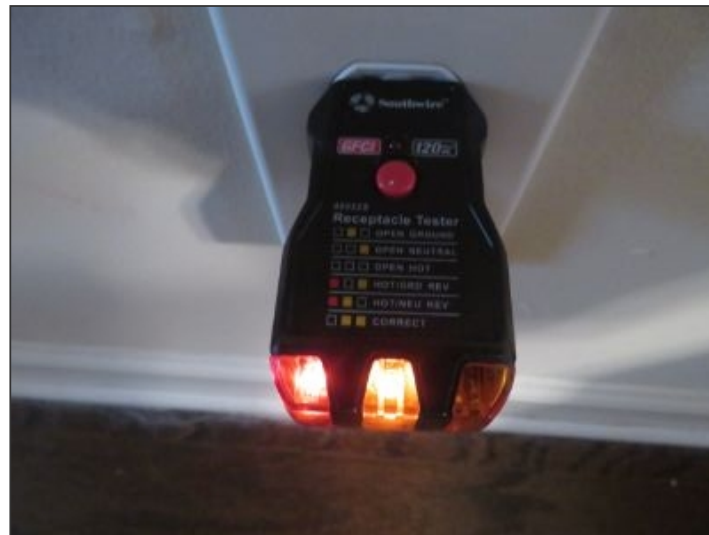
• **All of the outlets located at the guest bedroom above the family room are incorrectly wired and have the hot and neutral wires reversed (reversed polarity). Correction is recommended.**

Guest bedroom outlets incorrectly wired - hot and neutral wires reversed

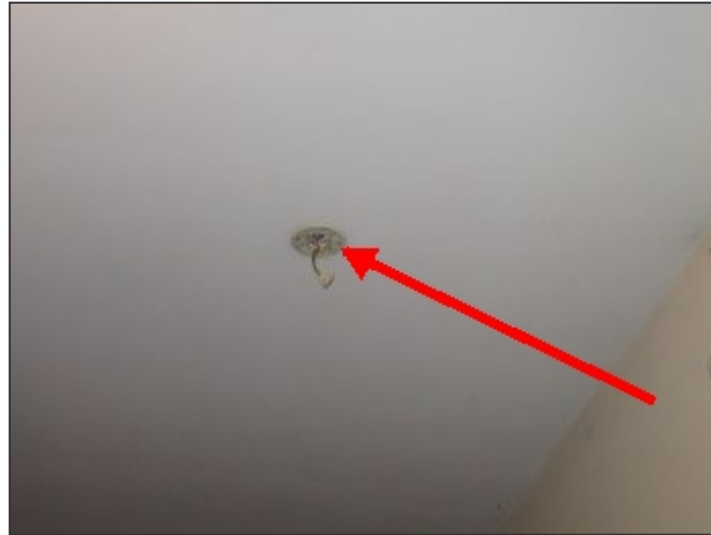
The smoke detector at the garage has been removed (see photo). This condition is a safety concern. Replacement of the missing smoke detector is advised.

Garage smoke detector removed

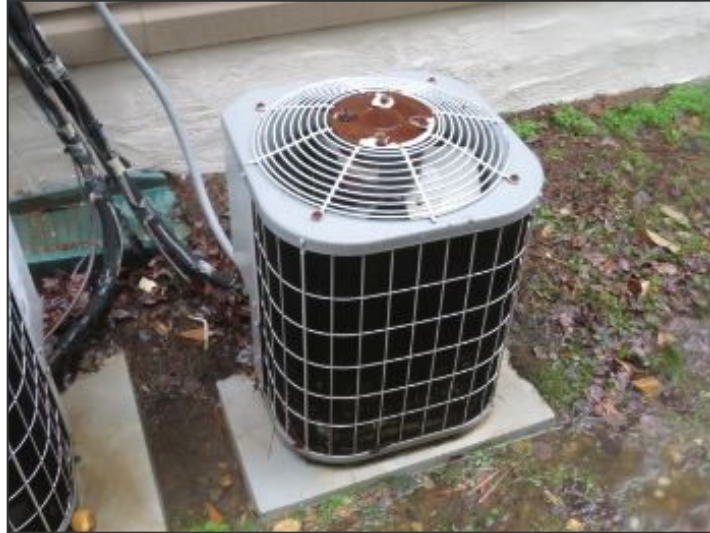
Due to the advanced age of this AC unit, client should budget for replacement soon which is expected to be a major expense. Based on the available manufacturing date on the equipment, the AC unit is at or past the normal expected lifespan of 12-15 years.

Second floor AC unit
