AMENDMENT TO ADDRESS CONCERNS WITH PROPERTY AMENDMENT #1

Whereas, the undersigned parties have entered into a certain Agreement between _____
An Do, ~~Do~~ _____ (“Buyer”) and H Donald Snapp, Linda W. Snapp _____ (“Seller”), with
a Binding Agreement Date of 1/4/2020 for the purchase and sale of real property located at:
175 Stone Pond Lane, Johns Creek, Georgia
30022-8471 (“Agreement”).

Thank you for the opportunity to conduct a home inspection of the property listed above. We understand that the function of this report is to assist you in understanding the condition of the property to assist in making an informed purchase decision.

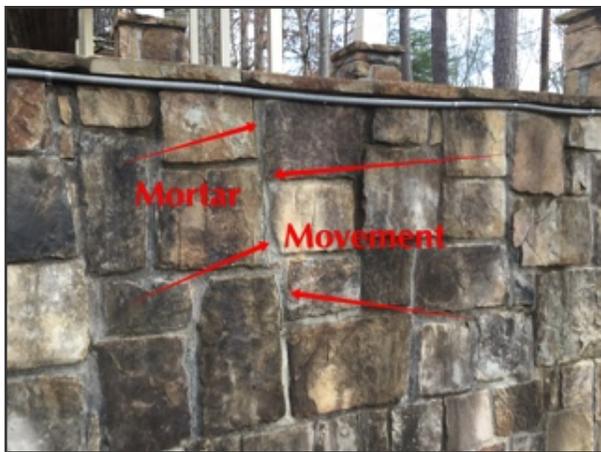
Figure 2-1

Monitor: The retaining wall shows evidence of movement. This condition should be monitored. It is impossible to determine the rate of movement during a one-time visit to the house. May desire to add mortar back where movement has concurred.

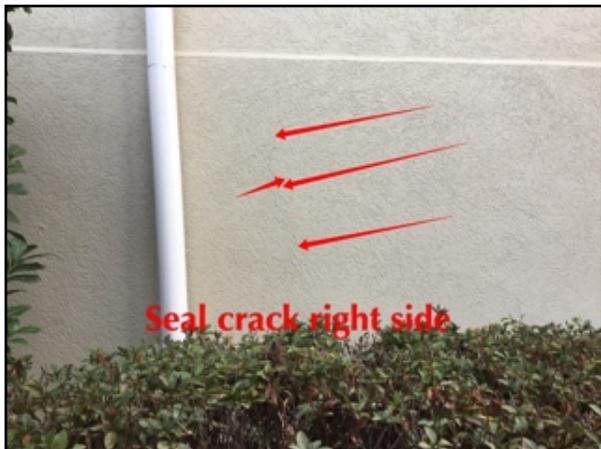
Figure 6-1

Cracks in stucco need sealed around perimeter of home.

- 1) All exterior of the foundation of the house will be fixed to have at least 6 to 8" clearance above the ground. (item #4 of inspection report)
- 2) All cracks in stucco need sealed around perimeter of home. (item #5)

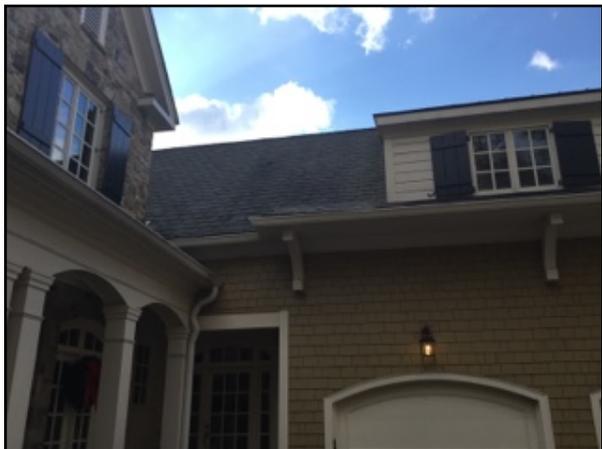
Figure 14-1

The roofing is middle aged material (estimated age is less than twenty years) and is in reasonably good condition. The typical life for this material is 40-45 years. In all, the shingles show evidence of normal wear and tear for a roof of this age. Keep in mind that these life expectancies are approximations only and other factors such as extreme weather conditions can result in a shorter life.

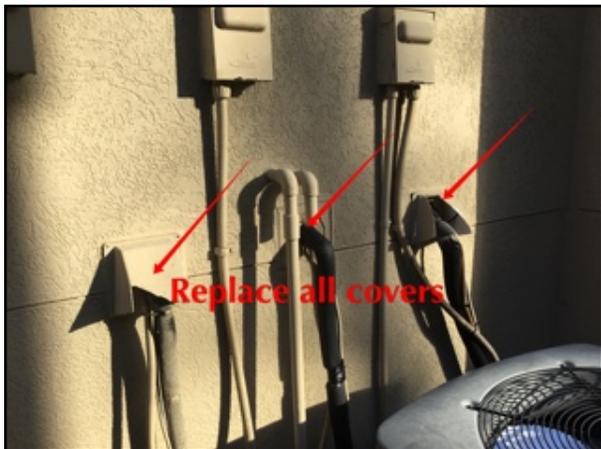
Figure 26-1

Vent covers for AC units are broke and should be replaced.

- 6) Replace/repair light in attic area of master closet, and cam light in pool room. (item #13)
- 7) Replace all broken vent covers for AC units. (item #14)

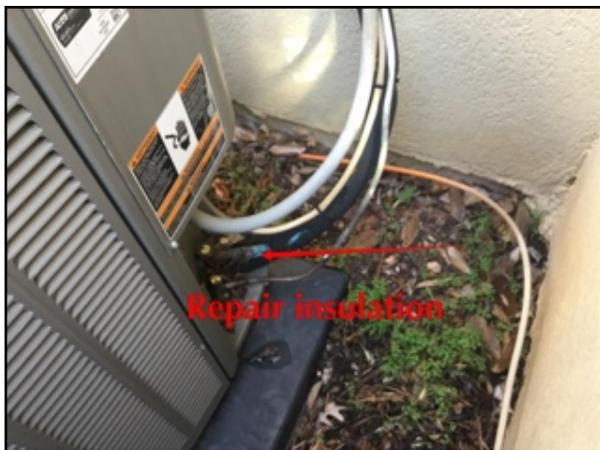
Figure 30-1

Repair: Damaged and or missing insulation on refrigerant lines should be repaired. These outside lines should be insulated all the way to the compressor unit to prevent loss of temperature in the lines.

- 8) Given the age of the furnaces and HVAC systems, sellers are to replace or repair and serviced by a qualified HVAC service company. (item #15)
- 9) Repairs all damaged and or missing insulation on refrigerant lines. (item #16)

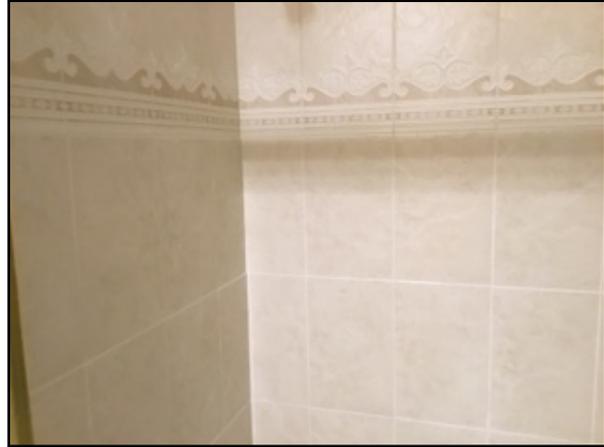
Additional mortar is needed in the corners of tile to prevent water intrusion behind walls.

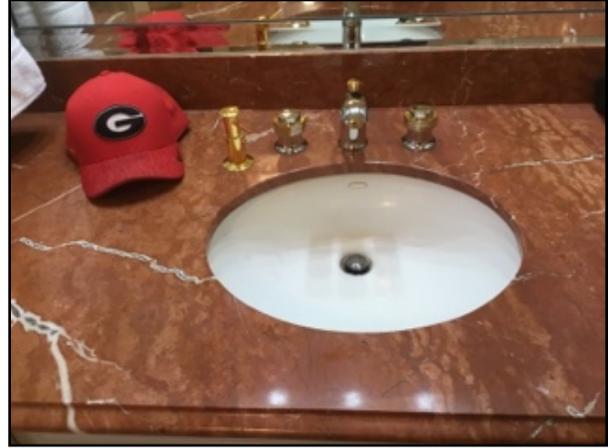
Sink on right side of master bath cold water not coming on. Further investigation required.

- 13) Repair sink on right side of master bath for cold water. (item #28)
- 14) Replace/repair ventilation fan. (item #35)
- 15) Repair/replace upstairs dishwasher in the kitchen. (item #37)

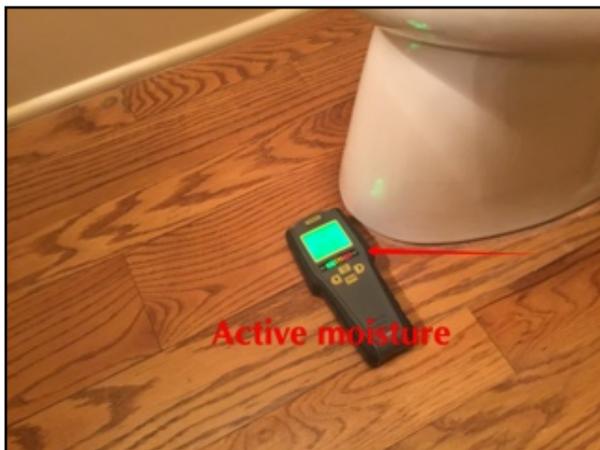
Figure 54-1

Moisture meter indicating there is active moisture under wood. Could be that the wax ring is bad as toilet is loose. Further evaluation is required by professional plumbing contractor.

- 12) Repair toilet in hallway bath, and toilet in hallway basement bath, and have the wax ring checked for leaks and the toilets properly bolted to the floor. (item #26,29, 31)

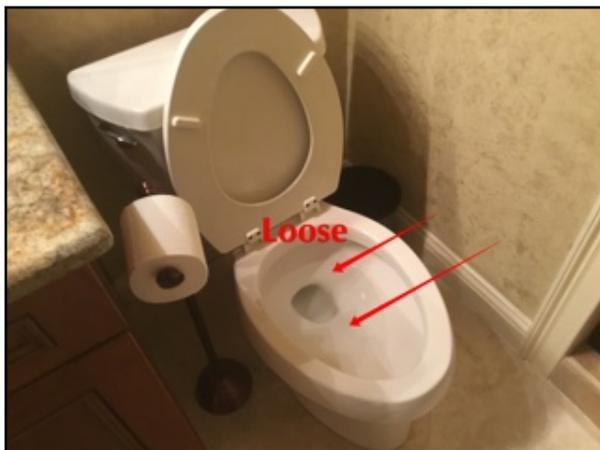
Figure 56-1

Repair: The toilet is loose as noted in hallway basement bath which needs repair. Have the wax ring checked for leaks and the toilet properly bolted to the floor.

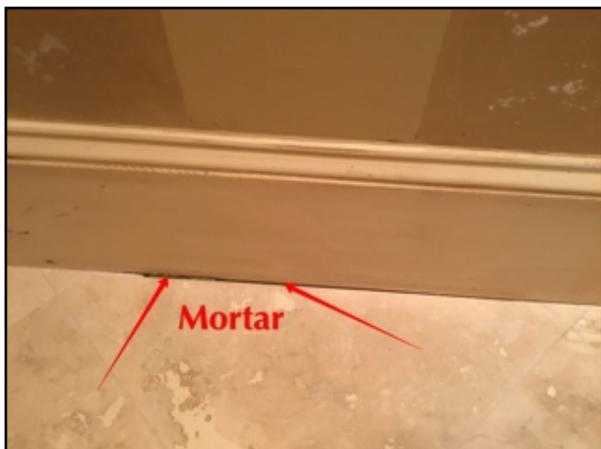
Figure 59-1

Where tile meets base trim needs repair as it needs additional mortar.

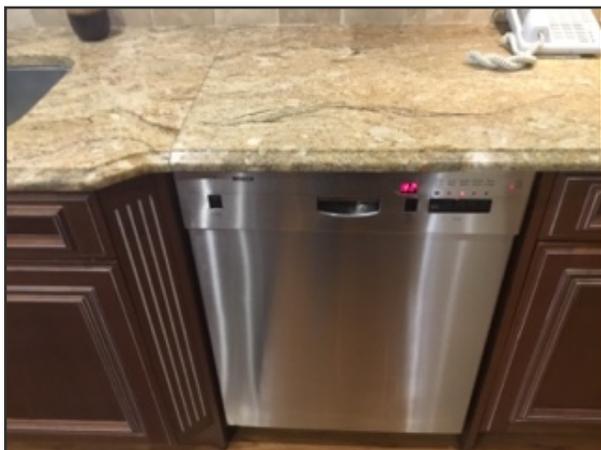
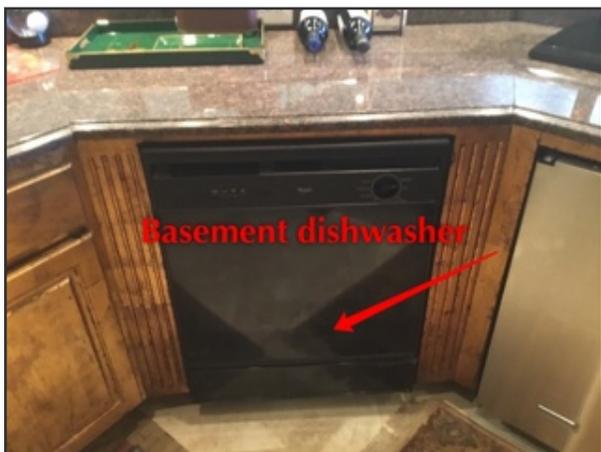
Upstairs kitchen dishwasher was not working correctly at time of inspection. Further evaluation needed.

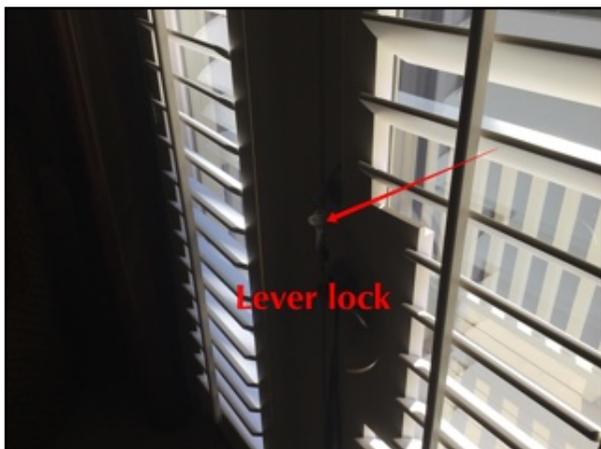
Figure 65-1

Improve, Safety Issue: Double keyed deadbolts were noted on the exterior doors, which is against current day codes for proper emergency egress from the home. Recommend replacing these with the type that have levers on the interior side.
