Atlanta Property Inspections, Inc.

HOME INSPECTION REPORT

712 Sandringham Drive, Alpharetta, GA 30004
Inspection prepared for: Hydi Kalmin
Date of Inspection: 1/9/2020 Time: 1:30 PM
Age of Home: 23 Years Old (1997) Size: 1630 SF
Weather: Sunny, 60 Degrees, Dry Soil

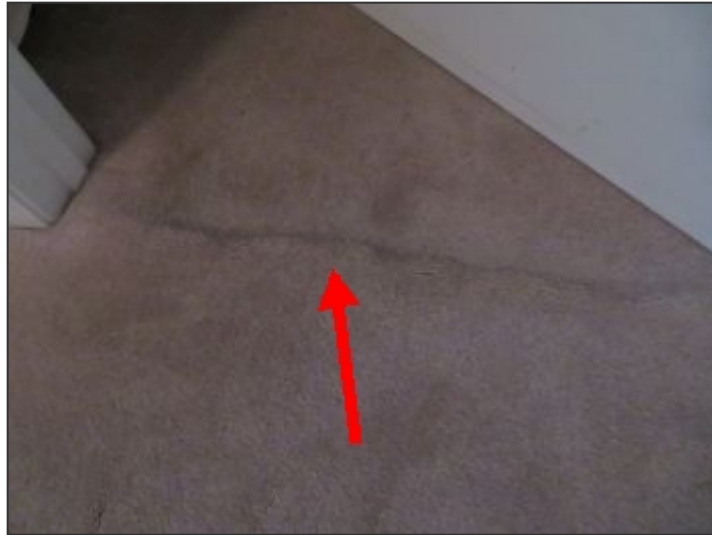
• **Two areas of the master bedroom carpet have high wrinkles in front of the master closet and the center of the bedroom. This condition is a possible trip hazard. Correction is recommended by a professional flooring contractor.**

Carpet wrinkle at master closet

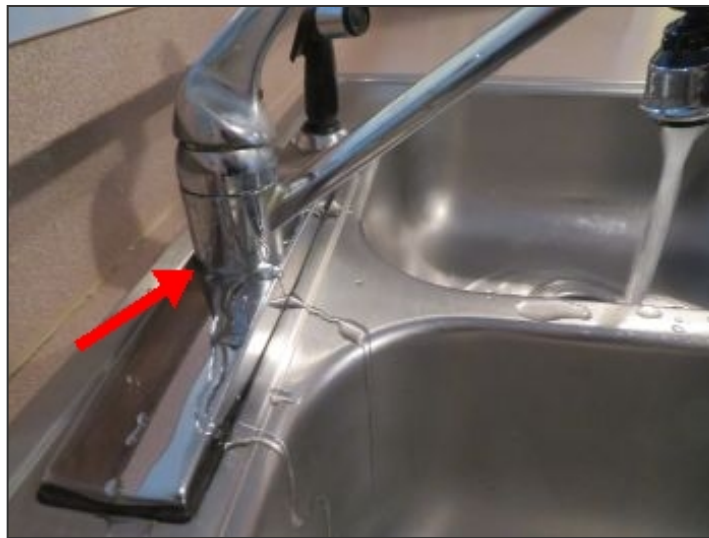
• **The kitchen sink faucet has an active leak at the cartridge seal or stem seal (see photo). Further evaluation and correction is recommended by a professional plumber.**

Faucet handle leaking when tested

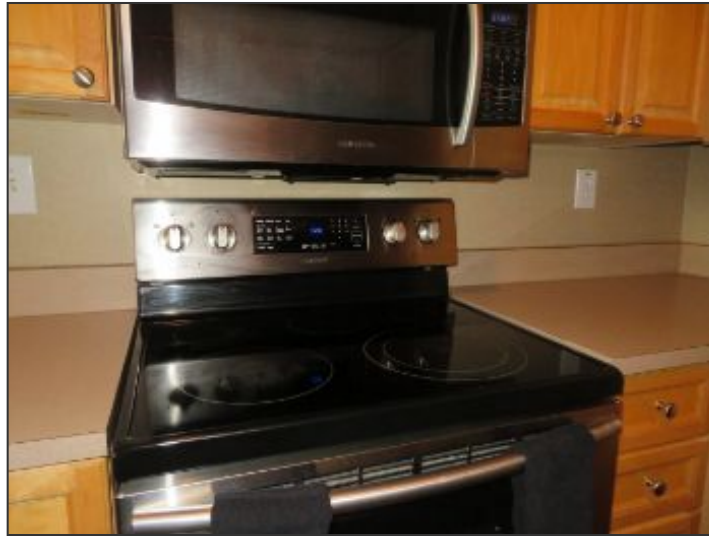
• **The microwave oven has been installed with an inadequate clearance between the bottom of the microwave and the top of the stove at 13 inches (see photo). Many manufacturers, such as GE, recommend a height of 16-18 inches from the top of the cooktop to the bottom of the microwave oven. Correction is recommended.**

Microwave clearance too low

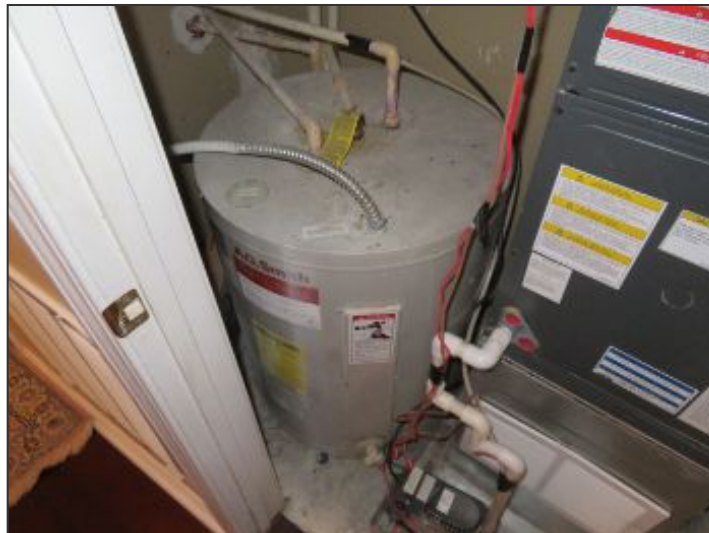
Due to the advanced age of this aging gas electric water heater, client should budget for replacement of the water heater tank soon. The water heater tank is at, or past, the normal expected lifespan of 15-20 years.

- No thermal **expansion tank** or valve is present. The expansion tank was not required at the time of this installation but is required now by local plumbing codes. Client should budget for an additional \$100 - \$200 for an expansion tank or valve when the water heater is replaced.

Water heater located in hall closet

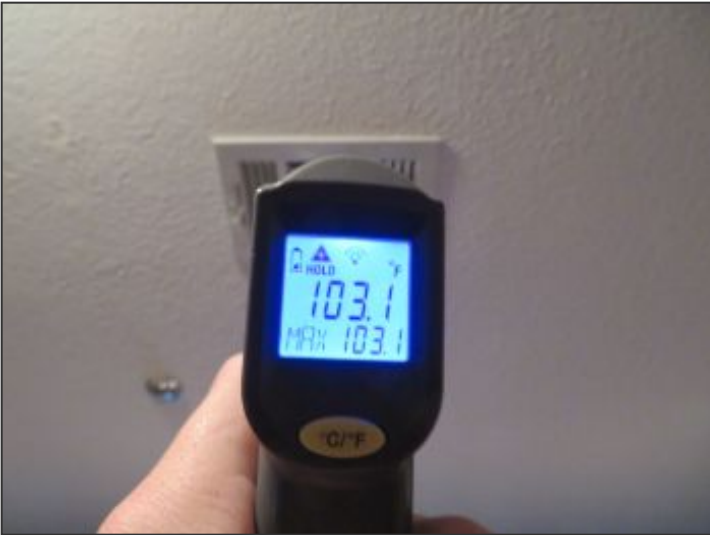
The heat pump was tested and produced heat at 103 degrees. The heat strips and heat pump were tested together and produced heat at 127 degrees. We recommend that you continue to maintain the system and have it serviced regularly, at least once per year for units over 5 years old.

Heat pump temp normal at 103 degrees

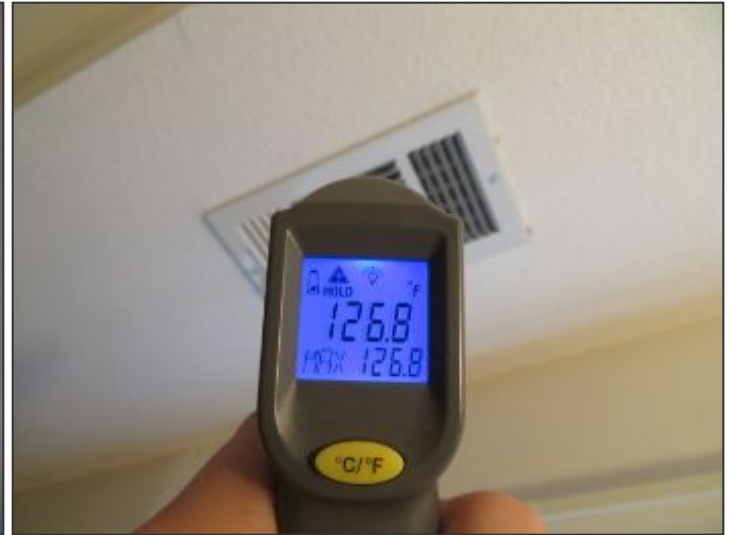
Heat pump / strips temp normal at 127 degrees
