Property Inspection Report

Property address: **6422 Vernon Woods Dr NE
Atlanta GA 30328**

Inspection date: **Saturday, February 1, 2020**

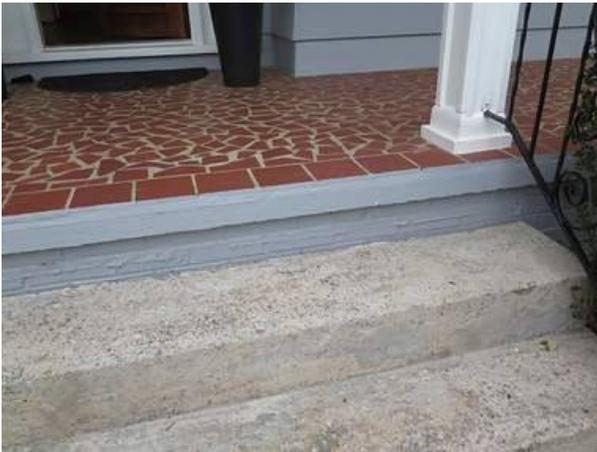
Photo 5-1

The risers for stairs at one or more locations varied in height and pose a fall or trip hazard. Risers within the same flight of stairs should vary by no more than 3/8 inch. At a minimum, be aware of this hazard, especially when guests who are not familiar with the stairs are present. Recommend that a qualified contractor repair per standard building practices.

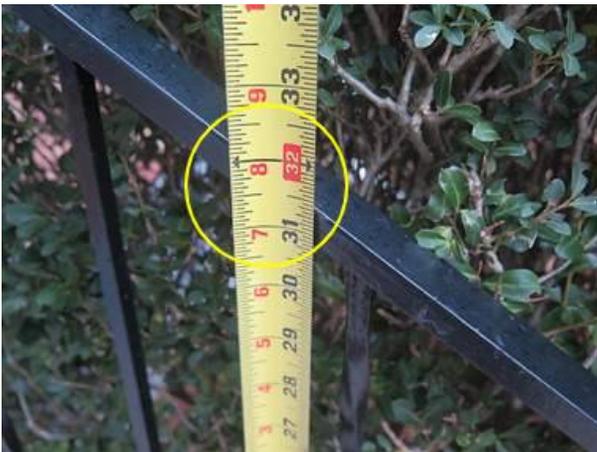
Photo 6-1

Handrails at one or more flights of stairs were too low or too high and pose a fall hazard. Handrails should be located at least 34 inches and at most 38 inches above the nose of each tread/riser. Recommend that a qualified person repair per standard building practices.

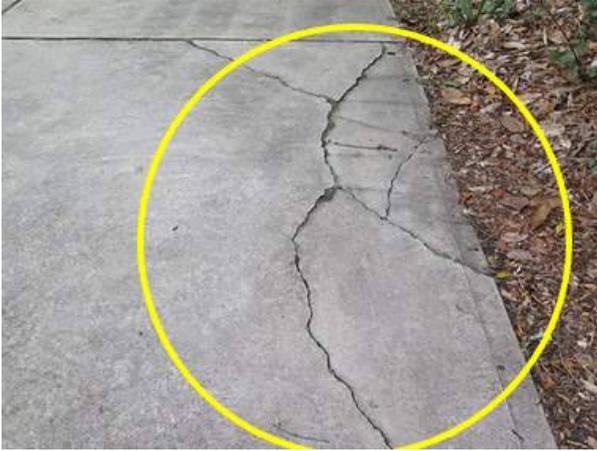
Photo 7-1

Cracks, holes, settlement, heaving and/or deterioration were found in the driveway. Recommend that qualified contractor repair as necessary.

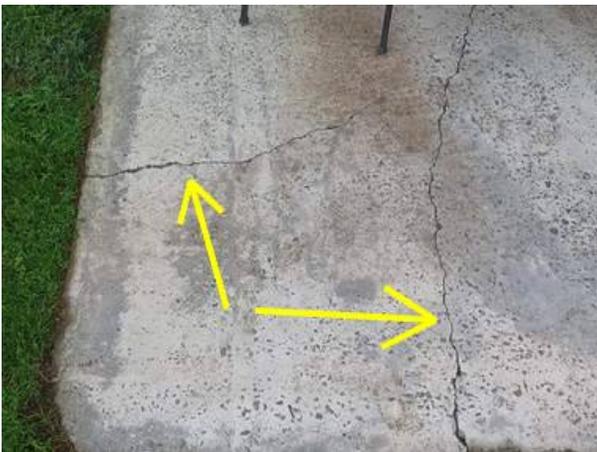
Photo 8-1

8) Cracks, holes, settlement, heaving and/or deterioration were found in sidewalks and/or patios. Recommend that qualified contractor repair as necessary.

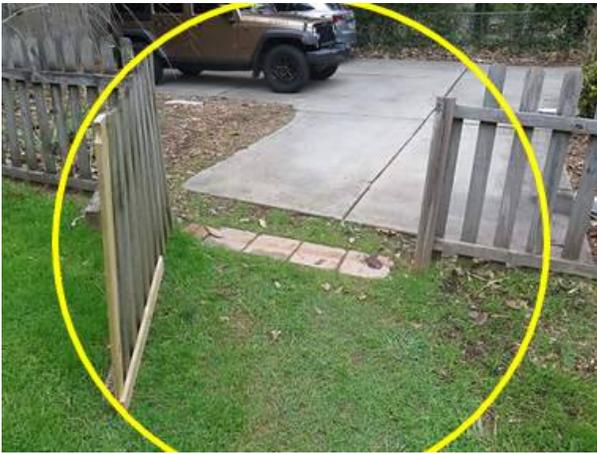
Photo 9-1

9) One or more fences and/or gates were damaged or deteriorated and need repair.

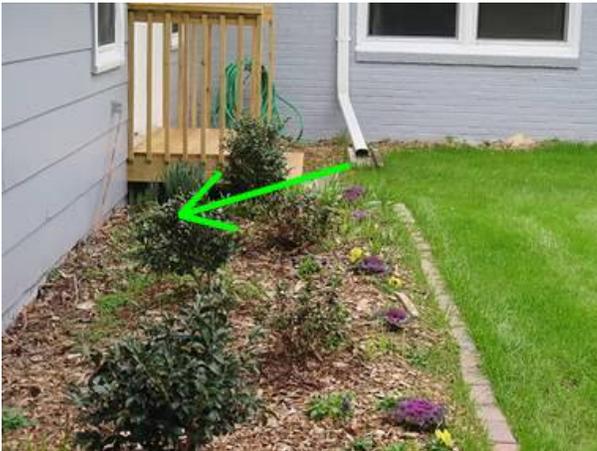
Photo 10-1

The soil or grading sloped down towards building perimeters in one or more areas. This can result in water accumulating around building foundations or underneath buildings. It is a conducive condition for wood-destroying organisms. Recommend grading soil so it slopes down and away from buildings with a slope of at least 1 inch per horizontal foot for at least 6 feet out from buildings.

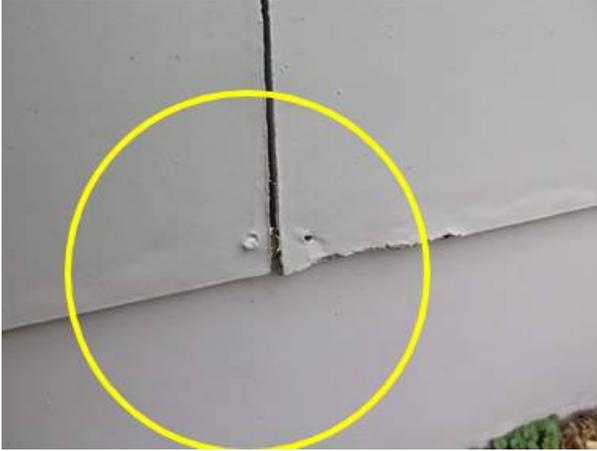
Photo 12-1

Some sections of siding and/or trim were deteriorated and/or damaged. Recommend that a qualified person repair, replace or install siding or trim as necessary.

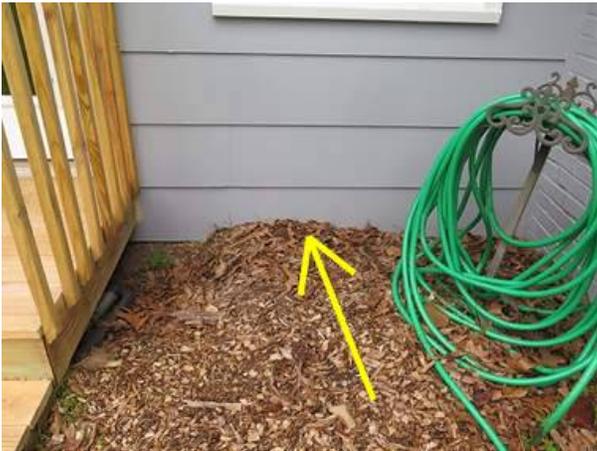
Photo 13-1

Soil was in contact with or less than 6 inches from siding, trim or structural wood. This is a conducive condition for wood-destroying organisms. Recommend grading or removing soil as necessary to maintain a 6-inch clearance. If not possible, then recommend replacing untreated wood with pressure-treated wood. Installation of borate-based products such as Impel rods can also reduce the likelihood of rot or infestation if soil cannot be removed. Note that damage from fungal rot and/or insects may be found when soil is removed, and repairs may be necessary.

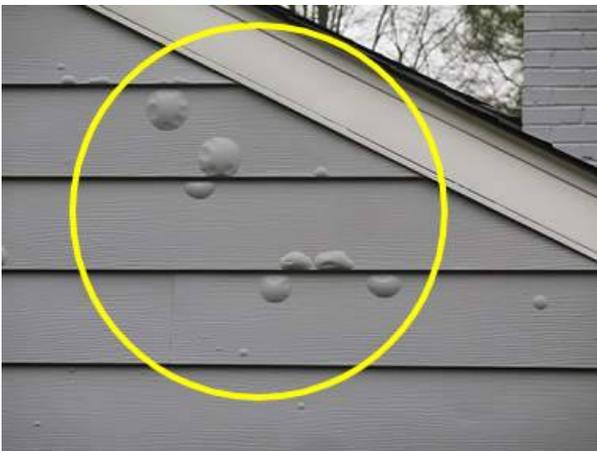
Photo 14-1

The paint or stain finish in some areas was failing (e.g. peeling, faded, worn, thinning). Siding and trim with a failing finish can be damaged by moisture. Recommend that a qualified contractor prep (e.g. clean, scrape, sand, prime, caulk) and repaint or restain the building exterior where necessary and per standard building practices. Any repairs needed to the siding or trim should be made prior to this.

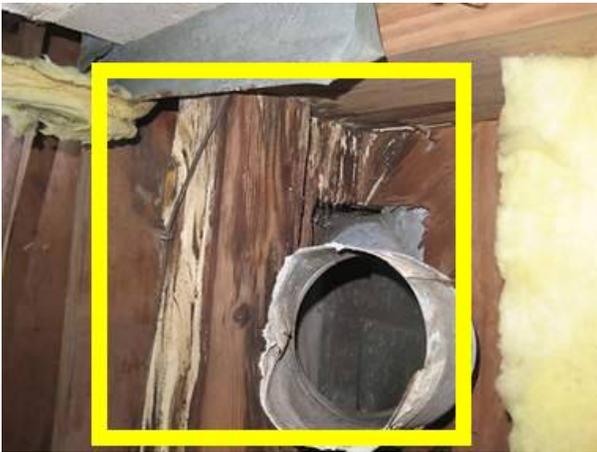
Photo 17-1

Fungal rot was found at one or more joists, beams and/or sections of floor sheathing. Recommend that a qualified contractor evaluate and repair as necessary. All rotten wood should be replaced.

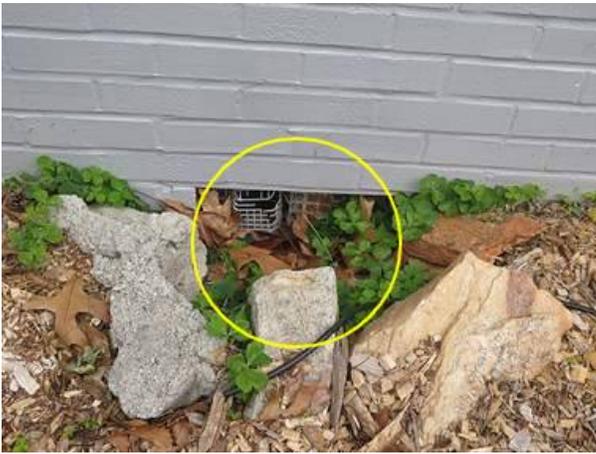
Photo 20-1

One or more crawl space vents were blocked by soil, debris and/or insulation. This restricts ventilation in the crawl space and can result in increased levels of moisture inside. This is a conducive condition for wood-destroying organisms. Materials or items blocking vents should be removed as necessary.

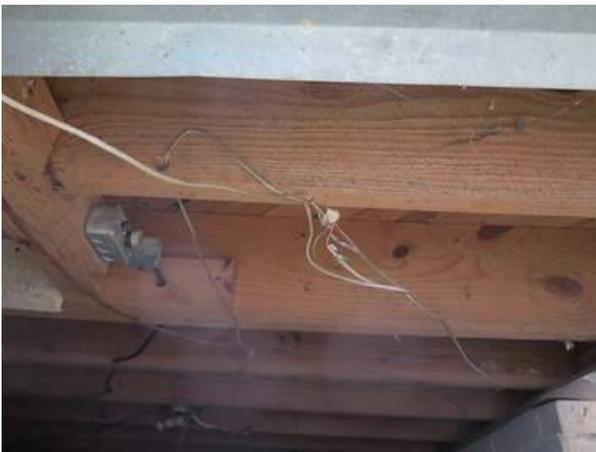
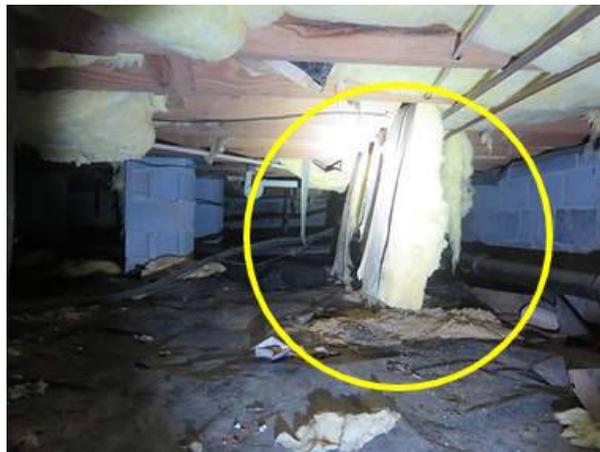
21) 🛠️💧 Under-floor insulation was damaged, missing, or deteriorated in many areas, and will likely result in reduced energy efficiency. A qualified contractor should replace insulation as necessary. Consider having all insulation replaced.

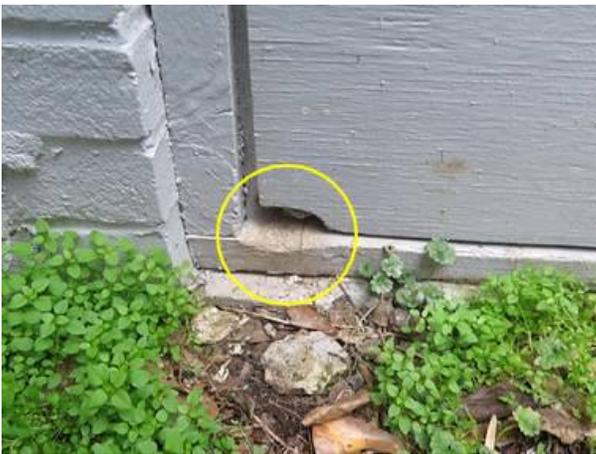
Photo 24-1

24) 🛠️ One or more outdoor crawl space access hatches or doors were missing, damaged, deteriorated or substandard. Water and/or vermin can enter the crawl space. Recommend that a qualified person replace, install or repair hatches or doors where necessary.

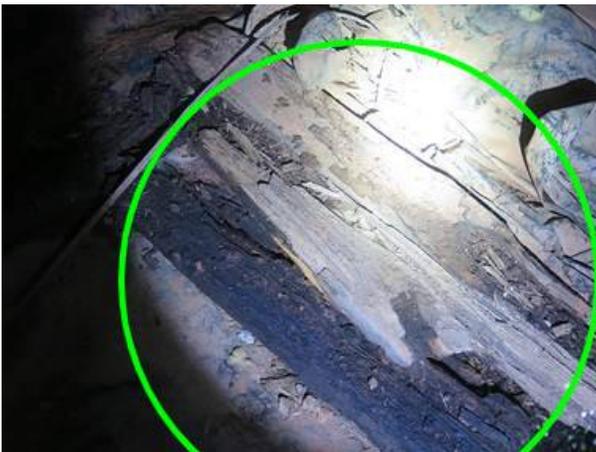
Photo 25-1

25) 🗑️💧 Cellulose material such as scrap wood was found in the crawl space. This is a conducive condition for wood-destroying organisms. Recommend removing all cellulose-based debris or stored items.

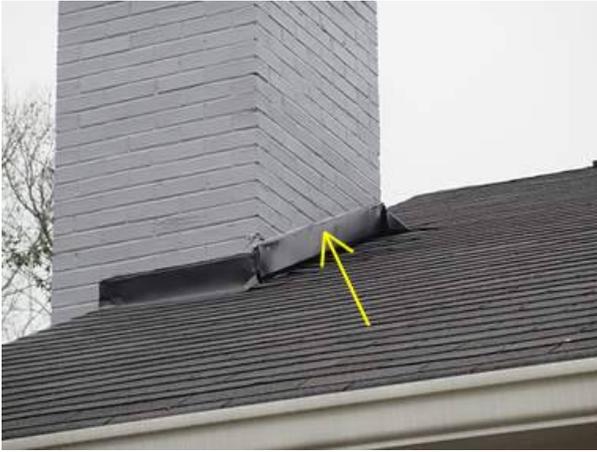
Photo 27-1

Flashings at the base of one or more chimneys were missing counter flashing. Leaks can occur as a result. This is a conducive condition for wood-destroying organisms. Recommend that a qualified contractor evaluate and repair as necessary.

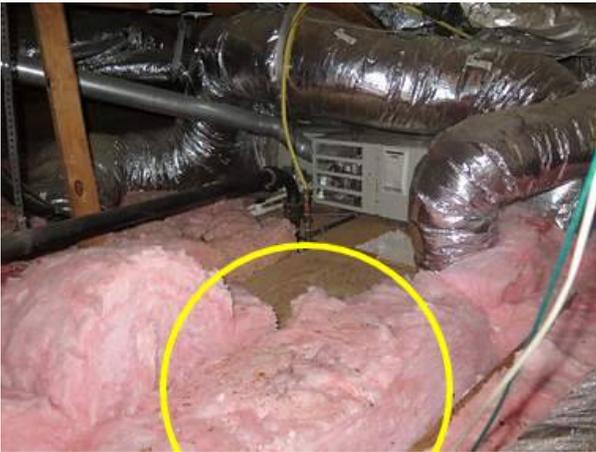
Photo 31-1

NOTE A passageway shall have continuous solid flooring not less than 24 inches wide. A level service space not less than 30 inches deep and 30 inches wide shall be present at the front or service side of the appliance. Have a qualified contractor evaluate and repair as necessary.

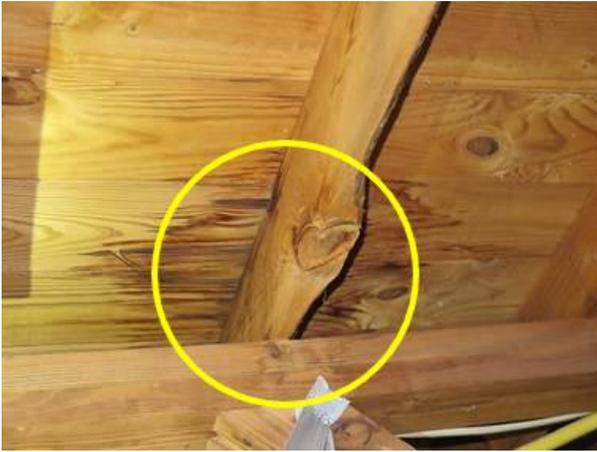
Photo 34-1

34) Evidence of past water stains were visible on the roof structure at one or more locations in the attic. However, no elevated levels of moisture were found at these stains during the inspection. The stains may have been caused by a past leak. Recommend asking the property owner about past leaks. Monitor these areas in the future, especially after heavy rains to determine if active leaks exist. If leaks are found, recommend that a qualified contractor evaluate and repair as necessary.

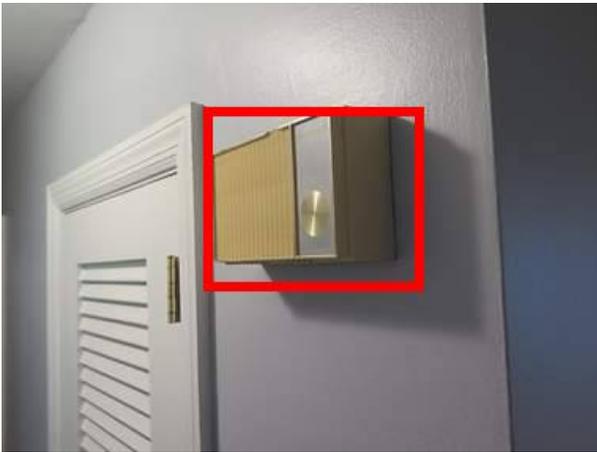
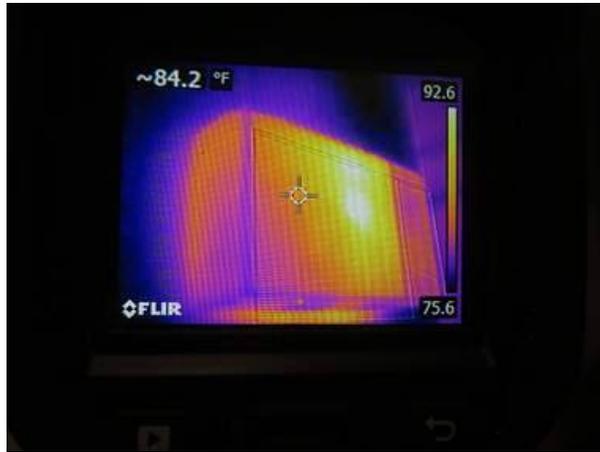
46) 🔧 The front and/or back door's doorbell appeared to be malfunctioning. Recommend that a qualified person repair as necessary.

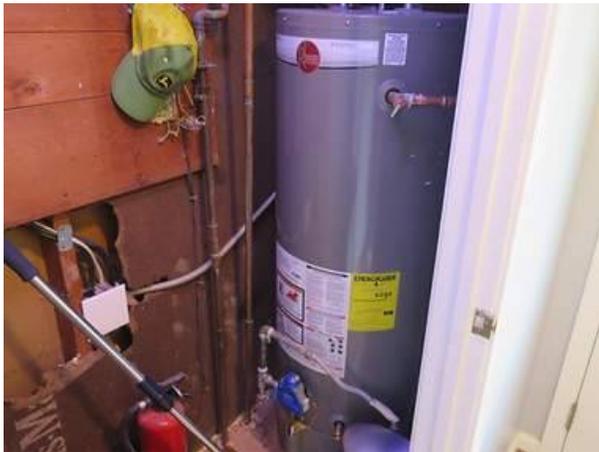
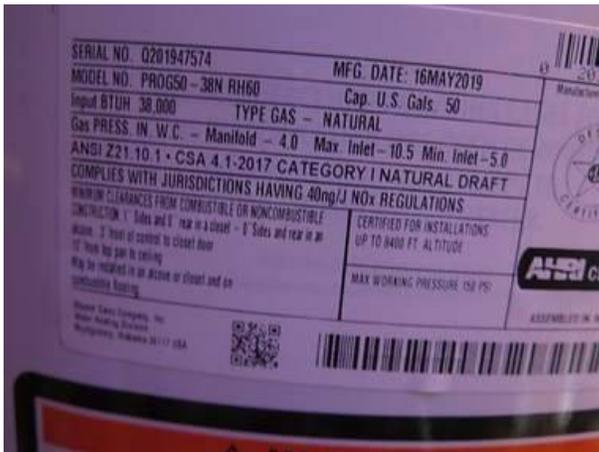
58) **i** A water heater was installed in or over a finished living space or in an area where leaking can cause damage, and no catch pan or drain was installed. Catch pans and drains prevent water damage to finished interior spaces below if or when the water heater leaks or is drained. If concerned, consult with a qualified contractor about installing these. Note that drain lines for catch pans are usually installed below the floor level and are difficult at best to install in an existing home. 510.7

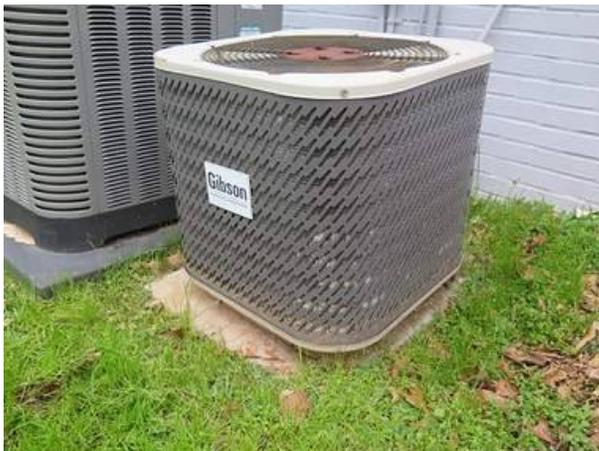
Photo 59-1

The estimated useful life for most heat pumps and air conditioning condensing units is 10-15 years. This unit appeared to be beyond this age and/or its useful lifespan and may need replacing or significant repairs at any time. Recommend budgeting for a replacement in the near future.

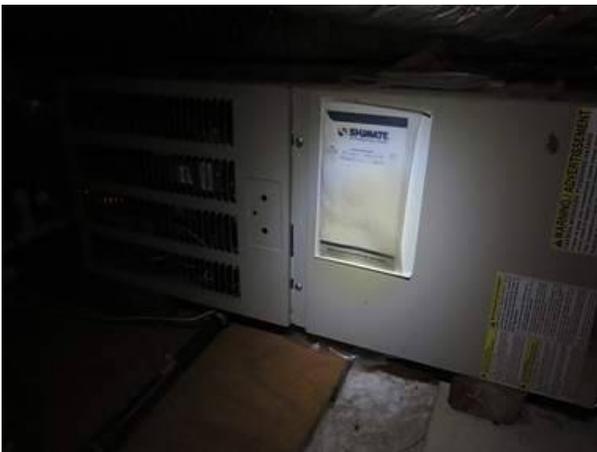
Photo 63-1

63) **i** The estimated useful life for most forced air furnaces is 15-20 years. This furnace appeared to be at this age and/or its useful lifespan and may need replacing or significant repairs at any time. Recommend budgeting for a replacement in the near future.

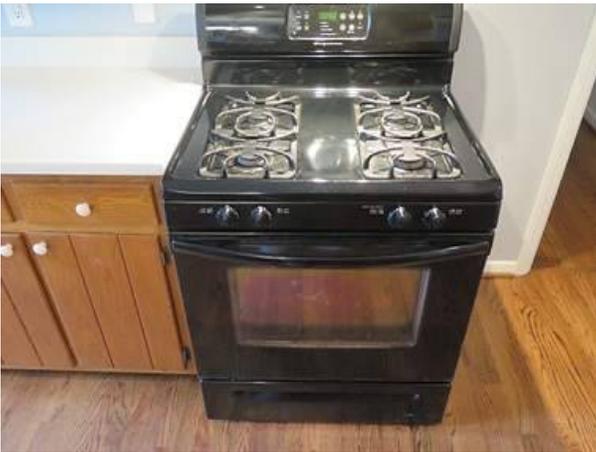
Photo 68-1

68) 🛠️🔪 The range could tip forward. An anti-tip bracket may not be installed. This is a potential safety hazard since the range can tip forward when weight is applied to the open door, such as when a small child climbs on it or if heavy objects are dropped on it. Anti-tip brackets have been sold with all free-standing ranges since 1985. Recommend installing an anti-tip bracket to eliminate this safety hazard. For more information, visit: <https://www.reporthost.com/?ATB>

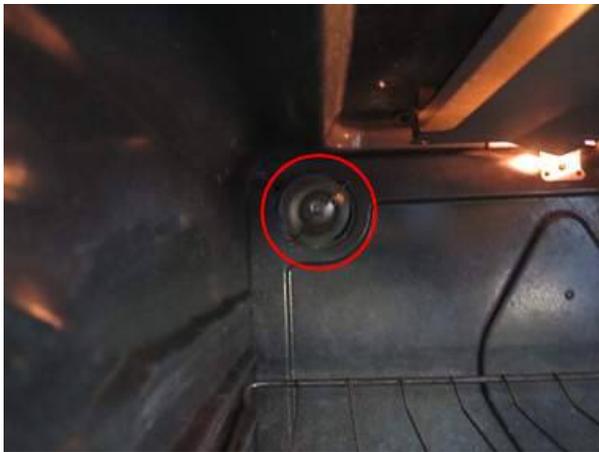
Photo 69-1

69) 🛠️ The oven light was inoperable. Recommend replacing bulb or that repairs are made, if necessary, by a qualified person.

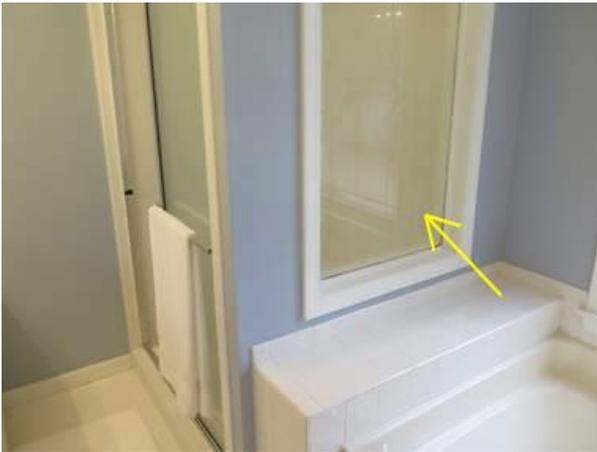
Photo 76-1

The inspector was unable to verify that the glass used in the shower enclosure at location(s) #B was approved safety glass. Glazing that is not approved safety glass, located in areas subject to human impact, is a safety hazard. Standard building practices generally require that approved safety glass be used in swinging and sliding doors except where "art glass," jalousie windows or glazing smaller than a 3-inch opening is used. Recommend that a qualified contractor evaluate further to determine if glazing is approved safety glass, and replace glass if necessary, and per standard building practices.

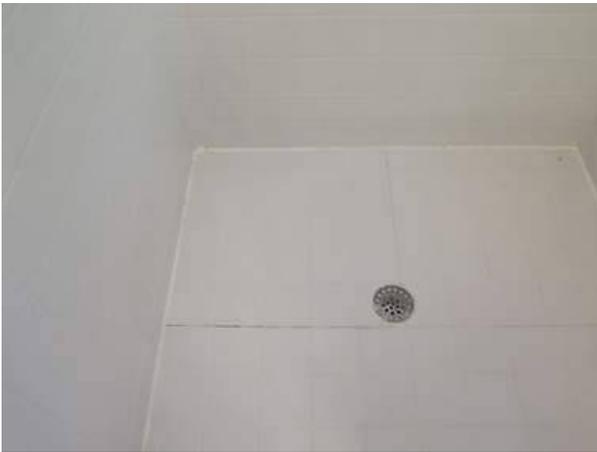
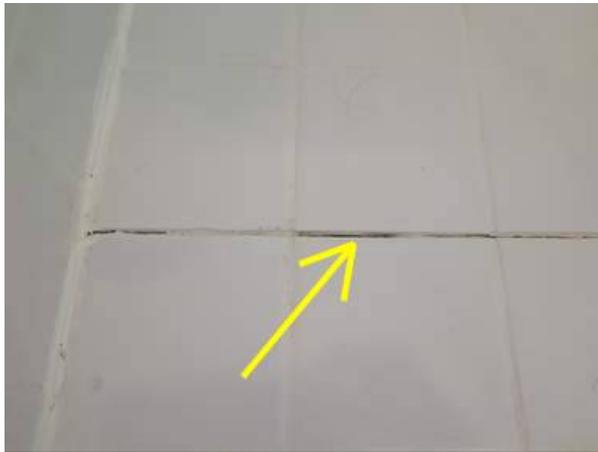
Photo 78-1

Tile and/or grout in the shower enclosure at location(s) #B and D were deteriorated (e.g. loose or cracked tiles, missing grout) or substandard. Water can damage the wall structure as a result. Recommend that a qualified contractor repair as necessary.

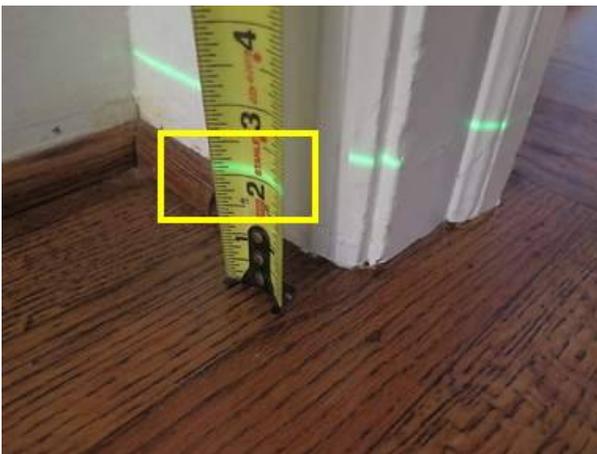
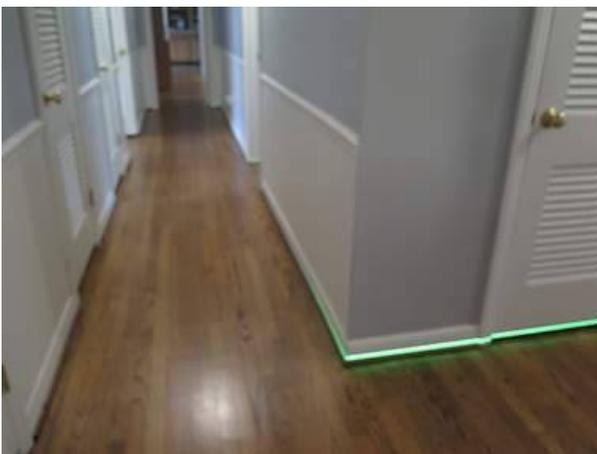
83) Floors in one or more areas were not level. This can be caused by foundation settlement or movement of the foundation, posts and/or beams. Significant repairs may be needed to make floors level. Recommend that a qualified contractor and/or engineer evaluate further. Repairs should be performed by a qualified contractor.

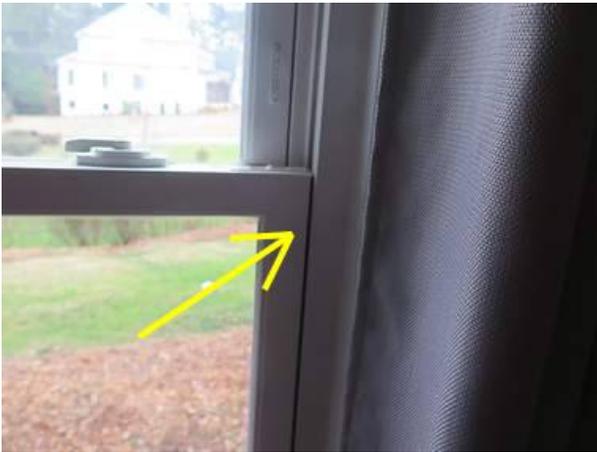
Photo 85-1

One or more windows that were designed to open and close were stuck shut. Recommend that a qualified person repair windows as necessary so they open and close easily.

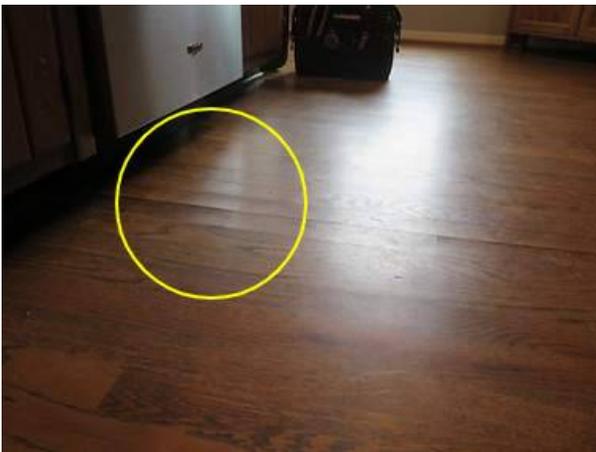
Photo 88-1

Wood flooring in one or more areas was significantly worn, deteriorated or damaged. Recommend that a qualified contractor refinish wood flooring as necessary.

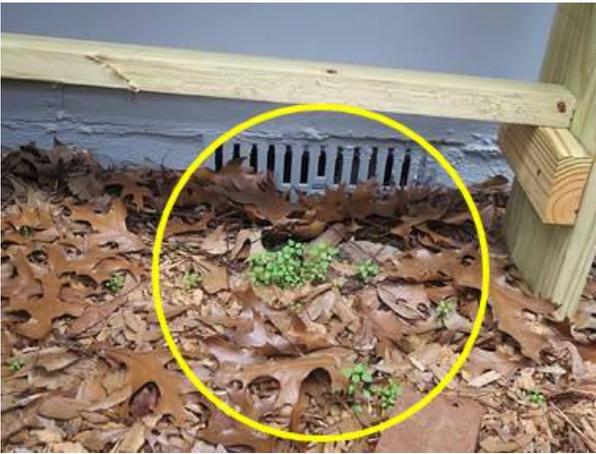
Photo 19-1

One or more crawl space vents were below grade, and either no wells were installed, or wells were substandard. Vent wells should be installed when vents are at or near grade to prevent debris from blocking vents and/or water from entering vents. This is a conducive condition for wood-destroying organisms. Recommend that a qualified person install, replace or repair vent wells per standard building practices.

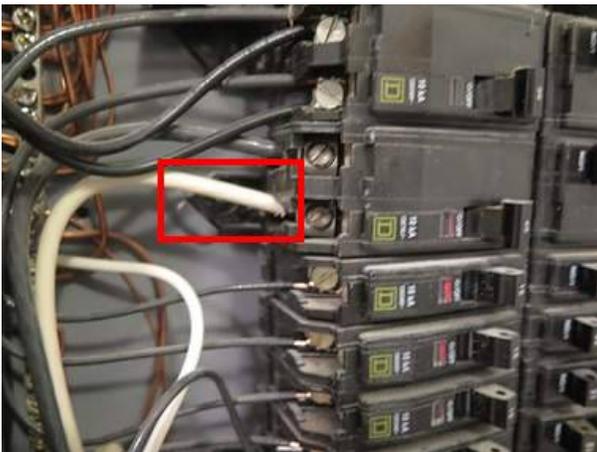
Photo 47-1

One or more energized conductors in panel(s) # A had white, gray or green insulation. Insulation on energized conductors should be black or red in color to identify them as energized wires. Recommend that a qualified electrician re-identify wires per standard building practices. For example, by wrapping in black vinyl tape or marking with a black permanent marker.

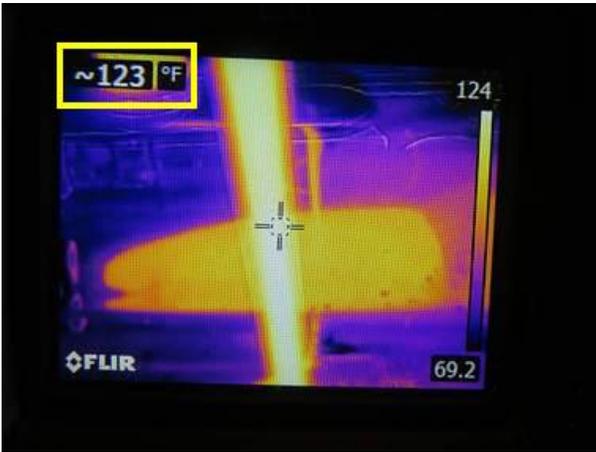
Photo 57-1

57) 🚑 The hot water temperature was greater than 120 degrees Fahrenheit. This is a safety hazard due to the risk of scalding. The thermostat should be adjusted so the water temperature doesn't exceed 120 degrees. If the water heater is powered by electricity, a qualified person should perform the adjustment, since covers that expose energized equipment normally need to be removed. For more information on scalding dangers, visit: <https://www.reporhost.com/?SCALD>

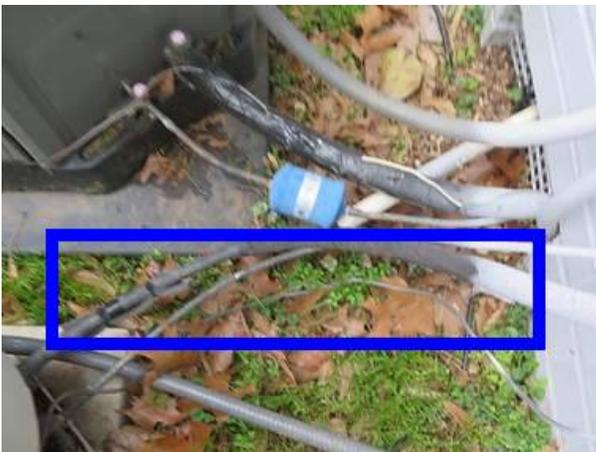
Photo 60-1

60) Insulation on the heat pump or air conditioning condensing unit's refrigerant lines was deteriorated or missing in some areas. This may result in reduced efficiency and increased energy costs. Recommend that a qualified person replace or install insulation as necessary.

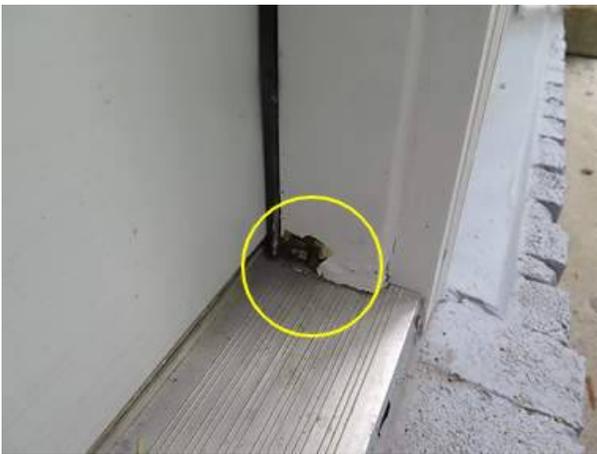
Photo 84-1

84) 🛠️🚧 Fungal rot was found at one or more exterior door jambs. Recommend that a qualified person repair as necessary. All rotten wood should be replaced.
