Trademark Home Inspections

Property Inspection Report

112 Newcastle Walk, Woodstock, GA 30188

Date of Inspection: 12/29/2019 Time: 9:00 AM

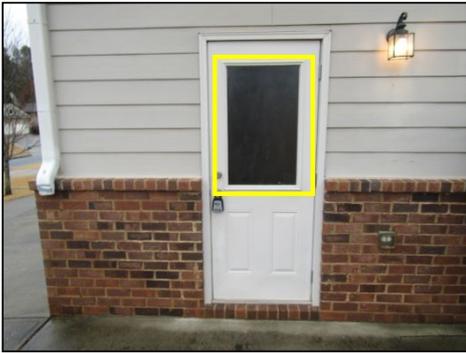
Fog/condensation observed in exterior garage door window. This indicates a failed seal. This reduces the energy efficiency of the window. Recommend review by a qualified contractor.

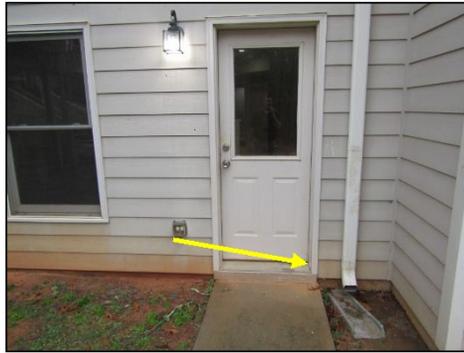
Moisture damage/wood rot noted at back door casing. Recommend review or repair by qualified contractor.

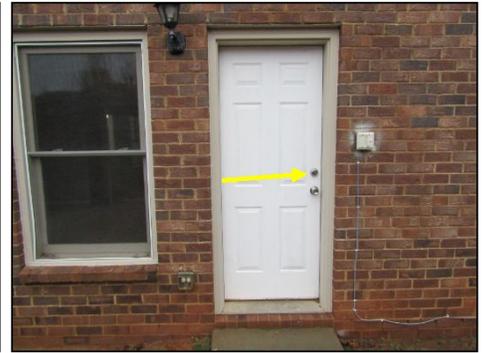
Left side, basement exterior door deadbolt does not engage. Recommend adjustment of the door or strike plate by a qualified contractor for added strength and security.

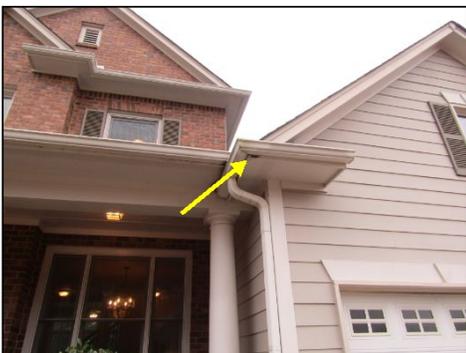
Peeling paint, damaged trim, split caulk, and exposed wood noted and should be addressed for repairs to prevent moisture damage. Recommend full review and repair of homes paintable areas.

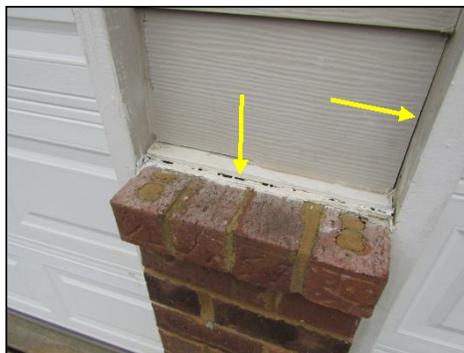
Peeling paint, damaged trim, split caulk, and exposed wood noted and should be addressed for repairs to prevent moisture damage. Recommend full review and repair of homes paintable areas.

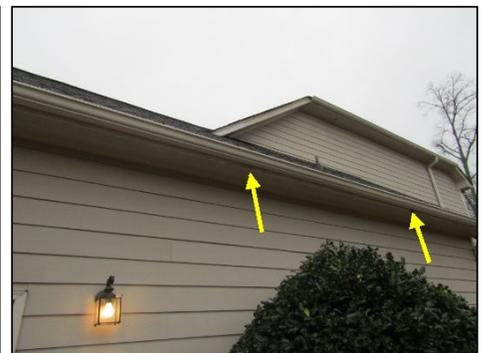
Peeling paint, damaged trim, split caulk, and exposed wood noted and should be addressed for repairs to prevent moisture damage. Recommend full review and repair of homes paintable areas.

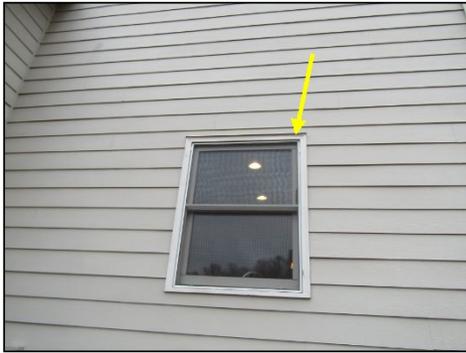
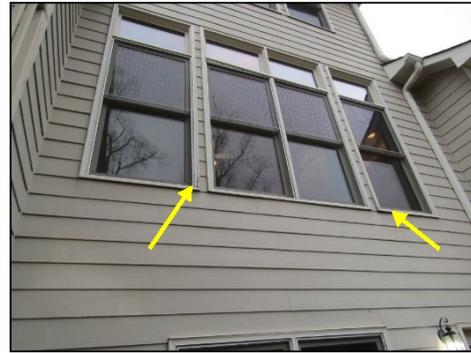
Peeling paint, damaged trim, split caulk, and exposed wood noted and should be addressed for repairs to prevent moisture damage. Recommend full review and repair of homes paintable areas.

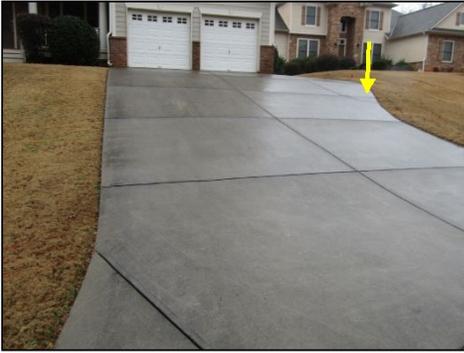
Driveway in overall good condition. Common settlement cracks noted. Recommend sealing to prevent further expansion.

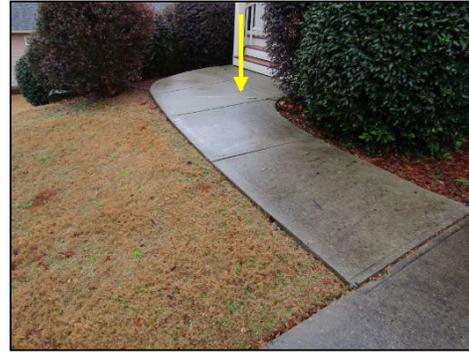
Sidewalk in good condition. Common settlement cracks noted. Recommend sealing to prevent further expansion.

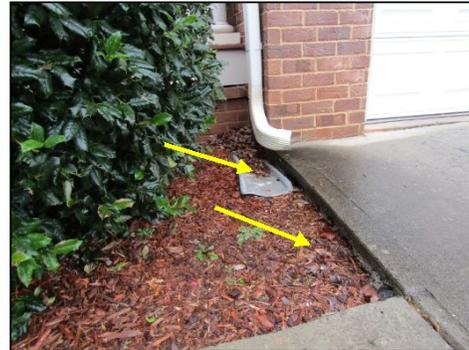
Erosion noted in some areas. Recommend review by a qualified contractor to prevent erosion and cracking of slabs or deck footings.

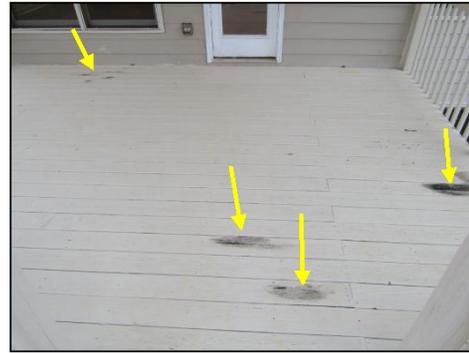
Staining bleeding through paint at deck. Typically this is caused when paint is applied over saturated wood. Recommend review by a qualified contractor.

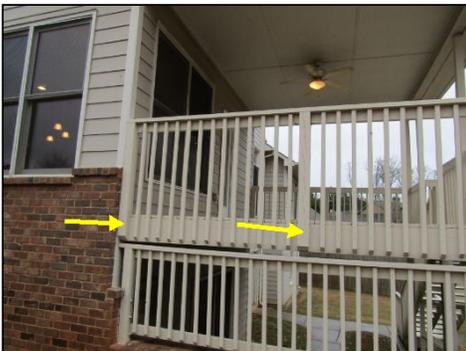
Some handrails are loose with lag bolts missing from handrail supports. It is recommend at least 2 bolts are installed to ensure the rails are secure. In the interest of safety, recommend review/repair by a qualified contractor.

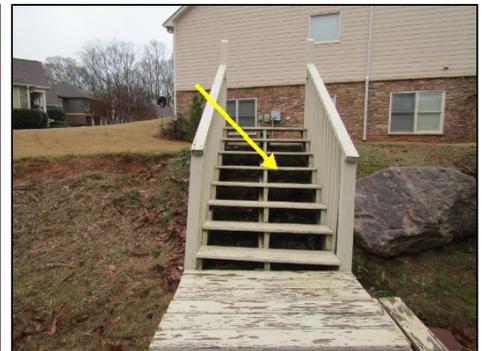
Stairway leaning. In the interest of safety, recommend repair by a qualified contractor.

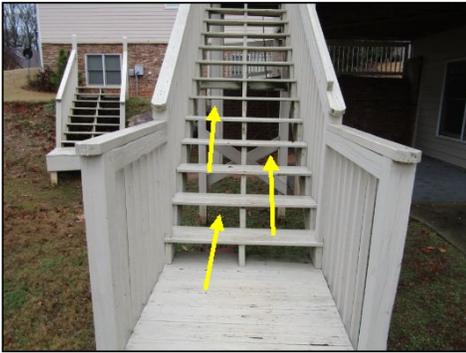
Stairs missing step risers. For the interest of safety, recommend step riser have no more than 4" of gap. Recommend review and repair by qualified general contractor.

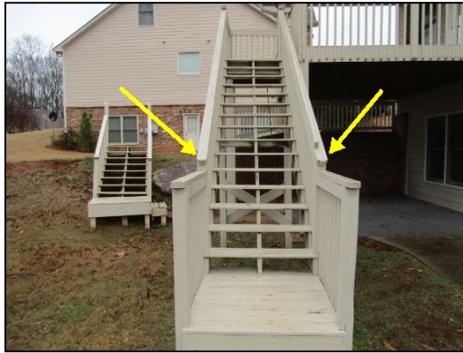
Some handrails are loose with lag bolts missing from handrail supports. It is recommend at least 2 bolts are installed to ensure the rails are secure. In the interest of safety, recommend review/repair by a qualified contractor.

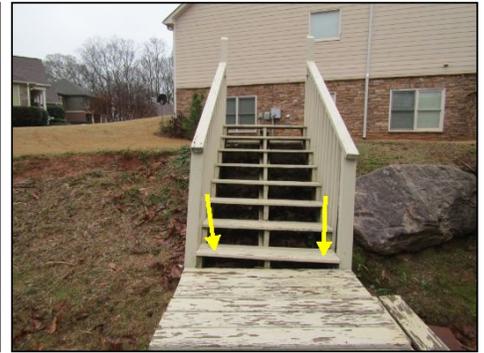
Noted uneven stairs risers. This is a trip hazard. In the interest fo safety, recommend review by a qualified contractor.

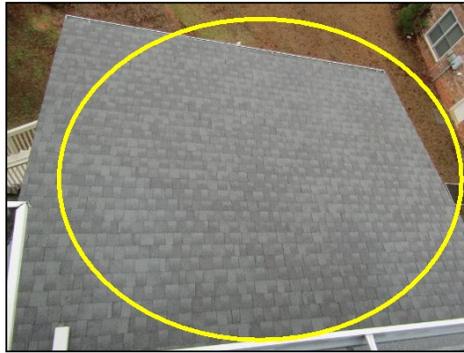
Patio roof has asphalt shingles installed on a slope of less than 2/12. Generally, this is not recommended as moisture can seep under the shingles and makes the shingles more prone to wind damage. Recommend review by a qualified roofing contractor.

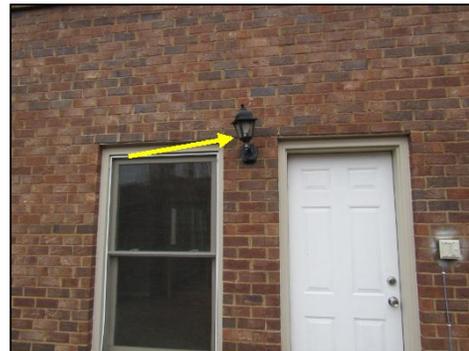
Light switch damaged or bulb inoperable. Recommend replacing bulbs and reviewing with seller prior to close to ensure it will not require professional repairs.

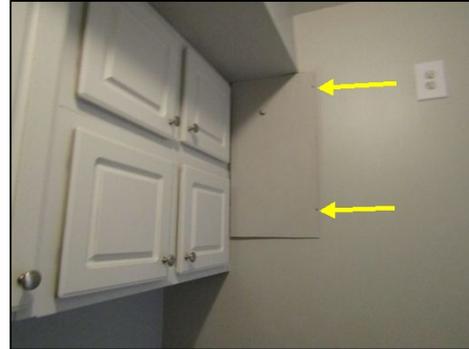
Main water valve is behind a cover that is screwed to the wall. Recommend changing cover to one with easier access in case the valve needs to be reached in an emergency.

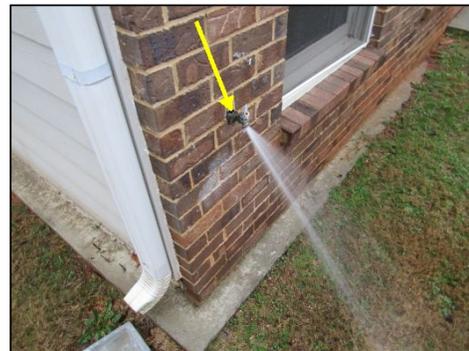
Left side of home: Faucet not sealed or secure to siding. Possible damage to supply line or moisture intrusion. Recommend repair by qualified contractor.

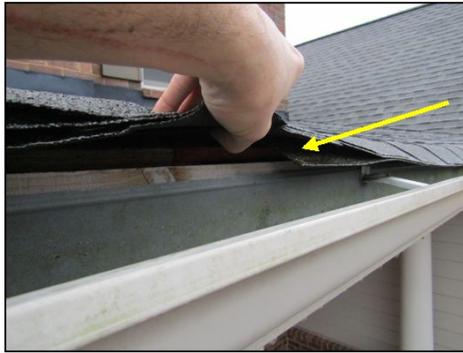
No drip edge flashing noted leaving underlying framing exposed to weather. While this was not a standard building practice at the time the home was constructed it is a recommended current standard. Recommend review by qualified roofing contractor.

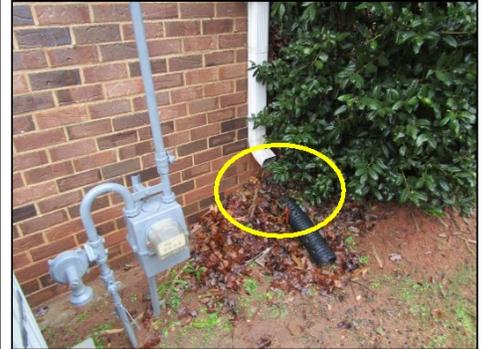
Extensions / Splash blocks missing or insufficient: Install to divert water away from the foundation.

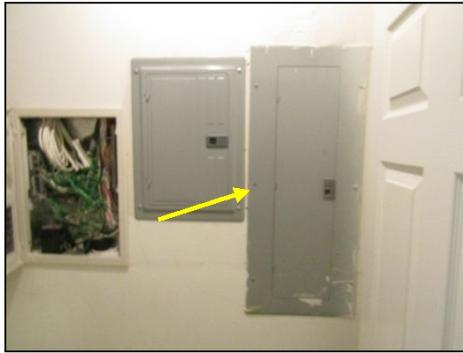
Missing screw in panel cover. Recommend installing the approved screw by a qualified contractor.

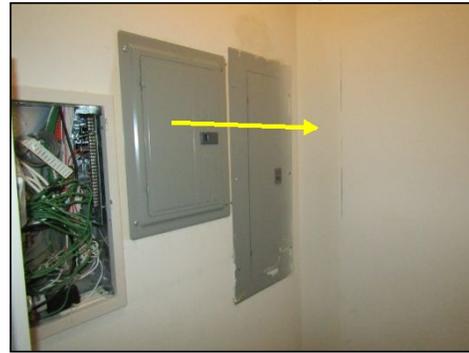
Improper clearance from panel front. 30 inches side to side is recommended. Recommend adding the proper clearance for safety.

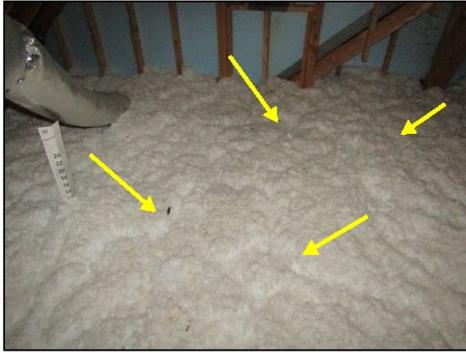
Rodent trails observed in attic. Recommend review and repair by a professional Pest or wildlife company.

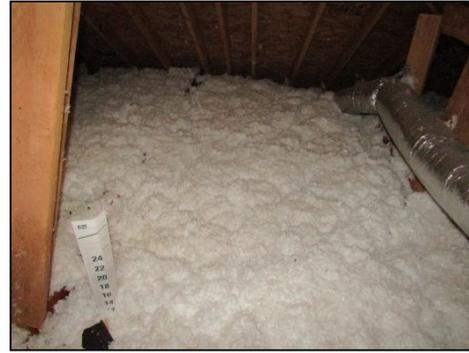
Insulation depth is less than 13 inches in some areas. Recommend adding insulation to achieve a consistent R-30 Value/ or 13+ inches for energy efficiency.

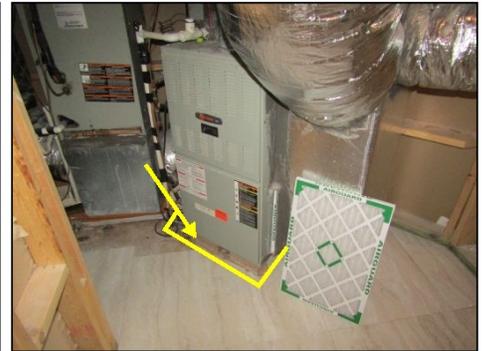
No overflow pan noted. While not required in unfinished slab areas, pan is suggested when finished area can be affected by leakage of the water heater. Recommend review or installing by qualified plumbing contractor.

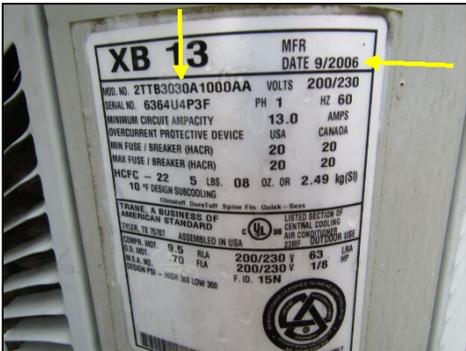
Compressor unit is a 2 1/2 ton system manufactured in 2006. National average designed life expectancy of AC unit is 10-12 years. Budget for possible repair or replacement in the near future.

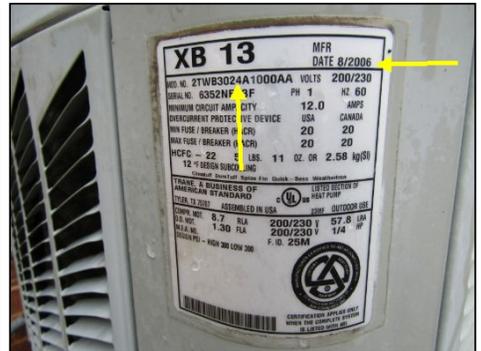
Compressor unit is a 2 ton system manufactured in 2006. National average designed life expectancy of AC unit is 10-12 years. Budget for possible repair or replacement in the near future.

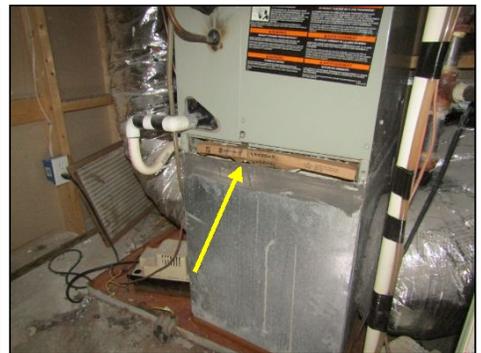
Filter covers missing. Recommend purchasing covers or keeping sealed with HVAC tape for proper functionality.

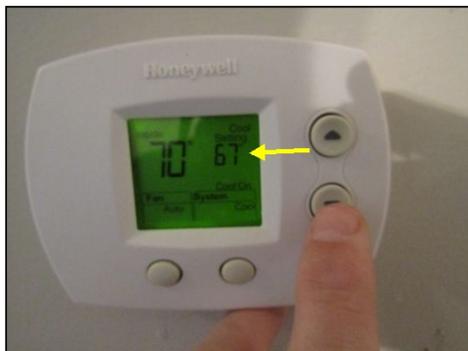
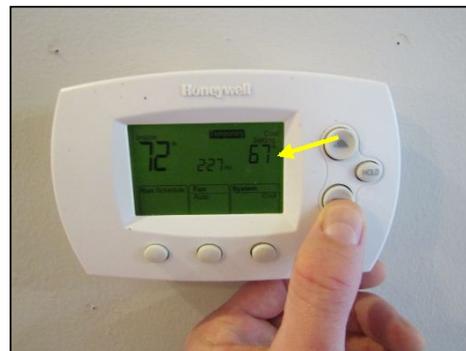
Functional at the time of inspection but the upstairs and the main level thermostat temperature would not go below 67 F when the air was on. This may be programmed stop. Recommend review with the seller or a qualified HVAC contractor.

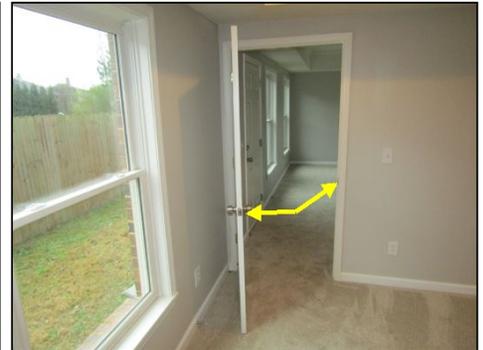
Some doors do not latch correctly. Recommend adjustment to door and/or striker plate by qualified contractor.

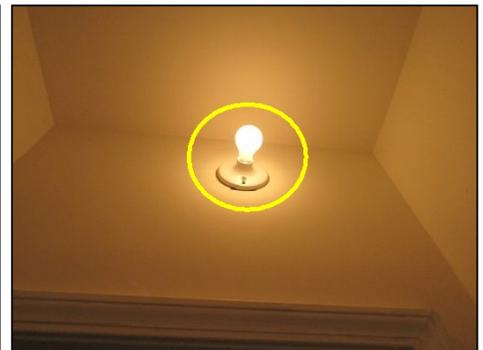
Page 31 Item: 4	Electrical	<ul style="list-style-type: none"> • FIRE HAZARD: No globe at basement closet lights. This can cause a fire should stored items come in contact with a hot bulb. Recommend install globe or install new fixture by qualified electrical contractor. • Hot-neutral reversed outlet present in basement, front left bedroom. This means that the black and white wires in the circuit have been reversed, and may be a concern with items such as computers and electronic devices. Recommend review by qualified electrical contractor. • Outlet damaged / inoperable at basement, back, right room. Recommend review by qualified electrical contractor.
Page 33 Item: 8	Fireplace	<ul style="list-style-type: none"> • Damper worked properly at time of inspection but missing damper clamp. This device is used when gas fireplace is in use. It prevents carbon monoxide from entering the home. Recommend installing by a qualified contractor.

FIRE HAZARD: No globe at basement closet lights. This can cause a fire should stored items come in contact with a hot bulb. Recommend install globe or install new fixture by qualified electrical contractor.

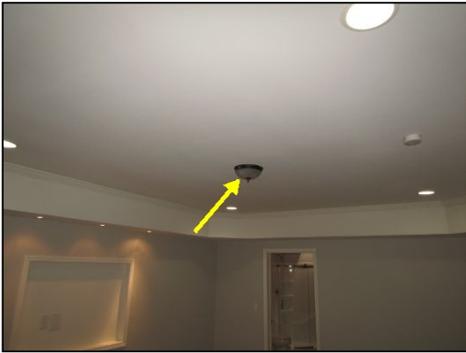
Light switch damaged or bulb inoperable. Recommend review with seller prior to close or review by qualified electrical contractor.

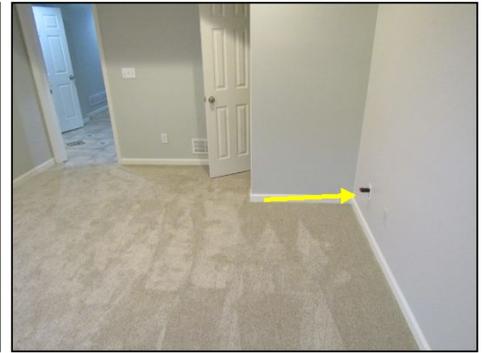
Hot-neutral reversed outlet present in basement, front left bedroom. This means that the black and white wires in the circuit have been reversed, and may be a concern with items such as computers and electronic devices. Recommend review by qualified electrical contractor.

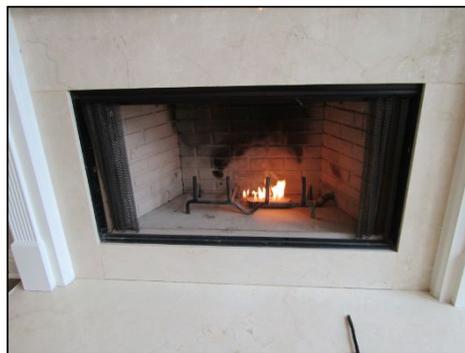
Damper worked properly at time of inspection but missing damper clamp. This device is used when gas fireplace is in use. It prevents carbon monoxide from entering the home. Recommend installing by a qualified contractor.

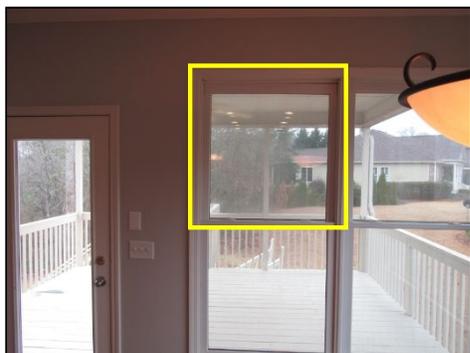
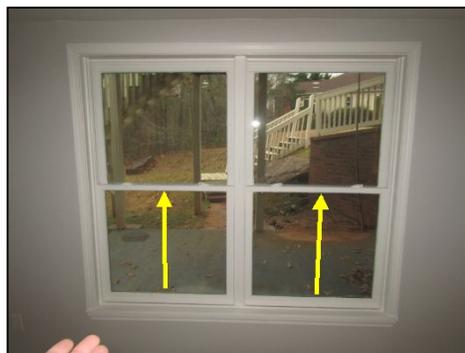
Cloudiness/condensation observed in double pane window. This is an indication of a failed seal. Recommend review by qualified contractor.

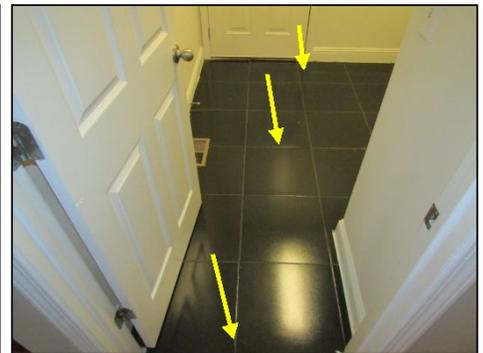
Cracking or popping ceramic tiles. This is an indication of inadequate subfloor installation. Recommend review and repair by qualified flooring contractor.

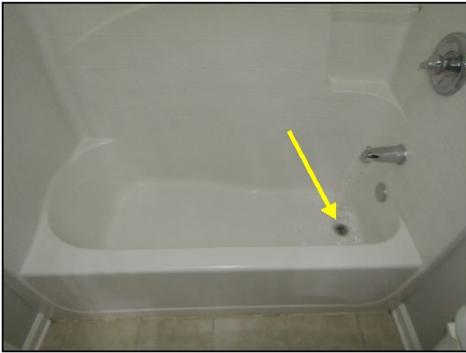
Tub functioned properly but drain stopper missing or not operational. Could not test overflow at time of inspection.

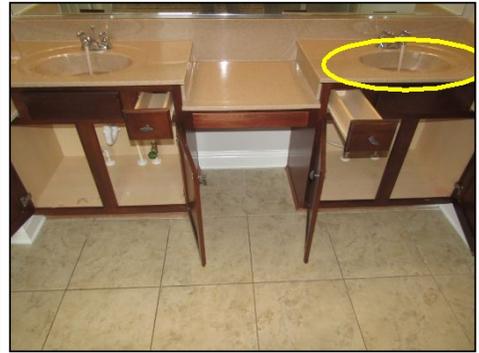
Slow drain at right side master sink, indicates drain line needs cleaning and/or drain not properly vented. Recommend review and repair by qualified plumbing contractor.

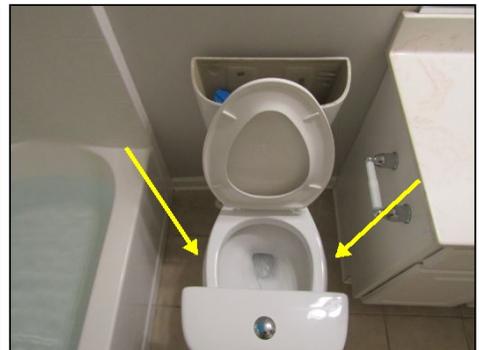
Multiple toilet bowls loose. The wax ring inside the unit must have a snug, secure fit in order to keep from leaking. Recommend repair by qualified plumbing contractor.

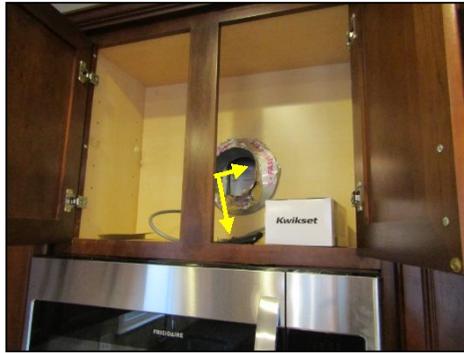
Vent functioned but exhaust vent was not connected to exterior venting. In order for the vent to function properly a pipe should be connected. Recommend review and repair by a qualified contractor.
