Atlanta Property Inspections, Inc.

HOME INSPECTION REPORT

8025 Paddocks Mill Drive, Cumming, GA 30041
Inspection prepared for: Ce Fuller & Beverly Fuller
Date of Inspection: 1/15/2020 Time: 1:00 PM
Age of Home: 18 Years (2002) Size: 2000 SF
Weather: Overcast, Wet Soil, 60 Degrees

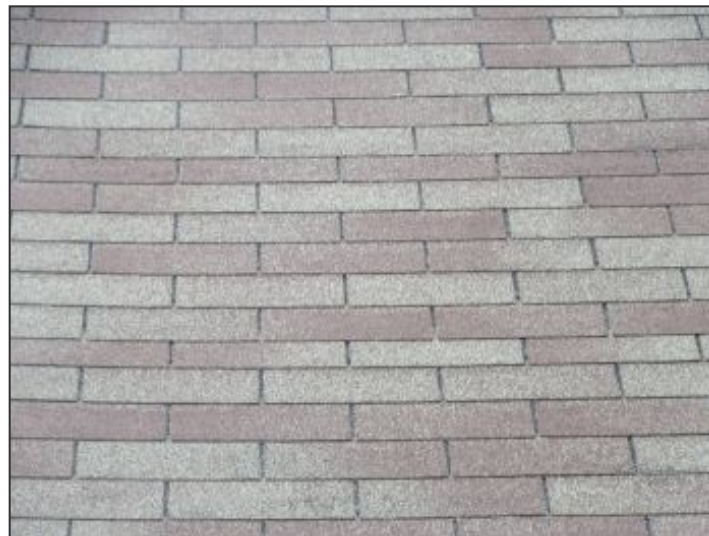
View of the roof shingles

• **The roof appears serviceable and within its normal useful life. No concerns were noted with shingles, flashings and valleys. Continue to monitor the roof for any changes. Annual inspections are suggested, particularly after heavy storms and high winds.**

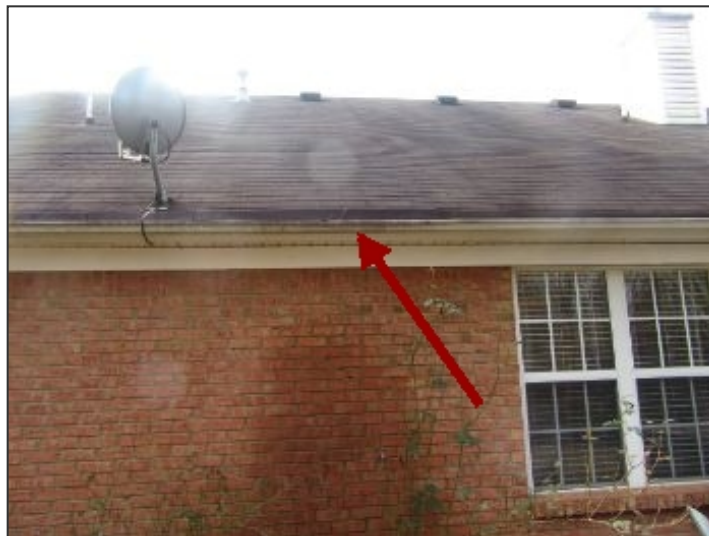
Page 7	GUTTERS:	<ul style="list-style-type: none"> The gutters are full of debris at the rear roof (see photo). In addition the rear gutter is sagging due to the weight of the debris and is leaking onto the wall. Gutter cleaning is recommended so that the gutters can drain correctly.
--------	----------	---------------------------------------------------------------------------------------------------------------------------------------------------------------------------------------------------------------------------------------------------------------------------------------------

- **The gutters are full of debris at the rear roof (see photo). In addition the rear gutter is sagging due to the weight of the debris and is leaking onto the wall. Gutter cleaning is recommended so that the gutters can drain correctly.**

Gutter full of debris and overflowing at the rear roof

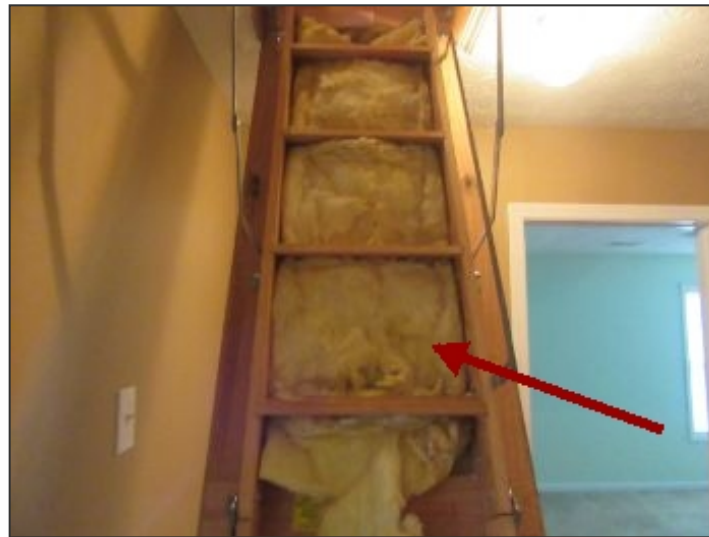
Page 10	ATTIC ACCESS:	<ul style="list-style-type: none"> CLIENT RECOMMENDATION: Safety Concern: The pull down attic ladder has a fiberglass insulation batt in the stair treads which is not advised. The insulation batt reduces the foot tread depth on the ladder steps which could create a slip hazard when using the ladder. In addition, when coming down the ladder, the fiberglass insulation becomes disturbed and airborne, creating fiberglass debris in the air that is breathed in by the person coming down the ladder. For improved safety, it is recommended that the insulation batt be removed and replaced with a 1/2 inch foam insulation board instead.
Page 11	ATTIC LEAKS:	<ul style="list-style-type: none"> Water stains were noted in the attic at the front porch roof (see photo). This condition may be the result of previous roof leaks from the older roof that has since been replaced but this could not be verified during this limited visual inspection. Ask seller for disclosure information regarding any past roof leaks. Continue to monitor, future repair may be needed.

Safety Concern: The pull down attic ladder has a fiberglass insulation batt in the stair treads which is not advised. The insulation batt reduces the foot tread depth on the ladder steps which could create a slip hazard when using the ladder. In addition, when coming down the ladder, the fiberglass insulation becomes disturbed and airborne, creating fiberglass debris in the air that is breathed in by the person coming down the ladder. For improved safety, it is recommended that the insulation batt be removed and replaced with a 1/2 inch foam insulation board instead.

Insulation nor recommended on the attic ladder

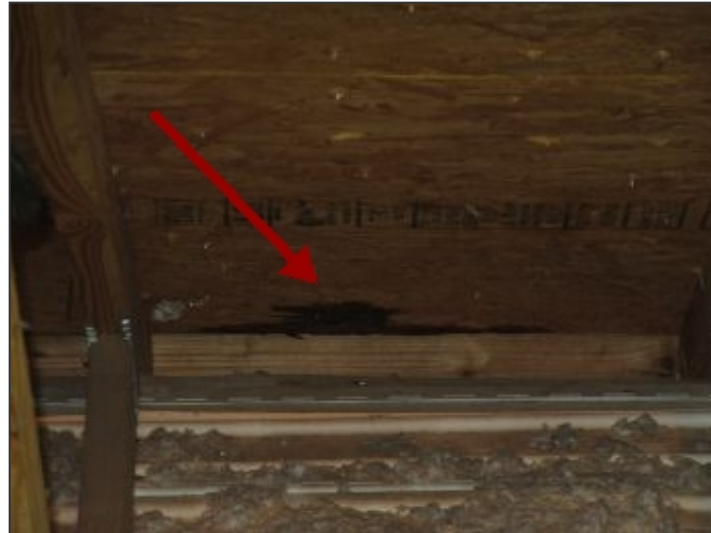
- **Water stains were noted in the attic at the front porch roof (see photo). This condition may be the result of previous roof leaks from the older roof that has since been replaced but this could not be verified during this limited visual inspection. Ask seller for disclosure information regarding any past roof leaks. Continue to monitor, future repair may be needed.**

Old stain in the attic above the front porch roof

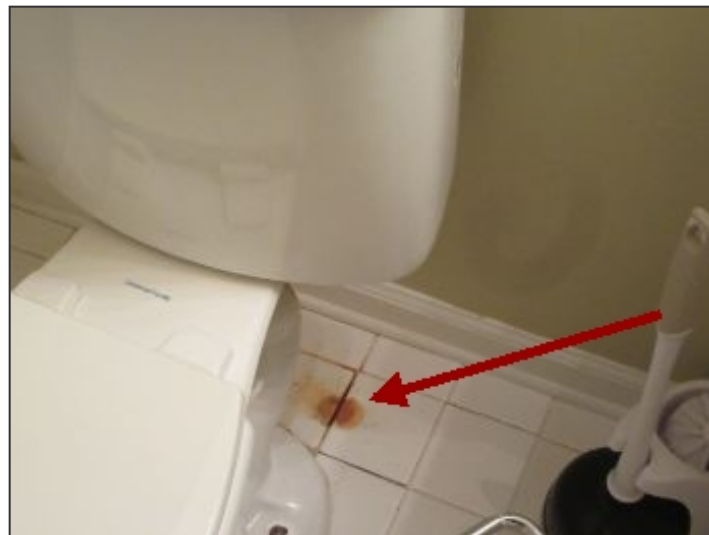
Page 15	BATH TOILETS:	<ul style="list-style-type: none"> An active leak was noted at the toilet tank bolt below the toilet in the guest bathroom (see photo). Further evaluation and repair is recommended by a professional plumber.
---------	---------------	--------------------------------------------------------------------------------------------------------------------------------------------------------------------------------------------------------------------------------

• An active leak was noted at the toilet tank bolt below the toilet in the guest bathroom (see photo). Further evaluation and repair is recommended by a professional plumber.

Guest bathroom toilet leaks at the bolts

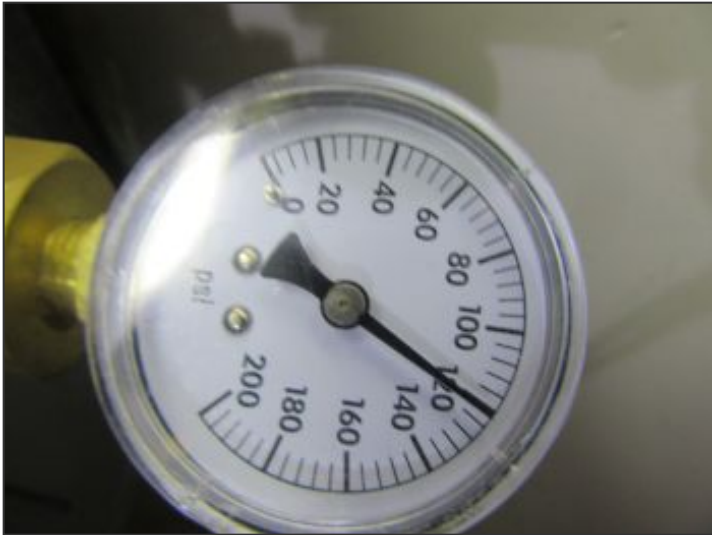
Page 17	PLUMBING SUPPLY:	<ul style="list-style-type: none"> WATER PRESSURE TOO HIGH: A water pressure reading was taken at the rear hose bib and was found to be too high at (120) PSI. A normal water pressure reading is in the 40 - 80 PSI range. This condition could be an indication that the pressure reducer valve is defective. Further evaluation is advised by a professional plumber to determine repair needs and costs. Excessive water pressure can create potential leaks in the plumbing system such as the water heater tank, the water heater T&P valve and the washing machine supply hoses.
---------	------------------	-----------------------------------------------------------------------------------------------------------------------------------------------------------------------------------------------------------------------------------------------------------------------------------------------------------------------------------------------------------------------------------------------------------------------------------------------------------------------------------------------------------------------------------------------------------------------------------------------------------------------

A water pressure reading was taken at the rear hose bib and was found to be too high at (120) PSI. A normal water pressure reading is in the 40 - 80 PSI range. This condition could be an indication that the pressure reducer valve is defective. Further evaluation is advised by a professional plumber to determine repair needs and costs. Excessive water pressure can create potential leaks in the plumbing system such as the water heater tank, the water heater T&P valve and the washing machine supply hoses.

Water pressure too high at 120 psi

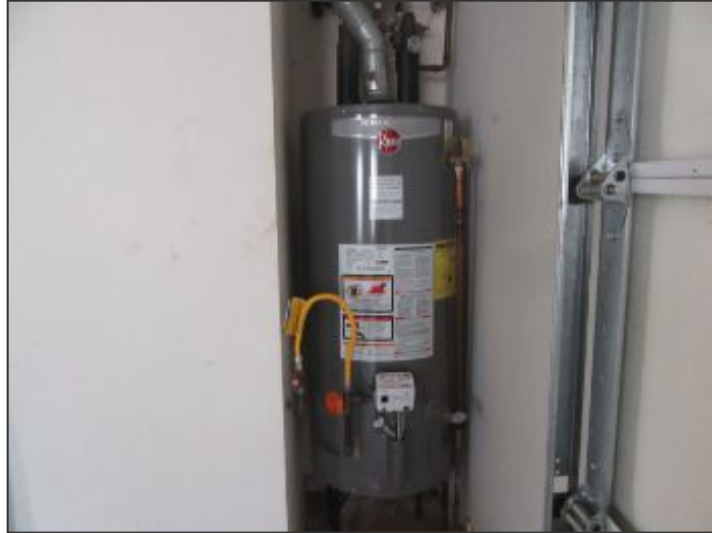
• The gas water heater appears serviceable, no concerns were noted. The gas piping, exhaust venting and **combustion air** requirements all look good.

Water heater in the garage

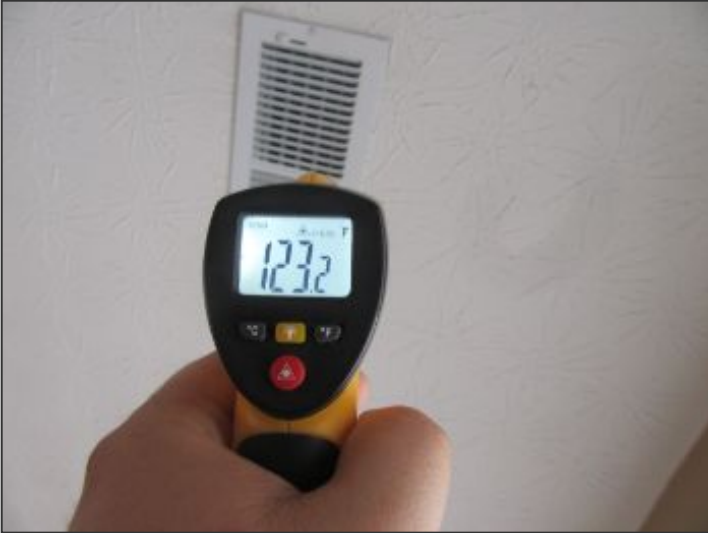
• **The heating system appears serviceable; the heating system was operated and was found to be functioning normally during a limited visual inspection, no significant concerns were noted. Continue to maintain the system and have it serviced regularly.**

Heating temps are normal

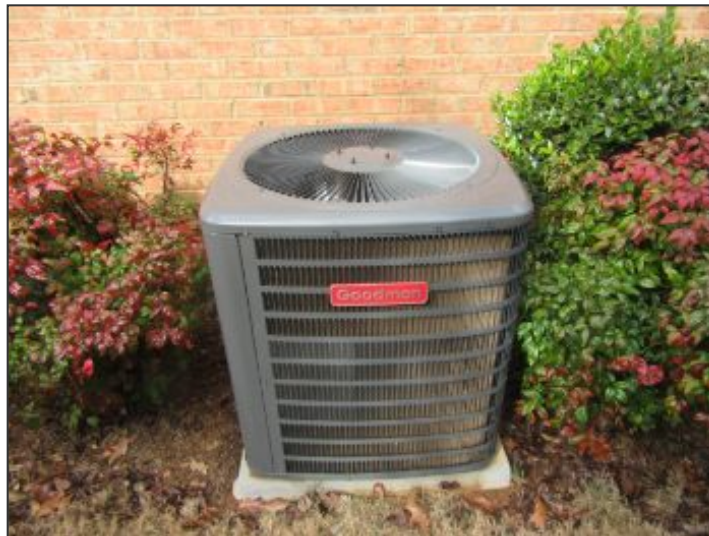
We are unable to inspect the cooling system due to cold weather. The outside temperatures have dropped below 60 degrees during the day or during the previous overnight hours. Due to concerns regarding possible damage to the unit, the air conditioner was not operated and could not be fully inspected during this cold weather inspection. This inspection is limited to a visual inspection and a quick start up to insure the unit is functional.

AC unit
