HomeCheck Property Inspections, LLC

Home Inspection Report

**1225 Roswell Manor Cir
Roswell, GA 30076**

Inspected on Sun, Jan 26 2020 at 9:00 AM

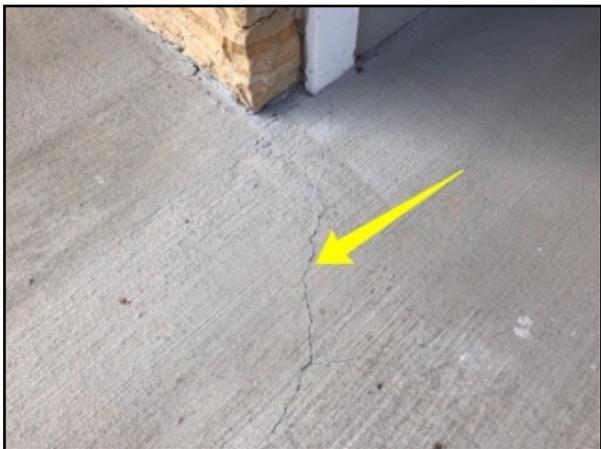
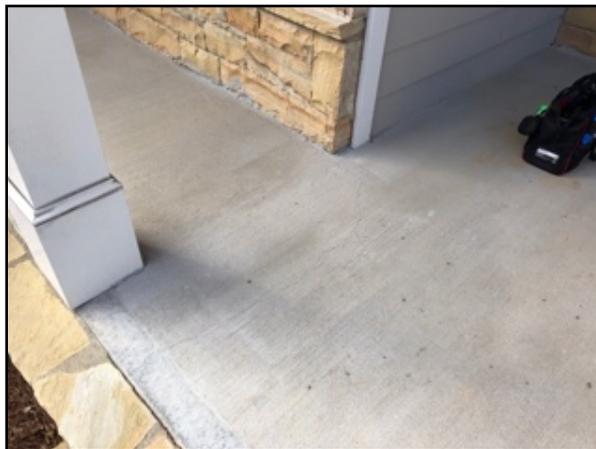
Comment 1:

Minor settlement crack in concrete slab on front stoop.

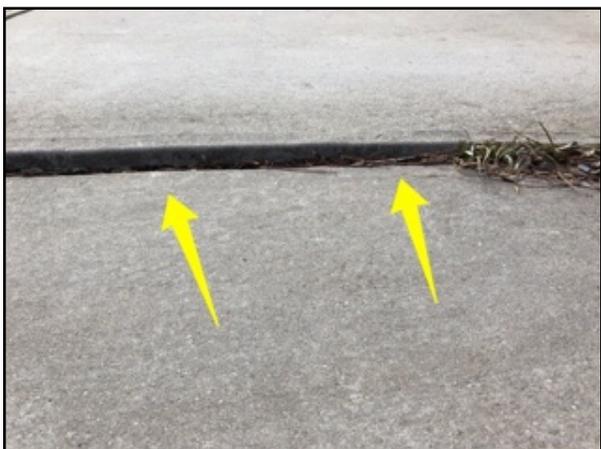
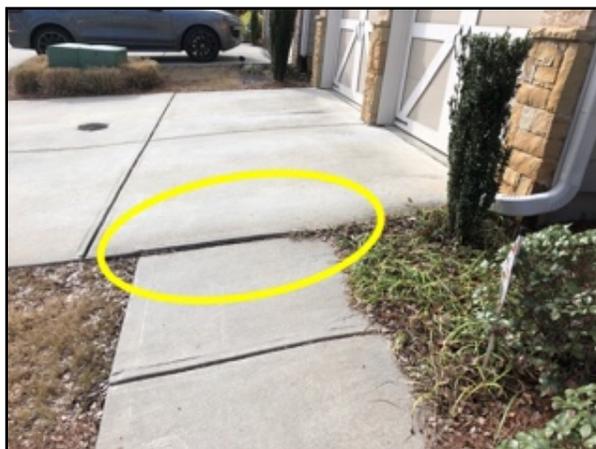
- 1) Comment 2: Settlement in concrete walkway has caused a trip hazard. Recommend mud jacking (pumping concrete under slab) to level walkway section.
- 2) Comment 3: Front stoop handrail is pulling away from porch post. Recommend qualified contractor repair.

Settlement in concrete walkway has caused a trip hazard. Recommend mud jacking (pumping concrete under slab) to level walkway section.

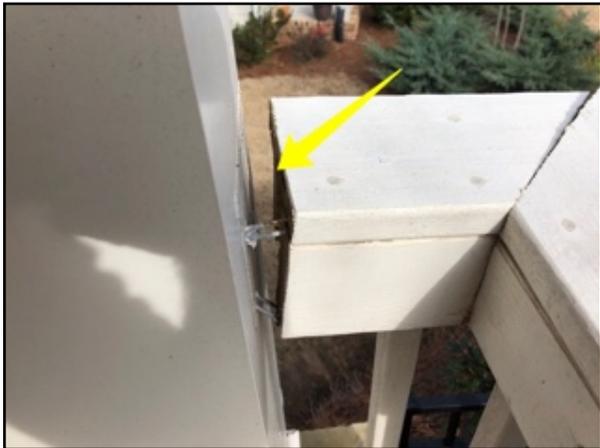
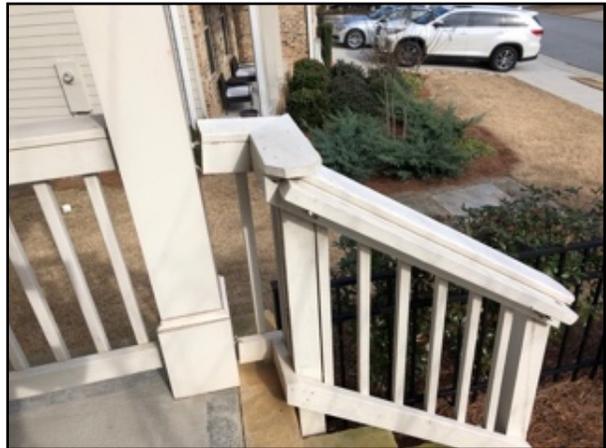
**Comment 3:**
Front stoop handrail is pulling away from porch post. Recommend qualified contractor repair.

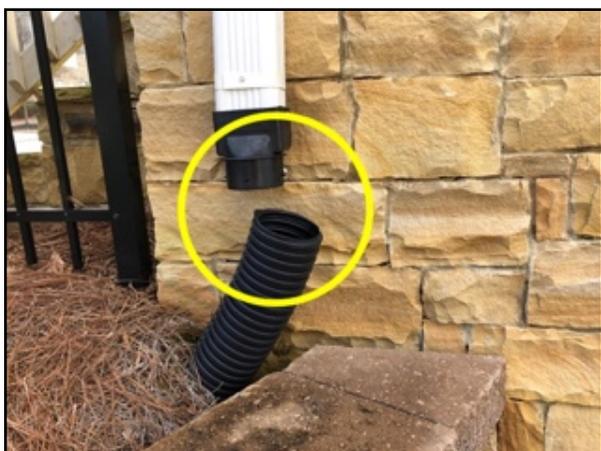
Comment 5:

Gutter drain line disconnected at front right side of house. Gutter water directed down exterior wall can cause foundation damage. Recommend reconnecting drain line.

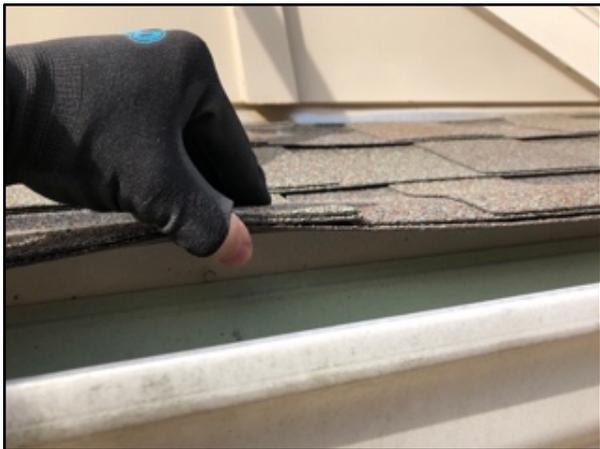
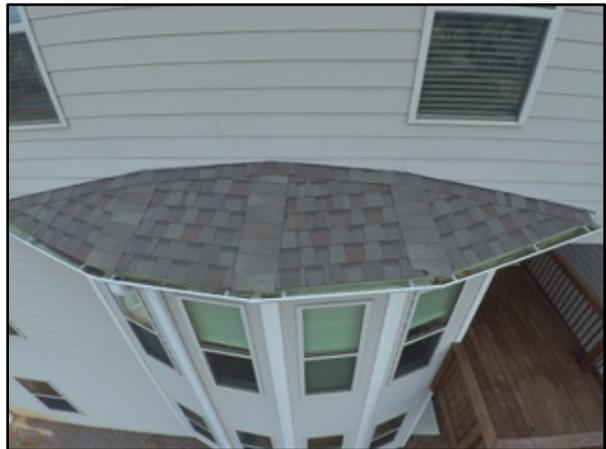
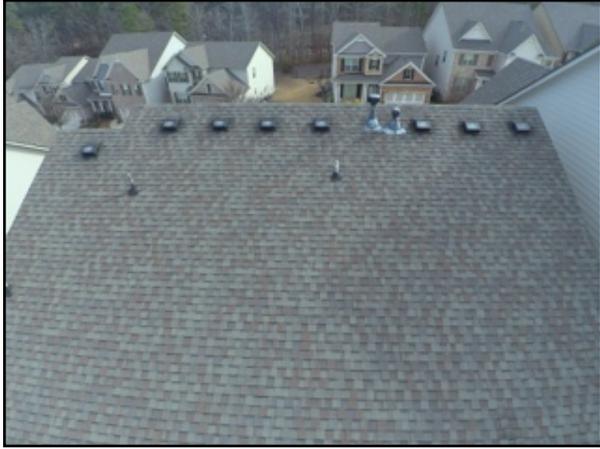
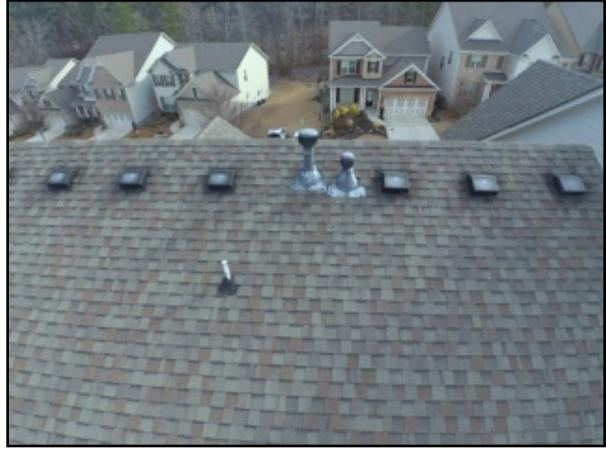
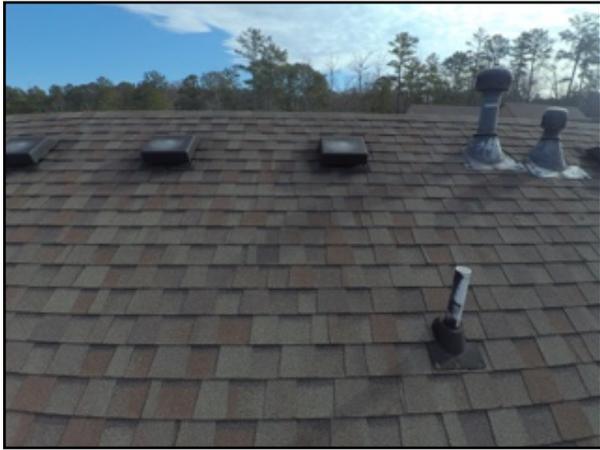
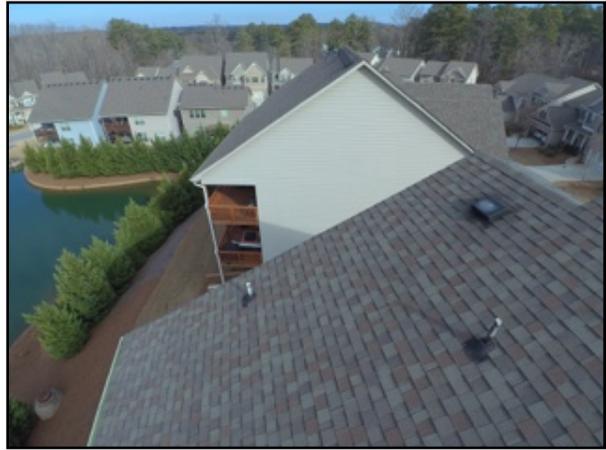
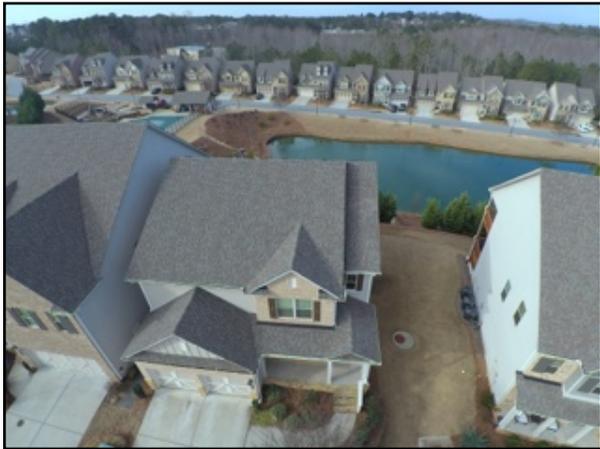
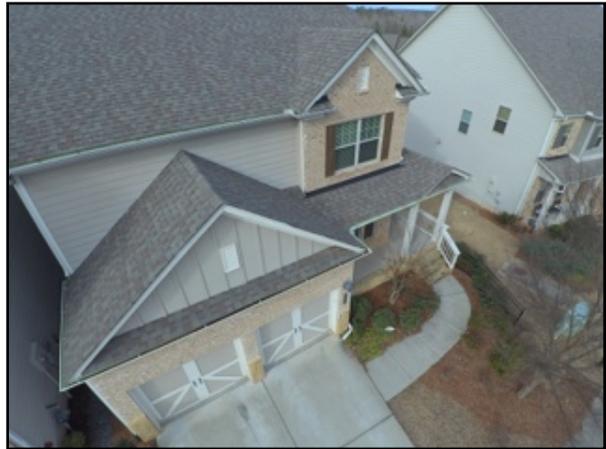
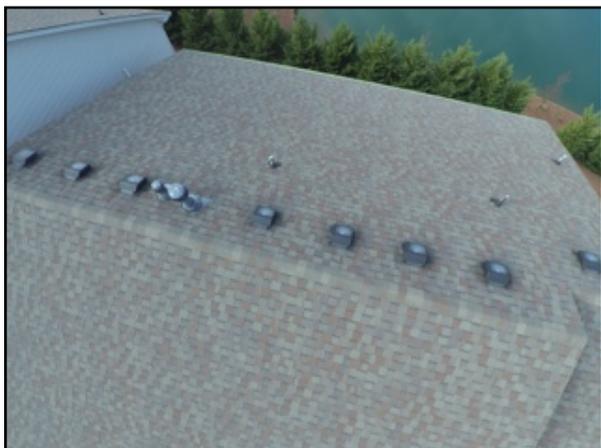
Comment 6:

Above Average: The 3-tab roofing is early life material (estimated age is less than ten years) and is in reasonably good condition. Normal granular loss has occurred. Roof penetration boots and flashings are in generally good condition. The typical life for this roofing material is 20 - 25 years. Keep in mind that these life expectancies are approximations only and other factors such as above average attic heat and extreme weather conditions can result in a shorter life. Any exceptions to this opinion are noted below.

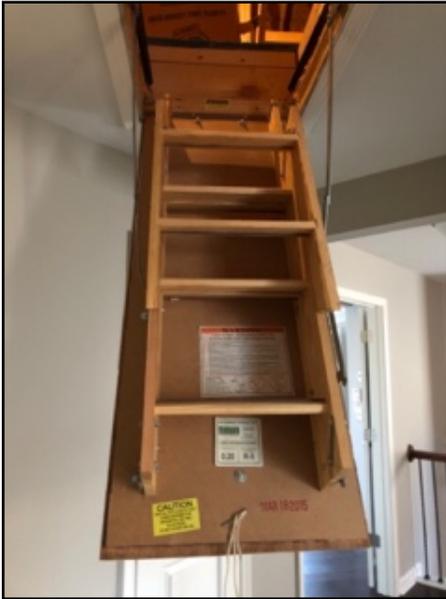
**Comment 10:**

Insulate Stairs: The pull-down attic access stairs should be insulated with foam board and / or fiberglass batt insulation and weather stripping to limit unconditioned air infiltration into finished areas.

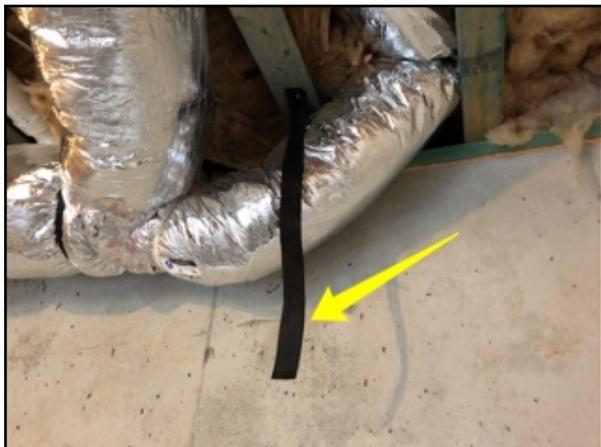
**Comment 13:**
Duct support strap in basement is not attached. Recommend reattachment.

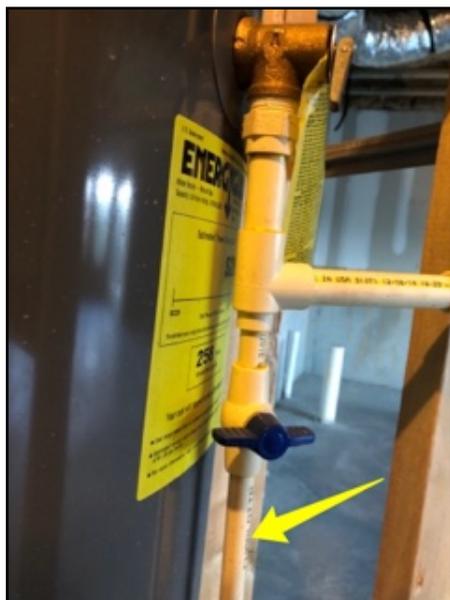
Comment 26:

Blow off leg for temperature pressure relief (TPR) valve at water heater is not of sufficient size. Safety Hazard. Recommend replacement with line sized same as TPR valve outlet connection.

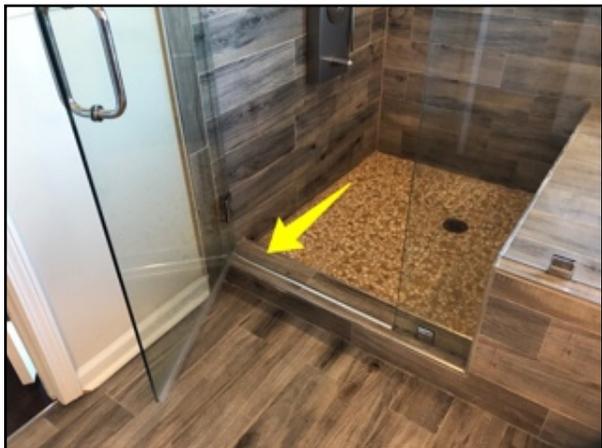
Comment 27:

Tile in master bathroom shower stall door opening should be re-grouted to prevent moisture intrusion and wood rot. Recommend qualified tile installer repair.

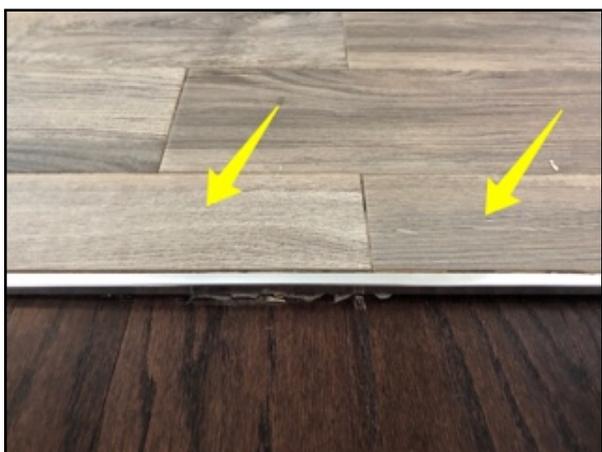
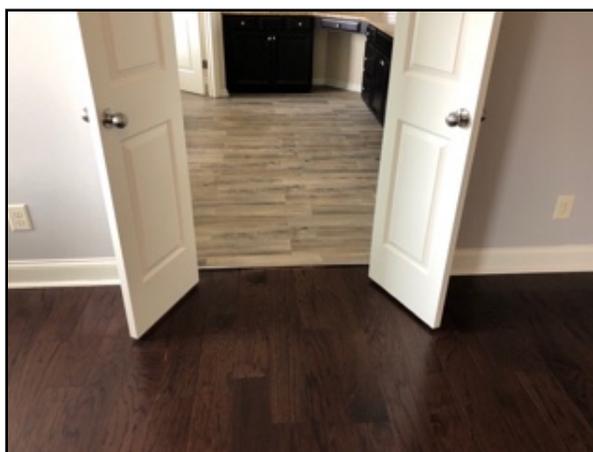
Comment 28:

Two floor tiles in master bathroom at entrance are loose. Recommend a qualified tile contractor re-cement and re-grout.

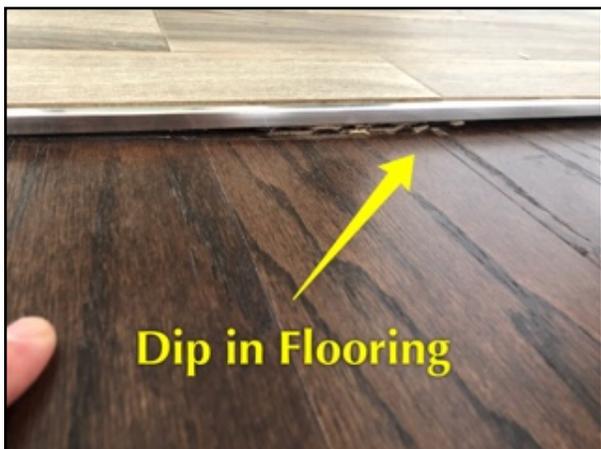
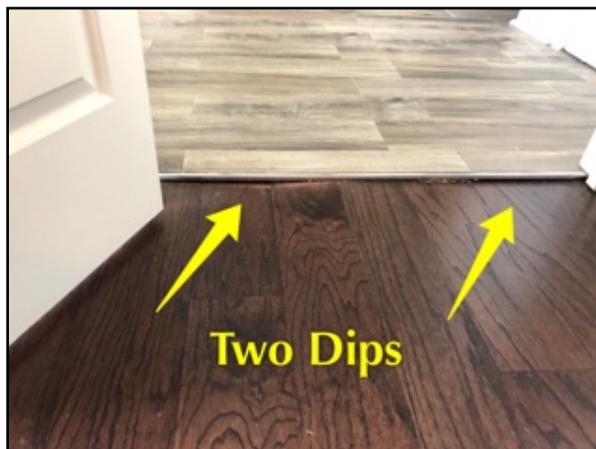
Comment 29:

Hardwood flooring in master bedroom at intersection with bathroom tile is unlevel and wavy. Recommend qualified flooring contractor inspect. Ask seller about history of any repairs in this area and construction techniques used. See notes in photos.

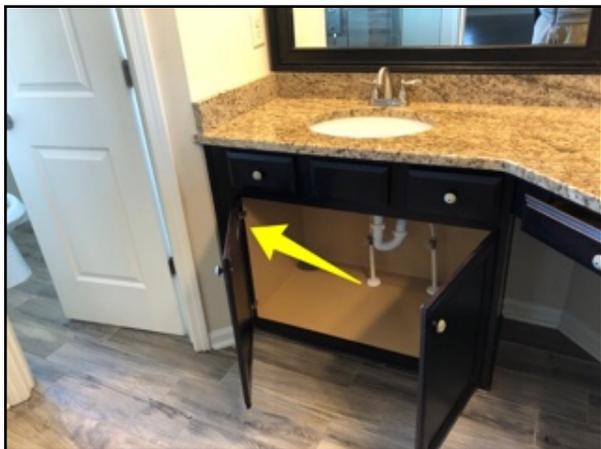
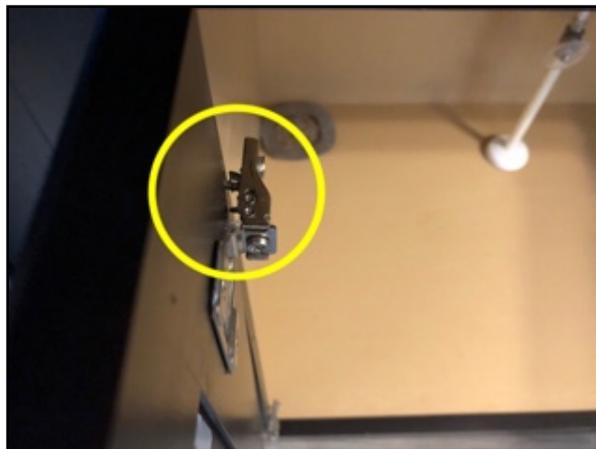
Comment 30:

Master bathroom cabinet door hinge mounting screws have pulled away from frame. Recommend repair.

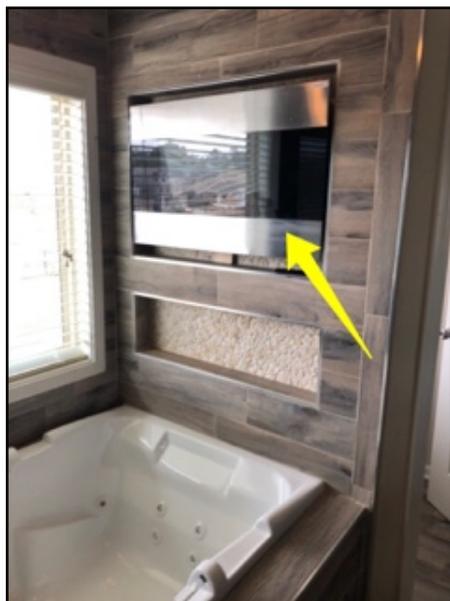
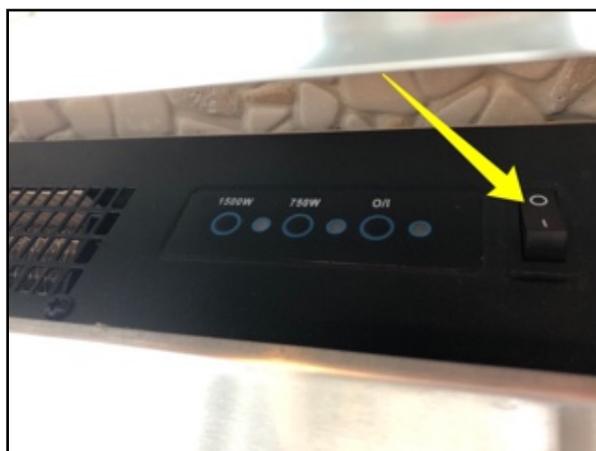
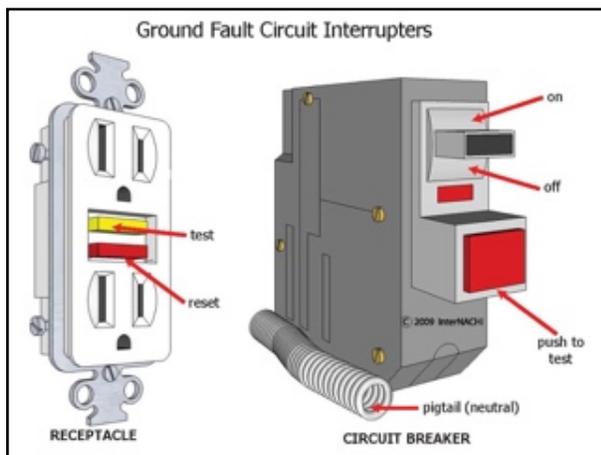
Comment 31:

Electric wall heater (fireplace) installed above Jacuzzi tub in master bath is located above footprint of tub and is a shock hazard. Recommend relocating at least 3 feet from tub footprint and powering by a GFCI (ground fault circuit interrupter) breaker. See image.

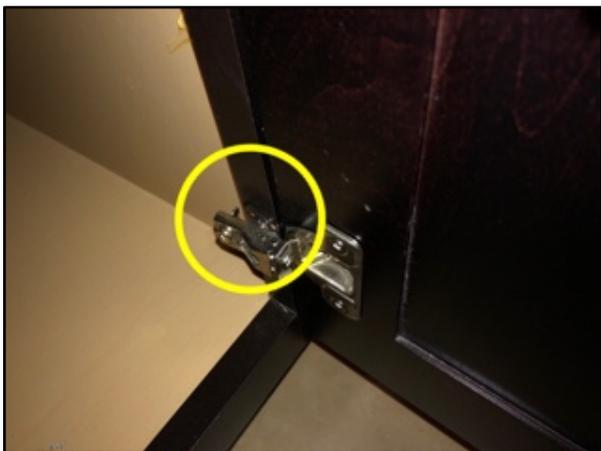
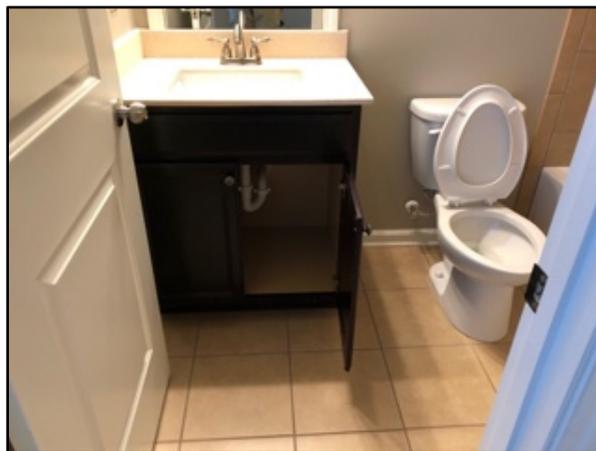
Comment 32:

Lower door hinge bracket in upstairs front left bathroom mounting screws have pulled out of frame. Recommend repair.

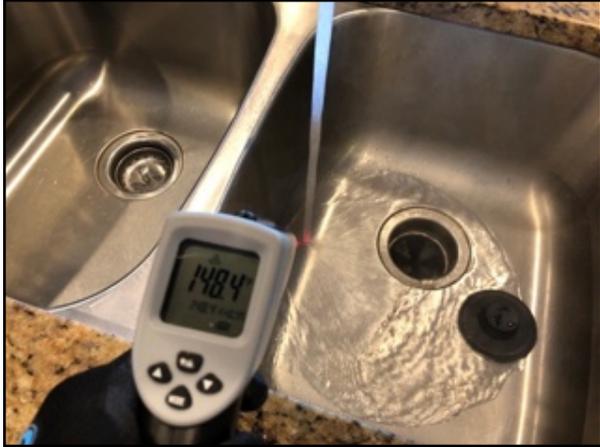
Figure 33-1

Temp Too High: Hot water temperature is 148 deg F raising the risk of scalding. Suggest lowering water heater set point to 120 deg F.

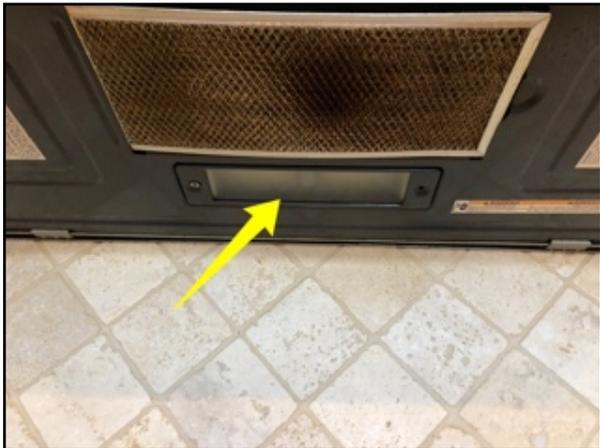
**Comment 34:**
Exhaust hood light was not operational. Recommend replacing bulb.

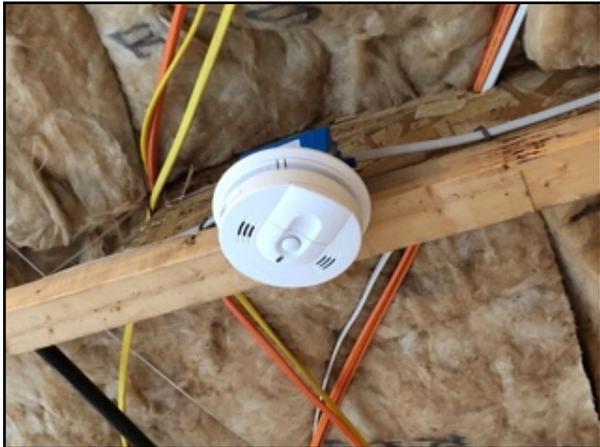
**Comment 37:**
Various smoke detectors throughout home and basement were beeping low battery. Recommend replacing batteries annually.
