Property Inspection Report
3715 Valleyway Road

Property Address:
3715 Valleyway Road
Cumming, Georgia 30040

Inspection Date:
February 8th, 2020

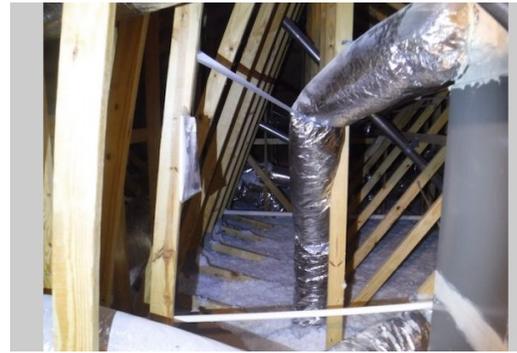
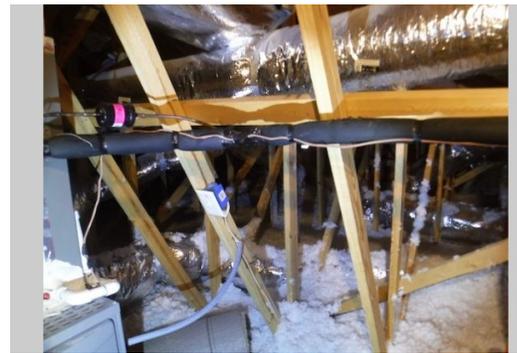
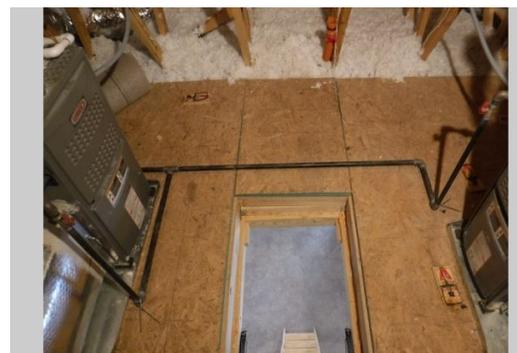
CONDITION #1

Description: Attic Access Limited
Location: Main and Garages
Condition: Access Limited or Obstructed
Explanation: Access throughout the main is limited to the furnace platforms. Truss bracing, insulation covering joists and no flooring limited inspection. The inspector did use the available flooring, attic lighting and flashlight to inspect what could be reached and seen. The garage attics are cramped with no flooring. Access was limited to the ladder and scuttle hole entry.

Significance: Needs Pro Repair

Suggested Action: Have a qualified contractor evaluate the current access and recommend access improvements. Undertake the recommended improvements as needed.

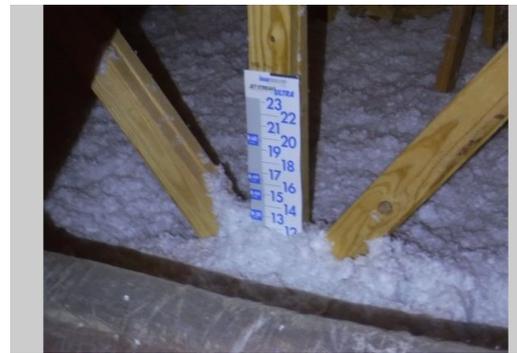
CONDITION #2

Description:	Blown Insulation
Location:	Main Attic
Condition:	Limited Insulation
Explanation:	The attic insulation level is less than current standards (R-38). The current is R-30.
Suggested Action:	Add additional blown insulation on top of the existing level, and batt insulation for vertical and diagonal spaces to a level of R-38.
Significance:	Needs Pro Repair

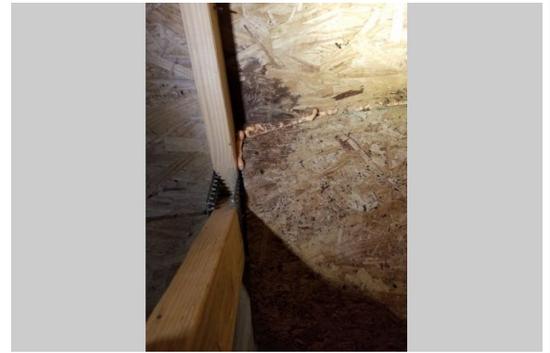
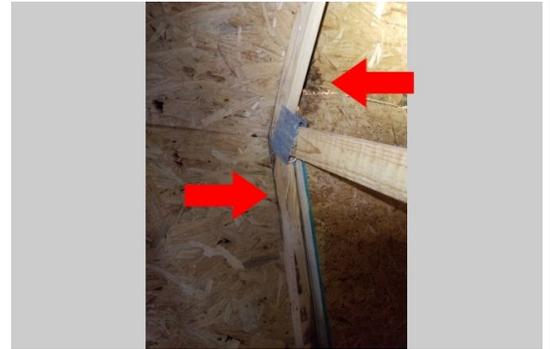
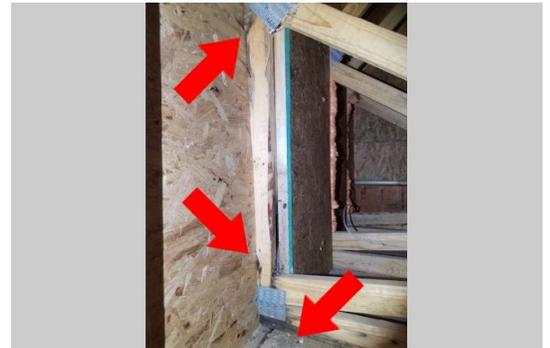
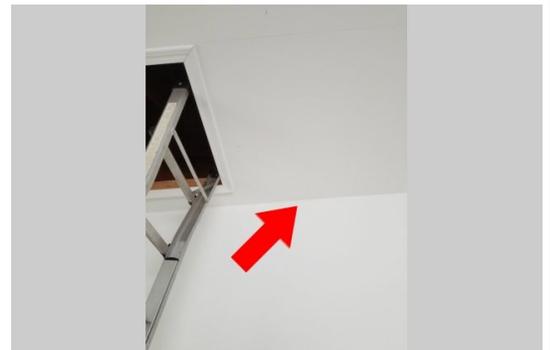
CONDITION #3

#	Condition	Location	Significance
3	Water Stains Noted at Sheathing and Truss	Garage Attic, Back Left Corner	Monitor
4	Additional Photos - Water Stains Noted at Sheathing and Truss	Garage Attic, Back Left Corner	Monitor

Description:	Sheathing and Truss Stain
Location:	Garage Attic, Back Left Corner
Condition:	Water Stains Noted at Sheathing and Truss
Explanation:	Water stains were noted at the roof sheathing and down the truss. Testing with a moisture meter showed slightly elevated moisture level at 13.3% compared to a non-stained truss member at 10.9% (Condition #2). Continued monitoring is advised to confirm that no ongoing leakage is occurring.
Suggested Action:	Consult the owner for further information regarding current or past leakage, repairs, and warranty information. Consult a qualified roofer for additional evaluation and repair as needed.
Significance:	Monitor

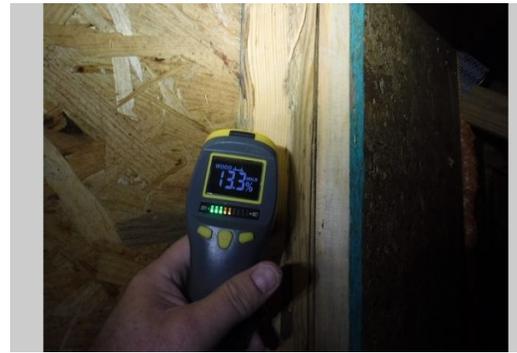
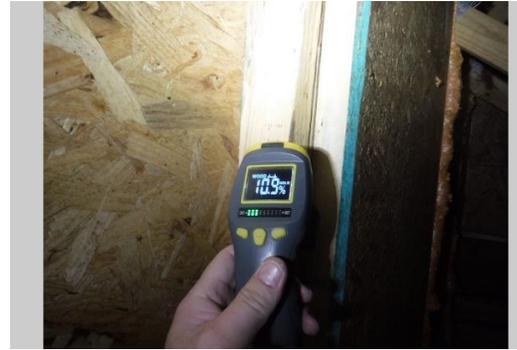
CONDITION #4

Description: Sheathing and Truss Stain
Location: Garage Attic, Back Left Corner
Condition: Additional Photos - Water Stains Noted at Sheathing and Truss
Explanation: See previous explanation.
Suggested Action: Follow recommendations at previous item.
Significance: Monitor

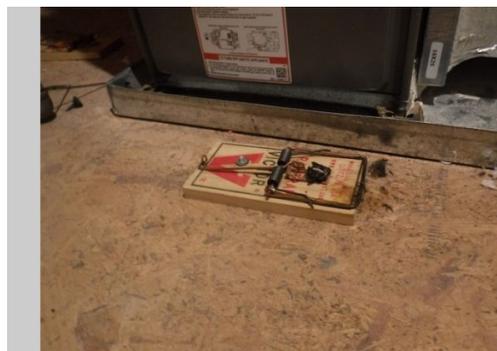
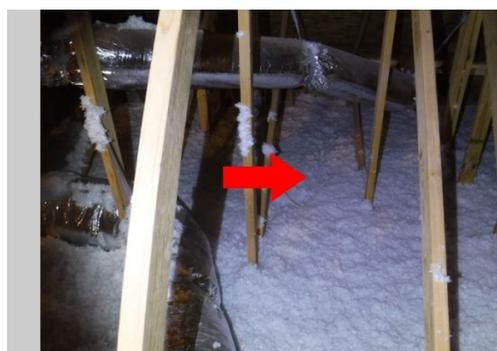
CONDITION #5

#	Condition	Location	Significance
5	Rodent Activity Noted	Main Attic and Both Attic Entries in Large Garage	Needs Pro Repair
6	Wasps Nests Observed	Single Garage, Front	Safety Concern

Description:	Rodents
Location:	Main Attic and Both Attic Entries in Large Garage
Condition:	Rodent Activity Noted
Explanation:	Rodent tunnels, paths, and traps indicate past or present activity. Rodents can chew wiring and stored items, displace insulation and cause damage to other attic components. The third picture shows a path through the insulation.
Suggested Action:	Consult a pest control specialist for further evaluation and eradication.
Significance:	Needs Pro Repair

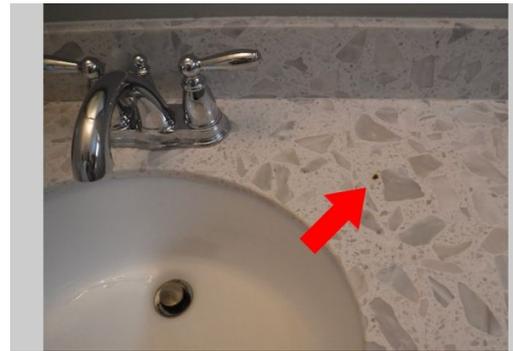
CONDITION #7

Description:	Sink Countertop
Location:	Main Level Bath
Condition:	Countertop Stain
Suggested Action:	Consult with a countertop contractor for options of removal.
Significance:	Needs Pro Repair

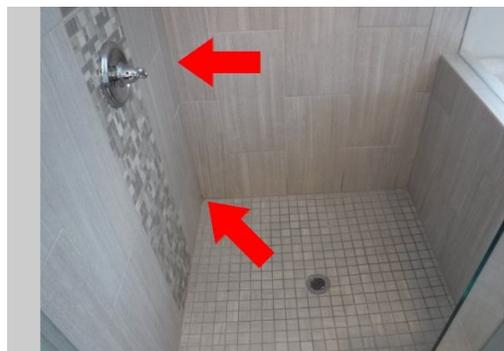
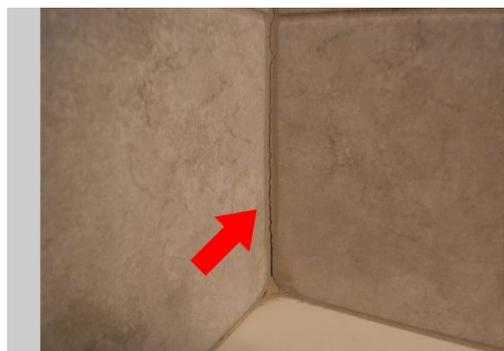
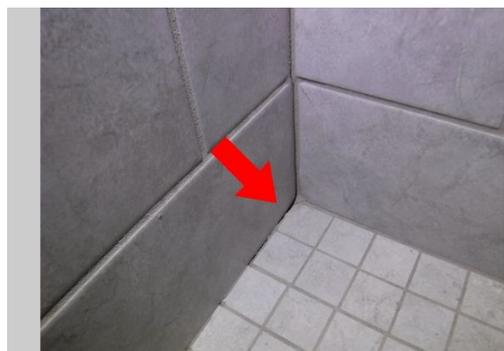
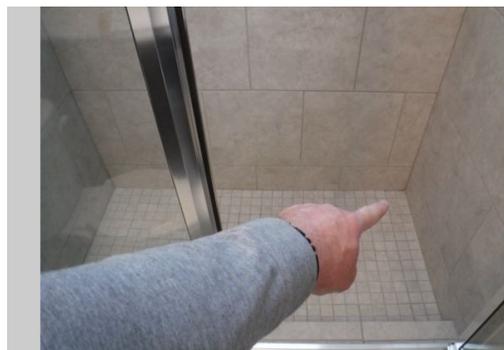
CONDITION #9

Description:	Shower Tile
Location:	See Explanation
Condition:	Caulk or Grout Missing
Explanation:	<p>Minor gaps/cracks were noted. Gaps at the grout joints can allow water to penetrate behind the tile.</p> <p>Locations are as follows: Master - back left corner Upstairs hallway - back left and right corners Main level - back left and right corners (large cracks that should be sealed before shower use)(as a result the shower was not fully inspected for operation)</p>
Suggested Action:	Touch up all cracks at the grout or caulk to provide a water tight seal. Sanded caulking is a suitable material for this application and the grout colors can be closely matched.
Significance:	Needs Handy Repair

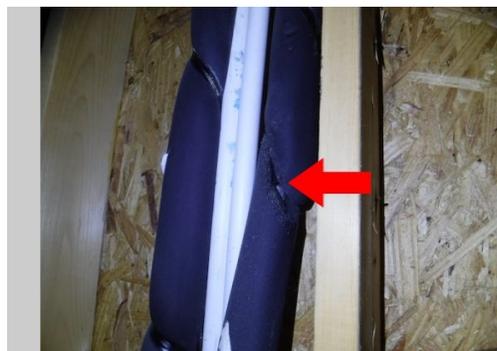
CONDITION #11

Description:	Refrigerant Line Insulation
Location:	Basement, Back Left Side
Condition:	Refrigerant Line Insulation Damaged/missing/constricted
Explanation:	The refrigerant line will produce excessive condensation if not properly insulated. The condensation will drip from the pipe, creating copper stains and increasing moisture levels. Tape used to hold the insulation can be installed too tight, thus constricting the foam insulation and will also cause dripping.
Suggested Action:	Replace where damaged. Ensure proper sealing at the coil.
Significance:	Needs Handy Repair

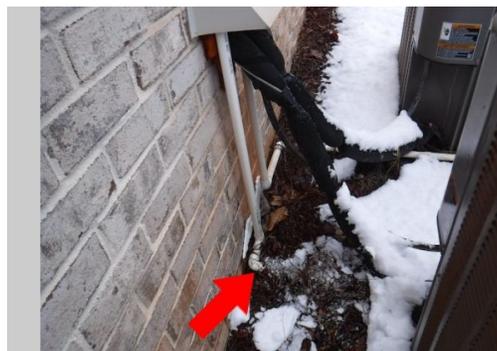
CONDITION #12

Description:	Condensate Drain
Location:	Left Side of Home
Condition:	Drain Termination Too Close to or Below Grade
Explanation:	The termination promotes clogging and is required to be 4-6 inches above the finished grade.
Suggested Action:	Cut the drain piping to provide suitable clearance above the ground.
Significance:	Needs Handy Repair

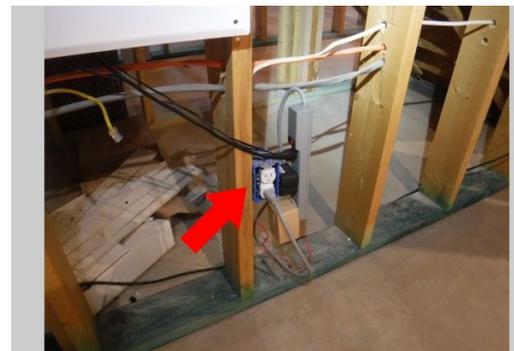
CONDITION #14

#	Condition	Location	Significance
14	Cover Plate Missing	Basement, Below Electrical Panels	Safety Concern

Description:	Receptacle
Location:	Basement, Below Electrical Panels
Condition:	Cover Plate Missing
Explanation:	The cover plate for a wiring device represents an important safety component.
Suggested Action:	Replace all missing cover plates.
Significance:	Safety Concern

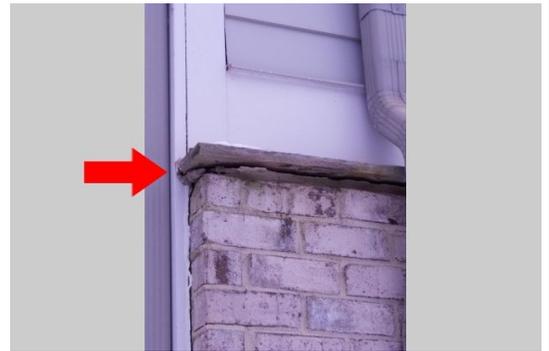
CONDITION #20

Description:	Stone Sill
Location:	Back Left Corner of Home
Condition:	Sill Slope Improper
Explanation:	The stone sill is lifting and improperly sloped allowing water to pond against the exterior veneer.
Suggested Action:	Have a mason adjust the pitch of the drainage sill/flashing to drain away from the exterior veneer.
Significance:	Needs Pro Repair

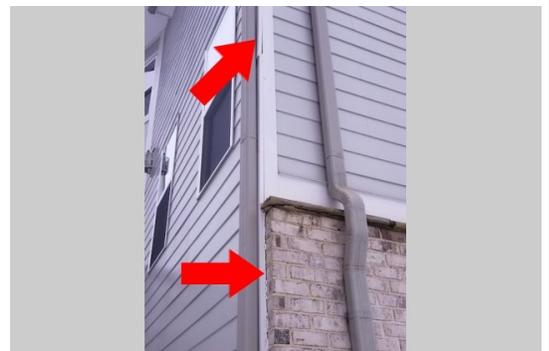
CONDITION #21

Description:	Trim Joints
Location:	Back Left Corner of Home
Condition:	Caulk Gaps at Trim Joints
Explanation:	Caulk is missing at the back left corner of home. Open caulk joints allow water penetration that contributes to damage over time. Regular maintenance of the home should include periodic touch-up of these open joints to minimize the potential for damage.
Suggested Action:	Caulk all trim areas where missing.
Significance:	Maintenance Item

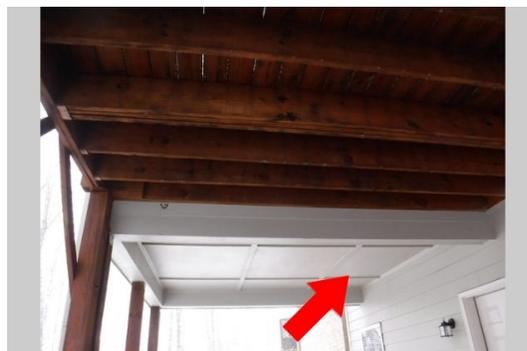
CONDITION #22

Description:	Home Connection
Location:	Back Right Side of Home, Below Dining Room
Condition:	Access to Deck-House Connection Limited
Explanation:	The ceiling boards added to the underside of the Deck Patio and the finished interior space limited the deck evaluation. The deck-house fastener connections could not, therefore, be evaluated.
Suggested Action:	Monitor deck components for issues and repair as needed.
Significance:	Monitor

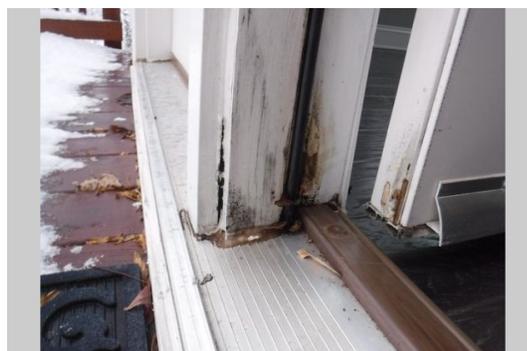
CONDITION #23

#	Condition	Location	Significance
23	Damage Noted at Wood Door Frame	Dining Room to Deck Access	Needs Pro Repair

Description:	Door Frame
Location:	Dining Room to Deck Access
Condition:	Damage Noted at Wood Door Frame
Explanation:	The base of the door frame exhibits water damage. Fungus or mushrooms are growing at the door frame.
Suggested Action:	Have a carpenter provide recommendations for repair or replacement.
Significance:	Needs Pro Repair

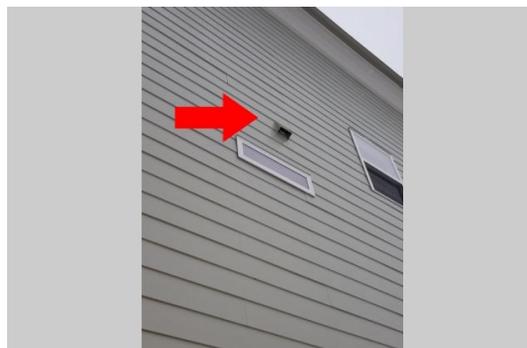
CONDITION #24

#	Condition	Location	Significance
24	Wasp Nest(s)	Left Side of Home in Bath Vent	Safety Concern

Description:	Wasp Nest
Location:	Left Side of Home in Bath Vent
Condition:	Wasp Nest(s)
Explanation:	Wasp nests were observed at the locations noted.
Suggested Action:	Remove the nest or consult a professional.
Significance:	Safety Concern

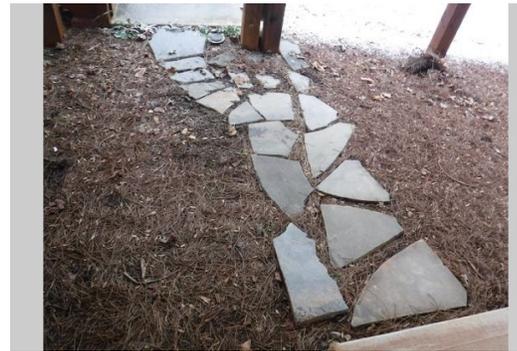
CONDITION #25

#	Condition	Location	Significance
25	Loose Steps	Under Deck	Safety Concern

Description:	Stone Steps
Location:	Under Deck
Condition:	Loose Steps
Explanation:	The stepping stones are loose and represent a safety hazard.
Suggested Action:	Consult a landscape contractor and/or a mason for repairs to ensure safe and stable walkways.
Significance:	Safety Concern

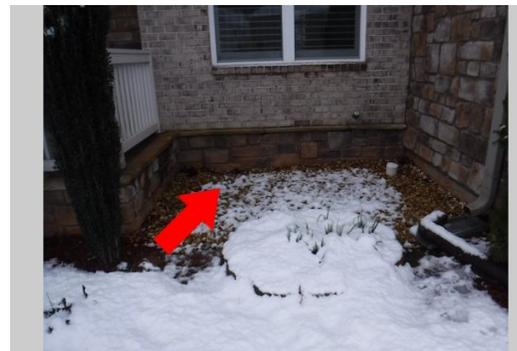
CONDITION #26

Description:	Level Grade
Location:	Front Center of Home
Condition:	Slope Improper
Explanation:	Soil should slope downward and away from the foundation for proper drainage.
Suggested Action:	Monitor for ponding after heavy rains. Modify the slope for proper drainage or add drains and underground piping. Consult drainage contractor as needed.
Significance:	Monitor

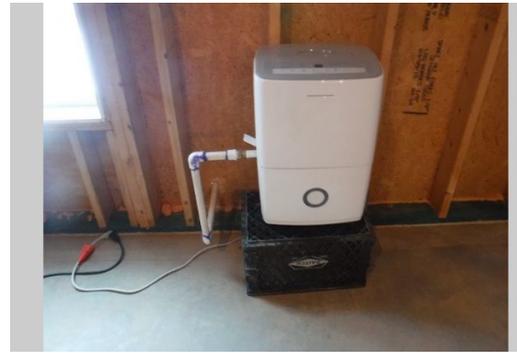
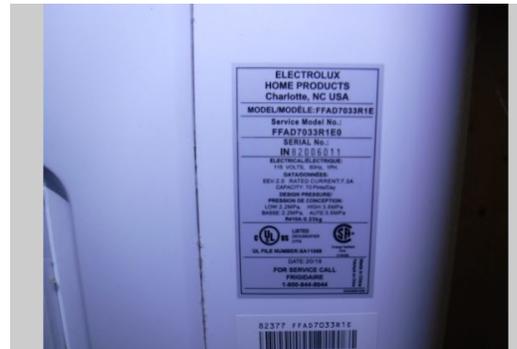
CONDITION #30

Description:	Dehumidifier
Location:	Basement, Back Left Room
Condition:	Dehumidifier Noted
Explanation:	Dehumidifiers reduce humidity levels, making your home less hospitable to allergens such as dust mites, mold, and mildew.
Suggested Action:	Consult owner as to need for dehumidifier.
Significance:	Monitor

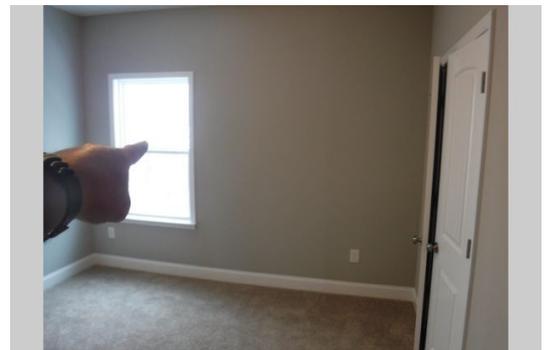
CONDITION #31

#	Condition	Location	Significance
31	Window Spring Kit Defective	Upstairs Back Left Bedroom	Needs Pro Repair

Description:	Window Operation
Location:	Upstairs Back Left Bedroom
Condition:	Window Spring Kit Defective
Explanation:	Portions of the window spring kits or mechanisms are defective.
Suggested Action:	Replace all defective components to ensure proper operation of all windows.
Significance:	Needs Pro Repair

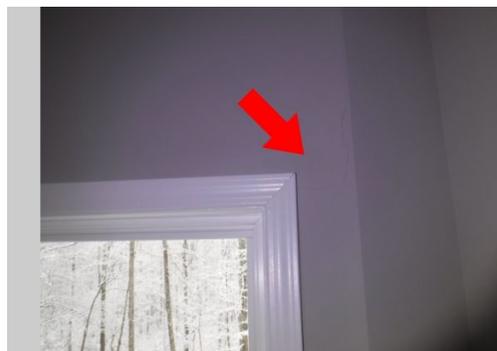
CONDITION #32

Description:	Wall Crack
Location:	Master Bedroom
Condition:	Abnormal Wall Cracks Present
Explanation:	Abnormal cracks indicate unusual movement of the structure, which can be caused by foundation or framing problems. These conditions can indicate deficiencies. The cracking is thin, less than 1/8th inch and not displaced.
Suggested Action:	Have a drywall/paint contractor repair. Monitor for any further cracking. If cracking continues, consult a qualified contractor to provide repair specifications
Significance:	Needs Pro Repair

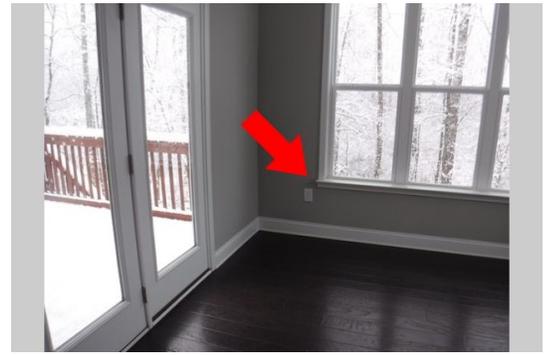
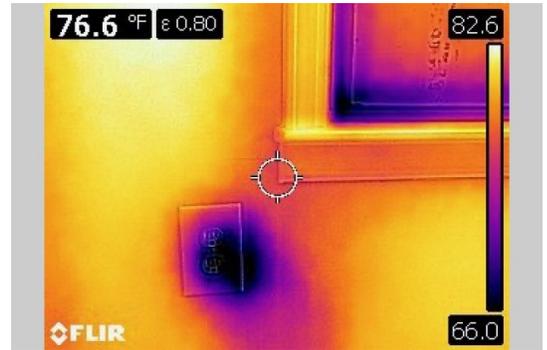
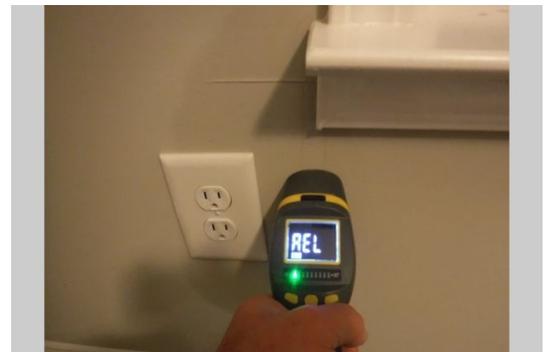
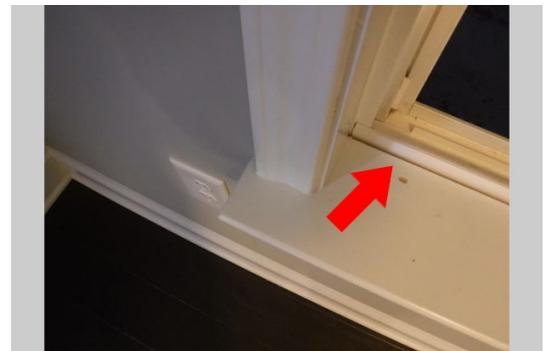
CONDITION #34

Description:	Wall Stain
Location:	Dining Room Off Kitchen, Window By Glass Door
Condition:	Water Stain on Wall Noted
Explanation:	There is a water stain at the base of the window with a slight crack at the wall. The inspector did not see any damage close by. The infrared camera is detecting cool spots between the window corner and receptacle. (all the receptacles on the outer wall all show a cool temperature possibly due to missing insulation in those areas) The difference in temperatures may be creating a condensation where the wall is warmer. The moisture detector did not indicate any elevated moisture levels. There is a slight gap between the window sill and window casing, but the window would have to be open for water or moisture to enter the gap.
Suggested Action:	Consult seller regarding history of stains and any repairs made to include warrantable conditions. Consult with a carpenter for any possible repairs. Have a drywall/paint contractor prime stains with a stain blocking agent and paint to desired color. Monitor for any additional staining subsequent to repairs and repainting.

Significance:	Needs Pro Repair

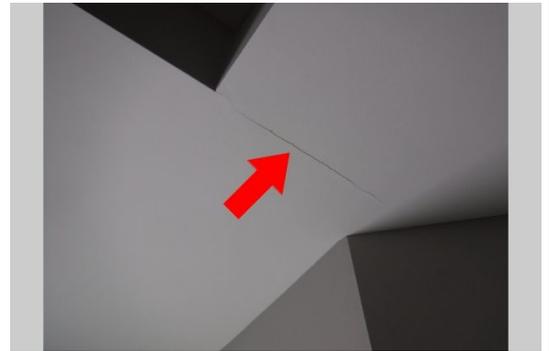
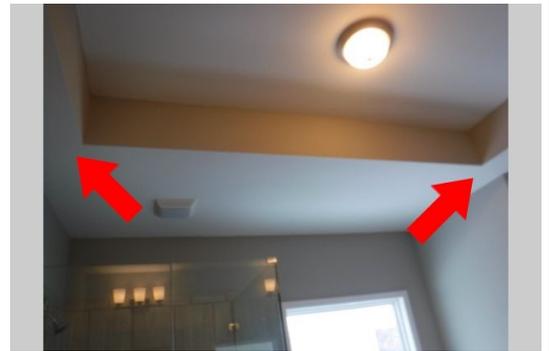
CONDITION #35

Description:	Ceiling Cracks
Location:	Master Bath, Above Tub and Shower
Condition:	Typical Ceiling Seam Cracks, Loose Tape
Explanation:	Drywall cracks and loose tape are typically due to the normal shrinkage, or expansion and contraction of the wood members to which the drywall is nailed, and of no structural significance.
Suggested Action:	This common problem requires only cosmetic repair.
Significance:	Needs Pro Repair

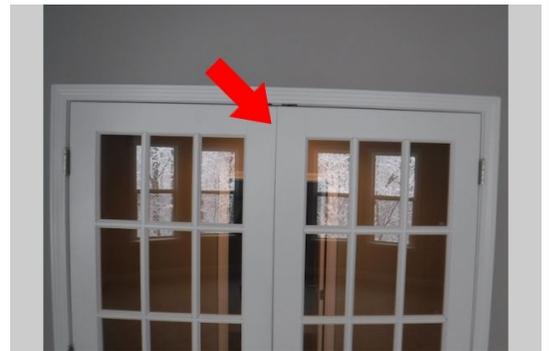
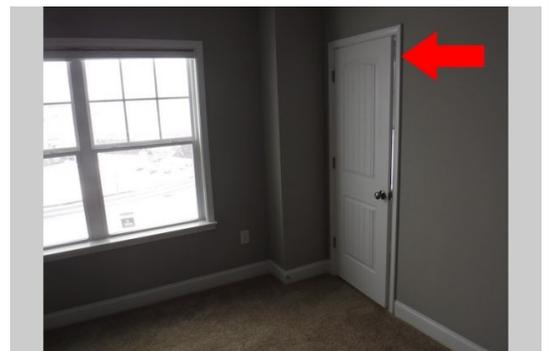
CONDITION #36

Description:	Door Operation
Location:	See Explanation
Condition:	Binding Door
Explanation:	Binding doors are common in structures, and are caused by many conditions, most of which are not serious. Locations are as follows: Master double doors Upstairs front right bedroom closet
Suggested Action:	Adjust/modify the installation to operate properly. Monitor for subsequent changes which may indicate structural movement.
Significance:	Needs Handy Repair

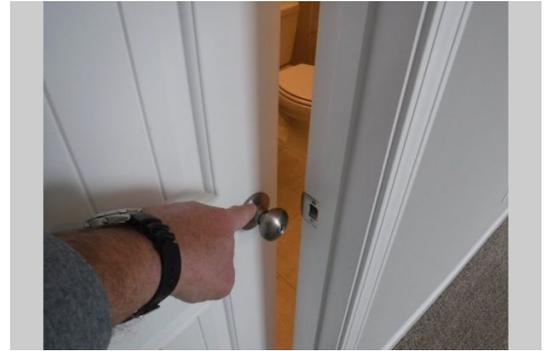
CONDITION #37

Description: Door Latch
Location: Upstairs Back Left Bedroom and Bath
Condition: Door Latch Misaligned
Explanation: The door lockset will not latch or lock properly. This condition is common and is typically the result of either misalignment of the strike plate at the jamb (relative to the latch at the door edge) or loose hinges.
Suggested Action: Adjust the components to latch properly.
Significance: Needs Handy Repair

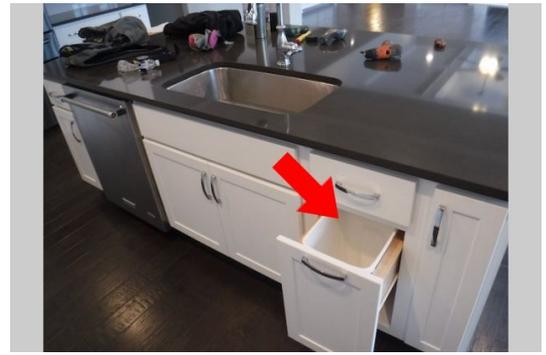
CONDITION #38

Description: Garage Cabinet
Location: Right of Sink
Condition: Cabinet Door Did Not Close Properly
Explanation: The guides for the door need adjustment. The door does not open or close properly.
Suggested Action: Replace the hinges on the affected doors.
Significance: Needs Pro Repair

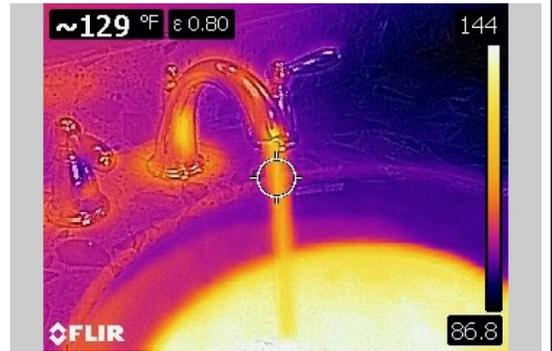
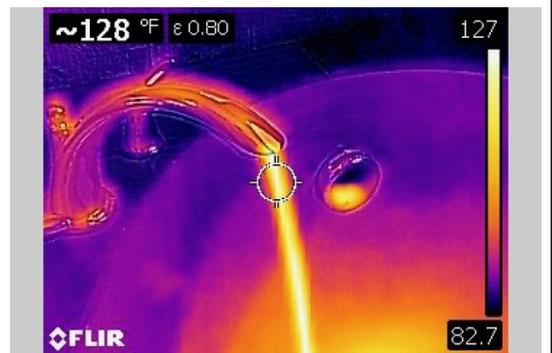
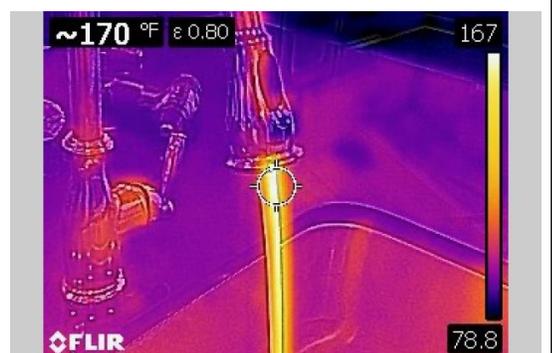
CONDITION #39

#	Condition	Location	Significance
39	Temperature Set Too Hot	Throughout	Safety Concern
40	Elevated Pressure	Back of Home	Needs Pro Repair

Description: Hot Water Temperature

Condition: Temperature Set Too Hot

Explanation: Setting the household water temperature between 90 and 124 degrees reduces the potential for scald injuries.

Significance: Safety Concern

Suggested Action: Turn the temperature dial down or consult a plumber for adjustment as needed.

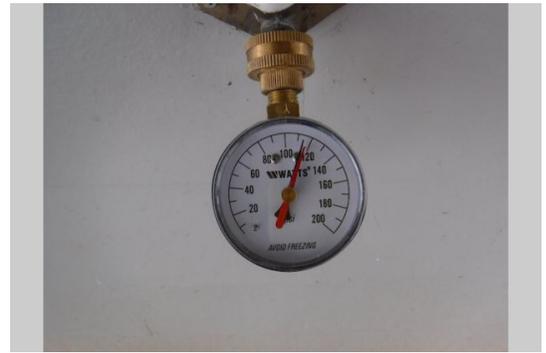
CONDITION #40

Description:	Water Pressure - 112 Psi
Location:	Back of Home
Condition:	Elevated Pressure
Explanation:	The water pressure was measured at more than 80 psi, which is considered maximum for most residential applications.
Suggested Action:	Have a plumber adjust or replace the pressure regulator if present, or add a pressure regulator as necessary to bring the water pressure to within the desired range of 40-80 psi.
Significance:	Needs Pro Repair

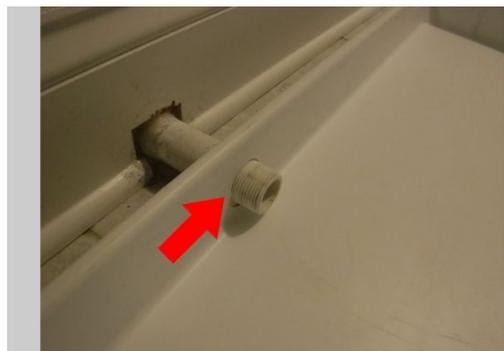
CONDITION #46

Description: Drain Pan and Piping
Location: Washer Location
Condition: Rubber Gasket Missing
Explanation: The rubber gasket is missing at the piping. Water would be able to drain out the opening between the pan and piping.
Suggested Action: Attach a gasket.
Significance: Maintenance Item

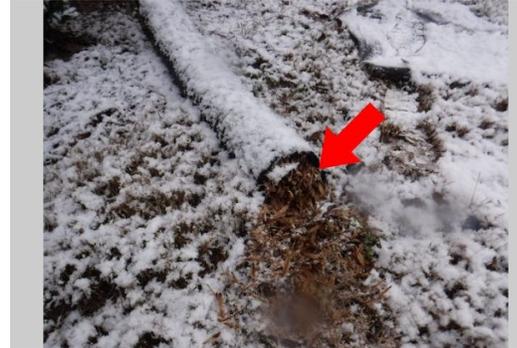
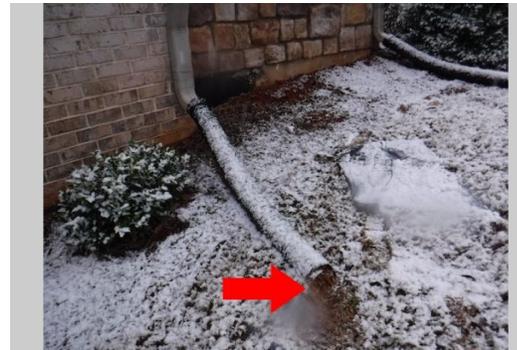
CONDITION #47

Description:	Downspout
Location:	Back Left Corner of Home
Condition:	Accumulated Debris in Downspout
Explanation:	Leaves and other debris prevent the gutter system from operating properly, and can contribute to gutter deterioration, foundation leakage and other problems.
Suggested Action:	Ensure that all gutter components are free of debris.
Significance:	Maintenance Item

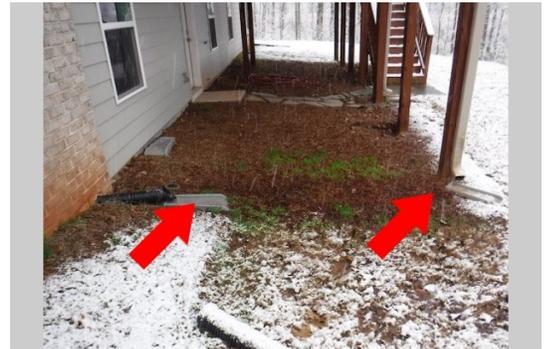
CONDITION #48

Description:	Downspout
Location:	Under Deck
Condition:	Downspouts Discharge Below Deck
Explanation:	Roof drainage should be discharged well away from the foundation and deck footings to reduce under structure water entry or undermining of foundation components.
Suggested Action:	Extend all downspouts well away from the foundation and deck footings with appropriate piping, or, at minimum, add splash blocks. Make sure the grade slopes downward from the point of discharge.
Significance:	Needs Handy Repair

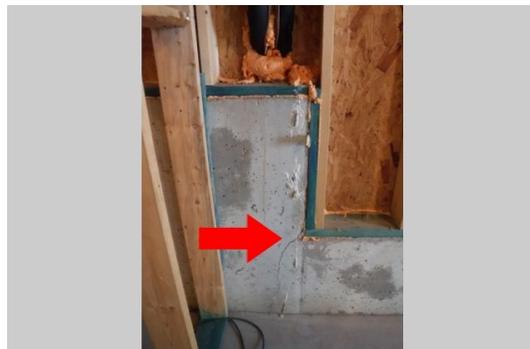
CONDITION #49

Description: Poured Concrete
Location: Back Left Room
Condition: Cracking
Explanation: Cracking was noted at the foundation components. Not all cracks in concrete or block foundation walls are indicative of structural problems. Cracks may be due to either normal expansion-contraction cycles, shrinkage of concrete or mortar, or settlement that has stopped. This area also has cool air seepage.
Suggested Action: Grout and monitor the cracks for subsequent movement. Repair as necessary.
Significance: Needs Handy Repair

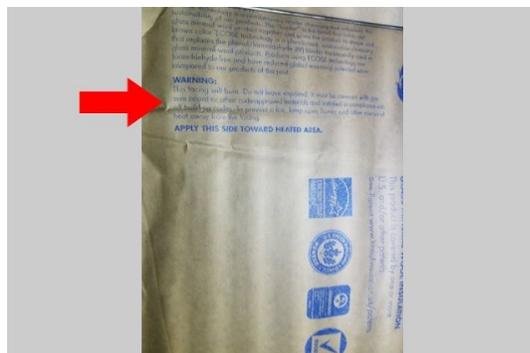
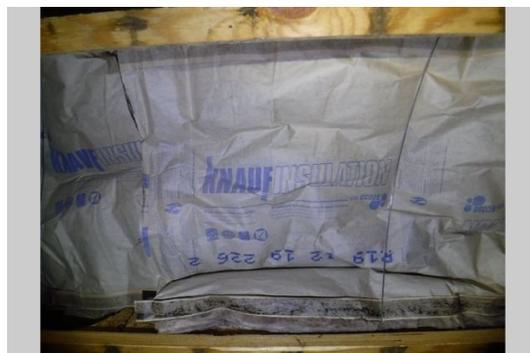
CONDITION #50

#	Condition	Location	Significance
50	Exposed Flammable Insulation Facing	Basement	Safety Concern

Description: Batt Insulation
Location: Basement
Condition: Exposed Flammable Insulation Facing
Explanation: Fiberglass batt insulation often comes with paper or foil facing, which can be combustible. This is of sufficient concern to the manufacturers that a warning label is usually printed on each insulation batt.
Suggested Action: Cover the insulation facing with a suitable building material, or replace with insulation that has a low flame spread rating.
Significance: Safety Concern
