Inspection Report

Property Address:
580 Kearny St
Alpharetta GA 30022

Residential Inspector of America
Inspector: Todd Rymer
3276 Buford Dr., Ste. 104-306
Buford, GA 30519
770.476.4963

Date: 2/10/2020	Time: 01:00:00 PM	Report ID: 021020TR287
Property: 580 Kearny St Alpharetta GA 30022	Customer: Bassem and Majd Elkhayat	Real Estate Professional: Rebecca Nelson Keller Williams (Roswell) Mansell Rd

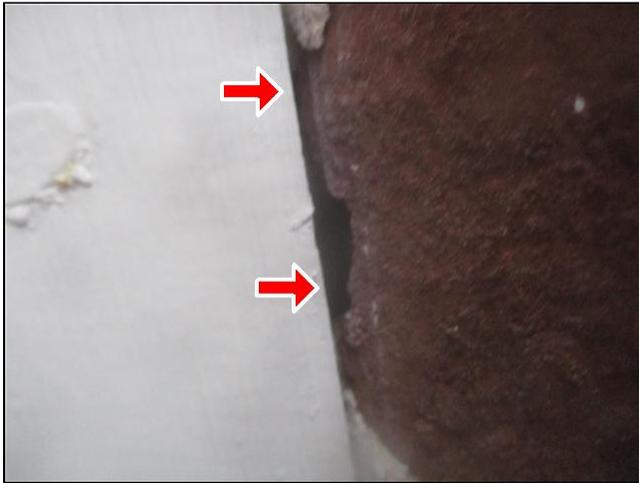
🔧 (2) Seal vertical gaps between brick veneer and lap siding around the home. See example photos. This will help prevent any possible water leaks into the wall cavity behind siding.

1.0 Item 1(Picture) Seal gap

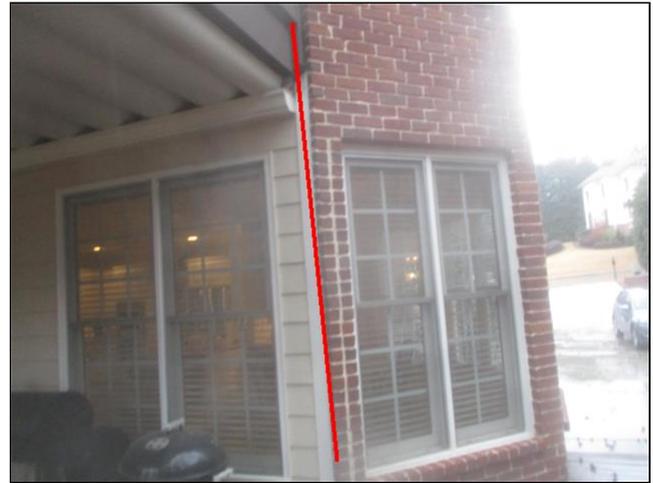
1.0 Item 2(Picture) Rear left corner

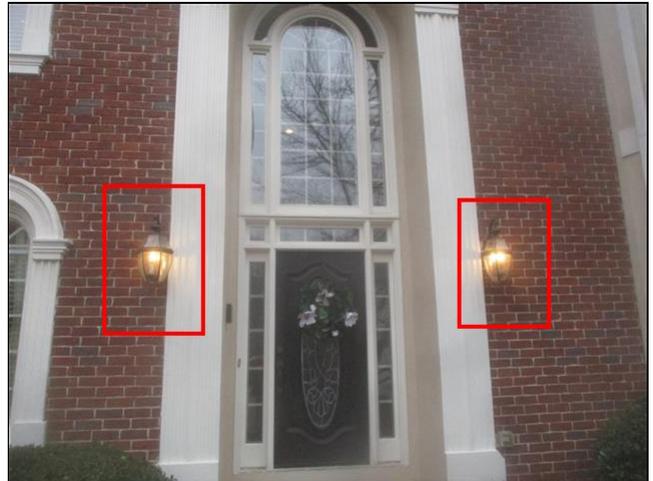
1.0 Item 4(Picture)

🔧 (3) Seal the light fixtures to the brick veneer at front of the home to prevent water entry into the wall cavity and fixture box.

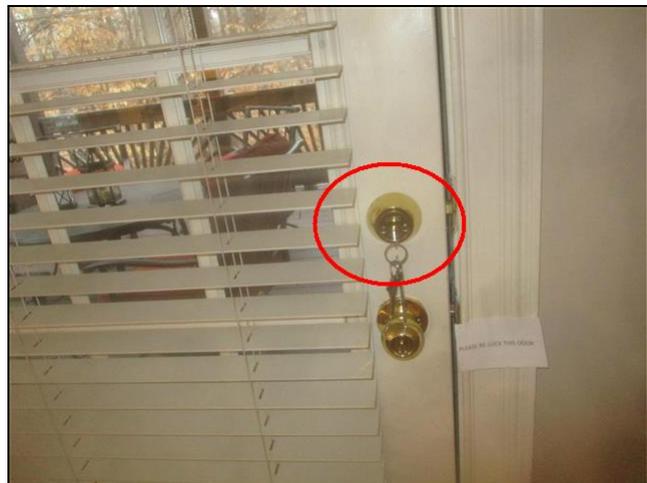
1.1 Item 1(Picture)

🔧 (1) Dead bolt locks on most exterior doors (~ 5 locations) are the type that uses a key to lock on the interior side of the door. This type of lock is no longer to code and is a safety concern due to emergency egress problems - lock could prohibit quick escape from house in case of a fire, etc. Resolve all concerns before closing.

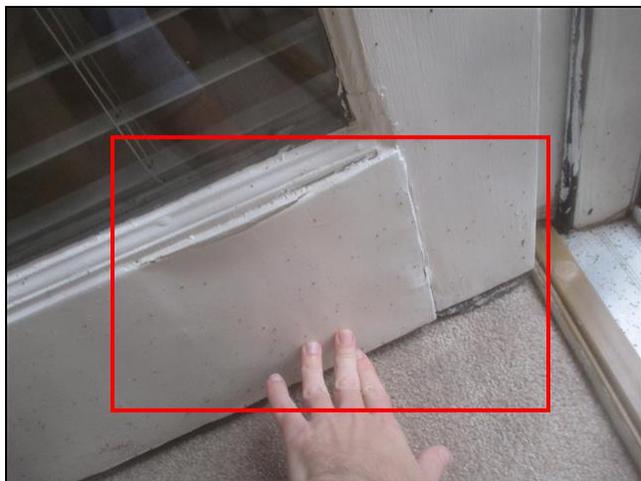
1.1 Item 2(Picture)

🔧 (2) Water damage to door and door frame of the rear upper level deck door. See photos. Have damaged wood repaired/replaced.

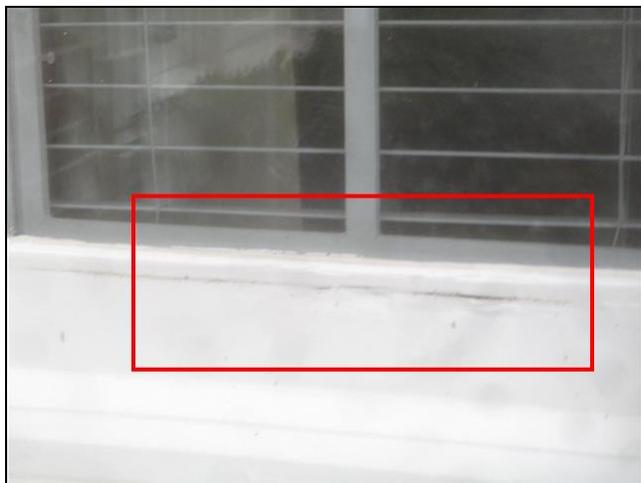
1.2 Item 1(Picture) Ground floor window to left of front entry

🔧 Water damage found on the exterior casing and other wood trim on a few windows. This is common for a house of this type and more should be expected in the future. Have damaged wood repaired or replaced as needed. Extent of any water damage or entry into wall cavity under or around window is not visible and is not known. See photos for locations of damaged trim on windows. Contractor should evaluate window trim on house and replace all as needed.

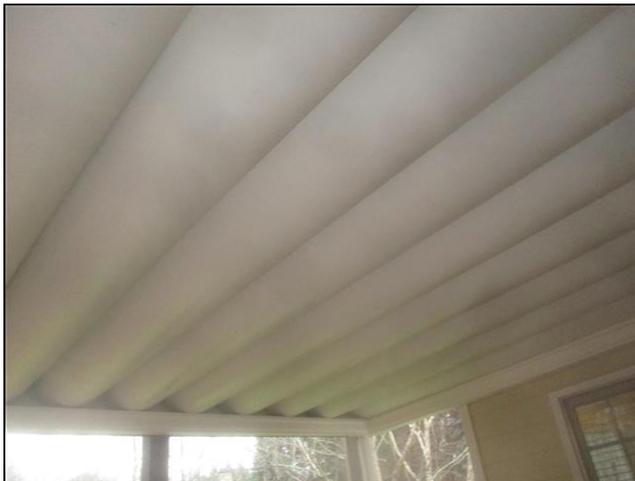
1.3 Item 1(Picture)

(1) Under side of rear deck is covered with a finish material, so the framing could not be inspected, and the attachment method and presence of flashing could not be verified.

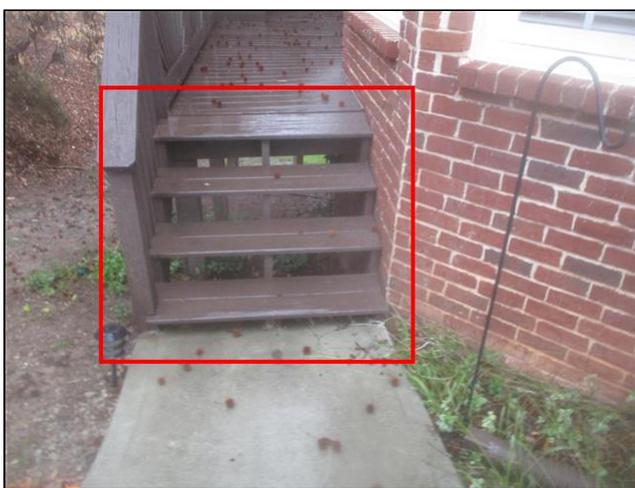
1.3 Item 2(Picture)

🔧 (2) Deck stairs shown in photos have settled. Stair riser height is not equal. Use with caution/resolve any concern prior to closing. Have repaired as required.

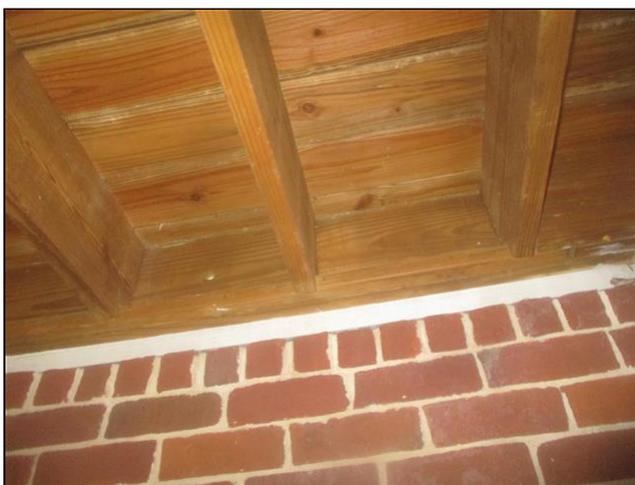
1.3 Item 3(Picture)

🔧 (3) No metal flashing could be seen between the rear deck and the rear wall. This was not often enforced or required in older homes, but flashing makes a better seal between the deck and house. Condition of framing between deck and house is not known.

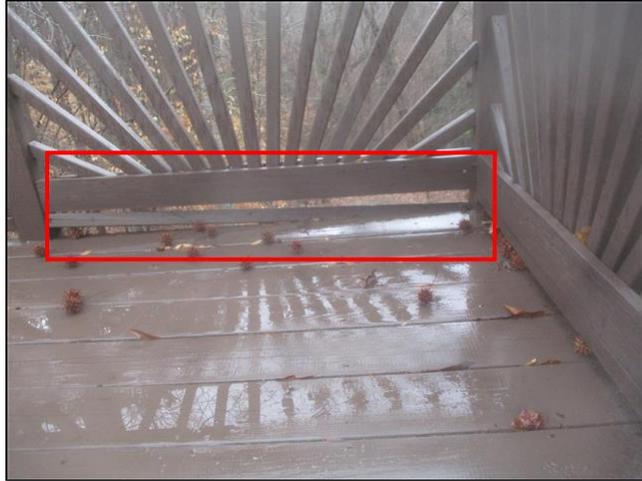
1.3 Item 4(Picture)

(4) Repair minor damage to guard rail associated with the upper level deck as shown in the photo.

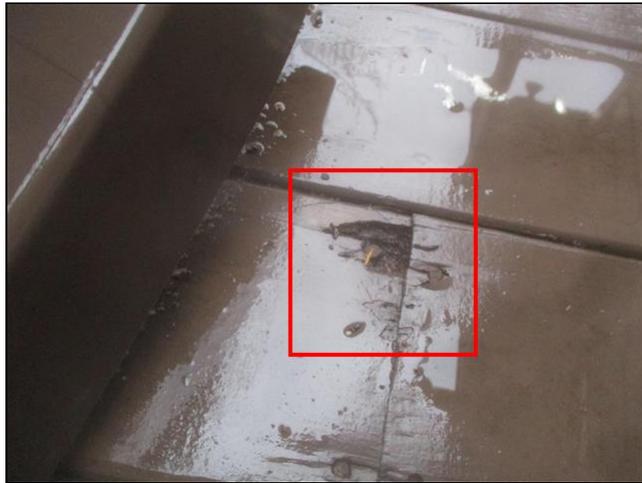
1.3 Item 5(Picture)

(5) Some deck floor boards and the tops of the deck guardrails are wearing out. See example photo. Some deck boards will require replacing in the near future.

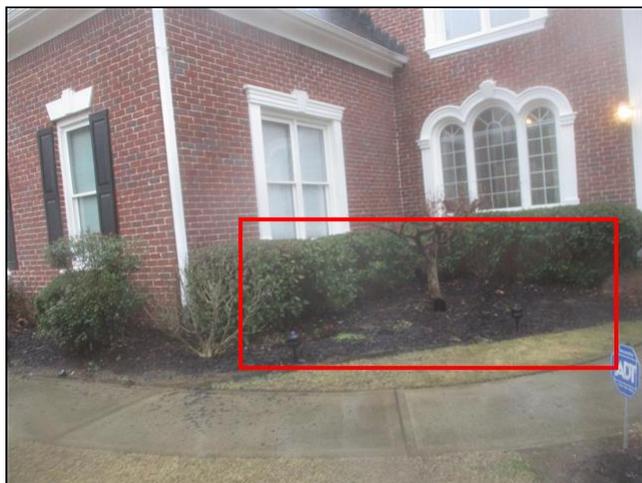
1.4 Item 1(Picture)

(1) The garden area formed by the front wall of the house, and the side walk from the driveway to the front landing, may prohibit quick drainage of run off water. These garden areas often are slow to drain and can cause water entry in the basement.

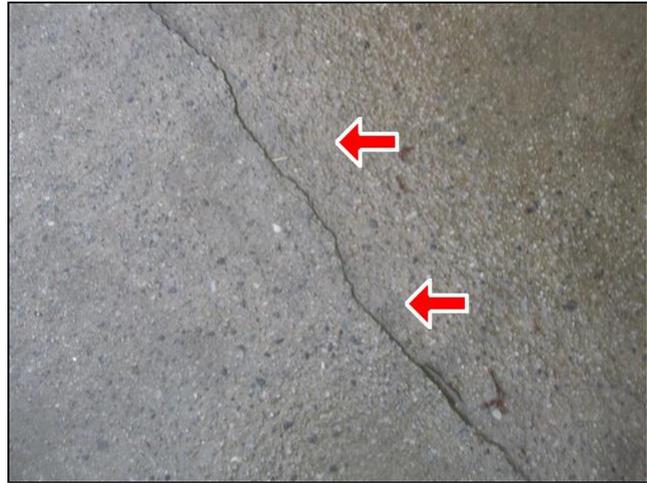
1.4 Item 2(Picture)

(2) Minor cracking in driveway.
Patch as needed.

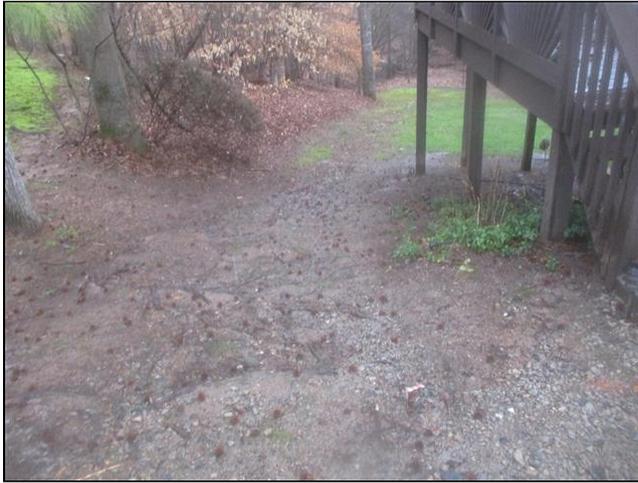
1.4 Item 3(Picture) Left side

(3) Poor drainage/erosion concerns observed on both the right and left sides of the home and near the front entry. See photos. Improvements would be required to improve drainage at these locations. Consult with a landscape professional for solutions/resolve all concerns before closing.

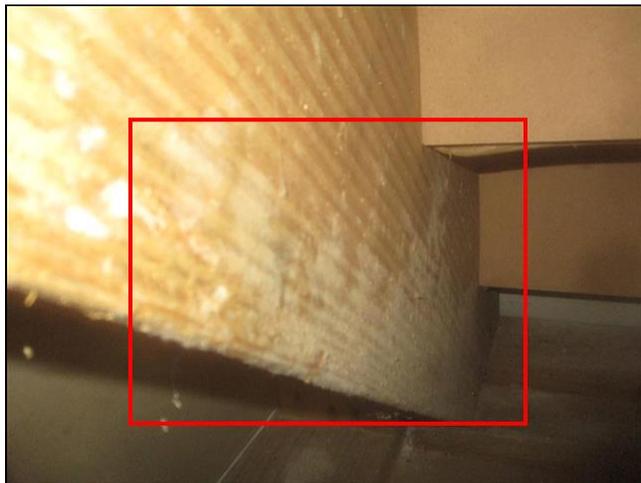
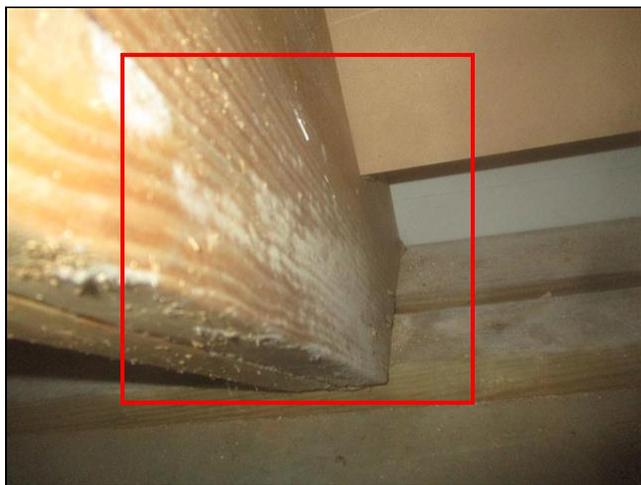
👁️ (3) Signs of a small amount of surface type mold or suspected mold growth is present on the unfinished basement under the stairs. See photos. The underlying cause of mold problems is normally moisture or high humidity. A visual inspection cannot determine the extent of the mold problem or if any health hazards exist. Mold testing is recommended and can be completed if desired. Resolve all mold concerns prior to closing. Please click [HERE](#) for more information on mold testing.

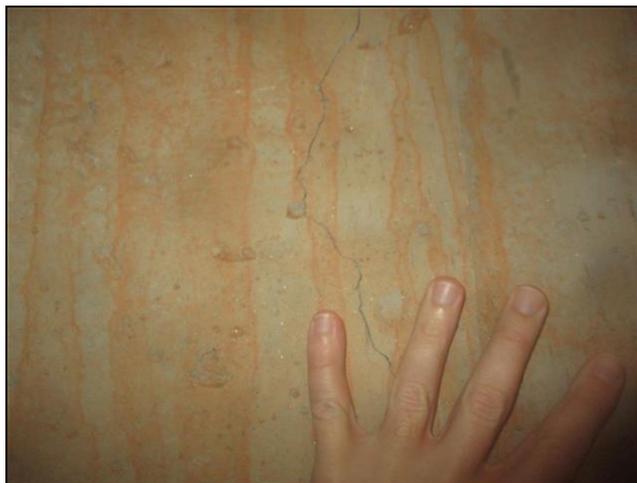
3.1 Item 1(Picture)

The small, hairline cracks in the foundation walls are not a structural concern, but should be patched to prevent any possible future leak. See example photo.

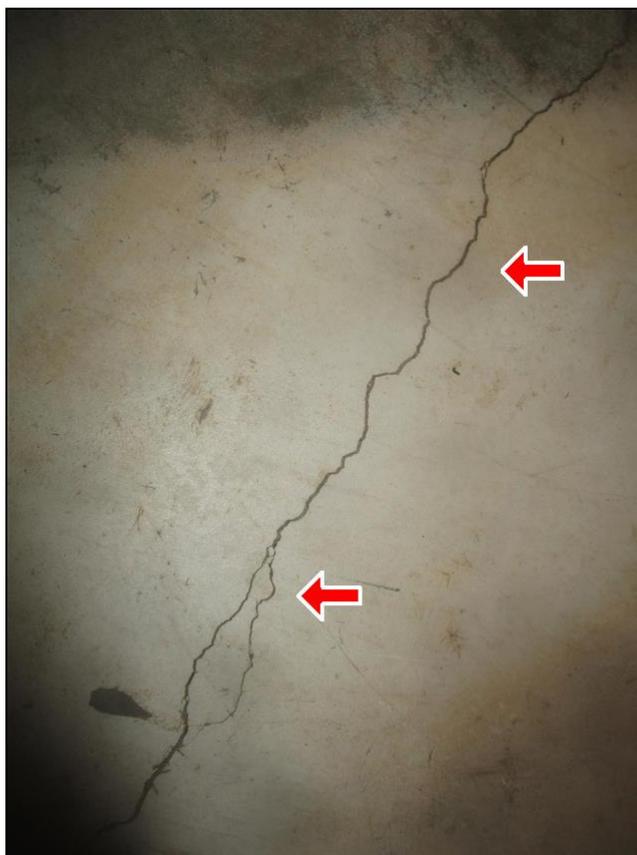
3.2 Item 1(Picture)

Cracks in concrete basement floor are not wide enough to be a structural concern and are likely due to settlement. See example photo. Have patched as needed.

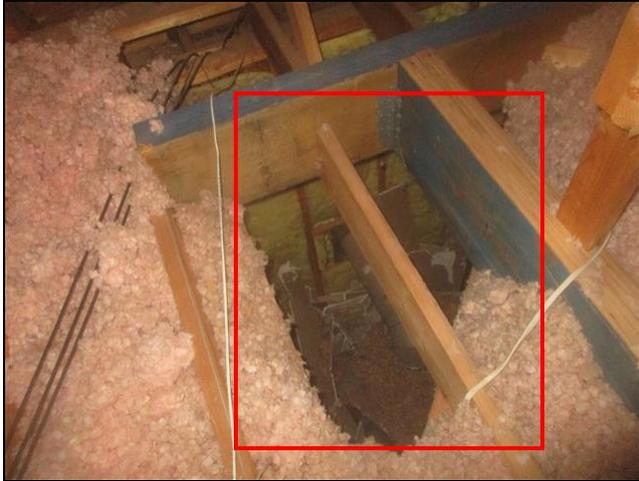
3.4 Item 1(Picture) Left side attic

🔧 Open chases in the attic in the areas shown in the photos. Recommend covering the area with ply wood and insulation to prevent cold air from falling into void from the attic.

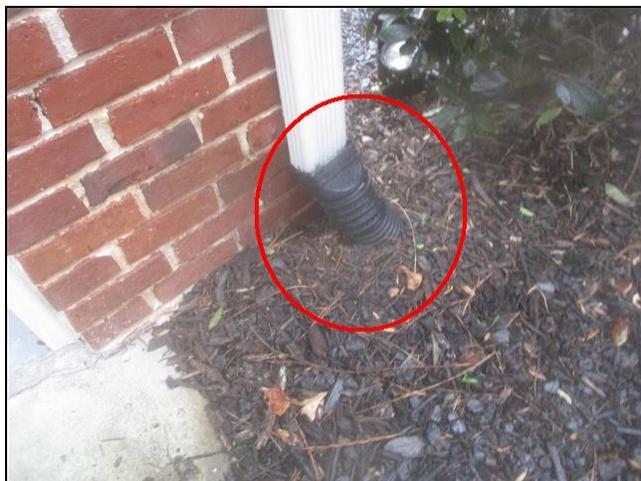
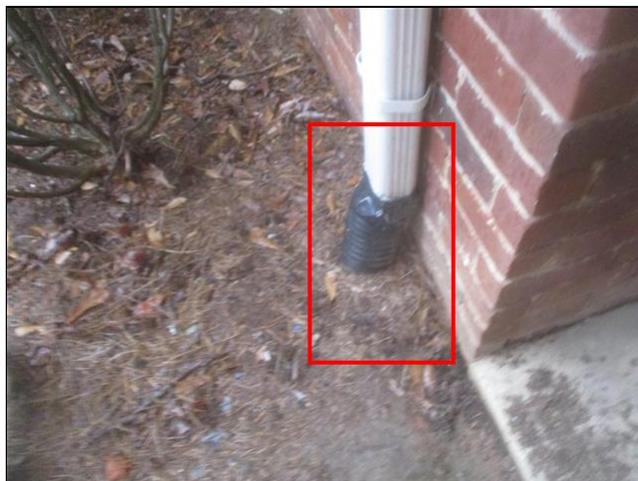
🔧 (1) Have owner point out location of the outlets of the buried down spout extensions. They should come to daylight and the ends were not all found.

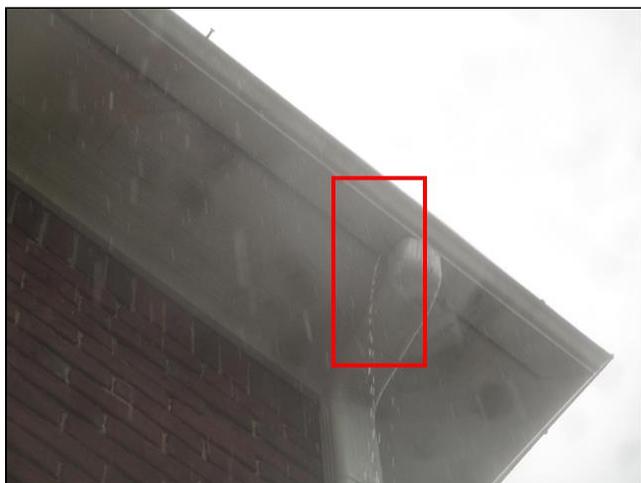
🔧 (2) Gutter concerns observed at locations shown in the photos. Have further evaluated by a professional gutter contractor and all repairs/corrections made as required to ensure that the gutter system for the entire home is adequately functional.

4.3 Item 3(Picture) Leaking gutter, above garage

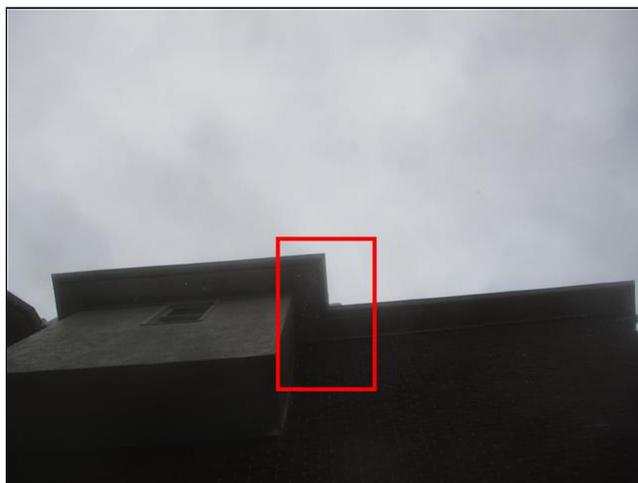
4.3 Item 4(Picture) Leaking gutter, above right side basement egress door

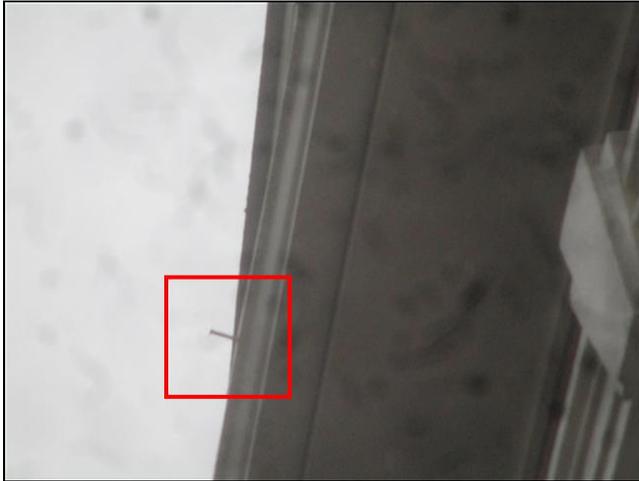
4.3 Item 5(Picture) Secure all loose gutter spikes

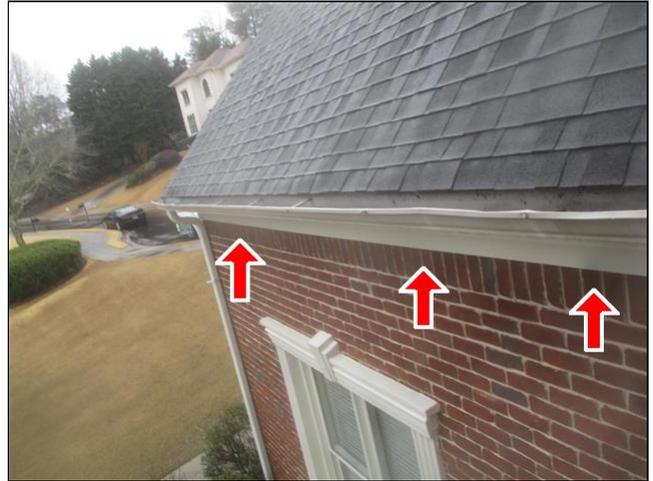
4.3 Item 6(Picture) Standing water in gutter to the left of front entry

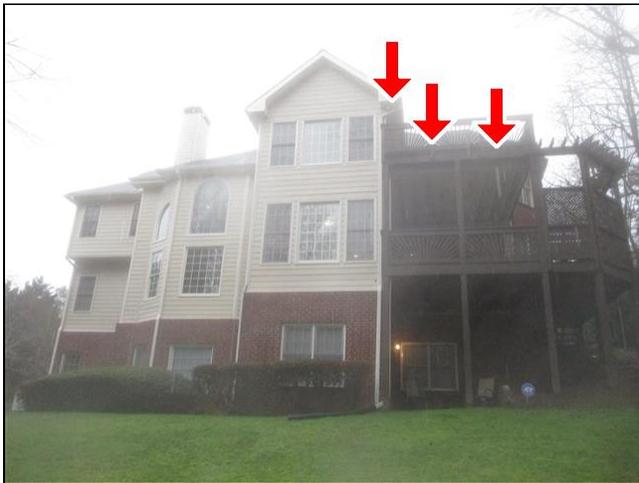
4.3 Item 7(Picture) Standing water in rear left area gutter system

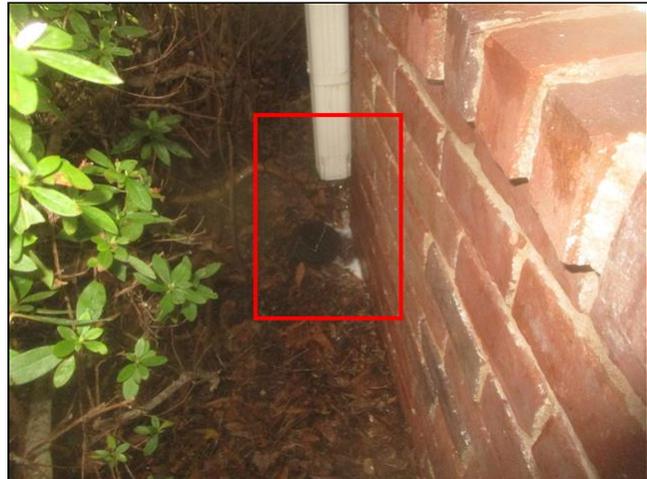
4.3 Item 8(Picture)

🔧 (3) Downspout at the rear central part of the home as shown in the photo was not connected to associated underground extension. Have corrected as required to ensure this downspout is adequately moving water away from the home.

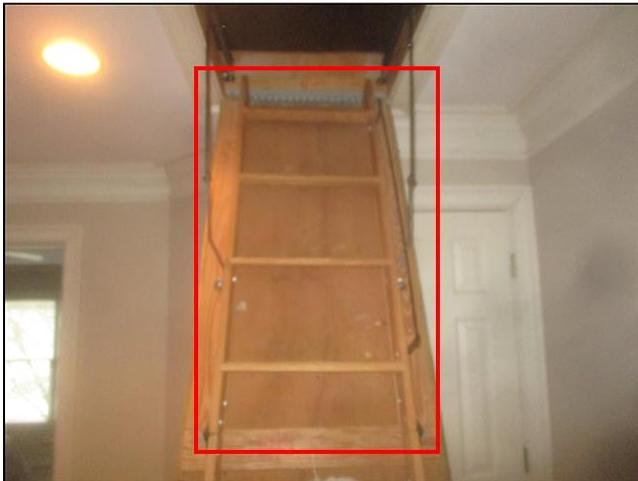
Insulation in the attic is missing or is less than normal in several areas. Have more added to bring levels equal to R-30.

5.0 Item 1(Picture) Insulate pull down stairs

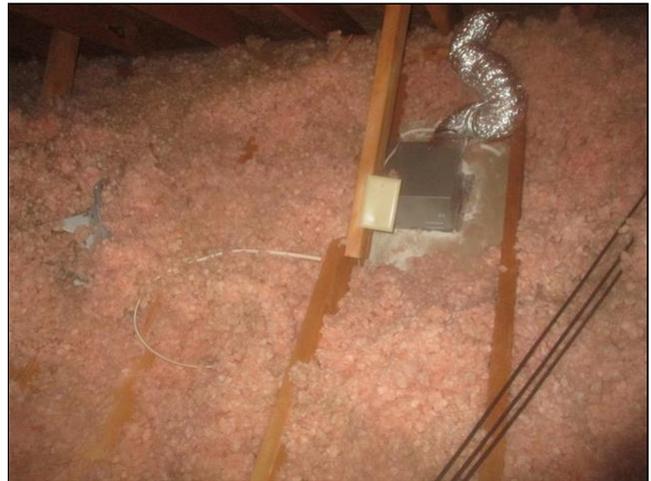
5.0 Item 2(Picture) Recommend additional attic insulation

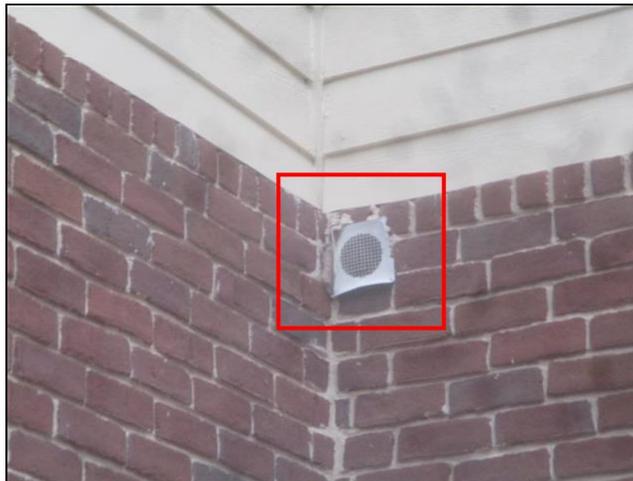
5.3 Item 1(Picture)

Replace damaged/missing vent exhaust cover at the rear right area of the home as shown in the photo.

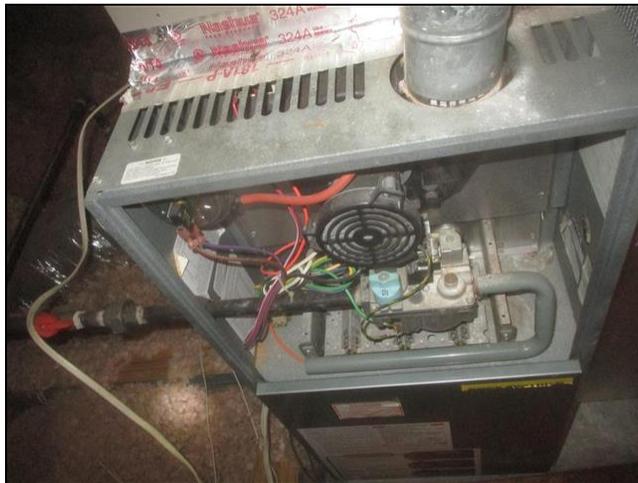
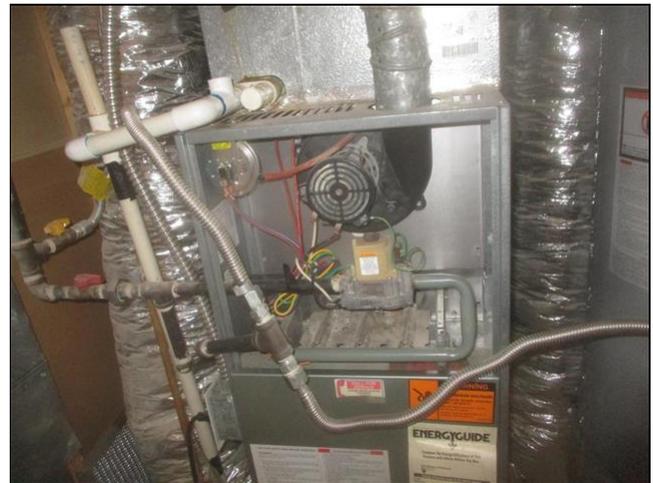
Heating equipment generally last around 15-20 years before needing replacement. Gas furnaces for the home may need replacing in the near future due to its age (both furnaces are 1997 models). The is a newer air handler (2019 model) that services the basement.

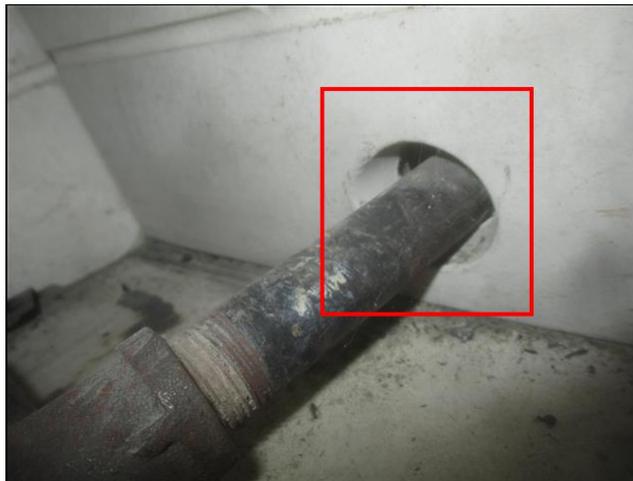
6.5 Item 1(Picture) Living room fireplace

🔧 Have heat resistant caulk applied around the gas pipe where it enters the fire box in the fireplace. This is needed to prevent any hot embers from entering framing behind fireplace.

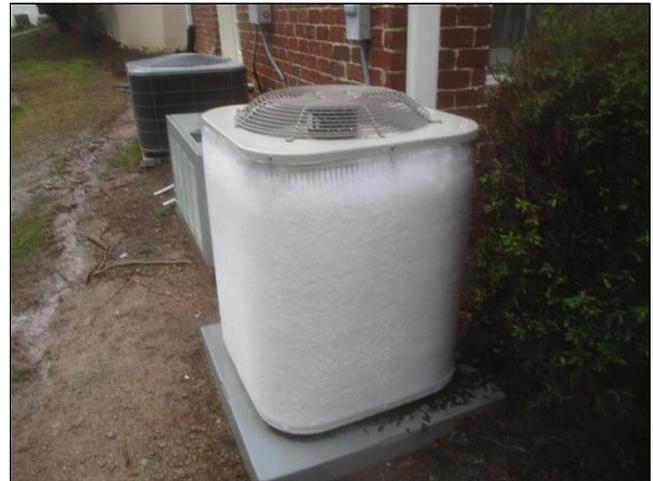
The a/c unit servicing the basement was covered in ice at the time of the inspection. This is indicative of functional concerns. Have further evaluated by a hvac service and have the unit repaired/replaced as required to ensure that there is fully functional a/c unit for the basement. This unit is a 2019 model and likely is under warranty - recommend replacement.

6.6 Item 2(Picture) Ice encased a/c unit

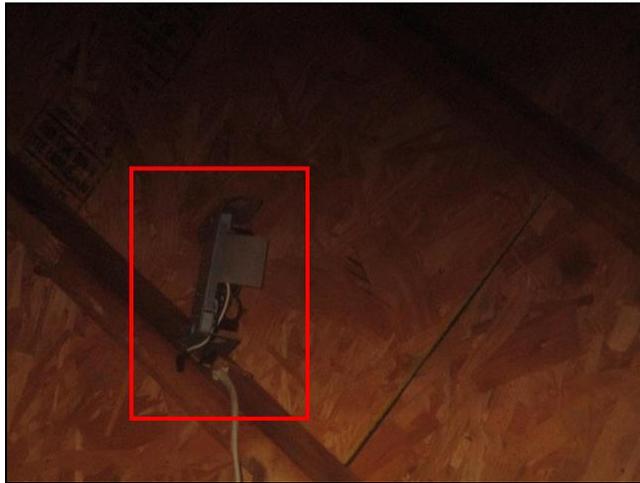
7.3 Item 1(Picture) Central attic

🔧 Have all terminated wiring in the attic either professionally removed or terminations put inside a covered junction box. At least two locations observed but electrician should further evaluate and resolve all attic wiring hazards as required.

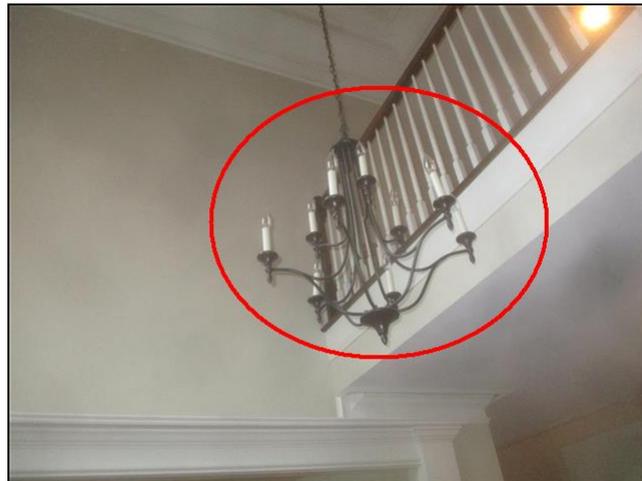
7.4 Item 1(Picture)

🔧 (1) Hanging light fixture at front entry as shown in the photo could not be made to turn on at the time of the inspection. Ensure this fixture is fully functional prior to closing.

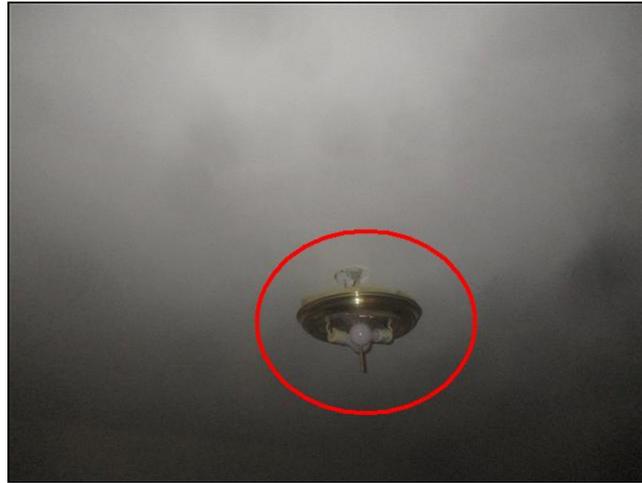
7.4 Item 2(Picture)

🔧 (2) Secure loose ceiling light located at the ground floor rear right side bedroom as shown in the photo.

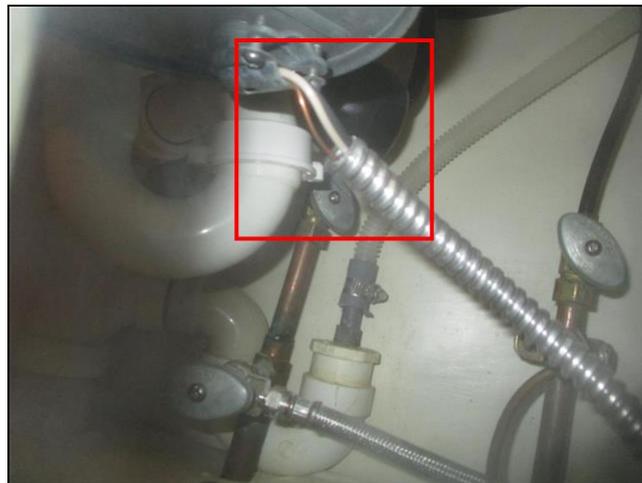
7.5 Item 1(Picture)

🔧 Secure loose conduit for wiring under the garbage disposal as shown in the photo.

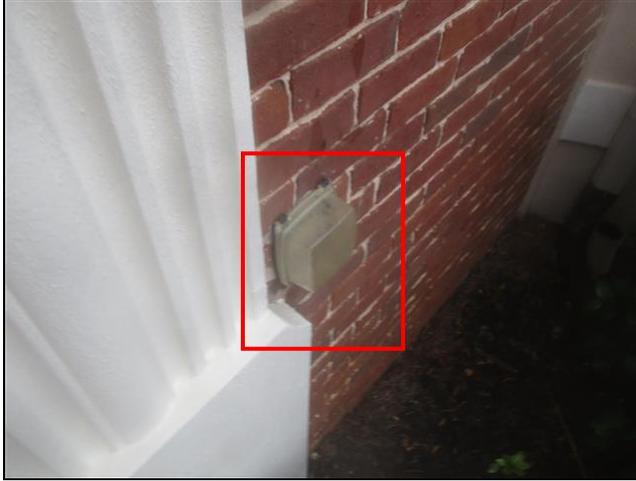
7.6 Item 1(Picture) Exterior, near front door

🔧 (2) Gfci outlets shown in the photos would not trip when tested. Have replaced with working gfci outlets.

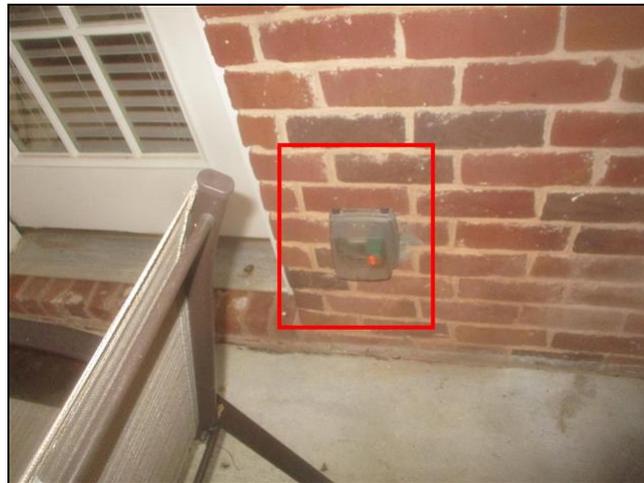
7.6 Item 3(Picture)

🔧 (3) Gfci outlet at the rear exterior of the home as shown in the photo was not functional. Have replaced with a operable gfci outlet.

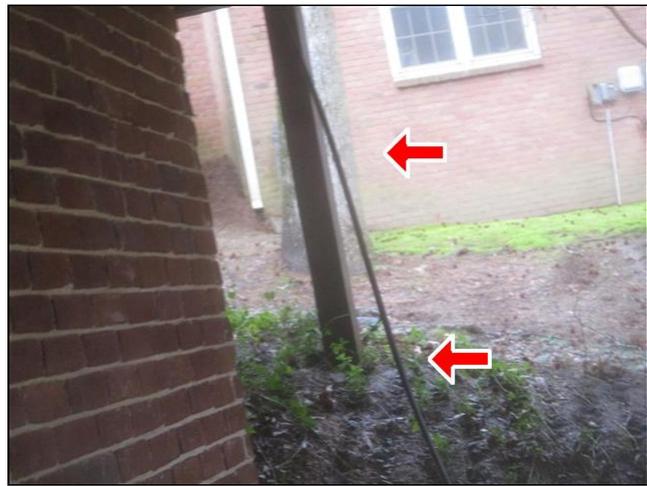
8.0 Item 1(Picture)

🔧 The purpose of the drain line type installation under the rear deck is unclear. Inquire with the owner the purpose of this installation. Depending on purpose of installation have it secured as required. Resolve any further concern prior to closing.

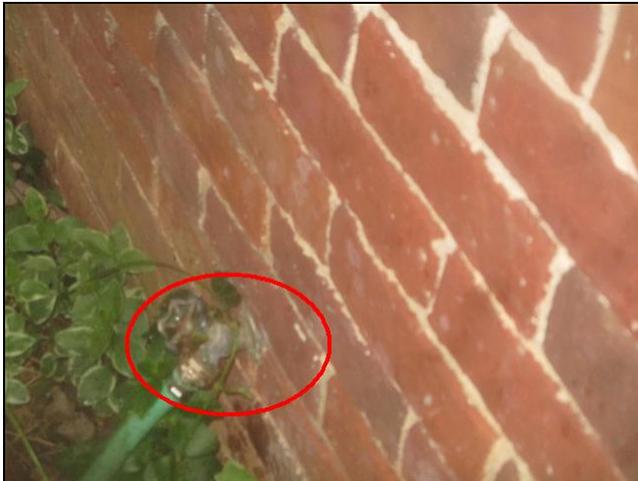
8.1 Item 1(Picture) Left side exterior spigot

🔧 Minor drip like leak associated with the plumbing fixtures shown in the photos. Have fixtures repaired or replaced.

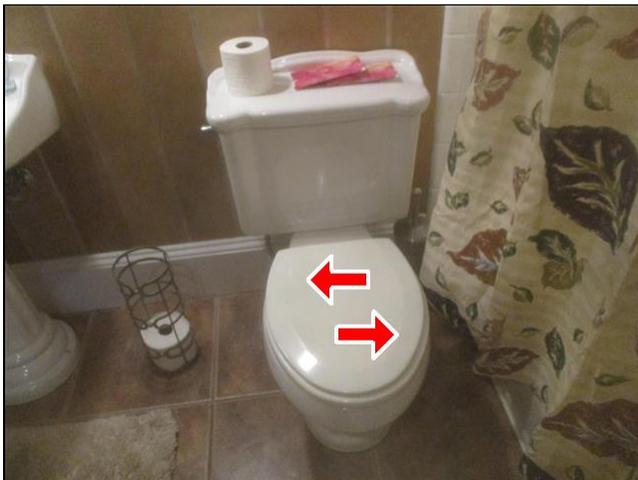
8.2 Item 1(Picture) Basement bathroom

🔧 Loose toilets at locations shown in the photos. Loose toilets can lead to broken wax sealing which could cause the toilet to leak. Have loose toilet secured to the floor.

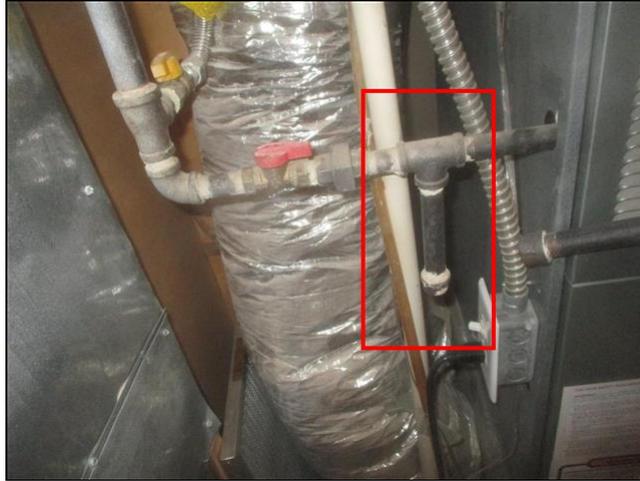
8.5 Item 1(Picture)

🔧 The "T" fitting, (more commonly known as a drip leg or sediment traps) for the basement furnace gas line is installed horizontally. This was permitted when the home was built, however, it does not meet current standards and the gas companies requirements. Hvac tech can evaluate. Gas company may not connect gas for new owner if this is discovered.

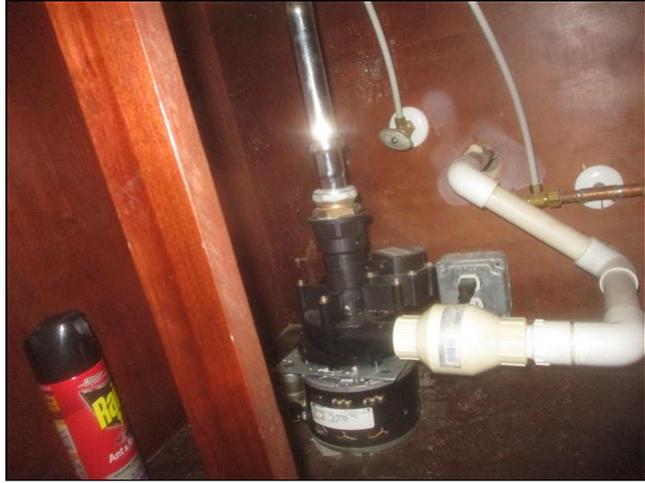
8.7 Item 1(Picture)

🔧 Drain pipe under basement bar sink drains directly into a pump installation. This is not a standard practice. Typically there is a container type installation set up under the sink with an associated pump. Have further evaluated by a plumber/resolve all concerns before closing.

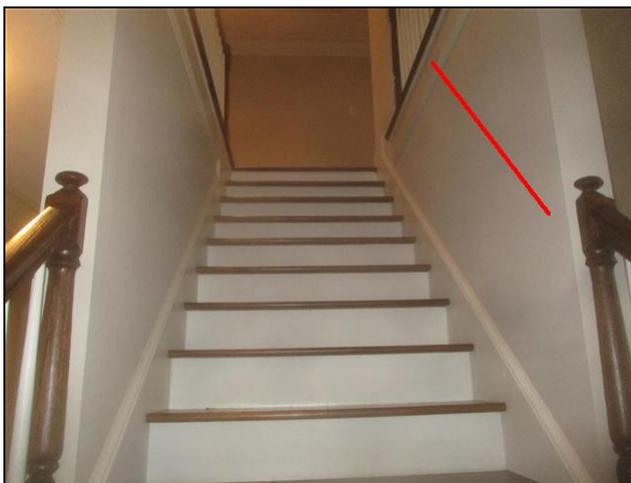
9.3 Item 1(Picture)

🔧 Recommend installing a hand rail for the stairs to the upper level.

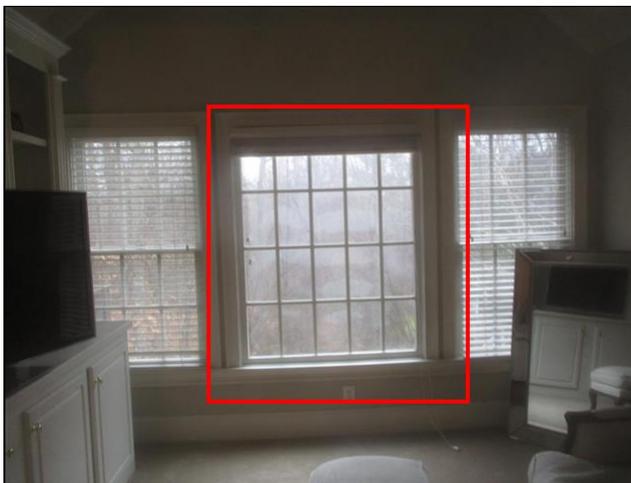
9.5 Item 1(Picture)

🔧 (1) The rear fixed window in the master bedroom as shown in the photo was fogged. The seal between the panes of glass has failed allowing moisture to enter between the panes. It is possible that more windows may fog in the future. Have window contractor evaluate all windows and replace all fogged windows as required.

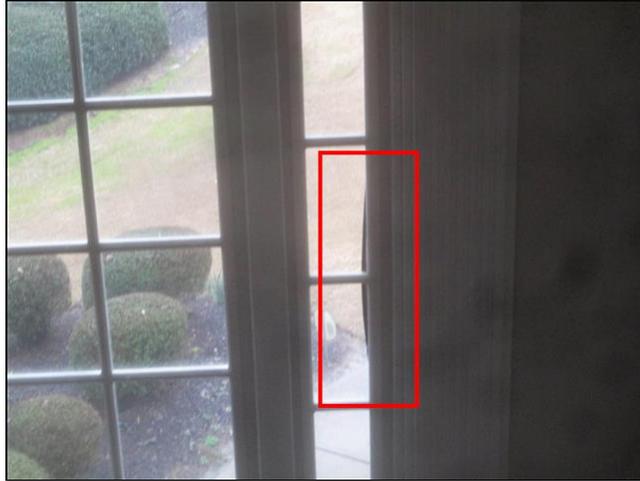
9.5 Item 2(Picture)

🔧 (2) Seal between panes of glass in the rectangle shaped transum type window above the front entry has moved out of position and can be seen in between the panes of glass. Seals have not failed and windows do not appear to be fogged. Resolve any concern prior to closing.

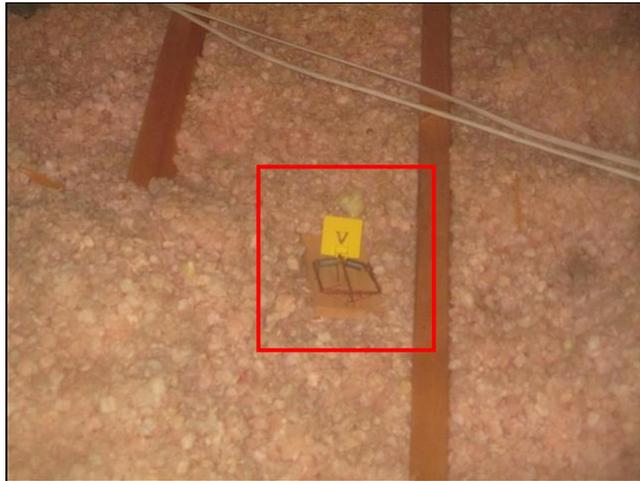
🔧 Evidence of rodent activity in the attic. A pest control company should be consulted to determine if activity is past or present and to repair all possible entry points to the attic and to the entire home.

9.8 Item 1(Picture) Rodent trap
