1289 Whitlock Ridge Dr
Marietta GA 30064

1/16/2020

Capstone MHT Dev, Inc dba HouseMaster
1110 Seale Drive
Alpharetta, GA

Standard Home Inspection - WDI

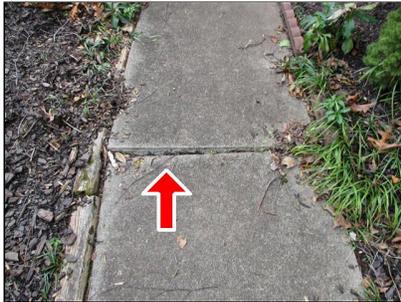
2.0(1) WALKWAYS (Picture 1)
Trip hazard

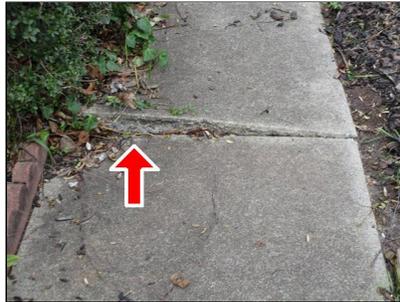
2.0(1) WALKWAYS (Picture 2)
Trip hazard

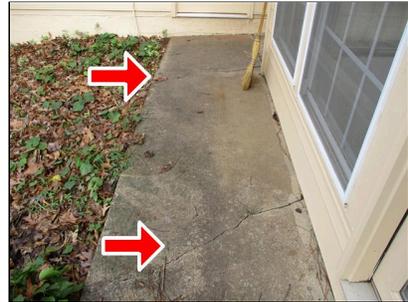
2.0(2) WALKWAYS (Picture 1)
Settlement cracking

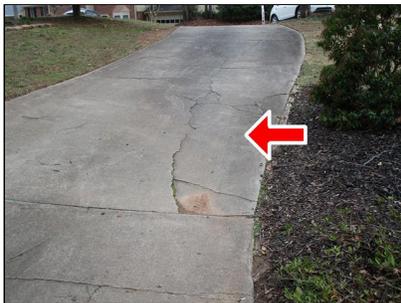
2.1 DRIVEWAY (Picture 1)
Settlement

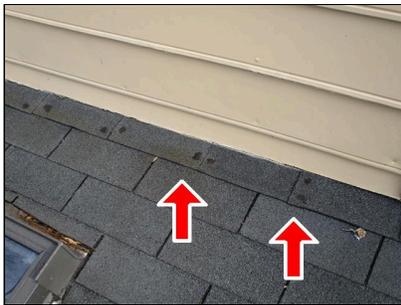
3.0 ROOF COVERING (Picture 1)
Worn sealant

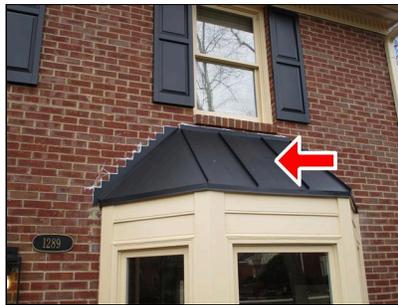
3.1 ROOF COVERING 2 (Picture 1)
Metal roofing

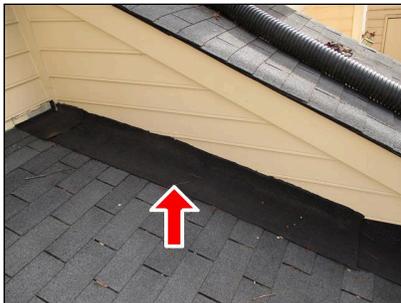
3.2(1) EXPOSED FLASHING
(Picture 1) Improper flashing

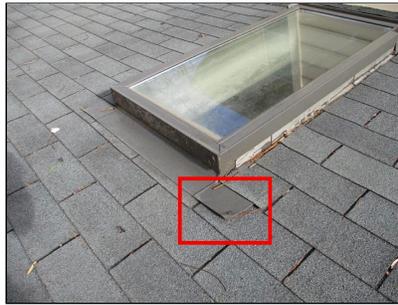
3.5(3) SKYLIGHT(S) (Picture 1)
Loose nail

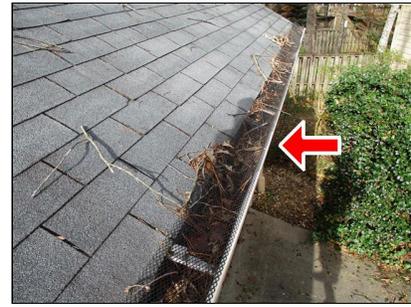
3.6 RAIN GUTTERS /
EAVESTROUGHS (Picture 1)
Clean gutters

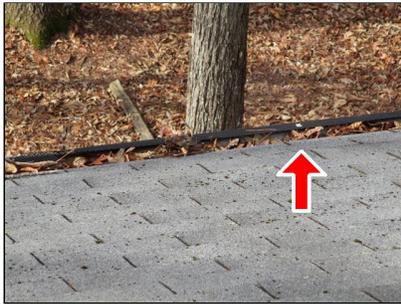
3.6 RAIN GUTTERS /
EAVESTROUGHS (Picture 2)
Missing screen

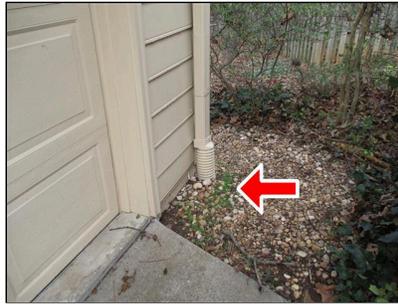
3.7(2) DOWNSPOUTS / ROOF
DRAINS (Picture 1) Ground drain

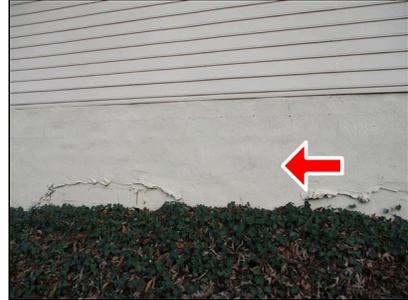
4.4 FOUNDATION (Picture 1) Foundation wall

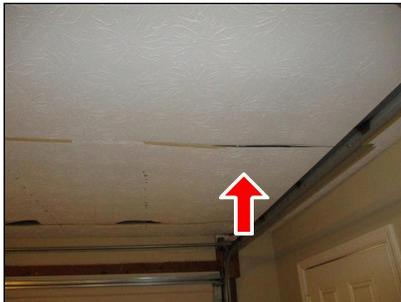
4.5 WALLS / CEILINGS (Picture 1) Settlement

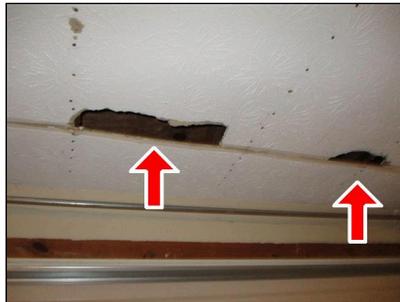
4.5 WALLS / CEILINGS (Picture 2) Damage

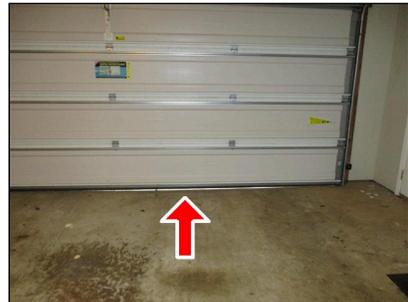
4.6 VEHICLE DOOR(S) (Picture 1) Daylight at door

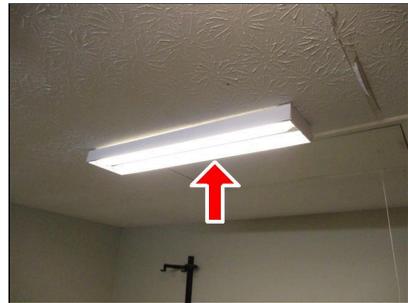
4.8(2) ELECTRIC / GFCI (Picture 1) Missing cover

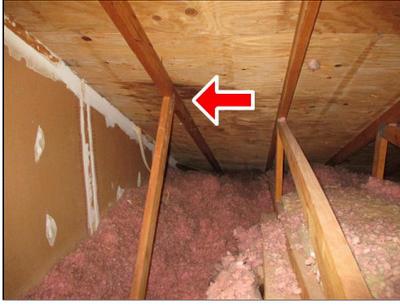
5.1(2) ROOF DECK / SHEATHING (Picture 1) Prior staining

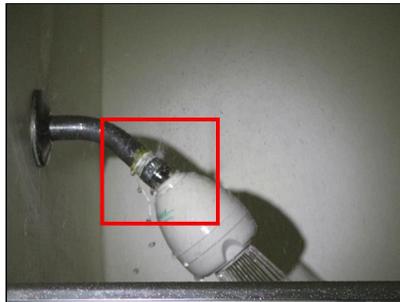
6.10 STALL SHOWER (Picture 1)
Leaking

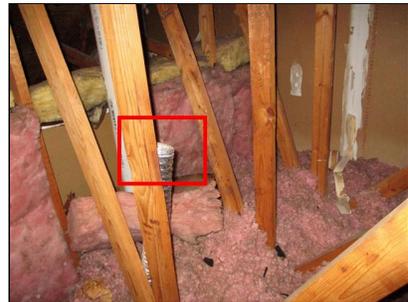
6.14 VENTILATOR (Picture 1)
Bathroom vent

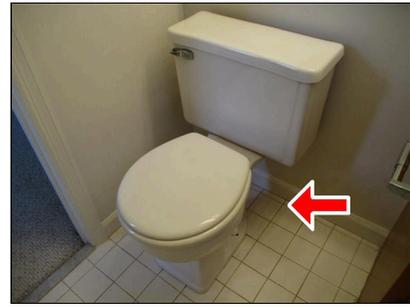
6.19 TOILET (Picture 1) Loose at
floor

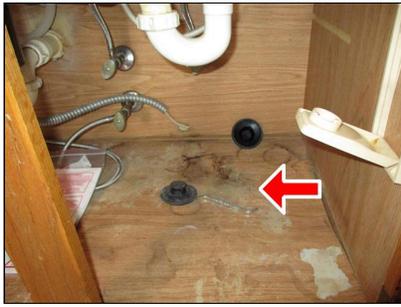
7.0 PLUMBING / SINK (Picture 1)
Prior staining

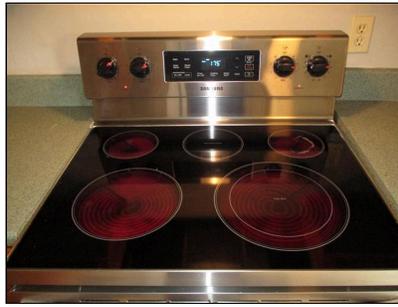
7.4(2) RANGE (Picture 1) No tip
over protection

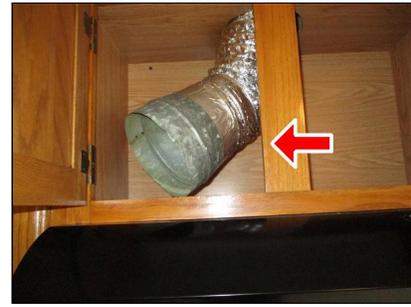
7.7 VENTILATOR (Picture 1)
Loose vent

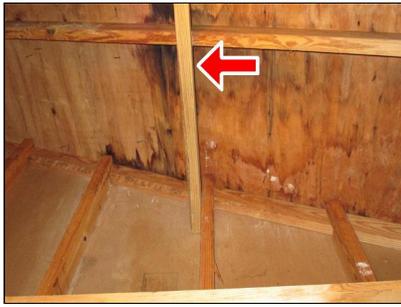
8.0(2) CEILING (Picture 1) Staining

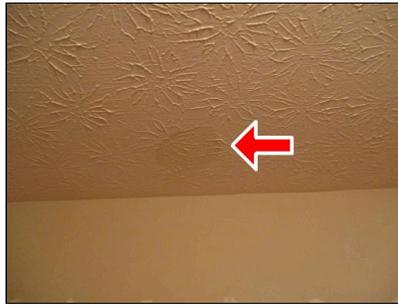
8.0(3) CEILING (Picture 1) Staining

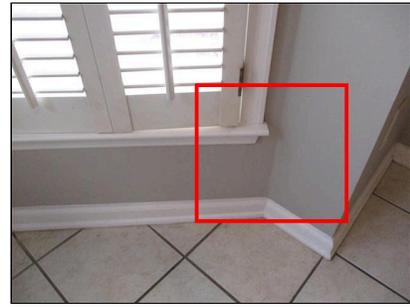
8.1 WALLS (Picture 1) Water intrusion

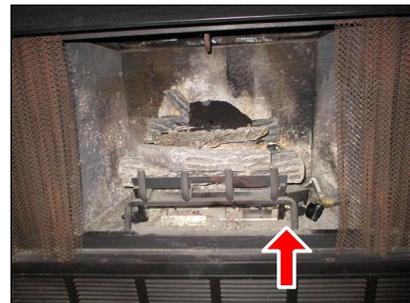
8.9 FIREPLACE (Picture 1) No gas/pilot/knob inoperable

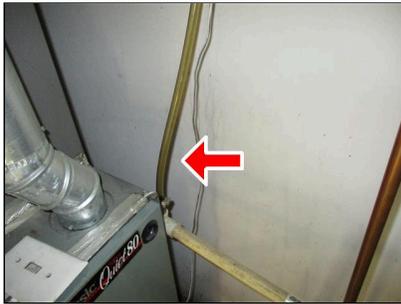
10.4(2) CONDENSATE PROVISIONS - 1 (Picture 1)
Undetermined line

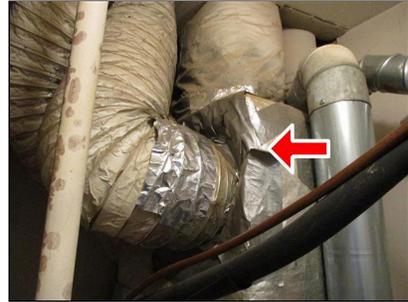
11.6 DISTRIBUTION SYSTEM
(Picture 2) Incorrect tape

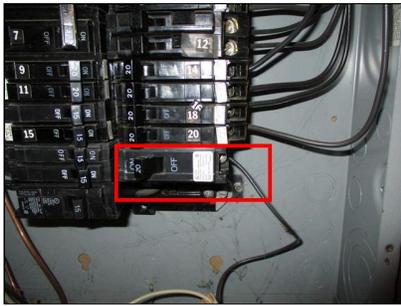
12.3(1) DISTRIBUTION PANEL (Picture 1) Incorrect wire size

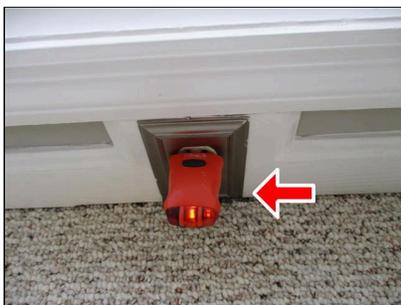
12.4(1) REPRESENTATIVE DEVICES (Picture 3) Check wiring

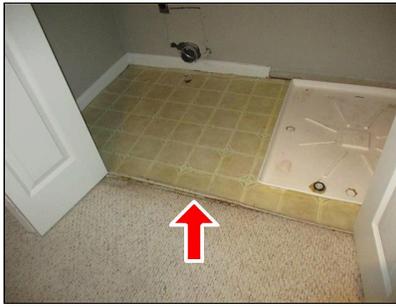
13.5 LAUNDRY ROOM (Picture 1) Peeling

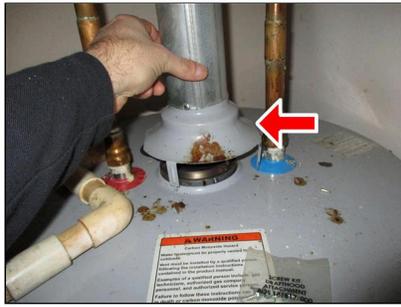
14.2 VENT CONNECTOR
(Picture 1) Loose diverter

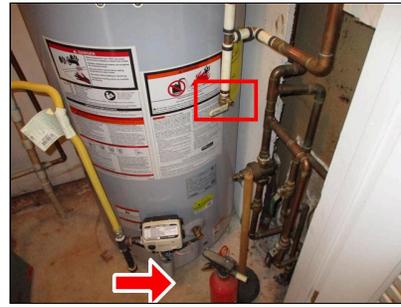
14.4 SAFETY VALVE
PROVISIONS (Picture 1) Drain
tube/no pan

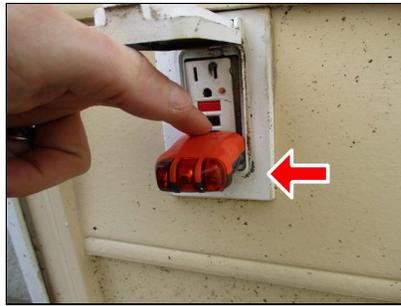
GFCI noted, however, test operation indicated unit malfunctioned or did not work properly. All related circuitry should be inspected by a qualified electrician. Unit is not tripping when tested and receptacle is not secured correctly in the box.

1.7 (Picture 1) Not tripping

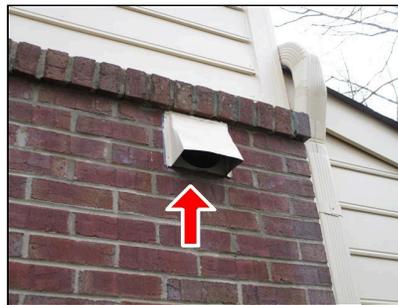
Noted kitchen vent is missing screen to prevent nesting; add as needed.

1.9 (Picture 1) No screen

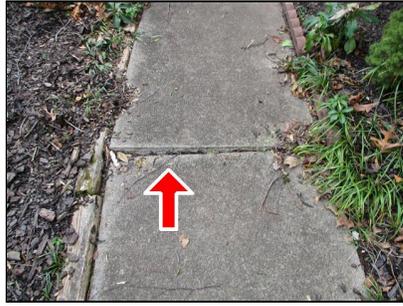
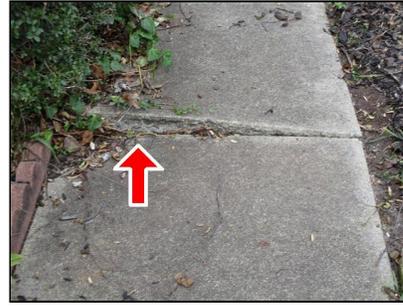
2.0 (1) Cracking noted-trip hazard; repair as required.

Trip hazard

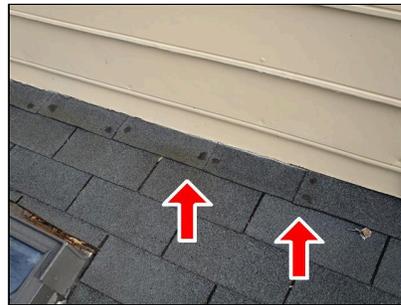
Noted exposed nails in shingles and improper flashing methods used at roof and siding unions; recommend consulting a qualified roofer for remedial needs and costs.

3.0 (Picture 1) Worn sealant

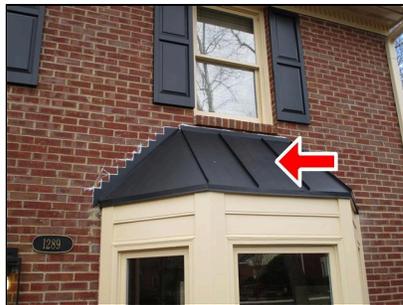
Typically metal sheathing is a superior roofing material than composite shingles; however the rubber grommets may dry and crack over time and allow water penetration. Also noted no sealant at brick veneer and flashing over roof covering as well as signs of water intrusion at bay window; repair as needed. See note 8.1

3.1 (Picture 1) Metal roofing

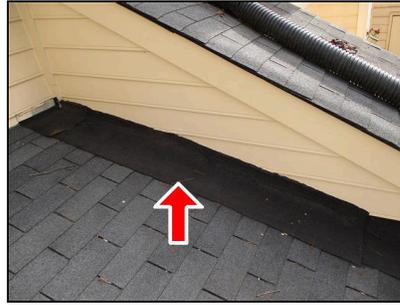
3.2 (1) Noted improper flashing at roof and siding union, step flashing/counter flashing is covered with roofing material and sealant; recommend having checked and repaired by a qualified contractor.

Improper flashing

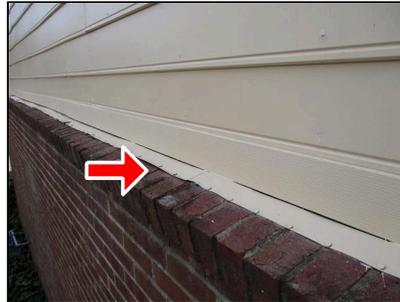
3.2 (2) Noted transition flashing at brick and siding union has been nailed into brick veneer. Exposed nails and improper installation could lead to water penetration; have checked and repaired by a qualified contractor.

Nailed flashing

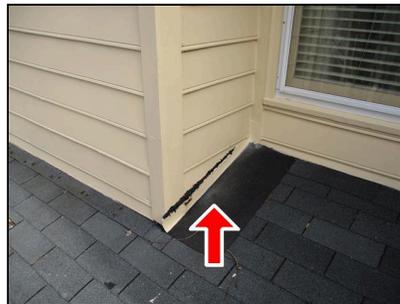
3.2 (3) Noted improper flashing at the chimney; reseal and maintain as required.

Check flashing

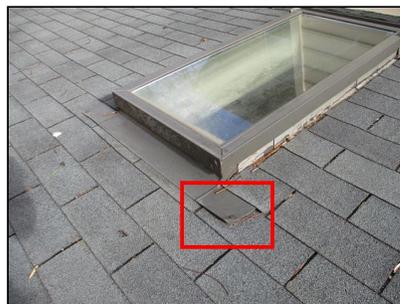
3.5 (3) Noted loose nails/exposed nails at skylight flashing; repair as needed. Have checked and repaired by a qualified roofer. Nails should not be used in the exposed area of the flashing. If and when nails are used, the nail heads should have asphalt plastic cement applied over them.

Loose nail

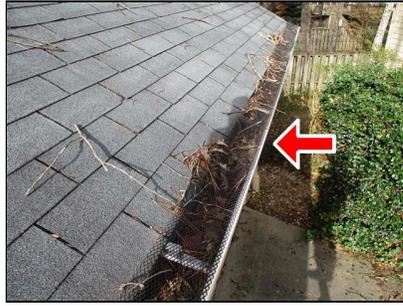
Gutters filled with debris; keep clean for proper function. Some areas of gutter screens are missing; repair as needed.

3.6 (Picture 1) Clean gutters

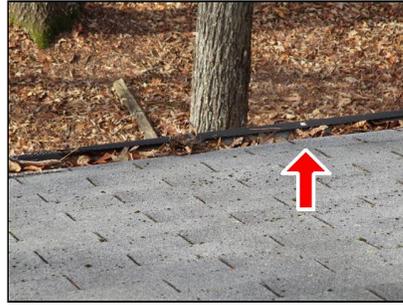
3.6 (Picture 2) Missing screen

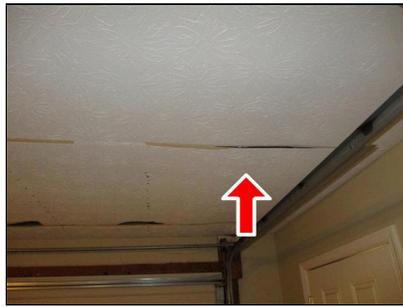
Noted areas of damage and settlement; repair as needed.

4.5 (Picture 1) Settlement

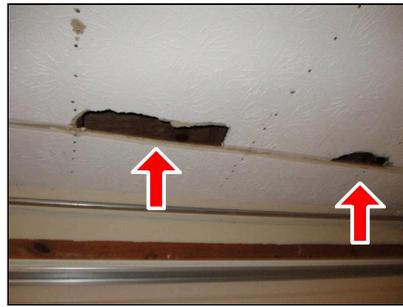
4.5 (Picture 2) Damage

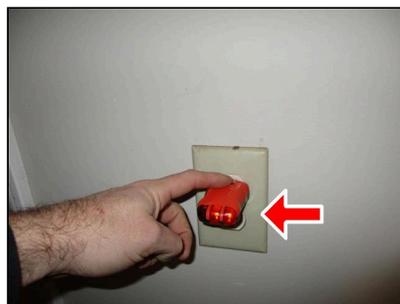
No GFCI

4.8 (1) Although perhaps not required when the home was built; strongly recommend installing GFCIs as appropriate.

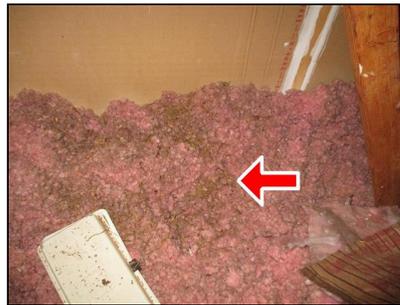
Noted traps and nesting in attic; recommend consulting a qualified pest control company for remedial needs and costs prior to closing.

5.6 (Picture 1) Nest

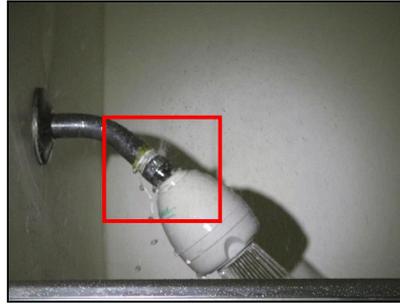
Noted showerhead is spraying walls and ceiling from connector. A leaking showerhead should be repaired for proper operation and to prevent consequential damage from uncontrolled spray. Long-term leakage can damage finishes and structural component.

6.10 (Picture 1) Leaking

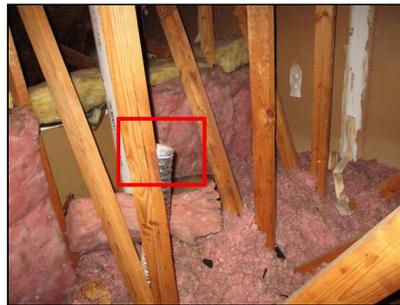
The bathroom exhaust fan should discharge directly to the exterior to prevent excess moisture concerns in the house or attic area. Recommend extending the duct to a suitable discharge point or correcting the current arrangement as conditions warrant.

6.14 (Picture 1) Bathroom vent

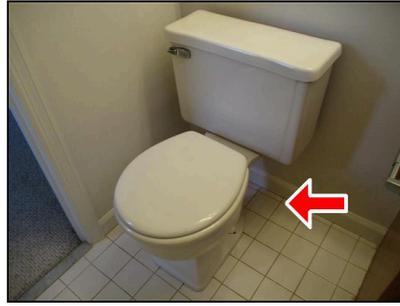
Toilet is loose at the floor; check for leakage/damage and secure as required.

6.19 (Picture 1) Loose at floor

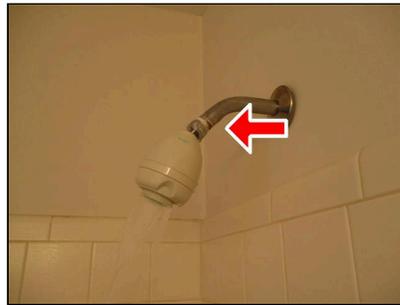
A leaking showerhead should be repaired for proper operation and to prevent consequential damage from uncontrolled spray. Long-term leakage can damage finishes and structural component.

6.20 (Picture 1) Leaking

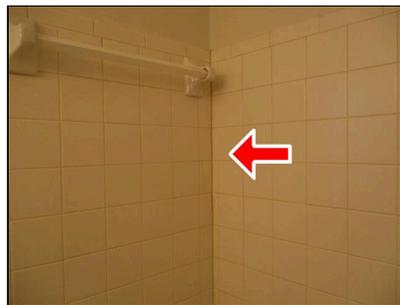
Noted worn grout at tile in shower. Caulking and/or grouting work is required to maintain the watertightness of tile and the tub/shower enclosures. Check for substrate damage if surface damage or leakage is present, and when performing regular maintenance.

6.21 (Picture 1) Seal as needed

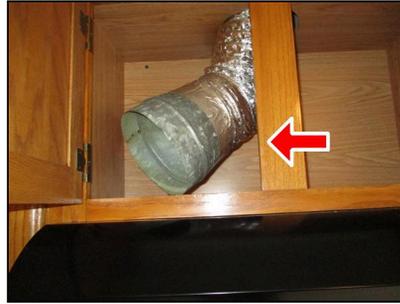
Noted vent is not attached in cabinet and hole in cabinet is not correct size to fit vent; repair as needed.

7.7 (Picture 1) Loose vent

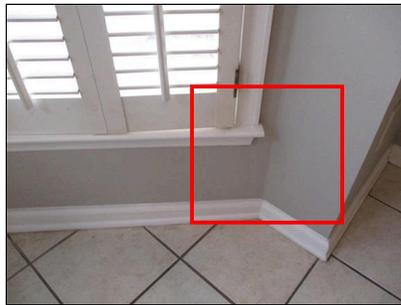
Noted water intrusion at bay window in kitchen; recommend further investigation by a qualified contractor to determine remedial needs and costs prior to closing.

8.1 (Picture 1) Water intrusion

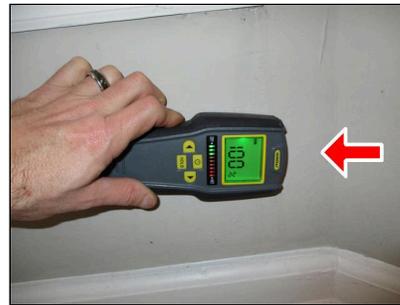
8.1 (Picture 2) Moisture 100%

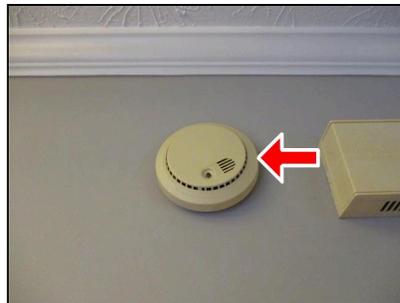
8.8 (1) Noted detector in foyer hallway failed to operate when tested; repair as required for safety. Although not required when the home was built, recommend adding carbon monoxide detectors as appropriate. Smoke and carbon monoxide detector should be tested upon moving in to home.

Inoperable

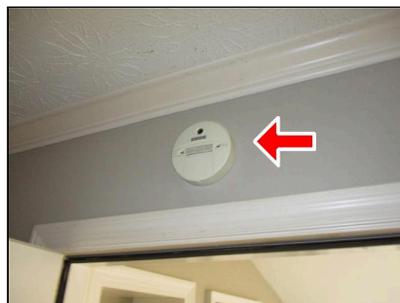
8.8 (2) CO detector over sunroom has expired; replace as needed.

Expired detector

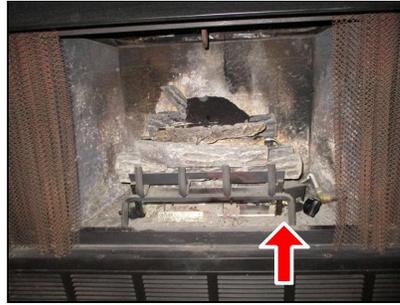
Noted gas was not operational at the burner unit; have checked and repaired by a qualified contractor.

8.9 (Picture 1) No gas/pilot/knob inoperable

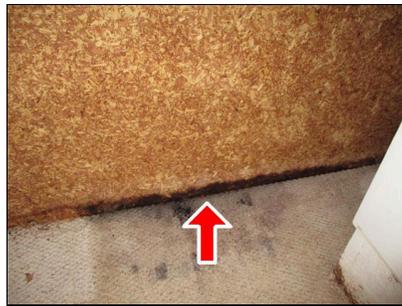
Noted water intrusion at storage room in rear of home; recommend consulting a qualified contractor for remedial needs and costs. This could be due to roof drainage concerns or patio slope from neighboring unit. Unable to determine as this area was not visible from the property and permission may be needed to access the neighbors property.

9.1 (Picture 1) Water intrusion

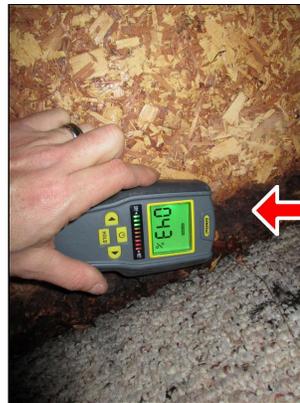
9.1 (Picture 2) High moisture

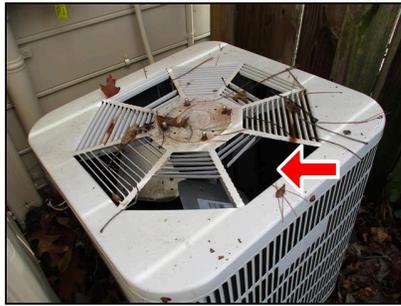
10.2 (2) Noted vent grates at top of unit have been removed. The fan should be protected from access to prevent possible injury; repair as needed.

Safety concern

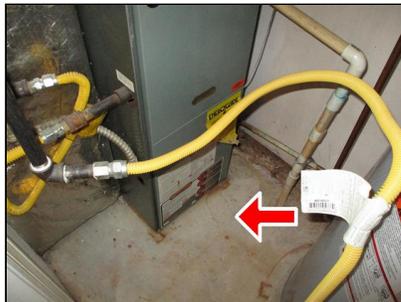
10.4 (1) Noted missing moisture cutoff switch and drip pan. Because the unit is in a finished area of the home, recommend adding as needed.

No pan/switch

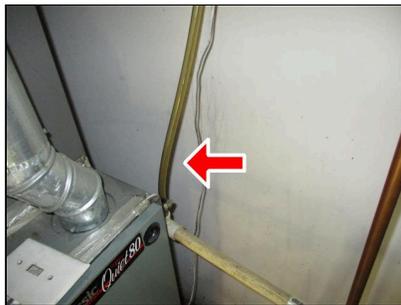
10.4 (2) Noted undetermined plastic drain line terminating into condensate line; recommend checking with seller regarding purpose.

Undetermined line

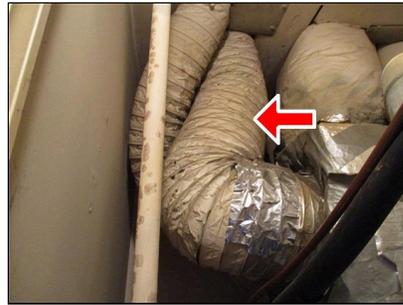
Noted some visible duct work is not insulated; add as needed for energy conservation and to prevent condensation. Also noted incorrect tape at duct and plenum connection, temperature rated foil tape and/or mastic should be used to seal vent. Duct tape will peel and fail over time.

11.6 (Picture 1) No insulation

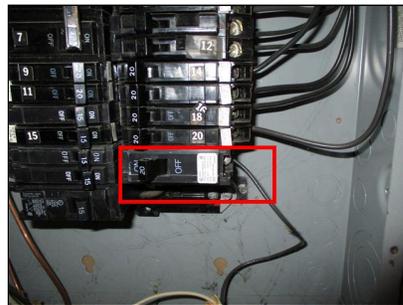
12.3 (1) Noted incorrect gauge wires for circuit breaker amperage; recommend consulting with qualified electrician for remedial needs and costs prior to closing.

Incorrect wire size

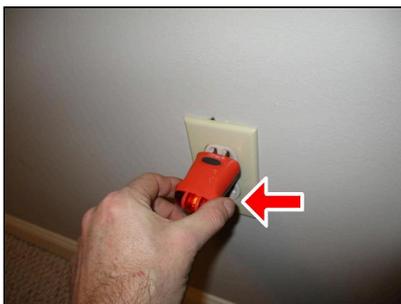
12.4 (1) Noted loose receptacles/flickering tester at outlet in living room and floor outlets in sunroom. Have receptacles checked for loose connections and repair as needed.

Check wiring

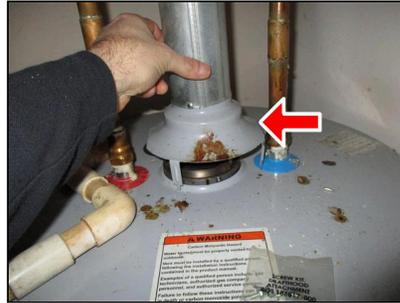
Noted drafter diverter is loose at unit; repair as required. All venting systems must be maintained to ensure an adequate draft. Any indication of a potential concern requires immediate attention as health/safety hazards may exist, including the introduction of carbon monoxide into the house air.

14.2 (Picture 1) Loose diverter
