# **Inspection Report**

Property Address: 3520 Newport Bay Dr Alpharetta Ga 30005

**Inspector: Brandon Williams**

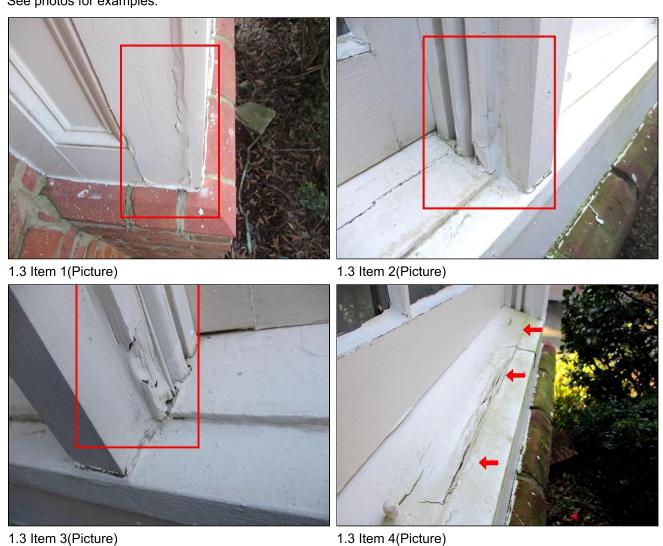
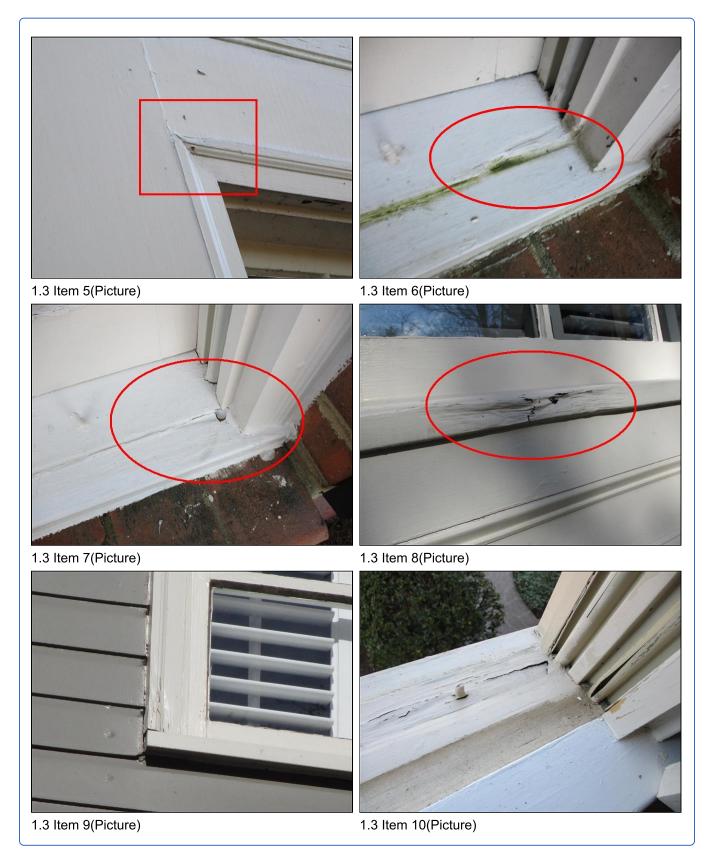
1.3 Item 11(Picture)

(1) Water damaged wood found on many windows, sills and trim. Have contractor evaluate all windows and have all damaged wood replaced. Extent of damage behind siding, if any, is not visible and is not known. See photos for examples.

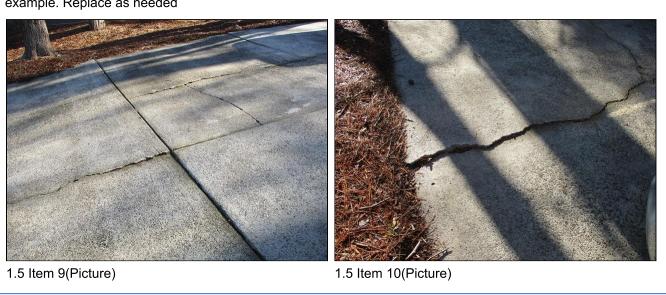
(4) Settlement of fill dirt under driveway has created some minor trip hazards in the concrete. See photo for example. Replace as needed

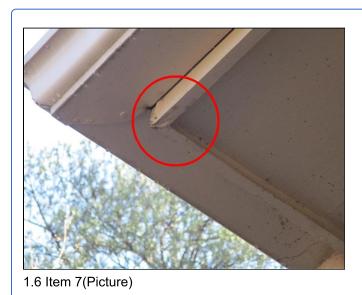
1.6 Item 5(Picture)

Water and rodent chewing damage found on soffit and fascia trim in several areas. See photos for examples. Have contractor evaluate all soffit/fascia and have all damaged wood replaced. 1.6 Item 1(Picture) 1.6 Item 2(Picture) 1.6 Item 3(Picture) rodent chewing damage 1.6 Item 4(Picture)

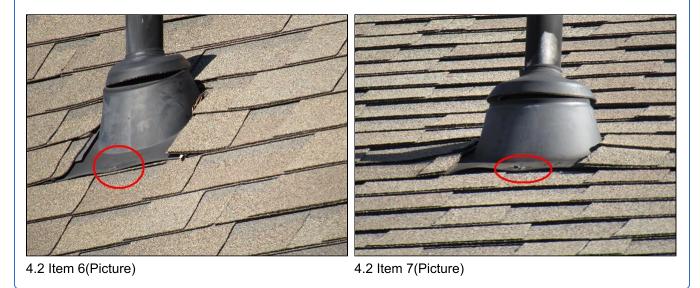
(2) Boot flashing around plumbing vents on the roof are ok now, but these last about 5-7 years before needing replacement. They crack and split and allow rain water to leak into attic.

Seal all exposed nail heads with tar or other type of sealant on the roof vents and exposed nail heads on the boot flashing. This will help prevent leaks.

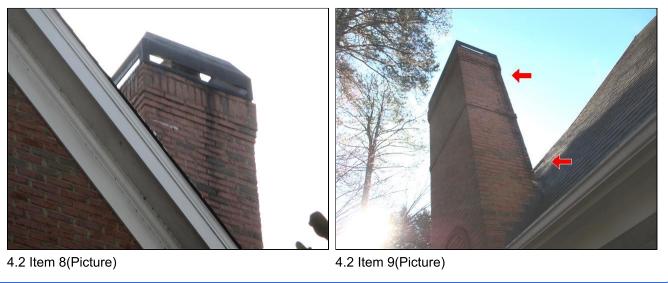
(3) Water stains noted on the chimney chase, originating from the chimney cap. It is believe that the chimney caps are bowl shaped and beginning to rust, but due to height I was not able to confirm. Have a roofer evaluate and replace chimney caps as needed

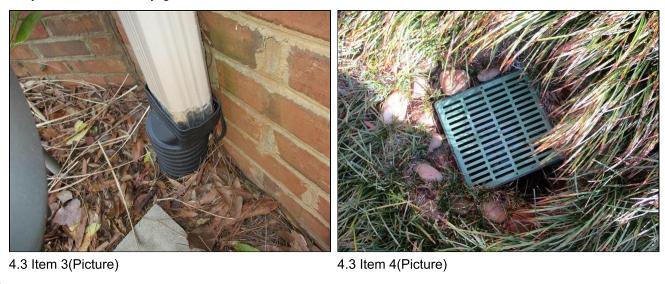
(3) Have owner point out location of the outlets of the buried down spout extensions and yard drains. They should come to daylight and the ends were not found.

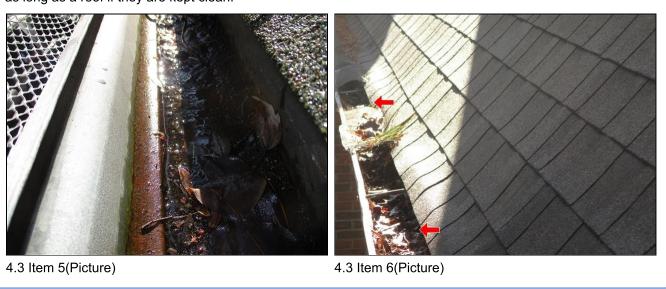
(4) Gutters are rusting in areas and will need to be replaced in the near future. Gutters usually last about as long as a roof if they are kept clean.

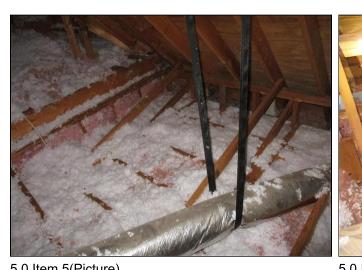
5.0 Item 4(Picture)

Insulation in the attic is missing or is less than normal in several areas. See photo. Have more added to bring levels equal to R-30 IECC

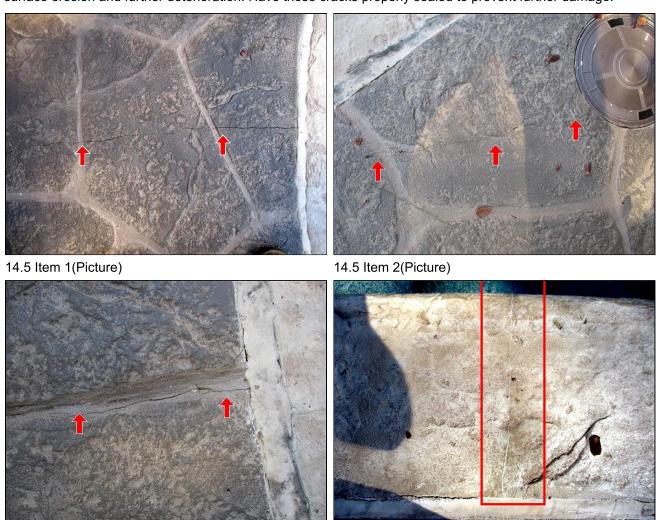
14.5 Item 4(Picture)

Cracks are visible in the pool deck and coping. These cracks are typically the result of water entering below the slab from gaps in the coping and/or wear. Exposed cracks will allow water to enter below, create sub surface erosion and further deterioration. Have these cracks properly sealed to prevent further damage.

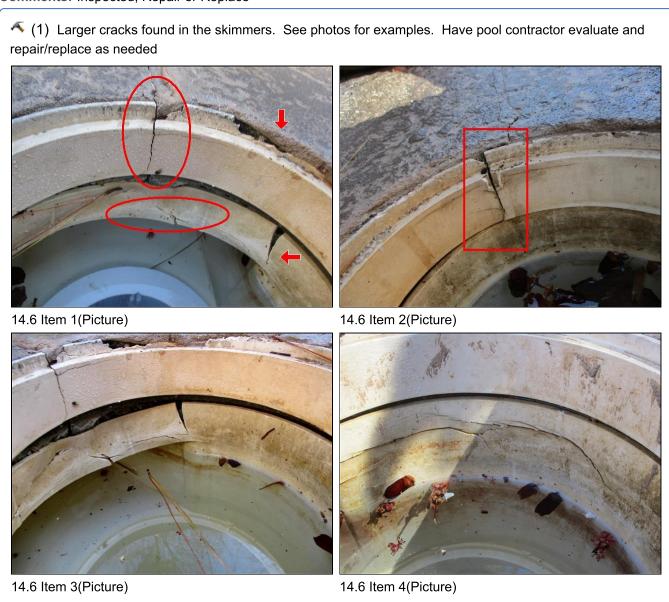
(2) The inner liner for the skimmer is not sealed to the walls. Seal the gaps between the liner and the wall. This will help prevent water from entering below the deck surface
