Atlanta Property Inspections, Inc.

HOME INSPECTION REPORT

2324 Blackberry Court, Snellville, GA 30078
Inspection prepared for: Mai Hue Welshams
Date of Inspection: 11/16/2019 Time: 9:30 AM
Age of Home: 21 Years Old (1998) Size: 2270 SF
Weather: Sunny, Damp Soil, 45 Degrees

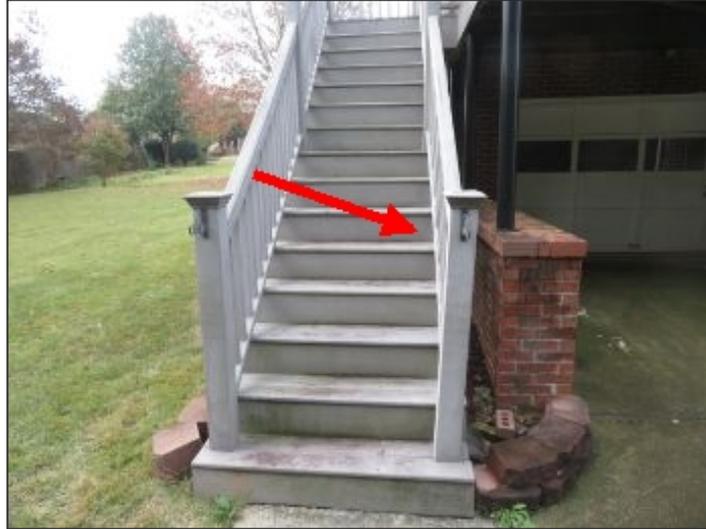
The hand / guard railings are loose at the rear deck steps. This condition is a safety concern. Repair is advised to fully secure the loose railings.

Loose railings at rear deck

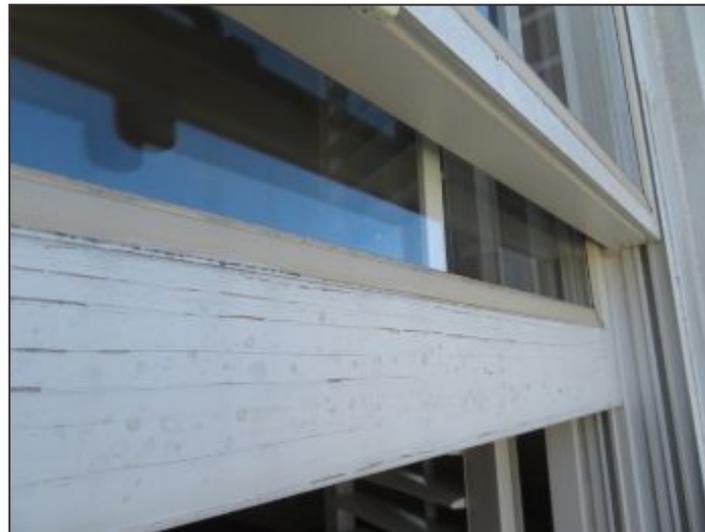
• **Peeling paint and bare wood was noted at several window frame locations (see photo of front bonus room window) Repainting is suggested to to fully seal and protect these locations.**

Peeling paint at exterior side of windows

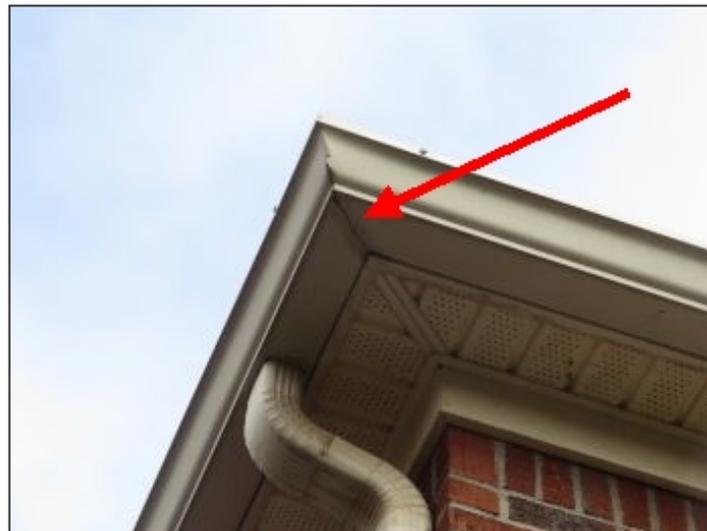
- **A gutter seam leak was noted at the rear right corner roof based on visible staining on the bottom edge of the gutter (see photo). This condition can lead to water damage at the roof fascia and soffit if not corrected. Repair is recommended.**

Gutter seam leak at rear corner roof

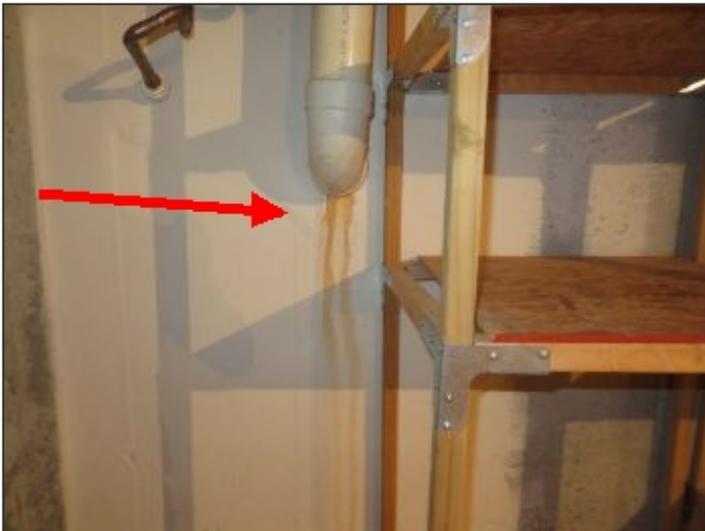
• **Evidence of water entry was observed at the basement wall plumbing drain pipe penetration based on water stains (see photo). It appears that ground water entry has occurred at this location. Further evaluation and repair is recommended by a professional water proofing contractor to fully seal this location to prevent future water entry.**

Evidence of water entry at plumbing drain line penetration

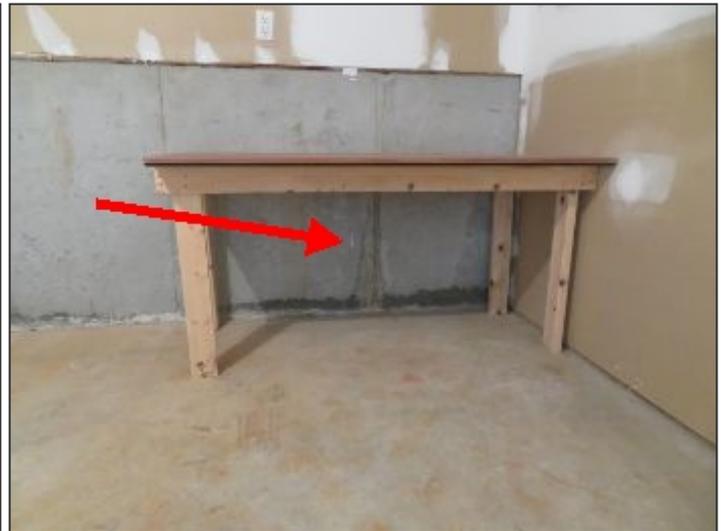
• **A few basement wall cracks were noted at the right side and rear basement garage walls. The cracks have some visible water staining which is an indication of ground water penetration through the wall (see photo). Further evaluation is recommended by a professional water proofing contractor to determine the full scope of repair needs and costs. The use of a professional grade epoxy sealant is suggested for a long term repair.**

Evidence of water entry at side foundation wall in garage

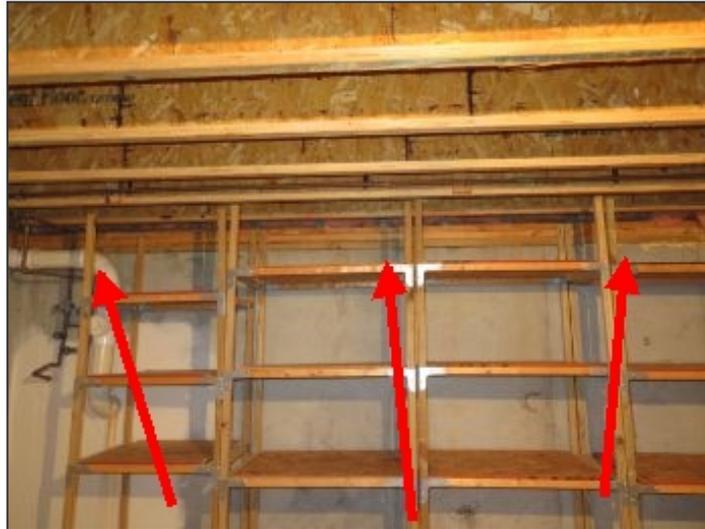
• **Multiple foundation anchor straps are not secured or nailed as required at the front and right side foundation walls (see photos). The inspector was able to count atleast 8 unsecured straps. Correction is recommended to meet minimum foundation anchorage requirements.**

Foundation anchors not secured to sill plate

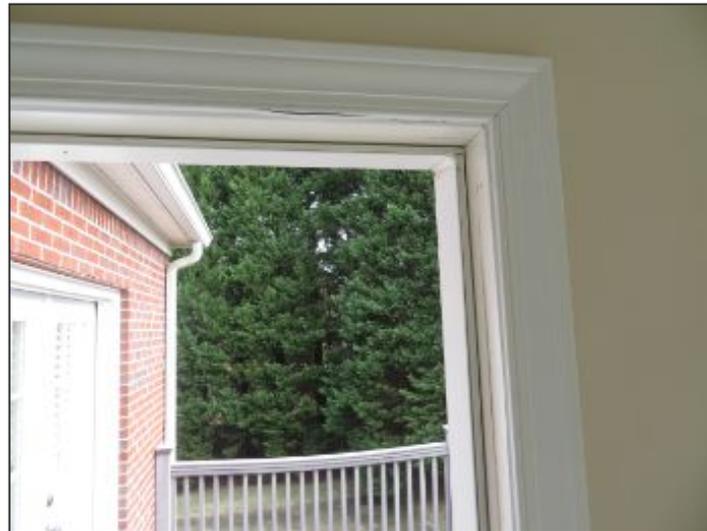
• **Missing and or defective weather stripping was found at the two deck entry doors (see photos). Daylight is present and air infiltration is occurring into the home. Repair is recommended so that the exterior doors are fully sealed when closed.**

Missing weatherstripping at rear deck entry door

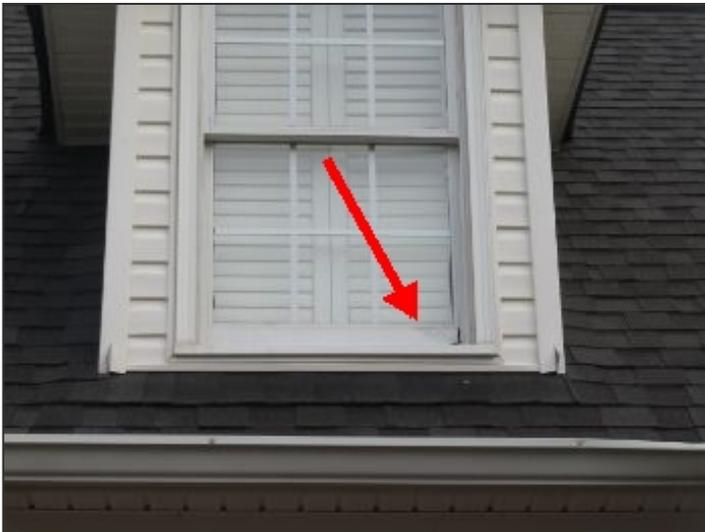
Damaged window frame at right dormer window

The damaged frame is difficult to repair and may require full window replacement. Further evaluation is recommended by a professional window contractor to determine the full extent of repair or replacement needs and costs.

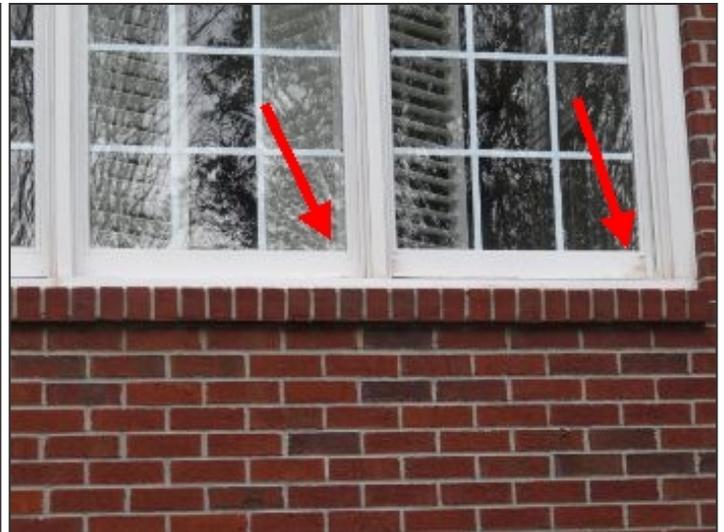
Damaged window frames at rear sun room

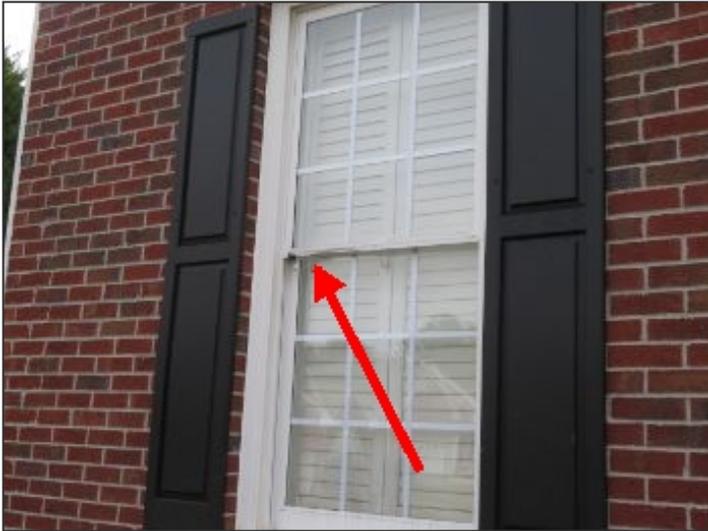
Damaged window frame at front left garage window

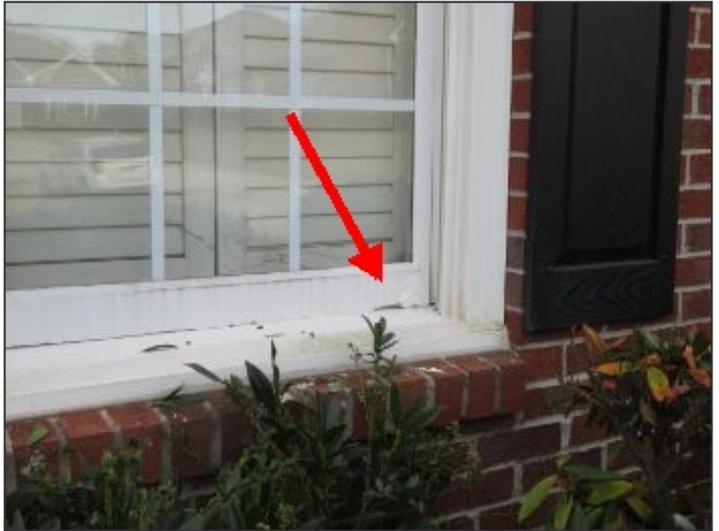
Damaged window frame at front right garage window

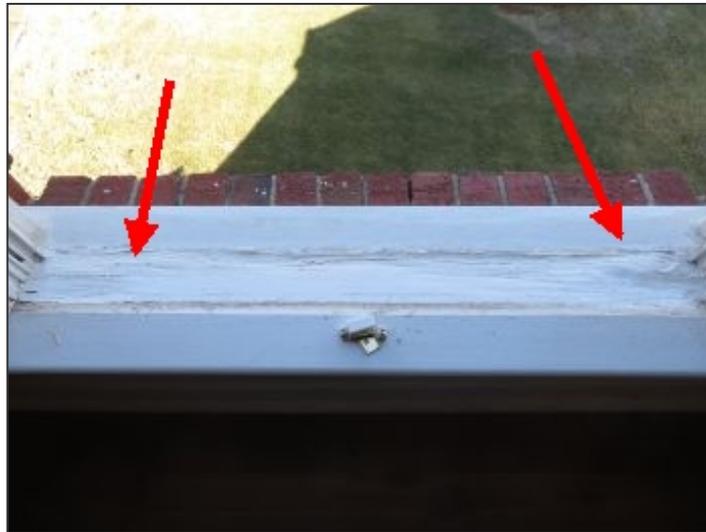
• Significant water damage was noted to the window sill at the front bonus room wall window (see photo). The damaged sill is difficult to repair and may require full window replacement. Further evaluation is recommended by a professional window contractor to determine the full extent of repair or replacement needs and costs.

Damaged window sill at front bonus room window

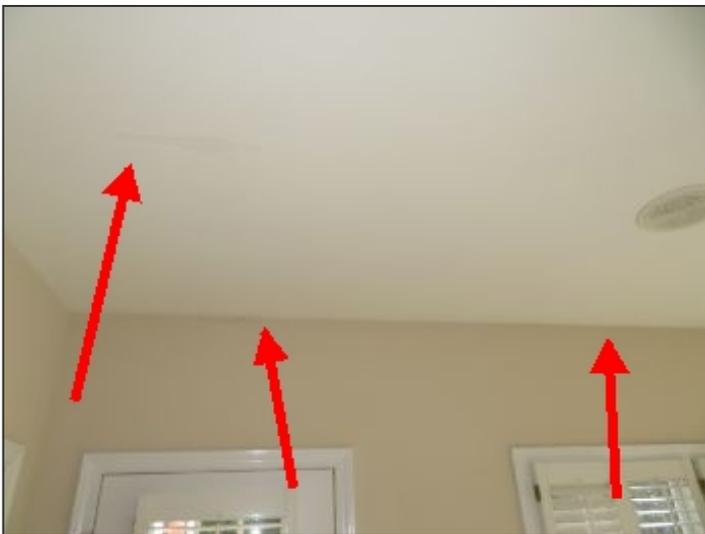
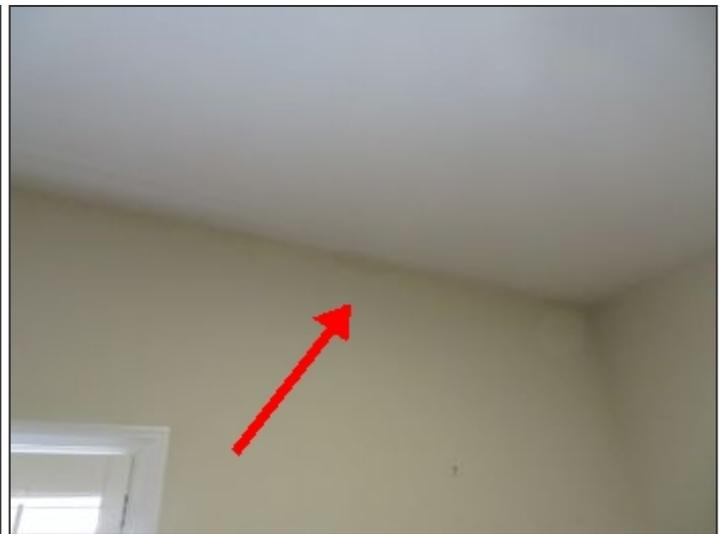
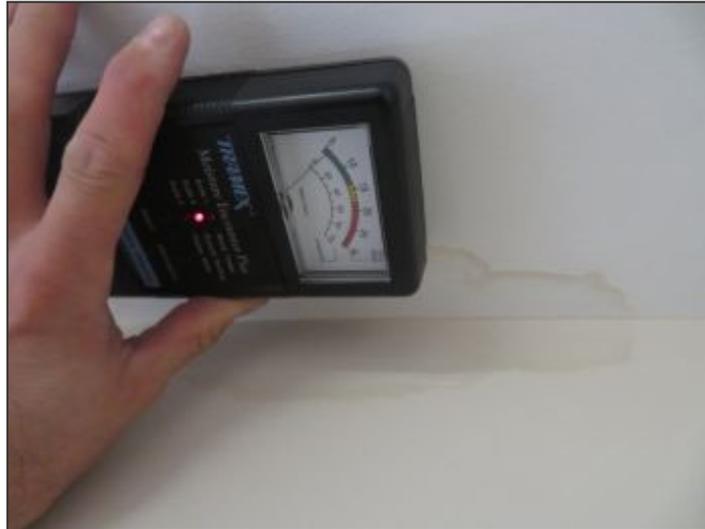
This is an indication of an active or previous leak. Ask seller for full disclosure information regarding this leak. The stained areas were tested with a moisture meter and was found to be dry (see photos). Continue to monitor, future repairs may be needed.

Water stains at sun room ceiling

Water stain in center bedroom

Water stain tested dry in center bedroom

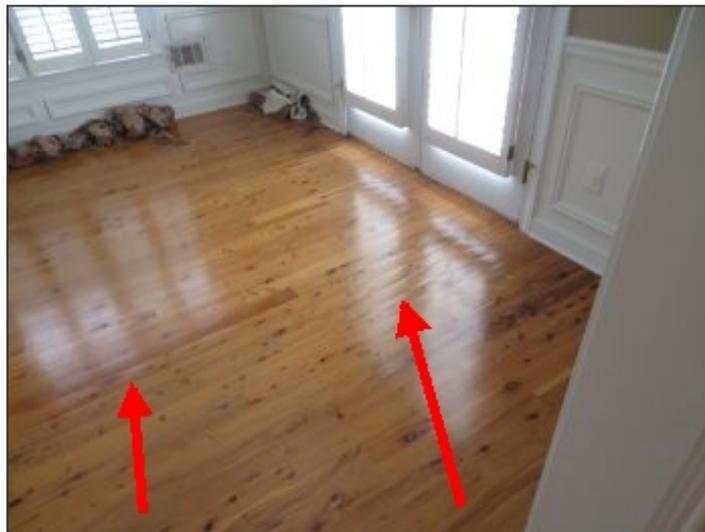
• The hardwood flooring at the rear dining room has suffered some minor moisture damage (see photo). The flooring is warped and cupped in this area. This condition is most often caused by a source of moisture such as a leak, or possible moisture / humidity from a crawl space or basement below the floor. Further evaluation is recommended by a professional hardwood flooring contractor to determine the full extent of repair needs and costs - some or all of the flooring may need to be sanded and refinished which could develop into a major expense. In addition, the source of the moisture should be evaluated and corrected.

Cupped flooring in dining room

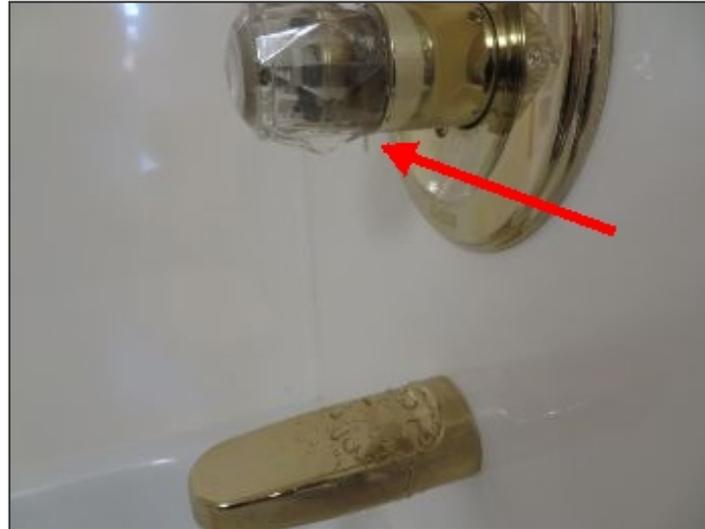
• An active leak was found at the upstairs bathtub handle valve when the water is turned on. This may be an indication of a worn washer inside the valve. Further evaluation and repair is recommended by a professional contractor.

Active leak at handle valve in upstairs bathroom tub

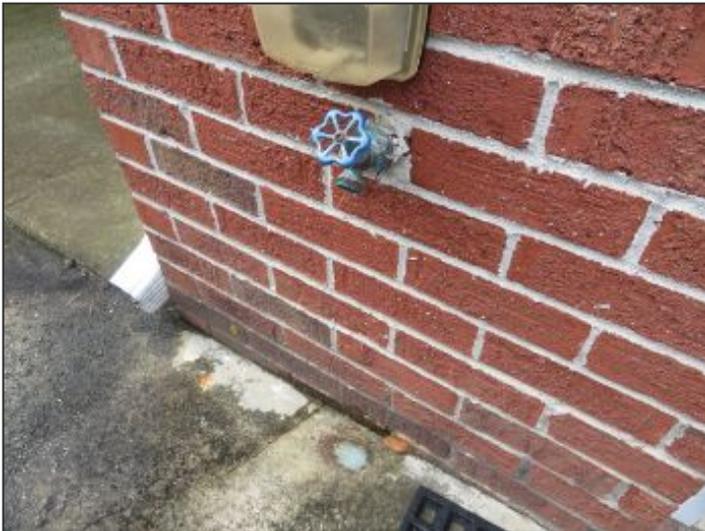
- **An active drip leak was found at the rear hose bib while the handle is in the off position (see photo). Further evaluation is recommended by a professional plumber to determine repair / replacement needs and costs.**

Active drip leak at rear hose bib while handle in off position

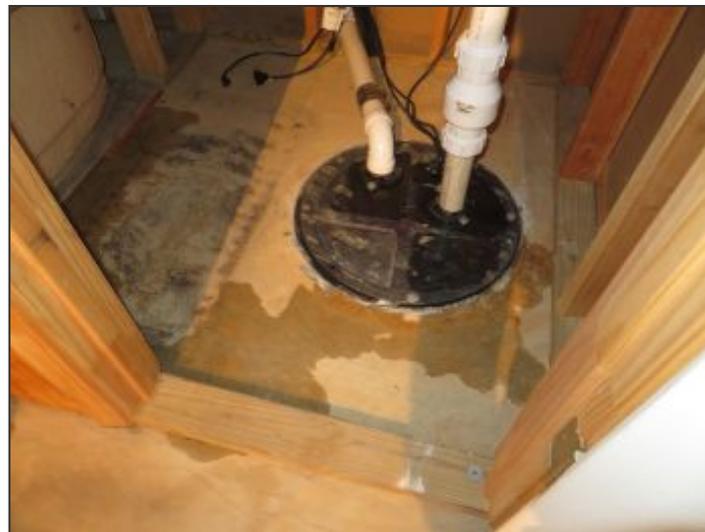
• The basement sewage ejector pump is inoperative and did not come on during testing of the basement bathroom. The pump motor pug was unplugged at the start of this inspection and was plugged in for testing. During testing of the basement bathroom, water started flowing from the tank lid. The bathroom fixtures were turned off and the plumbing test was stopped. Further evaluation is recommended by a professional plumber to determine the full scope of repair / replacement needs and costs.

Sewage ejector pump inoperative and overflowed

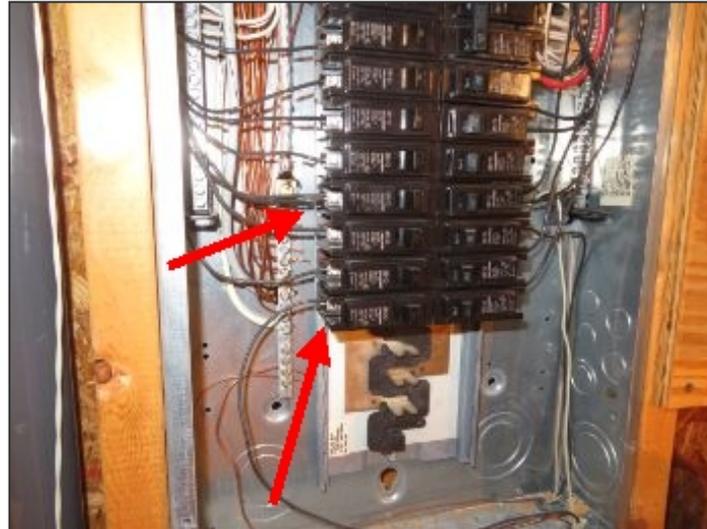
- **The two main panels are located in the basement. Circuit breakers are present.**
- **Improper wiring was noted at the bottom left 20 amp circuit breaker in the right panel box (see photo). The circuit incorrectly has 14 gauge wire which does not meet the safety requirements of the National Electric Code. The minimum wire size for this 20 amp circuit is a 12 gauge wire. Further evaluation and correction is advised by a licensed electrician to meet the safety requirements of the NEC.**

- **Improper Wiring: A **double tap** wiring connection is present inside lower left portion of the right the panel box - two wires are connected to one circuit breaker (see photo). This condition is not allowed for this type of circuit breaker and can create loose connections at the breaker or possible overload conditions. Correction is advised by a licensed electrician to meet the safety requirements of the National Electric Code (NEC).**

Improper wire size and double tap breaker in panel box

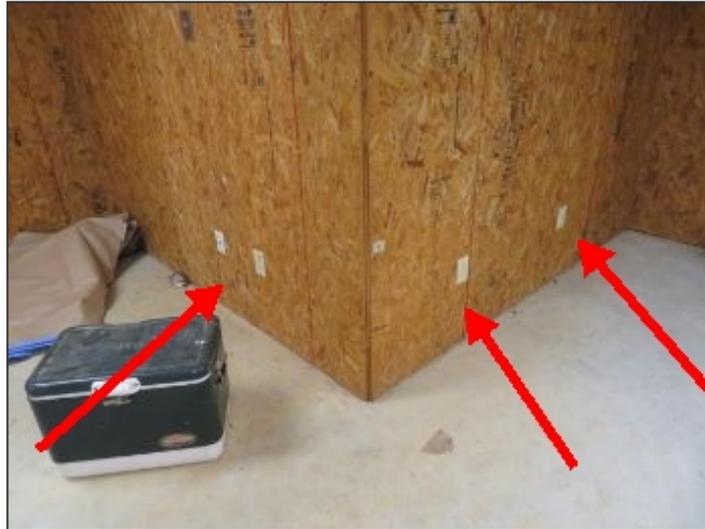
• **Three outlets at the front walls in the basement room below the kitchen are incorrectly wired and has hot and neutral wires reversed (reversed polarity - see photo). Correction is recommended.**

Improperly wires outlets in front basement room

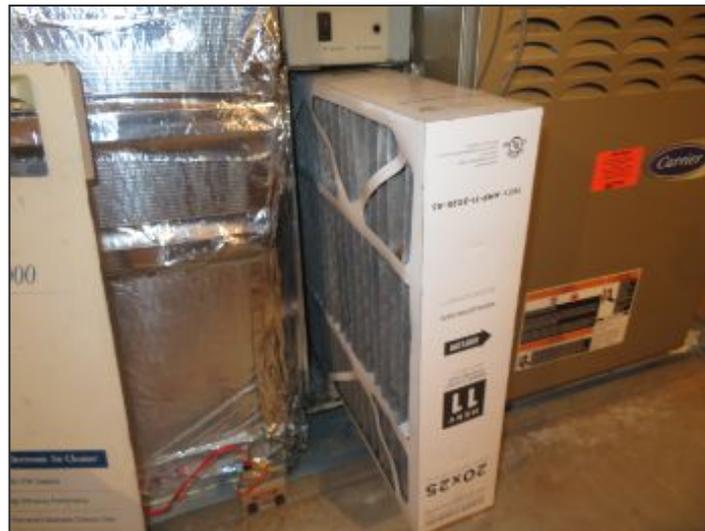
• The filters are dirty; because a dirty air filter decreases the filter's effectiveness and blocks air flow for the entire HVAC system, it is suggested that the filters be replaced with a new clean one.

Media filters present at HVAC systems
