Prepared for Exclusive Use by:

105 Bridge Ln
Smyrna GA 30082

2/8/2020

Capstone MHT Dev, Inc dba HouseMaster
1110 Seale Drive
Alpharetta, GA

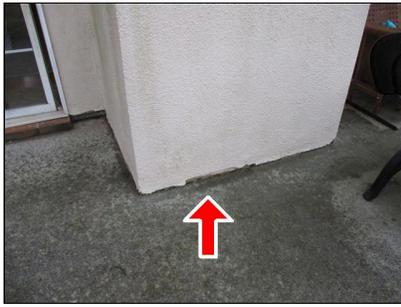
1.0(1) SIDING (Picture 1) Stucco/ ground contact

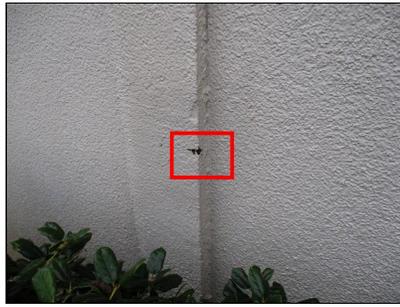
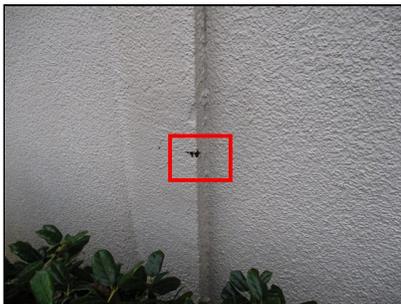
1.0(2) SIDING (Picture 1) Chip in stucco

1.0 (2) Noted settlement cracking and deterioration at stucco above sliding door (check for water penetration), below rear window and chip at front of home; repair as needed.

Chip in stucco

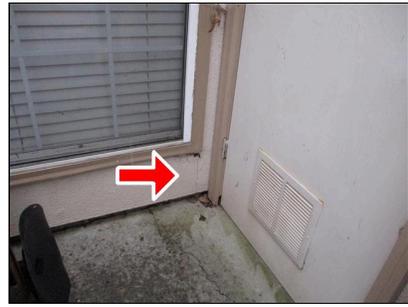
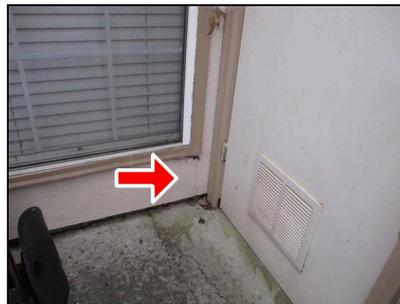
1.0(2) SIDING (Picture 2) Settlement

Settlement

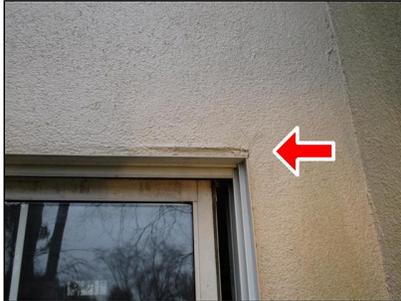
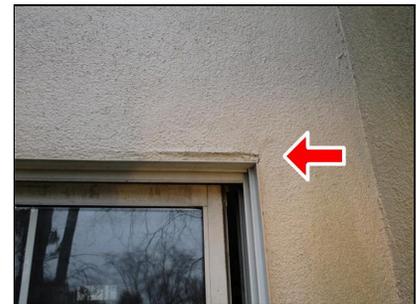
1.0(2) SIDING (Picture 3) Deterioration/water penetration

Deterioration/water penetration

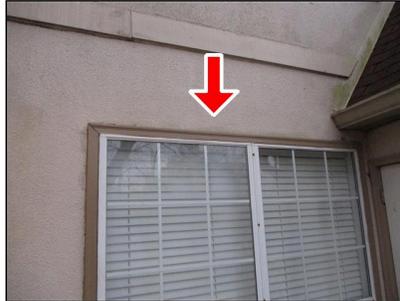
1.1(1) WINDOWS (Picture 1) No flashing

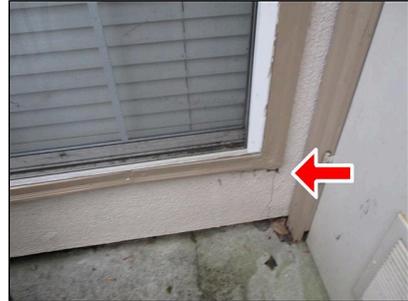
1.1(2) WINDOWS (Picture 1) Prior repairs

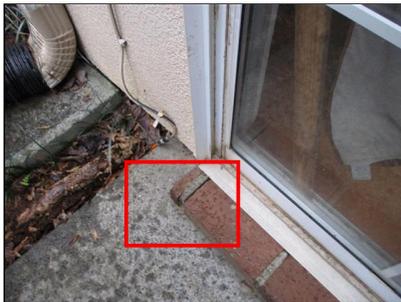
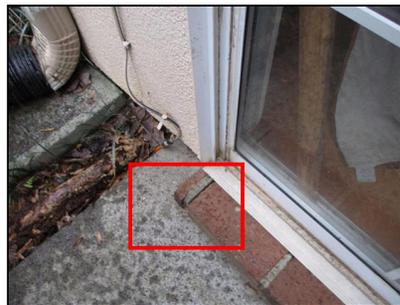
1.2(2) ENTRY DOORS (Picture 1) Loose brick

1.2 (2) Noted loose brick below sliding door; repair as needed.

Loose brick

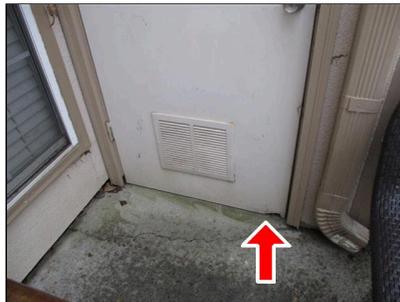
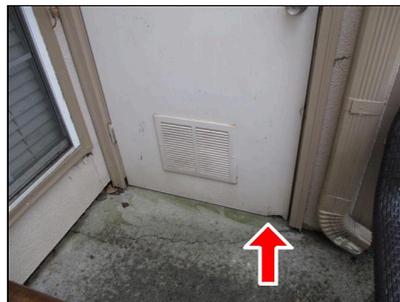
1.2(3) ENTRY DOORS (Picture 1) Deterioration

1.2 (3) Noted deterioration at storage door and trim; repair as needed.

Deterioration

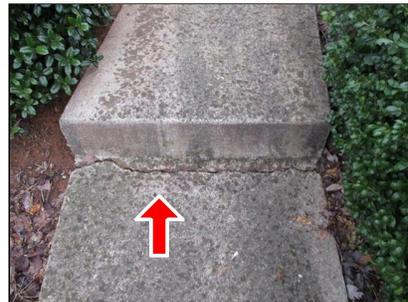
1.3 STAIRS / STOOPS (Picture 1) Settlement cracking

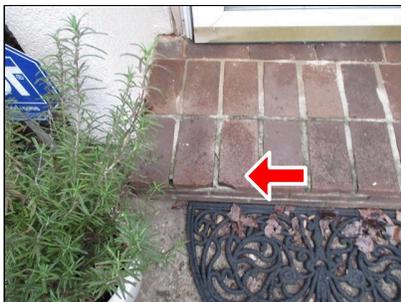
1.3 STAIRS / STOOPS (Picture 2) Settlement cracking

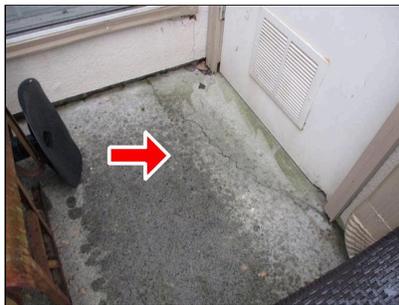
2.0 PATIO(S) (Picture 1)
Settlement cracking

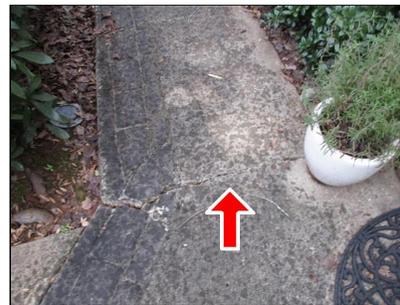
2.1 WALKWAYS (Picture 1)
Settlement cracking

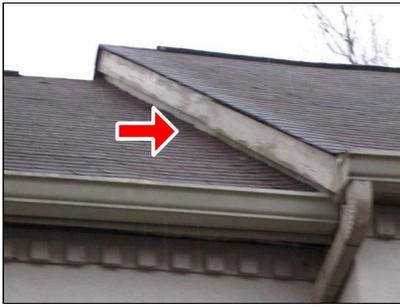
3.6(1) FASCIA / SOFFITS
(Picture 1) Paint as needed

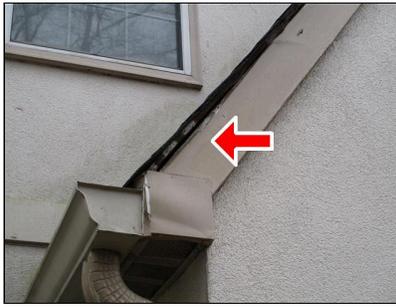
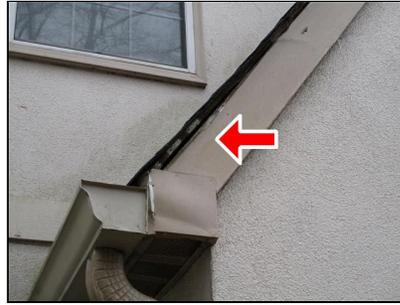
3.6(2) FASCIA / SOFFITS
(Picture 1) Separation

3.6 (2) Noted separation of fascia board and roof decking over storage room; repair as needed.

Separation

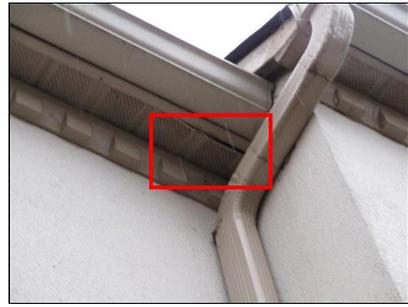
3.6(3) FASCIA / SOFFITS
(Picture 1) Loose soffit

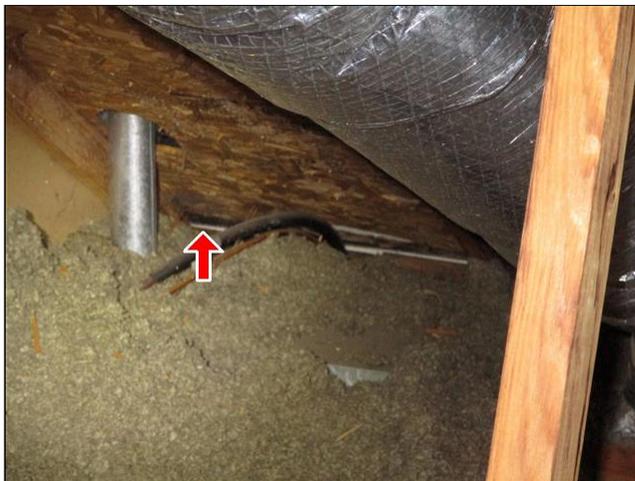
4.1(2) ROOF DECK / SHEATHING (Picture 1)
Deterioration

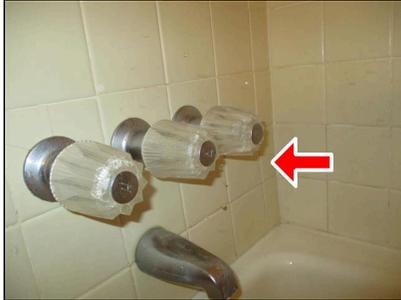
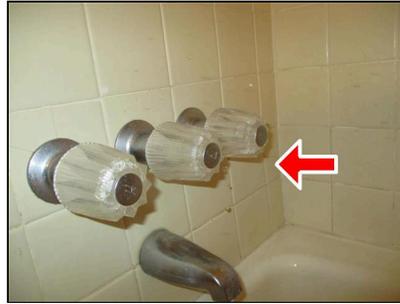
5.10 BATHTUB (Picture 1)
Leaking

Noted leaking at cold water valve; repair as needed.

5.10 (Picture 1) Leaking

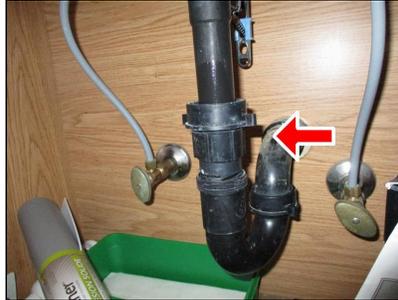
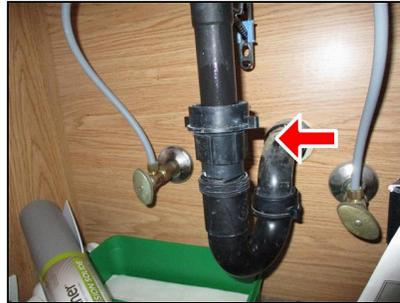
5.17 SINK(S) (Picture 1) Repair
drain

Noted sink drain is not installed properly at connections; repair as needed to prevent potential leakage.

5.17 (Picture 1) Repair drain

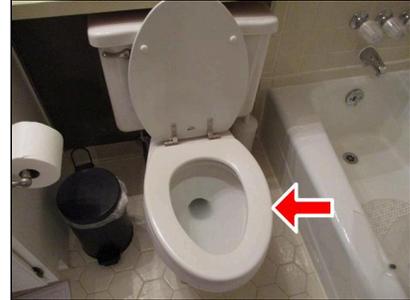
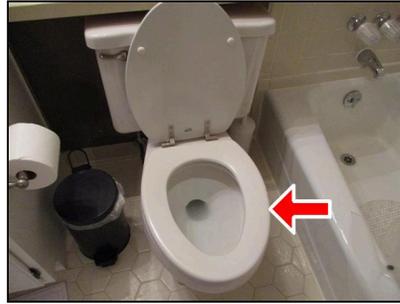
5.18 TOILET (Picture 1) Loose
toilet

Toilet is loose at the floor; check for leakage/damage and secure as required.

5.18 (Picture 1) Loose toilet

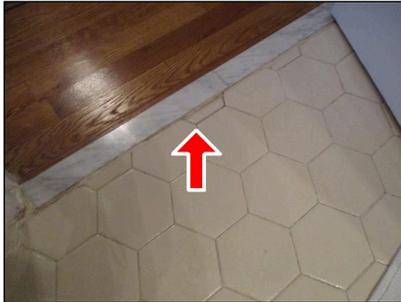
5.20 FLOOR(ING) (Picture 1)
Cracked grout

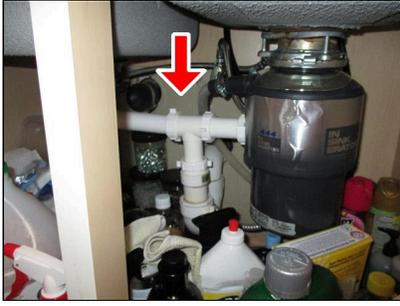
6.0 PLUMBING / SINK (Picture 1)
Monitor drain

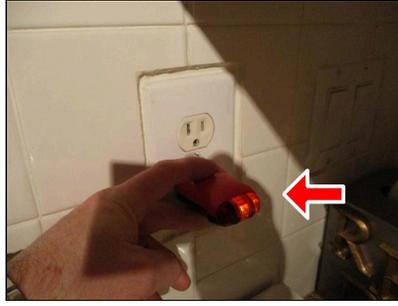
6.3 ELECTRIC / GFCI (Picture 1)
No GFCI protection

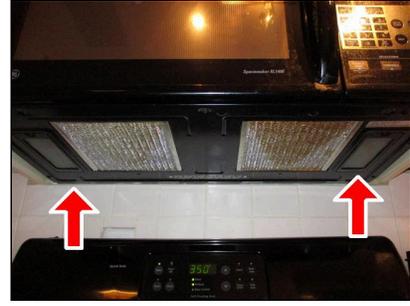
6.8 MICROWAVE (Picture 1)
Bulbs out

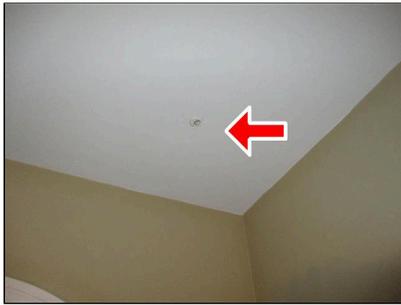
7.0(2) CEILINGS (Picture 1) Hole in ceiling

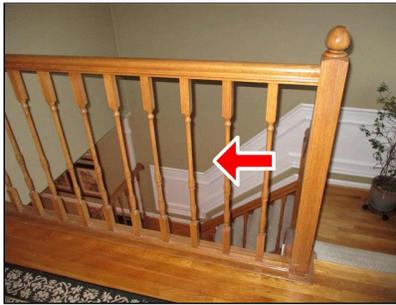
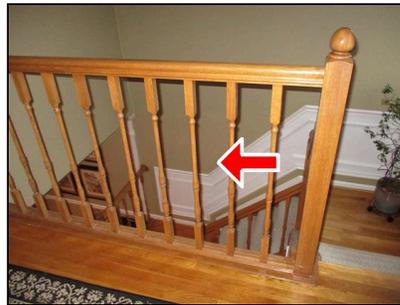
7.5 RAILINGS (Picture 1) Irregular spacing

Irregular baluster spacing noted; today's standard is a maximum of 4 inches; repair as needed for safety.

7.5 (Picture 1) Irregular spacing

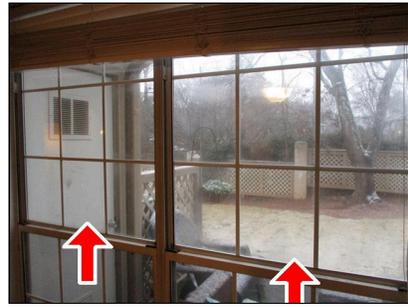
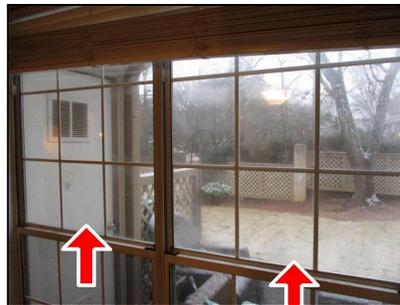
7.6(2) REPRESENTATIVE WINDOWS (Picture 1) Possible lost seals

7.6 (2) Note of possible lost window seals; recommend cleaning all windows and check for lost seal, repair as needed. Replacement of insulated glass windows or doors is usually required to correct failed or defective vacuum seals. Fortunately, the insulation value is usually not significantly reduced. Replacement time frame may be discretionary; however, conditions will gradually worsen with time.

Possible lost seals

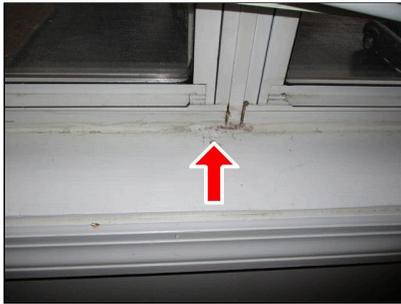
7.6(3) REPRESENTATIVE WINDOWS (Picture 1) Deterioration

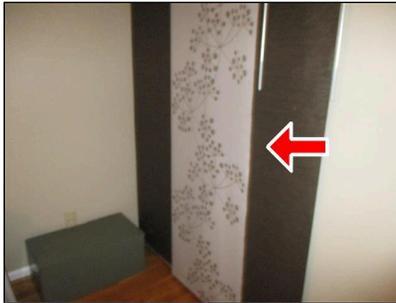
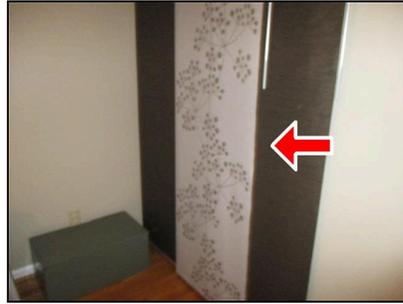
7.7 INTERIOR ROOM DOORS (Picture 1) Doors removed

Noted closet doors have been removed in guest room; repair as needed or desired.

7.7 (Picture 1) Doors removed

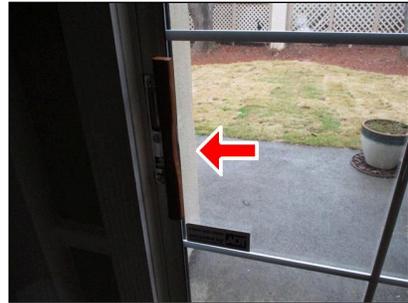
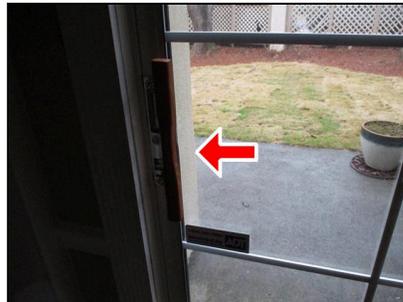
7.8 SLIDER/PATIO DOORS (Picture 1) Lock does not work

Noted slider door does not lock; repair as needed for safety.

7.8 (Picture 1) Lock does not work

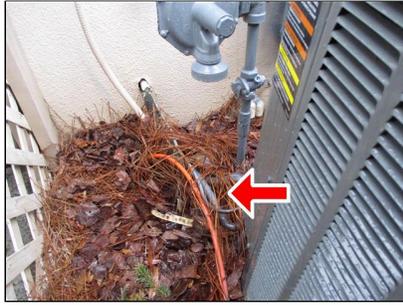
9.2(2) OUTDOOR UNIT - 1
(Picture 1) Insulate tubing

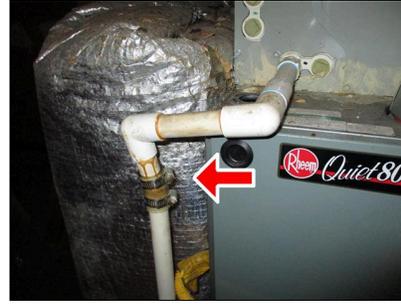
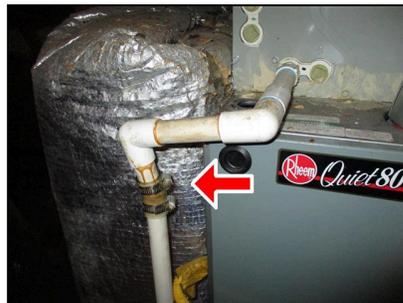
9.4 CONDENSATE PROVISIONS
- 1 (Picture 1) No air gap/clamp at
line

Noted missing moisture cutoff switch and no air gap at the condensate line. Also noted clamps at condensate connection; repair as needed.

9.4 (Picture 1) No air gap/clamp at line

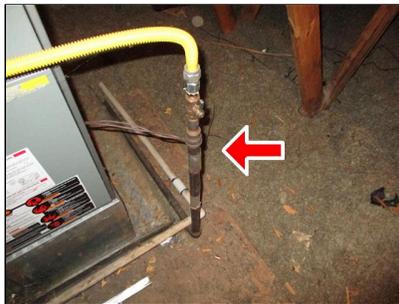
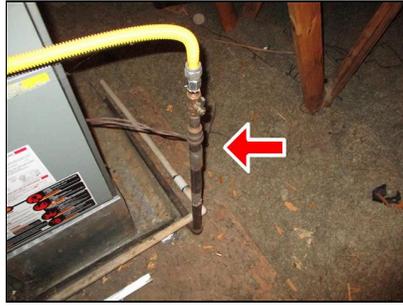
10.3 FUEL LINE AT UNIT
(Picture 1) No sediment trap

The use of flex tubing or copper piping is unacceptable in this area; also no sediment trap is present; recommend installation be checked by a licensed plumber or qualified mechanical contractor and repaired as needed.

10.3 (Picture 1) No sediment trap

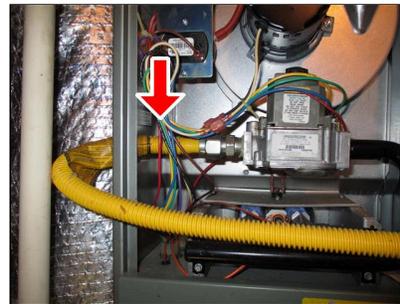
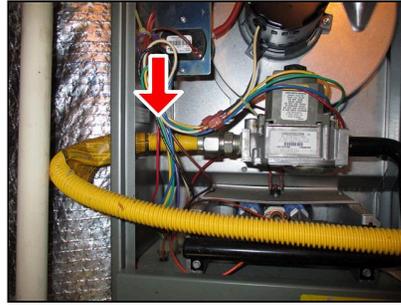
10.3 FUEL LINE AT UNIT
(Picture 2) Flex piping

10.3 (Picture 2) Flex piping

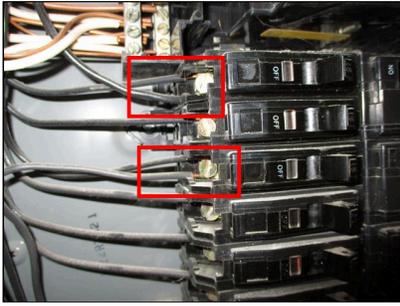
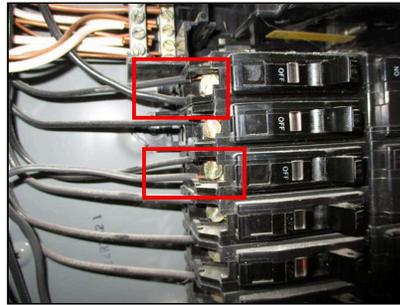
11.3(1) DISTRIBUTION PANEL
(Picture 1) Doubled circuits

11.3 (1) Doubled circuits noted. Generally, only one conductor (wire) should be connected at any fuse, breaker or panel lug. If the panel is near/at capacity, an upgrade may be necessary to correct this condition. Recommend consulting a qualified electrician for remedial needs and costs prior to closing.

Doubled circuits

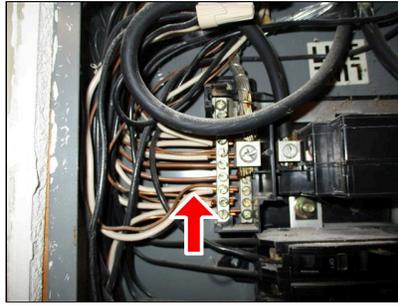
11.3(2) DISTRIBUTION PANEL
(Picture 1) Doubled neutrals

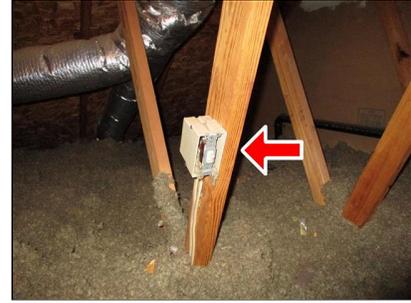
11.4(2) REPRESENTATIVE
DEVICES (Picture 1) Missing
cover

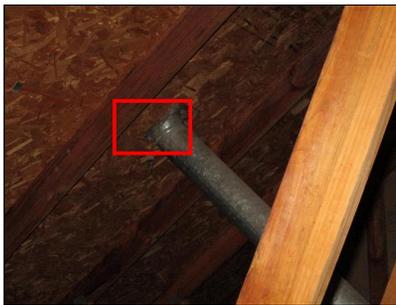
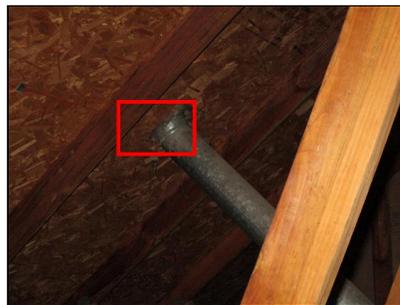
12.3 DRYER VENT (Picture 1)
Check/clean vent

Recommend checking dryer vent tubing and cleaning for safety prior to moving in. Noted some lint built up at attic/roof area.

12.3 (Picture 1) Check/clean vent

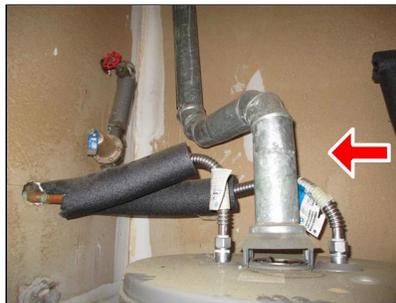
13.1 WATER HEATER (Picture 1)
No expansion tank
