Inspection Report

4502 Chartley Cir

Roswell, GA 30075

Wednesday, February 19, 2020

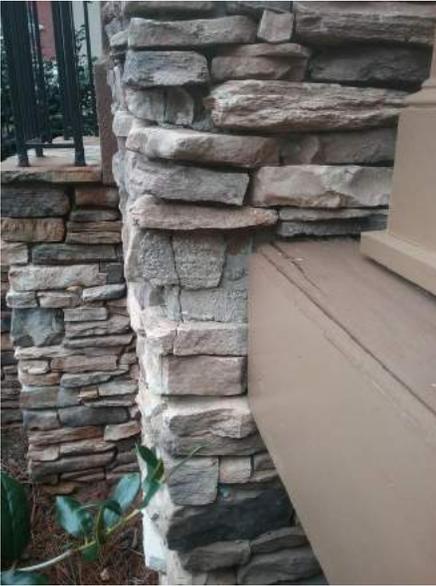
29: Broken or missing pieces noted.

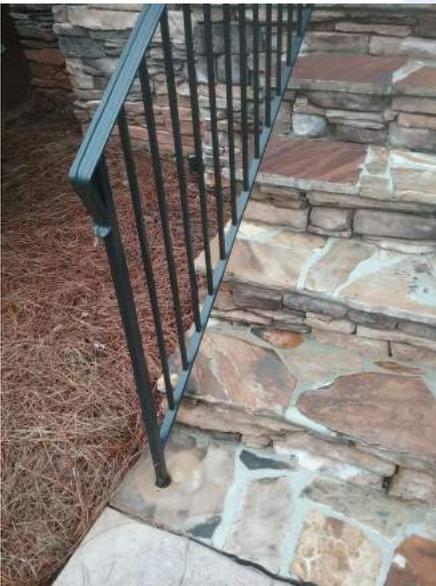
34: Loose railing noted. Repairs are recommended.

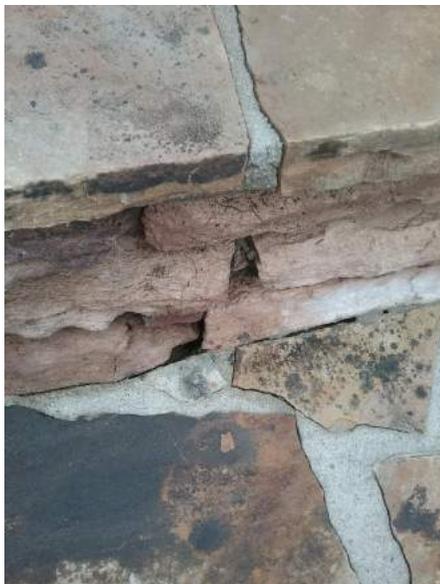
35: Recommend repointing mortar joints

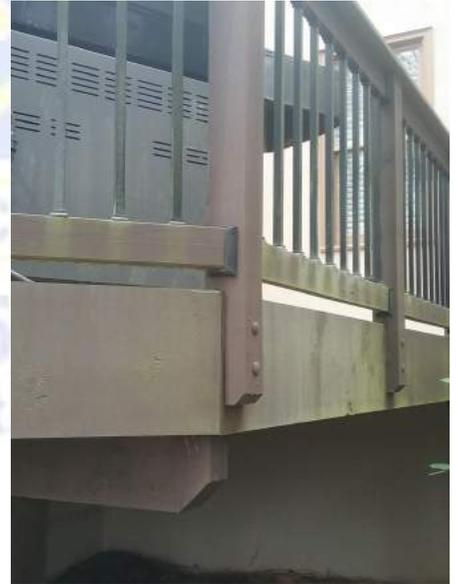
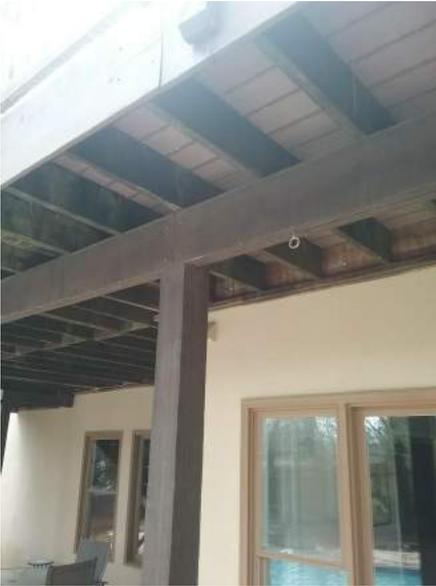
39: The deck was observed to have several deficiencies including but not limited to improper attachment over siding, no visible flashing at the house junction, lag bolts primarily attaching deck to house, improperly notched 4x4 guardrail support posts, loose guard rails, loose hand railings and missing lateral bracing on the support posts in need of further evaluation and repairs by a licensed deck contractor.

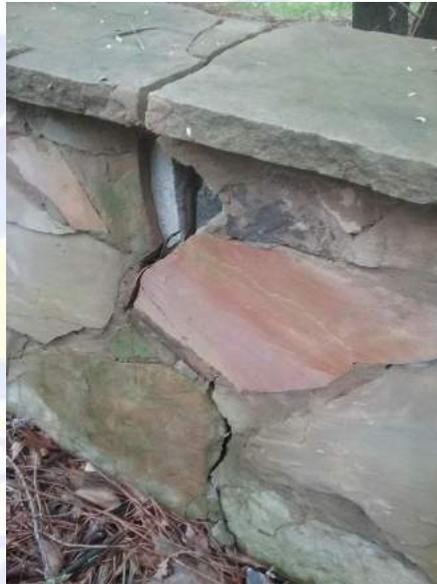
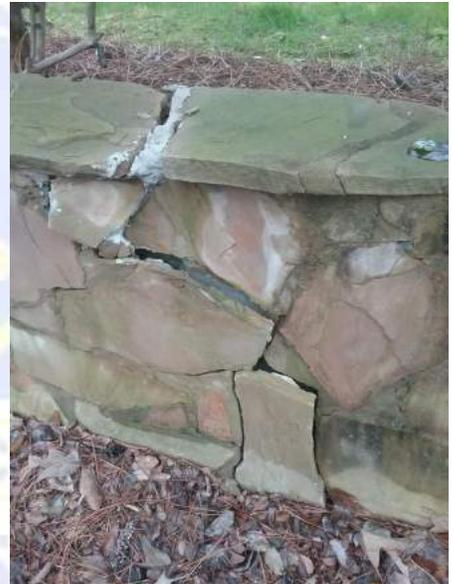
43: Settlement displacement/Cracks noted. Monitor in future years and budget to replace depending on the movement over the next few years.

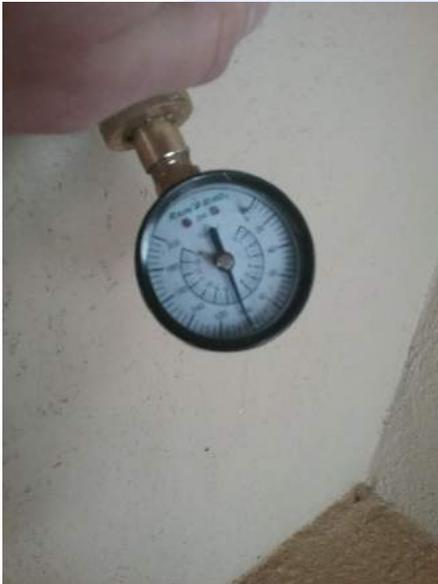
57: Elevated water pressure was observed to be above the acceptable range of 40 - 80 psi when tested. Elevated water pressure will put excessive stress on supply pipes and fixtures that will eventually cause water leaks. Water pressure can be adjusted at the water pressure regulator and regulators are a replaceable item that will eventually require replacement.

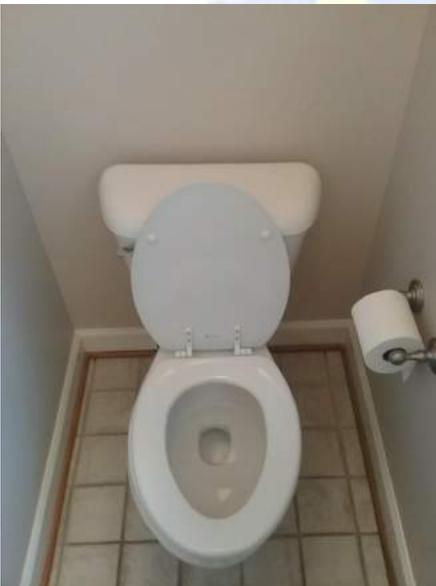
81: The commode is loose and needs to have the wax ring replaced at this time to prevent leaks visible and/or hidden. While this is generally not an expensive repair, it can be if the flange is cracked or broken.

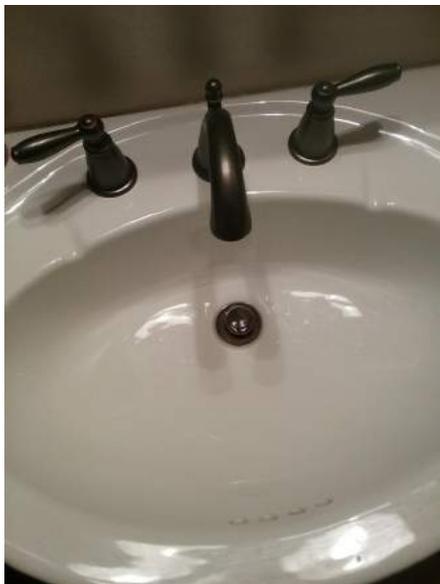
82: Stopper did not operate properly or is missing parts.

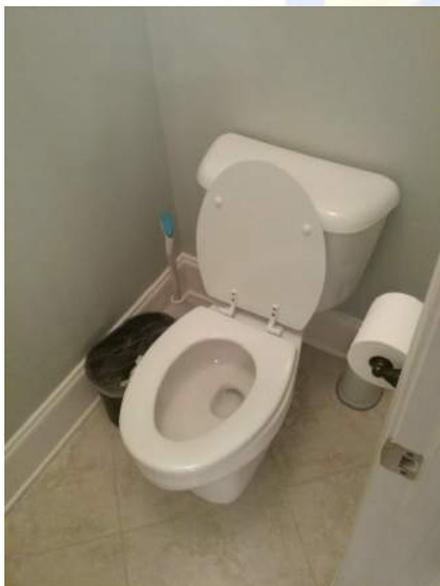
83: The toilet is loose and needs to have the wax ring replaced at this time to prevent leaks visible and/or hidden. While this is generally not an expensive repair, it can be if the flange is cracked or broken.

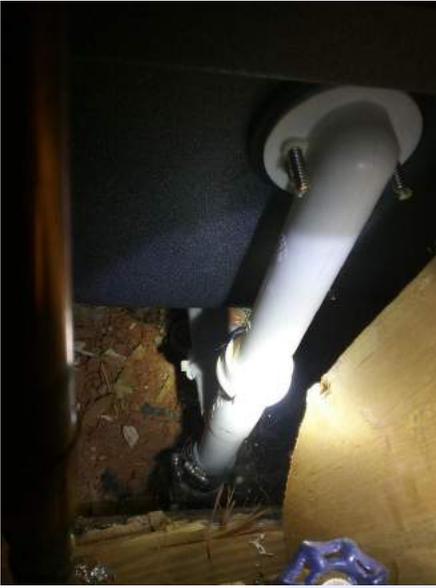
87: No P-trap visible at basement tub

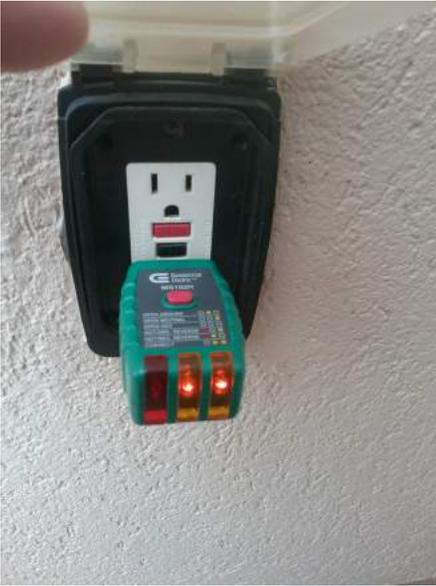
122: GFCI outlet defective and not tripping/resetting at the front door and rear patio

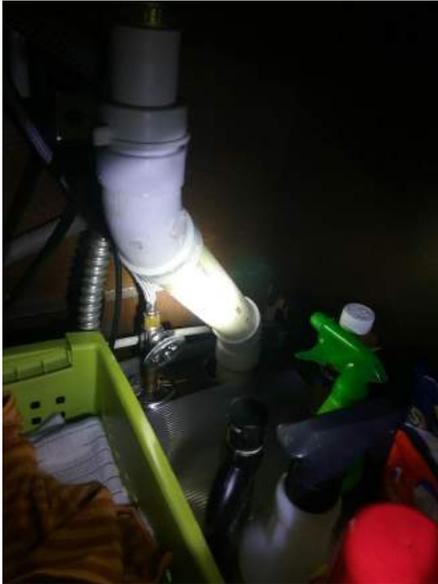
134: The dishwasher drain line is incorrectly installed. It should extend as high as possible under the counter to prevent grey water from entering the dishwasher in the event of a backup in the sink. Incorrect installation is a common problem that is easily corrected.

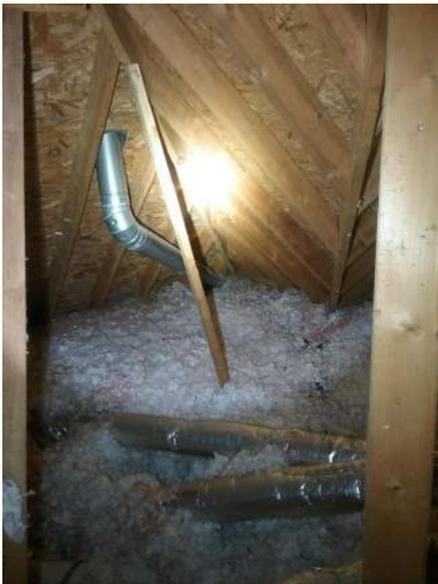
173: Inadequate clearance from insulation to a flue pipe noted in right side of attic

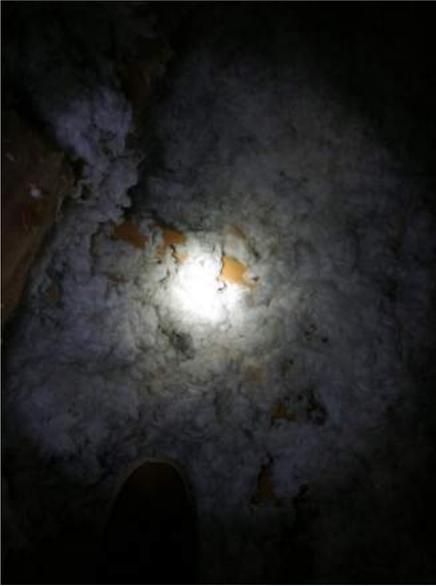
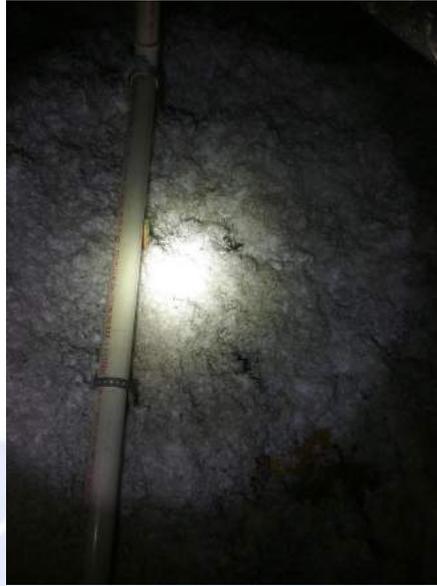
174: Wildlife nesting materials/ dive holes/ wildlife trails in the insulation were observed in the attic. Recommend removal. Wildlife in the attic can do substantial damage by chewing on wires and plastic ductwork.
